# PROPERTY CONDITION ASSESSMENT

MAINE SCHOOL OF SCIENCE & MATHEMATICS DORMITORY  
77 HIGH STREET  
LIMESTONE, MAINE

ECS PROJECT NO. 50:1008

JANUARY 20, 2019

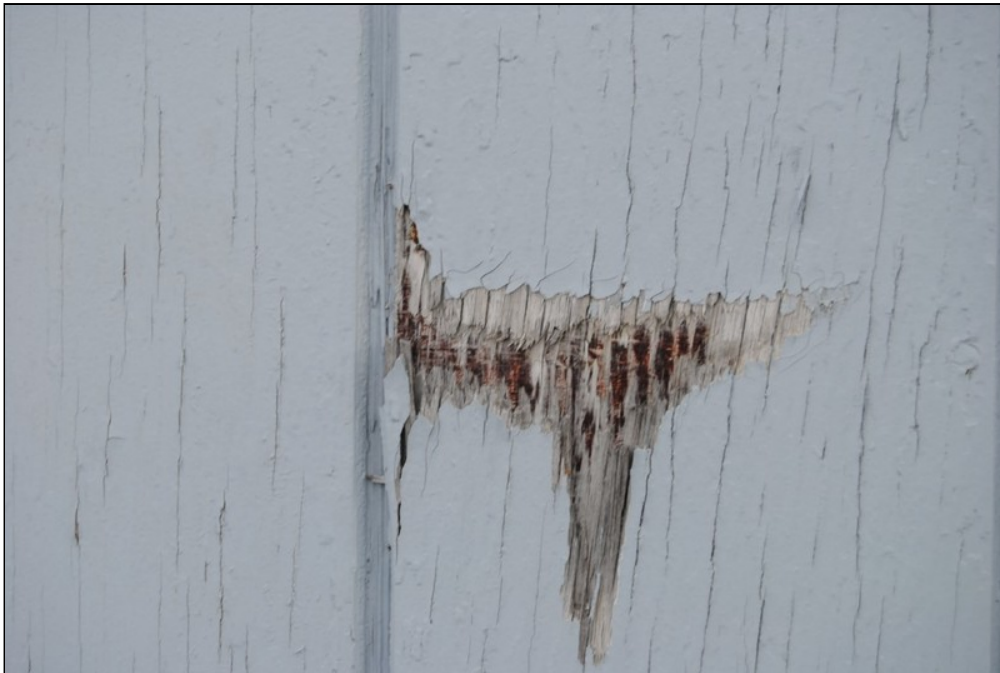
The primary exterior of the building consists of wood siding. The wood siding is showing signs of failure and is presently planned to be replaced. vinyl siding was observed at the gymnasium and was newly installed. Brick veneer was observed on A-wing. The brick veneer showed some sign of distress. The expected useful life of mortared joints is approximately 20 years before re-pointing is required. Deterioration of mortar joints was observed. ECS recommends re-pointing of the deteriorated mortar joints.

2 - deteriorating siding

Cost Recommendation	EUL	EFF AGE	RUL	Year	Cost
REPLACE WOOD SIDING WITH VINYL	25	23	2	2	\$18,000
				3	\$18,000
				4	\$18,000
				5	\$18,000
				6	\$18,000
				Total

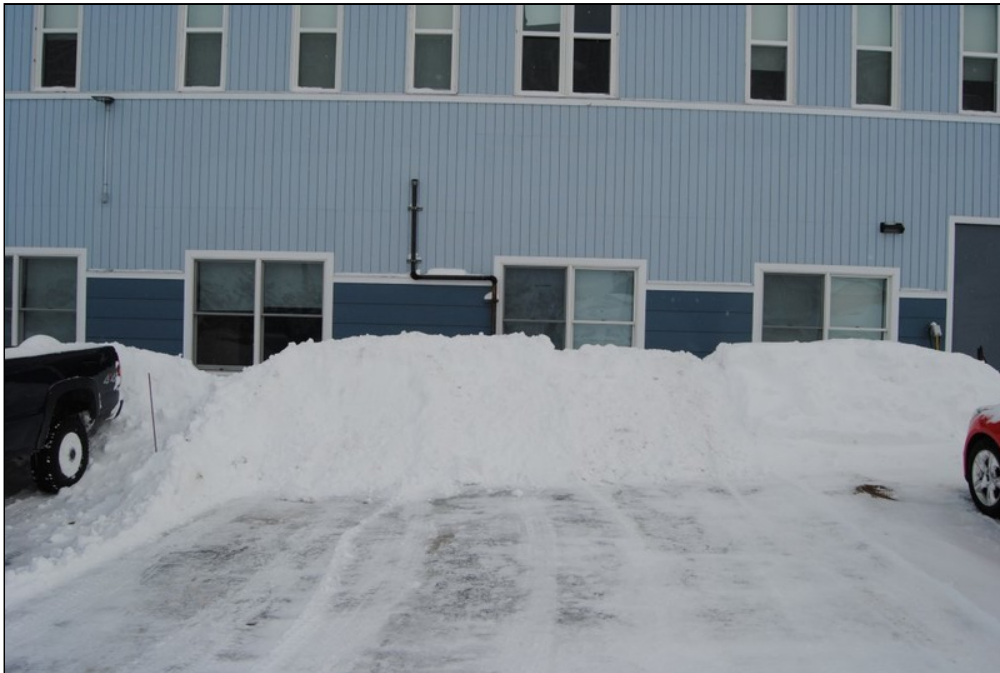
Asphalt pavement is located throughout the Property the A-wing sides of the buildings. The asphalt pavement was observed to be in generally fair condition with areas of cracked pavement and patched areas observed. The expected useful life of asphalt pavement is 20 years. We recommend repairing these areas of asphalt pavement and providing an allowance to seal and stripe the asphalt pavement.

4 - asphalt

Cost Recommendation	EUL	EFF AGE	RUL	Year	Cost
SEAL COAT ASPHALT PAVEMENT	7	1	6	8	\$19,550
PROVIDE PARTIAL DEPTH REPAIRS	20	13	7	2 5	\$2,500 \$2,500
Total					\$24,550

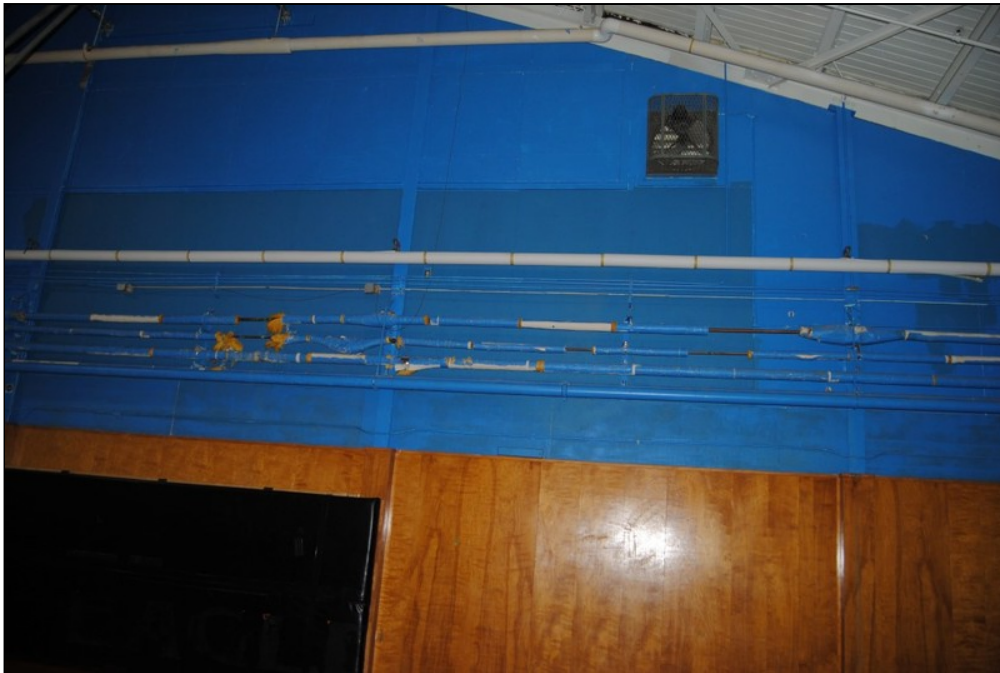
54 - damaged pipe insulation

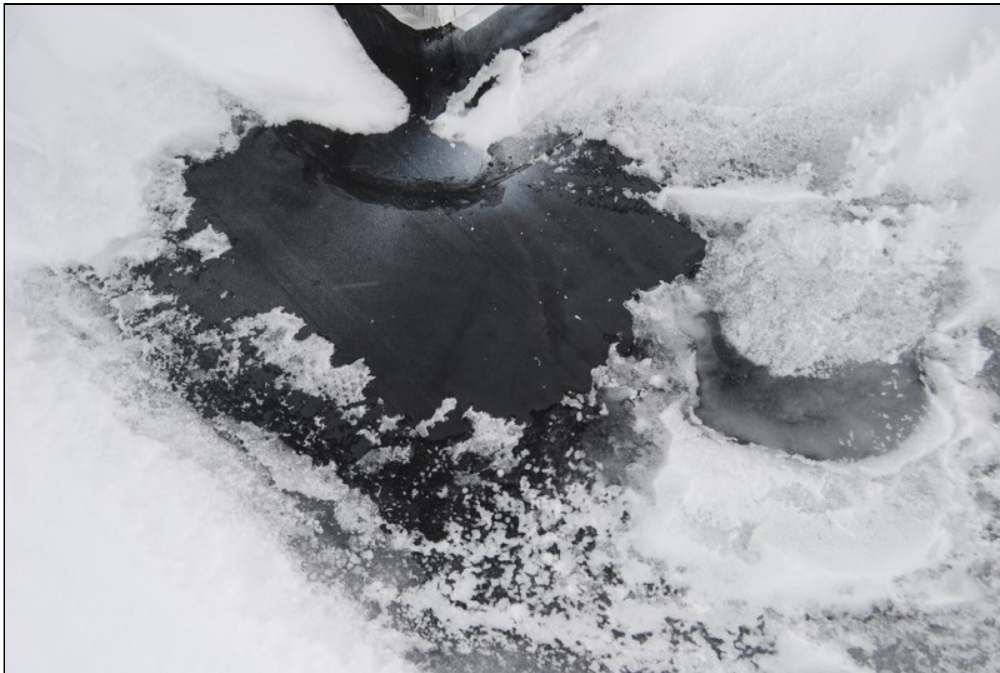
62 - membrane

3.3.6 Roofing Systems																			
REPLACE SINGLE-PLY ROOFING SYSTEM	15	15	0	380	Square	\$600.00	\$228,000	100%					\$114,000			\$114,000			\$228,000

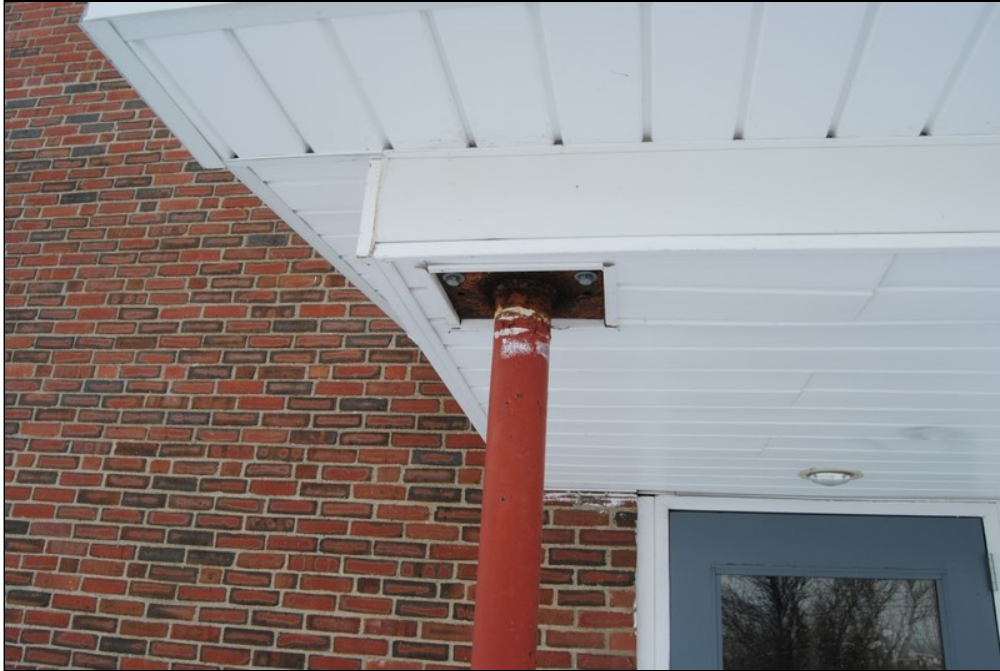
The wood trim and exterior framing are painted. The paint was peeling. Rust was observed on the exterior steel framing. Painting of exterior components is typically recommended every 5 to 7 years. ECS recommends the wood trim be painted. ECS recommends the steel framing be cleaned and painted.

67 - steel support

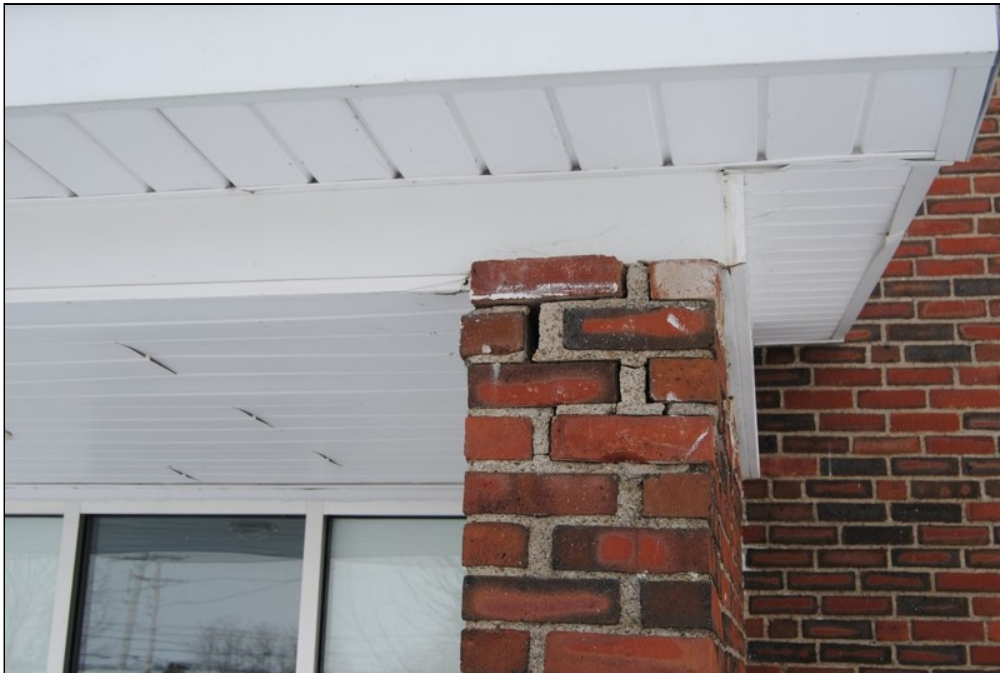
68 - deteriorated brick on pilaster

Cost Recommendation	EUL	EFF AGE	RUL	Year	Cost
REPOINT BRICKWORK	20	20	0	1	\$4,500

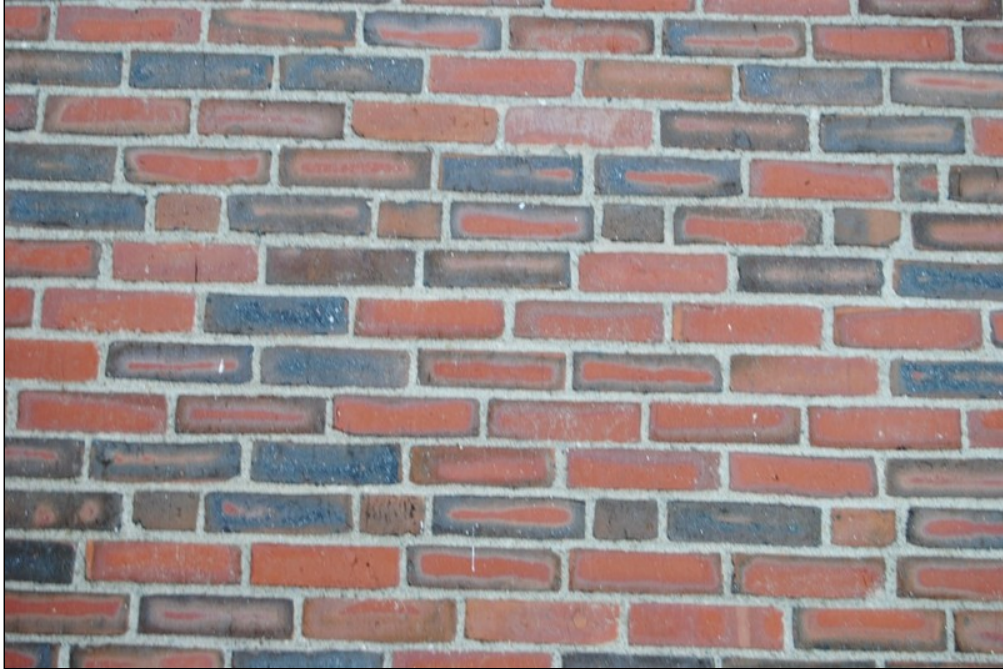
69 - mortar joints
