ELKHART LAKE - GLENBEULAH SCHOOL DISTRICT

DRAFT MASTER PLAN—FACILITIES ASSESSMENT REPORT

PRA Project No. 220066 | February 20, 2023

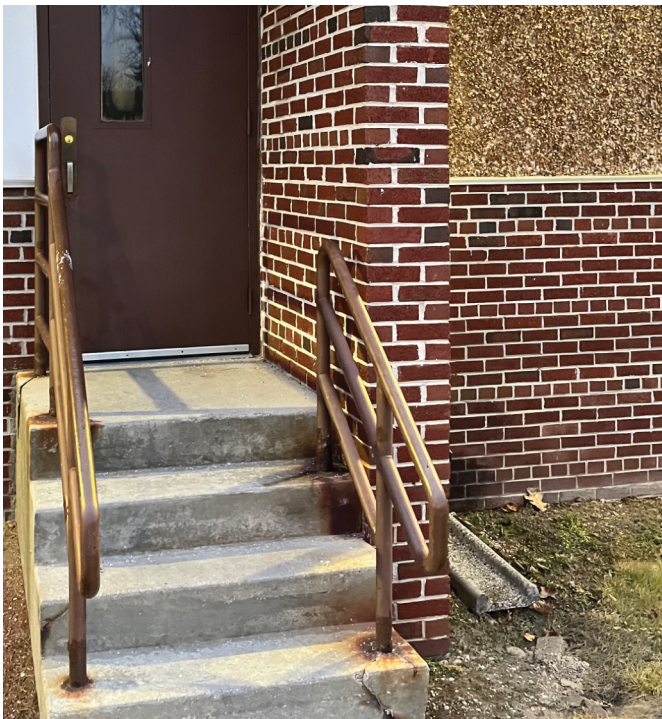
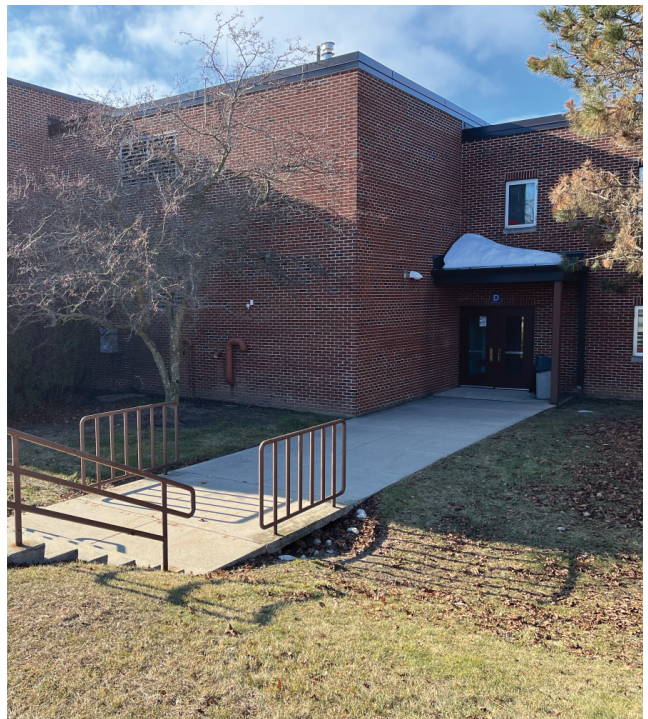
Updates to the exterior of the building have been made in the past when necessary. A few deficiencies are present with sidewalks, asphalt, and landscaping. Areas of the building materials are deteriorating around the perimeter.

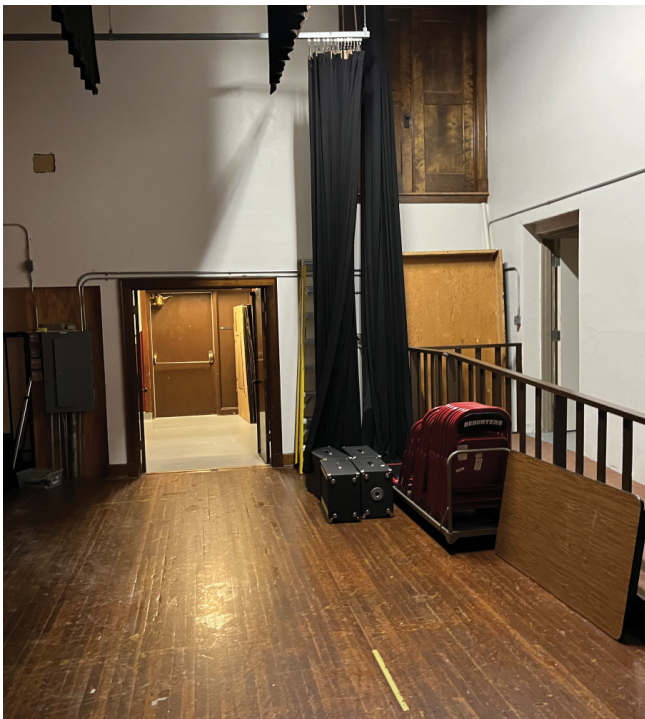
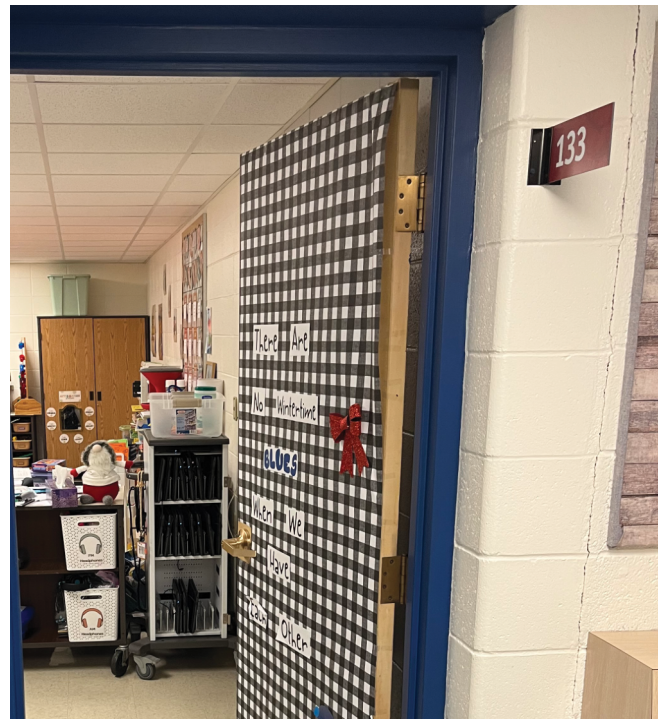
In general, the materials within the interior of the building, are worn and aging; cabinetry, ceilings, and doors/frames especially. Flooring materials in many areas are in good condition.

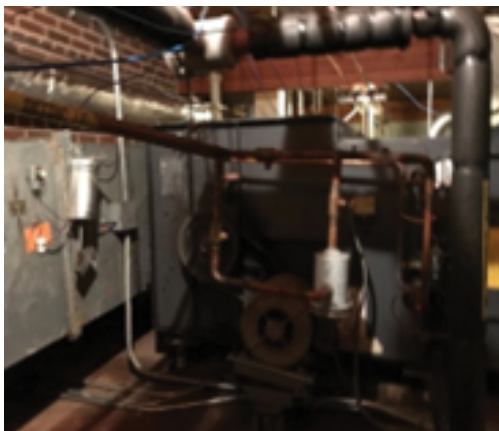
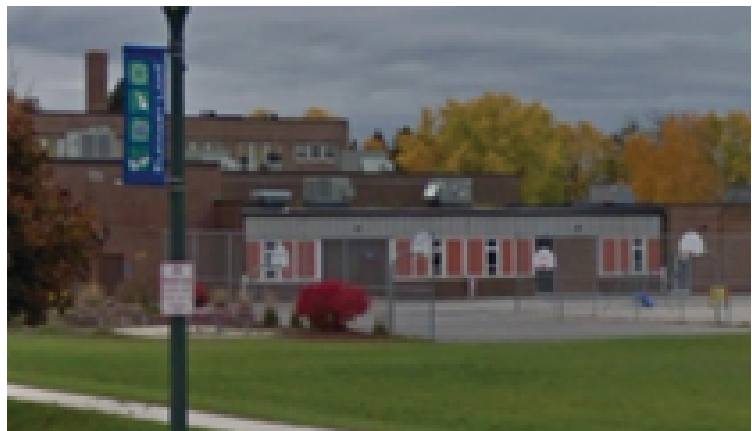
Indoor air handling units No. 1 & 2 were added through the 1989 building addition and renovation project. These units provide heating and ventilation only. All control devices for these units are pneumatic. These units have been well maintained and are in fair operating condition after 30+ years of service.

Air handling unit No.3 provides heating, ventilation and air conditioning to a portion of the 1989 building renovation project. All control devices at this unit are pneumatic. This unit is accessible only through removal of ceiling tile. Facility operating staff indicated that frequent service and repairs are required for this equipment.

The ductwork distribution systems connected to the facility air handling systems are constructed of sheet metal. Ductwork joints, seams and connections are not all sealed properly causing conditioned air leakage into the ceiling cavity.

Remove and replace all pneumatic controls with direct digital control equipment and devices wired into the building automation system.

Remove and replace existing indoor air handling unit No.3 and the connected roof mounted air cooled compressor condensing unit located on roof above as part of any upcoming facility renovation or equipment upgrade project.

Existing HVAC system distribution ductwork should be sealed and insulated to present code requirements during the time of equipment replacement.

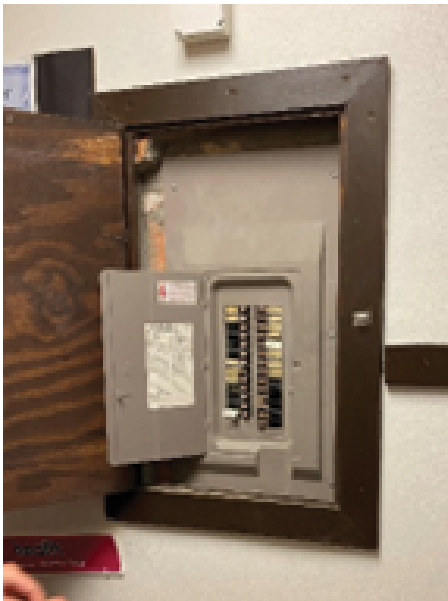
There are numerous age classes of panelboards throughout the facility with the majority of them being Square D NQOD type panelboards. These panelboards date to the 1989 building improvement project. These panels appear to be in fair condition.

There are also Square D NQ type panelboards that were recently installed, in general have room for additional breakers and are in good condition.

The Cutler Hammer Loadcenters and Square D NQOD type panelboards are nearing the end of their useful lives and should be replaced based on their age and condition.

Provide new replacement panelboards in each of these locations.

The Square D NQ type panelboards are in good condition and can remain. Add to the existing panelboards as necessary.

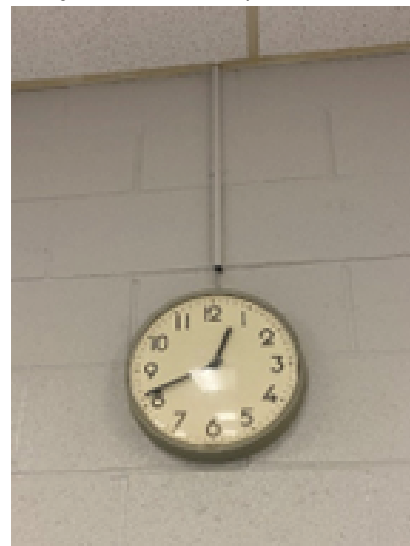
The existing clock system contains numerous, old 24V Franklin clocks throughout the facility. Staff indicated that the existing 24V clock system is failing.

We recommend replacing the existing clock system with a new wireless master clock system with a GPS receiver or an IP based master clock system.

Replace all hard wired synchronized clocks with battery or 120 volt powered GPS clocks.

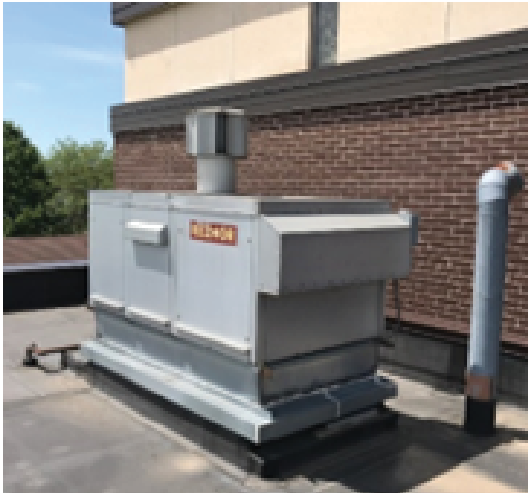
Heating and ventilation is provided to the facility locker rooms and storage spaces East of the gymnasium through a roof mounted make-up air unit manufactured by Reznor. This make-up air unit has exceeded the anticipated service life for equipment of this type.

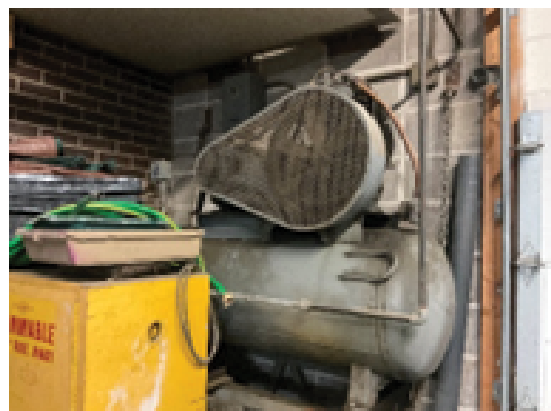
Compressed air system supplying technical education shop area's equipment and work stations. The piping system material is black iron steel. The piping system is in fair condition. The air compressor has exceeded its expected service life.

Any future renovations shall account for the resizing of the compressed air piping mains and air compressor to provide adequate pressure and flow to any new and existing equipment. fixtures where possible in toilet rooms.
