# **INFRARED ROOF INSPECTION**

LOCATION:  
STAPLES HIGH SCHOOL  
70 NORTH AVE  
WESTPORT CT 06880

This report summarizes the findings of our Infrared Roof Moisture Analysis of the roof at Staples High School, Westport, CT, performed on November 7, 2020.

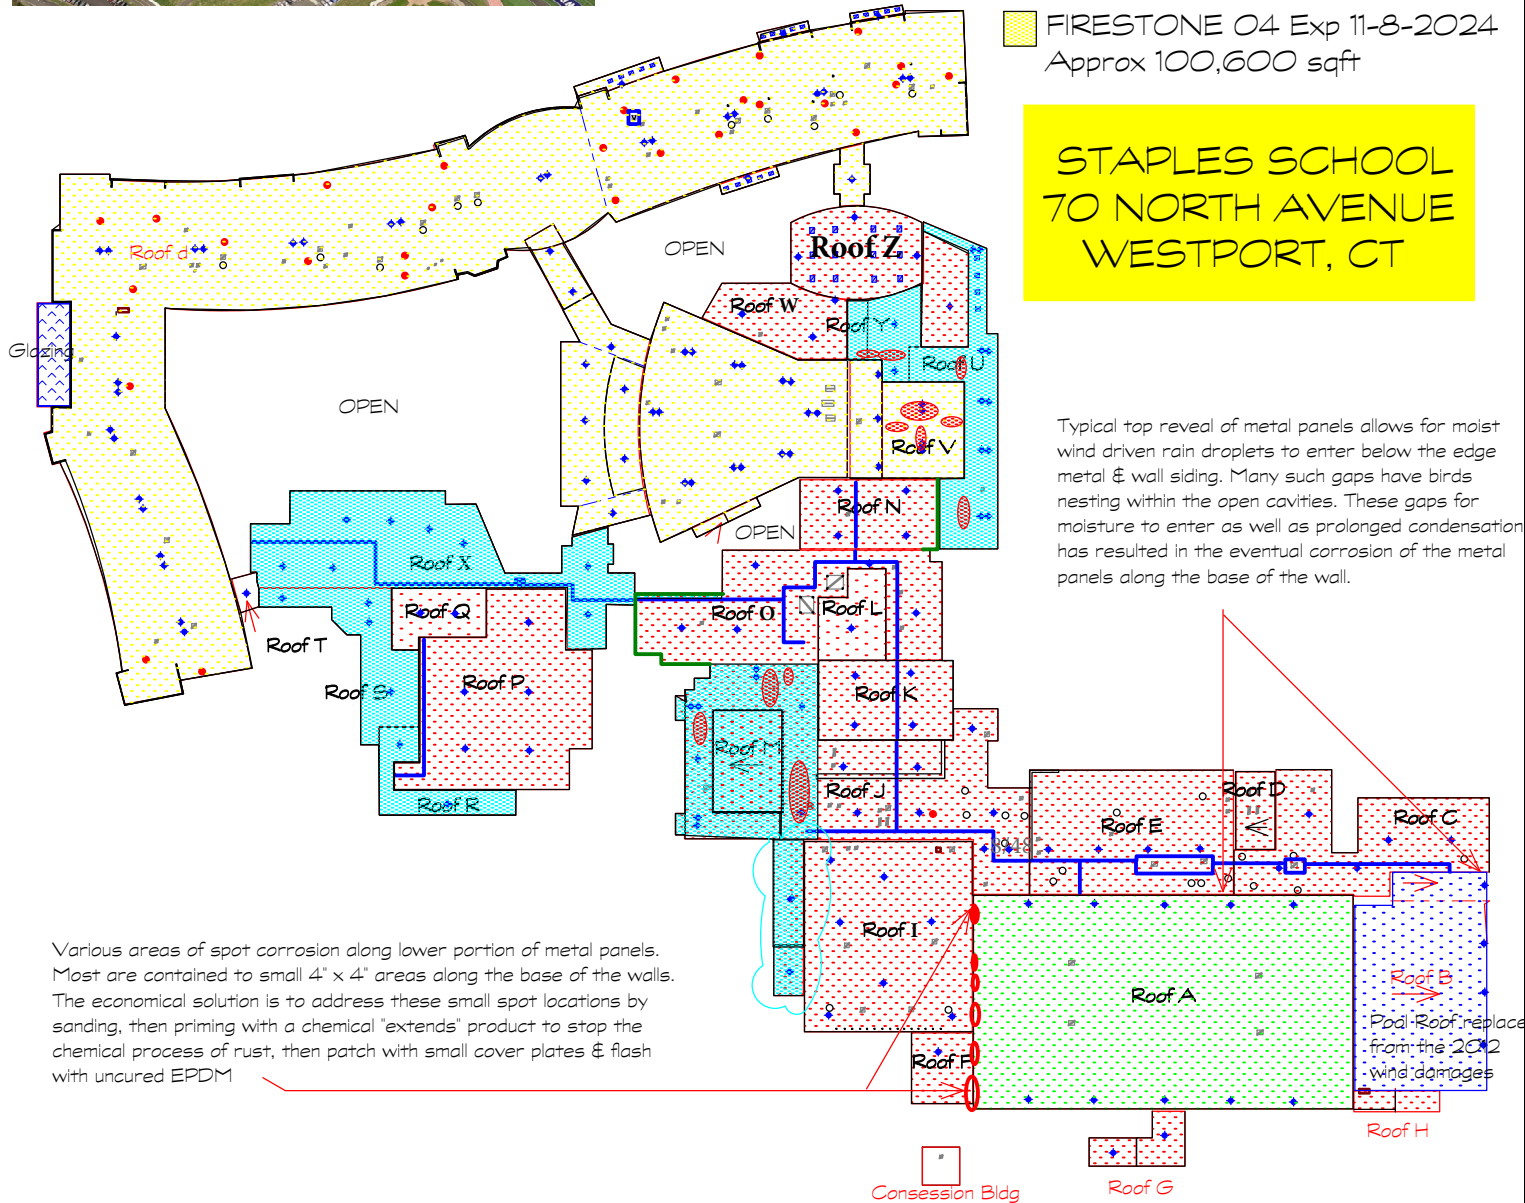
Typical top reveal of metal panels allows for moist wind driven rain droplets to enter below the edge metal & wall siding. Many such gaps have birds nesting within the open cavities. These gaps for moisture to enter as well as prolonged condensation has resulted in the eventual corrosion of the metal panels along the base of the wall.

Various areas of spot corrosion along lower portion of metal panels. Most are contained to small 4" x 4" areas along the base of the walls. The economical solution is to address these small spot locations by sanding, then priming with a chemical "extends" product to stop the chemical process of rust, then patch with small cover plates & flash with uncured EPDM

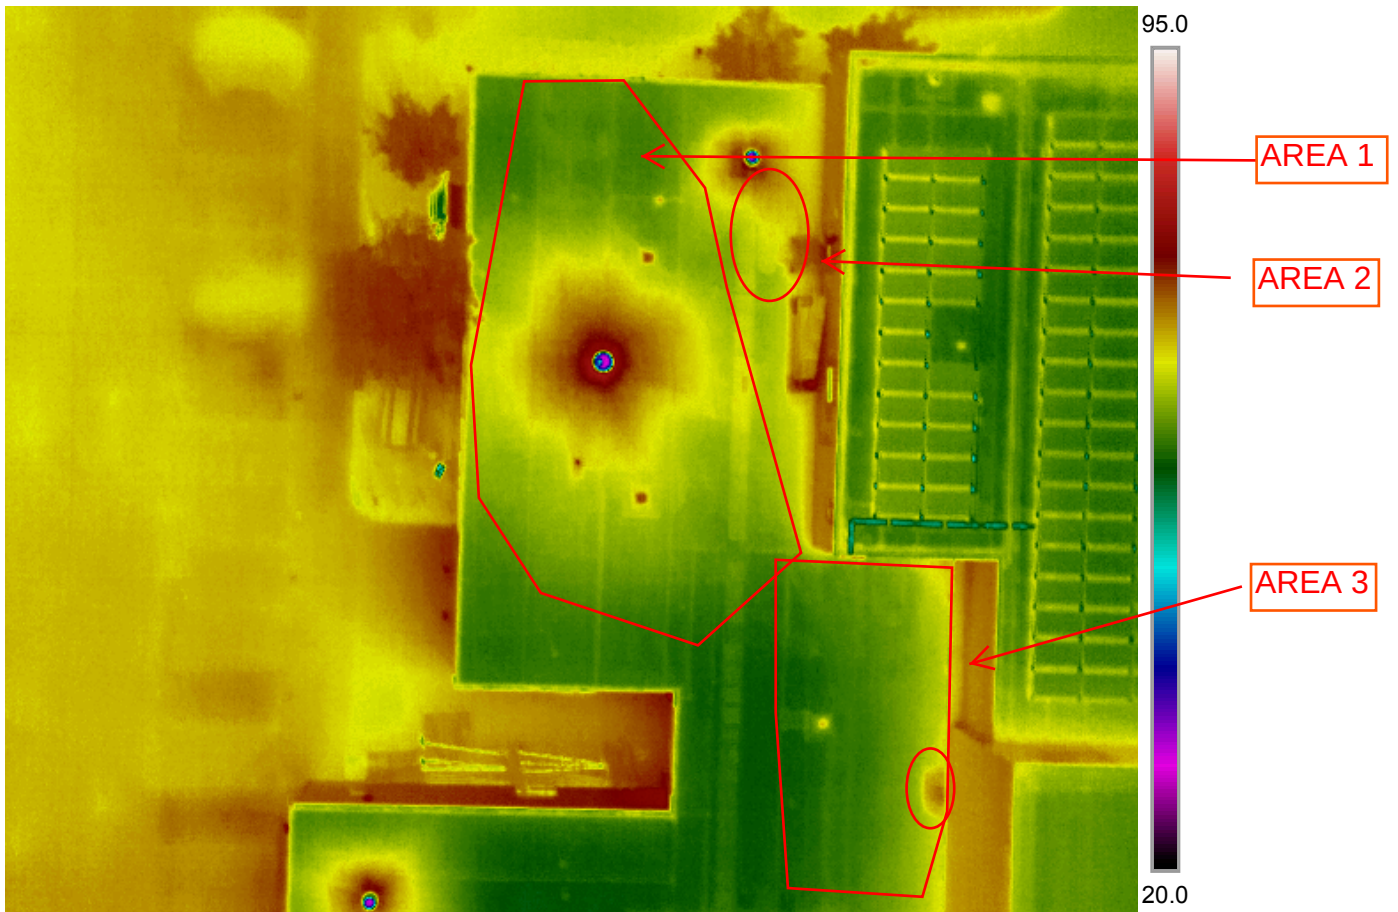
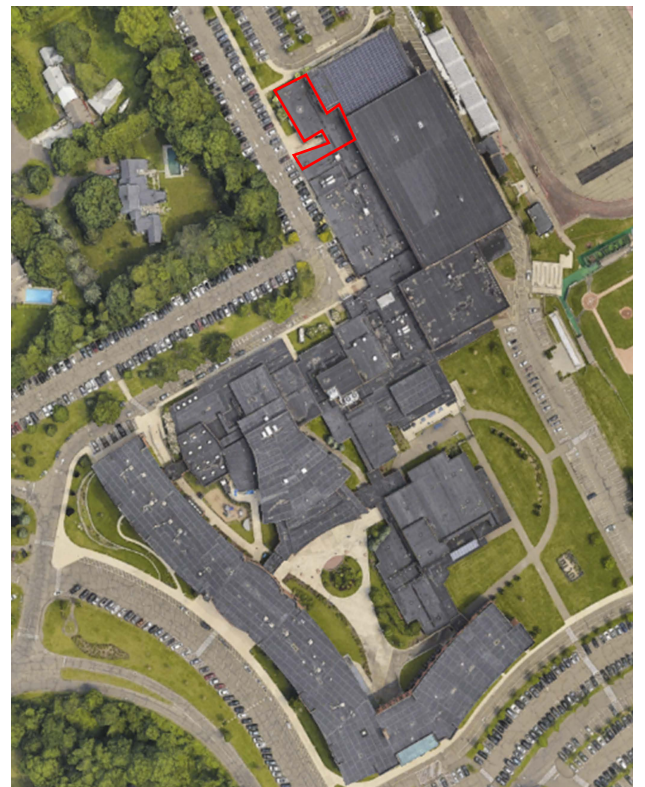
### Roof C

Area 1 ~ 1751 sqft. This area appears to have a significant amount of possible standing water or residue near and around the drain.

Area 2 ~ 97 sqft. There appears to be heat coming from a patch near the walk way pads as well as residual standing water around the drain and wall.

Area 3 ~ 916 sqft. The area along the Eastern wall and over to the walk way pads shows traces of heat and possible moisture.

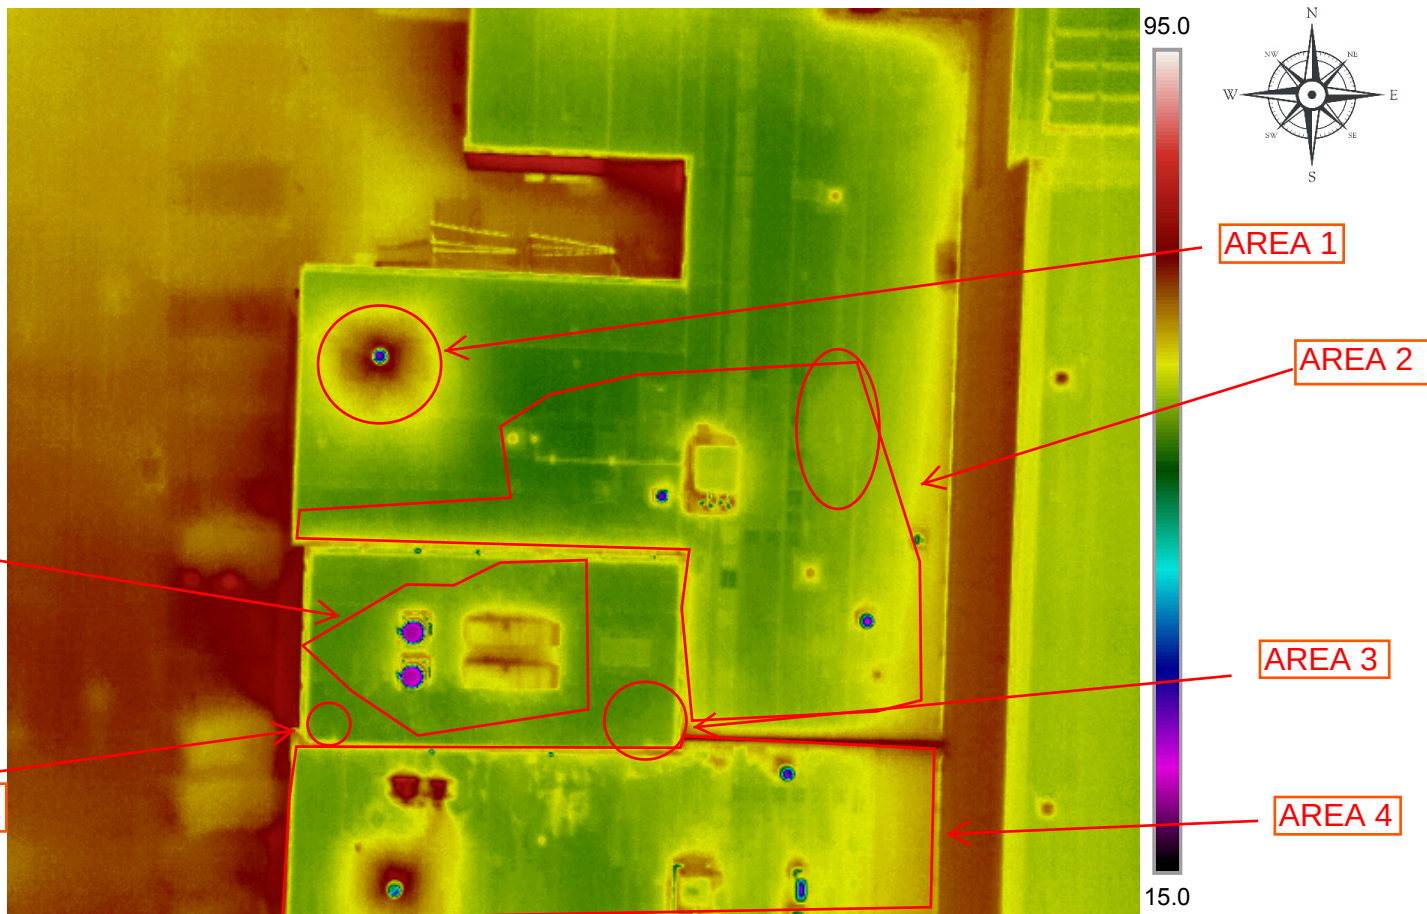
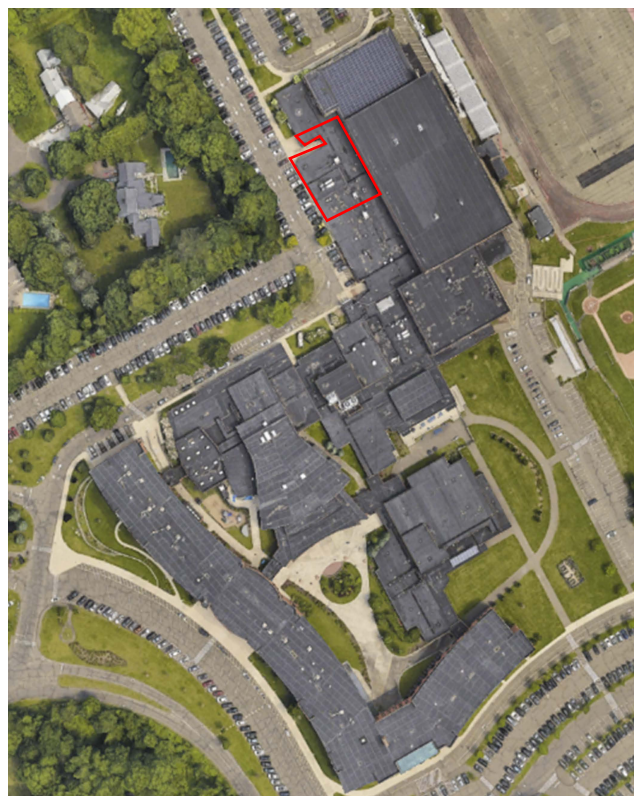
### Roof C, D, E

AREA 1 ~ 200 sqft. Area revolves around a possible drain or unit which will emit heat. Appears there may be some ponding water or residual moisture left.

Area 2 ~ 2126 sqft. Large area including the areas around the unit, stretching from the edge of the south, east and west portions of the area. Also the large oval shaped area East of the walk pads is called out.

Area 3 ~ 42 sqft. Small south eastern corner of this section Area 4 ~ 2422 sqft. Large area. Almost the entire portion of this section appears to have some sort of heat/possible moisture showing between many small sections and some larger areas. Area 5 ~ 30 sqft. Small SW corner.

Area 6 ~ 581 sqft. The majority of the area surrounding the 4 units on this roof appears to have heat and possible moisture present.

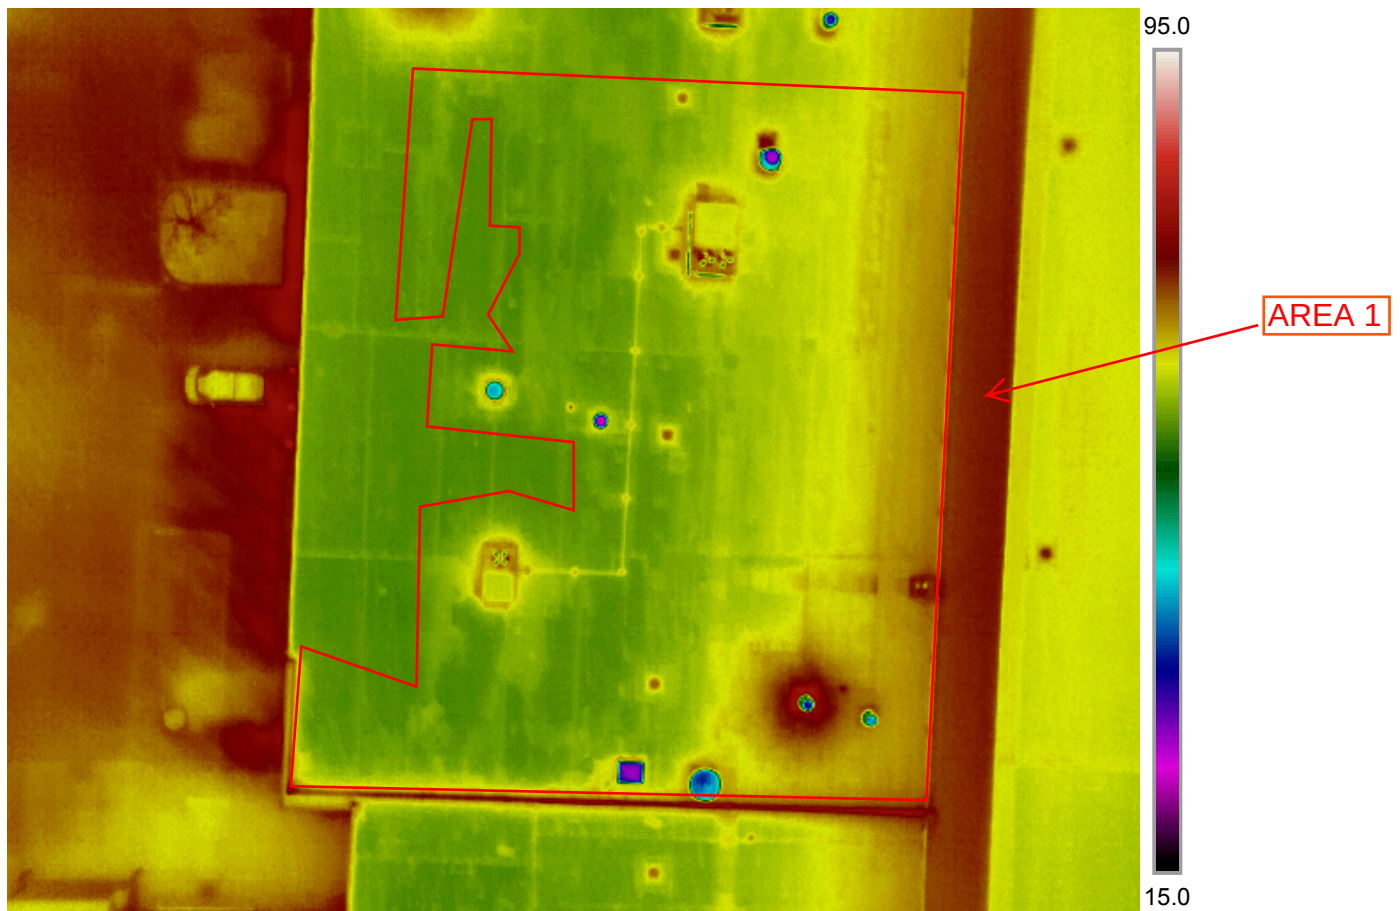
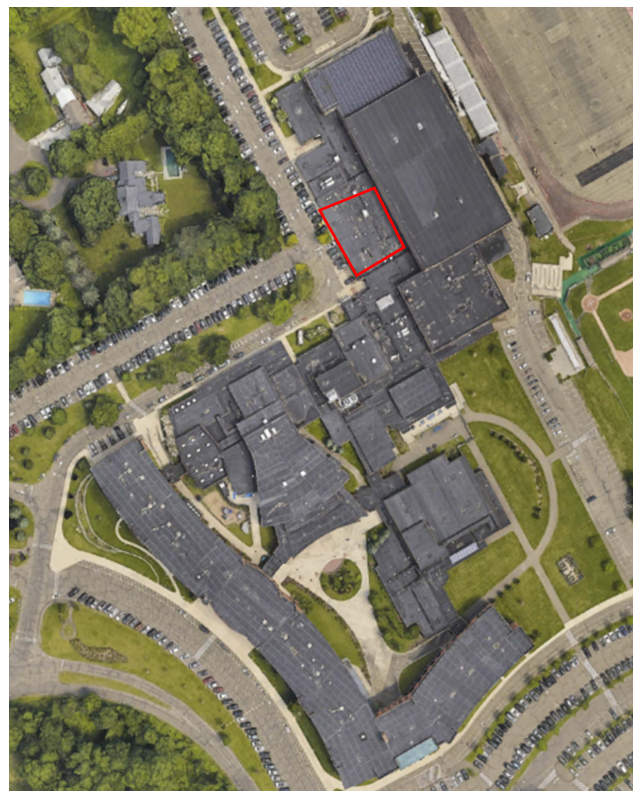
### Roof E

AREA 1 ~ 7111 sqft. A large area that has traces of heat/possible moisture almost entirely covering the section. It cannot be definitely determined whether these areas are standing water or wet insulation etc. However the presence of heat and possible moisture is abundant in this area of the roof.

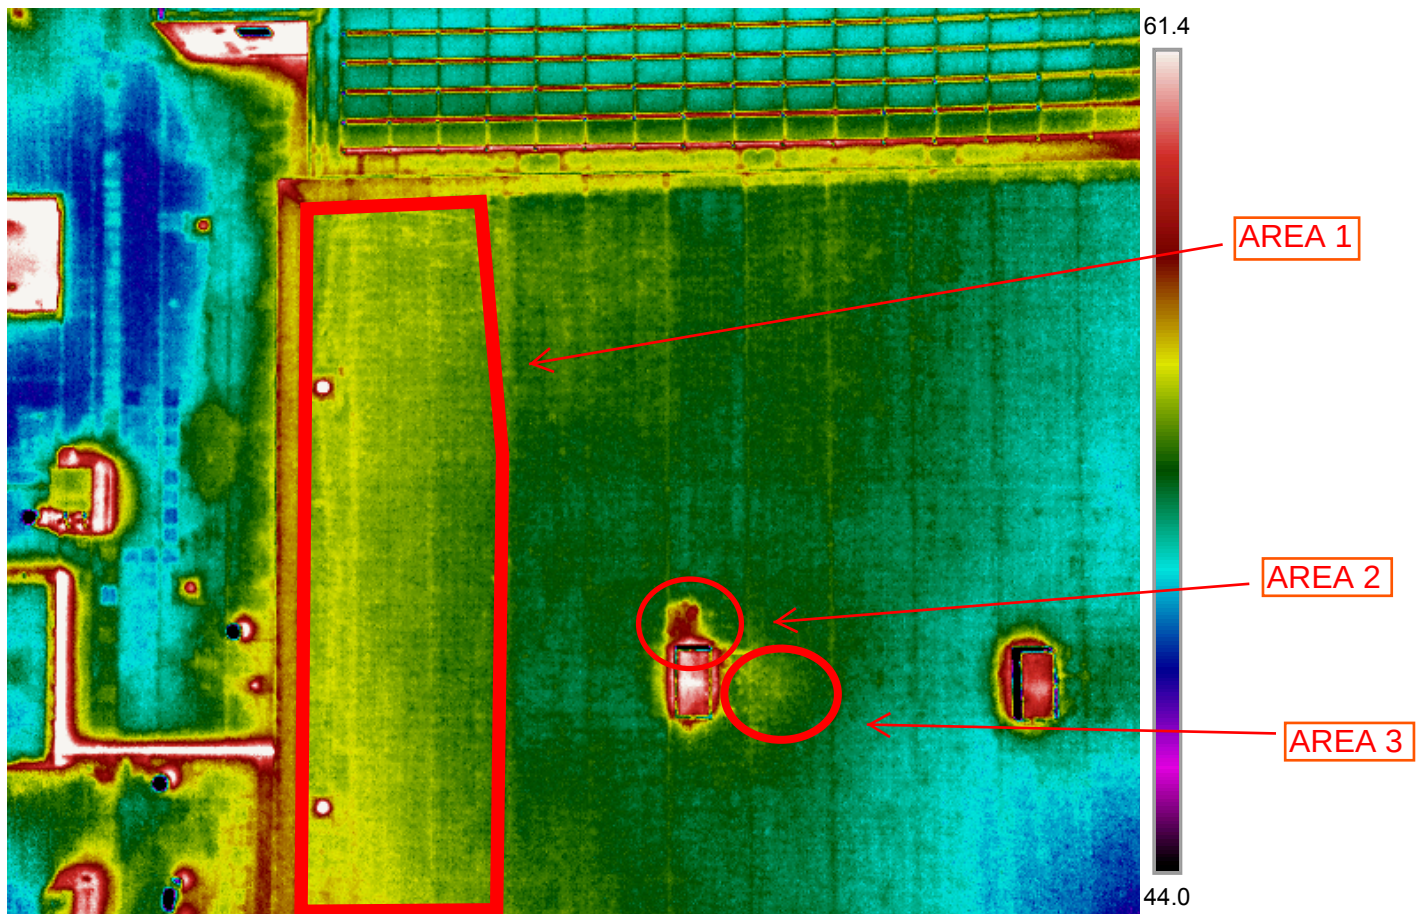
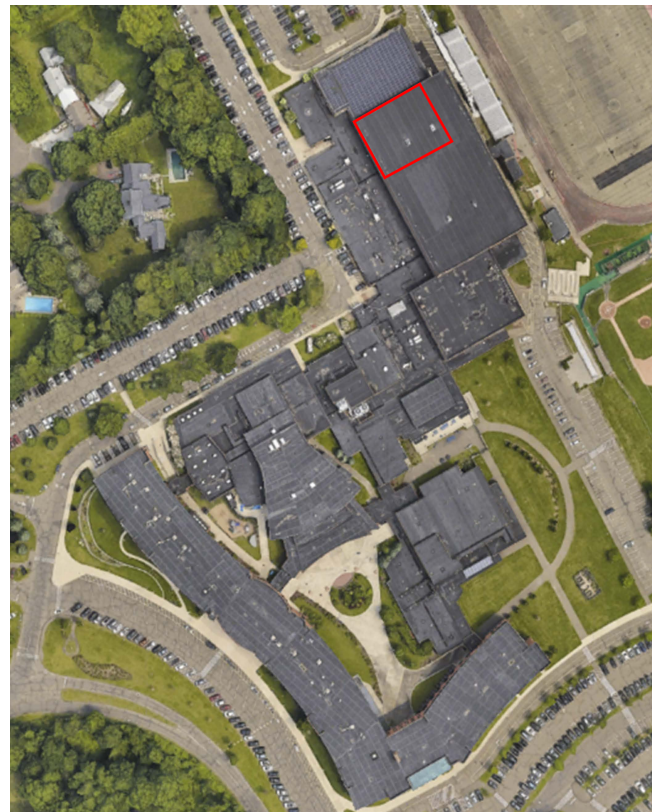
Roof A

Area 1 ~ 2539 sqft. Area that runs along the W edge of this section appears to have heat/possible moisture.

Area 2 ~ 30 sqft. Small area N of the closest unit to the marked location

Area 3 ~ 30 sqft. Small area E of the closest unit to the marked location

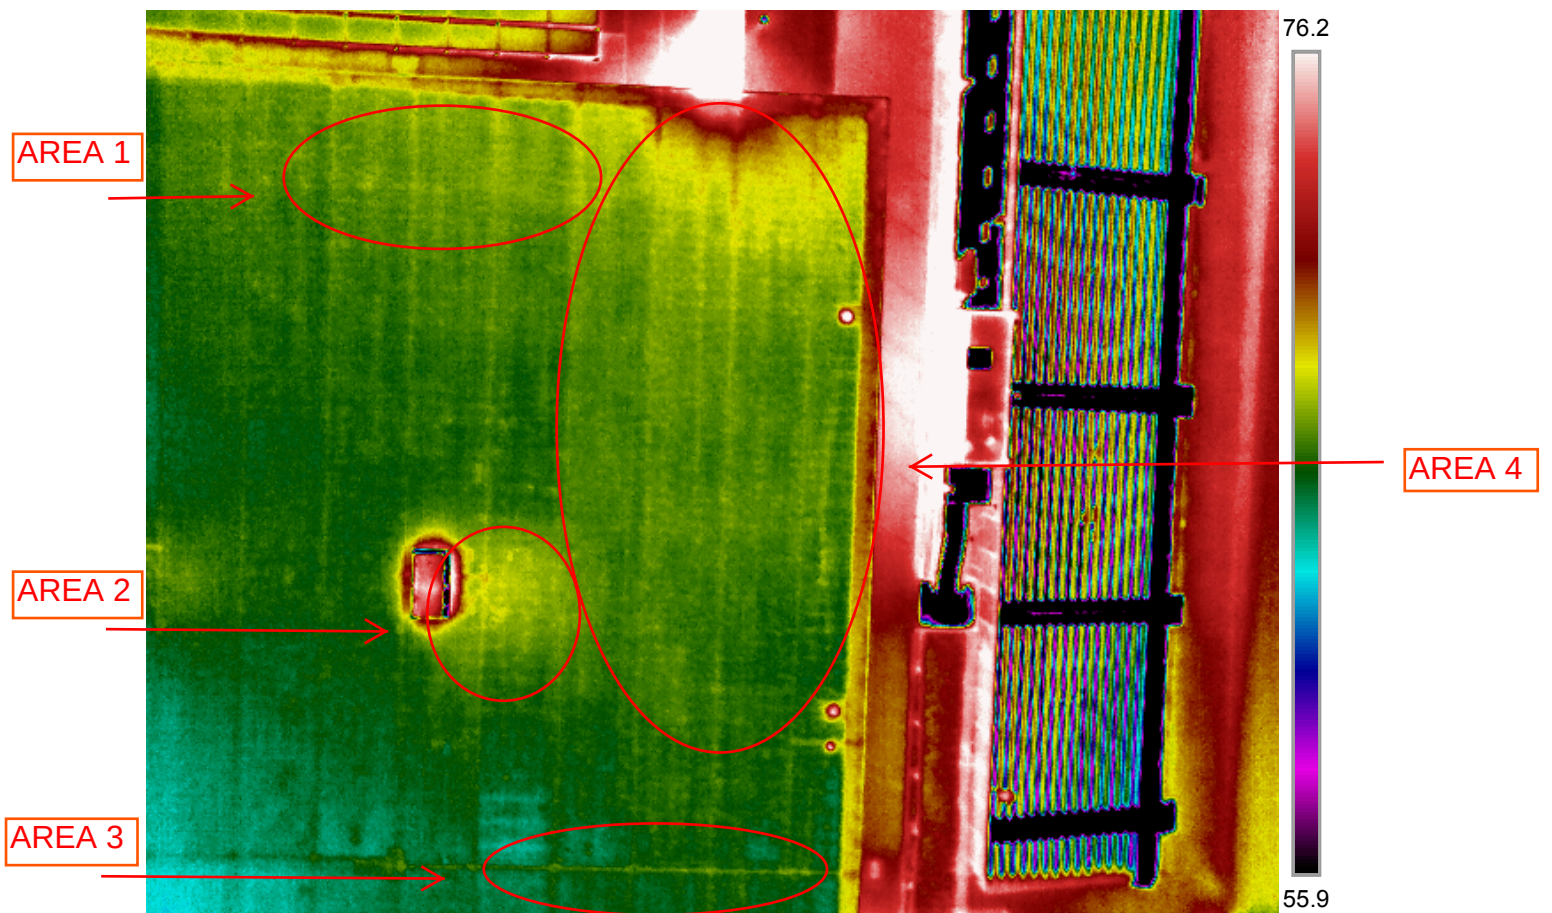
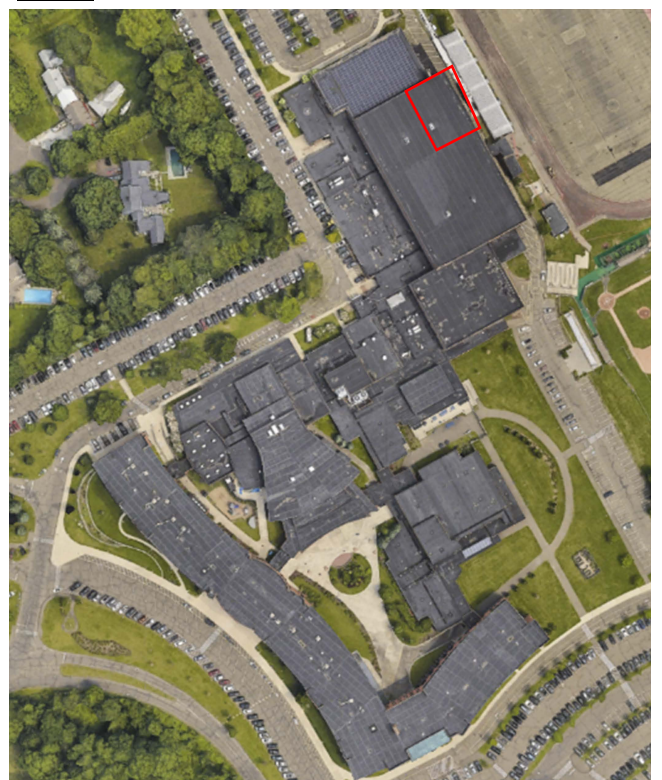
### Roof A

Area 1 ~ 684 sqft. Area along the N edge of the roof. Appears to be standing water marks or possible heat/moisture.  
 Area 2 ~ 113 sqft. Small area E of the closest unit.  
 Area 3 ~ 40 ft. Area that runs along a seam from E to W.  
 Area 4 ~ 2881 sqft. Large area along the E and NE part of the roof edge. Appears to be possible standing water marks or heat/moisture underlying.

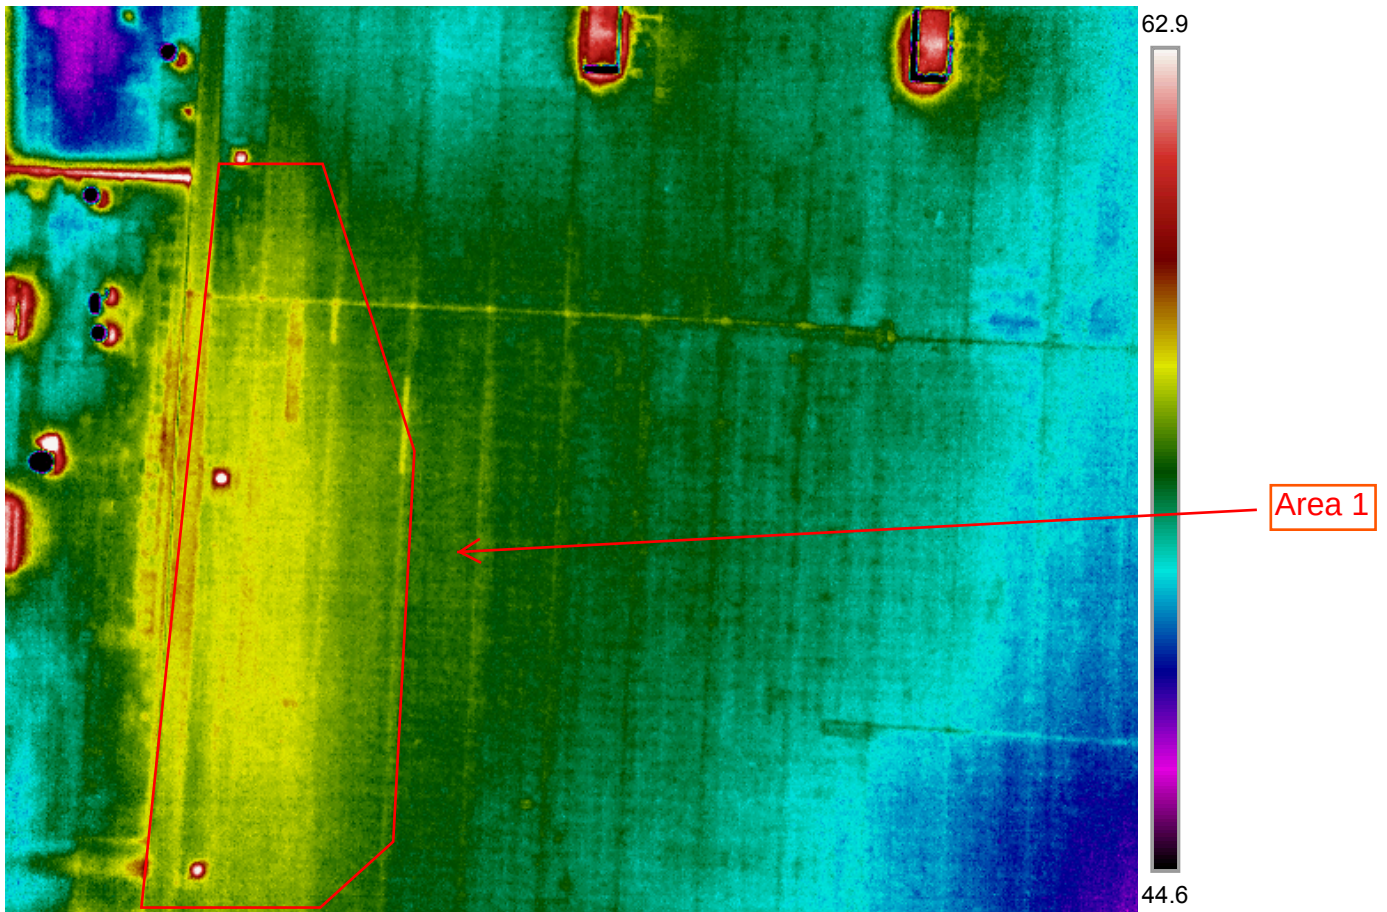
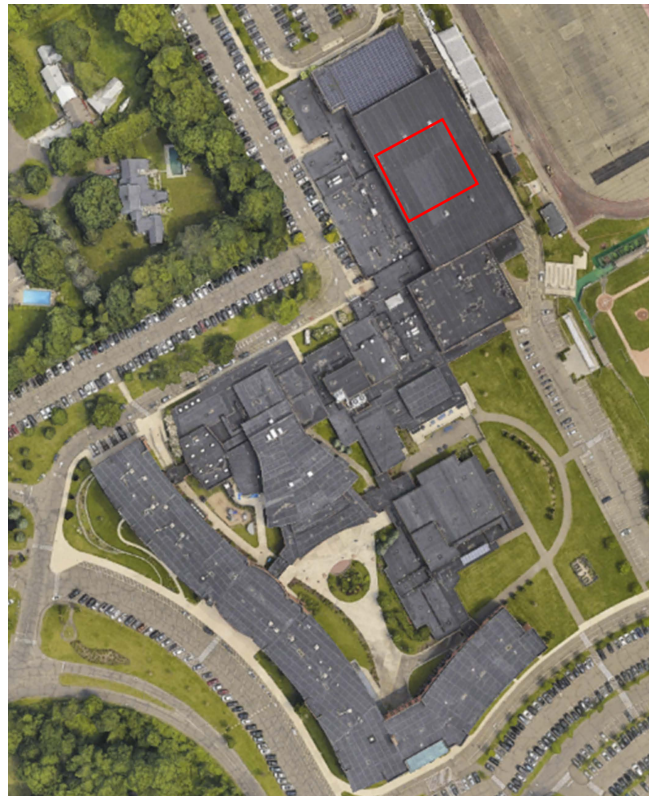
### Roof A

Area 1 ~ 2525 sqft. Area that runs along the W edge of this roof area.

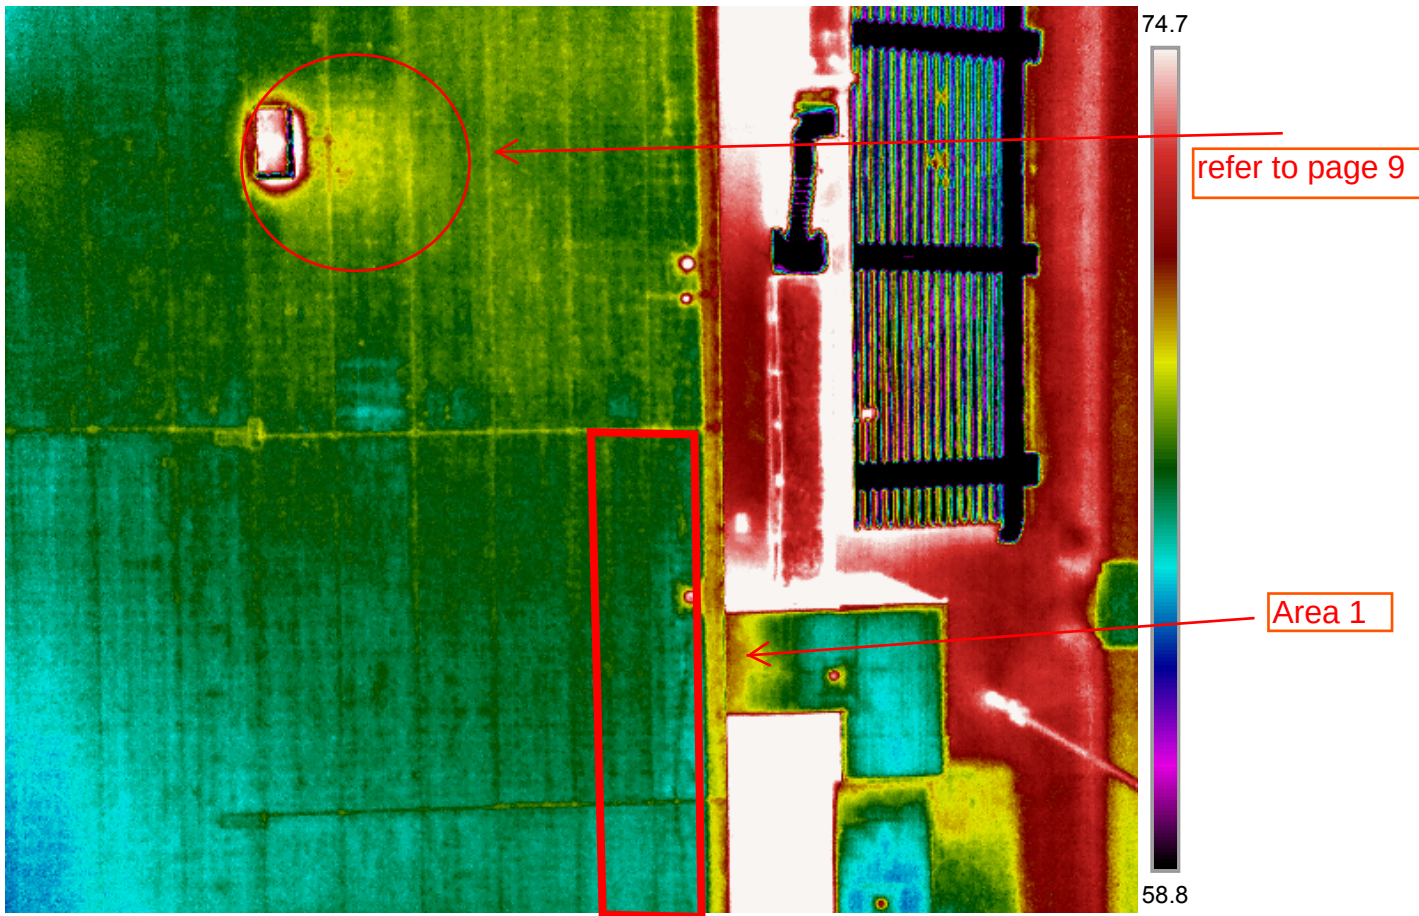
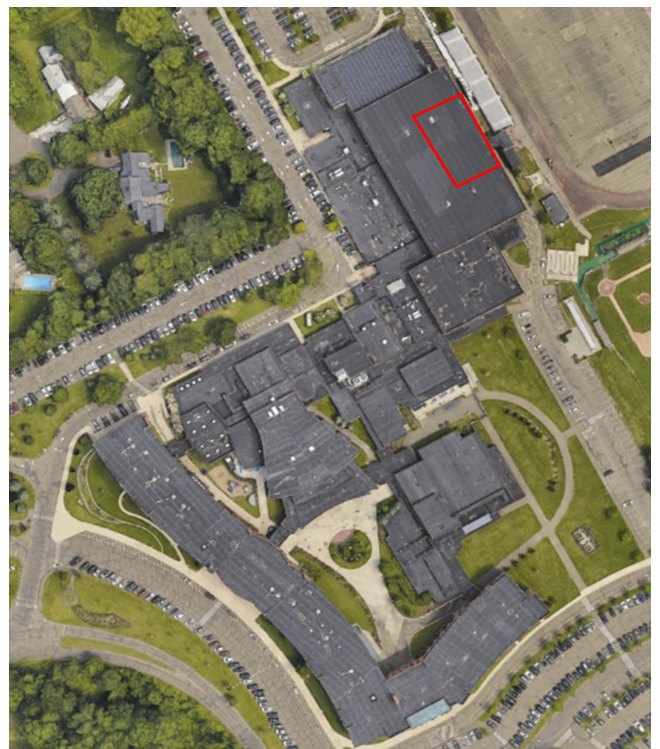
### Roof A

Area 1 ~ 272 sqft. Area that runs beneath the seam, along the E wall. Appears to be standing water spots or possible heat/moisture spots.

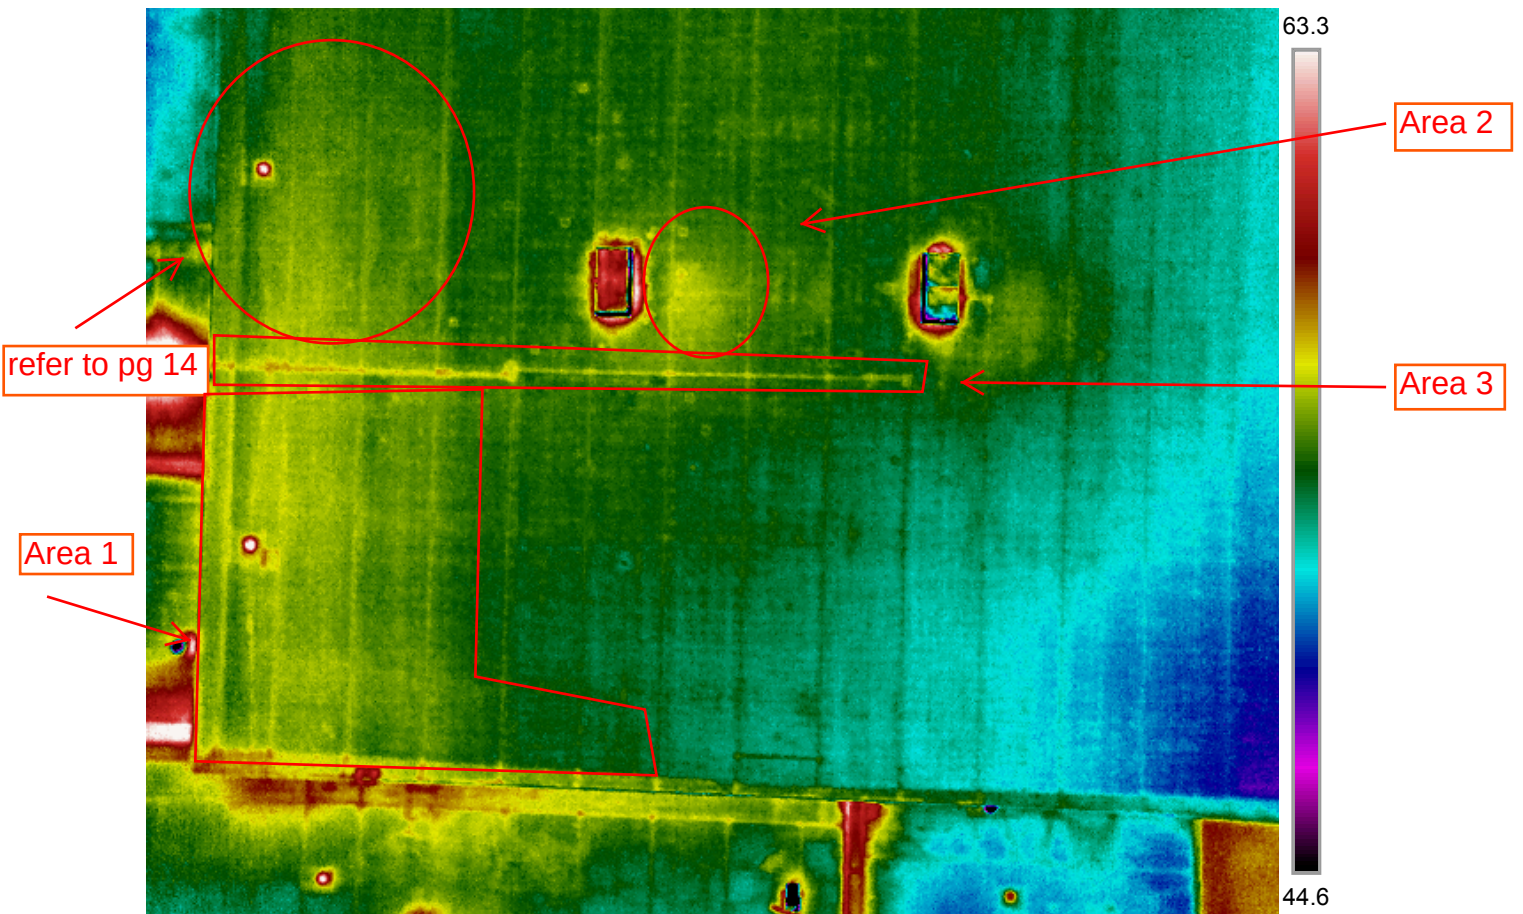
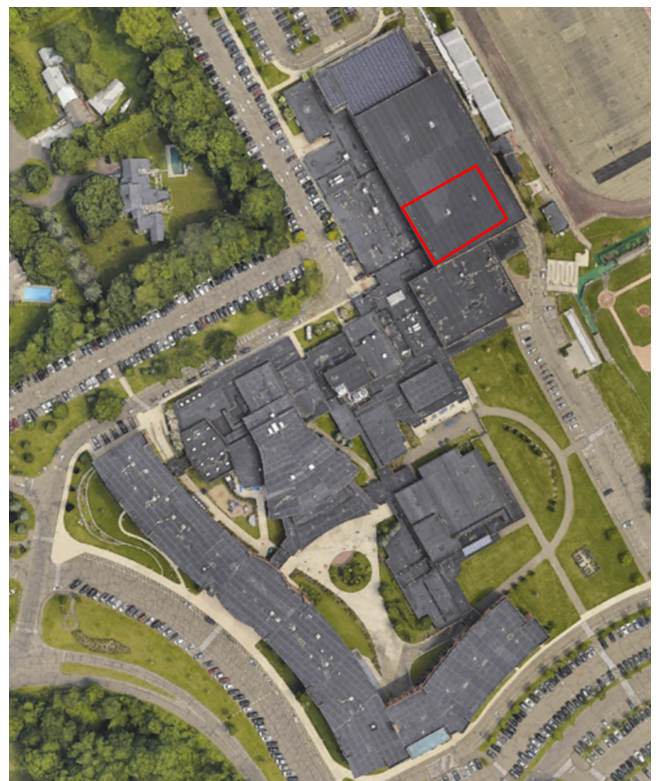
### Roof A

Area 1 ~ 2111 sqft. Area that runs along the W and S edge of the roof section and extends towards the middle of the roof.

Area 2 ~ 40 sqft. Small area on the E side of the closest unit to the marked location

Area 3 ~ 81 ft. Seam running from W to E below the two units in the middle of the roof.

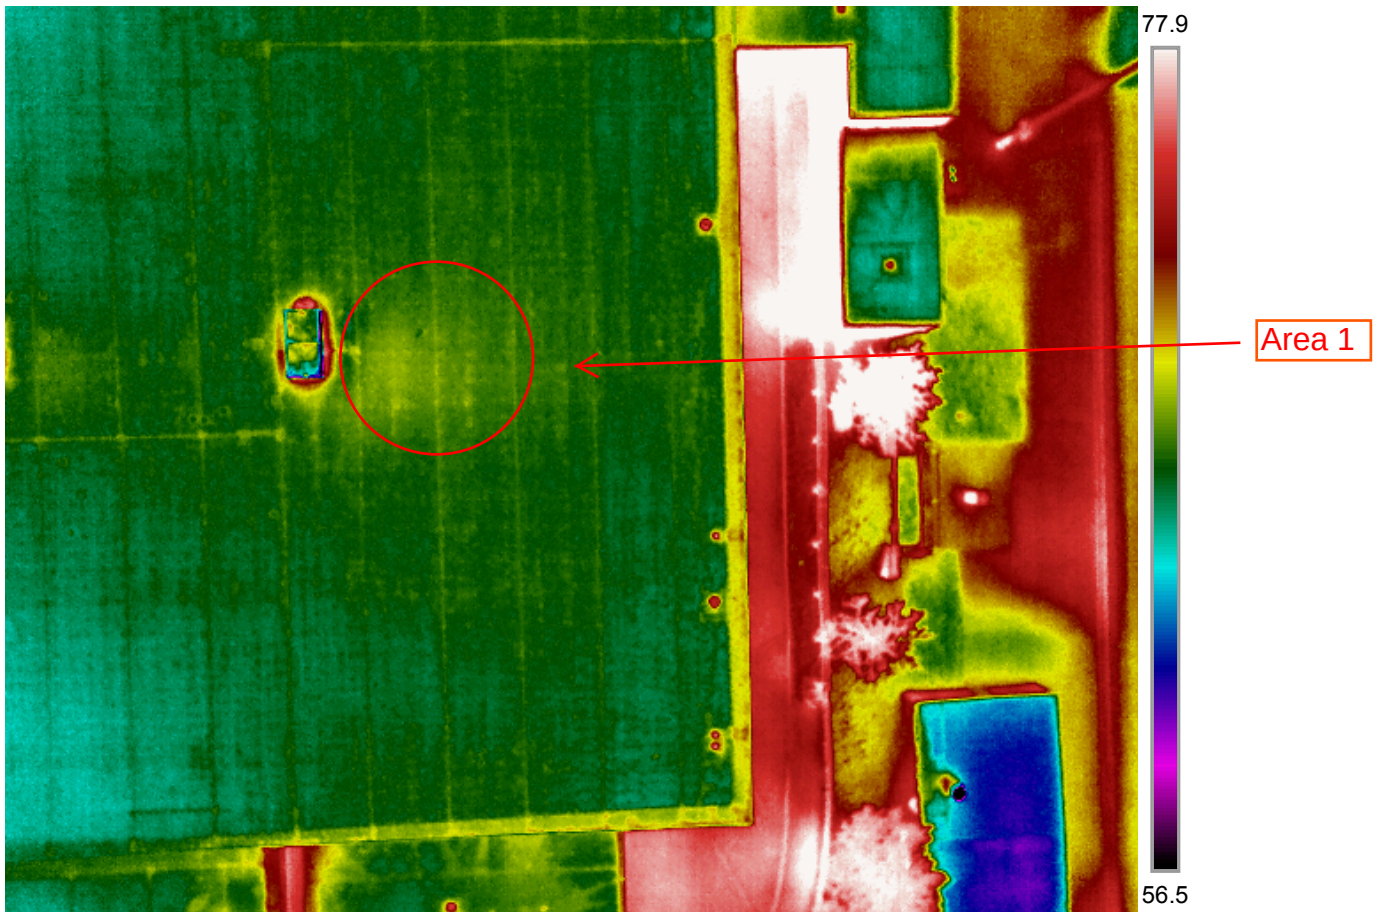
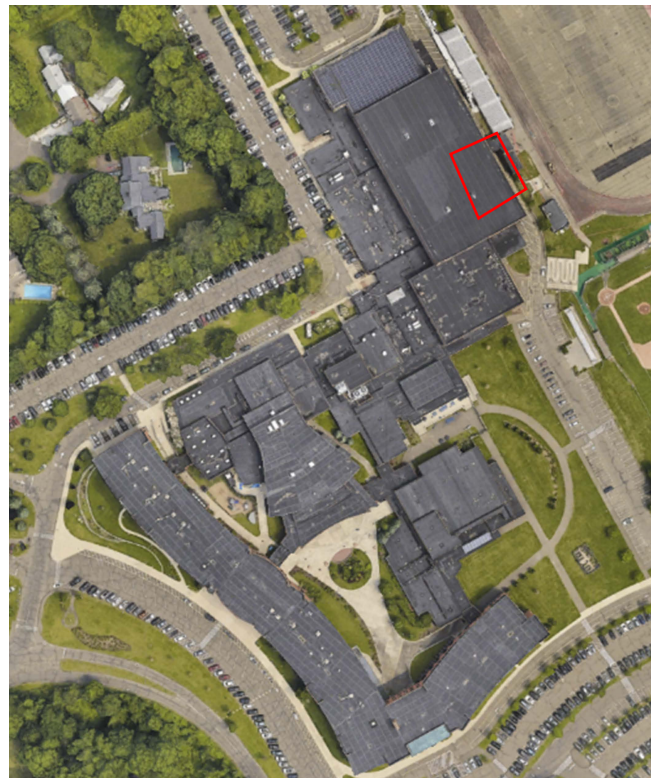
### Roof A

Area 1 ~ 50 sqft. Small area to the E of the closest unit

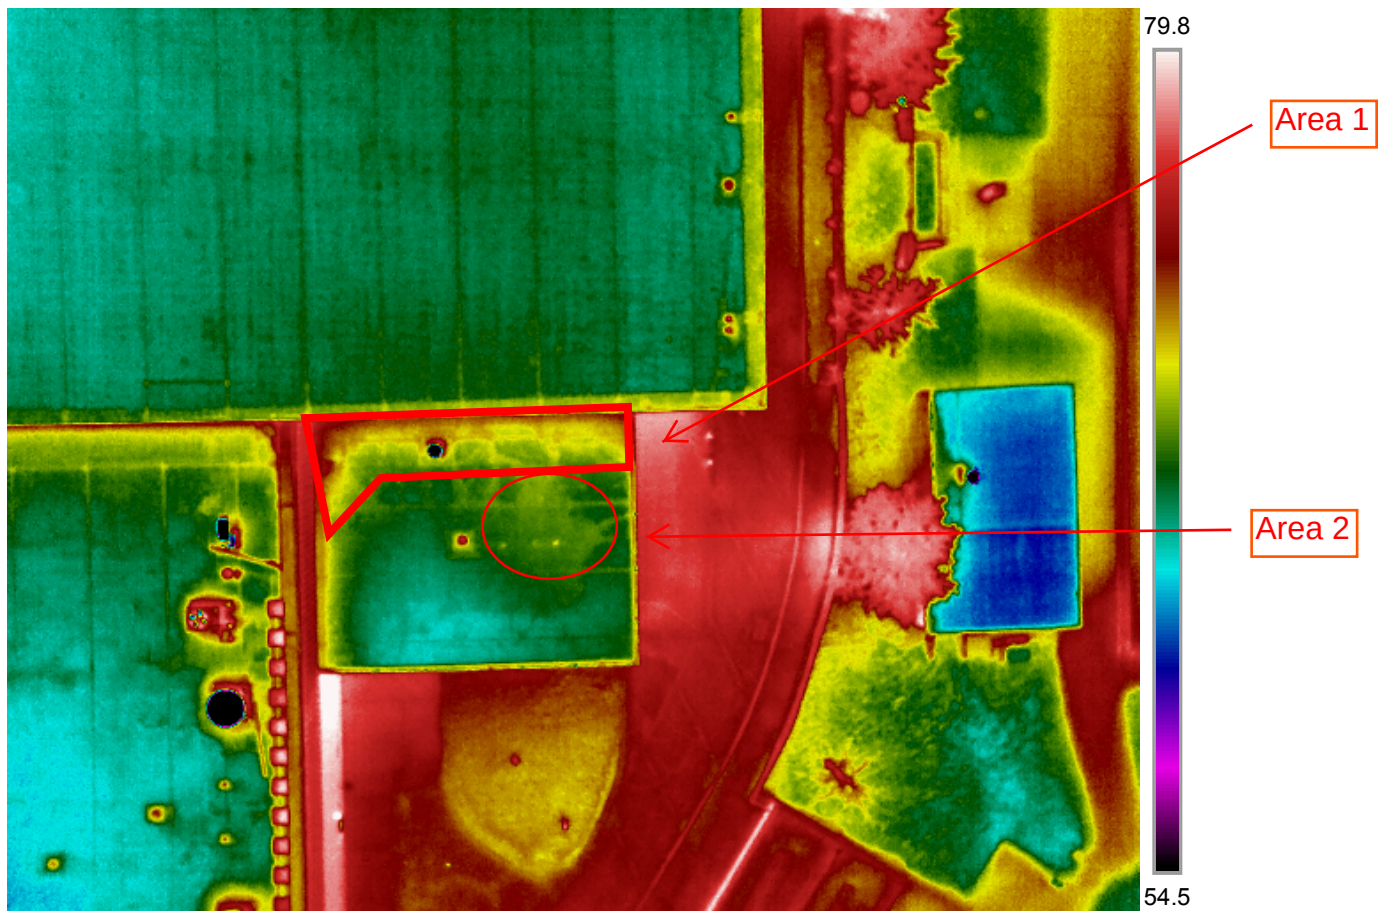
Roof F

Area 1 ~ 270 sqft. Along the N portion of this roof that runs against the wall leading up to Roof A.

Area 2 ~ 251 sqft. Area to the E of the drain in the center of the roof.

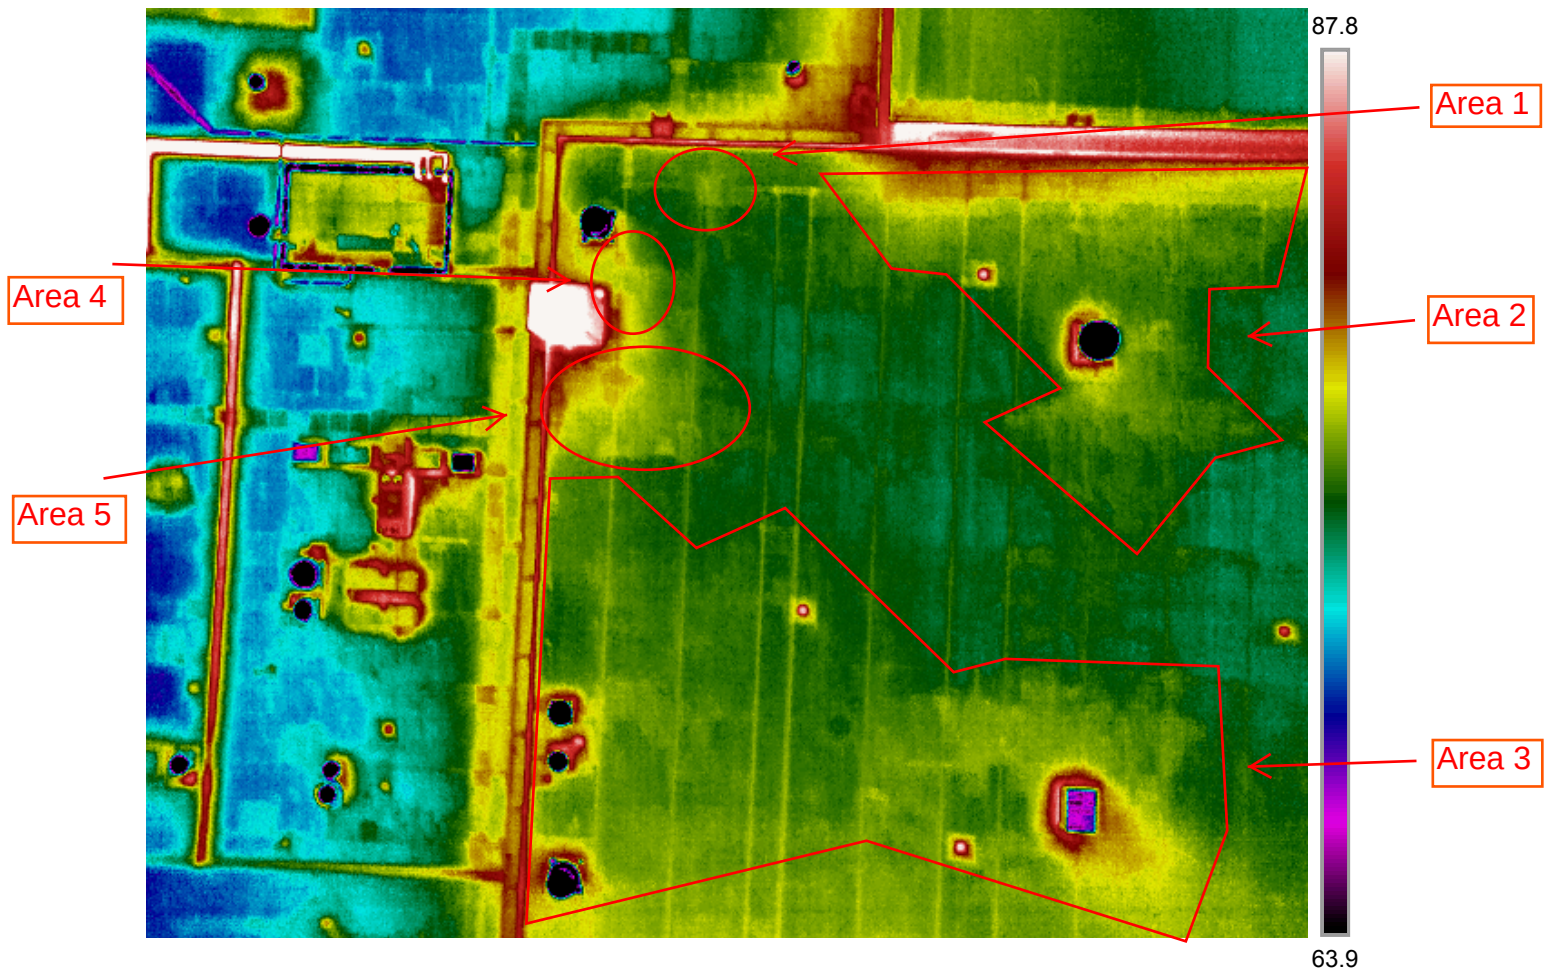
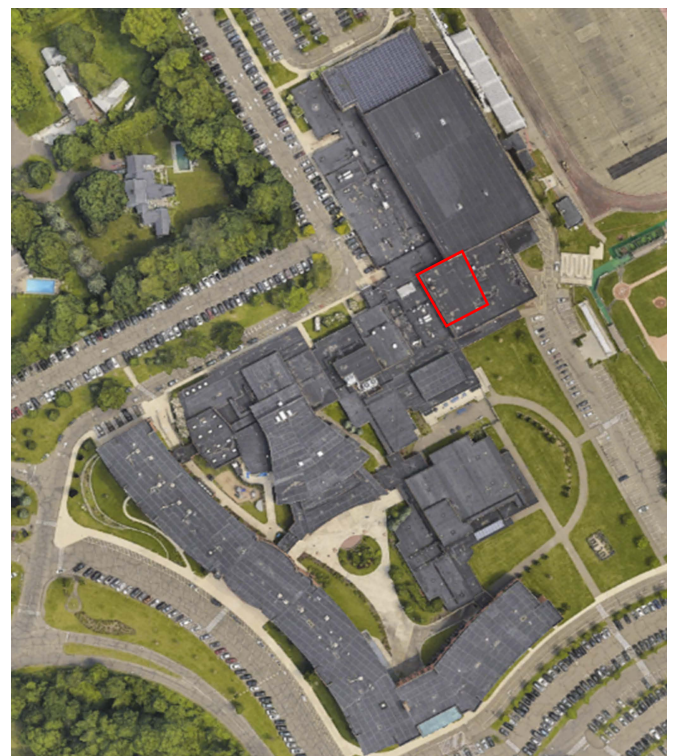
### Roof I

- Area 1 ~ 33 sqft. Small area along the N edge of the roof section. Appears to be on or next to a former roof patch.
- Area 2 ~ 1927 sqft. Large area surrounding the curb/unit in this marked area extending to the N edge of the roof section which goes up to Roof A. Appears to be an abundance of residual water/ponding or heat/moisture.
- Area 3 ~ 3177 sqft. Large area extending almost the entire S area of this roof section. Large thermal spots which could be standing water or heat/moisture underneath.
- Area 4 ~ 35 sqft. Small area next to the unit and seems to be on the SW corner of a roof patch
- Area 5 ~ 240 sqft. Area Just SE of the closest roof unit.
