# **INFRARED ROOF INSPECTION**

LOCATION:  
STAPLES HIGH SCHOOL  
70 NORTH AVE  
WESTPORT CT 06880

This report summarizes the findings of our Infrared Roof Moisture Analysis of the roof at Staples High School, Westport, CT, performed on November 7, 2020.

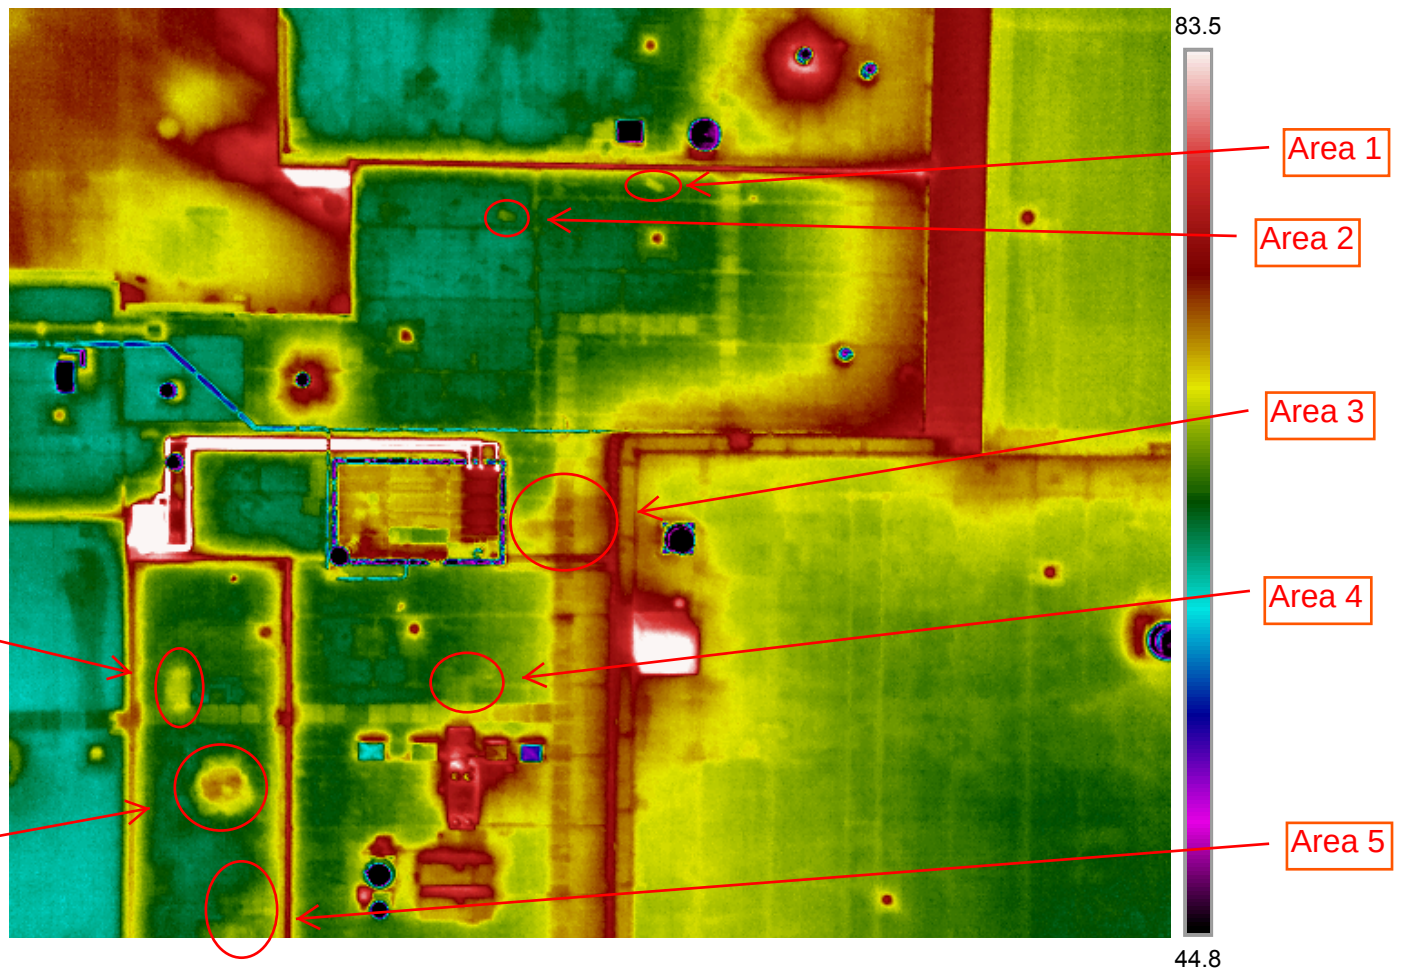
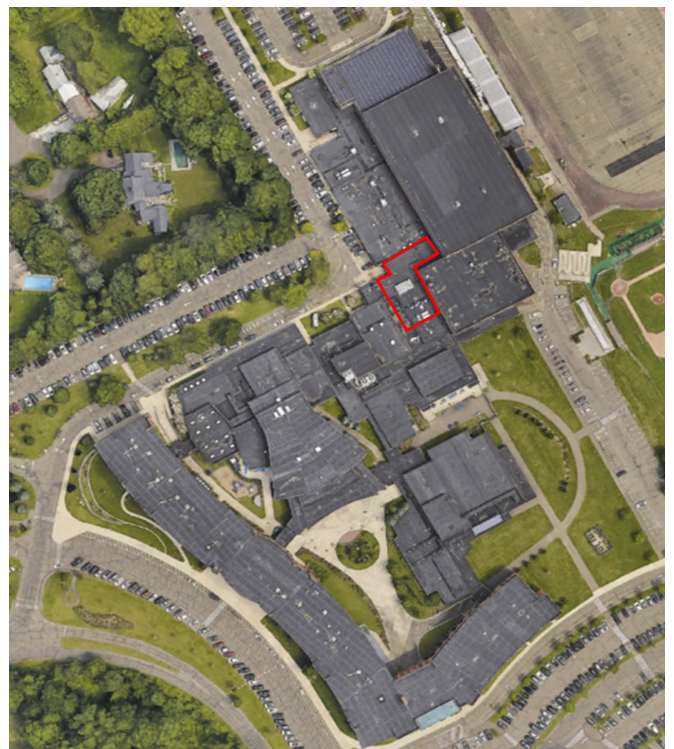
### Roof J

Area 1 ~ 8 sqft. Small area along the N edge of this roof section  
Area 2 ~ 8 sqft. Small area also along the N edge of this roof section  
Area 3 ~ 74 sqft. Area in between unit and E edge of adjacent wall mostly around the walkpads  
Area 4 ~ 43 sqft. Area of possible standing water/moisture/heat just N of the walkpads and unit.  
Area 5/6/7 ~ This section of the roof appears to be have lots of residual moisture spots or possible heat. The 3 main spots are pointed out.

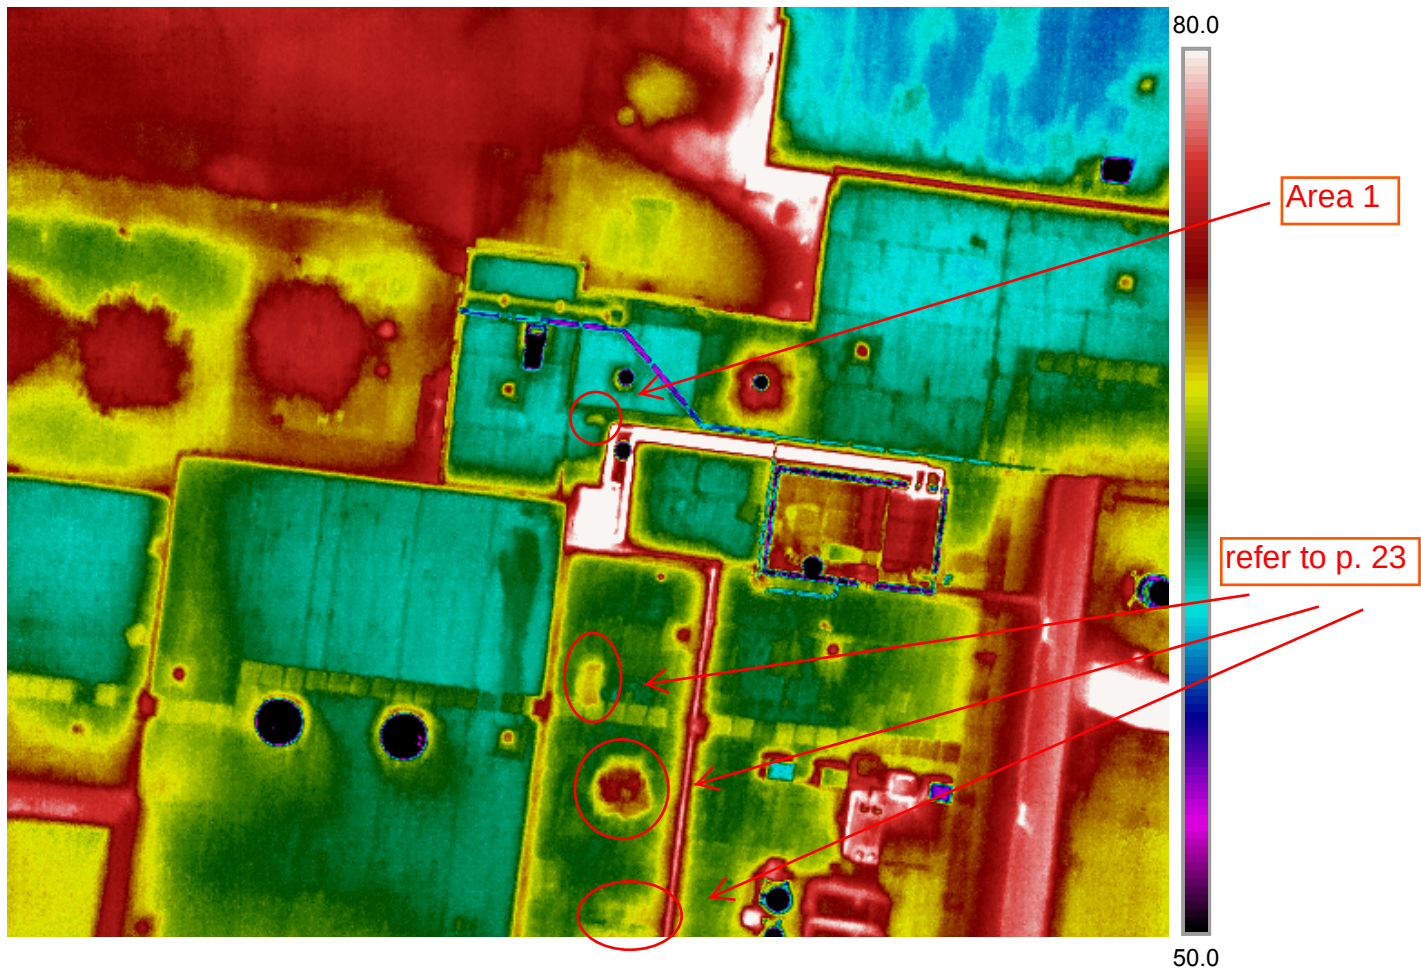
Roof J

Area 1 ~ 6 sqft. Small area in between roof vent/unit and pipe just S of what appears to be a roof patch.

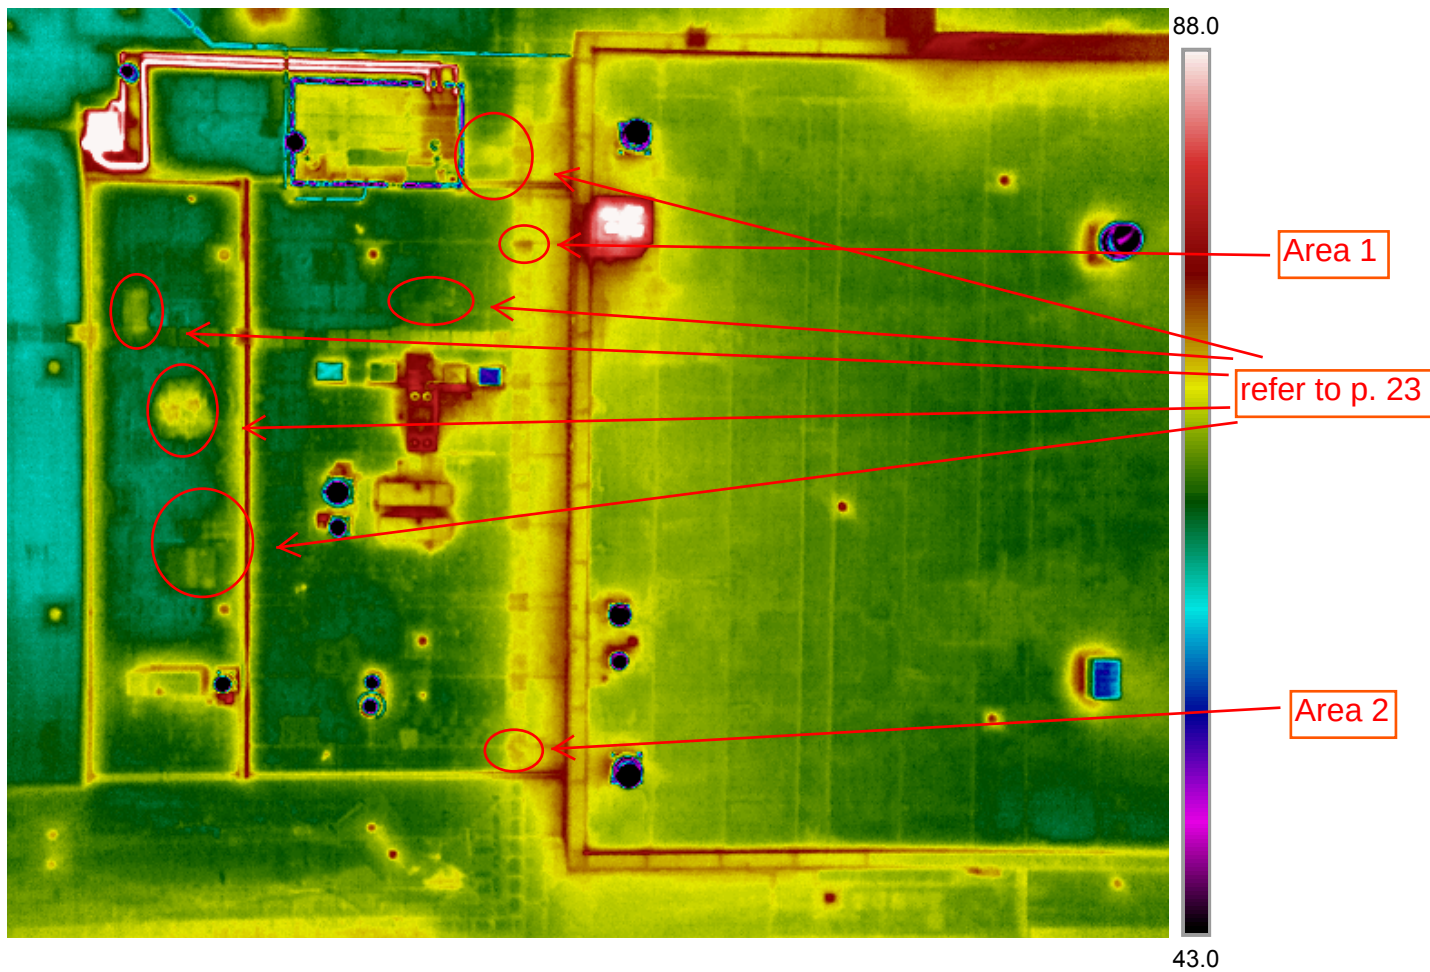
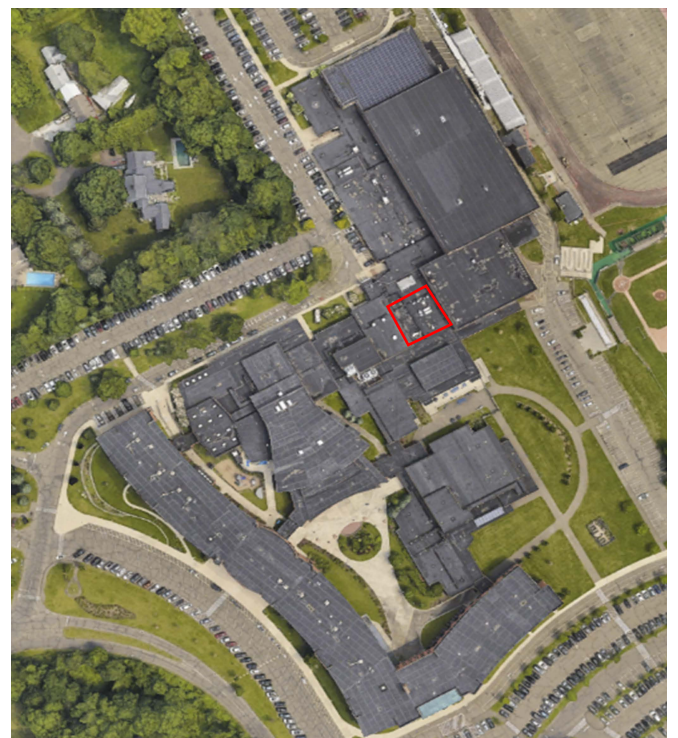
Roof J

Area 1 ~ 8 sqft. Small area of heat/possible moisture along the walk pads near the E edge of this roof section  
Area 2 ~ 8 sqft. Small area of heat/possible moisture along the walk pads near the SE edge of this roof section.

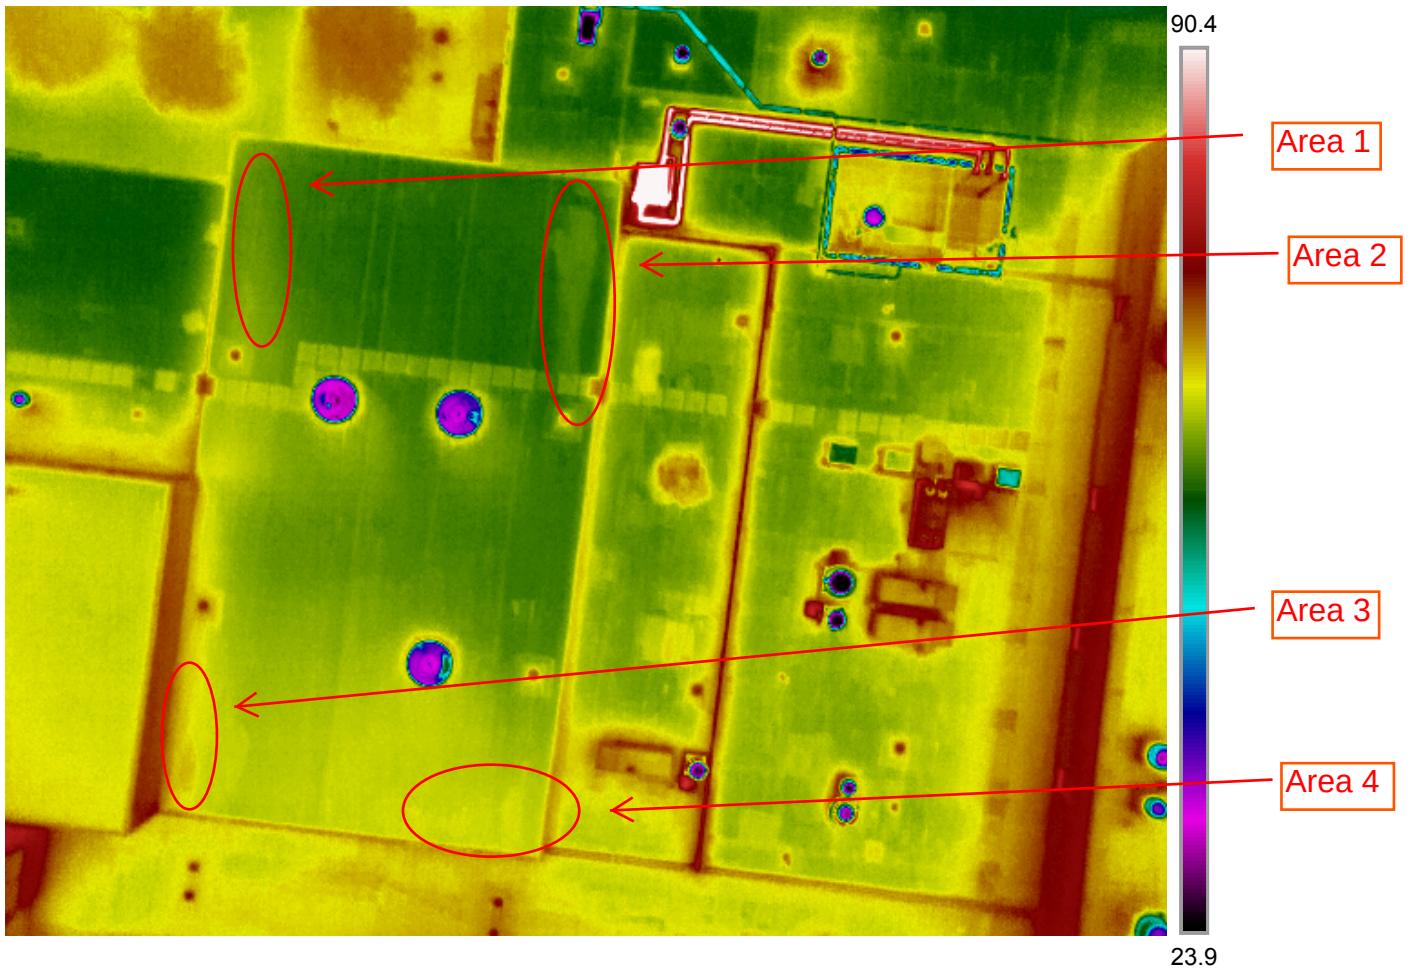
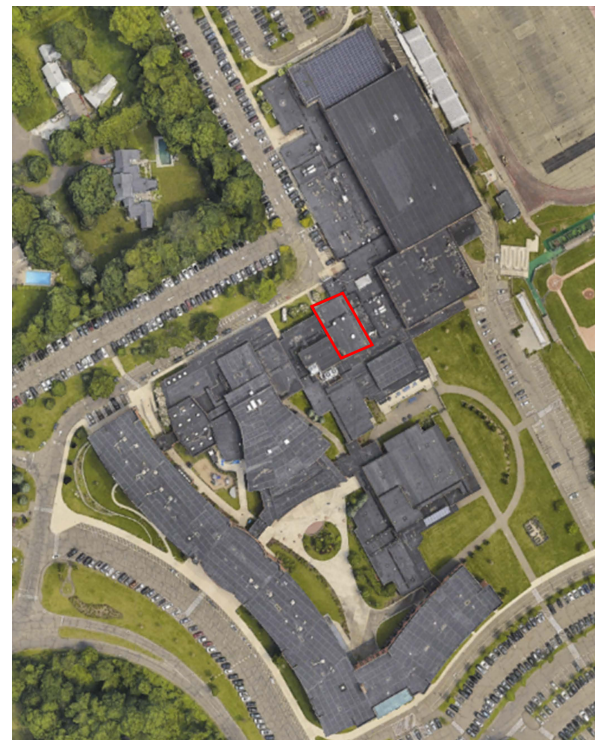
Roof K

Area 1 ~ 105 sqft. Area along the W edge of this roof section. Potential standing water residue or heat/moisture.

Area 2 ~ 117 sqft. Area along E edge of this roof section extending to the walk pads. Potentially standing water or heat/moisture presence.

Area 3 ~ 33 sqft. Small area in the SW corner.

Area 4 ~ 45 sqft. SE corner of this roof section. Possible standing water or heat/moisture.

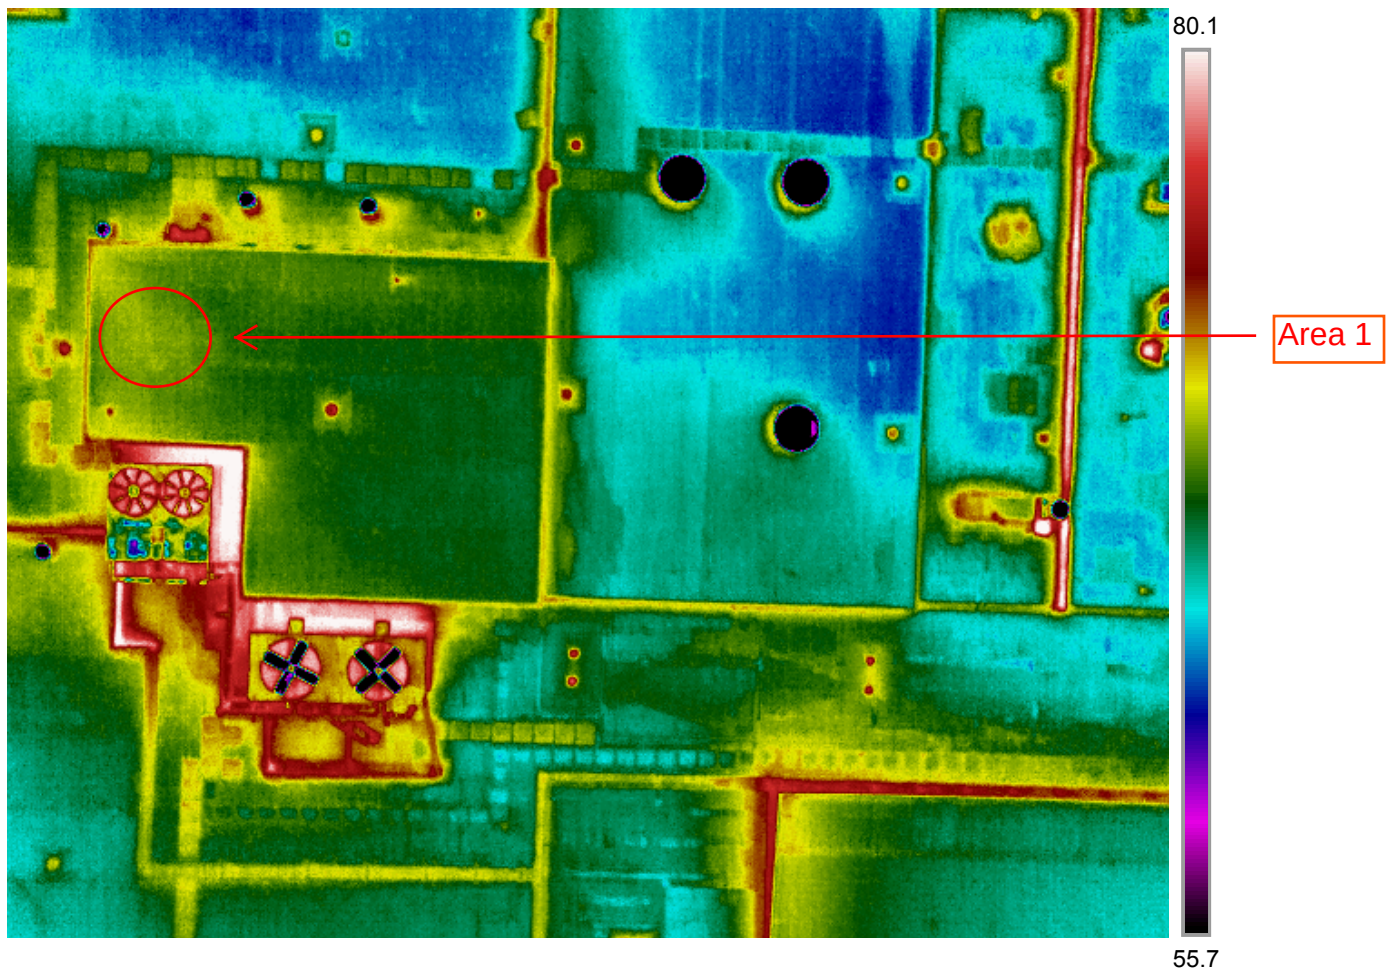
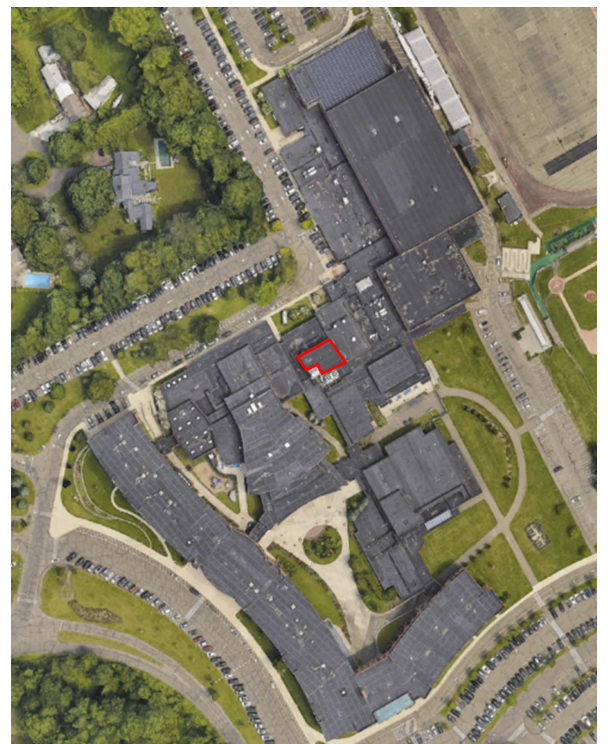
Roof L

Area 1 ~ 89 sqft. Possible area of standing water staining or heat/moisture.

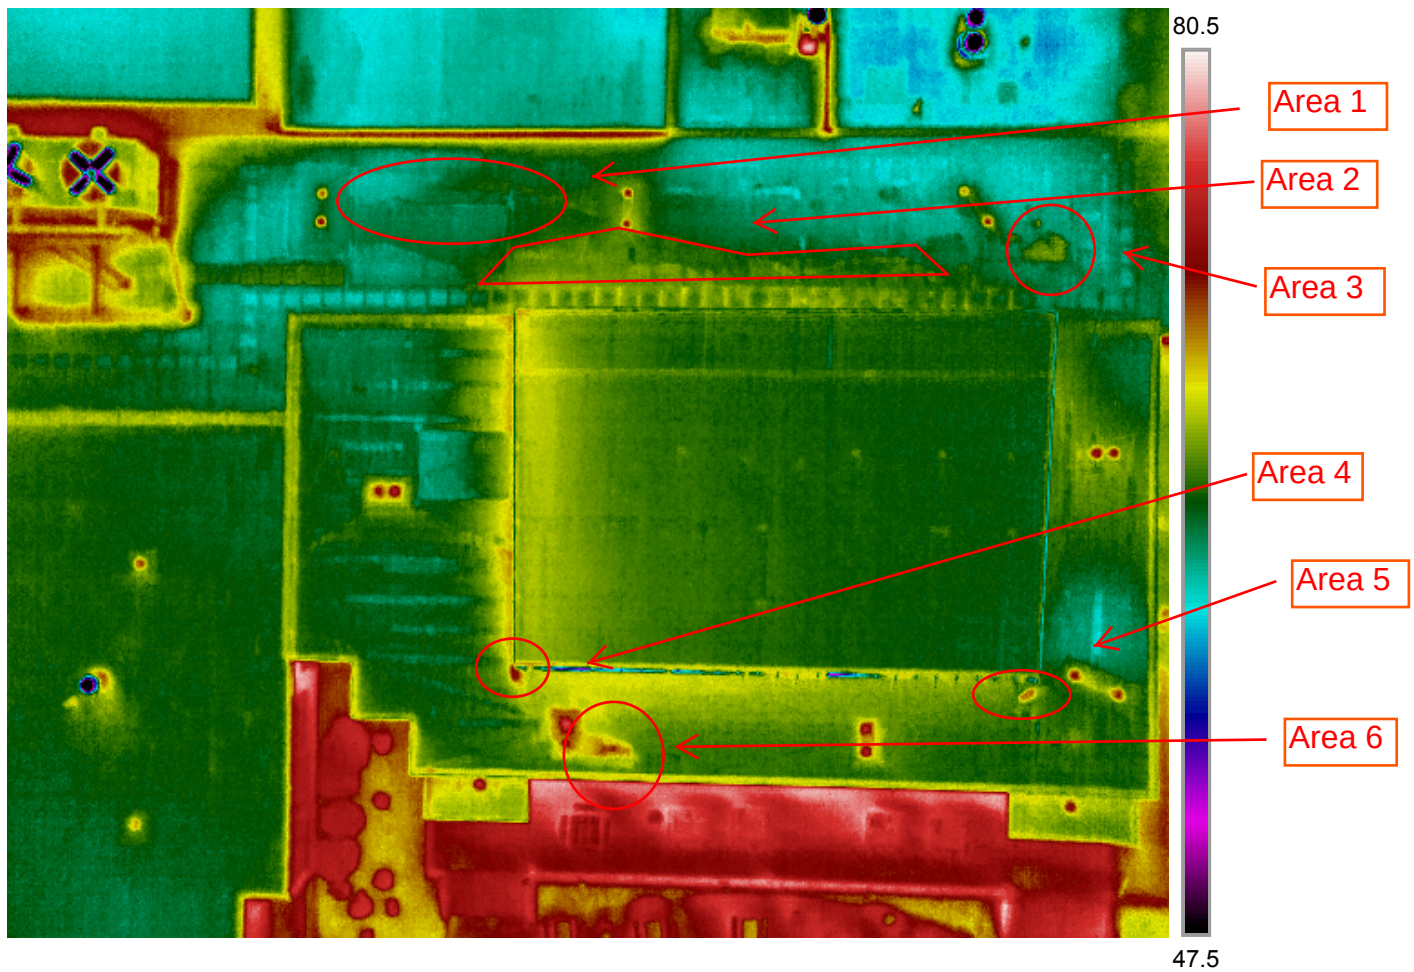
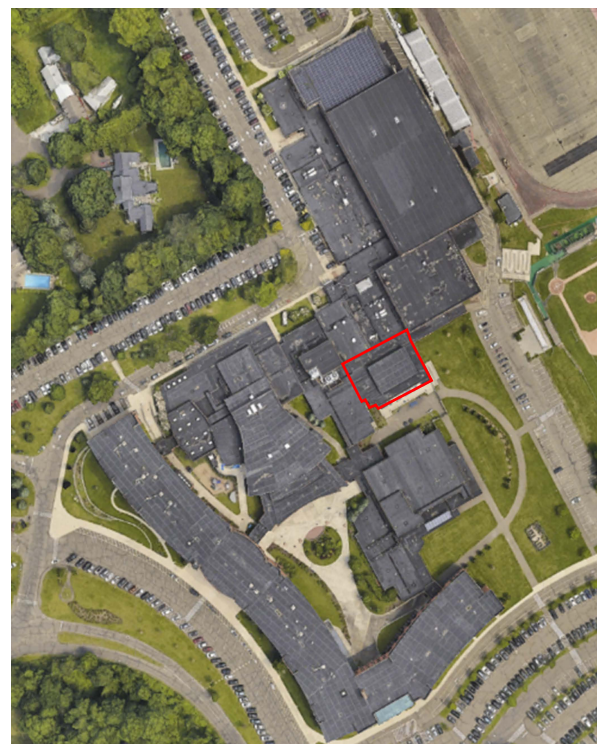
### Roof M

- Area 1 ~ 295 sqft. Possible standing water residue or heat/moisture. Runs along the NW section of this roof area
- Area 2 ~ 305 sqft. Long area stretching along the N side of the walk pads. Appears to be standing water residue or heat/moisture.
- Area 3 ~ 15 sqft. Small area in the NE area of this roof section.
- Area 4 ~ 6 sqft. Small area at the bottom of the wall that touches the SW corner of the upper roof.
- Area 5 ~ Small area on the bottom of the wall at the SE corner of the wall to the upper roof.
- Area 6 ~ 25 sqft. Area to the E of the unit closest to this marked area.

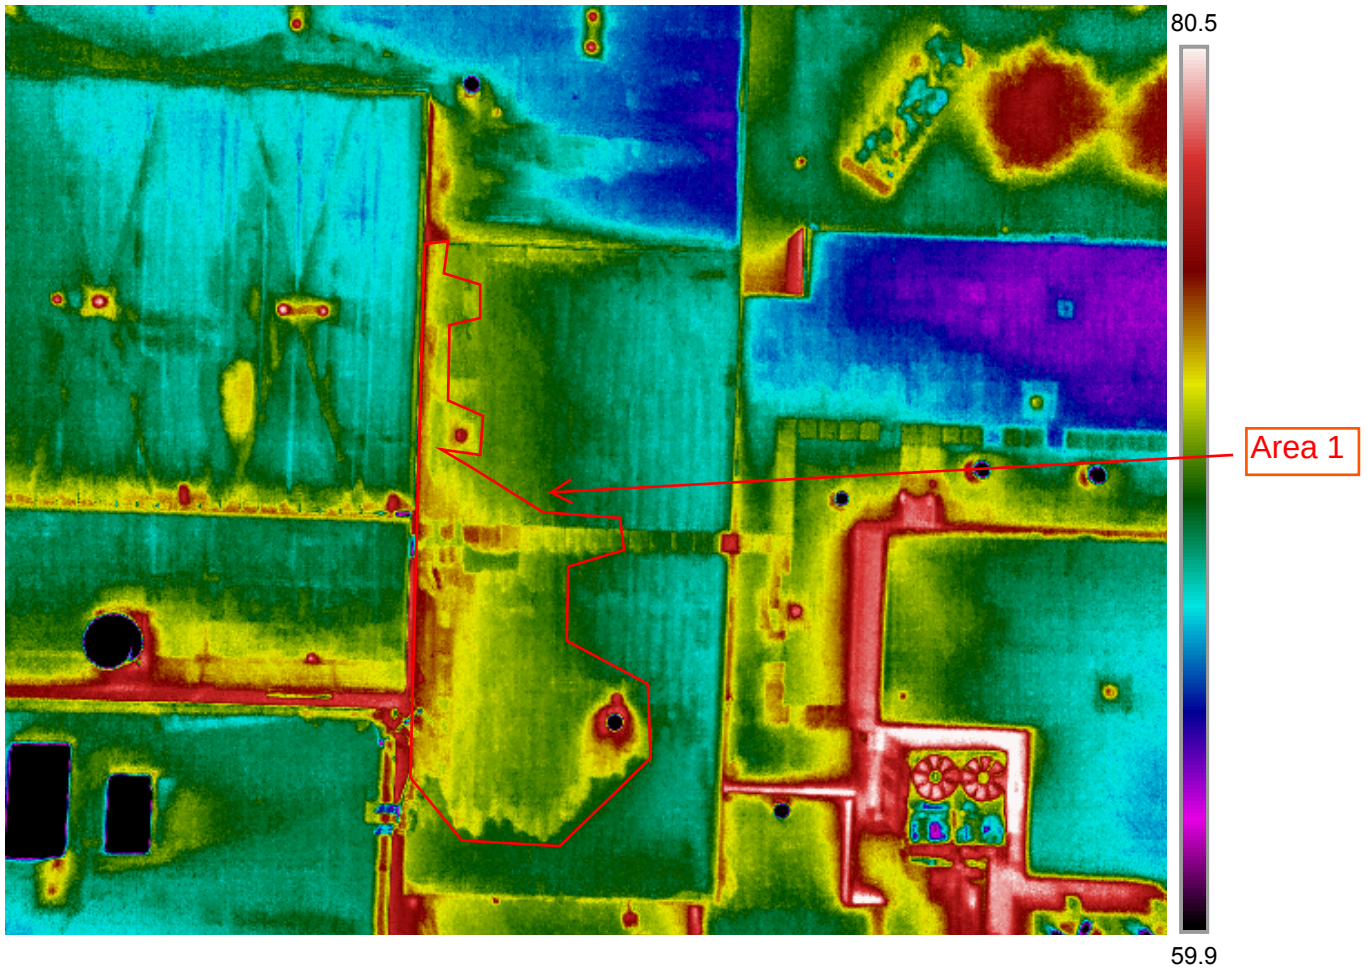
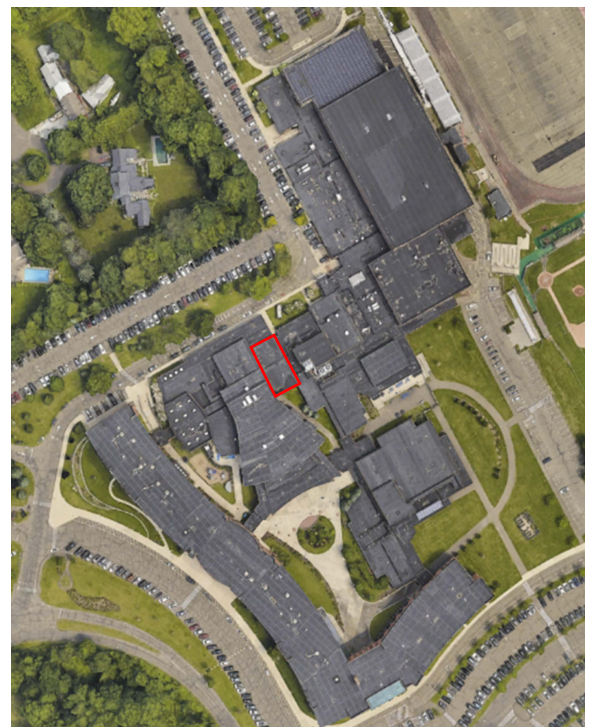
Roof N

Area 1 ~ 1228 sqft. Large area that encompasses almost the entire W edge of this roof section stretching in to the middle. Could be standing water residue or heat/moisture.

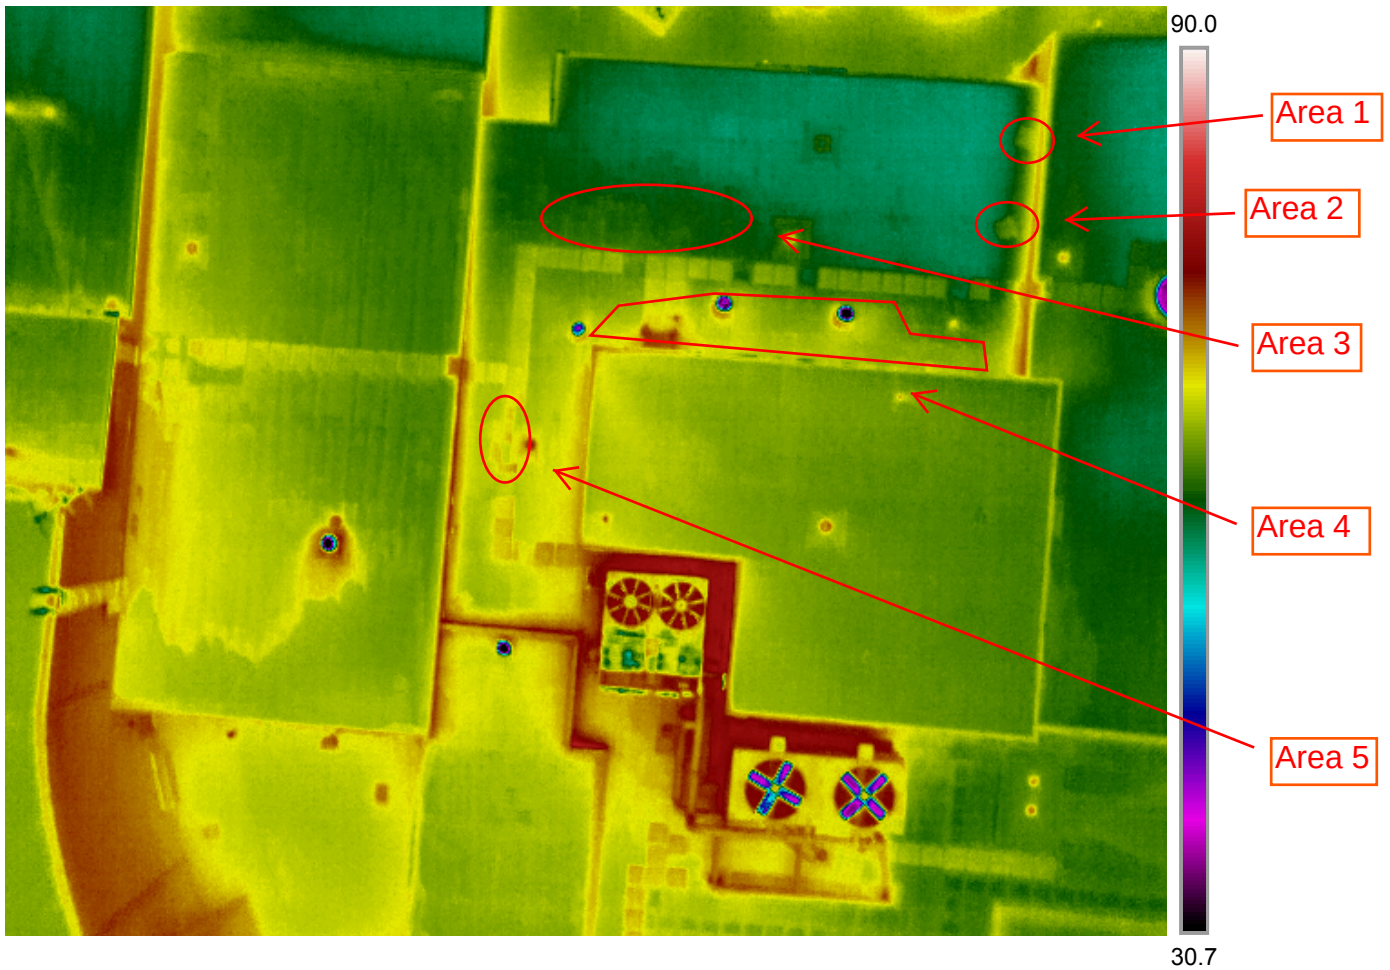
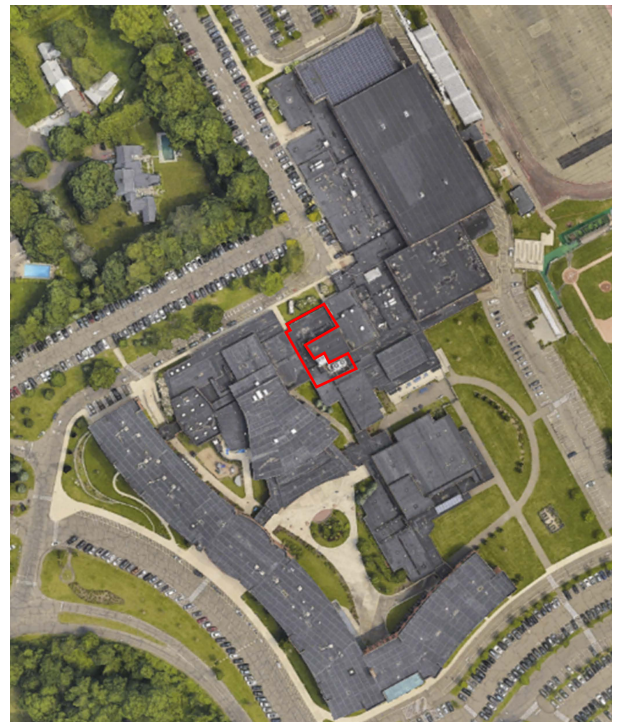
### Roof O

- Area 1 ~ 7 sqft. Small area in the NE corner of this roof section
- Area 2 ~ 8 sqft. Small area in the NE corner of this roof section.
- Area 3 ~ 127 sqft. Area along the N side of the walk pads appears to have possible standing water residue or heat/moisture.
- Area 4 ~ 350 sqft. Along the base of the wall to Roof Area L including the ladder and units. Possible stains from standing water or heat/moisture.
- Area 5 ~ Small area along the W edge of this section along walk pads.

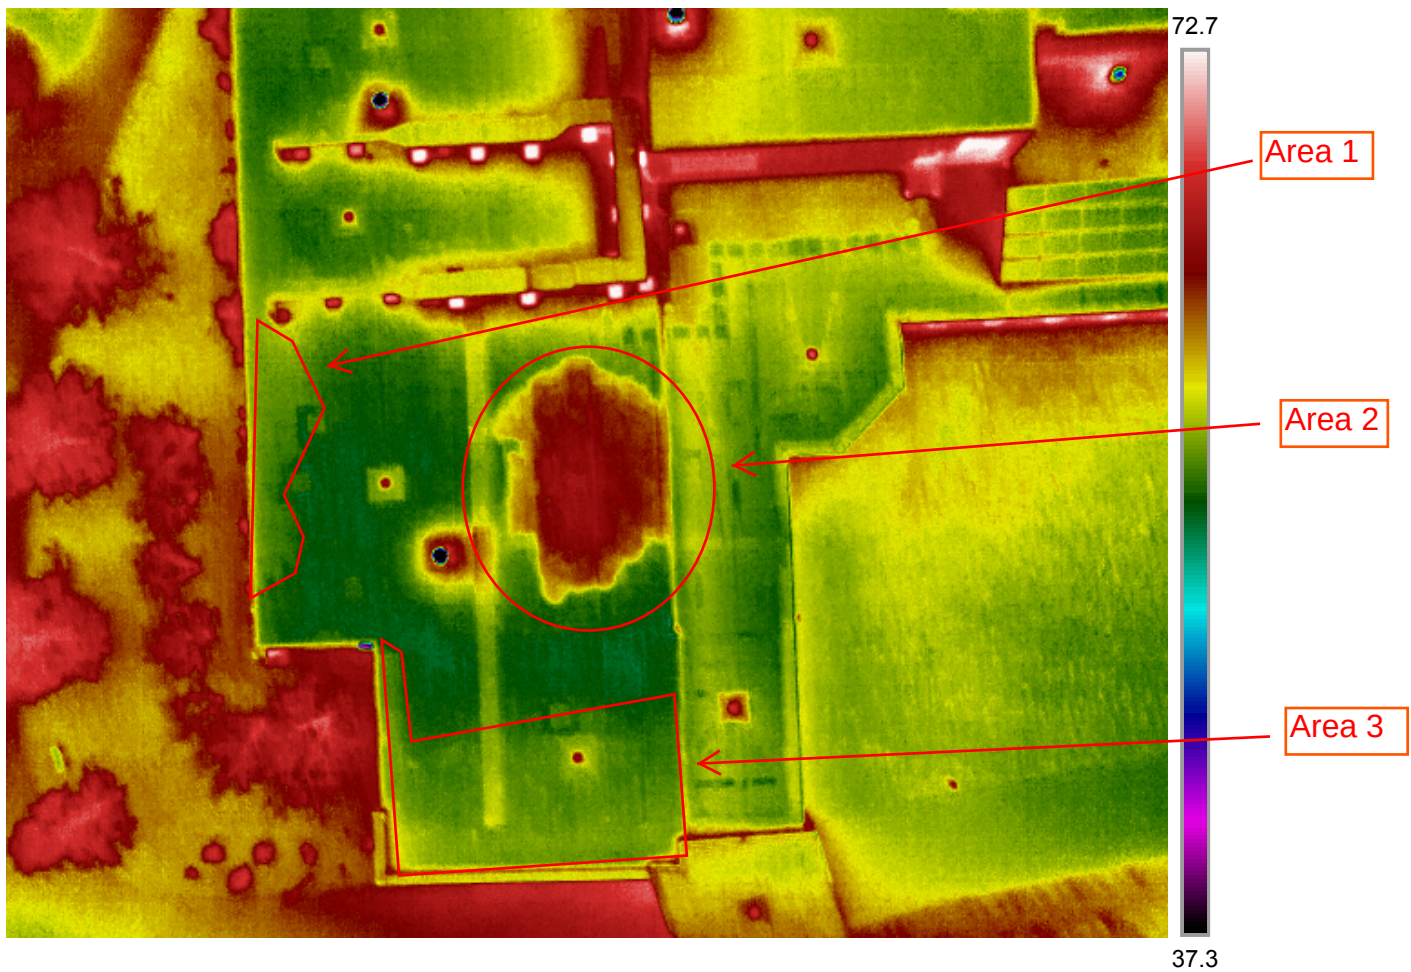
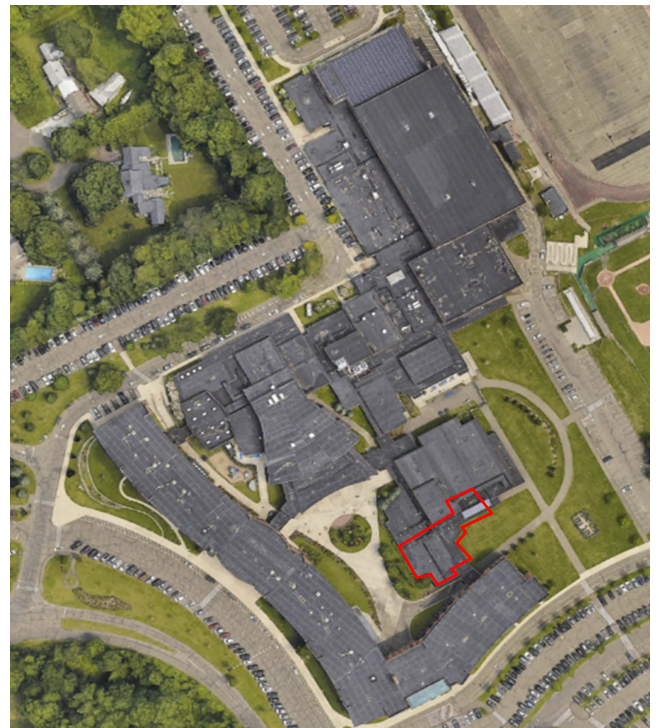
Area 1 ~ 225 sqft. Area along the W edge of this roof section. Appears to be possible standing water stain or heat/moisture.

Area 2 ~ 623 sqft. Large area of concern. Appears to be significant heat/moisture in this location.

Area 3 ~ 710 sqft. Area along the S edge of this roof section. Likely due to stain from standing water or light moisture/heat.

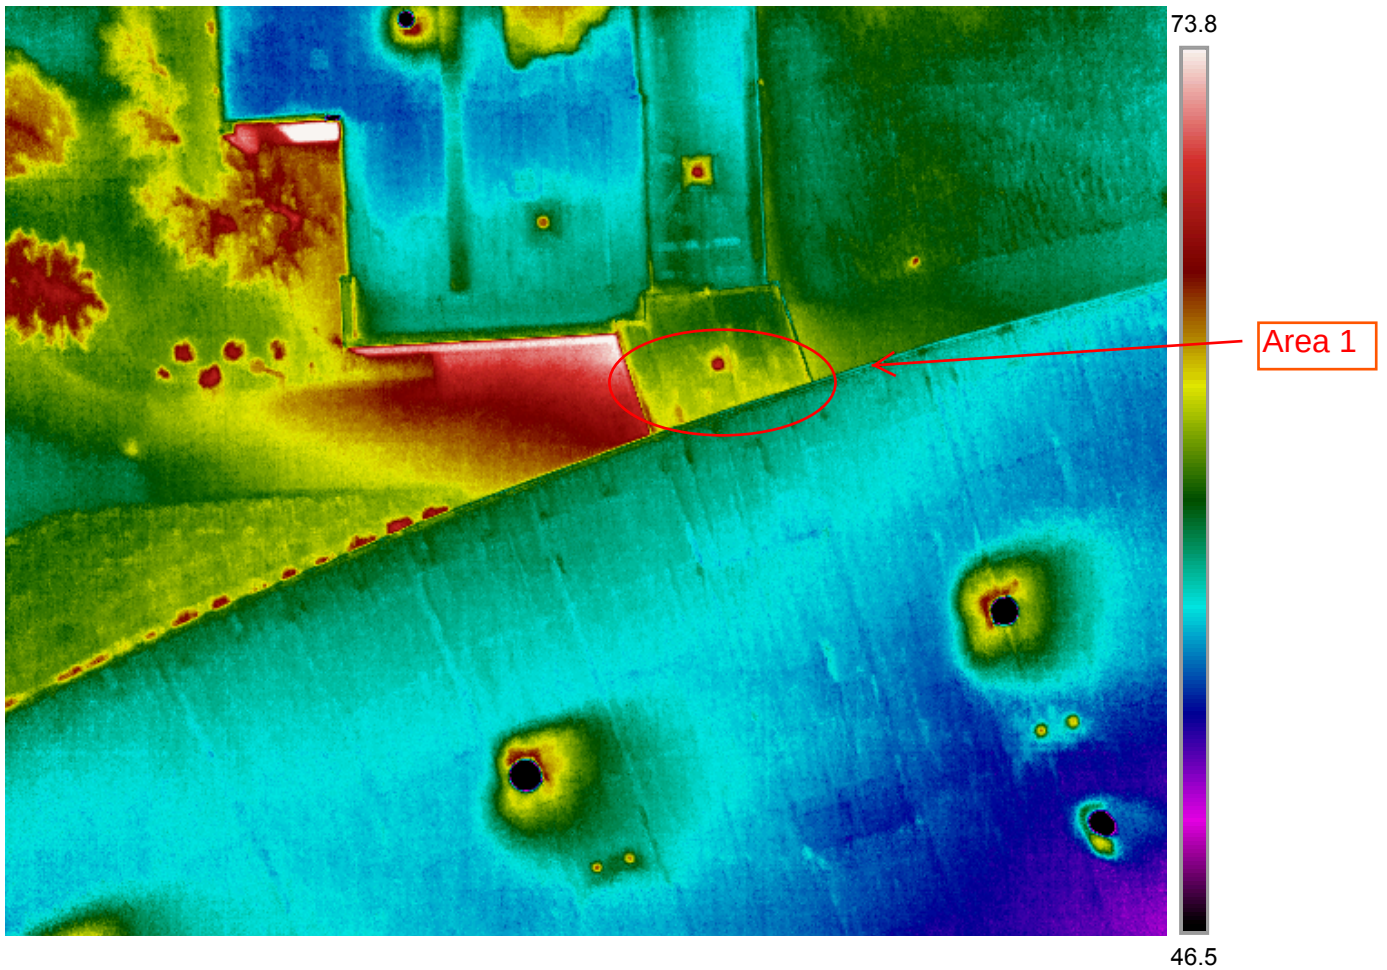
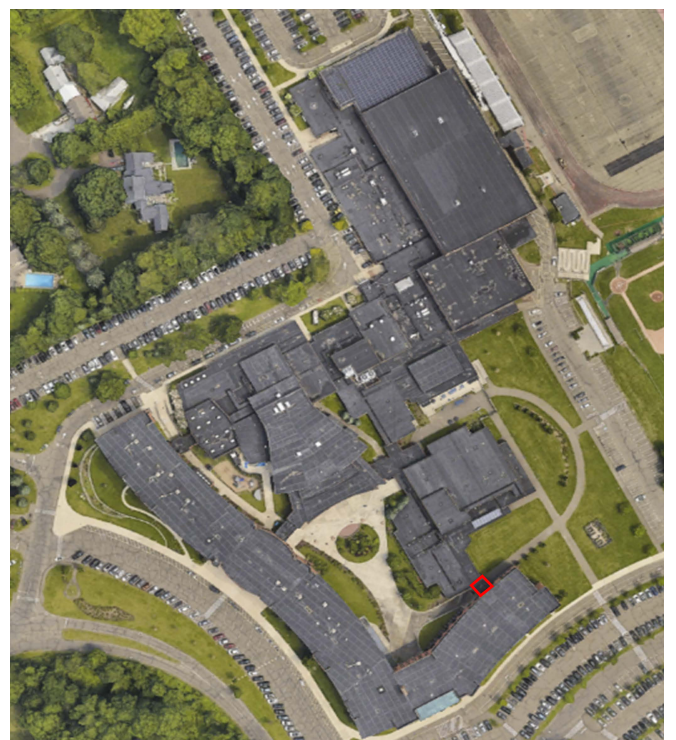
Roof T

Area 1 ~ 125 sqft. Small area along the south portion of this roof area.

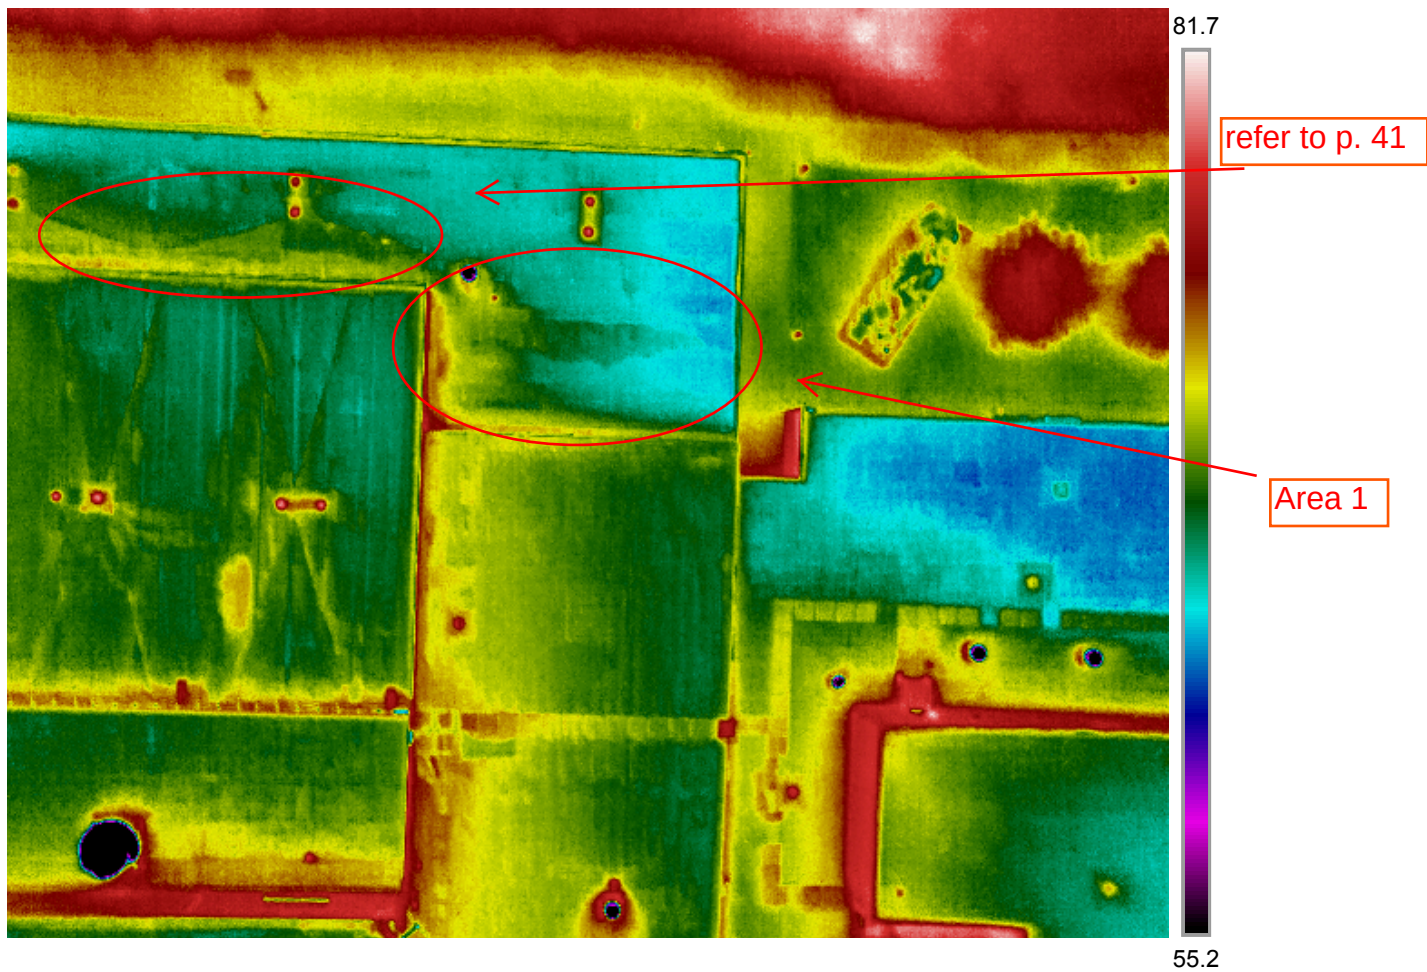
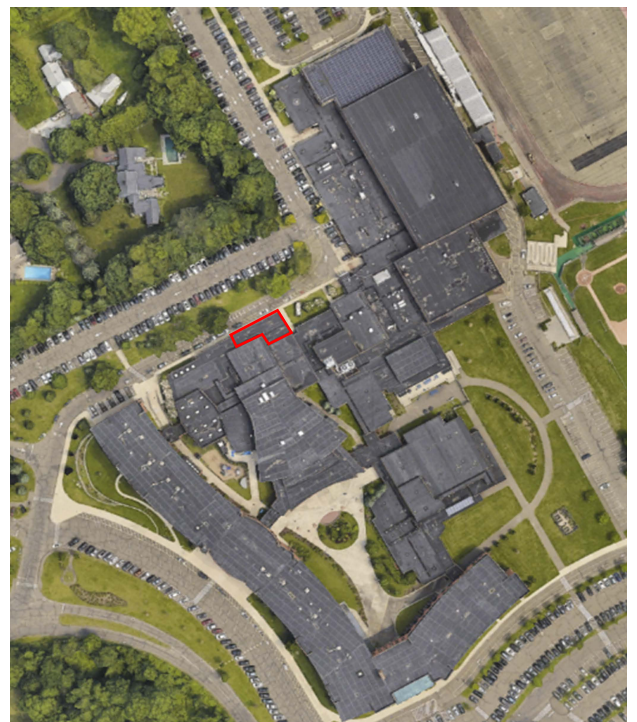
Roof U

Area 1 ~ 306 sqft. Area along the wall that is adjacent to Roof Area V. Could be presence of standing water or stains.

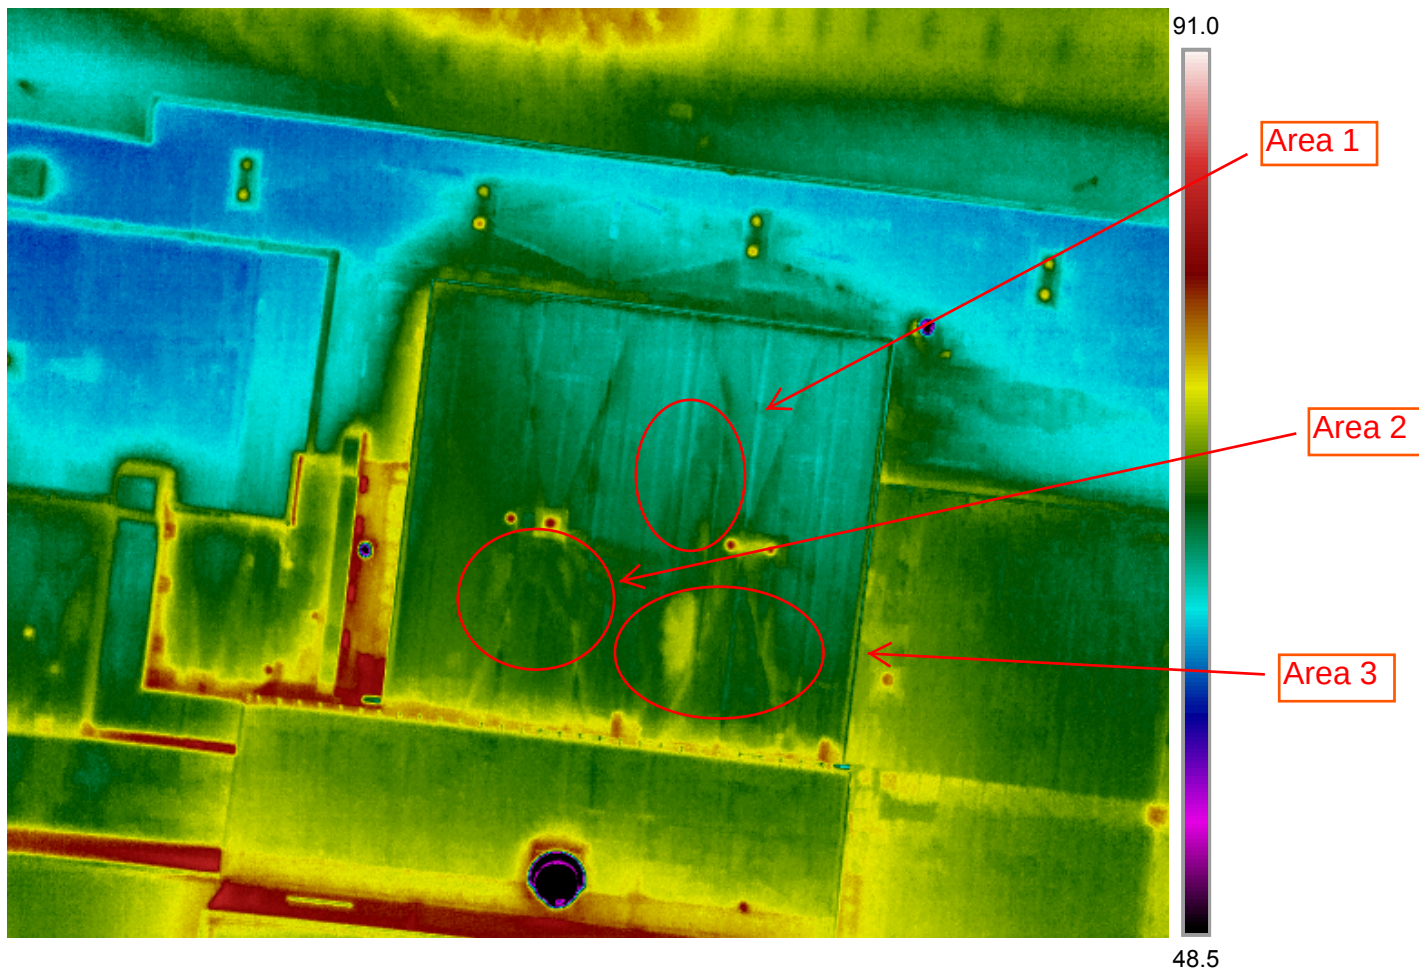
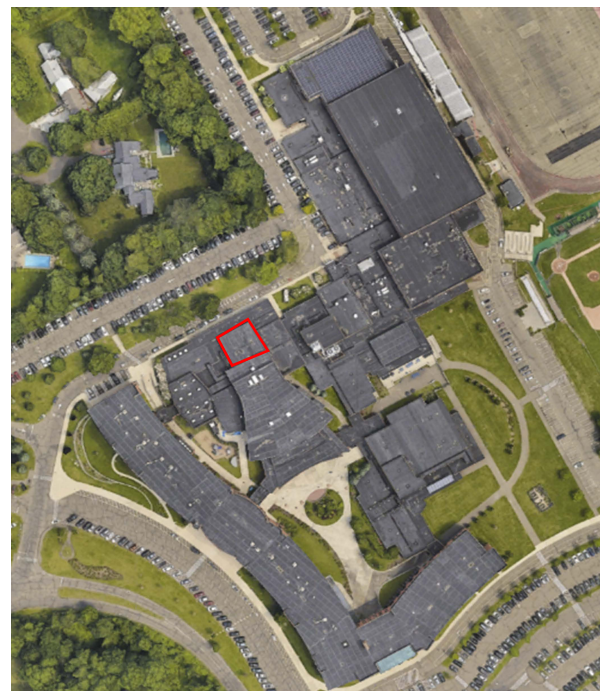
Roof V

Area 1 ~ 95 sqft. N of Area 3. Looks like possible standing water or staining resulting from crickets underneath.  
Area 2 ~ 115 sqft. Area just S of the drain. Appears to be standing water or stains.  
Area 3 ~ 361 sqft. SE corner of this roof section. Appears to be a combination of some standing water/stains and a large spot of moisture/heat.
