# **INFRARED ROOF INSPECTION**

LOCATION:  
STAPLES HIGH SCHOOL  
70 NORTH AVE  
WESTPORT CT 06880

This report summarizes the findings of our Infrared Roof Moisture Analysis of the roof at Staples High School, Westport, CT, performed on November 7, 2020.

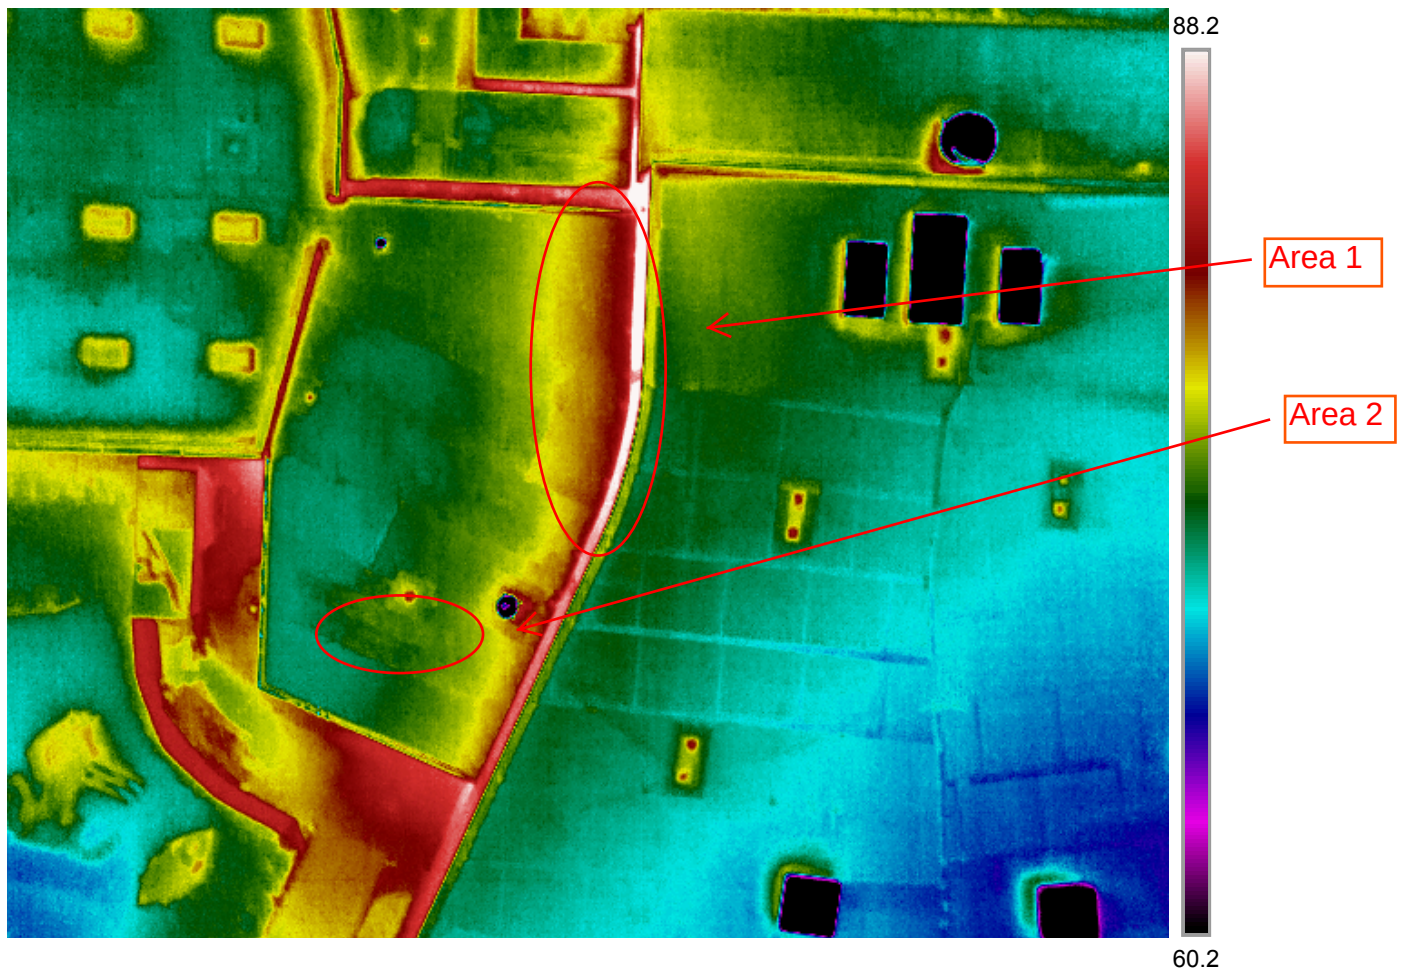
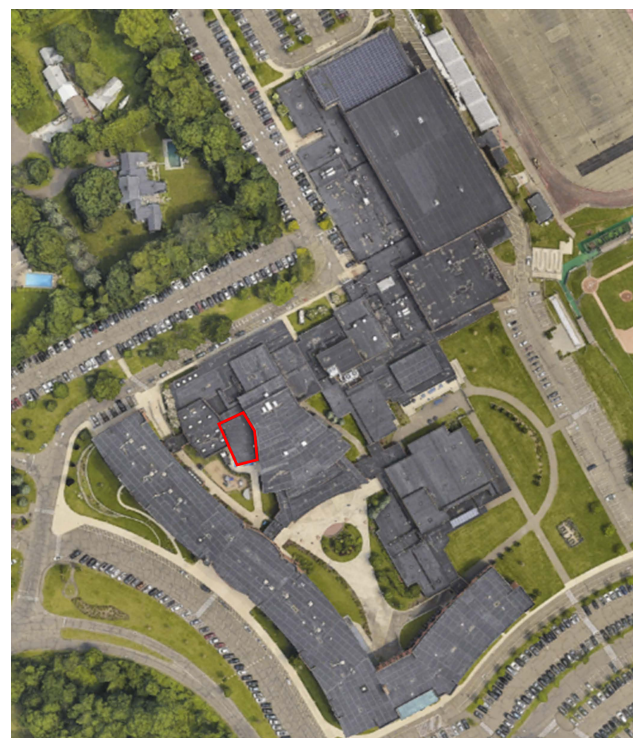
Area 1 ~ 250 sqft. Area along the E edge of this roof section where possible water stains/moisture come from the higher roof.

Area 2 ~ 52 sqft/ Small area S of the drain closest to the marked area. Appears to be residue from standing water or possible heat/moisture.

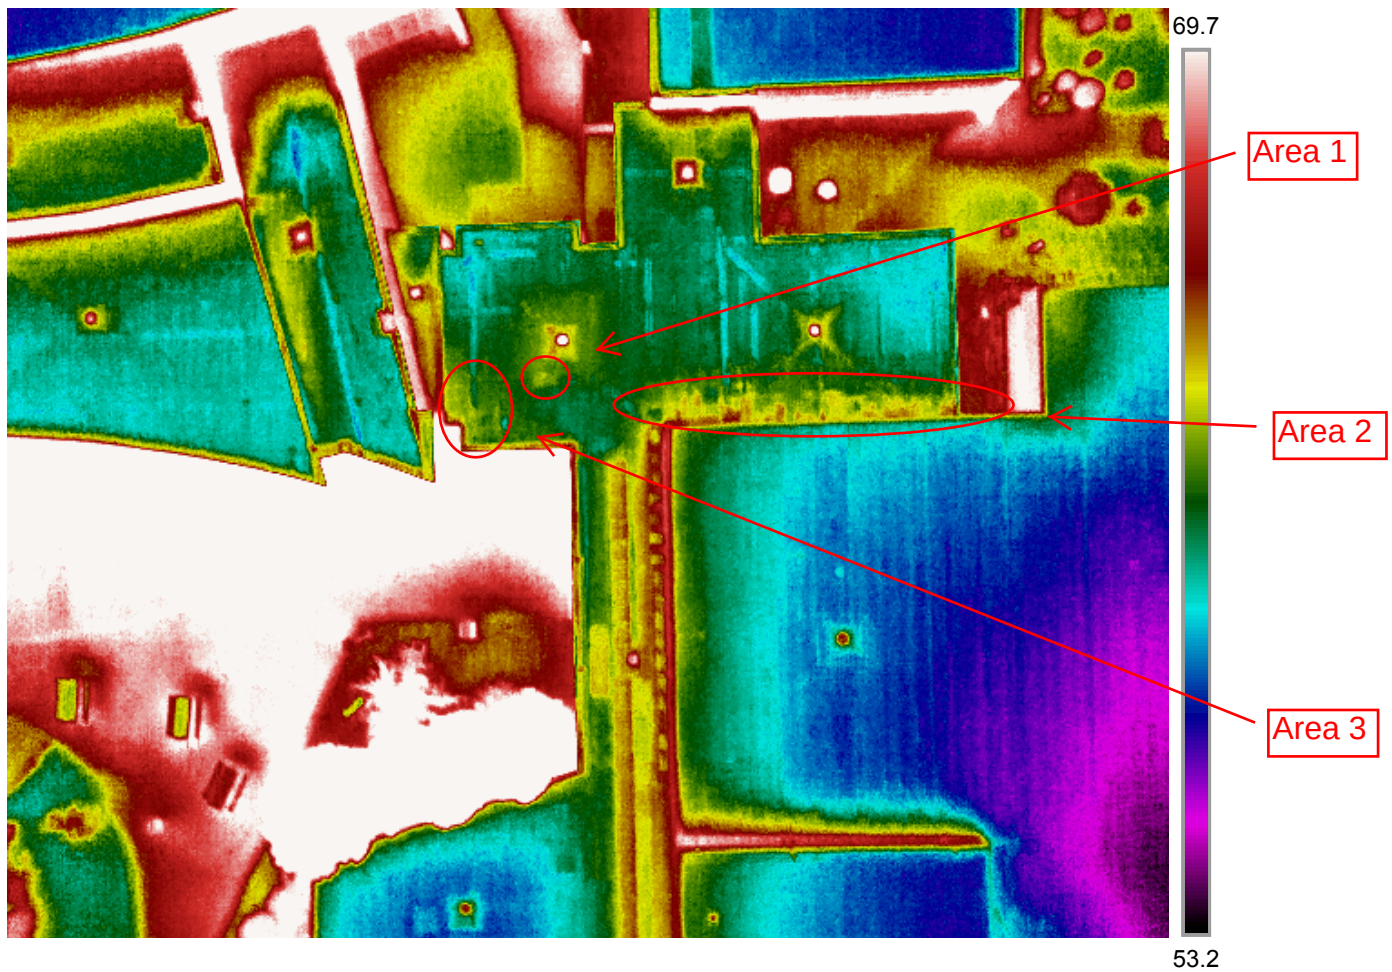
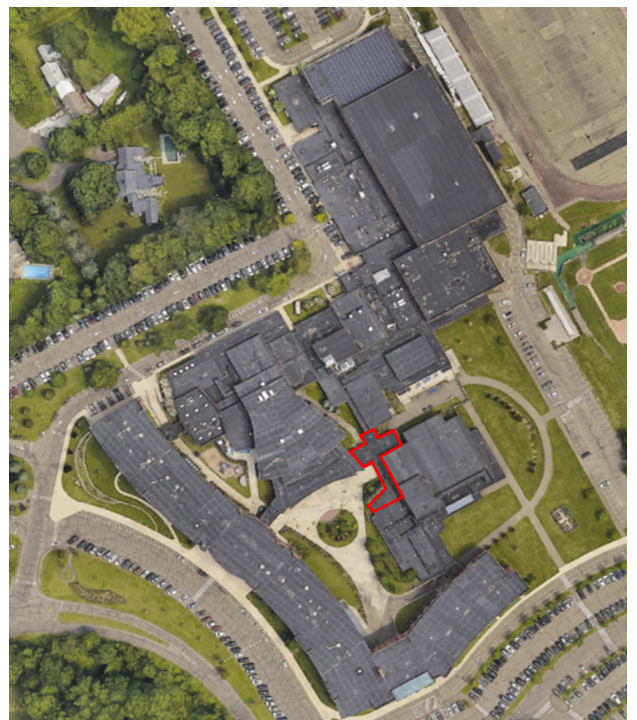
Area 2 ~ 185 sqft. Roof section along the base of the Roof P wall. Likely standing water or stains. Possible moisture/heat from water coming from above.

Area 3 ~ 43 sqft. Corner section along the base of the SW corner of this roof area.

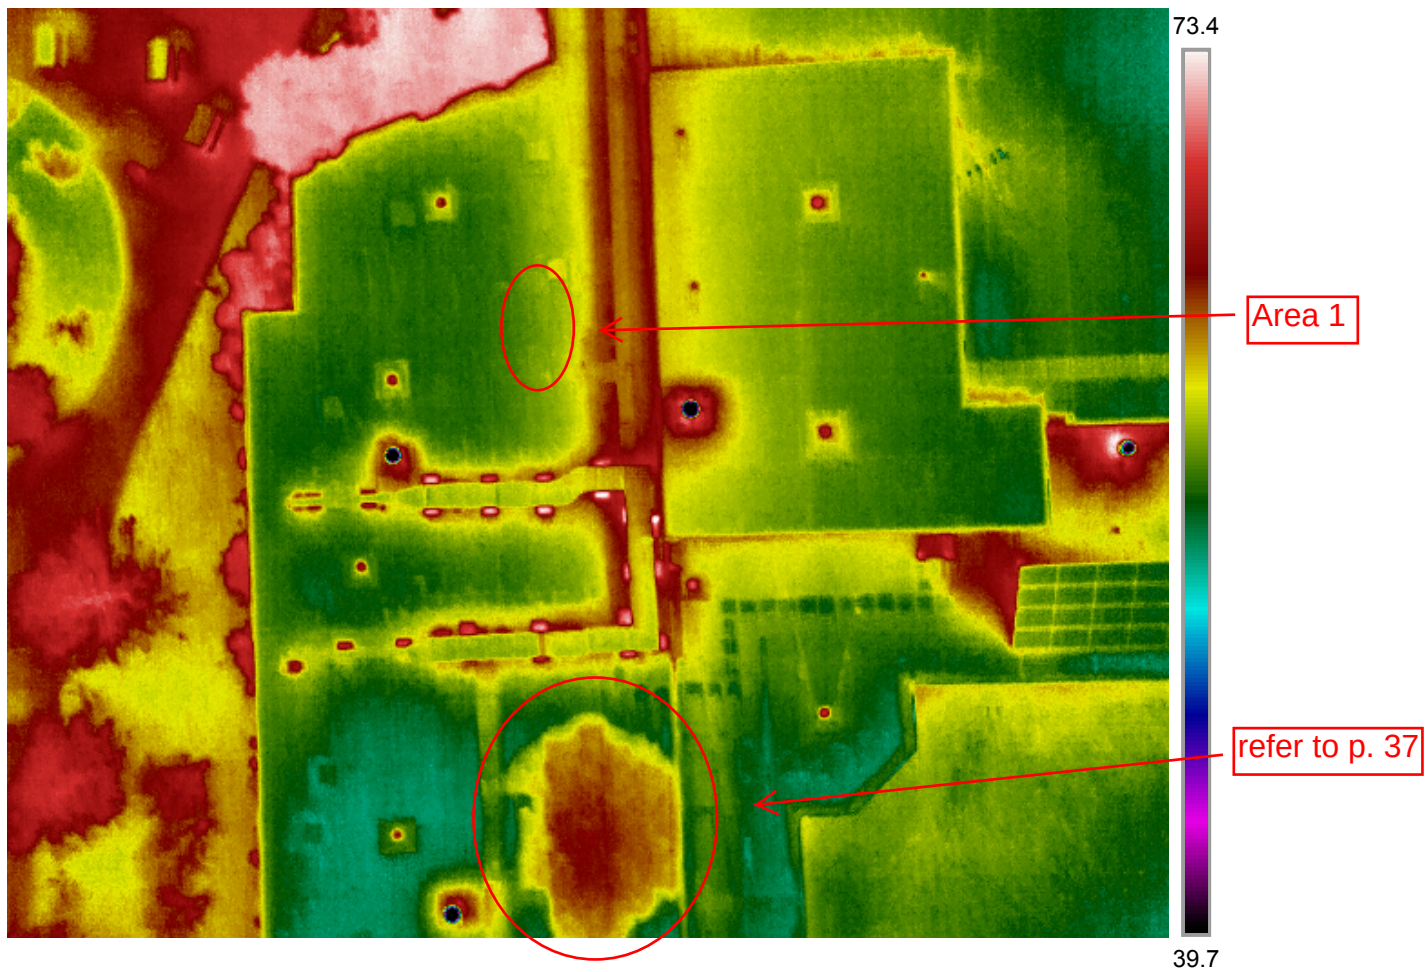
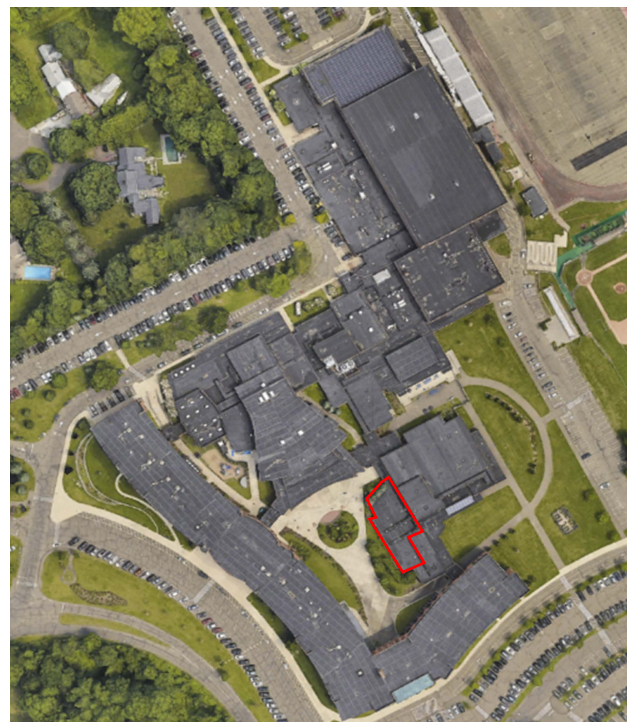
Roof X

Area 1 ~ 45 sqft. Area along the W edge of the walk pads that appears to have standing water or water staining. Possible moisture/heat.

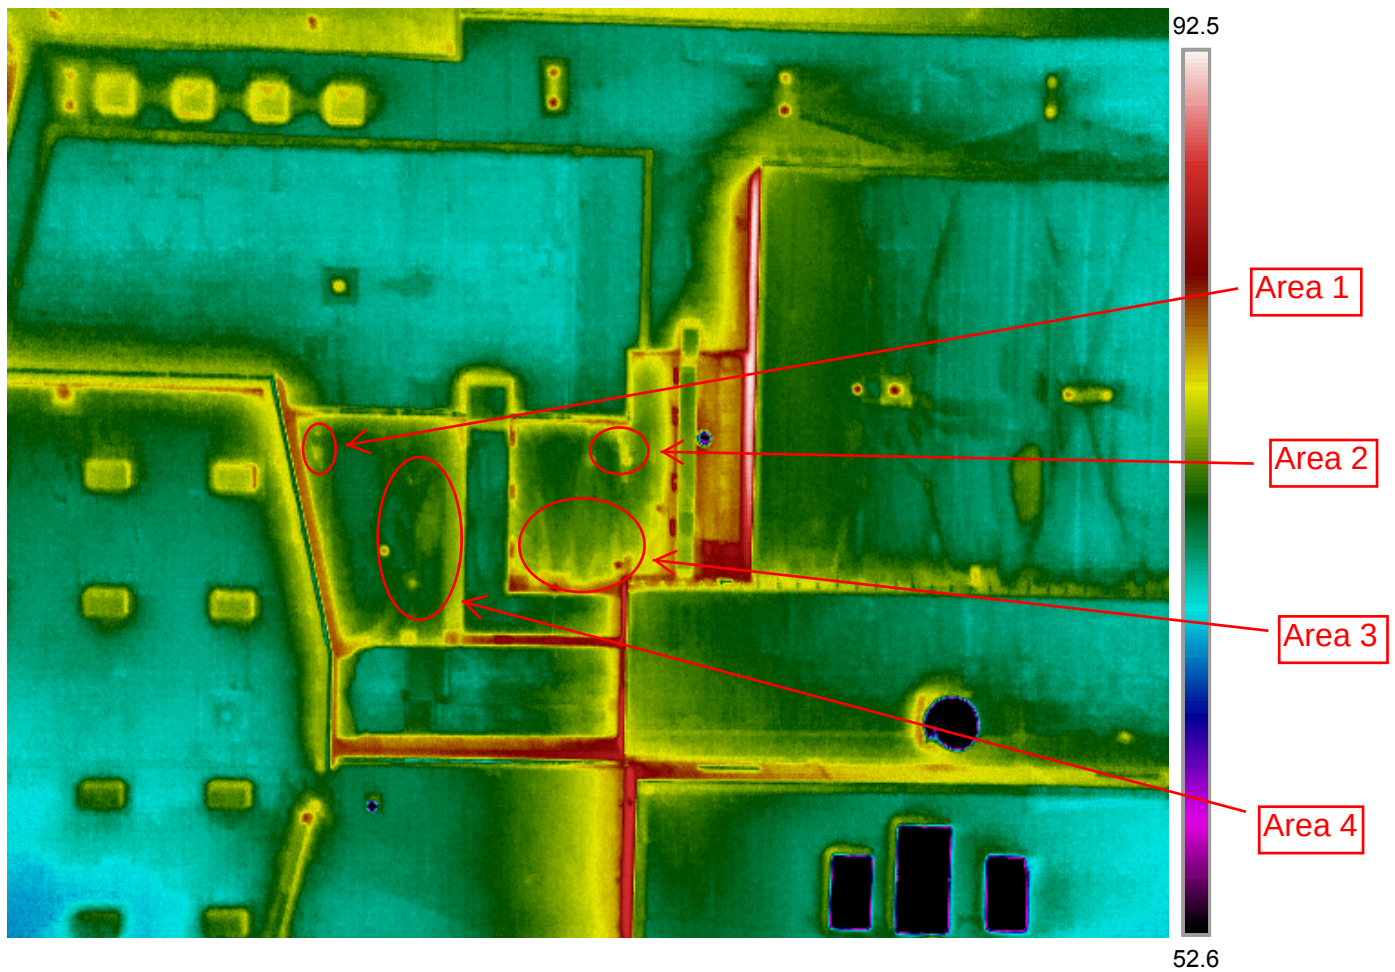
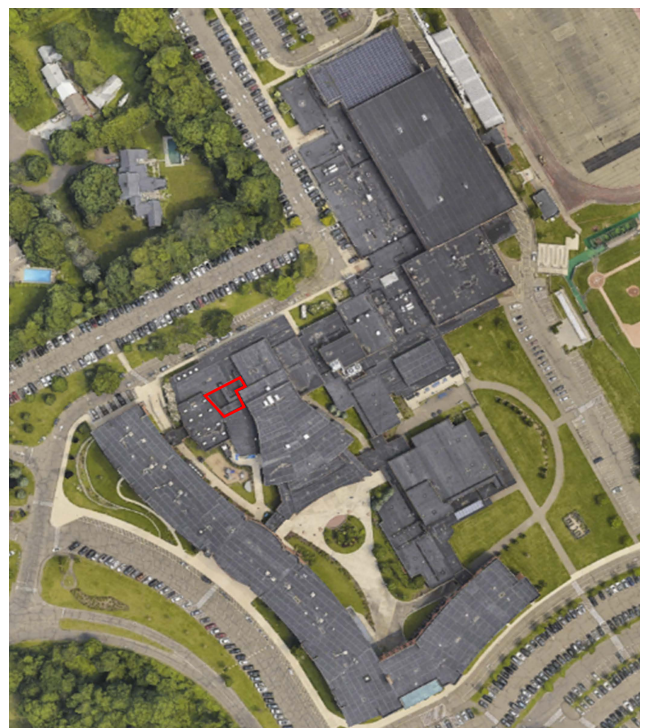
#### Roof Y

Area 1 ~ 6 sqft. Small spot in the NW corner of this roof section  
Area 2 ~ 25 sqft. Small area in the NE corner of this roof section  
Area 3 ~ 45 sqft. Area along the edge of the vent/ductwork.  
Area 4 ~ 65 sqft. Appears to be standing water or staining.  
Possible moisture/heat.

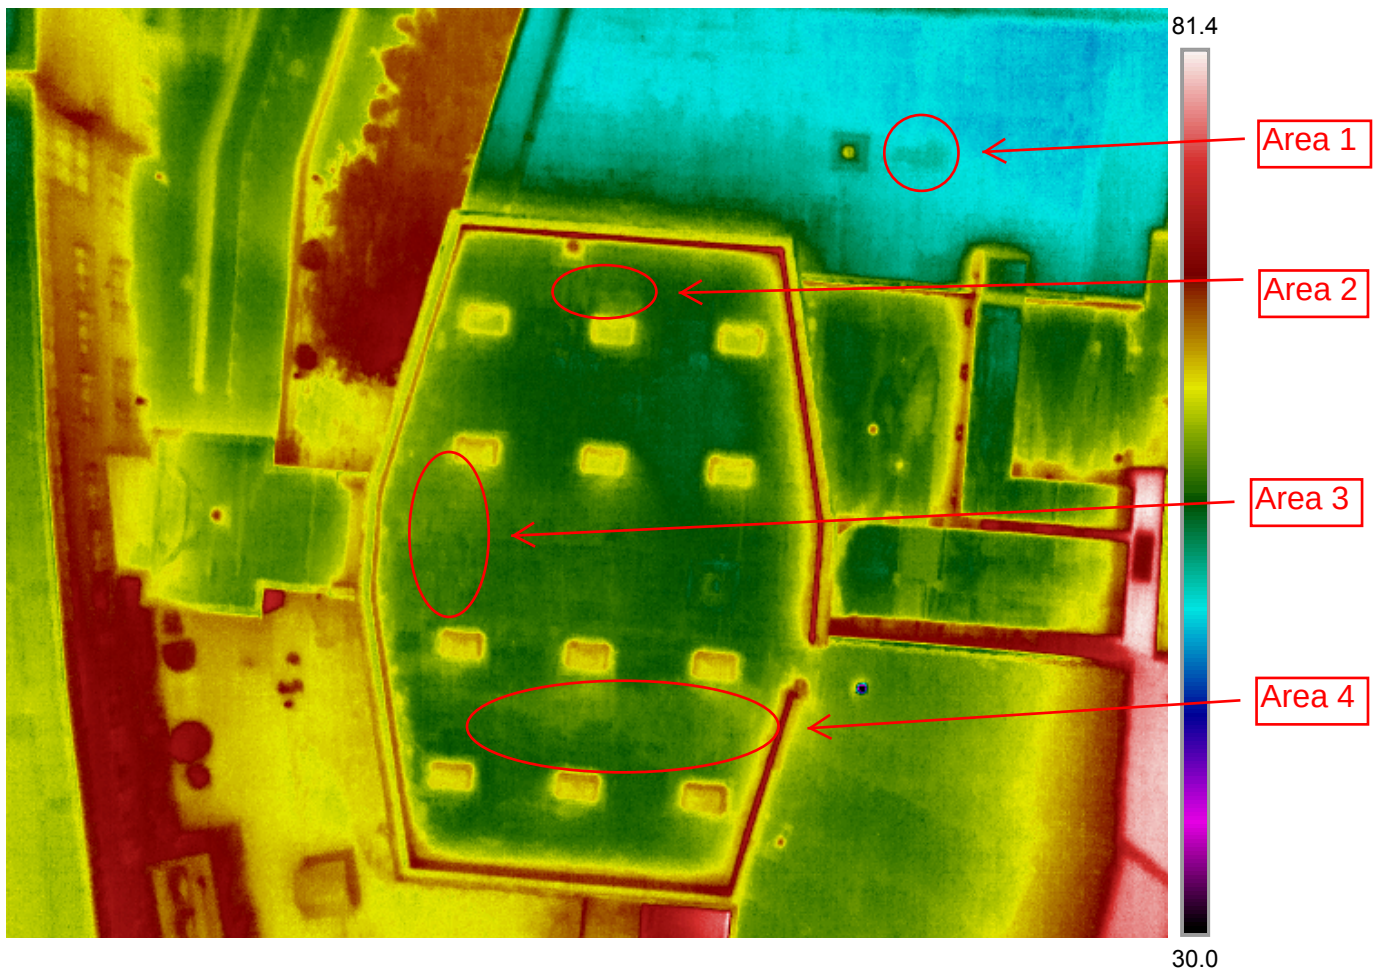
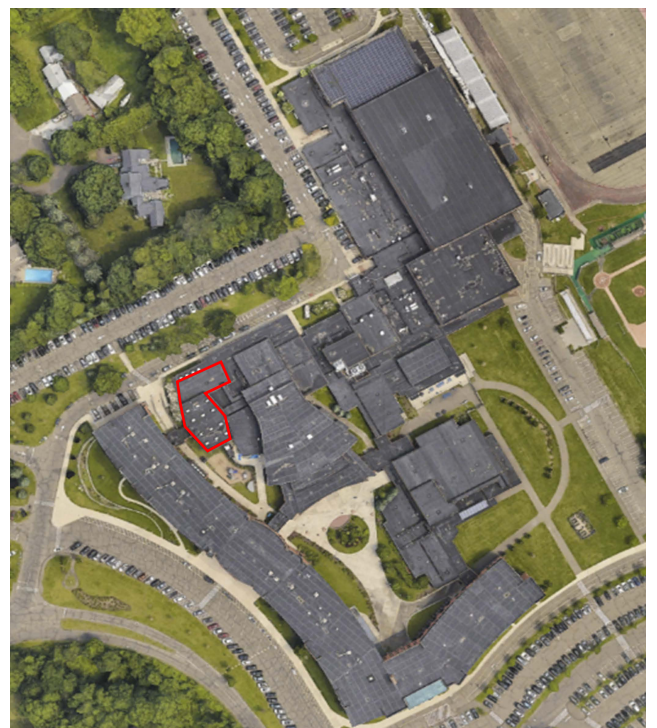
### Roof Z

Area 1 ~ 42 sqft. E side of the drain on the upper portion of this roof section.  
Area 2 ~ 38 sqft. N side of the closest unit to the marked area. Potential standing water/staining or heat/moisture.  
Area 3 ~ 105 sqft. Appears to be standing water or staining. Possible moisture/heat.  
Area 4 ~ 125 sqft. Appears to be standing water or staining. Possible moisture/heat.
