# MCKENZIE ENGINEERING COMPANY, INC.

August 28, 2023

Re: Roof Evaluation – Boylston Elementary School  
200 Sewell St, Boylston MA

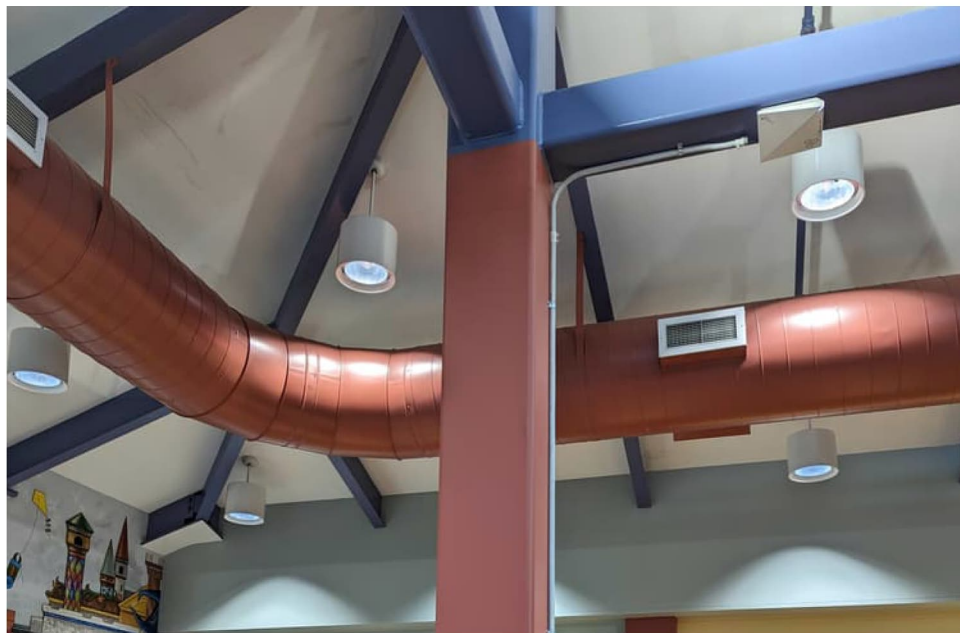
Library - Roof Framing  
PXL\_20230825\_141815951

The library roof structure is constructed of an 8x8 trussed tube steel frame supporting an arched upper roof and a hip style pitched lower roof with a standing seam metal roof deck. Calculations as to the roof capacity show that the roof was originally structurally overdesigned and can easily withstand double any code required loading. Two roof leaks were observed at the southeast and southwest columns, but these two leaks were not related to any structural issue but are most likely related to a caulking/flashing issue.

No structural issues were observed with the library roof or associated members and this roof is safe.

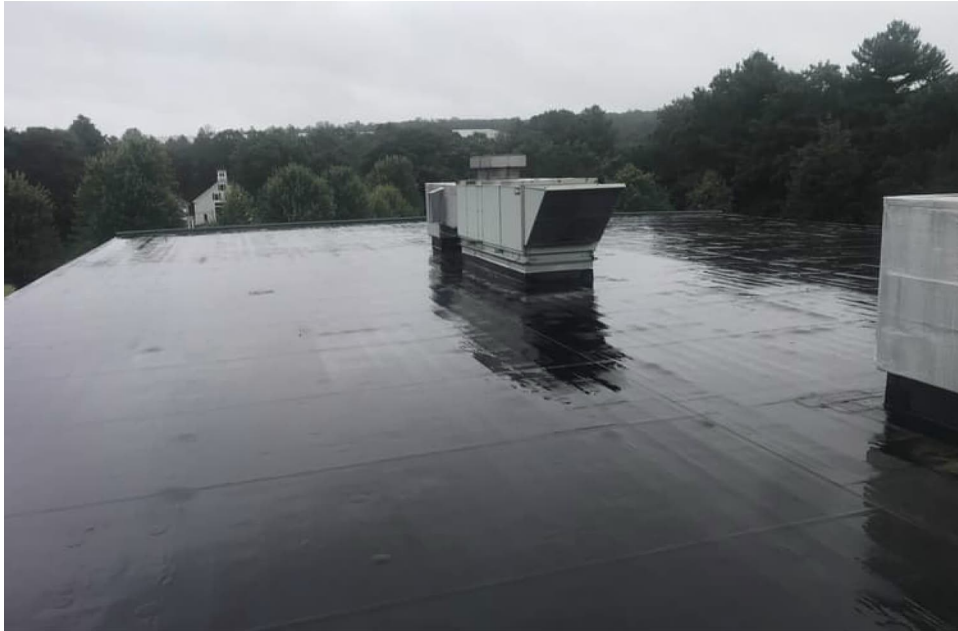
Gymnasium Roof  
IMG\_9705

The gymnasium roof is constructed of 36-inch-deep open web steel joists that span 63'-4". There were no observed structural issues from below or above on the roof. The calculated average allowable snow load for this roof is 50 pounds per square foot which exceeds the 35 pounds per square foot code requirement. There were no observed roof leaks.

No structural issues were observed with the gymnasium roof or associated members and this roof is safe.

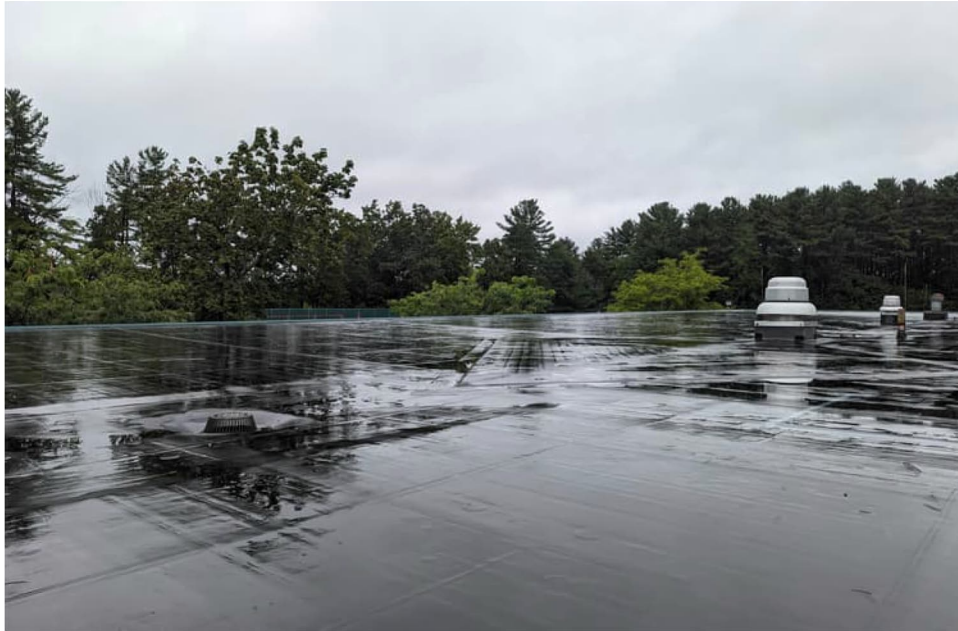
Other School Roof Areas  
PXL\_20230825\_144834566

Roof areas adjacent to the Library and Gymnasium were also evaluated and found to exceed code requirements for load capacity.
