# Model Assessment Status & Summary of Findings

November 30, 2016

# Model Assessment Status Update (Performed November 16,17,18)

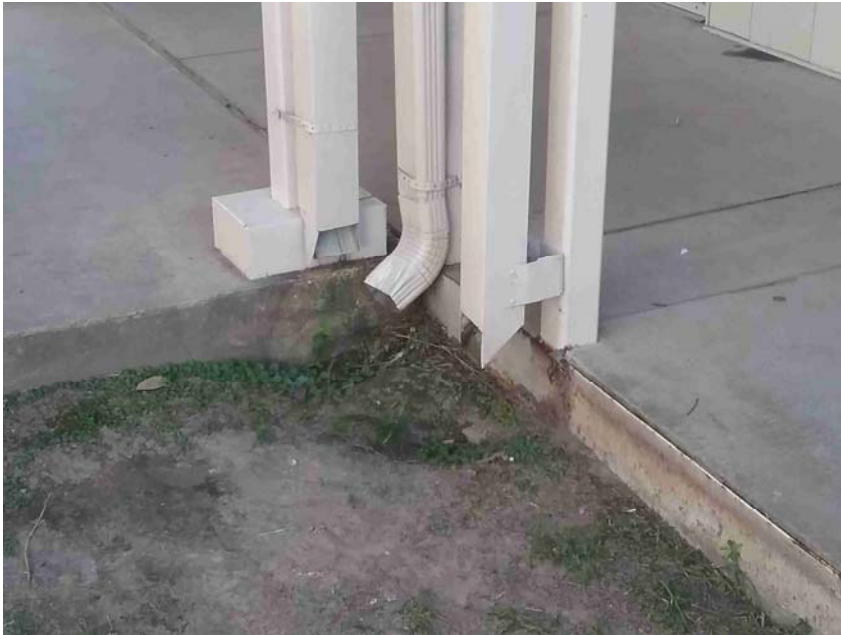
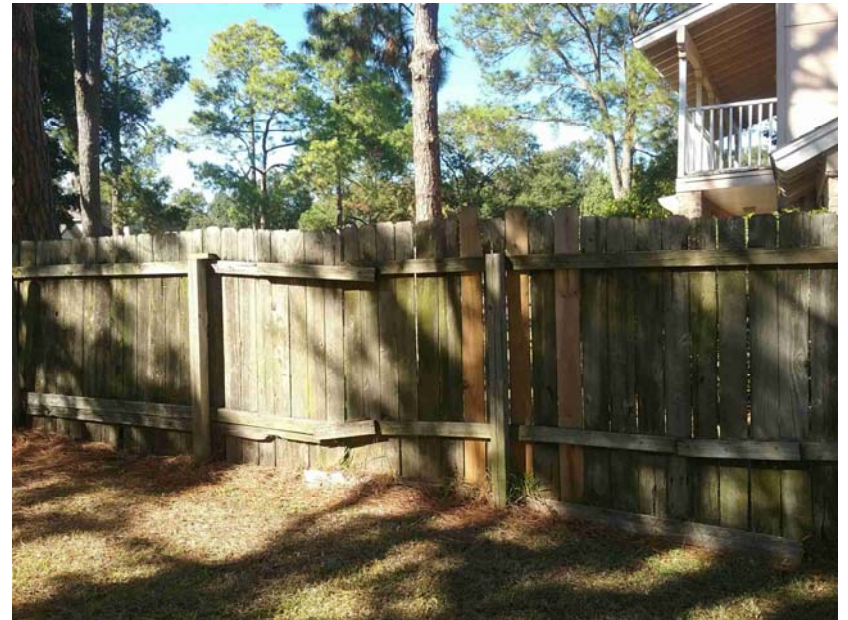
## Terrace ES

- Site Improvements
  - Site-wide asphalt paving for parking and vehicle circulation is deteriorated and failing in some areas
  - Perimeter site fencing is insufficient or inappropriate
  - Soil erosion noted at grade around perimeter of main building and concrete walk surfaces.
- Exterior Enclosures
  - Main building exterior window system is original and has single pane glazing in aluminum frames are at the end of their useful life.
  - Main building exterior aluminum framed doors with single pane glazing are original and are at the end of their useful life.

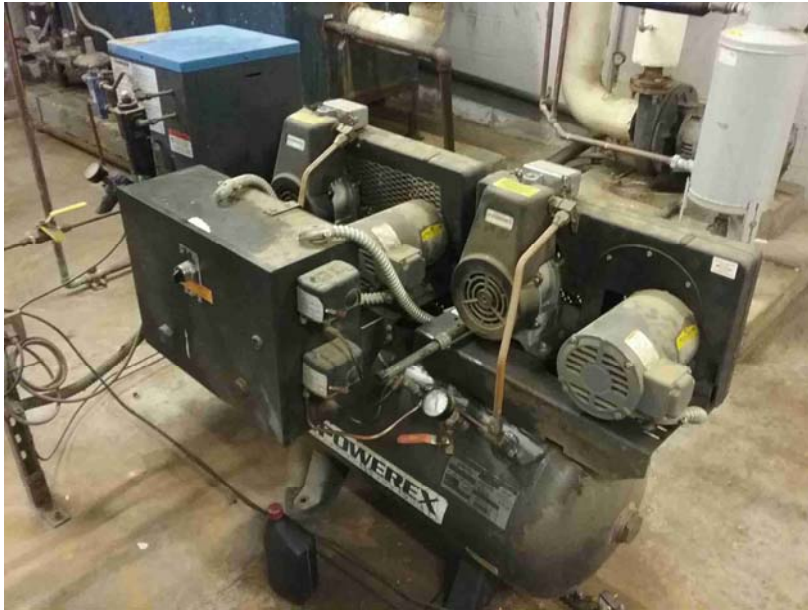
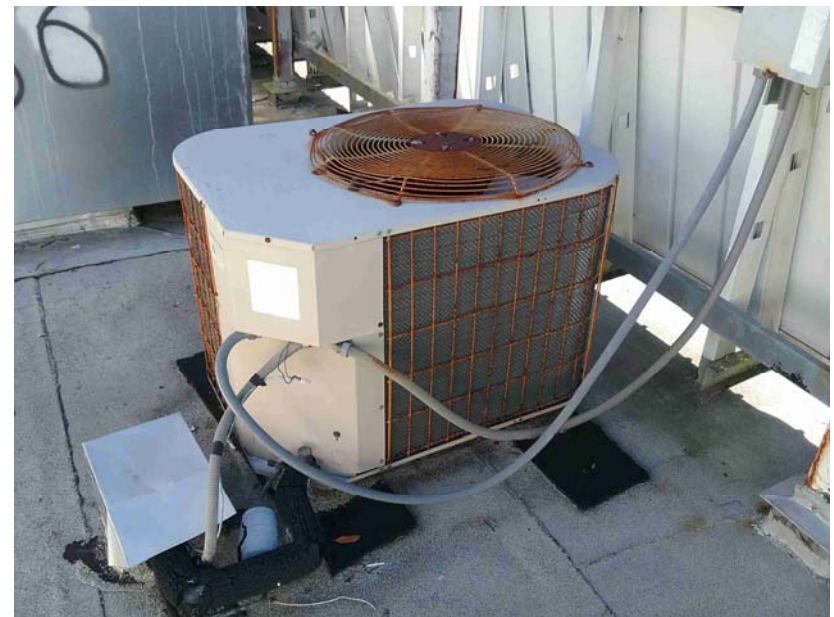
## Terrace ES

- Plumbing
  - Domestic water distribution piping (galvanized pipe) – 75% is original, 25% replaced.
- Heating, Ventilation, Air Conditioning (HVAC)
  - System designed for open plan school, air distribution outdated (**Big Ticket Item**)
  - Pneumatic controls on units are aged and at (**End of Useful Life**)
  - Multiple HVAC units use outdated refrigerant (**Deficiency**)
  - Eight air handling units appear to be original construction and are at the end of their useful life

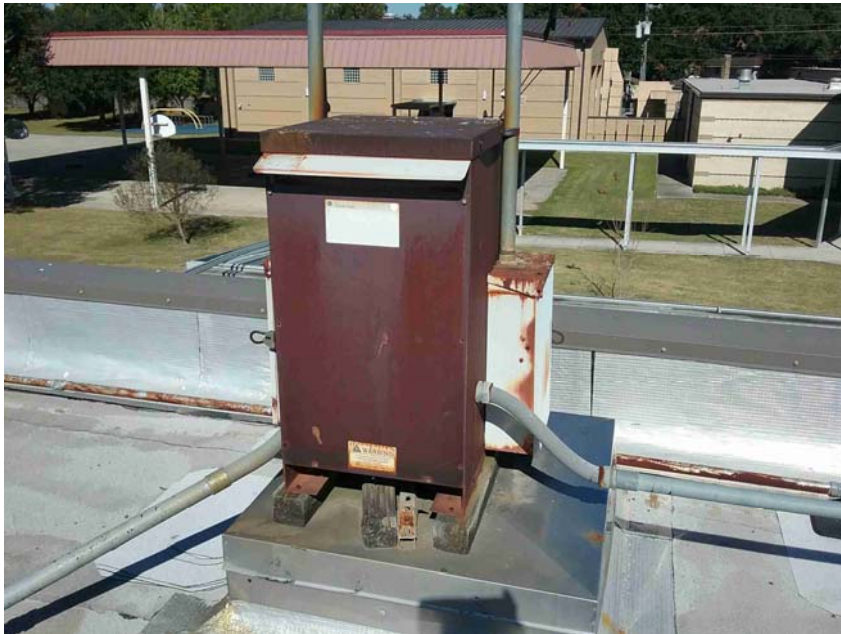
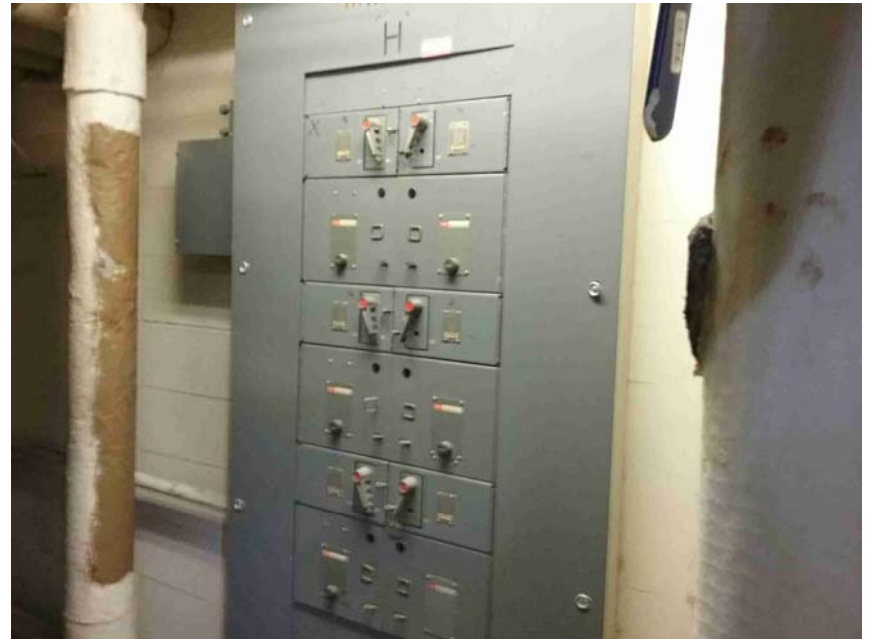
## Terrace ES

- Main electrical distribution equipment and switchboards are at the end of their useful life.
- Several rooftop equipment units, switches, panels are heavily corroded and need replacement
- Exit and emergency light fixtures are aged, battery pack replacement costs are excessive
- Clock system is out dated
- School lacks emergency generator and lightning protection

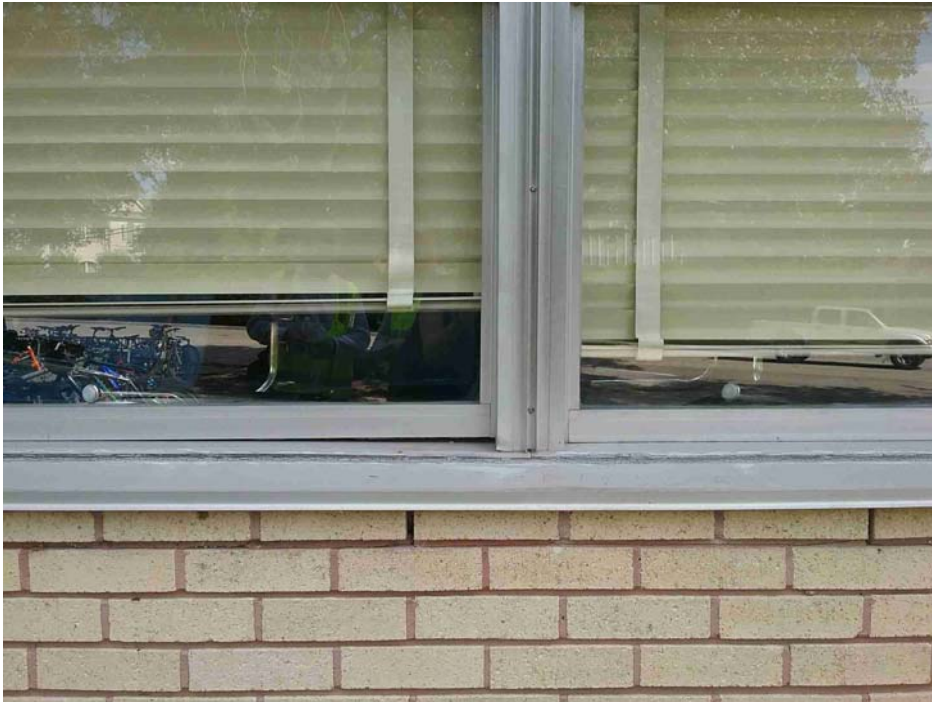
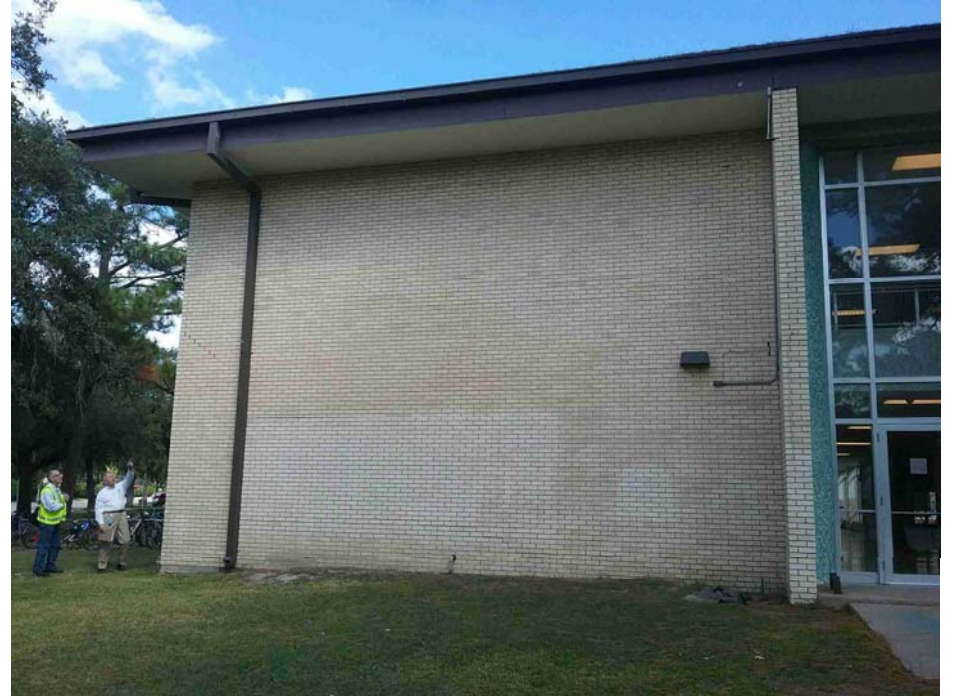
# Memorial MS

- Exterior Enclosures
  - Original building exterior window system and entry system (both single pane) are at the end of their useful life.
  - Brick façade at SW corner of main building experiencing moderate stress cracking. Similar conditions were not noted elsewhere on main building.
- Site Improvements
  - Several areas around the buildings experience storm drainage issues, multiple downspouts drain direct onto ground.

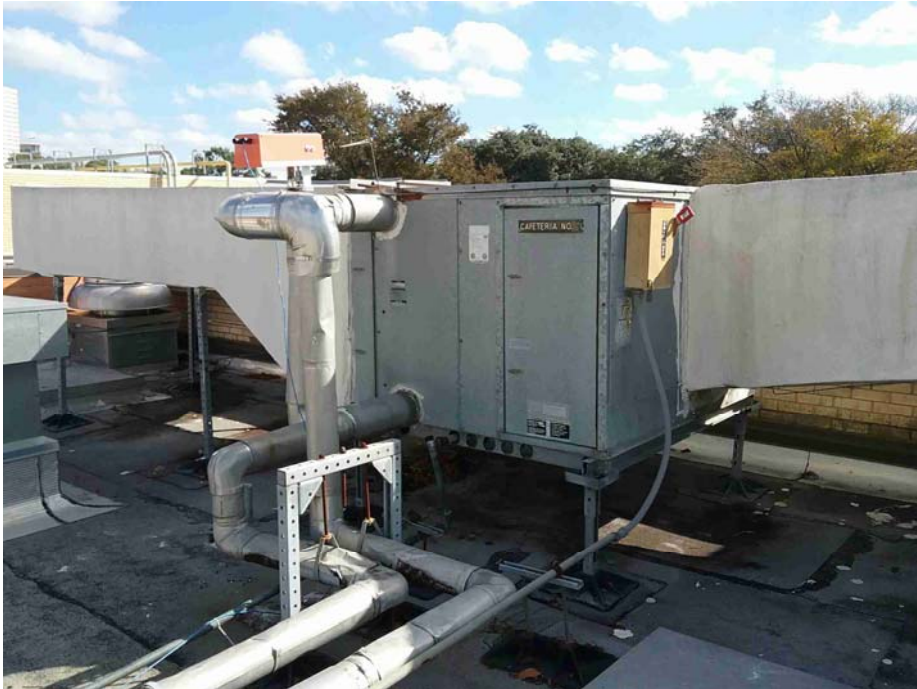
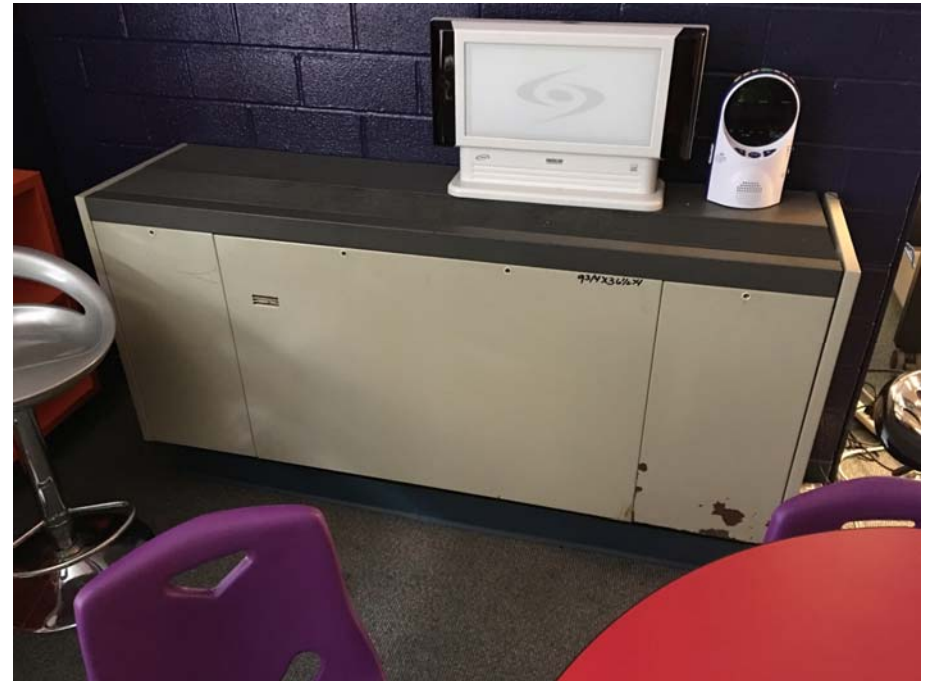
# Memorial MS

- Original 2 pipe water system and fan coil units are operational throughout the building. System is at the end of its useful life.
- Multiple HVAC package units use outdated refrigerant.
- HVAC system controls are outdated and require replacement.

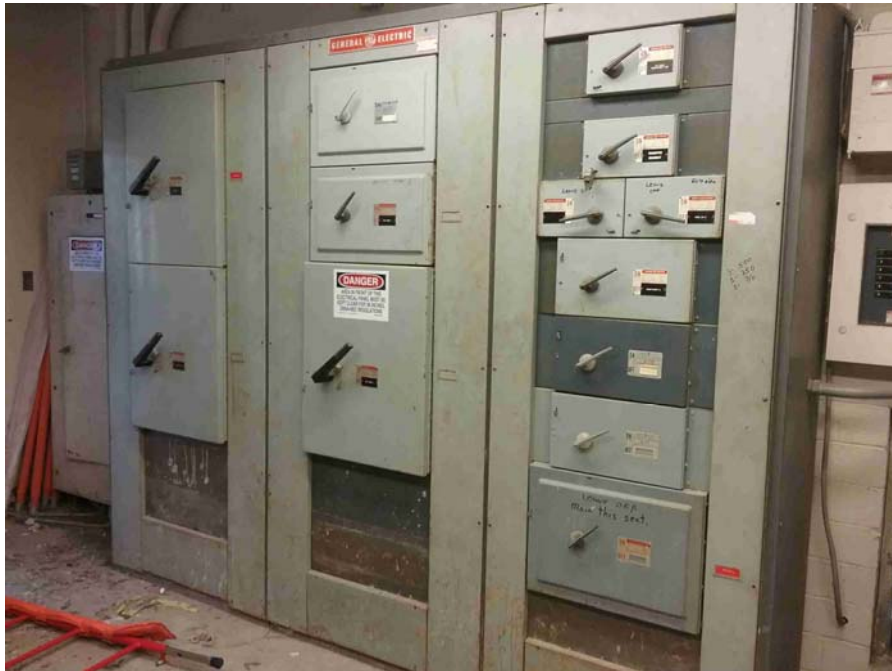
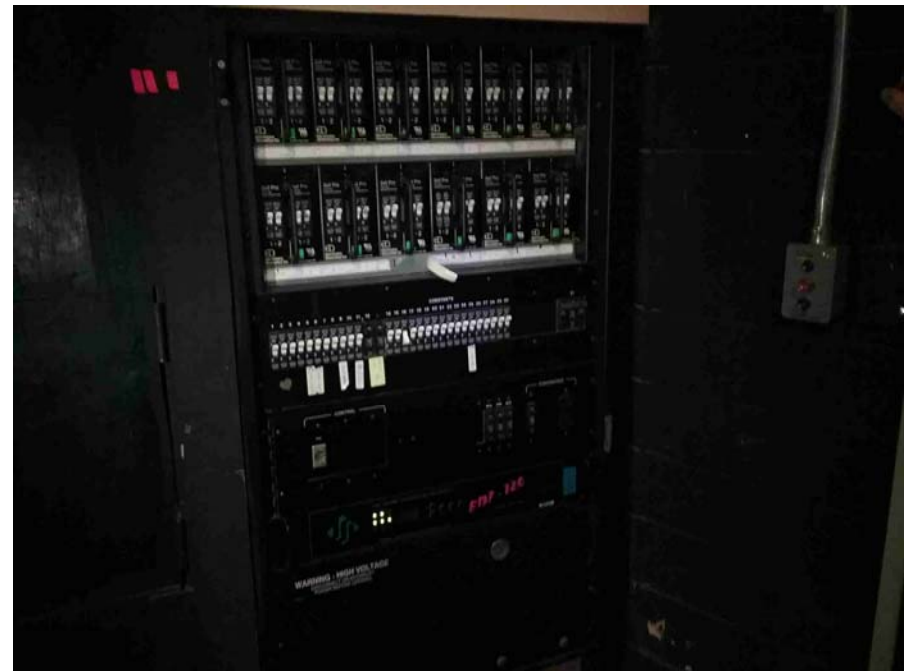
# Memorial MS

- Switchgear units appear original and are at the end of their useful life.
- School lacks emergency generator and lightning protection system
- Dimmer system in Auditorium is outdated, replacement parts are not available.
- Exit and emergency light fixtures are aged, battery pack replacement costs are excessive
- Clock system is outdated

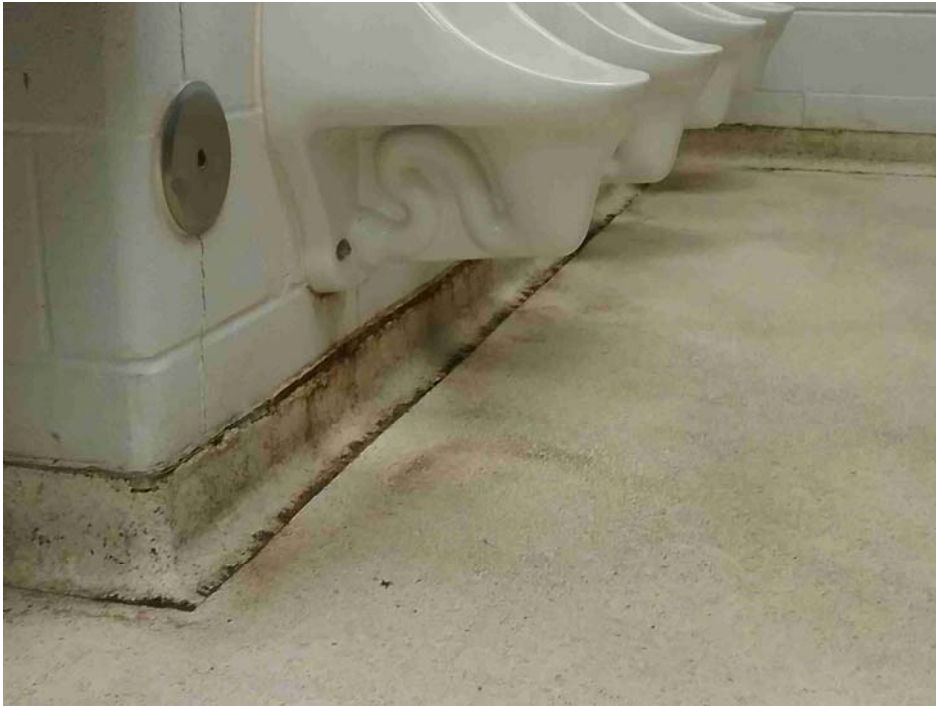
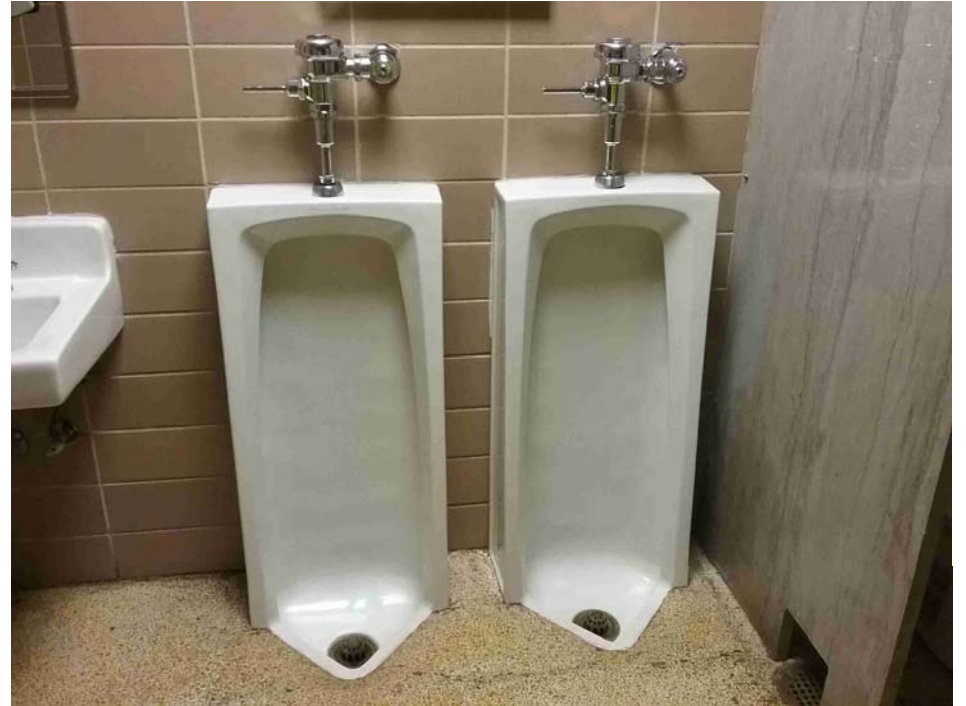
## Memorial MS

- Original terrazzo floors are severely stained and are deteriorating campus wide, most notably in restrooms

- Plumbing fixtures in original building are aged and at the end of their useful life. Fixtures do not meet accessibility standards and create unsanitary condition.

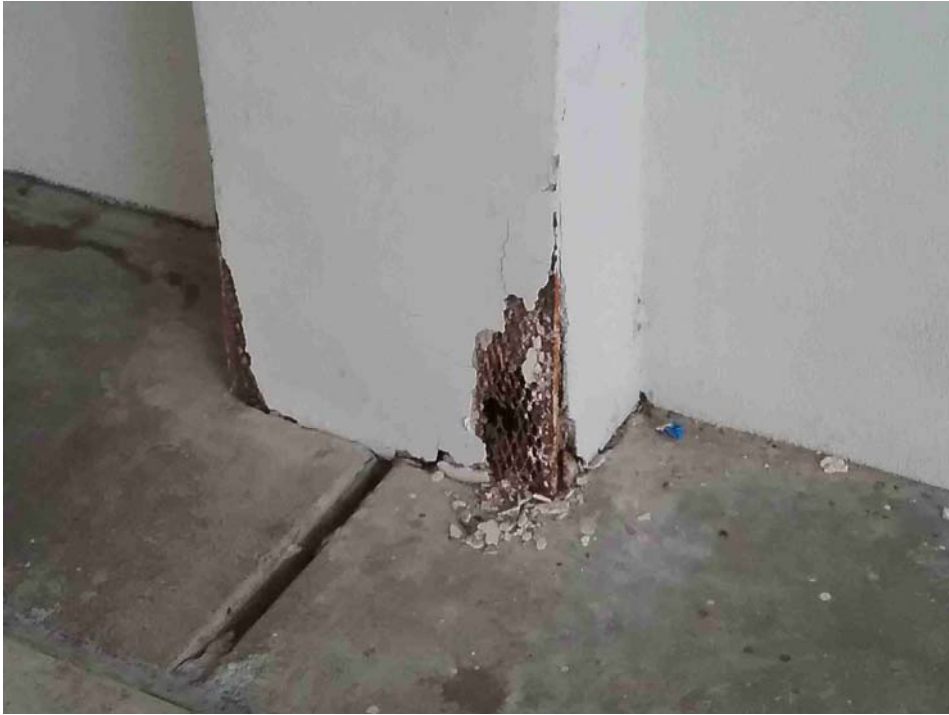
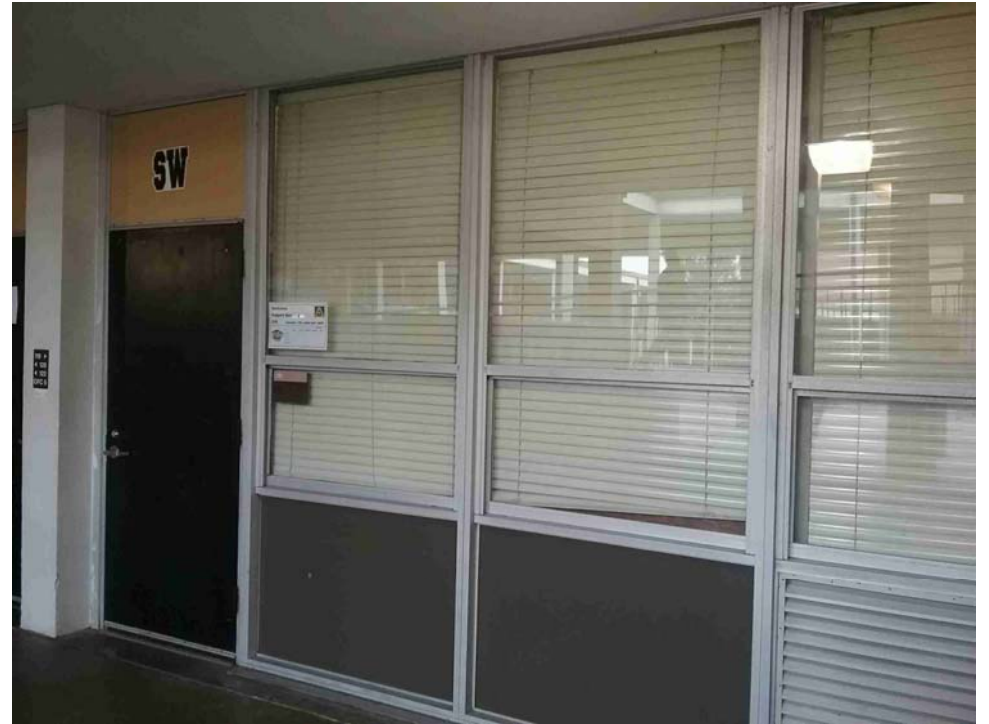
## Spring Woods HS

- Exterior Structure and Enclosure
  - Exterior Plaster Covered Columns are showing stress and the plaster veneer is deteriorating.
  - Exterior windows on main building are original and are at the end of their useful life. Glazing is single pane, some operable windows are damaged
  - Original exterior doors to classrooms (first and second levels) are wood with aluminum frames. Door System is at the end of its useful life and does not create a weathertight closure.

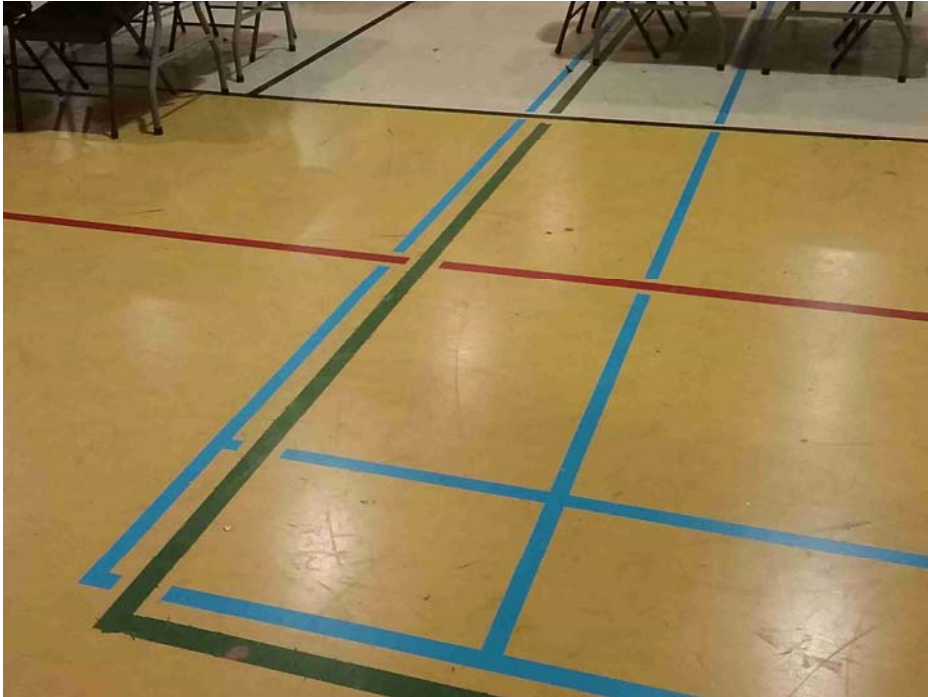
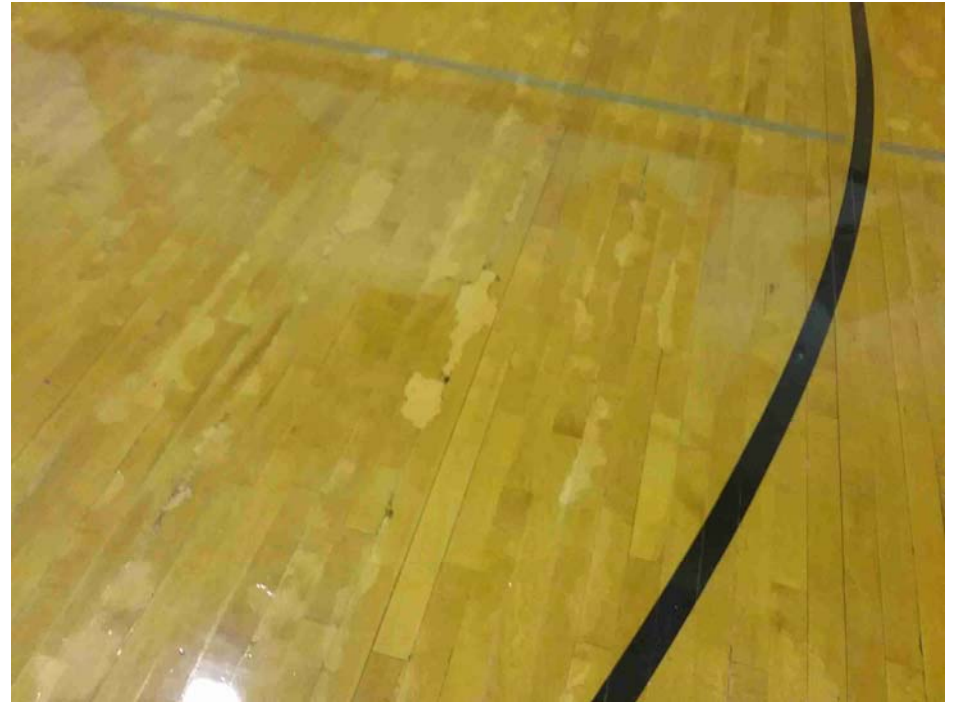
# Spring Woods HS

- Black and Gold Gym synthetic flooring is deteriorated and is at the end of its useful life.
- Mini Gym wood flooring is deteriorating and needs to be evaluated for replacement.
- Carpeting in various classrooms is roll type and in need of replacement. Carpet is worn, stained and is at the end of its useful life.

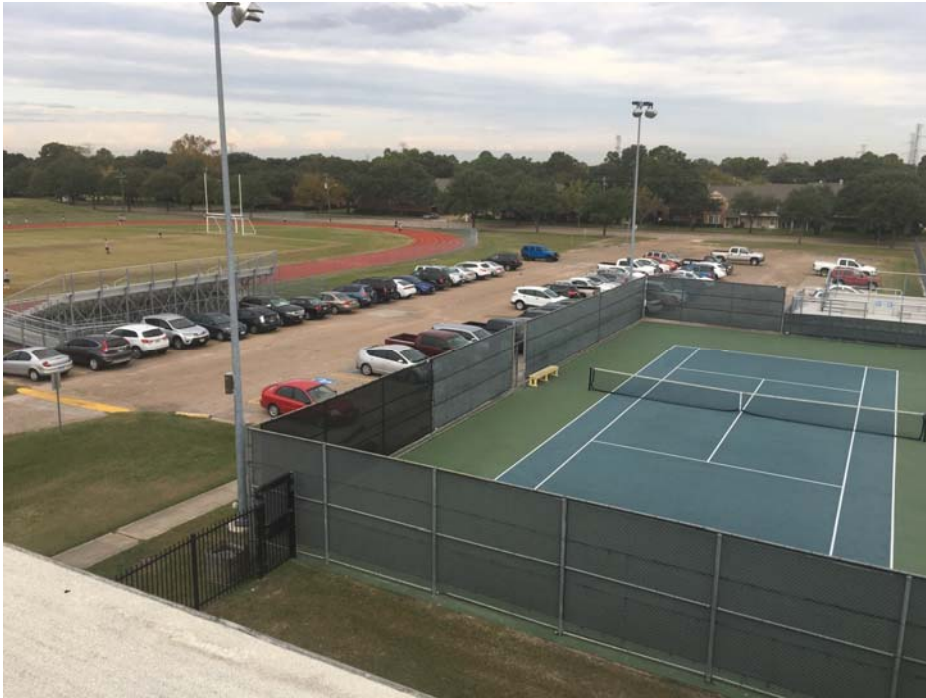
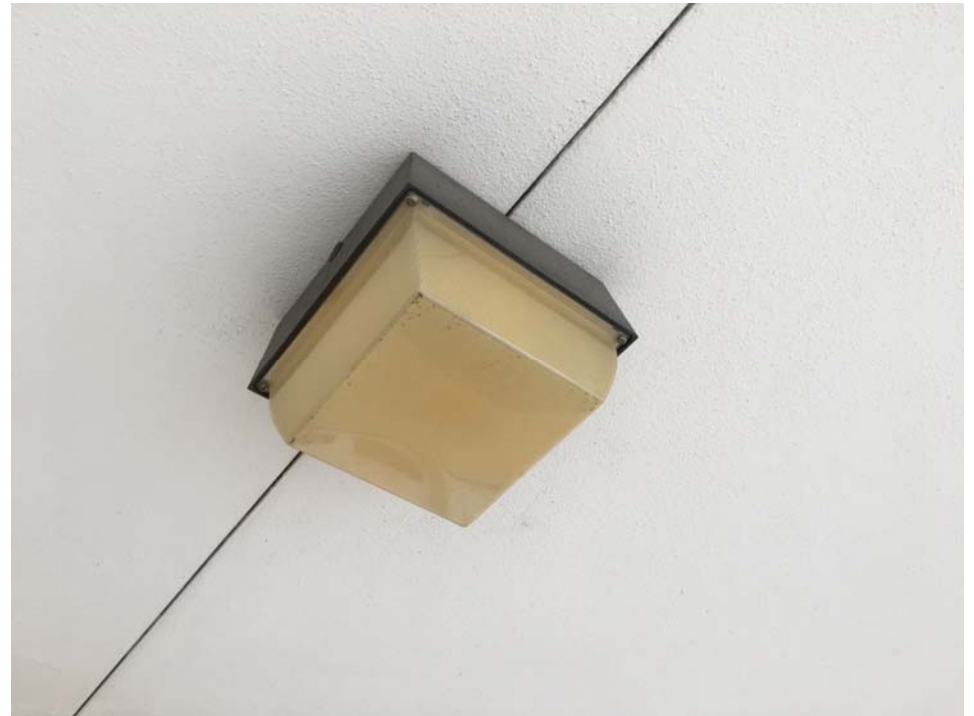
# Spring Woods HS

- Current HVAC system and unit ventilators is the original 2 pipe system.
- HVAC system in new Office Suite (converted from former classrooms) is inadequate.

- NW parking lot and track area lighting needs upgrading.
  - Existing athletic field lighting is outdated.
  - Exterior corridor canopy light fixture lenses are worn and discolored.
-

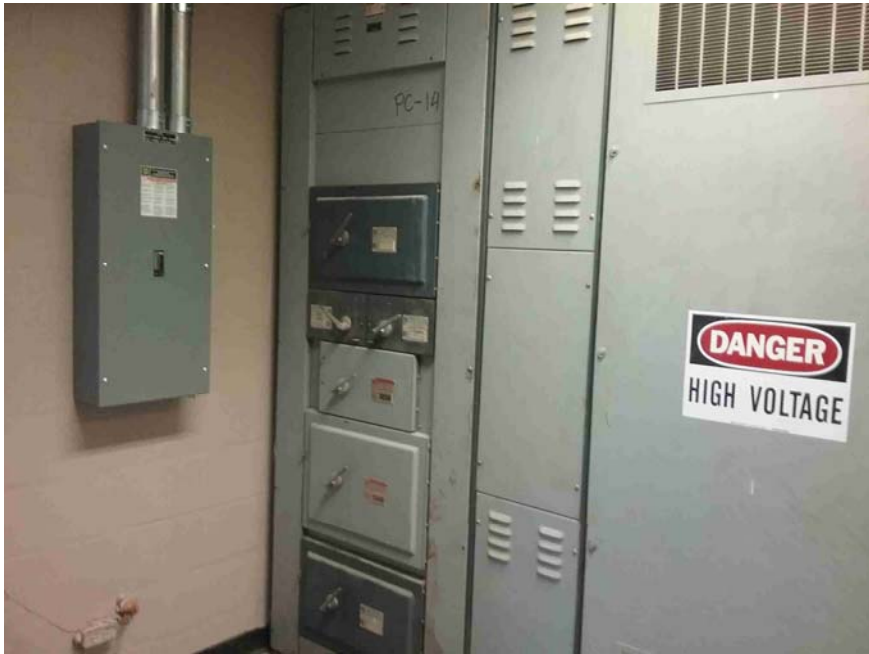
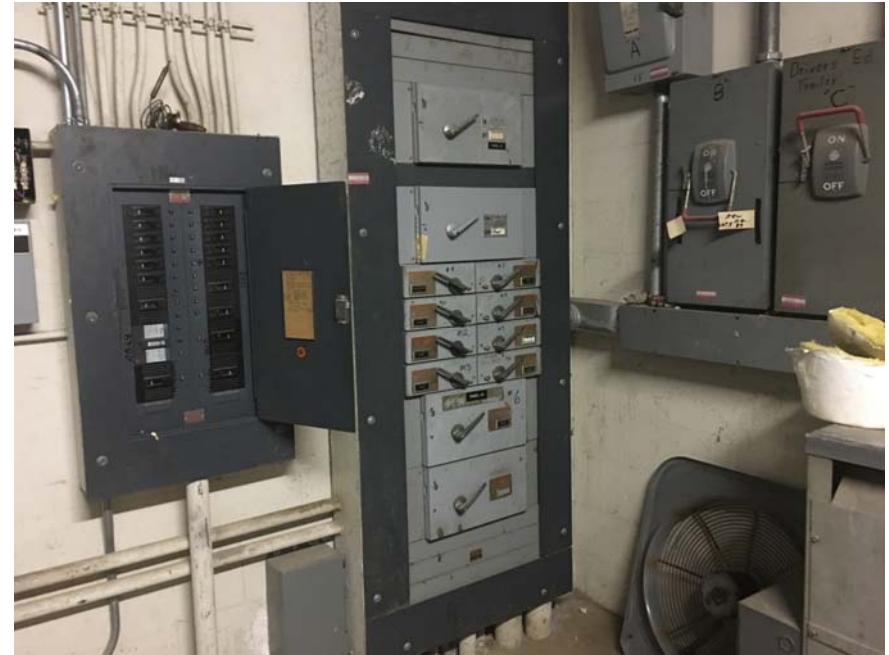
# Spring Woods HS

- Electrical
  - Electrical Switchgear in main mechanical room and other electrical distribution rooms reported as original to building and at the end of its useful life.
  - Exit and emergency lighting fixtures are aged, battery pack replacement costs are excessive
  - Clock system is outdated.
- Elevator cab, equipment and controls are outdated.

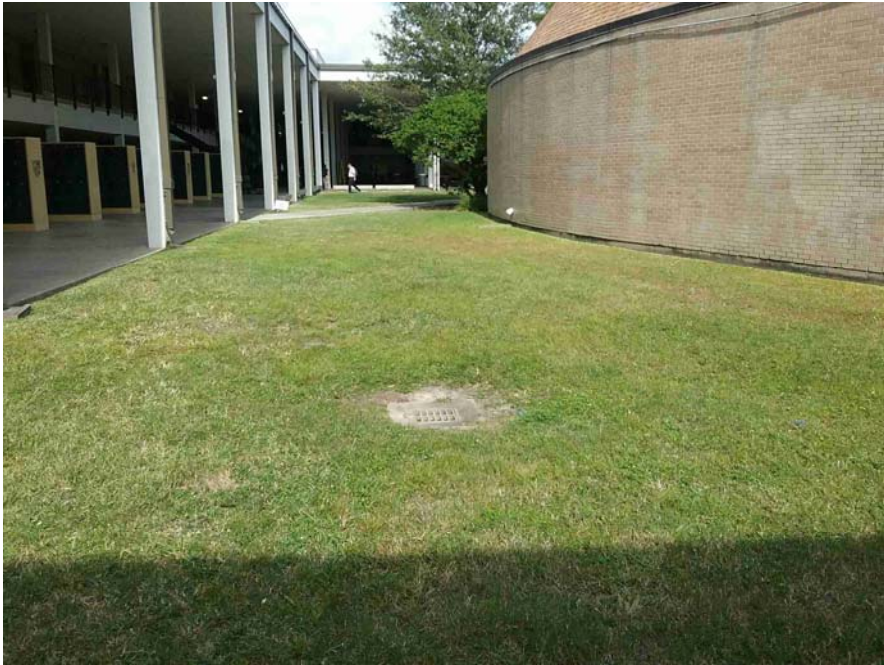
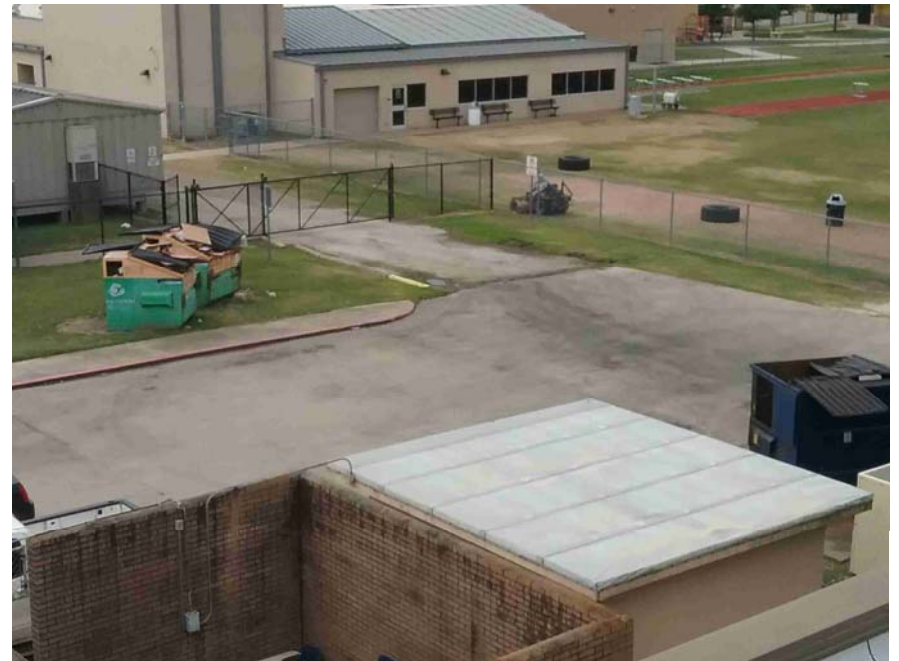
# Spring Woods HS

- Asphalt paving in parking areas and vehicle circulation was observed as deteriorating, cracked and crumbling in some areas. Parking lots are surface drained.

- Several areas are experiencing flooding due to insufficient drainage around the campus and within courtyards. Limited numbers and potentially undersized inlets were noted. In some areas, downspouts are not connected to underground storm drainage.
