Madison Schools –Comprehensive Assessment Study

Architectural Assessment October 6, 2015

TOWN CAMPUS EARLY LEARNING CENTER

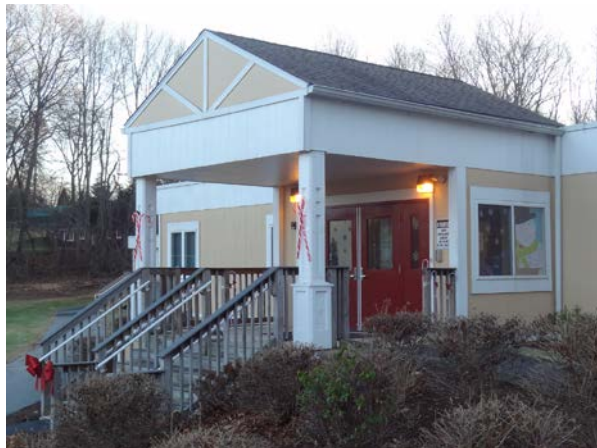
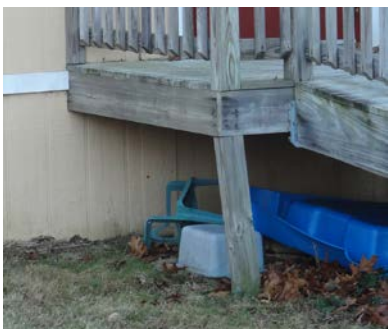
Wood Platform- Left 4x4 wood post on leg of ramp platform near play yard is bent inward and needs to be straightened and secured.

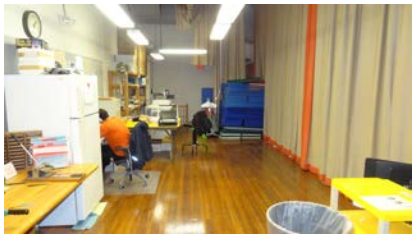
Flooring - Majority of the flooring is vinyl asbestos tile and is located throughout the building. (See Hazardous Section) Carpet has been installed in some of the classrooms, kitchen and Hallways over existing tile. These are in fair to poor condition. Platform or Stage flooring is a stained wood and is in good condition but stage is used as an office.

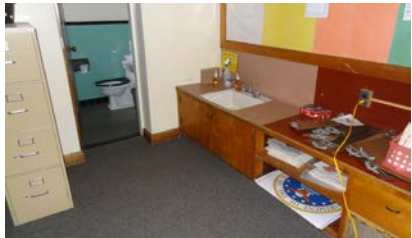
Casework - The casework in most classrooms and offices are old and showing signs of age. Doors to closet areas are hard to open and hardware and hinges are worn out.

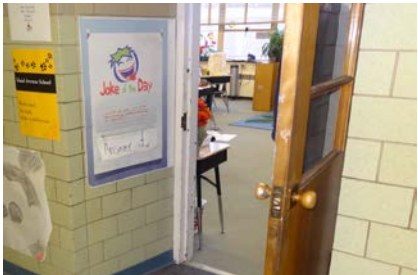
Pull Side of Doors - Pull side on entry doors to the classrooms in the main structure are recessed and don't have required 18 inch clearance which does not meet the ADA accessibility code. Modular classrooms have the required clearances.

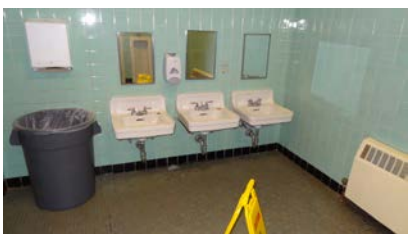
Toilet Facilities - Boys, Girls gang restrooms are non-compliant for accessibility, fixtures types and clearances at doors and fixtures.

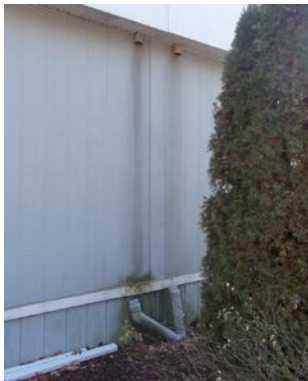
Portables or Modular Classrooms - The portables were installed in 2000 and are showing signs of age.

- Down spouts or roof drains are missing or detached on the North and South sides of the modular building..
- Stairs and ramp are aged and weather beaten. Handrails are not properly secured to either building or railings. (see ADA/ Accessibility Section)

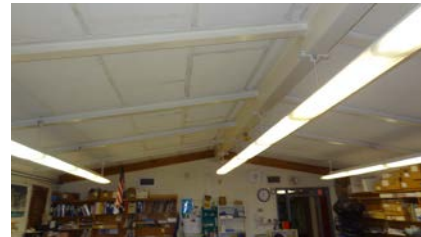
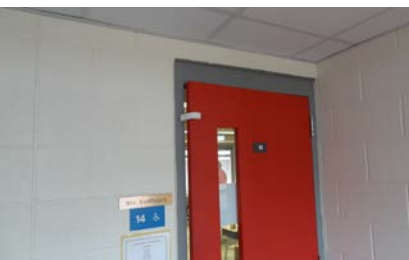
Ceilings - Corridors, office area and Modular's have suspended acoustical ceilings installed and were noted to be in fair to good condition on average. Classrooms all have exposed painted tectum ceilings. It was reported that Classroom 20,21 and 22 have occasional leaks in those rooms. Further investigation required to determine cause and location of leaks.

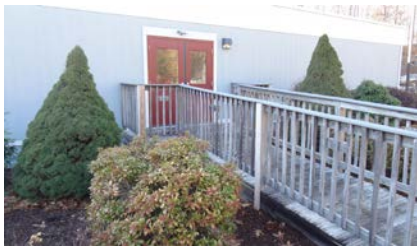
Exterior Ramp - Exit ramp from portable classrooms is non ADA compliant. The handrails do not extend at top or bottom of ramp.

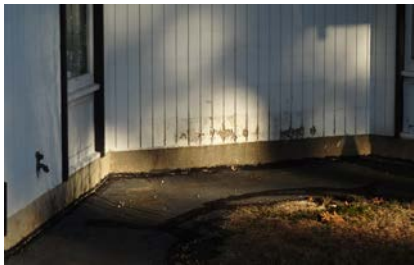
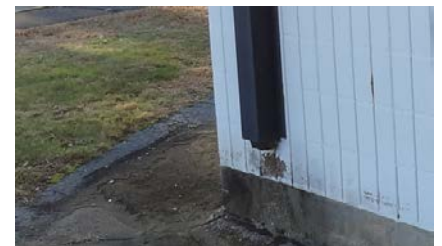
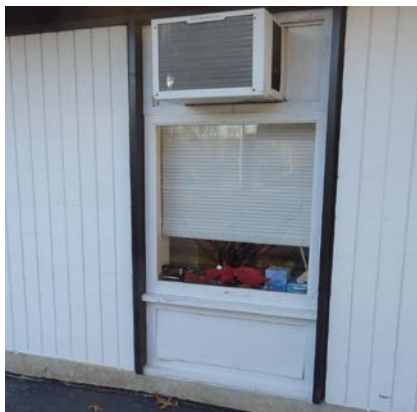
Exterior Walls - Exterior walls are painted block and are in fair to good condition. A few areas around structure are in need of attention. Paint chipping or peeling and need repaired at base of panels below down spouts.

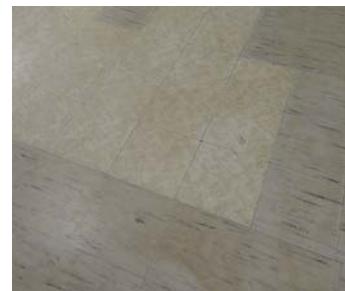
Floorings -Carpet in Corridors, Classrooms and Office areas appear to be in good condition. VCT tiles in classrooms , Nurses Office Gym/ Cafeteria and Kitchen appear to be in fair to poor condition. Ceramic tiles generally located in toilet rooms and appear to be in fair to good condition. Platform or Stage flooring is a stained wood and is in poor condition and should be refinished.

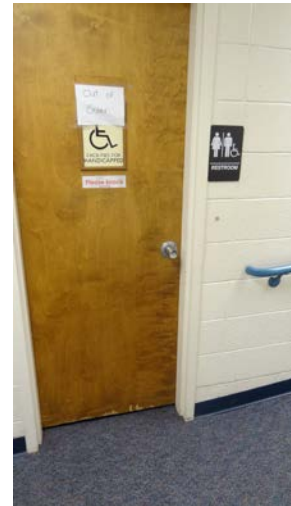
Toilet Facilities - Boys, Girls and Staff restrooms are non-compliant for accessibility, fixtures types and grab bars. Door width to staff H.C. restroom is too narrow and knob on door.

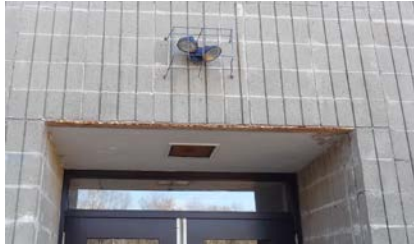
Lintels - Lintels above the doors and windows on the North-east side of the 1971 addition are rusting.

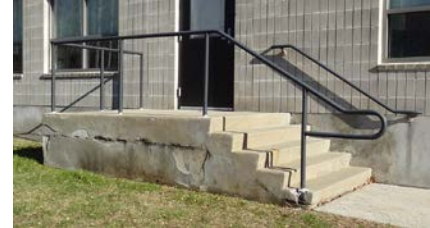
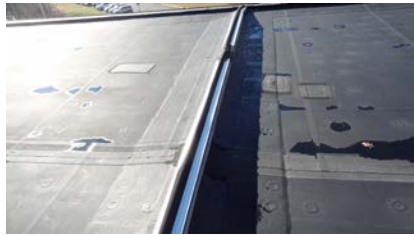
Spalling Concrete - - Concrete spalling and or cracked in multiple areas around structure.

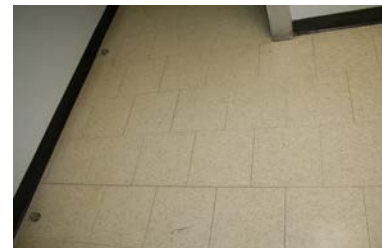
Flooring - VCT flooring in corridors, Classroom and Kitchen are warping, chipping and failing at the edges of the tile. Carpet in classrooms are in good condition.

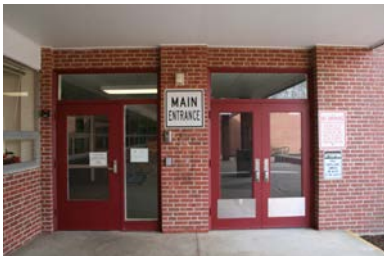
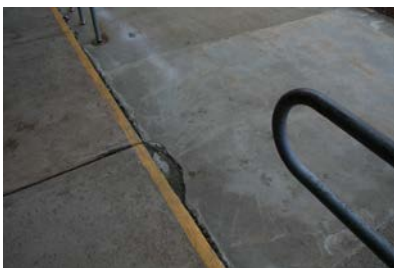
Exterior Walls - Exterior walls of the original 1960 building and all the other additions consist of 4" brick exterior facing and an exterior concrete masonry unit backup. Around the perimeter of the building bricks in the corners are broken, chipped or damaged in a number of areas and require repairing.

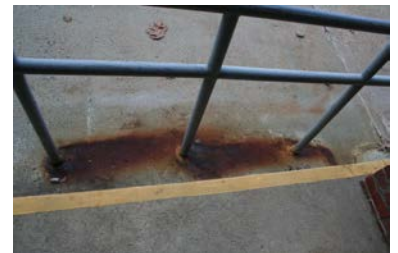
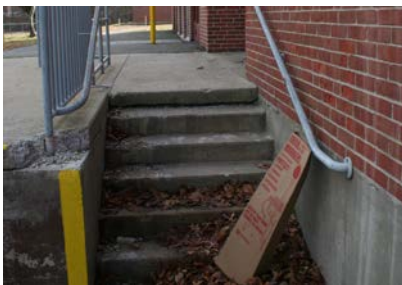
Main Entry Ramp - Concrete at main entry ramp is cracking and broken in a couple o areas and rust stained below handrails. Paint on handrails chipped and peeling.

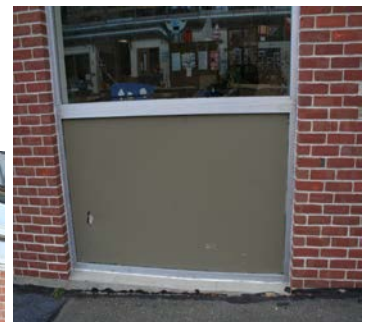
Loading Dock - Concrete at loading dock stairs and around platform is cracking, chipping and spalling. Lintel at receiving area entry is rusting. Broken panel below window.

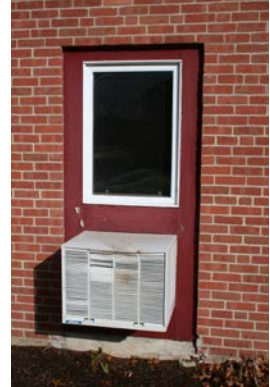
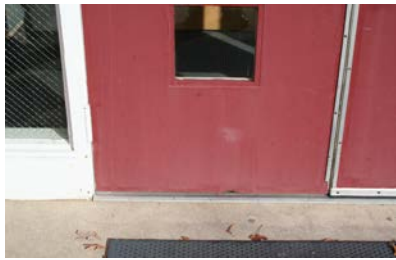
Windows - Existing window units are aluminum framed, single glazed windows and are original. Window AC units also appear to be in poor condition. Painted peeling around wood frame and plywood panel and metal exterior casing is dented or damaged. Glass block windows around Auxiliary Gym are broken and mismatched.
