# ARCHITECTURAL REVIEW

## Existing Conditions Assessment

# STRUCTURAL REVIEW

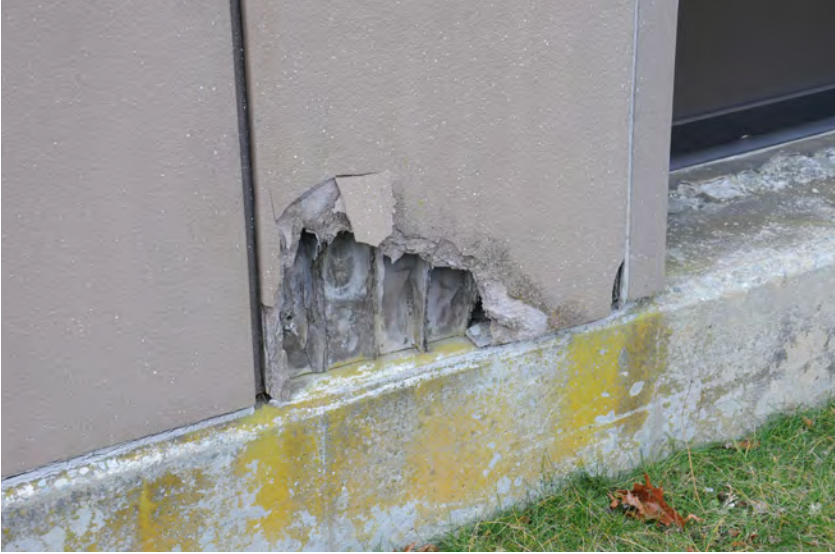
The exterior poured concrete foundation walls appear to be in fair condition with cracking, spalling in many locations. In some locations, the steel reinforcing is exposed due to concrete spalling. The school does not have a basement. That said, the athletic building does have a small lower level (approx. 1700sf) beneath the pool that houses mechanical and filtration systems for the pool and locker rooms. This area has flooded numerous times and, as a result, the steel (structural steel columns and steel stair risers) has corroded and rusted. (Refer to the structural evaluation

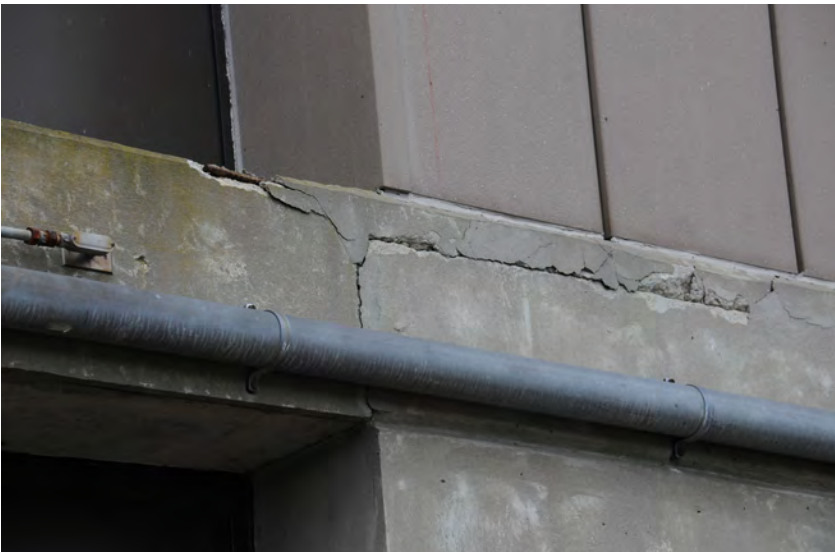
The exposed cast in place concrete structure is in good condition. There are varying size cracks, surface failure (spalling) due to

freeze-thaw cycling that has exposed steel reinforcing in some locations, evidence of water staining throughout the building, likely a result of moisture run-off from the adjacent window metals, and organic matter (moss or algae) growing on surface areas of the building where continuous contact with moisture and the surface does not dry frequently (ie. North facing elevations adjacent to trees and vines). Refer to the structural evaluation for additional information.

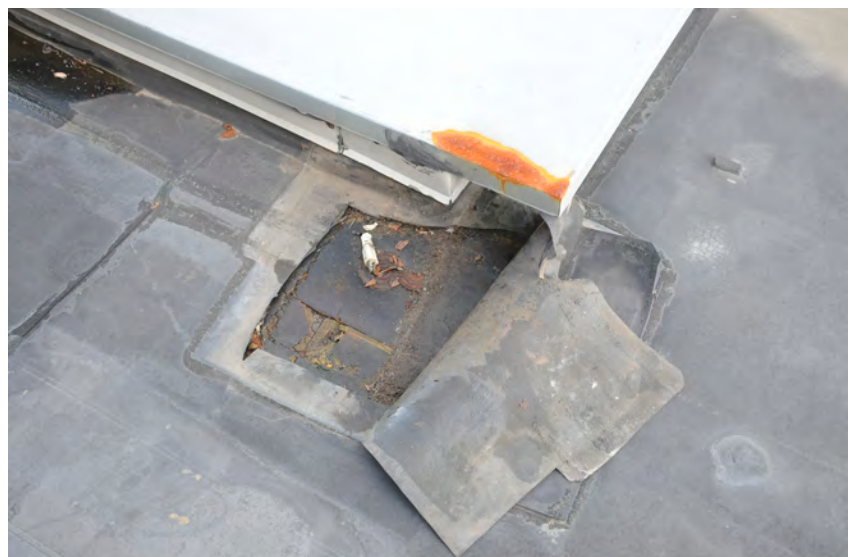
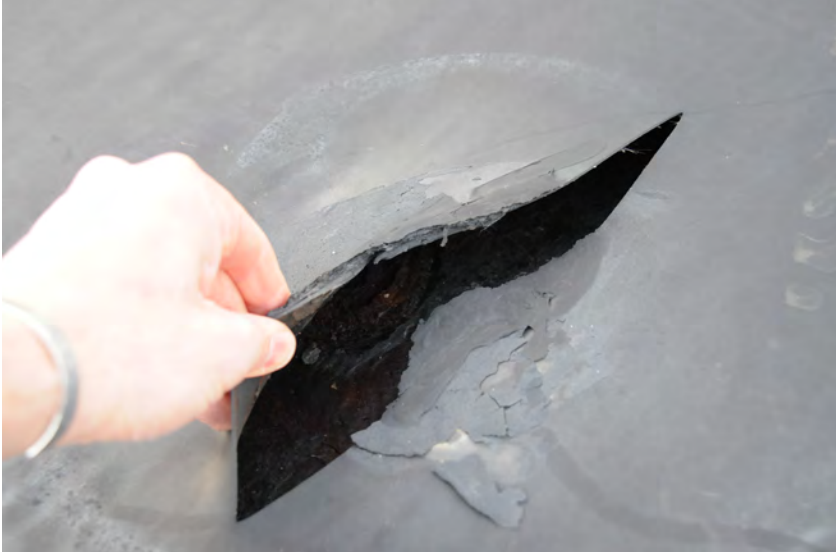
1. Standing water and sub-surface moisture:  
Standing water on any roof system, is, by industry-standards, considered a defect. Positive drainage is vital to the long-term success of any roofing system. Standing water can

substantially reduce the life of a membrane roof system. At BMC Durfee, there is evidence of water ponding with large mineral stains marking the extent of the water edges on the roof above all major areas of the building, including; the pool, gymnasium, classroom wings, administration spaces, auditorium, art classrooms, CTVE spaces, and lobbies. This standing water (and ice during the cold winter months) often results in early deterioration of any joints, seams, flashings, etc. Organic debris (grasses, lichen and moss) is growing in many areas throughout the roof surface as a result of the long-term standing water and location relative to solar exposure. This growth will hold moisture against the roof, create a freeze/thaw condition, and as a result, reduce the life of the roof covering. In some cases, the grasses may root eventually penetrate the roof covering.

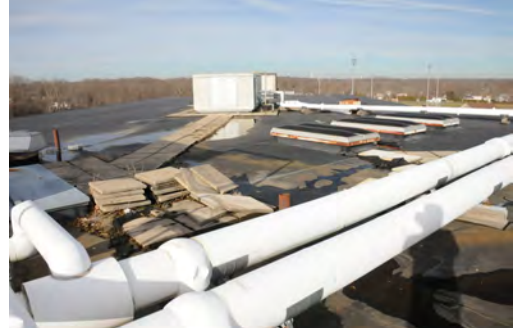
There is also evidence of sub-surface moisture on the roof areas above the classroom wing, auditorium, art classrooms and engineering classrooms. The underlayment (recovery board)

beneath the rubber membrane is warping and deforming as a result of absorbing a significant amount of moisture. In some cases, above the art and engineering classrooms, the underlayment has warped to a point where the seams in the roofing membrane has stretched and pulled apart and compromised, further exacerbating the water infiltration issue.

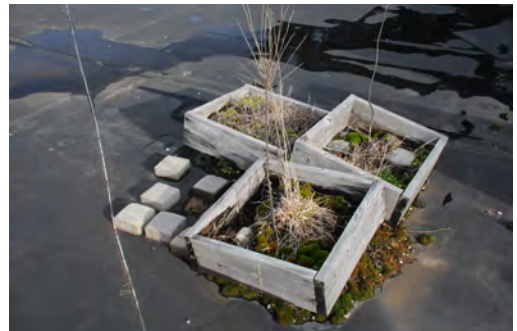
Rooftop debris has collected on the roof for many years. Not only is this unsightly, it can reduce the

life of the roofing system as a result of wear and tear, punctures, etc. Example of debris include, chairs, paint cans, bolts and brackets, piled up walkway pads (both rubber and pre-cast concrete), excess rubber membrane material, aluminum flashing, lumber and plywood, and excess steel heat/cooling mechanical piping and insulation that was not removed following system upgrades many years ago.

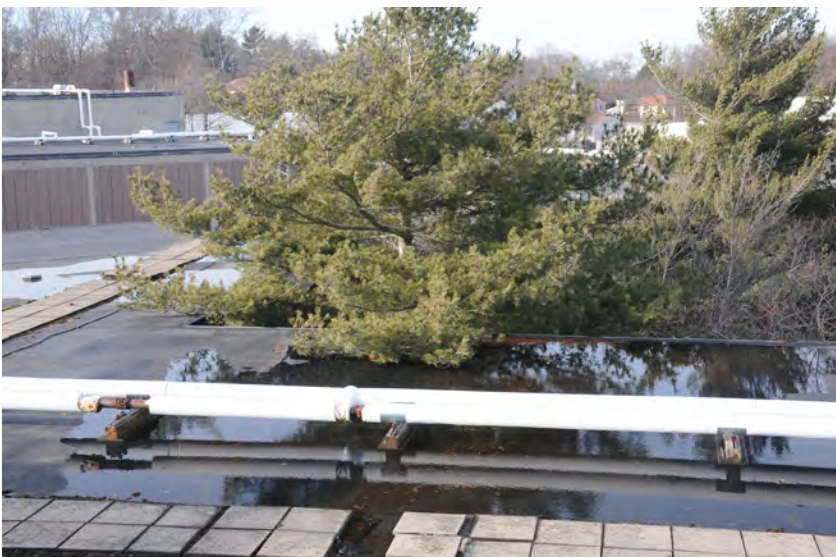
Deciduous and evergreen trees and vines have overtaken the center courtyard area. In many locations, the tree trunks are within a few feet of the building, limbs touching the building, and the canopy is touching and/or projecting over the roof. This condition has many inherent issues, including; retaining moisture close to or on the building (visible with the moss growing on the concrete structure), roots deteriorating the foundation system or compromise underground piping, leaves and tree limbs clogging the roof drainage system, old-damaged-weak trees may fall and damage the building, and may be used by insects or rodents to gain access to the building.

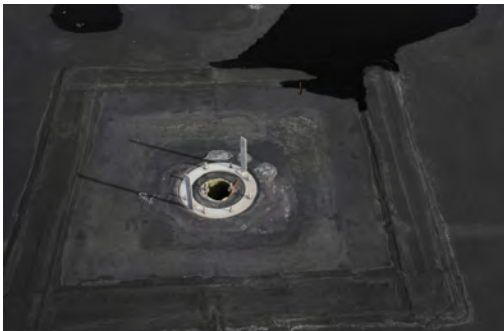
4. Metal fascia and counterflashing, EPDM membrane seams and roof penetration flashing:  
Much of the existing roof edge metal fascia at the roof perimeter

appears to be in fair condition. The existing metal counterflashing and termination bars have deteriorated and pulled from the adjacent vertical wall reglet. In other locations, the reglet counterflashing has pulled away from the wall system or is missing all together. The sealant at the termination bar and reglet is also weathered over time and separating, creating an open condition for water infiltration. The metal counterflashing at the roof transition from the two-story

auditorium to the lower roof is only a few inches above the adjacent EPDM roof system. This is inconsistent with current industry standards (min 8"-12" above adjacent surface). Overlapping rubber membrane sheet seams (seam tape) have weathered and are in poor condition and the EPDM cover tape at areas previously patched has delaminated in many locations. Roof penetrations have been compromised. Silicone caulking for EPDM installations is either significantly deteriorated or non-existent at inside corners, outside corners, penetrations, or patch locations.

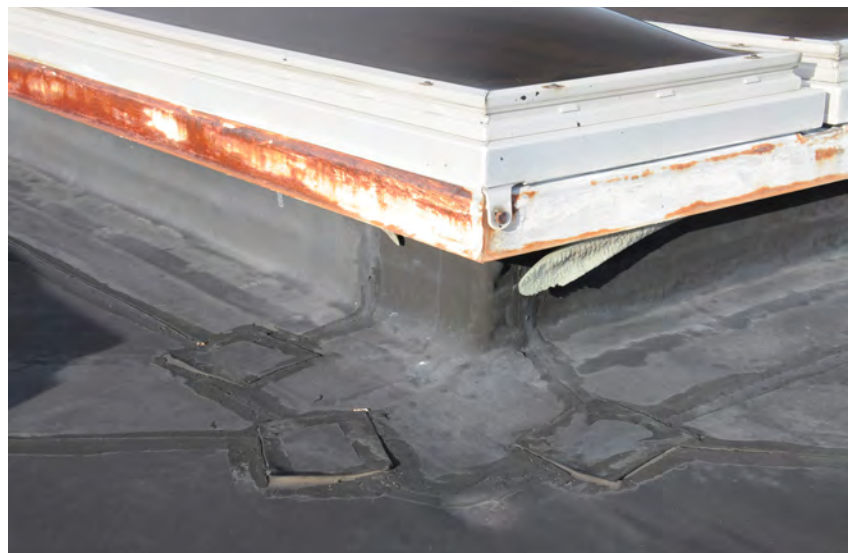
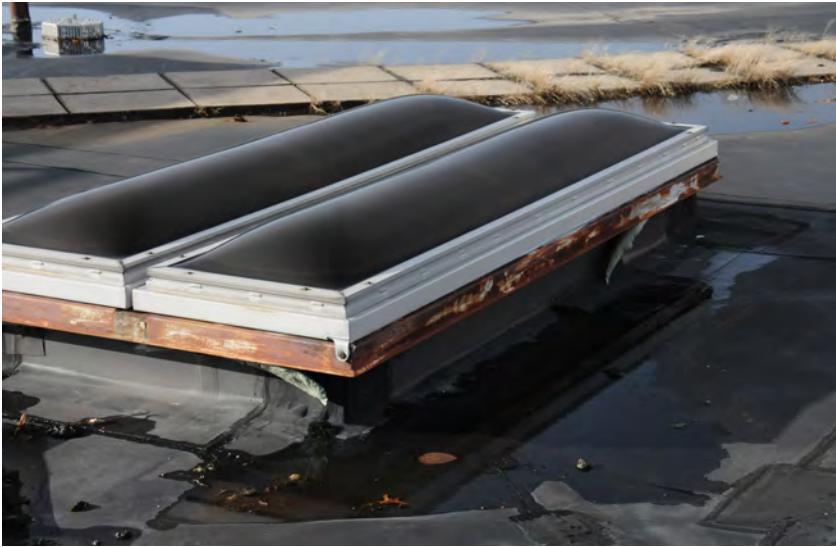
There is evidence of water ponding and several active leaks throughout the building, which often results in early deterioration of any joints or seams. A comprehensive renovation in the future should include complete replacement of the existing roof systems and an analysis of the benefits associated with adding insulation to the roof should be performed to ensure it complies with current energy code requirements. This may require some removal of the existing roofing system (down to the structural deck) in order to

expose a substrate which is appropriate for attachment of the new insulation. This removal would also assist in removing prior roofing layers which add unnecessary weight to the roof and lower its snow-load carrying capacity.

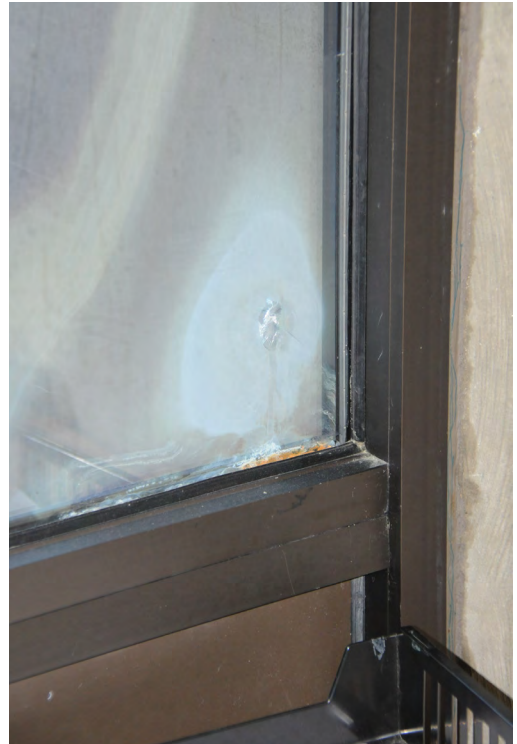
The original window system consists of a 5 ½" deep extruded aluminum window frame with 1" insulated glass or insulated panel (or in some rare cases, a ¼" tempered glass). The system is shimmed (1/4") and anchored to the adjacent cast in place concrete structural frame. The only thermal and moisture barrier between the exterior and interior space is a ¼" bead of sealant. The window system is set back from the face of the concrete panels and structural frame, allowing for moisture to pool and potentially migrate into the building. The lack of sill counter flashing (and relying on the sealant as the only thermal and moisture barrier) has resulted in moisture infiltration at numerous locations, with water damage evident on the interior surface of the exterior wall within most spaces in the building.

It is evident that the thermal seal of the insulated glass panel has failed in numerous locations and, as a result, the panel has become fogged or condensation has collected over time. As the condensation dries many times over, mineral deposits remain on the interior surface of the glass (between the two layers of glass), resulting in a window that appears constantly dirty, as can be seen in the photo.

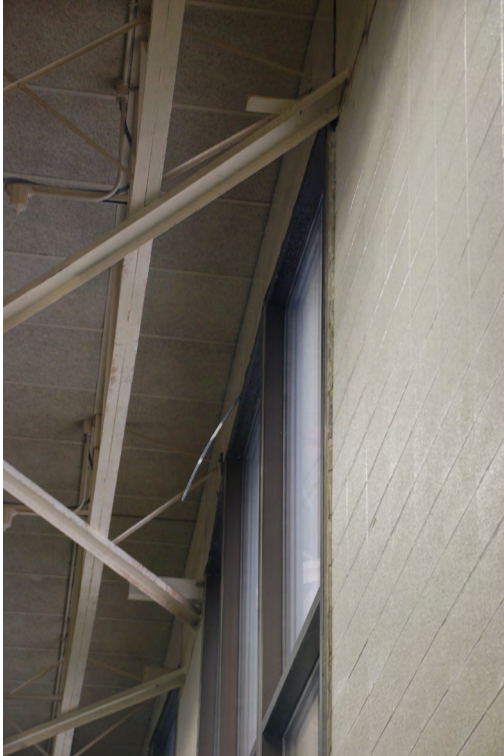
In some cases (exterior windows at the pool), the window system anchors have failed and the window system is leaning into the building as seen in the attached photo. The building maintenance personnel immediately

assessed and addressed this condition (temporary fix) once identified.

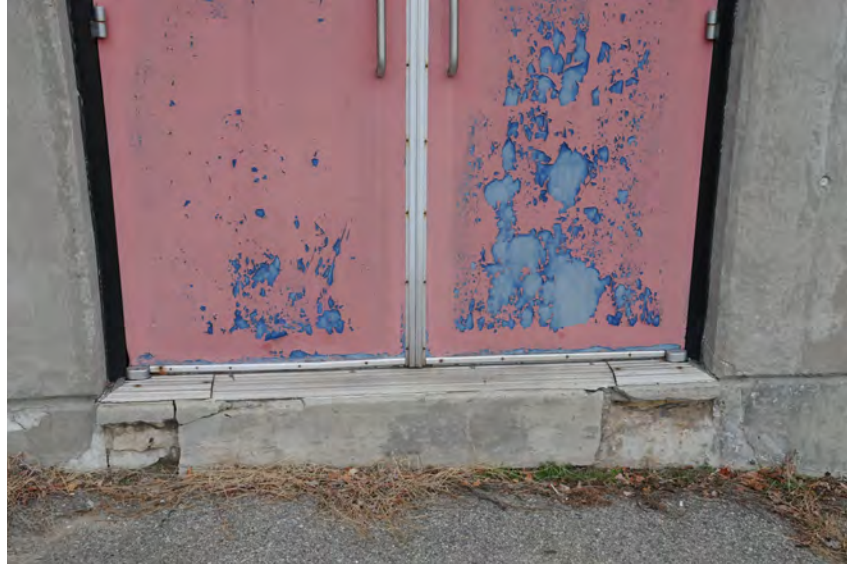
The original doors are constructed of 1 3/4" thick hollow metal and have vision panels inserted within metal frames. Overall, the door systems are

in extremely poor condition. In many instances, the frames have rusted, and in some cases, daylight can be seen through the rusted frame.

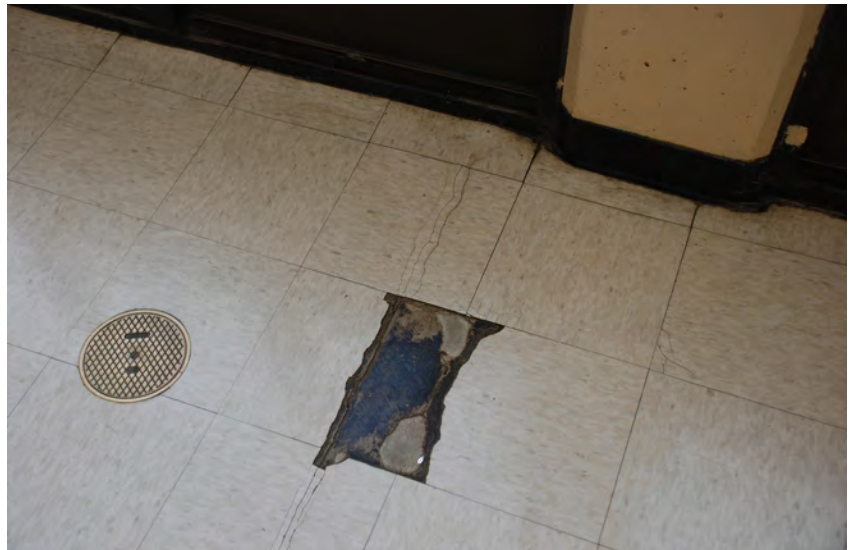
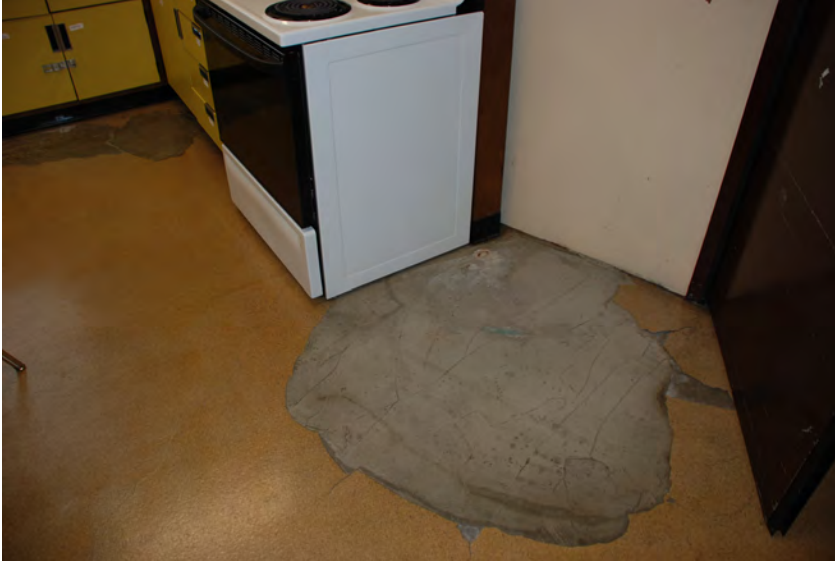
- Linoleum (Asbestos Containing Material): Classrooms, science classrooms, toilet rooms, and storage rooms.
- Ceramic Tile: Toilet rooms and showers.
- Athletic rubber flooring: fieldhouse
- Wood flooring: Auditorium stage, construction classrooms (butcher block flooring)
- Quarry Tile: Tradewinds Restaurant Kitchen

All of the floor materials are showing significant signs of wear and tear as a result of many years of service. The VCT is in fair to poor condition, delaminating in many locations. The carpet is frayed and worn through the outer pile and backing layer in most areas and, as a result, in extremely poor condition. The concrete floors have been painted on numerous occasions and wearing to bare concrete. The sheet linoleum material is ripped, torn, delaminating from the substrate and/or worn through to the substrate in many locations and in poor condition.

All flooring materials will need to be removed and replaced with new finishes as part of a major renovation.

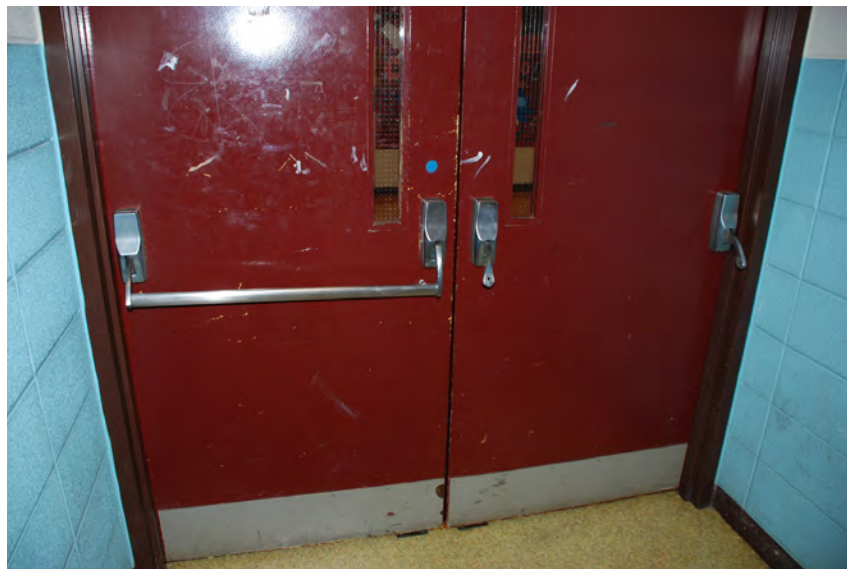
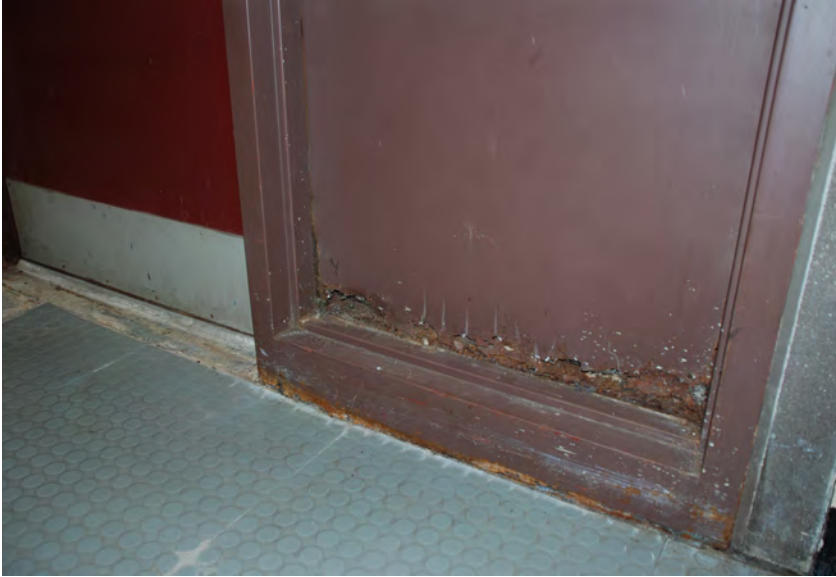
The interior painted hollow metal doors with hollow metal frames throughout the school are original and are in poor condition. Many of them show significant signs of wear, damage, denting, and chipped paint. The current door hardware lacks many of the modern safety and security feature and is difficult to operate. In various locations, the door hardware is non-existent and a rope

or fabric is used to operate the door. The classroom doors vary in style, but all have some amount of glass within the door or as part of a transom panel above the door. Over time, most of the glass transom panels have been replaced with a solid opaque panel. These older doors provide very little acoustical separation between the corridor and classroom when compared to modern doors, construction standards, and code requirements. The doors from the corridor to the egress stairs lack compliance with modern codes, regulations, and standards and do not provide the necessary fire ratings for protection of the egress stairways. The double doors located within corridors conflict (when open) with adjacent lockers, are not tied into a fire alarm system, do not provide the necessary fire rated separation, and include antiquated egress hardware that lacks proper function and operation.
