**Building Information - Oakwood City (44586) - Harman Elem**

**GENERAL DESCRIPTION**

Harman School, which is not on the National Register of Historic Buildings, and originally constructed in 1909, is a 3 story, 70,084 square foot brick and stone school building located in a suburban residential setting. There have been four additions to the facility in 1949, 1960, 1998 and 2003. The existing facility features a conventionally partitioned design, and does not utilize modular buildings. The structure of the 1909 Original Construction contains masonry type exterior wall construction, with wood framing and plaster type wall construction in the interior. The floor system consists of wood framing. The roof structure is wood framing. The roofing system of the overall facility is a combination of fully adhered TPO membrane, concrete slate shingles and asphalt shingles, installed in 1993, over 24 years ago. The structure of the 1949 Addition and 1960 Addition contains masonry type exterior wall construction, with wood framing and plaster type wall construction in the interior. The floor system consists of site cast concrete. The roof structure is wood framing. The 1998 Addition is a cour

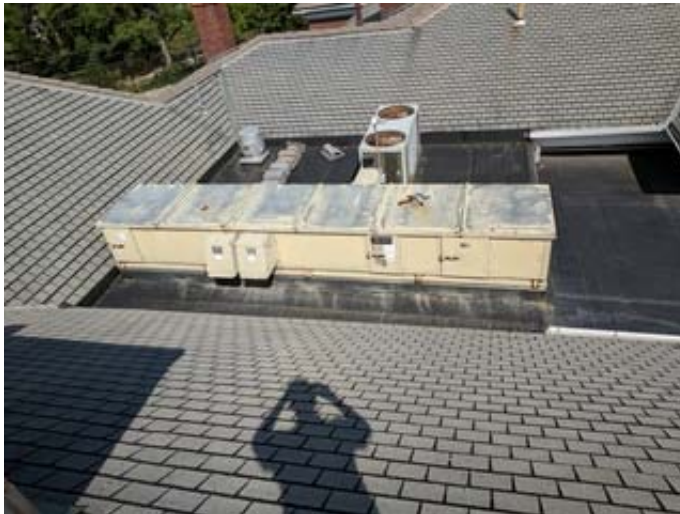
**Description:** The existing system for the Original Construction, 1949 Addition, 1960 Addition and 1998 Addition is a gas fired boiler, installed in 1994, and is in fair condition. The existing system for the 2003 Addition is a gas fired boiler, installed in 2003, and is in good condition. 2-pipe vs. 4-pipe designations are not applicable in this facility, as no central air conditioning is provided. The steam boiler, manufactured by Sellers, was installed in 1987 and is in fair condition. Steam is distributed to terminal units consisting of unit ventilators, cabinet heaters, unit heaters, fin tubes, rooftop units and air handlers. The terminal equipment is original to each Building Addition. The hot water boiler, manufactured by Lochinvar, was installed in 2003 and is in good condition. Hot water is distributed to terminal units consisting of reheat coils, unit ventilators, cabinet heaters, unit heaters, and rooftop unit. The terminal equipment was installed in 2003 and is in good condition. The system does not comply with the 15 CFM per person fresh air requirements of the Ohio Building Code mechanical code and Ohio School Design Manual. The pneumatic and electronic type system temperature controls were installed in 1987 and 2003 and are in fair to poor condition. The system does not feature individual temperature controls in all spaces required by the OSDM. The overall system does not feature any central energy recovery systems. The facility is not equipped with louvered interior doors to facilitate Corridor utilization as return air plenums. The existing system is ducted, but the ductwork cannot be integrated into a possible future system due to arrangement, air volume, and routing of existing ductwork. The overall heating system is evaluated as being in safe but inefficient working order, and long term life expectancy of the existing system is not anticipated with routine yearly maintenance. The structure is not equipped with central air conditioning. The site does not contain underground fuel tanks that are currently in use.

**Rating:** 3 Needs Replacement

Rooftop Unit Serving the 1998 Building Addition

**Recommendations:** Provide new overall heating, ventilating, and air conditioning system to achieve compliance with Ohio Building Code and Ohio School Design Manual standards. Convert to ducted system to facilitate efficient exchange of conditioned air.

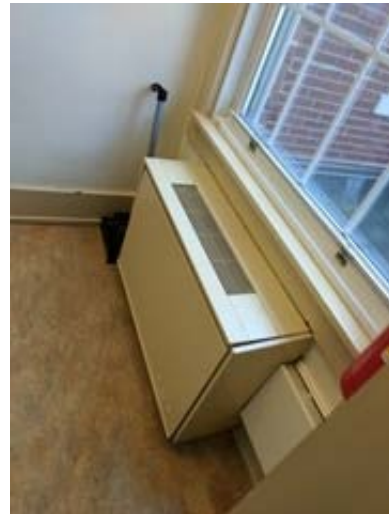
Unit Ventilator At Harman Elementary

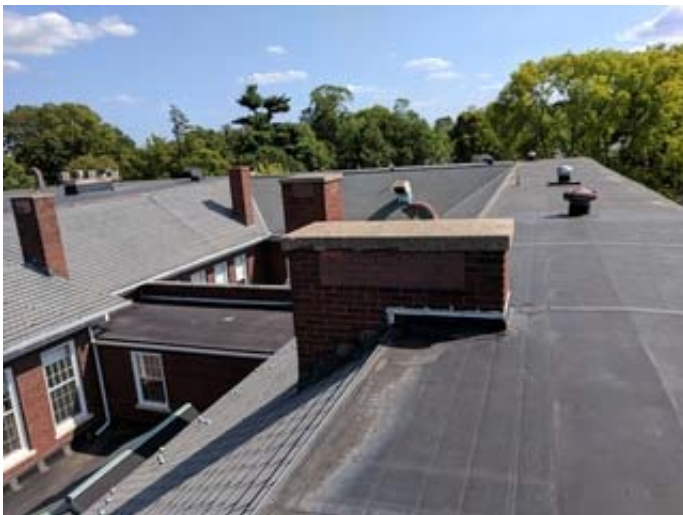
**Description:** The roofs over the 1909 Original Construction, 1949, and 1960 Additions are a combination of concrete slate shingles, asphalt shingles, and single-ply membrane roofing systems, installed in 1993. The concrete slate shingles are in good condition, but the other portions of the roof are in fair condition and are recommended to be replaced. The roof over the 1998 Addition is a TPO membrane system installed in 1998, and is in fair condition. The roof over the 2003 Addition is a combination of concrete slate shingles installed in 2003, which are in good condition, and a TPO membrane system installed in 2003, which is in fair condition. There are no District reports of current leaking. No signs of past leaking were observed during the physical assessment. Access to the roof was gained by 2 access hatches that are in good condition. Roof ladders and fall safety protection cages are not required. There were no observations of standing water on the roof. Metal cap flashings and stone copings are in fair condition. Roof storm drainage is addressed through a system of gutters and downspouts and roof drains, which are properly located, and in fair condition. The roof is equipped with overflow roof drains in the 2003 Addition in sufficient quantity and in good condition. Additional roof drains will be required in areas of roof replacement throughout the rest of the facility. No problems requiring attention were encountered with any roof penetrations. There is a covered walkway attached to this structure. The portico, enclosing the courtyard, is used for the main entry into the building and outdoor circulation between the two entries on the east side of the building. It is part of the 1928 Original Construction, has wood type construction and a concrete slate roofing system. The roof structure is in poor condition, but the roofing is in fair condition.

**Rating:** 3 Needs Replacement

Existing Roof Over 1909 Original Construction

**Recommendations:** All areas of roof throughout the facility that is either single-ply membrane, TPO membrane, or asphalt shingles require replacement due to age of system and projected life cycle. Provide insulation in areas of roof replacement to meet Ohio School Design Manual guidelines. Though it is in good condition, provide funding to replace roofing over the portico (funding included in asphalt shingle cost). Fixing the roof structure may require a roof replacement and will require further investigation by a structural engineer. Replace metal coping in areas of roof replacement. Replace roof drain covers in the areas of roof replacement in the 2003 Addition. In areas of membrane roof replacement, provide 1 new roof drain in the 1909 Original Construction, 2 new roof drains in the 1949 Addition, and 1 new roof drain in the 1960 Addition. Replace metal coping and flashing in areas of roof replacement. Replace gutters and downspouts in areas of asphalt roof replacement.

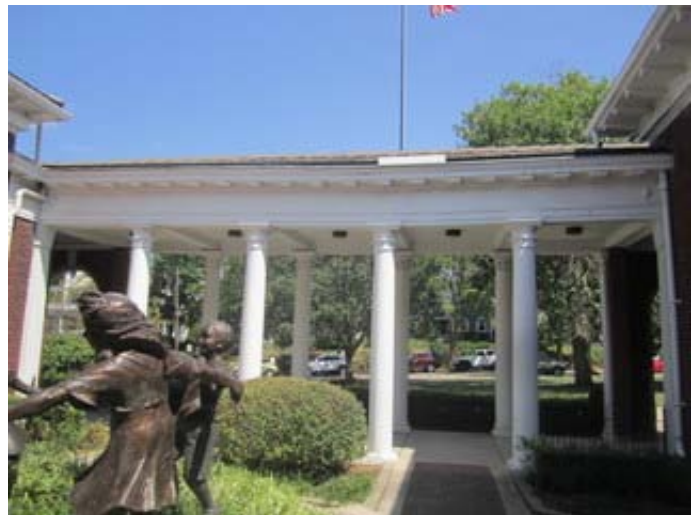
Portico With Sagging Roof Structure

**Recommendations:** Provide replacement for wood joist framing on the first and second floor of the 1909 Original Construction. Provide fire separation assembly for wood roof structure in the Original Construction, the 1949 Addition and the 1960 Addition. Refer to Item U for pricing of fire suppression system for wood structures. Provide cleaning and painting of all wood fascia, soffits and trim. Repair wood trim at all soffits of entries and front canopy. Pricing for canopy repairs included in this section.

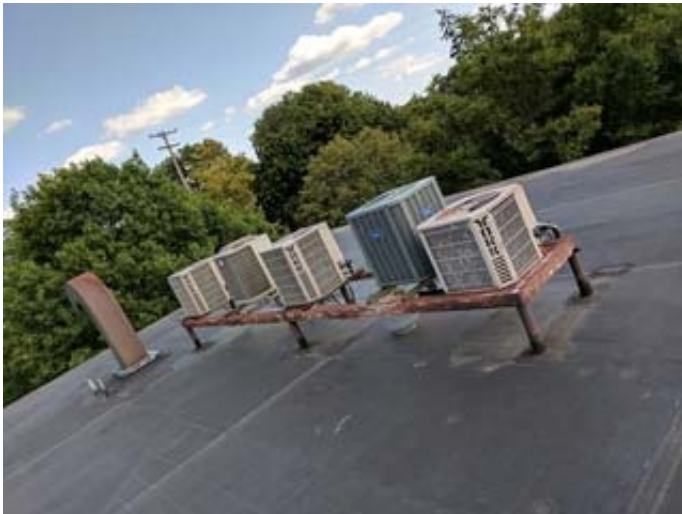
**Description:** The Original Construction, 1949 Addition and 1960 Addition is not equipped with a central air conditioning system. The 1998 Addition is equipped with a dx split system type central air conditioning system, which is in fair condition. The addition is served by a rooftop unit with a condensing unit located on the roof, ducted to Classrooms. The 2003 Addition is equipped with a dx packaged type central air conditioning system, which is in fair condition. The addition is served by a rooftop unit ducted to VAV terminals. Window units are provided in various locations. Split systems are provided in Rooms 34, 35, the Computer Lab and the South library. The ventilation system in the Original Construction, 1949 Addition and 1960 Addition consists of unit ventilators, original to each addition, providing fresh air to Classrooms, and dx split systems, installed in 1995 and in fair condition, providing fresh air to Rooms 34, 35, the Computer Lab and South Library. A second South Library split system was installed in 2015 and is in good condition. Relief air venting is provided by central relief fans. The ventilation system in the 1998 Addition consists of a rooftop unit, installed in 1998 and in fair condition, providing fresh air to Classrooms. Relief air venting is provided by central relief fans. The ventilation system in the 2003 Addition consists of a rooftop unit and vav terminals, installed in 2003 and in fair condition, providing fresh air to Classrooms. Relief air venting is provided by central relief fans. The ventilation system does not meet the Ohio Building Code 15 CFM per occupant fresh air requirement. The overall system is not compliant with Ohio Building Code and Ohio School Design Manual requirements. Dust collection systems are not required in this facility and no system is provided. The Art program is equipped with a kiln, though it is not in operation due to a lack of exhaust required per Ohio School Design Manual Requirements and Ohio Mechanical Code. General building exhaust systems for Restrooms / Storage Rooms / Art Rooms / Custodial Closets / Other are adequately placed, and in good condition.

**Rating:** 2 Needs Repair

Air Cooled Condensing Units Serving rooms 34, 35, the Computer Lab and South Library

**Recommendations:** Provide an air conditioning system to meet with Ohio Building Code and Ohio School Design Manual requirements. Replace general building exhaust systems located in Restrooms / Storage Rooms / Custodial Closets / Other. Pricing included in Item A. Provide a kiln exhaust system for the art room.

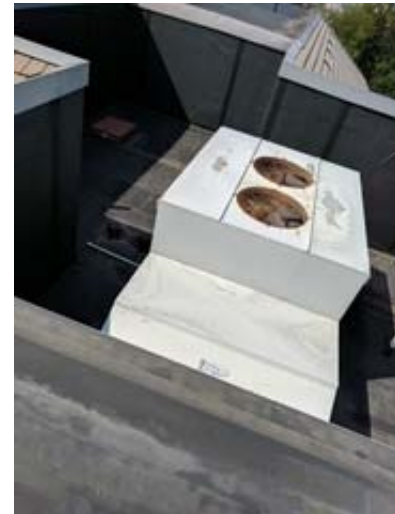
Aaon Rooftop Unit Serves the 2003 Building Addition

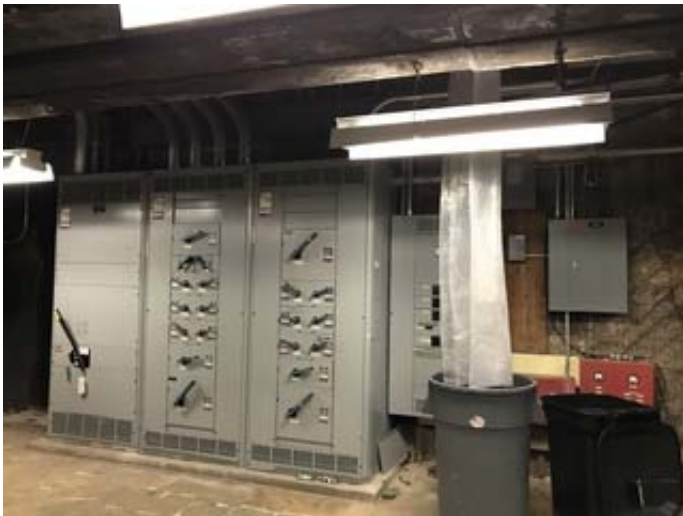
**Description:** The electrical system provided to the 1909 Original Construction is a 240/120V, 1200 amps, 3 phase and 4 wire system that was renovated in 1998, providing power to the 1949, 1960, 1998 and 2003 Additions, and is in good condition. Power to the 1909 Original Construction, 1949, 1960, 1998 and 2003 Additions is provided to the school by a single utility owned, pole-mounted transformer located outside, and in good condition. The panel system, installed in 1908 Original Construction, 1949, 1960, 1998 and 2003 Additions, is in fair condition, and cannot be expanded to add additional capacity. The Classrooms in the 1908 Original Construction, 1949, 1960 and 1998 Additions are equipped with inadequate electrical outlets. The typical Classroom contains (6) general purpose outlets, (0) dedicated outlet for each Classroom computer, and (0) dedicated outlet for each Classroom television. Some Classrooms are equipped with as many as (6) general purpose outlets, while others are equipped with as few as (4) general purpose outlets. There are not any spaces that have no electrical outlets. The Classrooms in the 2003 Addition are equipped with adequate electrical outlets. The typical Classroom contains (8) general purpose outlets, (2) dedicated outlets for each Classroom computer, and (1) dedicated outlet for each Classroom television. Some Classrooms are equipped with as many as (8) general purpose outlets, while others are equipped with as few as (6) general purpose outlets. There are not any spaces that have no electrical outlets. The Corridors are not equipped with adequate electrical outlets for servicing. Adequate GFI protected exterior outlets are not provided around the perimeter of the building. The facility is not equipped with a suitable emergency generator. Adequate lightning protection safeguards are not provided. Stage lighting power system including control panel, breakers, and dimmers is inadequately provided, in poor condition and does not meet OSDM requirements. The overall electrical system does not meet Ohio School Design Manual requirements in supporting the current needs of the school, and will inadequate to meet the facility's future needs.

**Rating:** 3 Needs Replacement

Main Electrical System

**Recommendations:** The entire electrical system requires replacement to meet Ohio School Design Manual guidelines for overall capacity, due to condition and age, lack of OSDM-required features, to accommodate the addition of an air conditioning system. Provide adequate electrical outlets for servicing at corridors and around the perimeter of the building. Provide an emergency generator, with funding included in the electrical system replacement. Provide adequate control panel, dimmers, and breakers to support the Stage lighting system. Provide adequate lightning protection safeguards in the overall facility, including associated grounding system, with funding included in the electrical system replacement.

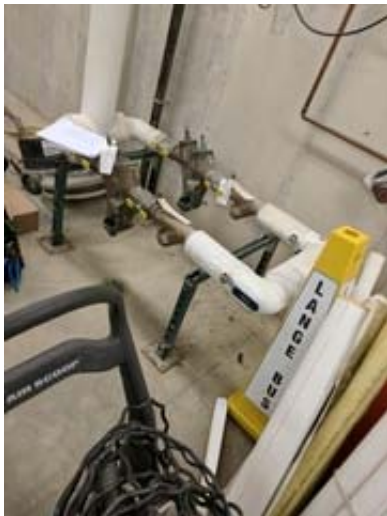
Backflow Preventers at the Domestic Water Service Entrance

Rating:	2 Needs Repair
Recommendations:	<p>To facilitate the school's compliance with OBC and OFCC fixture requirements, provide (13) new toilets / (18) new lavatories / (7) new urinals / (8) new Double ADA electric water coolers / (1) new lavatory mounted type drinking fountains. Due to age, condition, LEED, and OFCC requirements, provide (10) new toilets / (10) new lavatories / (5) new Double ADA electric water coolers / new lavatory mounted type drinking fountains. See Item O for replacement of fixtures related to ADA requirements. Replace faucets and flush valves for all fixtures in the 2003 Building Addition, and the fixtures that were replaced in the 1909 and 1949 Building Additions to meet LEED requirements. Replace galvanized water supply piping in the Original Building, 1949 Addition and 1960 Addition with copper piping. Provide 140 degree water supply to the kitchen from the existing 80 gallon electric water heater. Replace sanitary waste piping in the Original Building, 1949 Addition and 1960 Addition due to age. Provide a sink with solids interceptor and emergency eyewash station to the art room. Provide the Project Laboratory with the required utility sink, gas connections, compressed air connections, and safety shower / eyewash station. Provide a grease trap in the kitchen. Replace the mop sinks in the Janitor Closets. Replace the 2 compartment sink in the Kitchen.</p>

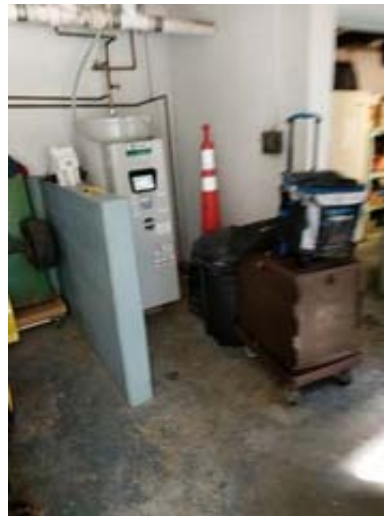
80 Gallon Electric Water Heater in Storage Room below the Kitchen at Harman Elementary School

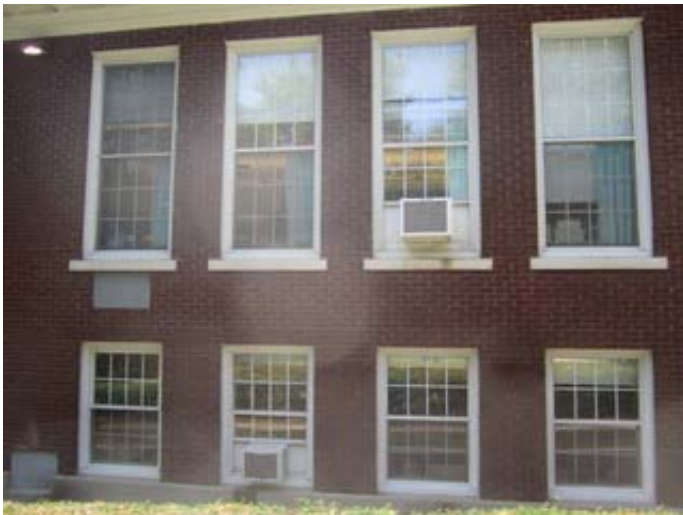
**Description:** The overall facility is equipped with thermally broken aluminum clad wood frame windows with double glazed insulated glazing type window system, which was installed in 2003, and is in good condition. The window system features operable windows in most areas of the building, and operable windows are not equipped with opening limiters, but are equipped with insect screens in fair condition. Window system seals are in fair condition, with minimal air and water infiltration being experienced. Window system hardware is in fair condition. The window system features no blinds. Surface mounted roller shades are installed. This facility is not equipped with any curtain wall systems. This facility does not feature any glass block windows. The existing windows throughout the facility seem to have been replaced at the time of the 2003 Addition. There are a select few windows that were not replaced due to existing single-zone air conditioning units. The exterior doors in the 1909 Original Construction, the 1949 Addition and the 1960 Addition are equipped with wood transoms with single pane glazing, in poor condition. Exterior door vision panels are single pane glazing. The exterior doors in the 2003 Addition are equipped with aluminum clad wood transoms with double-pane insulated glazing in good condition. Exterior door vision panels are double-pane insulated glazing. The school does not contain skylights. The school does not contain clerestories. Interior glass is not OSDM-compliant due to not being tempered. Window security grilles are provided for four ground floor windows by the hard-surface play area. There is not a Greenhouse associated with this school.

**Rating:** 2 Needs Repair

Windows at Entry Courtyard

**Recommendations:** Replace the existing non-insulated window system in the Original Construction, the 1949 Addition and the 1960 Addition with a new insulated window system to match existing insulated system and comply with Ohio School Design Manual requirements. Replace window transoms at exterior doors of the Original Construction, the 1949 Addition and the 1960 Addition. Exterior door vision panel replacement is addressed in Item S in exterior door replacement scope. Replace insect screens at the windows that are along the hard-surface play area. Provide security grilles at ground floor windows. Replace non-compliant interior glass.

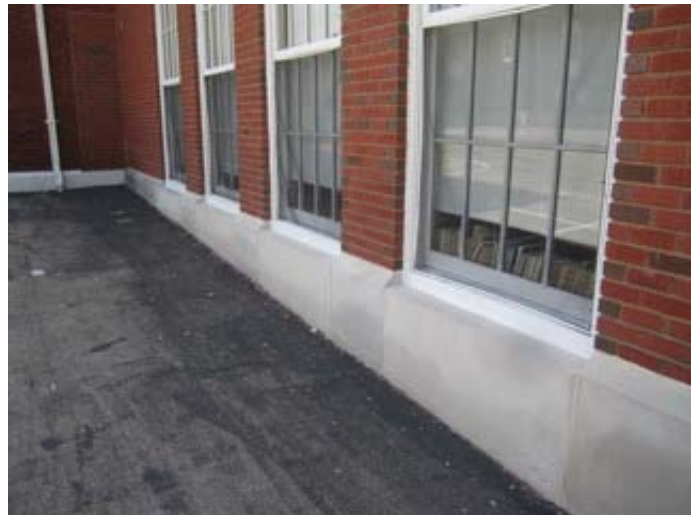
Windows Next to Hard-Surface Play Area

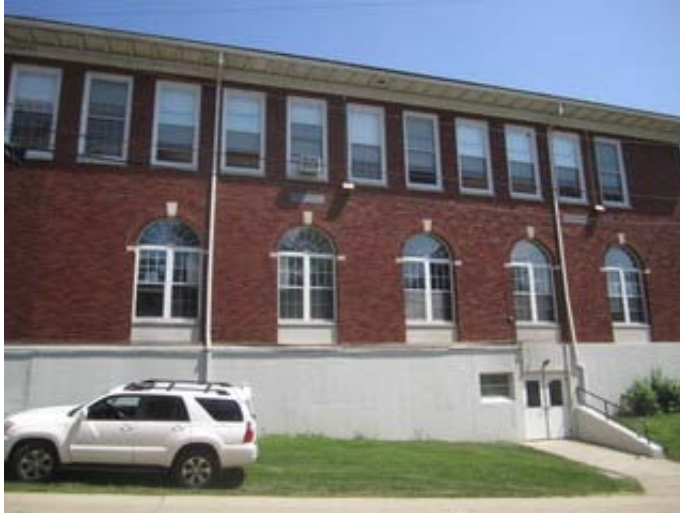
**Description:** The overall facility is equipped with concrete foundation walls on concrete footings, which displayed no locations of significant differential settlement, cracking, or leaking, and are in good condition. No significant issues related to foundation cracking or spalling were encountered. The District reports that there has been no past leaking. No grading or site drainage deficiencies were noted around the perimeter of the structure that are contributing or could contribute to foundation / wall structural deterioration.

West Elevation Foundation Wall

**Recommendations:** Existing conditions require no renovation or replacement at the present time.

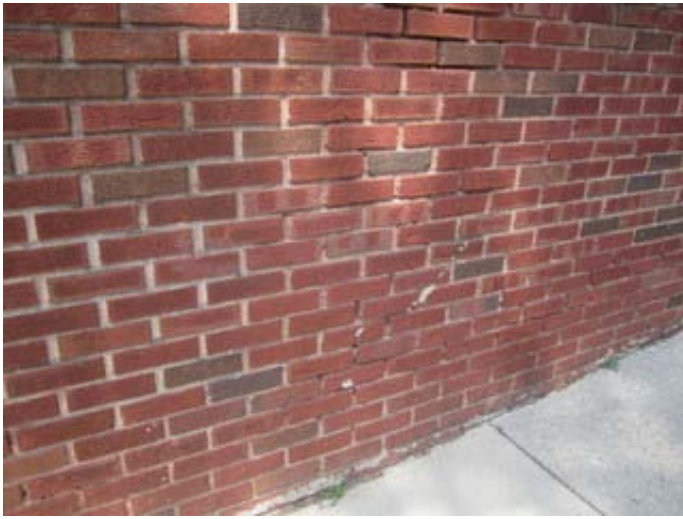
**Rating:** 2 Needs Repair

Base of Exterior Wall of 1949 Addition

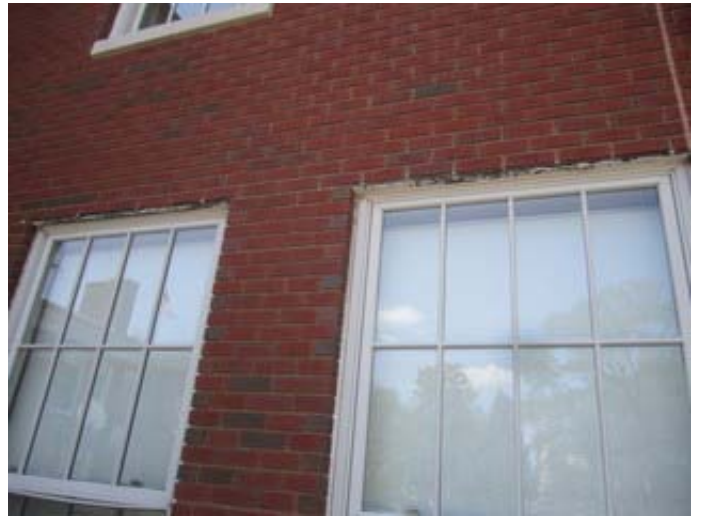
Steel Lintels at 1949 Addition

<b>Other:</b> Clean and Paint Steel Lintels	\$2.00	in.ft.		328 Required	184 Required	96 Required		276 Required	\$1,768.00	Lintels do not need to be replaced.
<b>Other:</b> Infill Brick @ Unit Ventilators	\$45.00	sq.ft. (Qty)		42 Required	63 Required	28 Required			\$5,985.00	Fill voids with matching materials.
<b>Other:</b> Remove Rope Weeps	\$5.00	each						70 Required	\$350.00	Replace with cell vents
<b>Sum:</b>			\$190,093.00	\$82,036.00	\$64,806.00	\$19,992.00	\$0.00	\$23,259.00

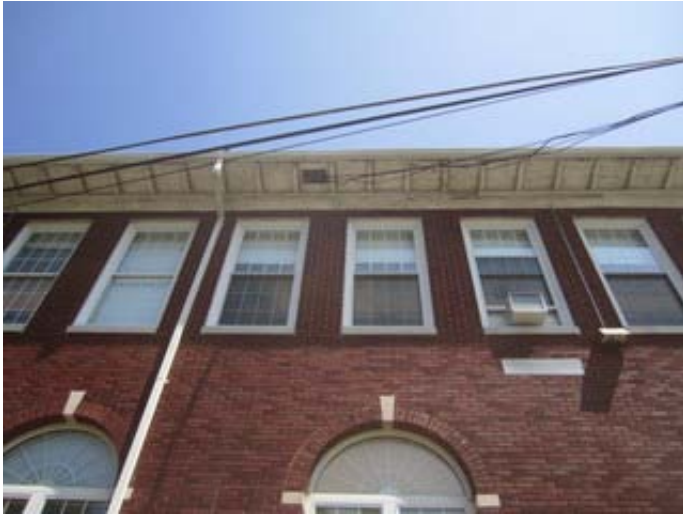
Soffit at 1949 South Elevation

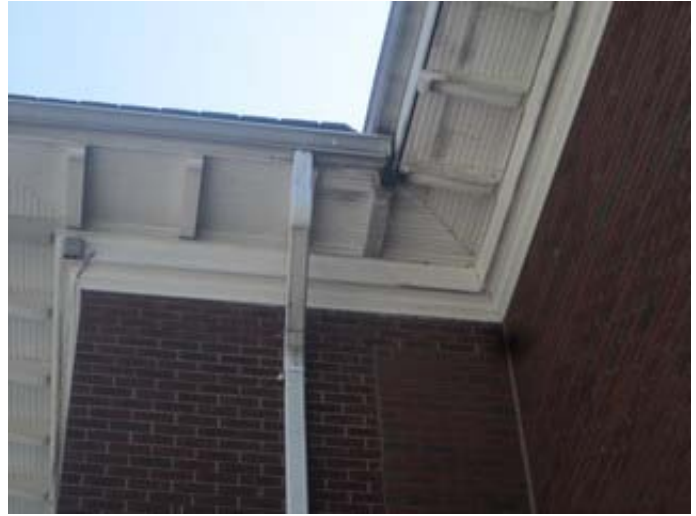
Soffit at 1949 and 1909 Intersection

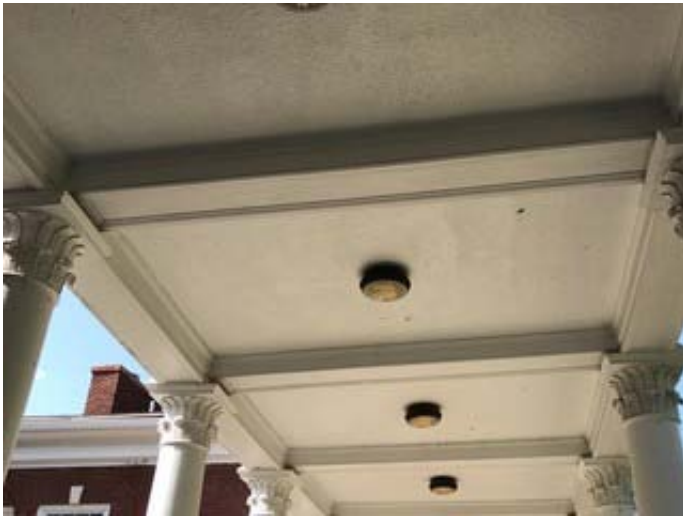
Lighting At Pedestrian Walkway

**Recommendations:** Provide complete replacement of security system to meet Ohio School Design Manual guidelines. Provide complete replacement of exterior site lighting system to meet Ohio School Design Manual guidelines. Provide Secure Entrance Vestibule at Main Entry to the facility. The allowance is based upon adding three sets of double doors and wall system to deny access to the school at the split-level stair at the main entry.

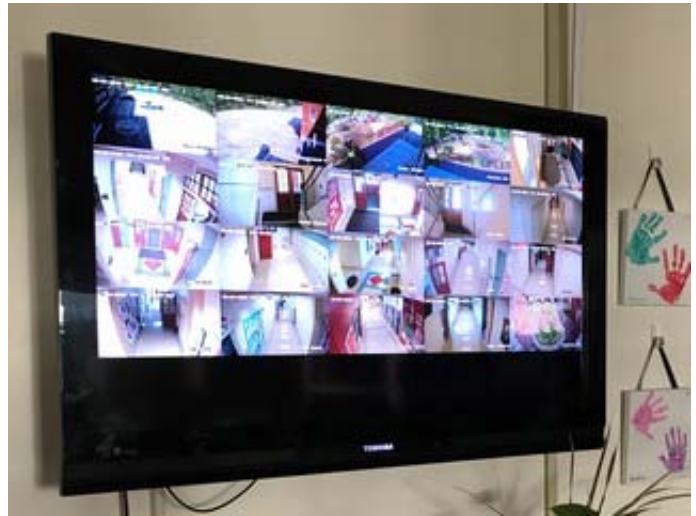
CCTV Type Security System Monitored In Administrative Area

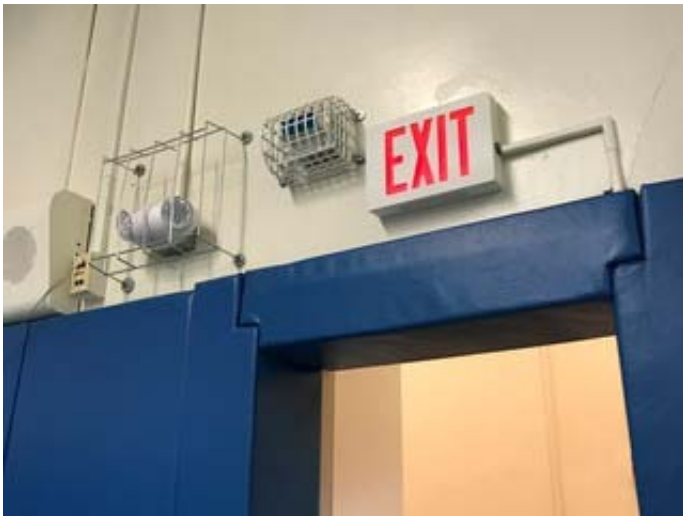
Typical Emergency And Egress Lighting In Original Construction

**Recommendations:** Provide complete replacement of emergency and egress lighting system, backed up by an emergency generator to meet Ohio School Design Manual and Ohio Building Code guidelines

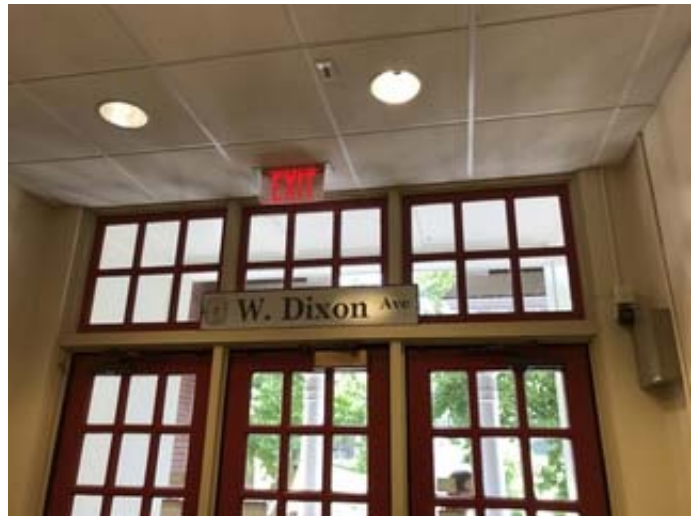
Typical Emergency And Egress Lighting In 2003 Addition

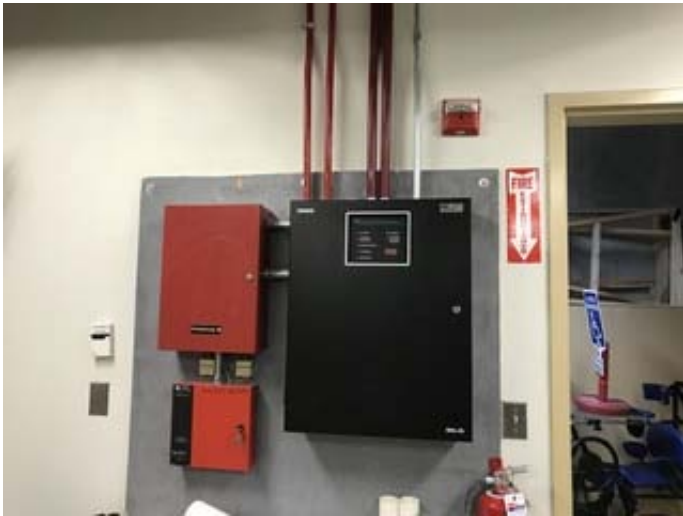
Fire Alarm System

**Recommendations:** Provide partial replacement of fire alarm system replacing the outdated fire alarm control panel for additional expansion capability to the overall facility, add heat sensor in elevator shaft, additional flow and tamper switches to support future fire suppression systems to the 1909 Original Construction, 1949, 1960 and 1998 Additions to meet OBC, NFPA, and Ohio School Design Manual guidelines.

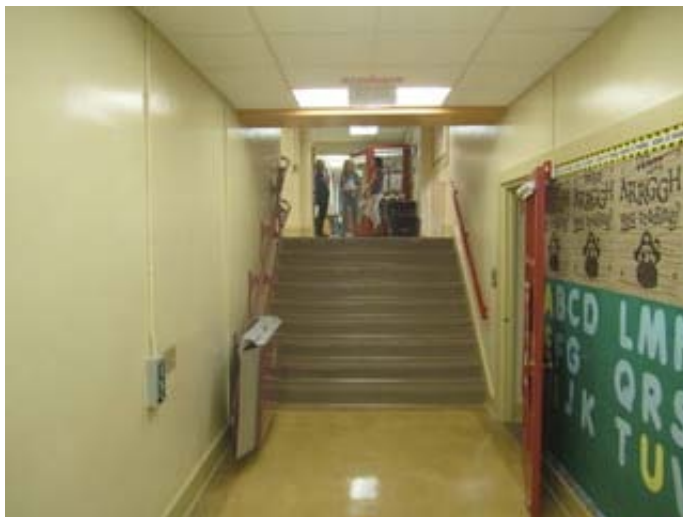
Existing Chair Lift

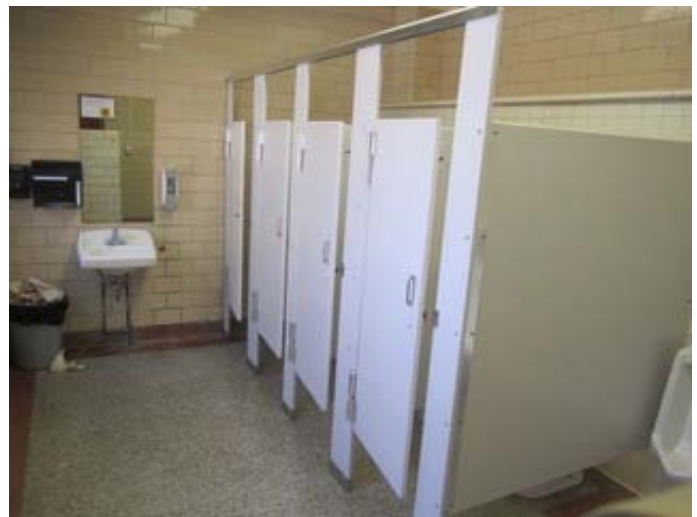
Typical Restroom in 1909 Original Construction

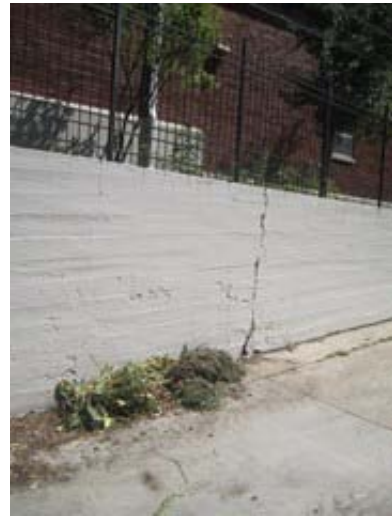
Cracked Retaining Wall

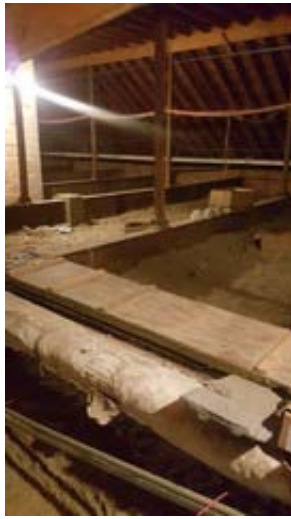
Pipe Fittings and Insulation in the Attic

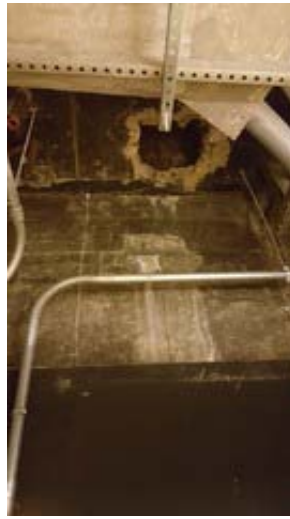
Pipe Fittings in Basement
