Building Information - Oakwood City (44586) - Lange School

Program Type	Expedited Local Partnership Program (ELPP)
Setting	Suburban
Assessment Name	Lange School with 2018 Costs, EEA & Related Scope Adjustments
Assessment Date (on-site; non-EEA)	2017-08-25
Kitchen Type	Warming Kitchen
Cost Set:	2018
Building Name	Lange School
Building IRN	94458601
Building Address	219 W. Dorothy Lane
Building City	Dayton
Building Zipcode	45429
Building Phone	(937) 299-8730
Acreage	1.60
Current Grades:	K
Teaching Stations	11
Number of Floors	2
Student Capacity	98
Current Enrollment	135
Enrollment Date	2017-10-04
Enrollment Date is the date in which the current enrollment was taken.	
Number of Classrooms	9
Historical Register	NO
Building's Principal	Mr. Frank Eaton
Building Type	Elementary

Building Construction Information - Oakwood City (44586) - Lange School (94458601)

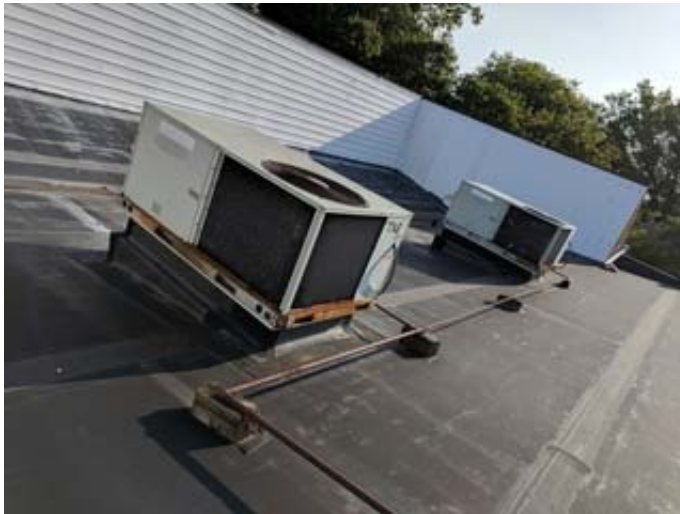
Description: The existing system for the overall facility consists of constant volume rooftop units with gas heat exchangers, delivering hot air to the spaces, installed in 1992, and are in poor condition due to age. 2-pipe vs. 4-pipe designations are not applicable in this facility due to ducted rooftop unit gas heat. The system does comply with the 15 CFM per person fresh air requirements of the Ohio Building Code mechanical code and Ohio School Design Manual. The electronic type system temperature controls were installed in 2003 and are in good condition. The system does not feature individual temperature controls in all spaces required by the OSDM. The overall system does not feature any central energy recovery systems. The facility is not equipped with louvered interior doors to facilitate Corridor utilization as return air plenums. The existing system is ducted, but the ductwork cannot be integrated into a possible future system due to arrangement, air volume, and routing of existing ductwork. The overall heating system is evaluated as being in safe but inefficient working order, and long term life expectancy of the existing system is anticipated with routine yearly maintenance. The structure is equipped with central air conditioning. The site does not contain underground fuel tanks that are currently in use.

Rating: 3 Needs Replacement

Gas Piping to Bryant Rooftop Units

Recommendations: Provide new overall heating, ventilating, and air conditioning system to achieve compliance with Ohio Building Code and Ohio School Design Manual standards. Replace existing ductwork to facilitate efficient exchange of conditioned air.

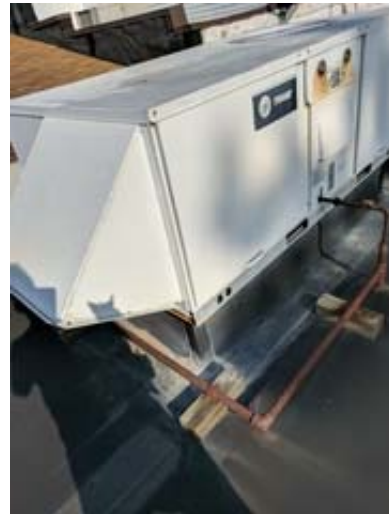
Gas Piping to Trane Rooftop Unit

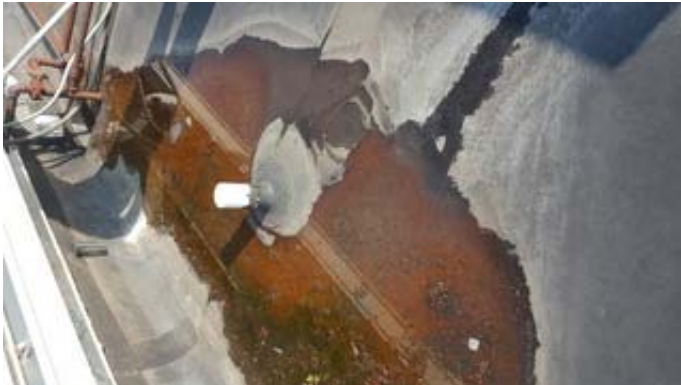
Description: The roof over the overall facility is a combination of fully adhered membrane, asphalt shingle, and clay tile systems that were installed over 7 years ago, and are in poor condition. There are District reports of current leaking. At the southwest corner of the second floor in the storage room, there is excessive leaking that the district has been unable to repair. Signs of past leaking were observed during the physical assessment. Access to the roof was gained by window that is in poor condition. Fall safety protection cages are not required. There were observations of standing water on the roof. Metal and clay tile cap flashings and stone copings are in poor condition. Roof storm drainage is addressed through a system of gutters and downspouts, scuppers, and roof drains, which are properly located, but in insufficient quantity, and in fair condition. The roof is equipped with overflow roof drains, in fair condition. No problems requiring attention were encountered with any roof penetrations. There are not any covered walkways attached to this structure.

Rating: 3 Needs Replacement

Area of Ponding

Recommendations: The roof over the overall facility requires replacement to meet Ohio School Design Manual guidelines, due to condition and age of system. Replace insulation on areas of roof replacement. Provide tapered insulation in areas where ponding has occurred. The flashing and coping on the overall facility requires replacement due to condition. Due to existing conditions gutters and downspouts, and roof drains require replacement.

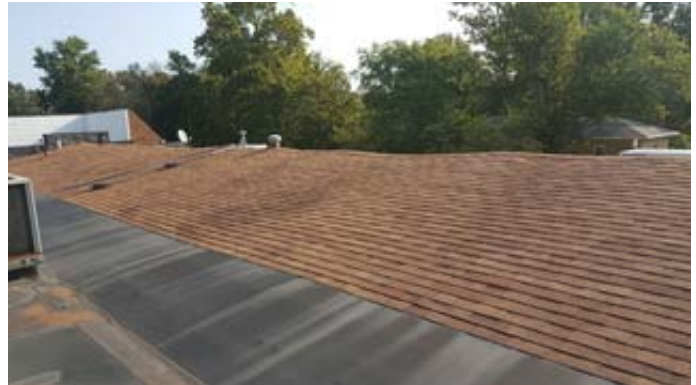
Membrane and Asphalt Shingle Portion of Roof

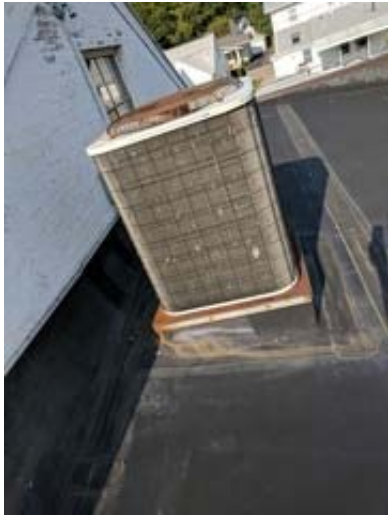
Description: The overall facility is equipped with a dx type central air conditioning system, which is in fair condition. There are (6) dx packaged rooftop units with R-22 refrigerant and (1) dx split system with air cooled condensing unit on the roof and indoor unit located in the mezzanine. Window units are provided in 0 locations. The ventilation system in the overall facility consists of rooftop units, installed in 1992 and in fair to poor condition, providing fresh air to interior Classrooms, two exterior Classrooms, the Office area, Activity area and Dining area, and dx split system air handling unit, installed in 1992 and in poor condition, providing fresh air to three exterior Classrooms. Relief air venting is provided by being ducted back through the rooftop units. The ventilation system does meet the Ohio Building Code 15 CFM per occupant fresh air requirement. The overall system is not compliant with Ohio Building Code and Ohio School Design Manual requirements. Dust collection systems are not required in this facility, and no system is provided. Due to existing grade configuration, there is no Art program. General building exhaust systems for Restrooms, Storage Rooms and Custodial are adequately placed, and in fair condition.

Rating: 3 Needs Replacement

Air Cooled Condensing Unit on Roof Serves Air Handling Unit in the Mezzanine

Recommendations: Provide an air conditioning system to meet with Ohio Building Code and Ohio School Design Manual requirements. Replace the HVAC equipment containing R-22 refrigerant. Pricing included in Item A.

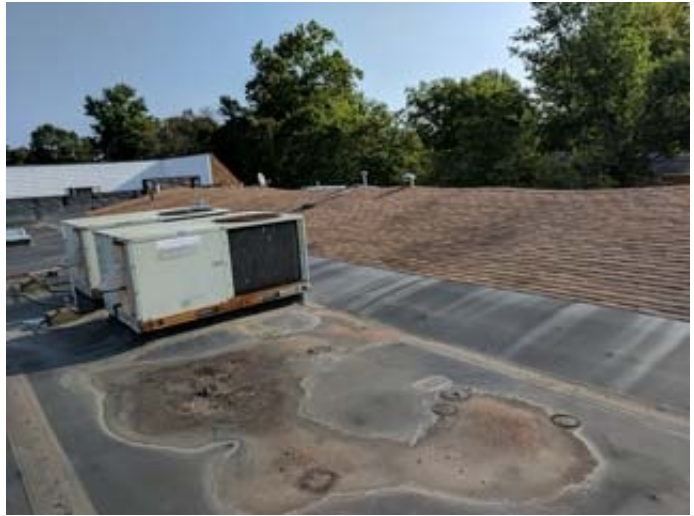
Two Bryant Rooftop Units at Lange School

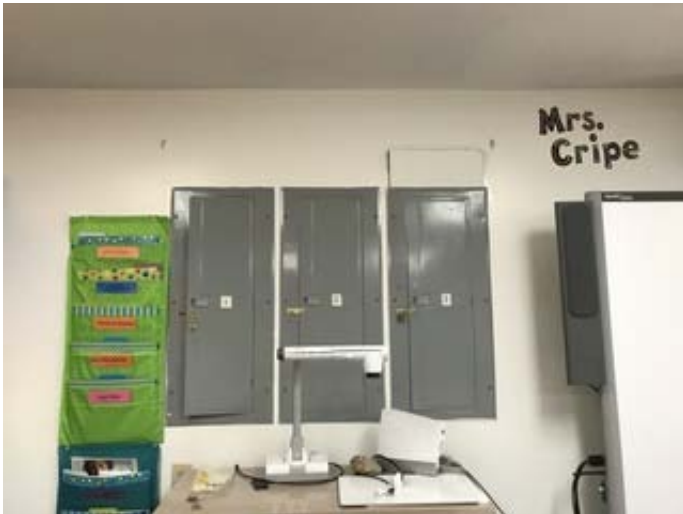
Description: The electrical system provided to the 1940 Original Construction is equipped with three (3) 200 amps main circuit breaker type panelboard distribution system, 240/120V, 1 phase and 3 wire system, installed in 1996, and is in good condition. Power is provided to the school by a single utility owned, pad-mounted transformer located outside, and in fair condition. The panel system, installed in 1996, is in good condition, but cannot be expanded to add additional capacity. The Classrooms are equipped with adequate electrical outlets. The typical Classroom contains (6) general purpose outlets, (2) dedicated outlets for each Classroom computer, and (0) dedicated outlets for each Classroom television. Some Classrooms are equipped with as many as (8) general purpose outlets, while others are equipped with as few as (4) general purpose outlets. There are not any spaces that have no electrical outlets. The Corridors are not equipped with adequate electrical outlets for servicing. Adequate GFI protected exterior outlets are not provided around the perimeter of the building. The facility is not equipped with an emergency generator. Adequate lightning protection safeguards are not provided. Stage lighting power system including control panel, breakers, and dimmers is inadequately provided, in poor condition and does not meet OSDM requirements. The overall electrical system meets does not meet Ohio School Design Manual requirements in supporting the current needs of the school, and will be inadequate to meet the facility's future needs.

Rating: 3 Needs Replacement

Building's Electrical Panels

Recommendations: The entire electrical system requires replacement to meet Ohio School Design Manual guidelines for overall capacity, Classroom capacity, due to condition and age, lack of OSDM-required features and to accommodate the addition of an air conditioning system. Provide adequate electrical outlets for servicing at Corridors and around the perimeter of the building. Provide an emergency generator, with funding included in the electrical system replacement. Provide adequate lightning protection safeguards in the overall facility, including associated grounding system, with funding included in the electrical system replacement. Provide adequate control panel, dimmers, and breakers to support the Stage lighting system.

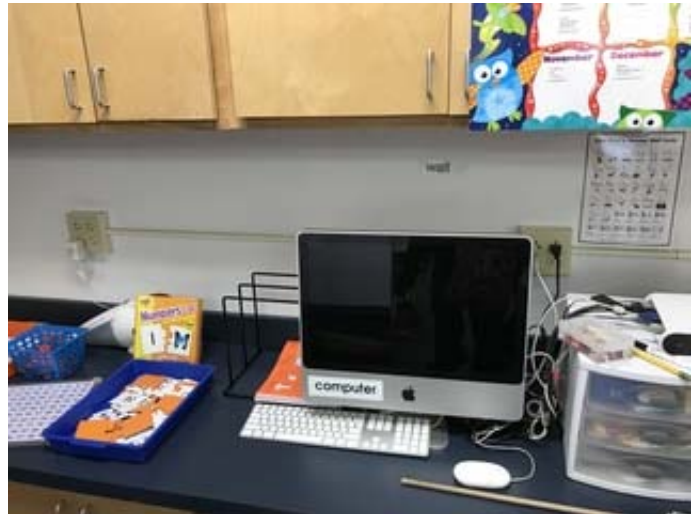
Typical Classroom Receptacle

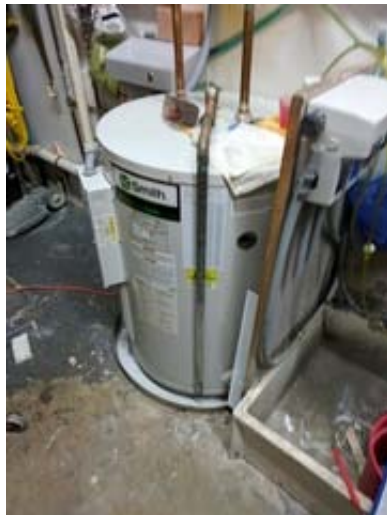
Description: The service entrance is equipped with a reduced pressure back flow preventer in fair condition. A water treatment system is not provided, though none is needed. The domestic water supply piping in the overall facility is copper, was installed in 2000, and is in good condition. The waste piping in the overall facility is PVC, was installed in 2000, and is in good condition. The facility is equipped with a 40 gallon electric water heater in good condition. The school contains (1) Large Group Restroom for boys, (1) Large Group Restroom for girls, (0) Locker Room Restrooms for boys, (0) Locker Room Restrooms for girls, (0) Restrooms associated with specialty Classrooms, and (2) Restrooms for staff. Boys' Large Group Restroom contains (0) ADA and (2) non-ADA floor mounted tank type toilets, (0) ADA and (1) non-ADA wall mounted flush valve urinal, (1) ADA wash fountain, as well as (0) ADA and (0) non-ADA wall mounted lavatories. Girls' Large Group Restroom contains (1) ADA and (2) non-ADA floor mounted tank type toilets, (1) ADA wash fountain, as well as (0) ADA and (0) non-ADA lavatories. Staff Restrooms contain (2) ADA and (1) non-ADA toilets, (0) ADA and (1) non-ADA urinals, as well as (2) ADA and (0) non-ADA lavatories. Condition of fixtures is fair. The facility is equipped with (0) ADA and (0) non-ADA drinking fountains, as well as (0) ADA and (2) non-ADA electric water coolers, in fair condition. The (7) Kindergarten Classrooms are equipped with (7) ADA and (0) non-ADA sink mounted type drinking fountains, in good condition. Special Education Classroom is not equipped with the required Restroom facilities. Kitchen is not equipped with the required Restroom. Heath Clinic is equipped with the required Restroom, and fixtures are in fair condition. Kindergarten Classrooms are not equipped with Restroom facilities. Kitchen fixtures consist of (1) three station lavatory and (1) two station lavatory, which are in fair condition. The Kitchen is not equipped with a grease interceptor due to the lack of need. The Kitchen is provided the required 140 degree hot water supply via a 40 gallon tank type water heater, which is in good condition. The school does meet the OBC requirements for fixtures. Relative to LEED requirements, the school is not equipped with low flow type fixtures. Per OBC and OSDM requirements this facility should be equipped with (5) toilets, (2) urinals, (3) lavatories, (7) Classroom sink mounted drinking fountains, and (1) electric water coolers. Observations revealed that the school is currently equipped with (9) toilets, (2) urinals, (3) wash fountains, (4) lavatories, (7) Classroom sink mounted drinking fountains, and (2) electric water coolers. ADA requirements are not met for fixtures and drinking fountains (see Item O). Custodial Closets are properly located and are adequately provided with required service sink or floor drain sink, which is in poor condition. Science Classroom / Lab utility sinks, gas connections, compressed air connections, and safety shower / eyewash are not provided, but are not required due to existing grade configuration. Due to existing grade configuration, no Biology or Chemistry Classroom acid waste systems are required. Adequate exterior wall hydrants are provided.

Rating: 2 Needs Repair

Electric Water Heater In the Janitor Closet

Recommendations: Due to LEED, and OSFC requirements, provide (7) new toilets / (4) new lavatories / (2) new urinals / (2) new double ADA electric water coolers / (7) new lavatory mounted type drinking fountains. Replace the 3 station lavatory and the 2 station lavatory to meet LEED requirements. Due to condition, replace the service sink / Floor Drain sink in the Janitors Closet. See Item O for replacement of fixtures related to ADA requirements.

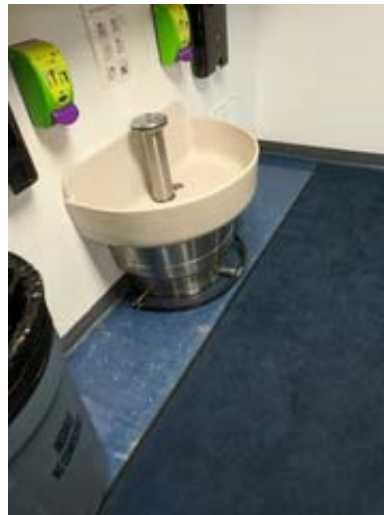
Typical Wash Fountain at Lange School

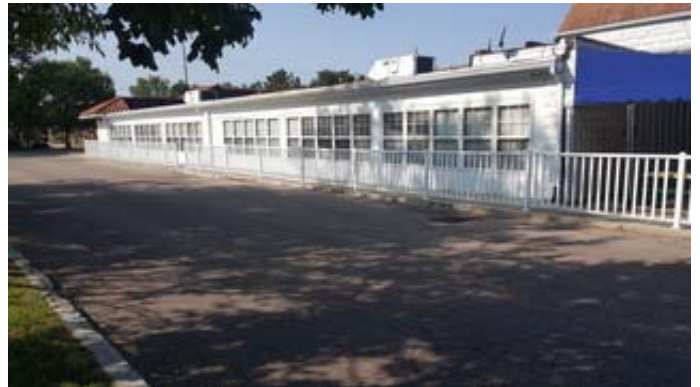
Description: The majority of the facility is equipped with thermally broken vinyl frame windows with double glazed insulated glazing type window system. The exact installation date is unknown, but reported by District that the windows are 20-25 years old, in fair condition. The window system features operable windows in most of the building, and operable windows are not equipped with opening limiters, but are equipped with insect screens in fair condition. Window system seals are in fair condition, with minimal air and water infiltration being experienced. Window system hardware is in fair condition. The window system features surface mounted blinds, which are in fair condition. This facility is not equipped with any curtain wall systems. There are glass block windows on the west elevation, in fair condition. There is one window in the attached that is a metal frame window with single pane glazing, and is in poor condition. The exterior doors in the overall facility are not equipped with sidelights or transoms. Exterior door vision panels are single pane glazing. The school does contain 6 acrylic bubble type skylights in good condition. The school does not contain clerestories. Interior glass is not OSDM-compliant due to not being tempered glazing. Window security grilles are not provided, but no ground floor windows are present. There is not a Greenhouse associated with this school.

Rating: 3 Needs Replacement

Windows in East Elevation

Recommendations: Provide a new insulated window system with integral blinds to meet with Ohio School Design Manual requirements. Exterior door vision panel replacement is addressed in Item S in exterior door replacement scope. Replace interior glazing with compliant tempered glazing.

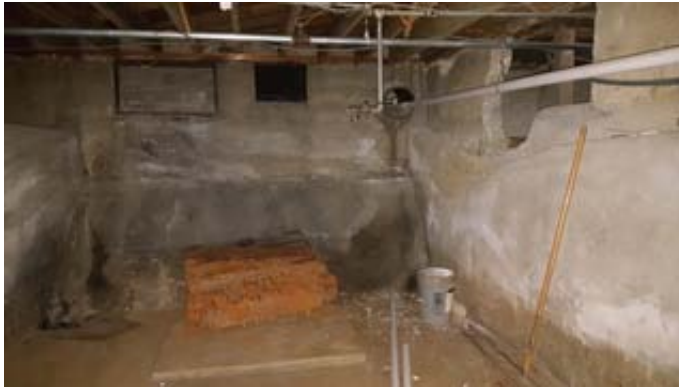
Description: The overall facility is equipped with concrete foundation walls on concrete footings, which displayed no locations of significant differential settlement, cracking, or leaking, and are in good condition. No significant issues related to foundation cracking or spalling were encountered. The District reports that there has been past leaking. No grading or site drainage deficiencies were noted around the perimeter of the structure that are contributing or could contribute to foundation / wall structural deterioration.

Crawl Space

Recommendations: Existing conditions require no renovation or replacement at the present time.

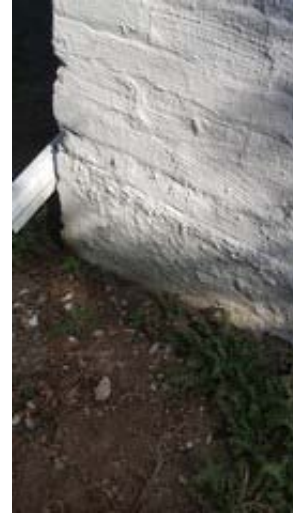
Exposed Foundation Wall

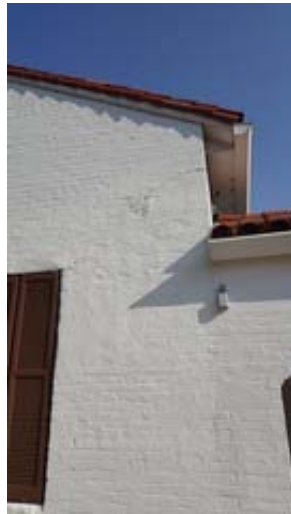
Description: The overall facility has a brick veneer and split-face block on a load bearing masonry wall system with gypsum board interior finish which displayed locations of deterioration, and is in fair condition. The exterior masonry appears to have no caulked control joints. Control joints are not provided at lintel locations, at doors and windows, building corners, and wall offsets. Control joints are provided at connection of dissimilar materials. The school does not contain expansion joints and none are needed, as there is no indication of exterior masonry cracking or separation. Exterior walls in the overall facility are adequately insulated. Brick veneer masonry walls are not cavity walls. Weep holes and vents are not provided or required. The exterior masonry has been painted in recent years, and shows evidence of mortar deterioration, especially at the base of the walls. Architectural exterior accent materials consist of painted wood, which is in poor condition. Exterior framing for walls above the roof is non-treated lumber and is in poor condition. Exterior building fenestration in the overall facility represents 13.75% of the exterior surfaces. Interior Corridor and demising walls are either metal stud or wood framed partitions with gypsum board. Corridor walls project full height from floor to bottom of deck, and are in good condition. Classroom and office walls do not project full height from floor to bottom of deck, and are in good condition. Interior soffits are of either plaster type construction in good condition, or acoustical ceiling tile in fair condition. The window sills are an element of the aluminum window system, and are in poor condition. The exterior lintels are steel, and are in fair condition. There are no chimneys. Canopies over entrances are wood-framed and aluminum-finished type construction, and are in poor condition. Exterior soffits are of aluminum type construction, and in poor condition. The school is not equipped with a loading dock.

Rating: 2 Needs Repair

Masonry Wall on South Elevation

Recommendations: Provide tuckpointing in all areas of mortar deterioration as required through the overall facility. Provide masonry cleaning, caulking and painting as required through the overall facility. Repair the caulked control joints at the connections of dissimilar materials. Replace aluminum soffits. Repair or replace wood trim and paint. Window sill replacement is addressed in Item F. Exterior wall insulation deficiencies are addressed in Item J.

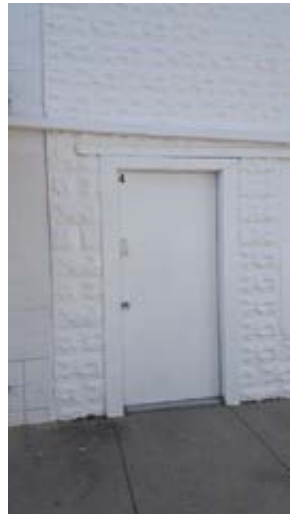
Control Joint at Dissimilar Materials

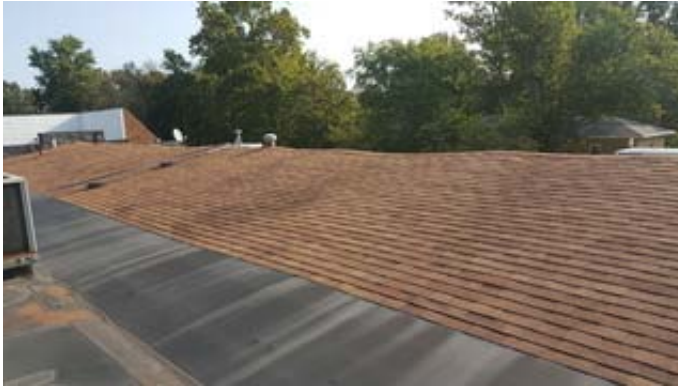
Description: The floor construction of the base floor of the overall facility is wood planking on wood joist type construction, and is in fair condition. Crawl space is located under the group boys room section of the facility. The floor construction of the second floor of the overall facility is wood planking on wood joist type construction, and is in fair condition. Ceiling to structural deck spaces are sufficient to accommodate HVAC, electrical, and plumbing scopes of work in required renovations. The roof construction of the overall facility is wood planking on wood rafter type construction, and is in poor condition.

Rating: 2 Needs Repair

Sagging Roof Framing

Recommendations: Refer to Item U for pricing of fire suppression system. Provide fire separation assembly for wood roof and floor. Replace wood roof framing at section of roof over the Media Center, Corridor and Group Restrooms.

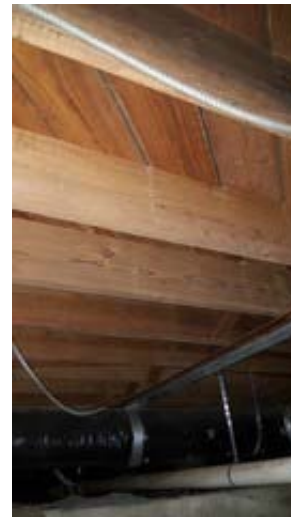
Floor Framing above Crawl Space

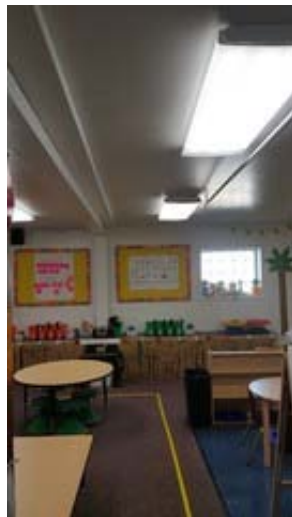
Description: The overall facility features conventionally partitioned Classrooms with carpet and VCT type flooring, with either painted plaster or ACT type ceilings, as well as painted plaster type wall finishes, and they are in good condition. The overall facility has Corridors with carpet type flooring, ACT or painted plaster type ceilings, as well as painted plaster type wall finishes, and they are in good condition. The overall facility has Restrooms with VCT type flooring, ACT type ceilings, as well as painted plaster type wall finishes, and they are in good condition. Toilet partitions are metal or wood, and are in fair condition. Classroom casework in the overall facility is wood type construction with plastic laminate tops, is adequately provided, and in good condition. The typical Classroom contains 10 lineal feet of casework, and Classroom casework provided ranges from 7 to 15 feet. Classrooms are provided adequate markerboards and tackboards, which are in good condition. The lockers and storage cubbies, located in the Corridors, are adequately provided, and in good condition. Due to existing grade configuration, there is not an Art Program. The facility is equipped with wood non-louvered interior doors that are flush mounted with and some without proper ADA hardware and clearances, and in fair condition. The Gymnasium space has carpet type flooring, painted plaster type ceilings, as well as painted plaster type wall finishes, and they are in good condition. Student Dining, has VCT type flooring, ACT type ceilings, as well as painted plaster type wall finishes, and they are in good condition. Student Dining shares the Gymnasium space, but there is a clear division with floor and ceiling materiality changes. OSDM-required fixed equipment for Stage is not provided. Existing Gymnasium, Student Dining, and Media Center spaces are adequately provided with appropriate sound attenuation acoustical surface treatments. The existing Kitchen is a Warming Kitchen only, is undersized based on current enrollment, and the existing Kitchen equipment is in fair condition. The Kitchen is not equipped with a hood. The Kitchen is equipped with a standard size refrigerator in good condition.

Rating: 2 Needs Repair

Typical Classroom Finishes

Recommendations: Provide funding to paint interior of overall facility. Replace toilet accessories. Replace toilet partitions. Replace existing Kitchen equipment due to age and condition. Funding for replacement of interior doors is provided in Item O. POST-ASSESSMENT NOTE: Rii 3-9-18 Scope added to replace Non-ACM ceiling panels and resilient flooring to coordinate with Item T.

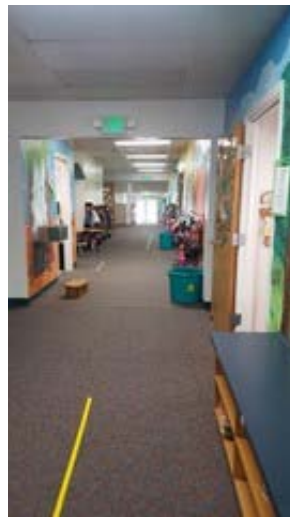
Typical Corridor Finishes

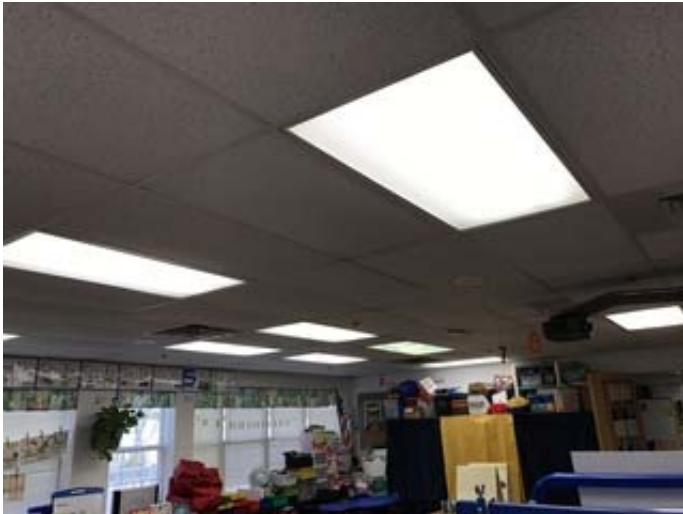
Description: The typical Classrooms in the overall facility are equipped with T-8 fluorescent, 2x4 lay-in and 2x4 wraparound surface mount fixture type lighting with single level switching. Classroom fixtures are in good condition, providing an average illumination of 78 FC, thus complying with the 40 FC recommended by the OSDM. The typical Corridors in the overall facility are equipped with T-8 fluorescent, 2x4 wraparound surface mount fixture type lighting with single level switching. Corridor fixtures are in good condition, providing an average illumination of 20 FC, thus complying with the 15 FC recommended by the OSDM. There is no Gymnasium space in the facility. There is no Media Center space in the facility. The Student Dining spaces are equipped with T-8 fluorescent, 2x4 lay-in and 2x4 wraparound surface mount fixture type lighting with single level switching. Student Dining fixtures are in good condition, providing an average illumination of 45 FC, thus complying with the 40 FC recommended by the OSDM. The Kitchen spaces are equipped with T-8 fluorescent, 2x4 lay-in fixture type lighting with single level switching. Kitchen fixtures are in good condition, providing an average illumination of 53 FC, thus complying with the 50 FC recommended by the OSDM. The Service Areas in the overall facility are equipped with T-8 fluorescent, 1x4 indirect suspended and 2x4 recessed mount fixture type lighting, in good condition. The typical Administrative spaces in the overall facility are equipped with T-8 fluorescent, 2x4 recessed mount fixture type lighting in good condition, providing adequate illumination based on OSDM requirements.

Rating: 3 Needs Replacement

Typical Classroom Lighting

Recommendations: Provide complete replacement of lighting system due to condition, lighting levels, lack of multi-level switching, and installation of systems outlined in Items A, J and U. Provide adequate occupancy sensors to areas currently lacking for compliance with ASHRAE 90.1.

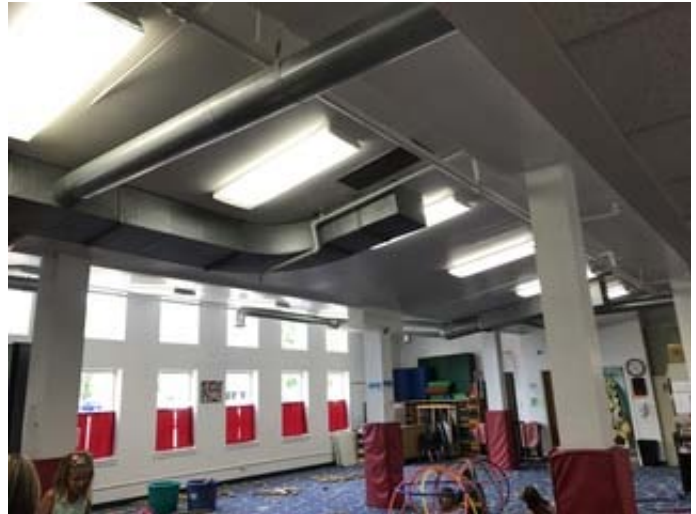
Dining Room Lighting

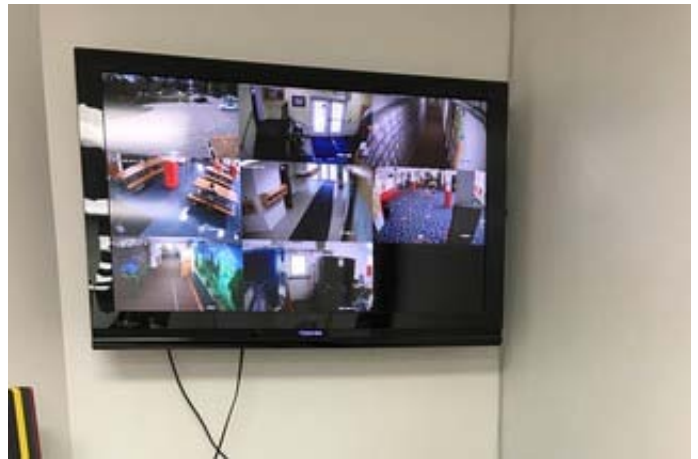
Description: The overall facility contains a CCTV (Honeywell) and Door access control security system (Ademco), in good condition. Motion detectors are not provided in main entries, central gathering areas, offices, main Corridors, and spaces where 6 or more computers are located. Exterior doors are not equipped with door contacts, but are equipped with door alarm modules. An automatic visitor control system is not provided. The Administrative office is located adjacent to the Main Entrance to the facility and though a secure Entrance vestibule is not provided, the Main Entry is equipped with Door Buzzer Entry system and CCTV camera monitored and controlled by a computer in the Administrative office. Compliant color CCTV cameras are provided at main entry areas, parking lots, central gathering areas, and main Corridors. CCTV is monitored in Administrative Area with the use of a LCD monitor, computer based recording device. A compliant computer controlled access control system integrating alarms and video signals, with appropriate UPS backup, is not provided. The system is not equipped with card / biometric readers. The security system is not adequately provided throughout, and the system is not fully compliant with Ohio School Design Manual guidelines. There are no playground fencing issues requiring attention. The exterior site lighting system is equipped with fluorescent, recessed downlight fixtures at entry lights, in fair condition. Pedestrian walkways are illuminated with surface mount decorative wall sconce fixtures in fair condition. Parking pick-up / drop off areas are illuminated with high pressure sodium, ground mounted floodlight fixtures, in fair condition. The exterior site lighting system provides inadequate illumination due to insufficient fixture capacity and sparse placement of fixtures.

Security Monitor At Reception Area

Recommendations: Provide complete replacement of security system to meet Ohio School Design Manual guidelines. Provide complete replacement of exterior site lighting system to meet Ohio School Design Manual guidelines.

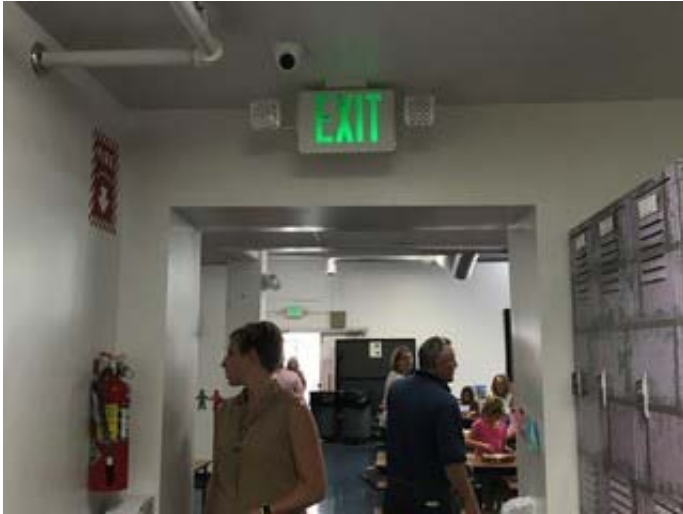
Description: The overall facility is equipped with an emergency egress lighting system consisting of non-compliant green lettered, plastic construction, incandescent illuminated exit signs, as well as OSDM compliant red lettered, plastic construction, LED illuminated exit signs, and the system is in good condition. The facility is adequately equipped with emergency egress floodlighting, that is powered on separate circuits, and the system is in good condition. The facility is not equipped with recessed fluorescent lighting used as emergency egress lighting. The system is provided with appropriate battery backup, but is not backed up by an emergency generator. The system is not adequately provided throughout, and does not meet Ohio School Design Manual and Ohio Building Code requirements.

Rating: 3 Needs Replacement

Typical Exit Sign

Recommendations: Provide complete replacement of emergency / egress lighting system to meet Ohio School Design Manual and Ohio Building Code guidelines.

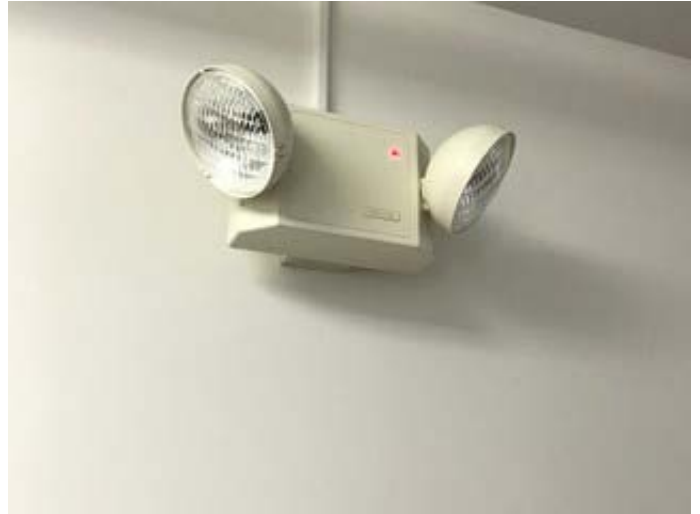
Typical Emergency Lighting

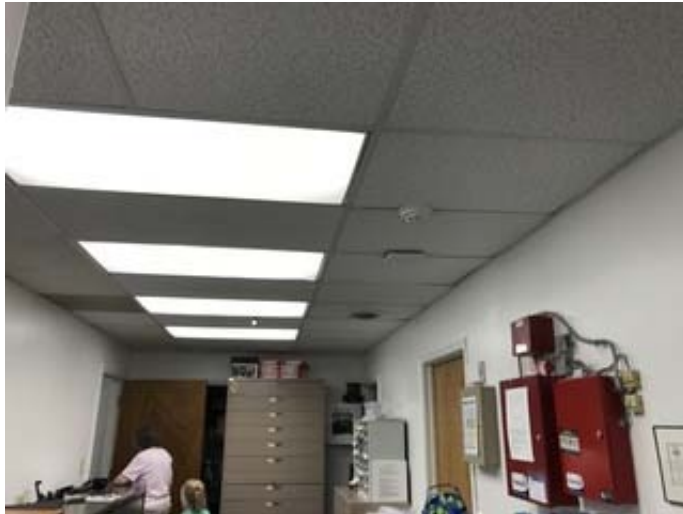
Description: The overall facility is equipped with a Honeywell (Ademco) type fire alarm system, installed in 2015, and in good condition, consisting of manual pull stations, bells, horn and strobe indicating devices. The system is automatic and is monitored by a third party (Protection 1). The system is equipped with sufficient audible horns and strobe indicating devices, flow switches, tamper switches, smoke detectors. The system is not equipped with any heat sensors. The system thus will support future fire suppression systems. The system is adequately provided throughout, but does not have additional zone capabilities. The system is not fully compliant with Ohio Building Code, NFPA, and Ohio School Design Manual requirements.

Rating: 2 Needs Repair

Fire Alarm Panel And Smoke Detector

Recommendations: Provide partial replacement of fire alarm system replacing the outdated fire alarm control panel for additional expansion capability to the overall facility to meet OBC, NFPA, and Ohio School Design Manual guidelines.

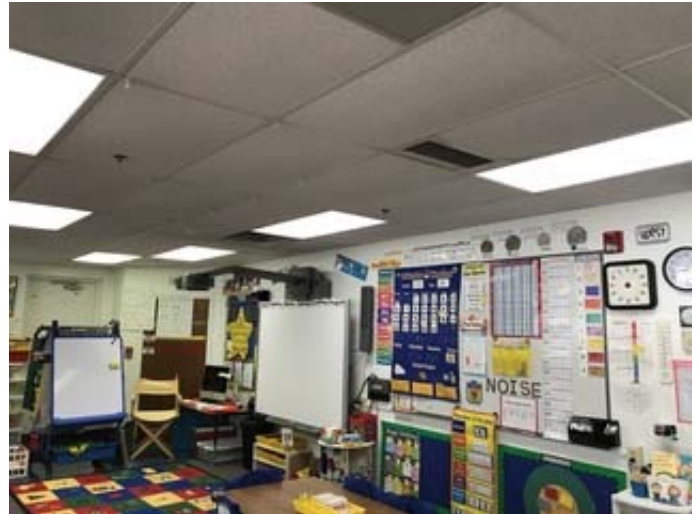
Typical Audible Horn and Strobe Device

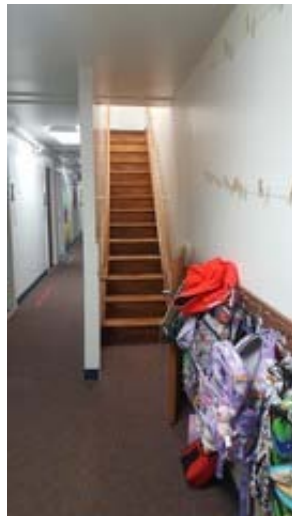
Description: At the site, there is an accessible route provided from the public right-of-way, the accessible parking areas, and from the passenger unloading zone to the main entrance of the school. There is not an accessible route connecting all areas of the site because there is not a designated walking path/sidewalk to the playground. The exterior entrances are not ADA accessible due to improper hardware. Access from the parking / drop-off area to the building entries is not compromised by steps or steep ramps. Adequate handicap parking is not provided. Exterior doors are not equipped with ADA hardware. Building entrances should be equipped with 1 ADA power assist door, and none are provided. The main entry located in the front of the building requires a power assist door. Playground layout and equipping are compliant. On the interior of the building, space allowances and reach ranges are mostly compliant. There is an accessible route through the building which does include protruding objects. Ground and floor surfaces are compliant. Stairs do not meet all ADA requirements due to width of stairwell. There are no ramps. Elevation changes within the overall facility are facilitated by 3 compliant and 1 non-compliant stairwell in good condition, 1 compliant lift in fair condition. This multistory building does not have a compliant elevator that accesses every floor. Access to the Stage is not facilitated by a Corridor at Stage level, chair lift, or ramp. Interior doors are not recessed, are provided adequate clearances, and are not provided with ADA-compliant hardware. 5 ADA-compliant toilets are required, and 4 are currently provided. 5 ADA-compliant Restroom lavatories are required, and 2 are currently provided. 0 ADA-compliant Science Classroom lab sinks are required, and 0 are currently provided. 2 ADA-compliant urinals are required, and 2 are currently provided. 0 ADA-compliant showers are required, and 0 are currently provided. 2 ADA-compliant electric water coolers are required, and 0 are currently provided. Toilet partitions are metal or wood, and do not provide appropriate ADA clearances. ADA-compliant accessories are not adequately provided and mounted. Mirrors do meet ADA requirements for mounting heights. Due to existing grade configuration, no Science Classroom considerations require evaluation. Health Clinic and Special Education Restrooms are not compliant with ADA requirements due to non-compliant fixtures. ADA signage is not adequately provided throughout the building.

Rating: 2 Needs Repair

Non Compliant Stairwell

Recommendations: Provide ADA-compliant signage, 1 power assist door opener, toilets, toilet accessories, sinks, toilet partitions, toilet accessories, doors and frames, and door hardware in the overall facility to facilitate the school's meeting of ADA requirements. Parking issues are corrected in Item P. Provide ramp for access to stage. Provide elevator to access teacher's lounge on second floor. Provide funding to expand stairwell to second floor to allow for compliant width. Replace existing chair lift due to condition.

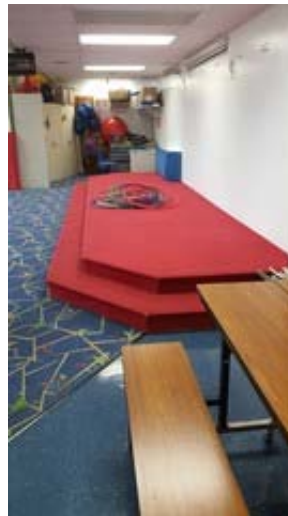
Stage

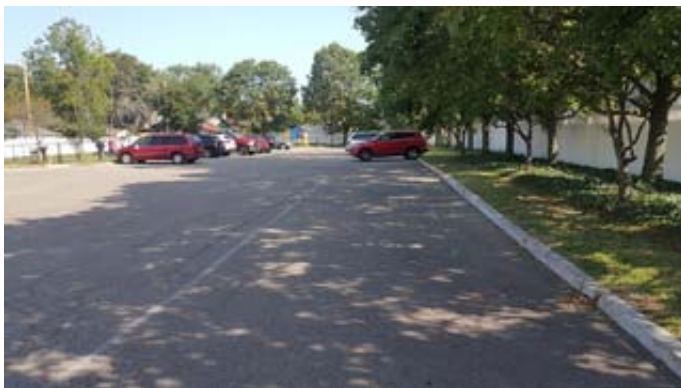
Rating: 2 Needs Repair

Entry Drive and Staff Parking

Recommendations: Provide new asphalt wear course on the hard-surface play area. Provide new heavy-duty paving at the entry drives to new dumpster pad. Provide new light-duty paving at parking areas. Provide funding to repair concrete curbing and concrete sidewalks. Replace the main entry concrete steps and provide a compliant guardrail. Provide a compliant ramp at the main entry. Replace damaged concrete dumpster pad. Provide linework for designated ADA parking spots. Replace the wood tables and benches at the playground area.

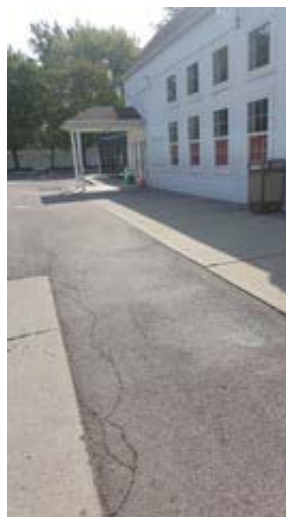
Hard-Surface Play and Dumpster Pad

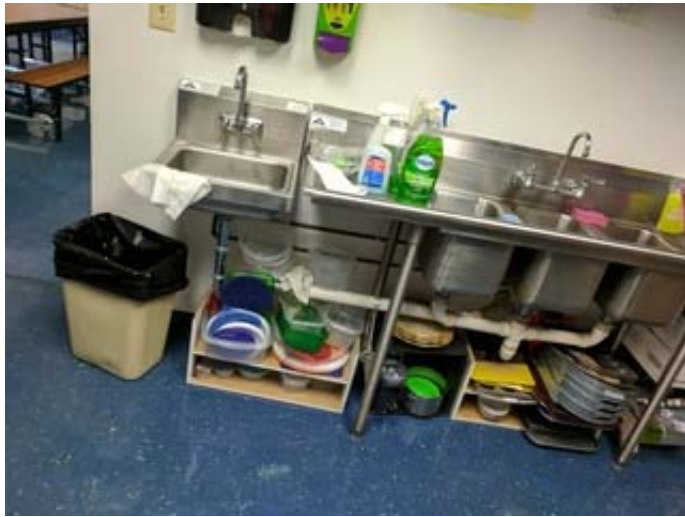
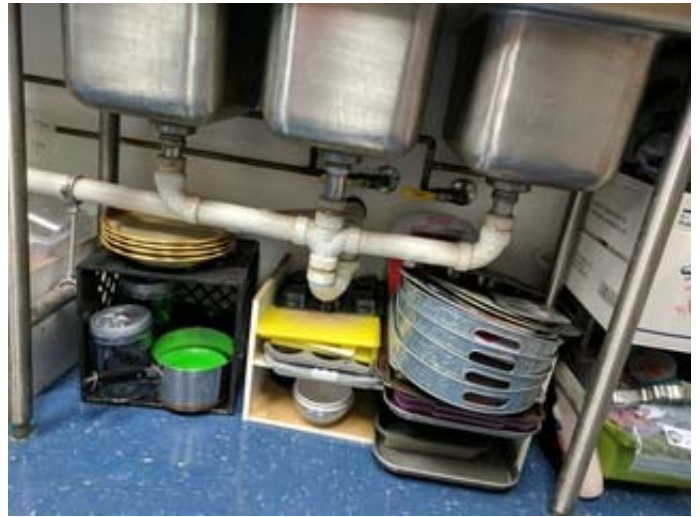
Description: The sanitary sewer system is tied in to the city system, and is in good condition. No significant system deficiencies were reported by the school district or noted during the physical assessment.

PVC Drain Piping

Recommendations: Existing conditions require no renovation or replacement at the present time.

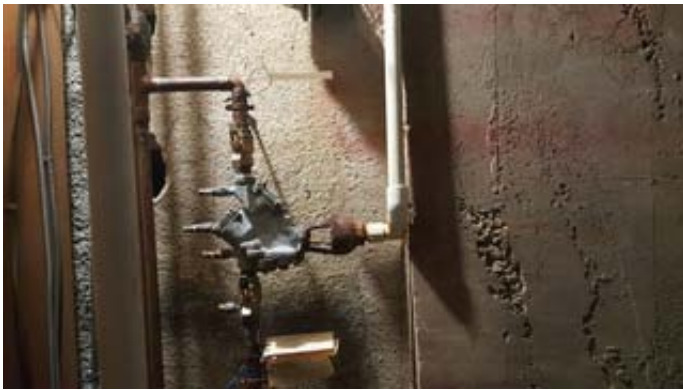
Description: The domestic water supply system is tied in to the municipal system, features 1" service and 1" water meter, and is in good condition. The District was not able to provide water supply flow test data. The existing domestic water service appears to meet the facility's current needs. The facility is equipped with an adequately sized automated fire suppression system, for which the existing water supply provides adequate support. The domestic water service is not equipped with a water booster pump, and none is required. The system provides adequate pressure and capacity for the future needs of the school.

Backflow Preventer at Lange

Recommendations: Existing conditions require no renovation or replacement at the present time.

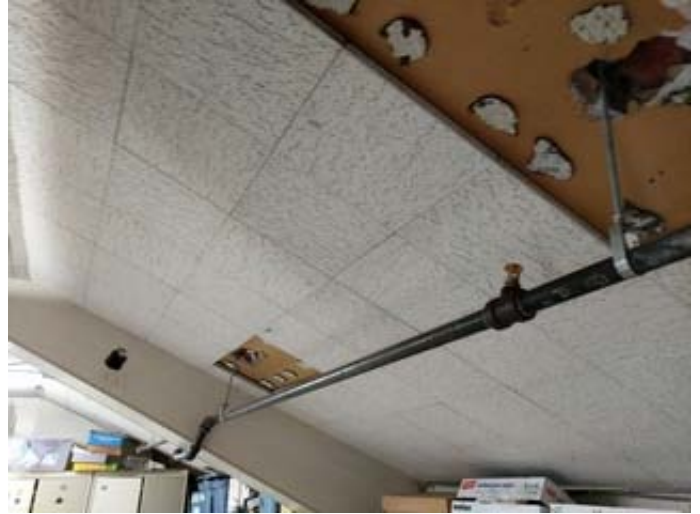
Sprinkler Piping in the Mezzanine at Lange

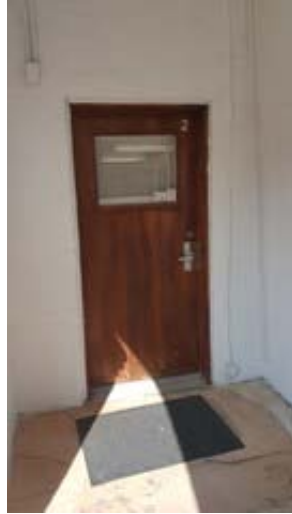
Description: Typical exterior doors in the overall facility are wood type construction, installed on wood frames, and in poor condition. Typical exterior doors feature single glazed unprotected vision panels, and inappropriate hardware. Entrance doors in the overall facility are hollow metal type construction, installed on hollow metal frames, and in fair condition. Entrance doors feature single glazed unprotected vision panels and inappropriate hardware. The facility is not equipped with any roof access doors. There are no overhead doors in the facility.

Rating: 3 Needs Replacement

Typical Exterior Door

Recommendations: Replace all exterior and entrance doors to comply with Ohio Building Code, ADA, and Ohio School Design Manual guidelines.

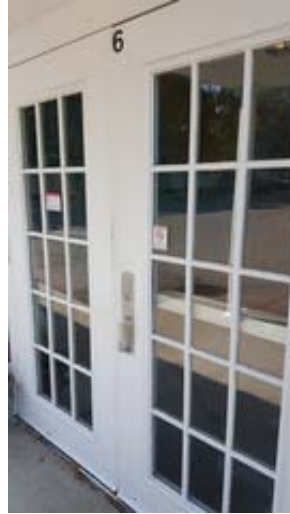
Typical Entrance Door

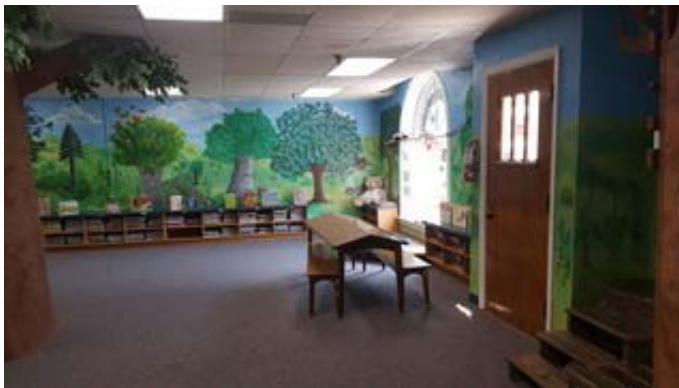
Rating: 2 Needs Repair

Reading Room with Fire Extinguisher and Sprinkler Heads

Recommendations: Provide complete replacement of automated fire suppression system to meet Ohio School Design Manual guidelines. Provide new emergency generator, with funding provided via complete replacement of electrical system in Item D. Provide new handrails to meet the requirements of the Ohio Building Code. Rework existing non-compliant stair tower and Corridor.

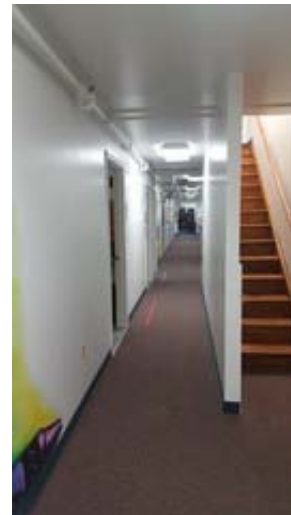
Non-compliant Stair and Corridor

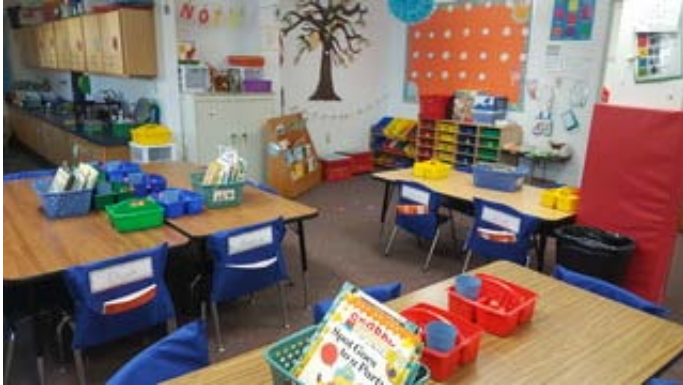
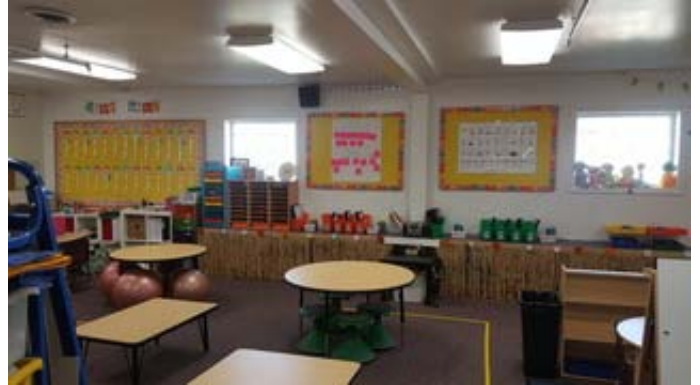
Typical Classroom Furniture

Recommendations: Provide for replacement of outdated or inadequate furnishings.

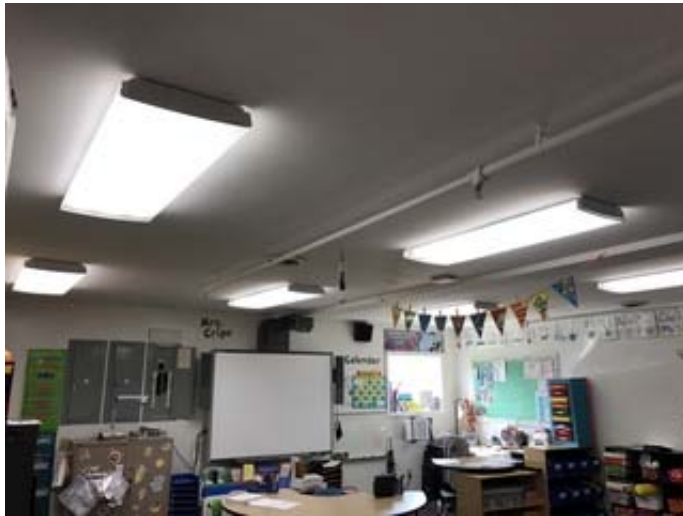
Rating: 3 Needs Replacement

Typical Ceiling Devices And Smartboard

Recommendations: Provide complete replacement of technology systems to meet Ohio School Design Manual requirements, and to sustain the capacity to keep pace with technological development.

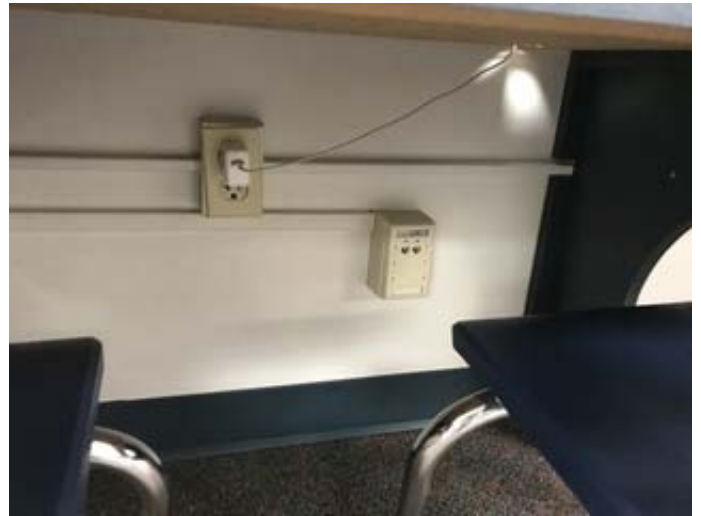
Typical Classroom Data Ports
