**Building Information - Oakwood City (44586) - Oakwood Jr./Sr. High**

| Assessment Name | Oakwood Junior/Senior High with 2018 Costs, EEA & Related Scope Adjustments |
| Assessment Date (on-site; non-EEA) | 2017-08-23 |

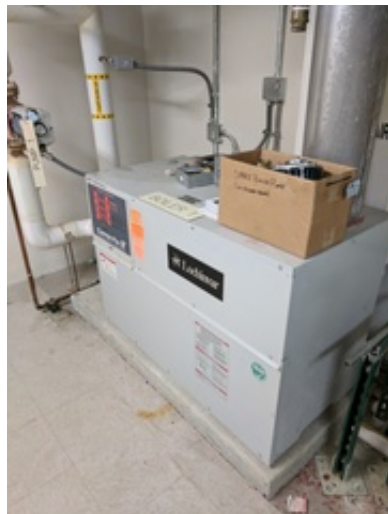
The existing system for the 1927 Original Construction is a gas fired steam boiler, installed in 1991, and is in fair condition. The existing system for the 2003 Addition is a gas fired hot water boiler, installed in 2014, and is in good condition. 2-pipe vs. 4-pipe designations are not applicable in this facility, as no central air conditioning is provided. The (2) steam boilers, manufactured by Kewanee, were installed in 1991 and are in fair condition. Steam is distributed to air handling units, heat exchangers, radiators, unit ventilators, cabinet heaters and unit heaters. The terminal equipment is original to each addition and is in fair to poor condition. The heat exchanger serves the Science wing, installed in 1960 and in fair condition, distributing hot water to terminal units consisting of fan coils, unit ventilators and cabinet heaters. The Lochinvar heating hot water boiler was installed in 2003 and is in good condition. Heating water is distributed to terminal units consisting of rooftop units, reheat coils and cabinet heaters. The terminal equipment was installed in 2003 and is in fair condition. The system does not comply with the 15 CFM per person fresh air requirements of the Ohio Building Code mechanical code and Ohio School Design Manual. The electronic and pneumatic type system temperature controls were installed in 1991 and 2003 and are in fair to poor condition. The system does not feature individual temperature controls in all spaces required by the OSDM. The overall system does not feature any central energy recovery systems. The facility is equipped with widespread louvered interior doors to facilitate Corridor utilization as return air plenums, which does not comply with Ohio Building and Mechanical Code. The existing system is ducted, but the ductwork cannot be integrated into a possible future system due to arrangement, air volume, and routing of existing ductwork. The overall heating system is evaluated as being in safe but inefficient working order, and long term life expectancy of the existing system is anticipated with routine maintenance. The structure is not equipped with central air conditioning. The site does not contain underground fuel tanks that are currently in use.

Lochinvar Hot Water Boiler in the 2003 Building Addition

Provide new overall heating, ventilating, and air conditioning system to achieve compliance with Ohio Building Code and Ohio School Design Manual standards. Convert to ducted system to facilitate efficient exchange of conditioned air. Replace existing ductwork to facilitate efficient exchange of conditioned air. Provide new DDC type temperature controls only meet Ohio Building Code and Ohio School Design Manual standards. Provide architectural soffits to accommodate the installation of ductwork.

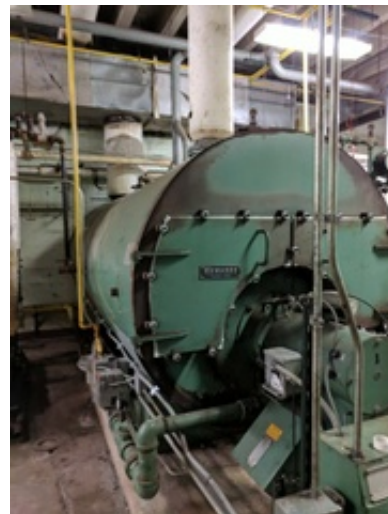
Kewanee Steam Boiler in the Original Construction

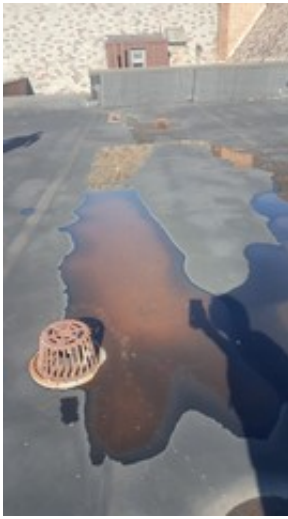
The roof over the 1927 Original Construction and 1932 Addition is a combination of a fully adhered membrane on the low-slope portions, installed between 14 and 19 years ago, and a slate system on the high-pitched portions, installed the year of construction, and they are in fair to poor condition. The roof over the 1960 and 1969 Additions is either a modified bitumen or a fully adhered membrane system, installed between 14 and 19 years ago, and is in poor condition. The roof over the 1989 Addition is a fully adhered membrane system, installed between 14 and 19 years ago, and is in fair condition. The roof over the 2003 Addition is a fully adhered membrane system on the low-slope portion, which is in fair condition, and slate on the high-pitched portions, which is in good condition, and both were installed in 2003. There are District reports of current leaking around the existing chimneys, in the library, and in a Classroom on the 3rd floor of the 1927 Original Construction at the windows. According to the district, these areas are repaired annually. Access to the roof was gained by a window, and an access hatch that is in fair condition. Fall safety protection cages are not required. There were observations of standing water on the roof. Metal cap flashings and stone copings are in fair condition. Roof storm drainage is addressed through a system of gutters and downspouts, roof drains, and through-wall scuppers, which are properly located, and in fair condition. The roof is not equipped with overflow roof drains in the 1927 Original Construction, 1932, 1960, and 1969 Additions, though they will be required in areas of roof replacement. No problems requiring attention were encountered with any roof penetrations. There are covered walkways attached to this structure in the 1932 Addition that are used to provide shelter over entries. They have masonry column construction with wood framed roof structure and a slate roof system, all in good condition.

Ponding on Roof Over the 2003 Addition

The roof over the overall facility, with the exception of the slate roof over the 2003 Addition, requires replacement to meet Ohio School Design Manual guidelines due to condition and age of system/projected lifecycle. Provide insulation in areas of roof replacement to meet Ohio School Design Manual guidelines. Replace flashing and coping and gutters and downspouts in areas of roof replacement. Replace roof drains in areas of roof replacement in the 1932, 1960, and 1969 Additions. Replace only roof drain covers in the areas of roof replacement in the 1927 Original Construction and 2003 Addition. Provide overflow roof drains as needed in the 1927 Original Construction, 1932, 1960, and 1969 Additions. Replace existing roof hatch in the 1969 Addition due to condition.

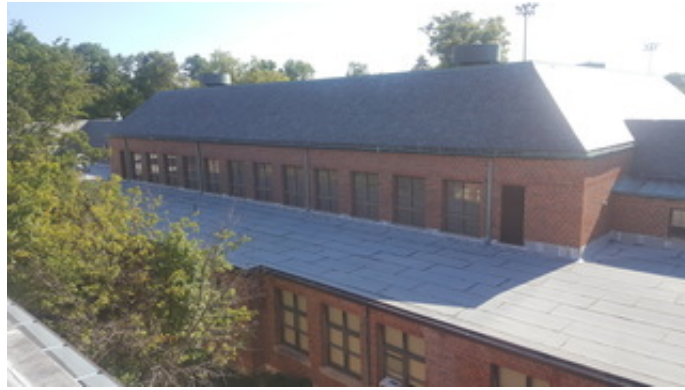
Roof Over the 1932 Addition

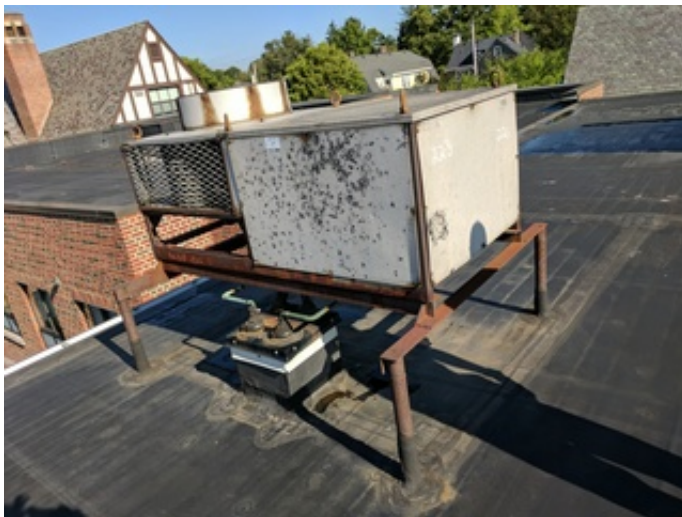
The Original Construction is not equipped with a central air conditioning system. The 1960 Science Wing Addition is equipped with a dx type central air conditioning system, which is in fair condition. The dx packaged rooftop unit delivers chilled air to variable volume reheat terminal units serving the first floor Science Classrooms. The 1969 Addition is equipped with a dx unit ventilator type central air conditioning system, which is in fair condition. The unit ventilator dx split system type air conditioning system delivers chilled air to the spaces, with refrigerant piping routed from the unit ventilators to air cooled condensing units on the roof for heat rejection. The 2003 Addition is equipped with a dx type central air conditioning system, which is in fair condition. The packaged dx rooftop unit delivers chilled air to variable volume terminal units serving Science Wing Classrooms. Window units are provided in 29 locations. Isolated room systems consisting of dx split systems and mini split units are provided in 2 locations. The ventilation system in the Original Construction and the 1931 Addition consists of air handlers, original to each addition and in fair condition, providing fresh air to Classrooms, these units are beyond their life expectancy. A heating and ventilating unit, installed in 1969 and in fair condition, provides fresh air to the Auditorium. A rooftop unit, installed in 2004 and in fair condition, provides fresh air to the second floor conference rooms. Relief air venting is provided by louvered interior doors, which is not in accordance with the Ohio Building Code and Ohio Mechanical Code. The ventilation system in the 1960 Addition consists of (2) Aaon rooftop units, installed in 1998 and 2003, and are in fair condition, providing fresh air to Science Wing Classrooms. Relief air venting is provided by transfer grilles and ceiling plenums. The ventilation system in the 1969 Addition consists of unit ventilators, installed in 1969 and in fair condition, providing fresh air to the Classrooms, and a heating and ventilating unit, installed in 1969 and in fair condition, providing fresh air to the Wrestling Room. Relief air venting is provided by louvered interior doors, which is not in accordance with the 2011 Ohio Building Code and Ohio Mechanical Code. The ventilation system in the 2003 Addition consists of rooftop units, installed in 2003 and in fair condition, providing fresh air to the Locker rooms, Faculty Workroom and Classrooms. Relief air venting is provided by transfer grilles and ceiling plenums. The ventilation system does not meet the Ohio Building Code 15 CFM per occupant fresh air requirement. The overall system is not compliant with Ohio Building Code and Ohio School Design Manual requirements. Dust collection systems are not required in this facility to support career technology Program, and existing equipment is adequate. The Art program is equipped with a kiln, and existing kiln ventilation is adequate, and in good condition. General building exhaust systems for Restrooms / Storage Rooms / Art Rooms / Custodial Closets are adequately placed, and in fair condition.

Air Cooled Condensers Serving the 1969 Building Addition

Provide an air conditioning system with ducted return to meet with Ohio Building Code and Ohio School Design Manual requirements. Pricing included in Item A.

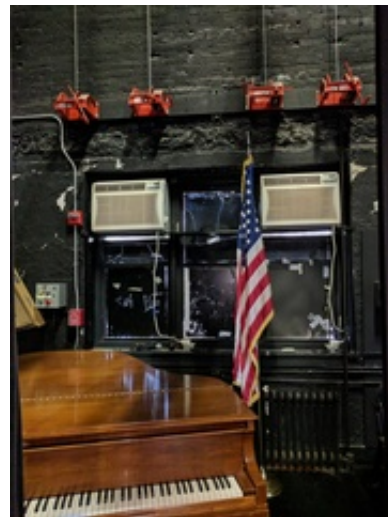
Two Window Units Provide Air Conditioning to the Auditorium Stage

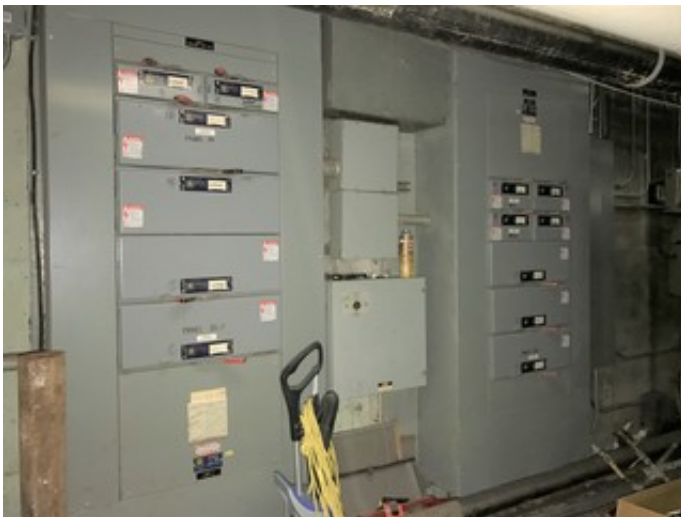
**Description:** The electrical system provided to the 1927 Original Construction is a 240/120 volt, 800 amps, 1 phase and 3 wire system installed in 1927, and is in poor condition. The electrical system in the 1927 Original Construction is providing power to the 1932 1969, 1989 and 2003 Additions. The electrical system provided to the 1960 Addition is equipped with an 800-amp main service fused disconnect switch, serving power to the 1969 and 1989 Additions, equipped with two distribution panel systems - (1) 800 amps, 240/120V, 3 phase, 4 wire system and (1) 800 amps, 240/120V, 1 phase, 3 wire system, and is in fair condition. The electrical system provided to the 2003 Addition is equipped with a 400-amp main service fused disconnect switch, serving power to a 240/120V, 400 amps, 3 phase, 3 wire distribution panel, in good condition. Power is provided to the school by multiple utility owned (DP&L), pole-mounted transformers located outside, and in fair condition. The panel system, installed in 1927 Original Construction, 1931, 1932, 1960 and 1969 Additions, is in fair condition, and cannot be expanded to add additional capacity. The panel system, installed in the 1989 and 2003 Additions, is in good condition, and cannot be expanded to add additional capacity. The Classrooms in the 1927 Original Construction, 1931, 1932, 1960 and 1969 Additions are not equipped with adequate electrical outlets. The typical Classroom contains (6) general purpose outlets, (0) dedicated outlets for each Classroom computer, and (0) dedicated outlets for each Classroom television. Some Classrooms are equipped with as many as (8) general purpose outlets, while others are equipped with as few as (4) general purpose outlets. There are not any spaces that have no electrical outlets. The Classrooms in the 1989 and 2003 Additions are equipped with adequate electrical outlets. The typical Classroom contains (8) general purpose outlets, (1) dedicated outlets for each Classroom computer, and (2) dedicated outlets for each Classroom television. Some Classrooms are equipped with as many as (15) general purpose outlets, while others are equipped with as few as (6) general purpose outlets. There are not any spaces that have no electrical outlets. The Corridors in the 1927 Original Construction, 1932, 1960, 1969 and 1989 Additions are not equipped with adequate electrical outlets for servicing. The Corridors in the 2003 Addition is equipped with adequate electrical outlets for servicing. Adequate GFI protected exterior outlets are not provided around the perimeter of the building. The facility is not equipped with an emergency generator. Adequate lightning protection safeguards are not provided. Stage lighting power system including control panel, breakers, and dimmers is adequately provided, in good condition and does meet OSDM requirements. The overall electrical system meets does not fully meet Ohio School Design Manual requirements in supporting the current needs of the school, and will be inadequate to meet the facility's future needs.

**Rating:** 3 Needs Replacement

Electrical System To The 1960 Addition

**Recommendations:** The entire electrical system requires replacement to meet Ohio School Design Manual guidelines for overall capacity, Classroom capacity, due to condition and age, lack of OSDM-required features, to accommodate the addition of an air conditioning system. Provide adequate electrical outlets for servicing at Corridors and around the perimeter of the building. Provide an emergency generator, with funding included in the electrical system replacement. Provide adequate lightning protection safeguards in the overall facility, including associated grounding system, with funding included in the electrical system replacement.

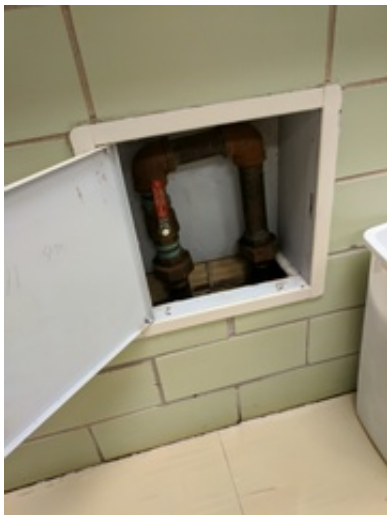
Master Shutoff For Gas in A Science Laboratory

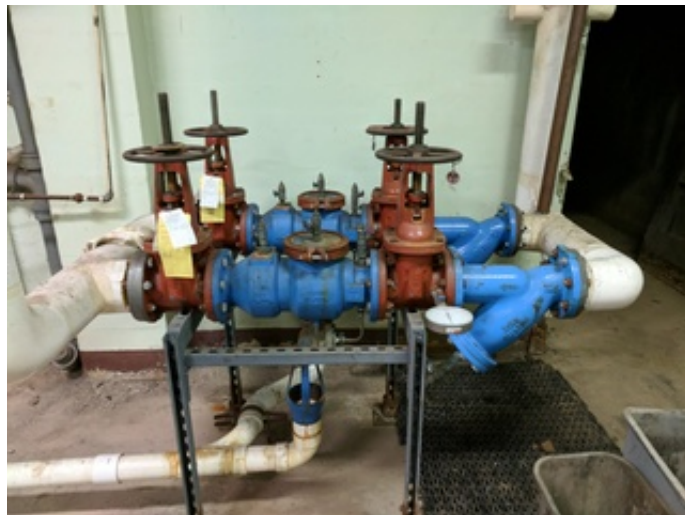
Backflow Preventers at Oakwood HS/JHS

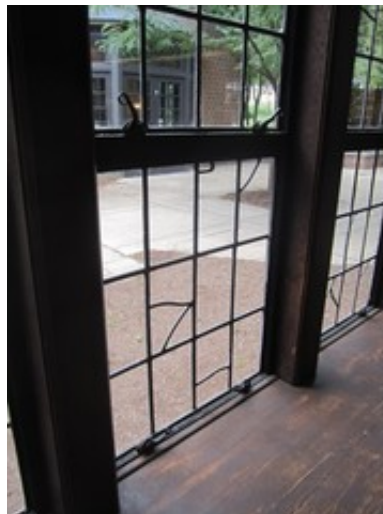
The overall facility is equipped with thermally broken aluminum windows double glazed insulated glazing type window system, which was installed in 2003, and is in good condition. The window system features operable windows in most of the building, and operable windows are equipped with opening limiters in good condition and insect screens in good condition. Window system seals are in good condition, with no air and water infiltration being experienced. Window system hardware is in good condition. The window system features no blinds, but features roller shades. Aluminum frame curtain wall systems with a translucent sandwich panel are found in the Original Construction on the third floor installed in 2003, and is in good condition. There are glass block windows in the 1932 Addition, in fair condition. The Media Center in the 1927 Original Construction has artistic windows with single pane glazing with no operable sashes and no blinds. The exterior doors in the 1927 Original Construction and the 1932 Addition are equipped with wood frame sidelights and transoms with single pane, in poor condition. Exterior door vision panels are single pane. The exterior doors in the 1969 Addition and the 2003 Addition are equipped with thermally broken sidelights and transoms with double glazed insulated glazing, in good condition. Exterior door vision panels are double glazed insulated glazing. The school does contain 2 acrylic bubble type skylights and 2 aluminum skylights in fair condition. The school does not contain clerestories. Interior glass in the Original Construction, the 1932 Addition and the 1969 Addition is not OSDM-compliant including wire glazing or not being tempered glazing. Window security grilles are not provided for ground floor windows. There is a 210 SF Greenhouse associated with this school, and it is in poor condition.

Windows in Media Center from 1932 Addition

Replace the existing non-insulated window system in the Media Center and glass block in the 1932 Addition with a new insulated window system to match existing insulated system and comply with Ohio School Design Manual requirements. Replace window transoms and sidelights at exterior doors of the Original Construction the 1932 Addition and the 1969 Addition. Exterior door vision panel replacement is addressed in Item S in exterior door replacement scope. Replace the two aluminum skylights. Replace the existing greenhouse. Replace interior glazing with compliant tempered glazing at the entry vestibules of Original Construction and the Auditorium.

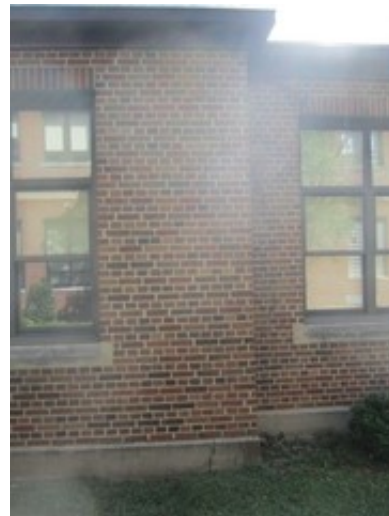
**Rating:** 2 Needs Repair

Foundation Crack, Courtyard Side of 1932 Addition

| Item | Cost | Unit | Whole Building | Auditorium Fixed Seating (1927)<br>4,706 ft² | Original Construction (1927)<br>76,823 ft² | Addition 1 (1932)<br>44,332 ft² | Addition 2 (1960)<br>15,790 ft² | Addition 3 (1969)<br>21,881 ft² | Addition 4 (1989)<br>550 ft² | Addition 5 (2003)<br>14,156 ft² | Sum | Comments |
|---|---|---|---|---|---|---|---|---|---|---|---|---|
| <b>Other:</b> Repair foundation cracks | \$38.00 | sq.ft. (Qty) | | | | 16 Required | | | | | \$608.00 | includes chipping, cleaning and epoxy grout |

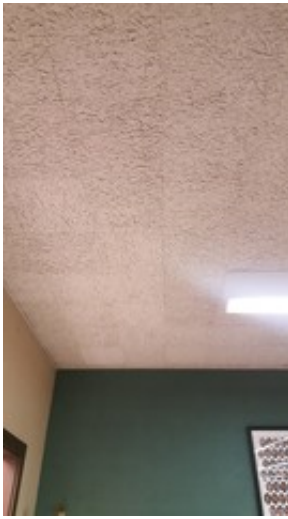
Asbestos Ceiling Tile
