Building Information - Oakwood City (44586) - Edwin D Smith Elem

Program Type	Expedited Local Partnership Program (ELPP)
Setting	Suburban
Assessment Name	Edwin D Smith Elementary with 2018 Costs, EEA & Related Scope Adjustments
Assessment Date (on-site; non-EEA)	2017-08-24
Kitchen Type	Warming Kitchen
Cost Set:	2018
Building Name	Edwin D Smith Elem
Building IRN	34694
Building Address	1701 Shafor Blvd
Building City	Dayton
Building Zipcode	45419
Building Phone	(937) 297-5335
Acreage	3.00
Current Grades:	PK, 1-6
Teaching Stations	36
Number of Floors	3
Student Capacity	557
Current Enrollment	458
Enrollment Date	2017-10-04
Enrollment Date is the date in which the current enrollment was taken.	
Number of Classrooms	34
Historical Register	NO
Building's Principal	Ms. Lynn Cowell
Building Type	Elementary/Middle

Building Construction Information - Oakwood City (44586) - Edwin D Smith Elem (34694)

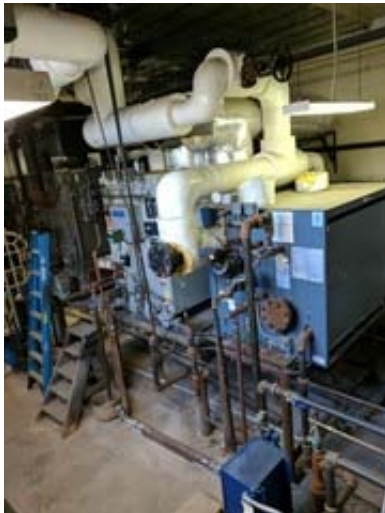
The existing system for the Original Construction and 1968 Addition is a gas fired boiler, and is in fair condition. There are a total of 4 boilers in the Mechanical Room of the Original Construction, 2 of which are abandoned in place, and 2 of them are currently in operation (Weil McLane and Bryan). The existing system for the 2003 Addition is a gas fired boiler, and is in fair condition. 2-pipe vs. 4-pipe designations are not applicable in this facility, due to packaged unitary dx split system air conditioning. The (1) steam boiler, manufactured by Bryan, was installed in 1994 and is in fair condition. (1) steam boiler, manufactured by Weil McLain, was installed in 2011 and is in good condition. Steam is distributed to terminal units consisting of unit ventilators, radiators, cabinet heaters, and air handlers. The central air handler was installed in 1928, and is in poor condition. The remaining terminal equipment was installed in 1968 and is in fair to poor condition. The hot water boiler, manufactured by Lochinvar, was installed in 2003, and is in good condition. Hot water is distributed to terminal units consisting of reheat coils, cabinet heaters, unit heaters and a rooftop unit. The terminal equipment was installed in 2003 and is in fair condition, though is reaching the end of it's life expectancy. The system does not comply with the 15 CFM per person fresh air requirements of the Ohio Building Code mechanical code and Ohio School Design Manual. The pneumatic type system temperature controls were installed in 1998, 2011 and 2003 and are in fair condition. The system does not feature individual temperature controls in all spaces required by the OSDM. The overall system does not feature any central energy recovery systems. The facility is equipped with moderate quantities of louvered interior doors to facilitate corridor utilization as return air plenums, which is not in accordance with the Ohio Mechanical Code. The existing system is ducted, but the ductwork cannot be integrated into a possible future system due to arrangement, air volume, and routing of existing ductwork. The overall heating system is evaluated as being in safe but inefficient working order, and long term life expectancy of the existing system is not anticipated. The structure is not equipped with central air conditioning. The site does not contain underground fuel tanks that are currently in use.

3 Needs Replacement

Existing Steam Boilers in the Mechanical Room at Smith Elementary School

Provide new overall heating, ventilating, and air conditioning system to achieve compliance with Ohio Building Code and Ohio School Design Manual standards. Convert to ducted system to facilitate efficient exchange of conditioned air, in the Original Construction and 1968 Building Addition. Replace existing ductwork to facilitate efficient exchange of conditioned air in the 2003 Building Addition. Remove the abandoned boilers in the Mechanical Room to allow for future capacity. Provide architectural soffits to accommodate the installation of ductwork.

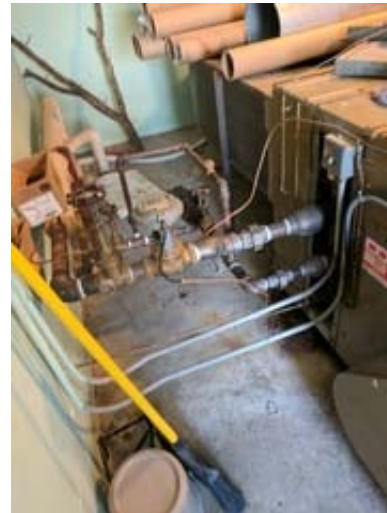
Existing Heating and Ventilating Unit Located in the Mechanical Room Behind the Music Classroom

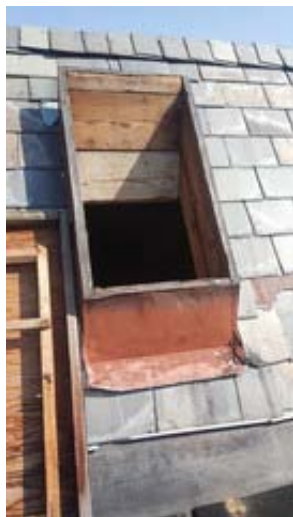
Description: The roof over the 1928 Original Construction is either a slate over copper deck system that was installed at time of construction, and is in fair condition, or a TPO roofing system that was installed over 7 years ago, and is in poor condition. The roof over the 1968 Addition is either a modified bitumen roofing system that was installed in 2010, and is in fair condition, or a slate system that was installed at the time of construction, and is in fair condition. The roof over the 2003 Addition is either slate or a TPO membrane system that was installed in the year of construction, and both are in good condition. There are District reports of current leaking in the Media Center. The district says every year a certain area of the Media Center needs to be patched and painted. No signs of past leaking were observed during the physical assessment. Access to the roof was gained by 3 separate access hatches. The access hatch in the 1928 Original Construction is in poor condition, while the access hatches in the 1968 and 2003 Additions are in good condition. Fall safety protection cages are not required. There were observations of standing water on the roof. Stone copings are in good condition. Roof storm drainage is addressed through a system of gutters and downspouts and roof drains, which are properly located, and in fair condition. The roof is over the 2003 Addition is equipped with overflow roof drains in sufficient quantity and in good condition. The rest of the overall facility will require overflow roof drains in areas of flat roof replacement. No problems requiring attention were encountered with any roof penetrations. There are covered walkways attached to this structure. The portico, used for outdoor circulation between the north and south corridors of the building, is located on the east side of the 1928 Original Construction has wood type construction and a slate over copper deck roofing system. The roof is in fair condition.

Rating: 3 Needs Replacement

Original Roof Hatch Over the 1928 Original Construction

Recommendations: The roof over the 1928 Original Construction requires replacement to meet Ohio School Design Manual guidelines due to condition, age of system and projected lifecycle. The slate roof over the 1968 Addition requires replacement due to condition. The modified bitumen roof over the 1968 Addition requires replacement due to age of system and projected lifecycle. The TPO roof over the 2003 Addition requires replacement to meet Ohio School Design Manual guidelines age of system and projected lifecycle. Provide insulation in areas of roof replacement to meet Ohio School Design Manual guidelines. Due to existing conditions in the 1928 Original Construction and 1968 Addition, gutters and downspouts and roof drains require replacement. Provide overflow roof drains areas of flat roof replacement of 1928 Original Construction and 1968 Addition. Replace existing roof hatch in the 1928 Original Construction. (Funding provided is to replace slate roofs with asphalt shingles)

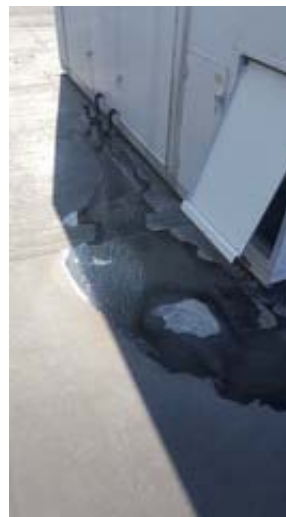
Standing Water on Roof Over the 2003 Addition

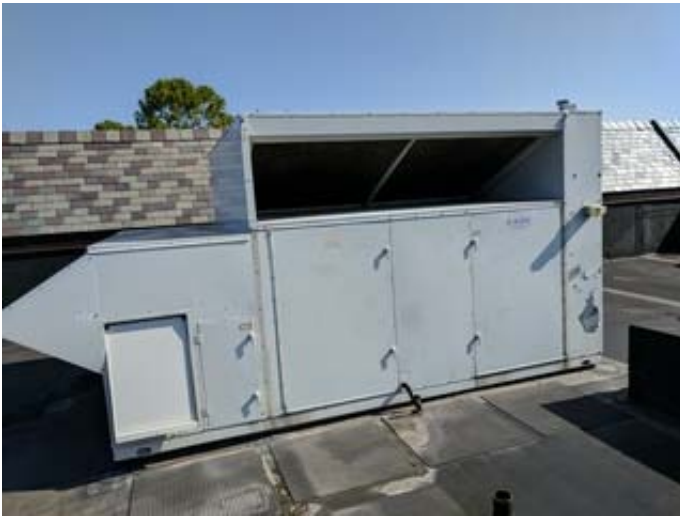
Description: The Original Construction and 1968 Addition is not equipped with a central air conditioning system. The 2003 Addition is equipped with a dx type central air conditioning system, with r-22 refrigerant, which is in fair condition. Window units are provided in 32 locations. The ventilation system in the Original Construction consists of one air handling unit as a central air system, installed in 1928 and in fair condition, providing fresh air to Classrooms, Cafeteria, and miscellaneous spaces. Relief air venting is provided by louvered interior doors, which is not in accordance with Ohio Mechanical Code. The ventilation system in the 1968 Addition consists of cabinet heaters and (2) Nesbitt air handlers, installed in 1968 and in poor condition, providing fresh air to the Gymnasium. Relief air venting is provided by exhaust fans. The ventilation system in the 2003 Addition consists of a rooftop unit, installed in 2003 and in fair condition, providing fresh air to Classrooms. Relief air venting is provided by being ducted back through the rooftop unit. The ventilation system does not meet the Ohio Building Code 15 CFM per occupant fresh air requirement. The overall system is not compliant with Ohio Building Code and Ohio School Design Manual requirements. Dust collection systems are not required in this facility and no system is provided. The Art program is not equipped with a kiln. General building exhaust systems for Restrooms / Storage Rooms / Art Rooms / Custodial Closets / Other are adequately placed, and in poor condition.

Aeon Rooftop Unit Serves the 2003 Building Addition

Recommendations: Provide an air conditioning system with ducted return to meet with Ohio Building Code and Ohio School Design Manual requirements. Replace general building exhaust systems located in Restrooms, Storage Rooms, Custodial Closets. Pricing included in Item A. Provide an exhaust system for new kiln.

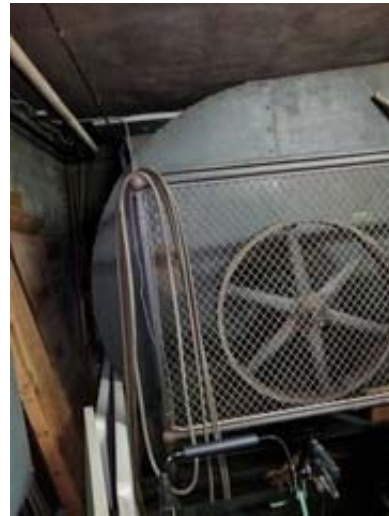
Fan Providing Central Air to the Original Building at Smith Elementary

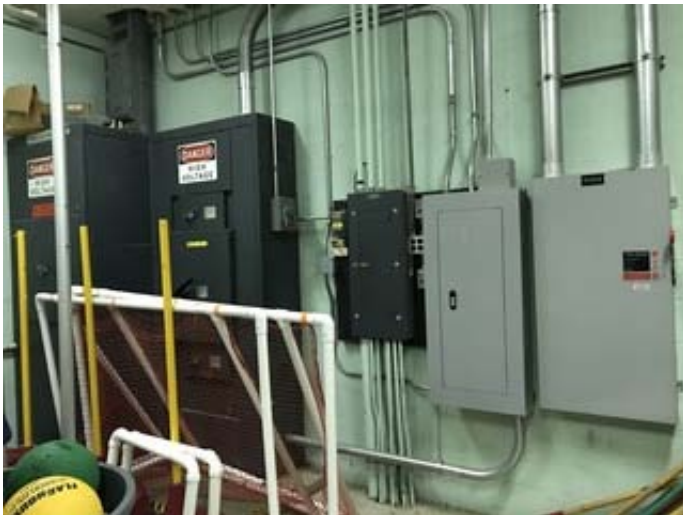
Description: The electrical system provided to the 1928 Original Construction is a 208V/120V, 1000 amps, 3 phase and 4 wire system installed in 1928, and is in poor condition. The electrical system in the 1968 Addition is a 208/120V, 800 amps, 3 phase, 4 wire system installed in 1968 and is fair condition. The electrical system in 2003 Addition is a 208/120V, 400 amps, 3 phase and 4 wire system installed in 2003, and is in good condition. The electrical system in the 1928 Original Construction is providing power to the 1968 and 2003 Additions. Power is provided to the school by a single utility owned (DP&L), pole-mounted transformer located outside, and in fair condition. The panel systems, installed in 1928 Original Construction and 1968 Addition are in poor condition. The panel systems in the 2003 Additions, are in good condition. The panel systems in the overall facility cannot be expanded to add additional capacity. The Classrooms in the 1928 Original Construction and 1968 Addition are equipped with adequate electrical outlets. The typical Classroom contains (12) general purpose outlets, (3) dedicated outlets for each Classroom computer, and (1) dedicated outlet for each Classroom television. Some Classrooms are equipped with as many as (14) general purpose outlets, while others are equipped with as few as (4) general purpose outlets. There are not any spaces that have no electrical outlets. The Classrooms in the 2003 Addition are equipped with adequate electrical outlets. The typical Classroom contains (15) general purpose outlets, (12) dedicated outlets for each Classroom computer, and (1) dedicated outlet for each Classroom television. Some Classrooms are equipped with as many as (22) general purpose outlets, while others are equipped with as few as (6) general purpose outlets. There are not any spaces that have no electrical outlets. The Corridors are not equipped with adequate electrical outlets for servicing. Adequate GFI protected exterior outlets are not provided around the perimeter of the building. The facility is not equipped with an emergency generator. Adequate lightning protection safeguards are not provided. Stage lighting power system including control panel, breakers, and dimmers is inadequately provided, in fair condition and does not meet OSDM requirements. The overall electrical system does not meet Ohio School Design Manual requirements in supporting the current needs of the school, and will be inadequate to meet the facility's future needs.

Rating: 3 Needs Replacement

The Building's Electrical System

Recommendations: The entire electrical system requires replacement to meet Ohio School Design Manual guidelines for overall capacity, due to condition and age, lack of OSDM-required features, to accommodate the addition of an air conditioning system. Provide adequate electrical outlets for servicing at corridors and around the perimeter of the building. Provide an emergency generator, with funding included in the electrical system replacement. Provide adequate lightning protection safeguards in the overall facility, including associated grounding system, with funding included in the electrical system replacement. Provide adequate control panel, dimmers, and breakers to support the Stage lighting system.

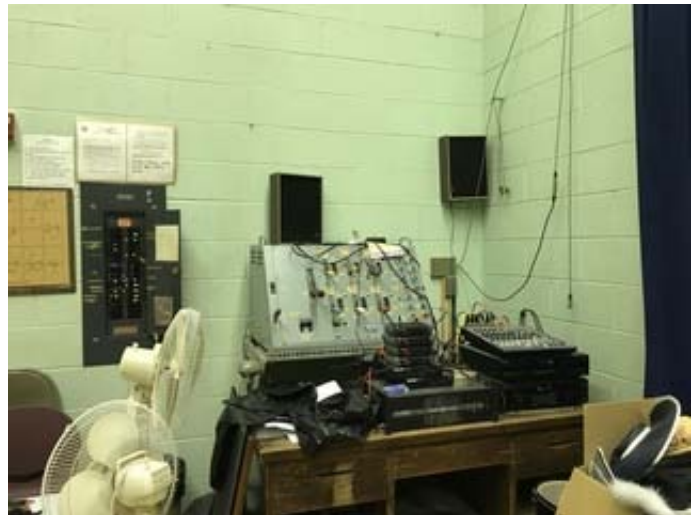
Stage Lighting Control Panel And Breakers

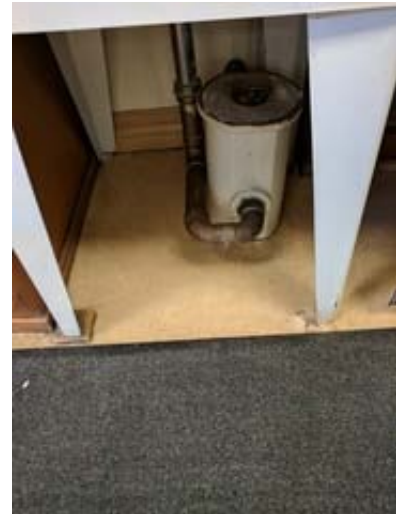
Solids Interceptor Under the Sink in the Art Room

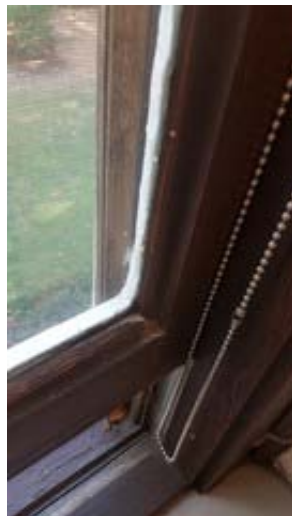
Description: The second and third floors of the Original Construction and the 1968 Addition area equipped with wood windows with single glazed type window system, which was installed in 1968, and is in poor condition. The window system features operable windows throughout the building which are not equipped with opening limiters, but are equipped with insect screens in poor condition. Window system seals are in poor condition in the Original Construction and the 1968 Addition, with frequent air and water infiltration being experienced. Window system hardware in the Original Construction and the 1968 Addition is in poor condition. The window system features no blinds, but has interior surface mounted roller shades. The overall facility at the first floor (ground level) and the 2003 Addition are equipped with thermally broken aluminum windows with double glazed insulated glazing type window system, which was installed in 2003, and is in fair condition. This window system features operable windows not equipped with opening limiters, but they are equipped with insect screens in good condition. Window system seals are in good condition, with minimal air and water infiltration being experienced. Window system hardware is in good condition. The window system features no blinds, but roller shades which are surface-mounted. This facility is not equipped with any curtain wall systems. This facility does not feature any glass block windows. One exterior door in the 1928 Original Construction is equipped with a wood transom with single pane in poor condition. Exterior door vision panels in the Original Construction are single pane. Exterior door vision panels in the 2003 addition are thermally broken and tempered glazing. The school does not contain skylights. The school does contain four clerestories in the 1968 Addition and they are in poor condition. Interior glass is not OSDM-compliant due to being non-tempered glazing. Window security grilles are not provided for ground floor windows. There is not a Greenhouse associated with this school.

Rating: 2 Needs Repair

Window of 1928 Original Construction

Recommendations: Replace the existing non-insulated window system in the 1928 Original Construction and the 1968 Addition window system and clerestories with a new insulated window system to match existing insulated system on the first (ground) floor and the 2003 Addition to comply with Ohio School Design Manual requirements. Replace window transom at the one exterior door in the 1928 Original Construction. Exterior door vision panel replacement is addressed in Item S in exterior door replacement scope. Provide metal security grilles over ground floor windows.

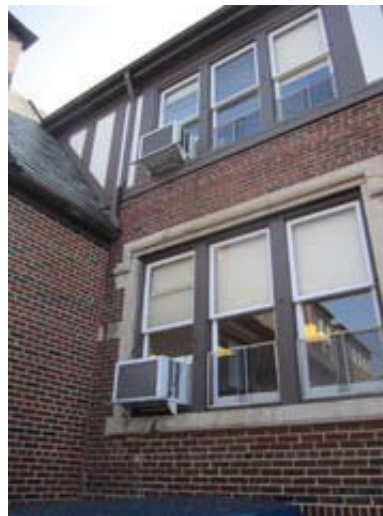
Windows of 1968 Addition

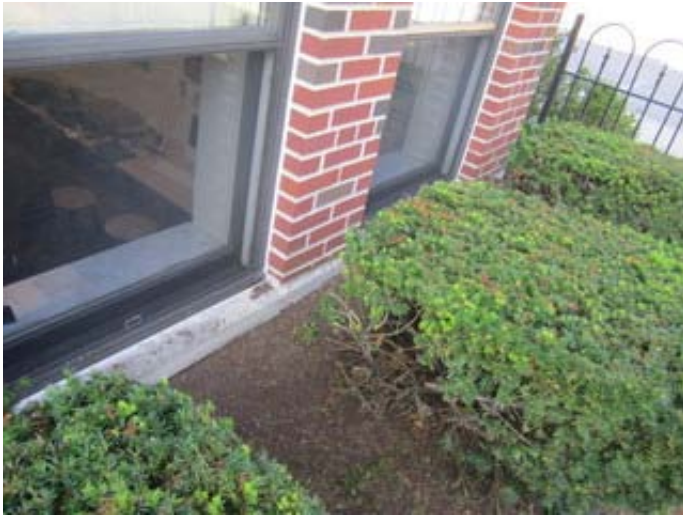
Description: The overall facility is equipped with concrete foundation walls on concrete footings, which displayed no locations of significant differential settlement, cracking, or leaking, and are in good condition. No significant issues related to foundation cracking or spalling were encountered. The District reports that there has been past leaking at the west side of the 1928 Original Construction at the location of the service entry and abandoned coal chute. No grading or site drainage deficiencies were noted around the perimeter of the structure that are contributing or could contribute to foundation / wall structural deterioration. The porch at the main entry of the 1928 Original Construction shows visible signs of differential settlement.

Foundation at Ground Floor Showing No Signs of Repair

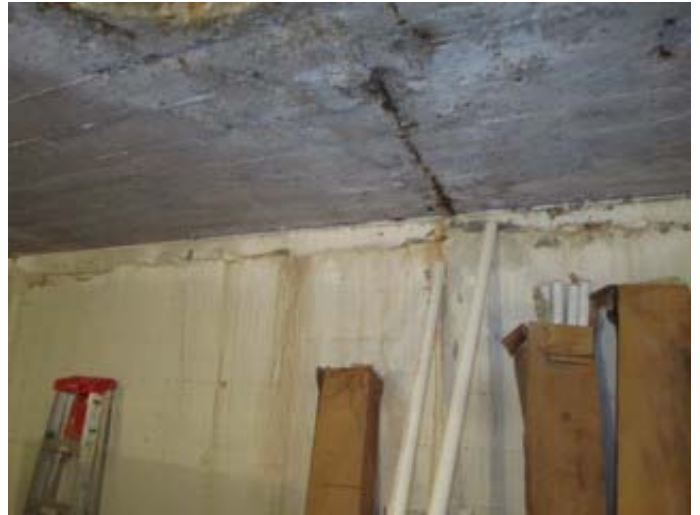
Foundation at Abandoned Coal Chute

Recommendations: Provide sprayed on (membrane) waterproofing system in the location of the abandoned coal chute. Further exploration under the existing porch (not accessible) to address the settlement.

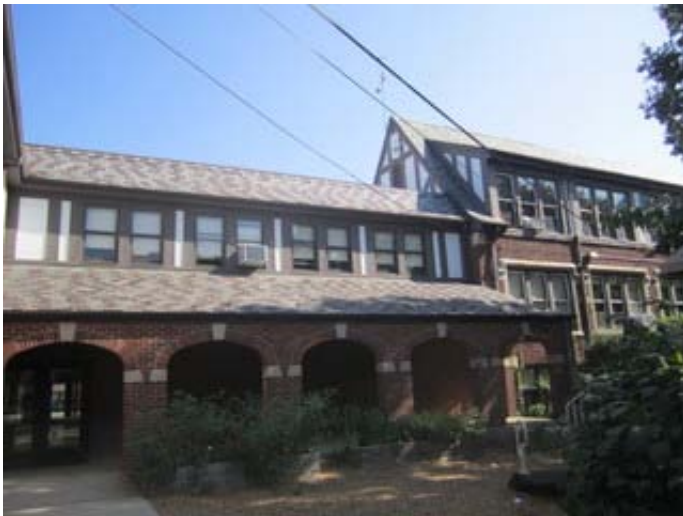
Description: The 1928 Original Construction and the 1968 Addition have a brick veneer on load bearing masonry wall system, which displayed some locations of minor deterioration, and is in good condition. The 2003 Addition has a steel frame with brick veneer, which displayed no locations of deterioration, and is in good condition. The Original Construction and the 1968 Addition do not have masonry control joints. The exterior masonry in the 2003 Addition appears to have appropriately spaced and adequately caulked control joints in good condition. Control joints are provided at lintel locations, at doors and windows, building corners, and wall offsets of the 2003 Addition and are in good condition. The school does not contain expansion joints and none are needed, as there is no indication of exterior masonry cracking or separation. Exterior walls in the 1928 Original Construction and the 1968 Addition are inadequately insulated. Brick veneer masonry walls are not cavity walls. In the 2003 Addition, weep holes are provided in sufficient quantity at 24"-48" on center at lintels, below sills, and the base of masonry cavity walls, and are in good condition. Weep holes are rope type weeps. Vents are not provided. In the Original Construction and 1968 Addition, the exterior masonry has not been cleaned and sealed in recent years, and shows evidence of mortar deterioration by ground floor windows to 4 feet above grade. Architectural exterior accent materials consist of stone, which is in good condition. Exterior building fenestration in the 1928 Original Construction represents 32.58% of the exterior surfaces. Exterior building fenestration in the 1968 Addition represents 6.55% of the exterior surfaces. Exterior building fenestration in the 2003 Addition represents 28.31% of the exterior surfaces. Interior Corridor and demising walls are masonry and plaster partitions with gypsum board that project full height from floor to bottom of deck, and are in good condition. Interior masonry appears to have inadequately spaced and caulked control joints in. Interior soffits are of framing and gypsum board type construction, and in good condition. The window sills are stone, and are in good condition. The exterior lintels in the Original Construction are cast concrete, and are in good condition. The exterior lintels in the 1968 and 2003 Addition are steel and in good condition. Chimneys are in good condition. The chimneys are no longer used, but would be very challenging to remove. Canopies over entrances are wood timber type construction, and are in fair condition. Exterior soffits are of plaster type construction, and in fair condition. The school is not equipped with a loading dock.

Rating: 2 Needs Repair

Exterior Wall at Joint of Original Construction and 1968 Addition

Recommendations: Provide tuckpointing in all areas of mortar deterioration as required through the 1928 Original Construction and 1968 Addition. Provide masonry cleaning, sealing, caulking as required through the overall facility. Sawcut and caulk new appropriately spaced control joints in existing masonry in the Original Construction and the 1968 Addition. Recaulk existing control joints in the 2003 Addition. Repoint stone window sills through the overall facility. Exterior wall insulation deficiencies should be addressed in the 1928 Original Construction and the 1968 Addition as noted in Item J.

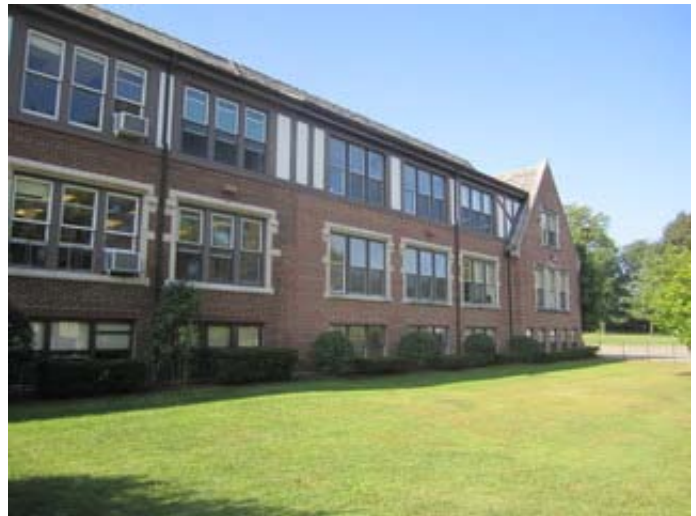
Exterior Wall at Joint of Original Construction and 2003 Addition

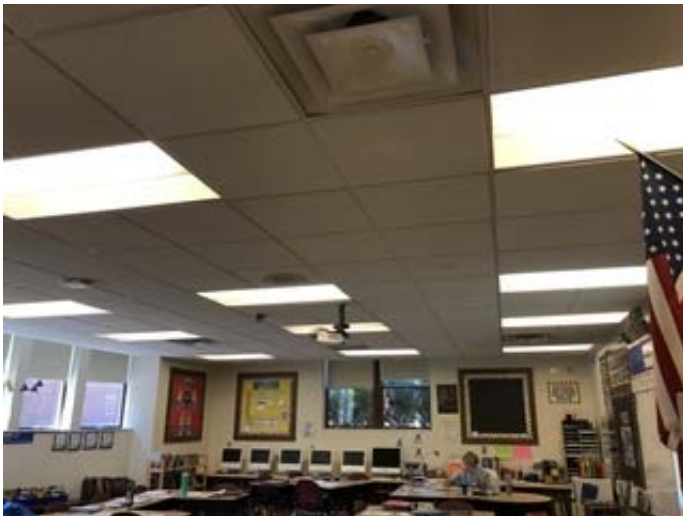
Rating: 3 Needs Replacement

Typical Classroom Lighting

Recommendations: Provide complete replacement of lighting system due to condition, lighting levels, lack of multi-level switching, utilization of metal halide fixtures and installation of systems outlined in Items A, J, and U. Provide adequate occupancy sensors to areas currently lacking for compliance with ASHRAE 90.1.

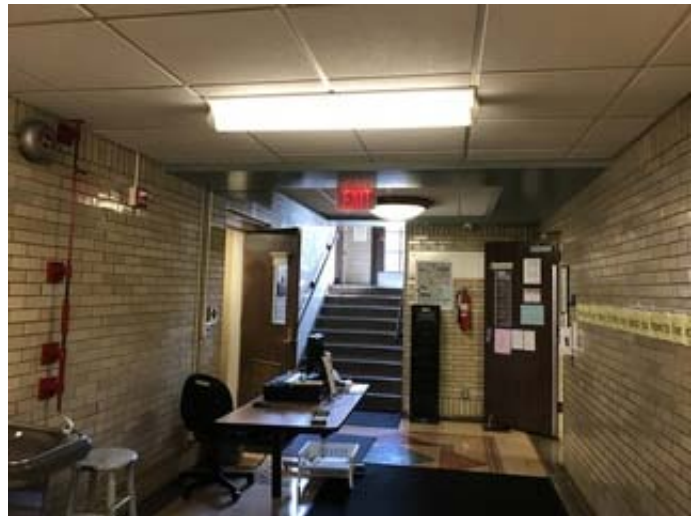
Typical Corridor Lighting

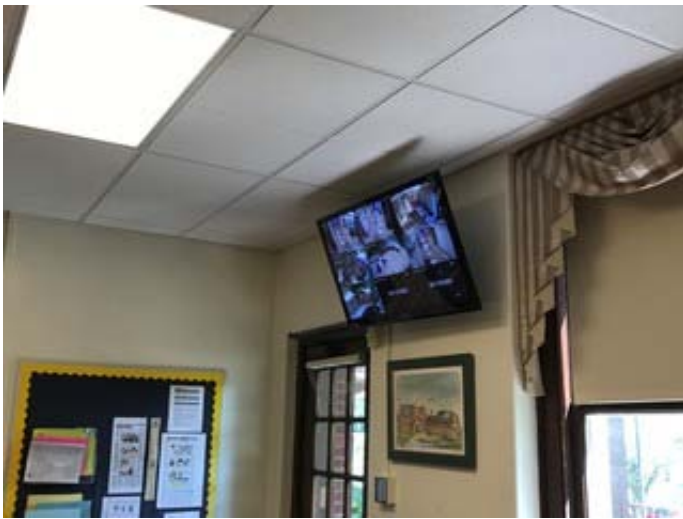
Rating: 3 Needs Replacement

CCTV Monitoring System In Administrative Area

Recommendations: Provide complete replacement of security system to meet Ohio School Design Manual guidelines. Provide complete replacement of exterior site lighting system to meet Ohio School Design Manual guidelines. Provide Secure Entrance Vestibule at Main Entry to the facility. The allowance is based upon adding three sets of double doors and wall system to deny access to the school at the split-level stair at the main entry.

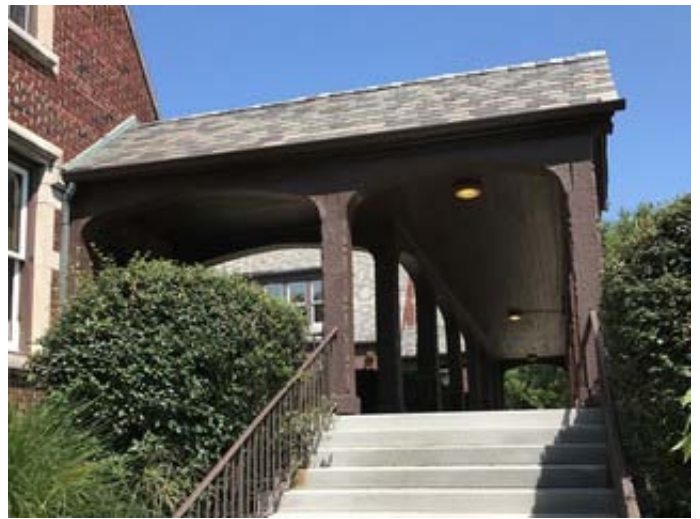
Pedestrian Walkway Lighting

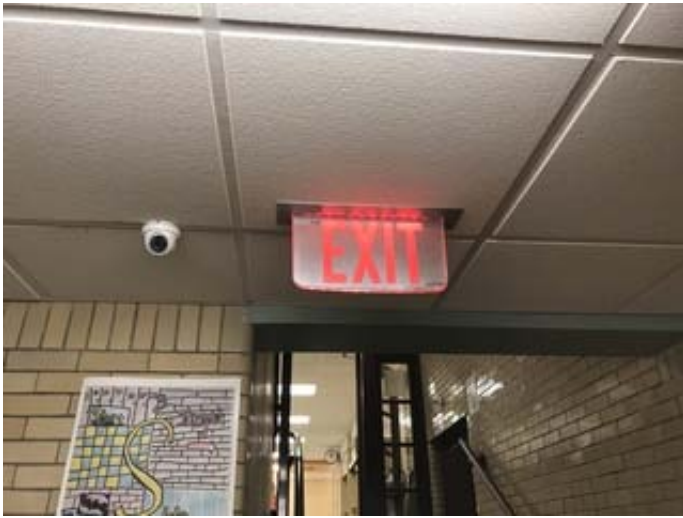
Rating: 3 Needs Replacement

Typical Exit Sign

Recommendations: Provide complete replacement of emergency and egress lighting system, backed up by an emergency generator to meet Ohio School Design Manual and Ohio Building Code guidelines.

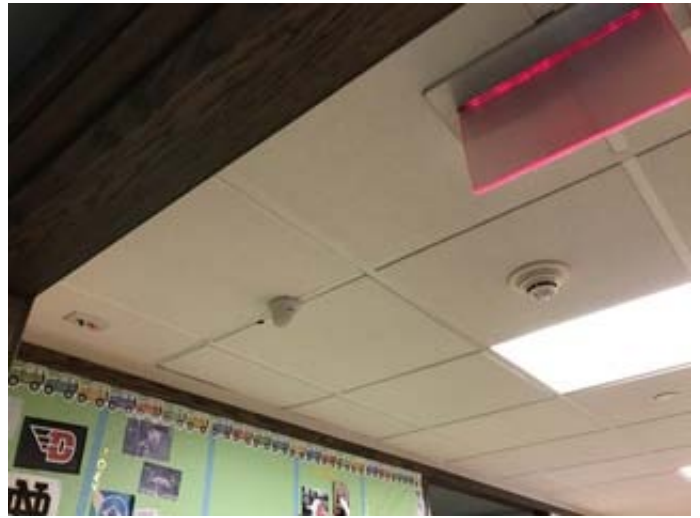
Typical Emergency Egress

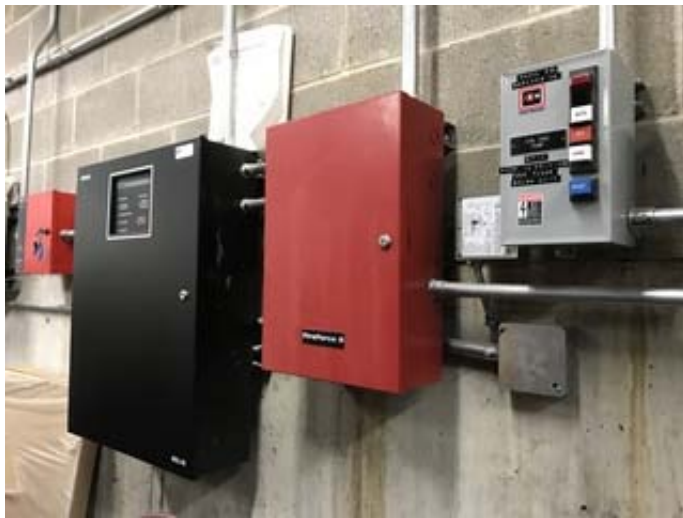
Rating: 3 Needs Replacement

Main Fire Alarm Panel

Recommendations: Provide new fire alarm system to meet OBC, NFPA, and Ohio School Design Manual guidelines.

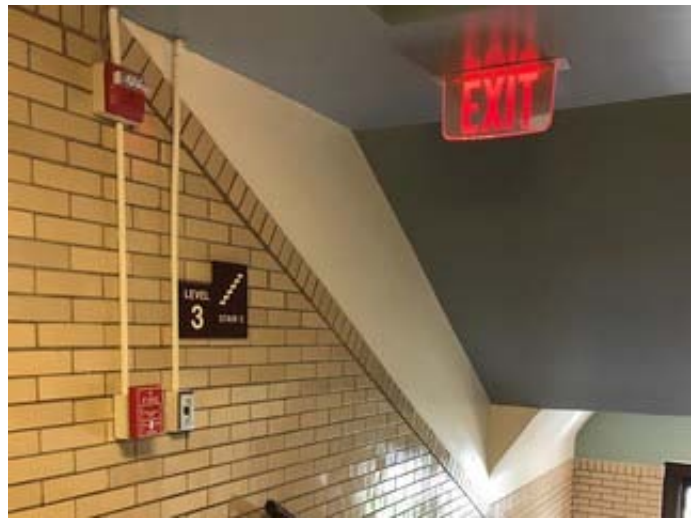
Typical Manual Pull Station, Horn And Strobe Devices

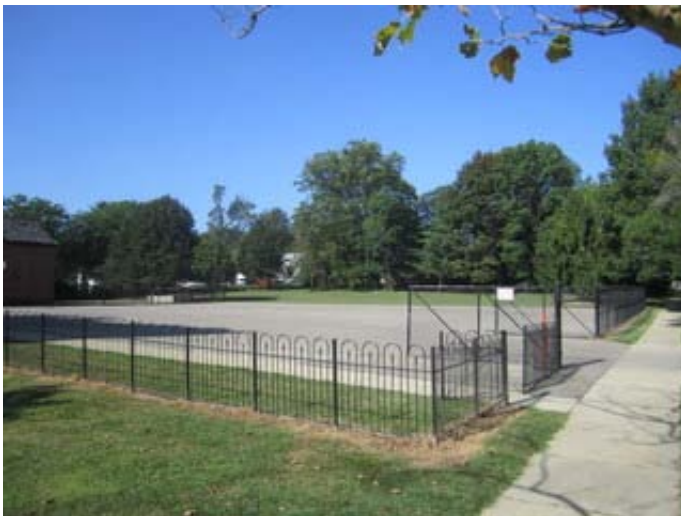
2 Needs Repair

Playground Fencing
