Town of Hamden

Feasibility Study for Northern/Central Hamden Schools Rebuild/Renovation Projects

FINAL Prepared for:
Town of Hamden
September 3, 2014

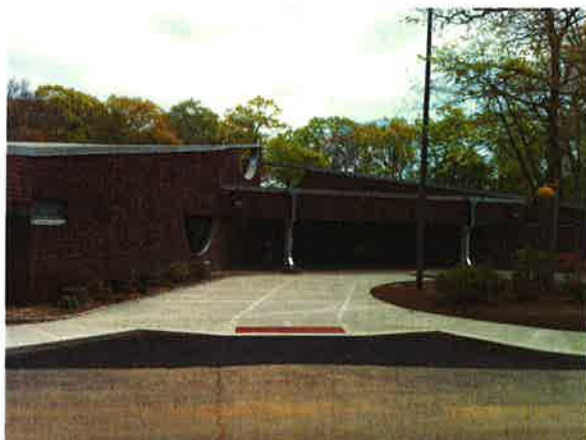
The loading area is at the front of the building located off of the one way traffic circle. Although it is hidden, it is also awkward and narrow. The trash dumpster is located within the loading area.

Most of the on-site asphalt sidewalks are cracking or deteriorating. The concrete sidewalks at the entry are in good condition as they were replaced in 2012. Landscaping is largely overgrown encroaching pathways.

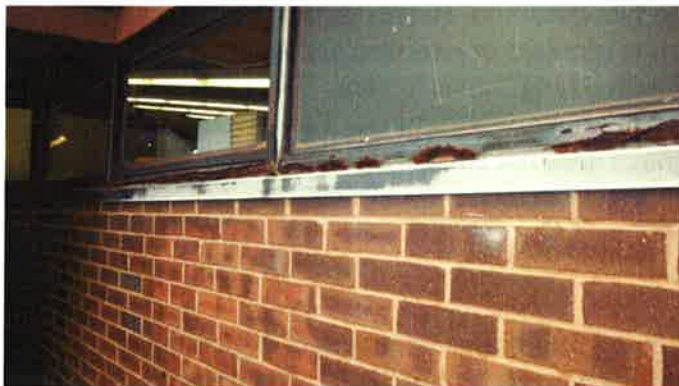
On a masonry building, one area of concern is that often window heads will spall and crack at the lintel bearing points and this is typical of the doors as well. In addition, the potential for experiencing water infiltration and associated damages at the brick intersections and flashings should be inspected in detail. Overall, the mortar is in reasonably good condition although the age of the building suggests in the near future a detail review should evaluate if limited or whole sale repointing is required. The areas of concern are near the gym where water has been splashing against the façade. There are many areas around the building where mold/mildew has built up on the brick and should be cleaned.

When evaluating the energy efficiency of a building, it is known that nearly 25–40% of all heat energy is lost through windows. The original windows are in disrepair. The single layer of glazing is highly inefficient. The original frames are practically rusted through. Most of these windows are a “storefront” system. It can be assumed that a great deal of energy is being lost through these openings. Due to the inefficiency and age of the window

system, it is recommended they be replaced with insulated double or triple glazed systems which will significantly reduce heating and cooling costs in these sections of the building. This change would then incorporate security design elements to be determined once the design proceeds and the risk assessment is complete.

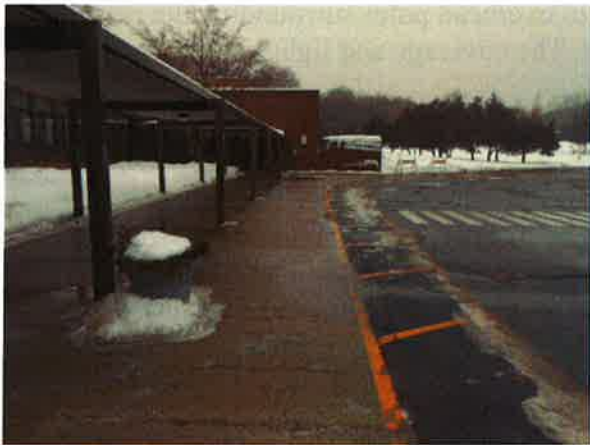
Most of the on-site sidewalks are in fair to poor condition. The front sidewalk is in poor condition and consists of cracking and uneven patching. Some of this is due to water infiltration via aluminum posts at the covered walkway that empty into drains that are likely backed up or inefficiently engineered. The stair that leads to the lower parking area is also in disrepair. The nosing has been destroyed and is creating a safety hazard. However, both the front sidewalk and the stair will be resolved and corrected for the beginning of the 2014 school year. The exit doors from the front of the school have a flush

condition at the sidewalk. Staff has requested a paved path around the building especially in the winter months. Some thresholds have a greater than ½ inch differential. Some of the sidewalk ramps appear to be non-conforming to the required standards, including tactile warning. Final proposed construction documents should review all existing cross slopes, heights, gaps, etc.

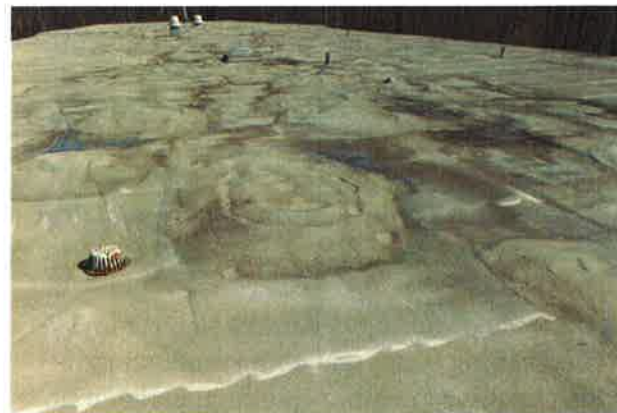
The existing roof is a Dow Corning Silicone/Polyurethane Foam Roof System. It was replaced in 1999 and only had a ten year warranty. This roof system is completely failing as you can see the bubbling in the photographs. Not only is the roof leaking but the skylights are too. The roof and skylight replacement should be included in the scope and budget of the new project as it is a major priority.

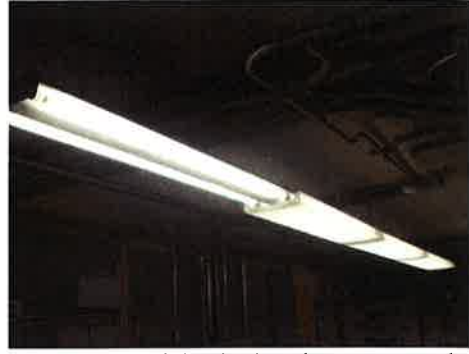
Damaged / missing lens example

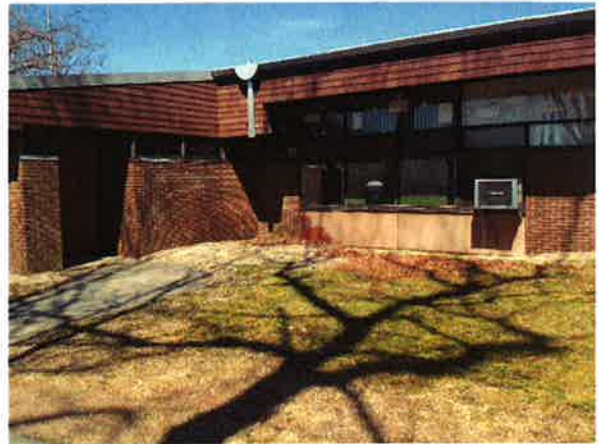
The building is due for roof replacement and has passed the “20-year” life threshold and therefore this has been incorporated in the planning. The drywells and exposed rain leaders have failed and the roof storm drain system should be re-designed.

Typical exterior, rain leader and mech. unit

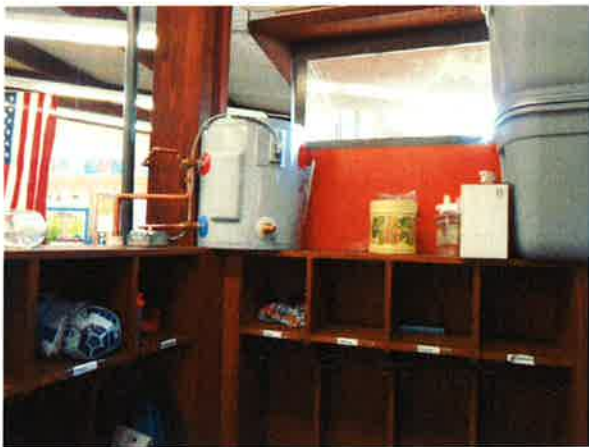
Hot water tank replacement

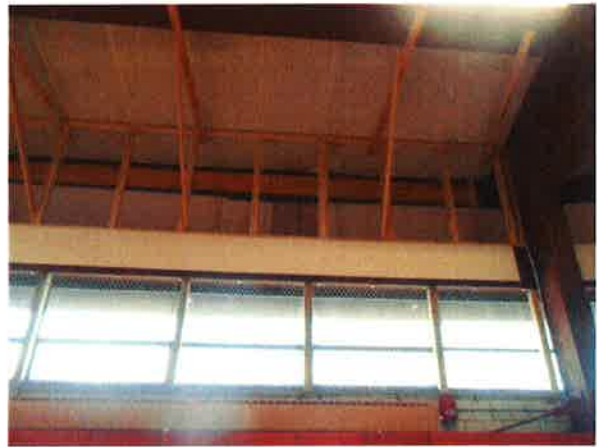
- Music is taught in the corridor, only one room available.
- There is a wood partition in the corridor.
- Wood beams in gym were evaluated by BL Company's structural engineer and then repair at Christmas break. BL recommended a review throughout the building of all of the structural beams.

Gym dry rot repair

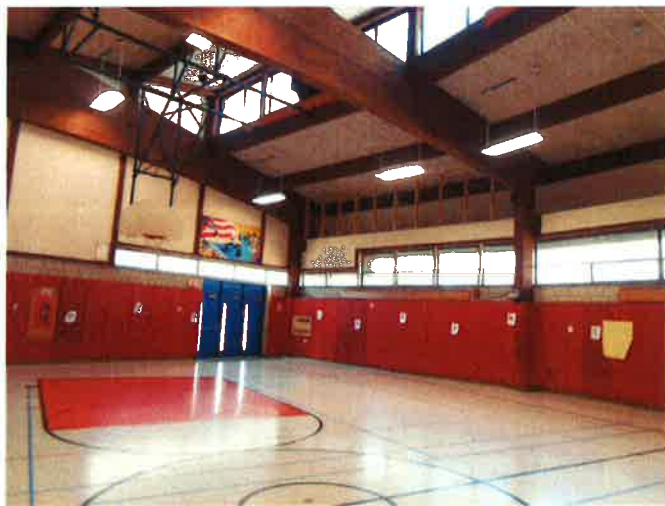
Gym and repair, HVAC exposed to left

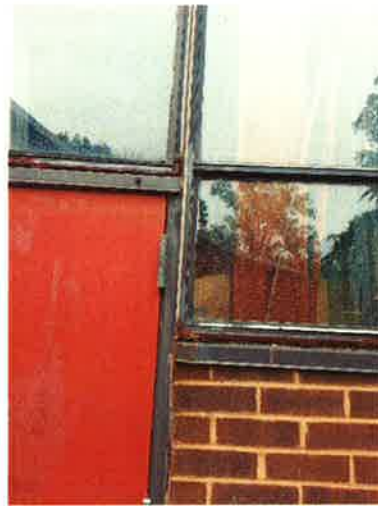
Rusted thru steel window frame

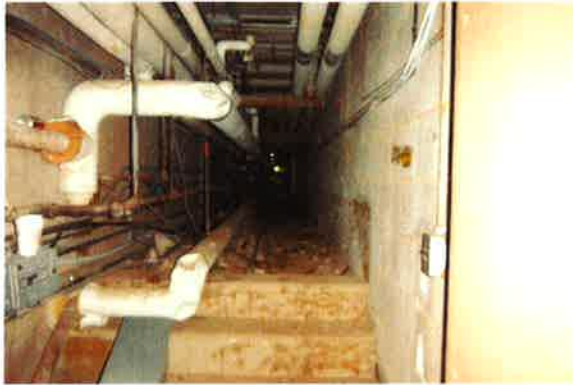
Tunnel in basement, typical two wings both sides

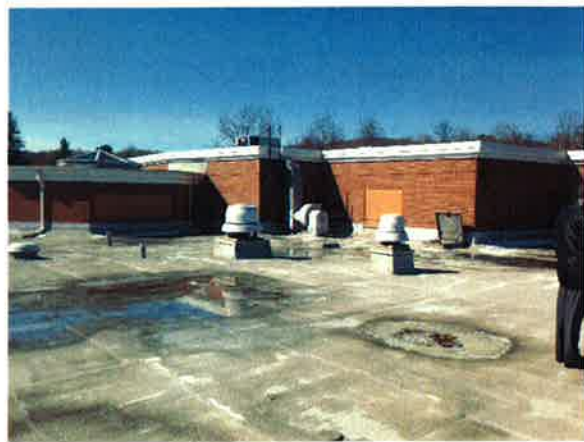
The building is due for roof replacement and has passed the “20-year” life threshold and therefore this has been incorporated in the project scope. The spray on roof has failed and is past it 10 year life. The skylights and roof leak.

Failed roof toward gym, entry

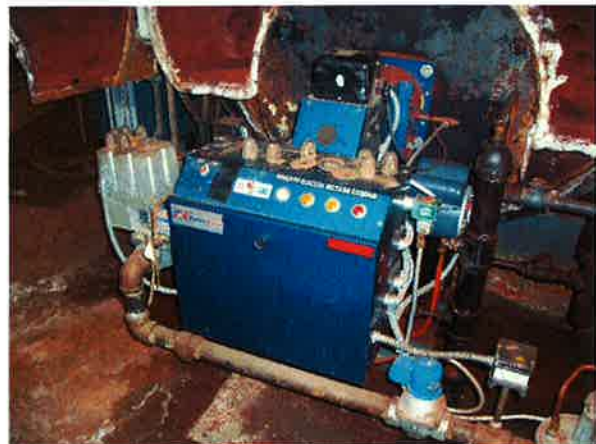
Retrofit burner on original boiler
