SUPPLEMENTAL HAZARDOUS MATERIALS SURVEY REPORT

Arts & Communication Magnet Academy

**11375 SW Center Street
Beaverton, OR 97005**

TRC Project Number: 293358

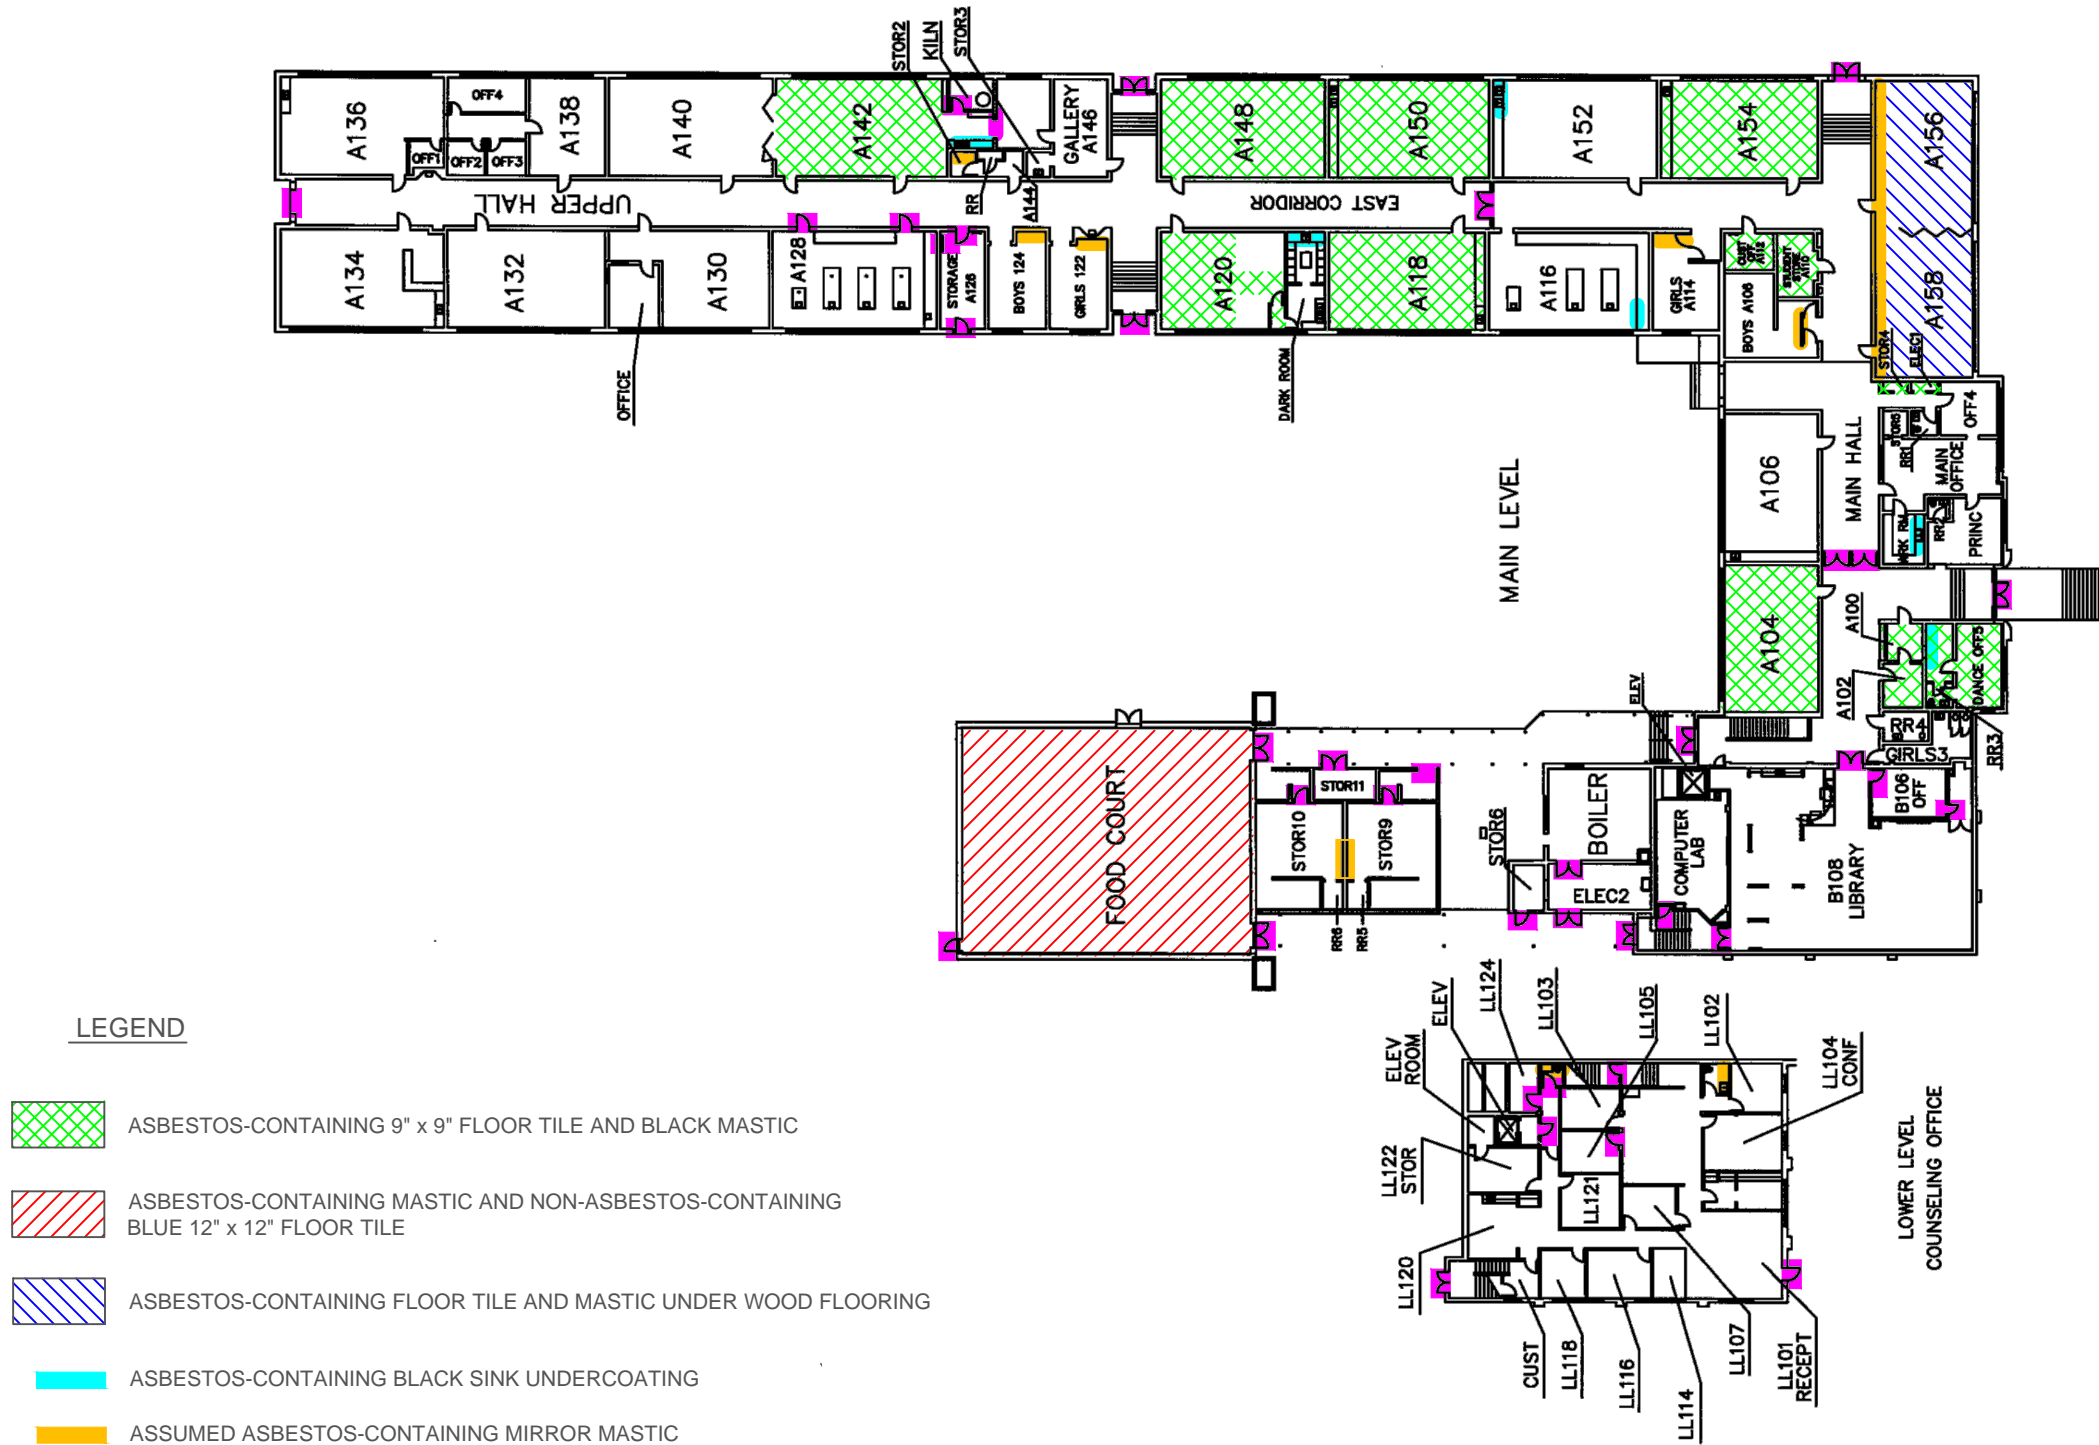
- ASBESTOS-CONTAINING 9" x 9" FLOOR TILE AND BLACK MASTIC
- ASBESTOS-CONTAINING MASTIC AND NON-ASBESTOS-CONTAINING BLUE 12" x 12" FLOOR TILE
- ASBESTOS-CONTAINING FLOOR TILE AND MASTIC UNDER WOOD FLOORING
- ASBESTOS-CONTAINING BLACK SINK UNDERCOATING
- ASSUMED ASBESTOS-CONTAINING MIRROR MASTIC
- ASSUMED ASBESTOS-CONTAINING FIRE DOORS
