Property Assessment Report

Brookridge Elementary School

9920 Lowell Ave, Overland Park, KS 66212

SHAWNEE MISSION SCHOOD DISTRICT BROOKRIDGE ELEMENTARY SCHOOL BUILDING SUMMARY IMAGES

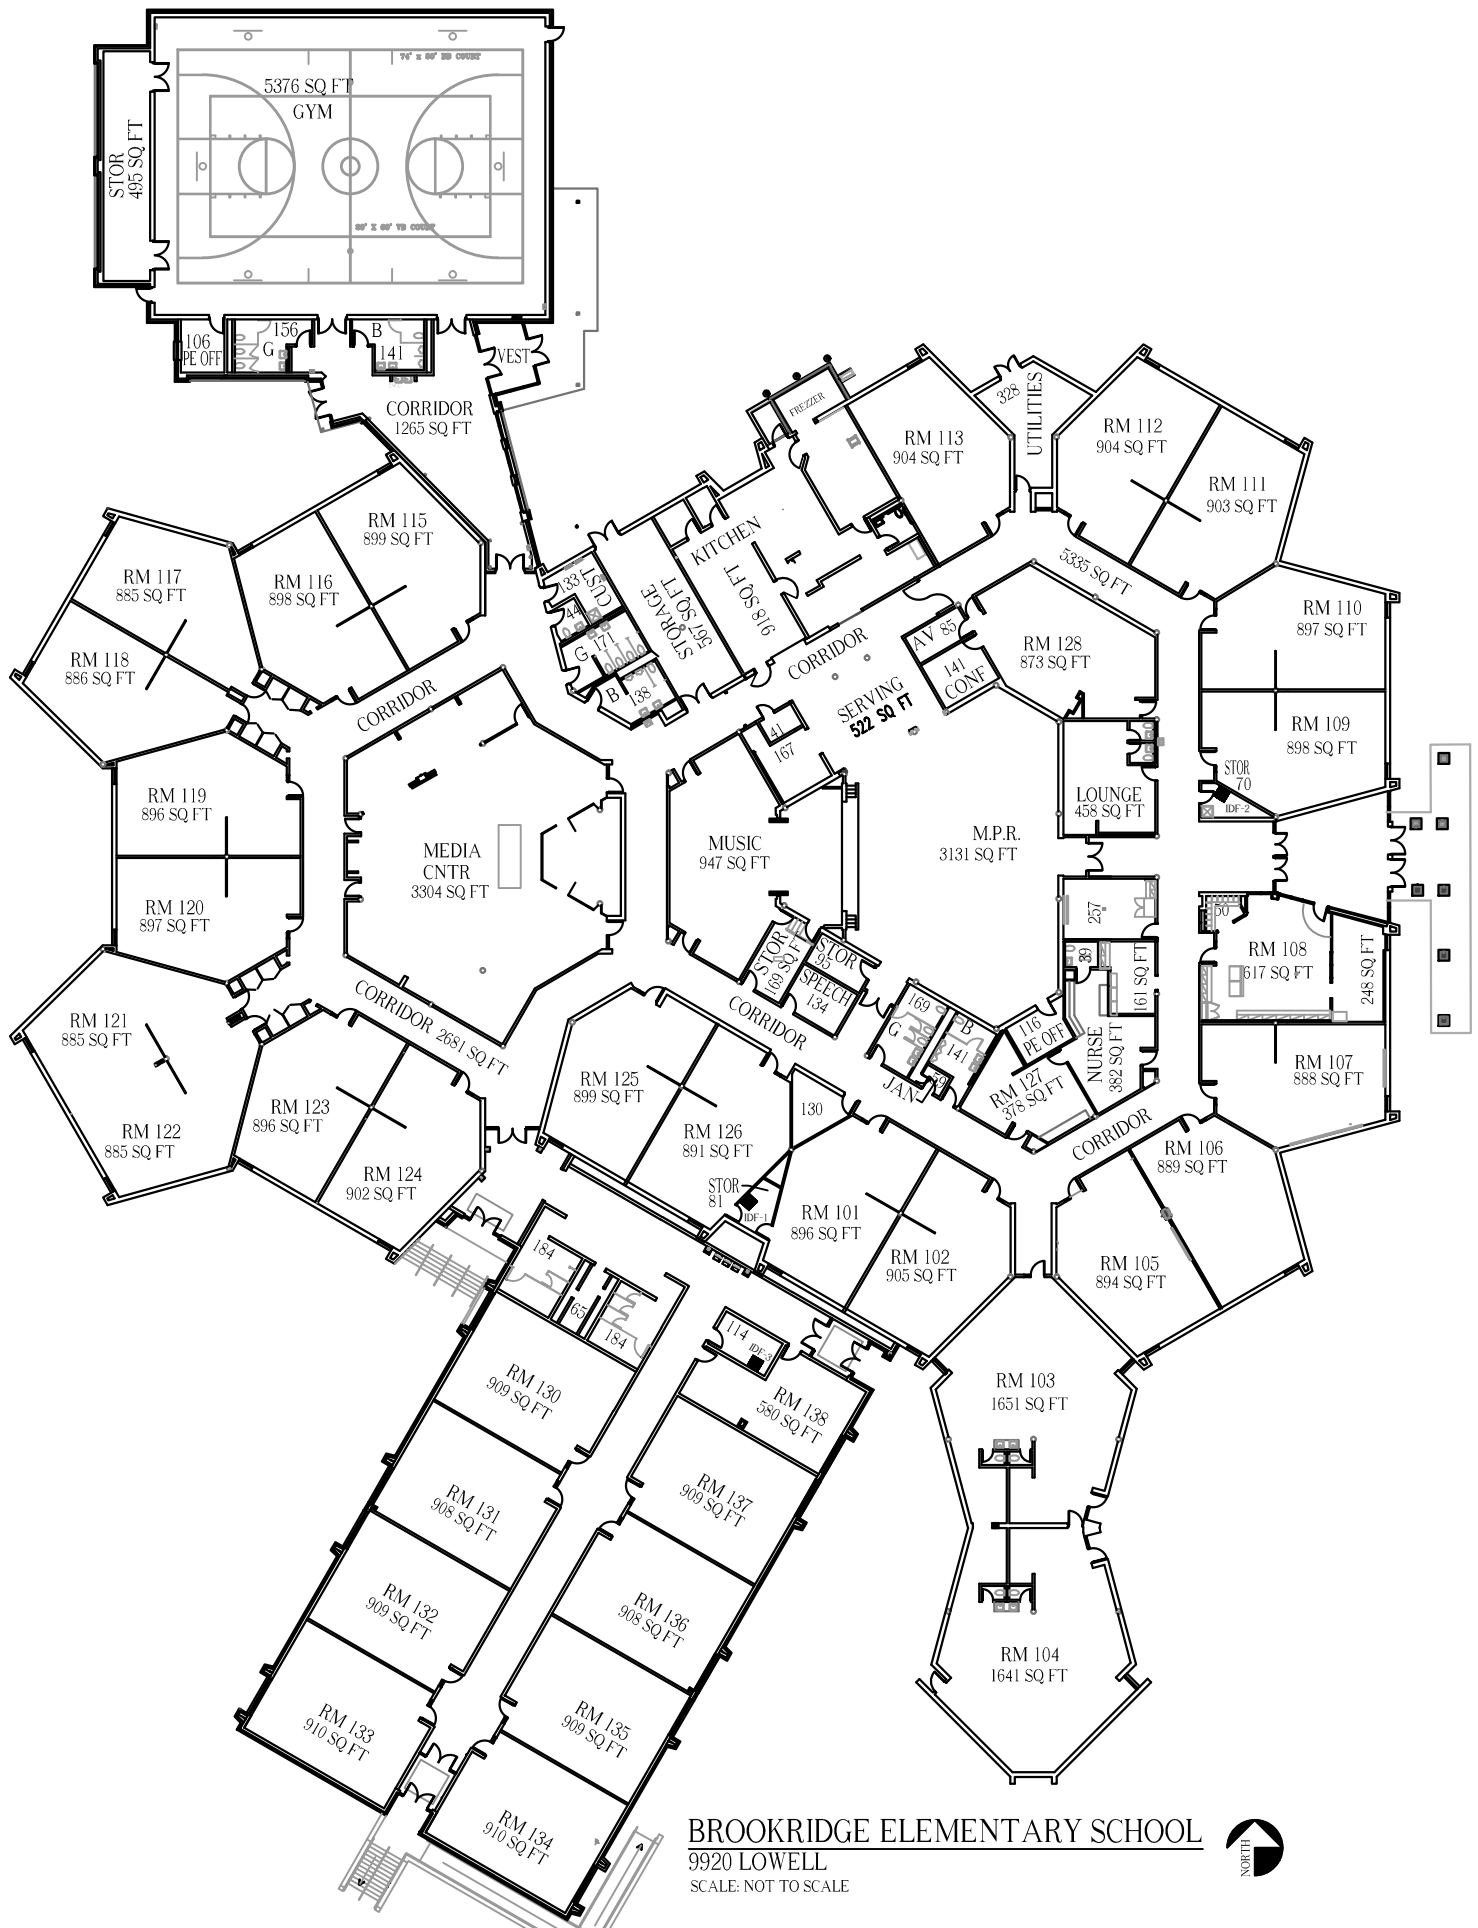
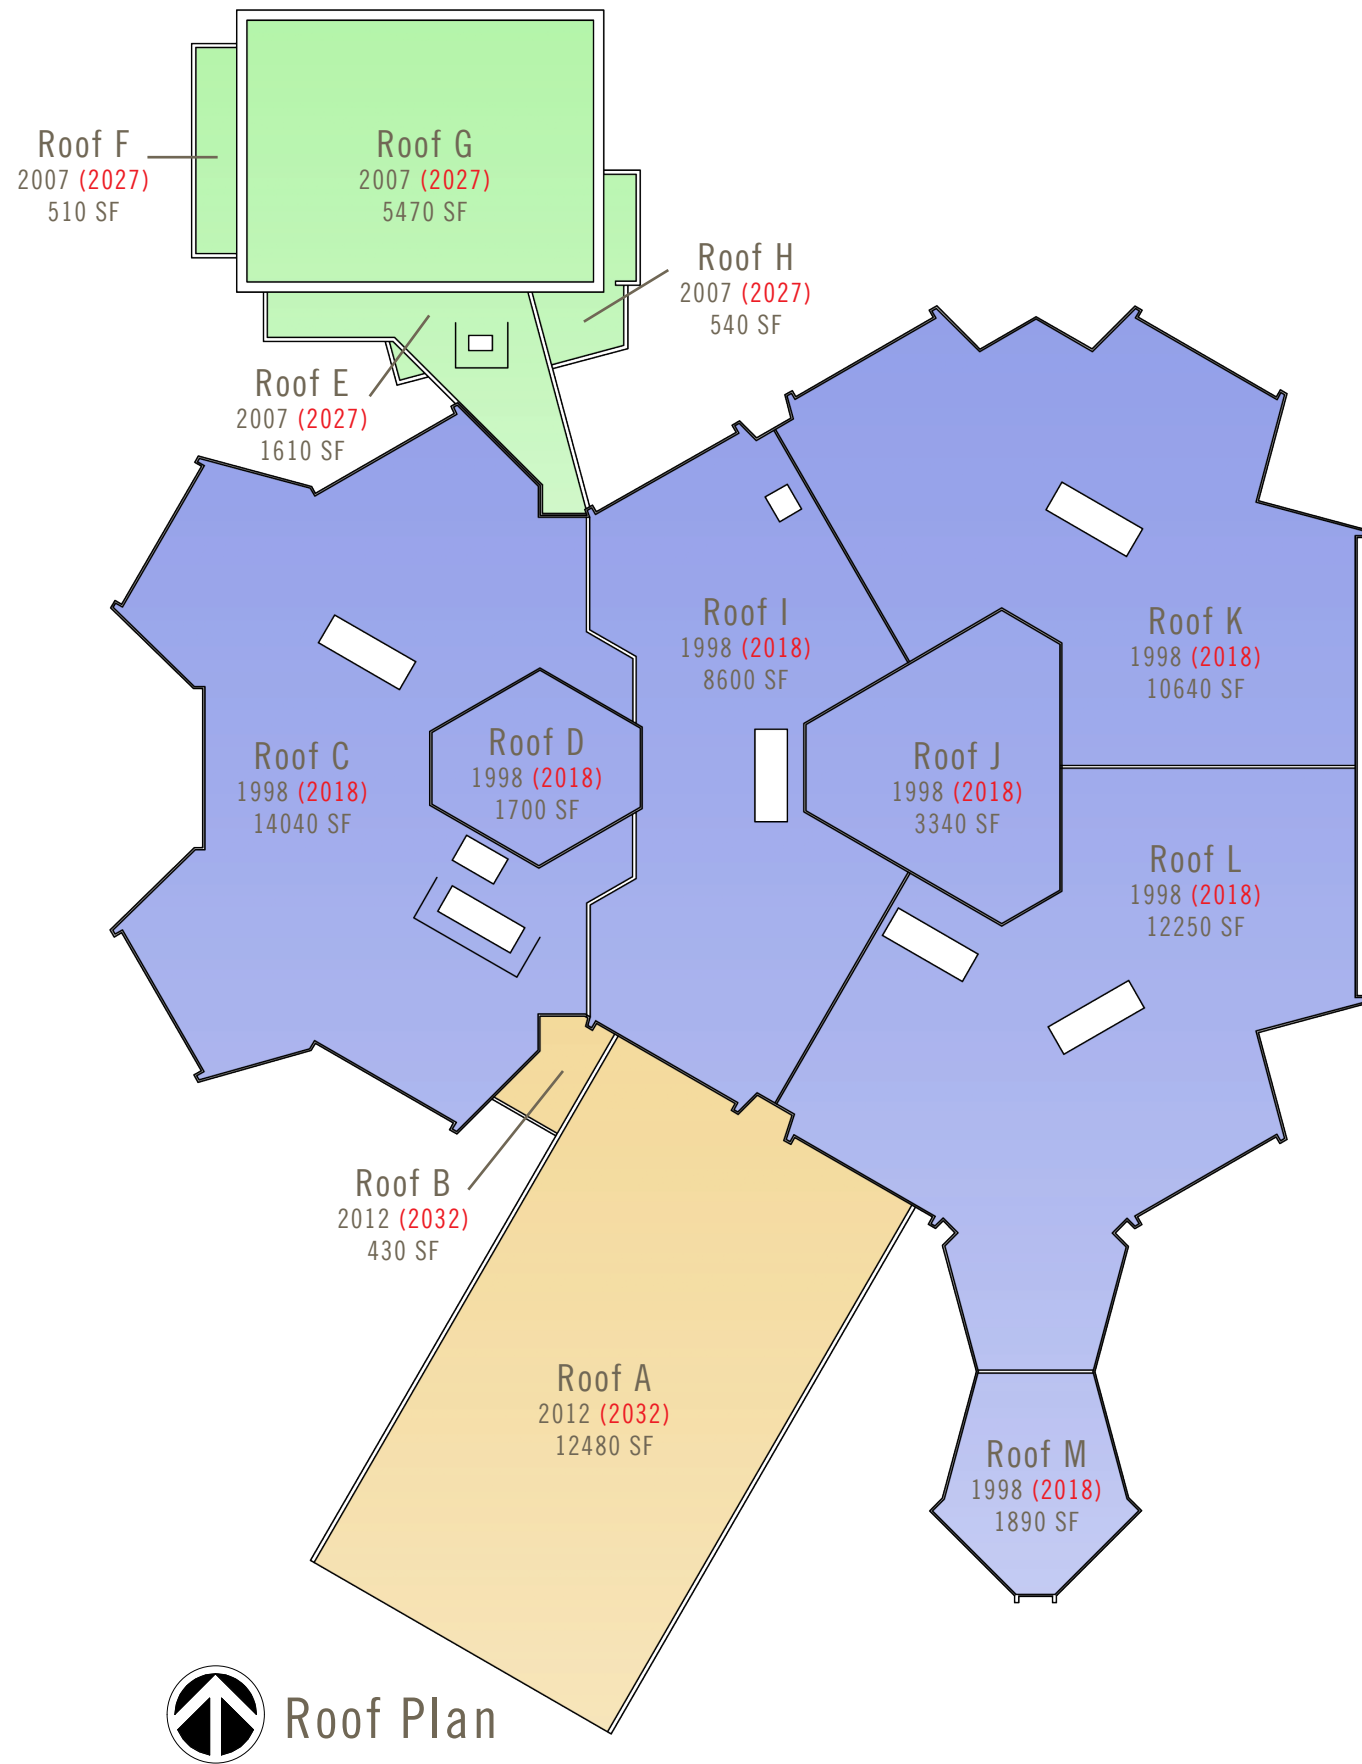
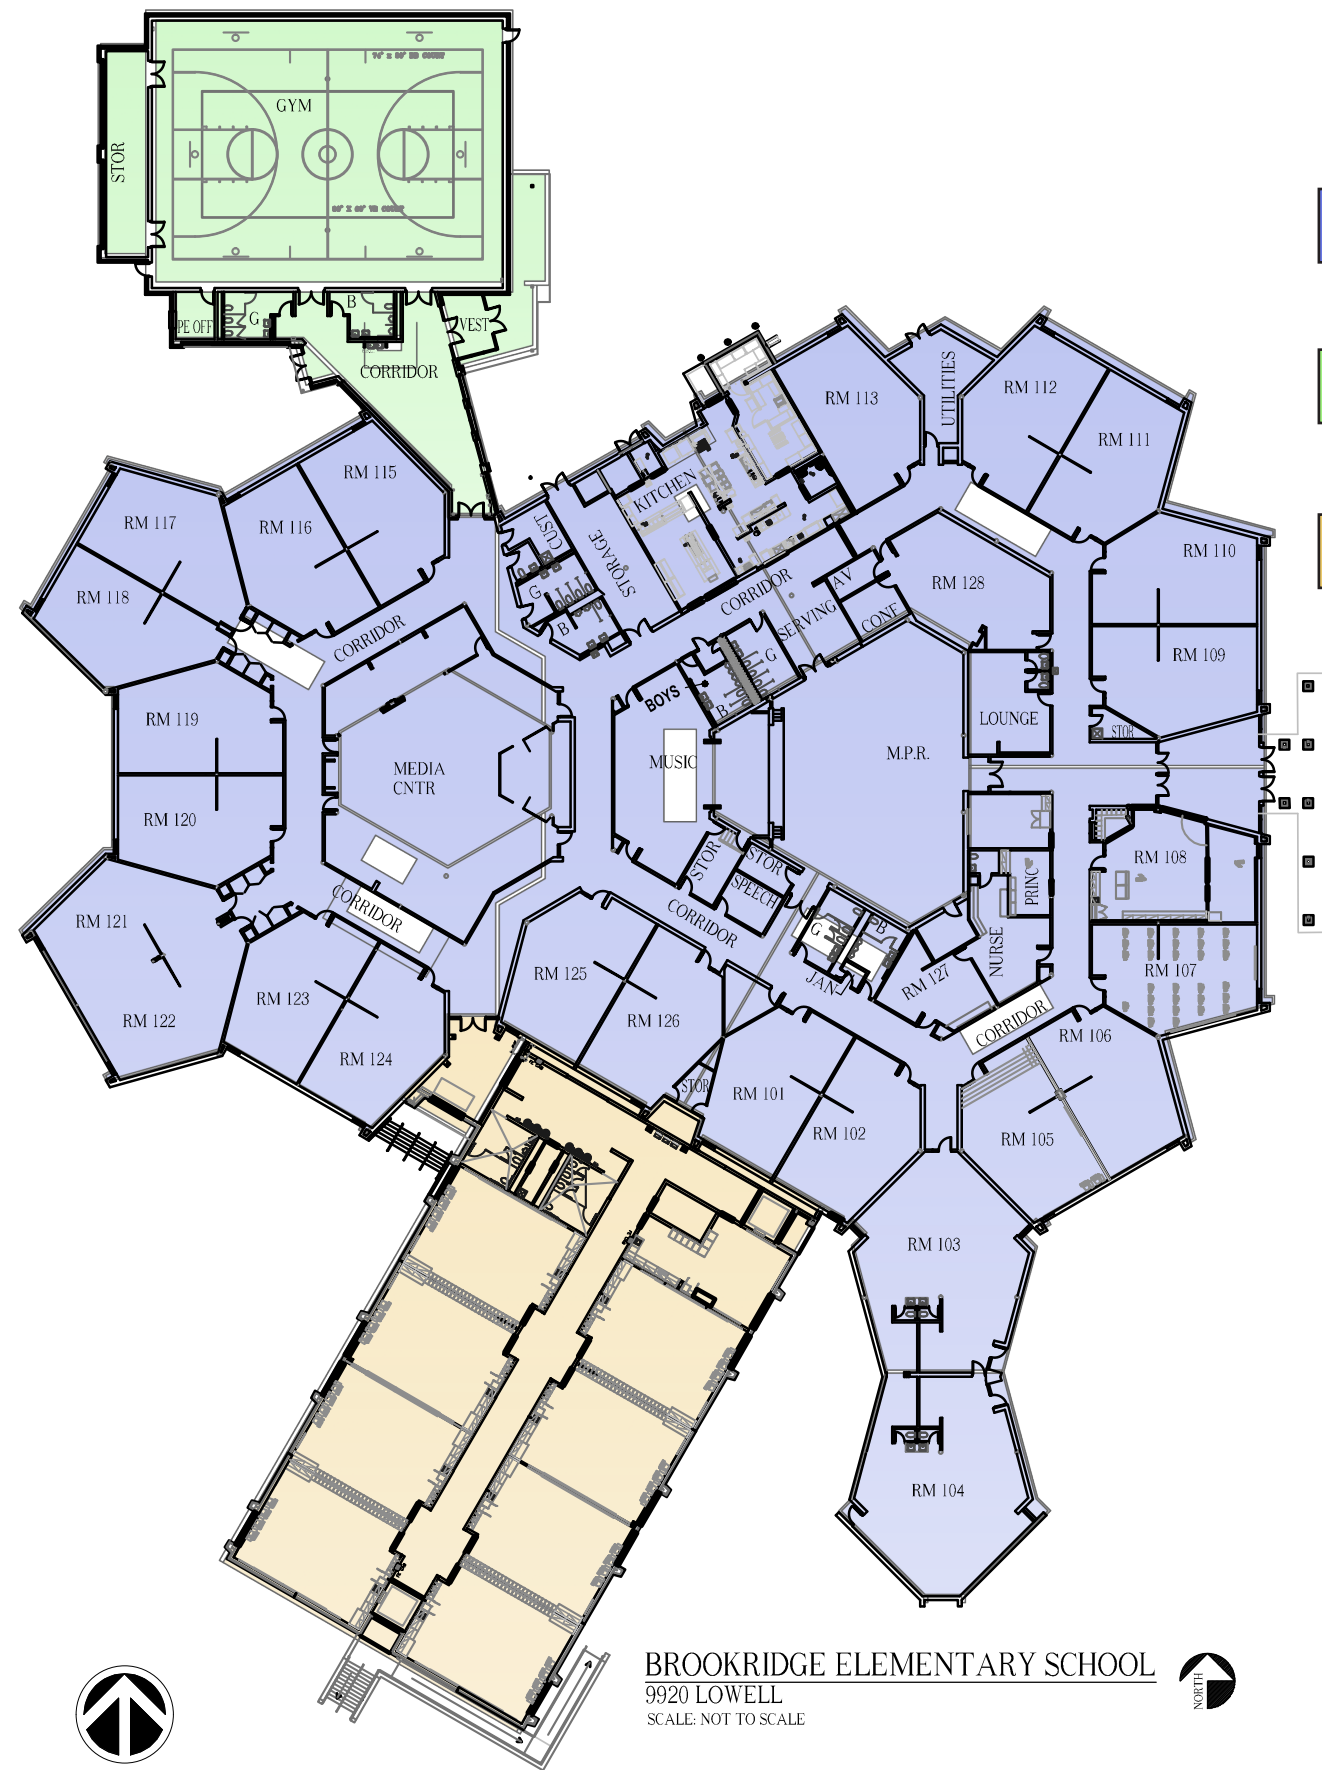
Roof Areas

- Roofs C,D,I,J,K,L,M
Tamko 103 / 510 squares
November 1998 (20 year) **2018**
- Roofs E,F,G,H
Tamko 109FR / 84 squares
January 2007 (20 year) **2027**
- Roofs A,B
Tamko 109FR / 131 squares
April 2012 (20 year) **2032**

- Roof construction is low slope modified bitumen roofing and in fair condition. A majority of the roof system will have its warranty expire in 2018 and will need to be considered for improvements in the near future.
- Exterior walls are face brick and stucco and are in good condition.
- Exterior windows and doors are aluminum framed, have insulated glass and appropriate hardware.

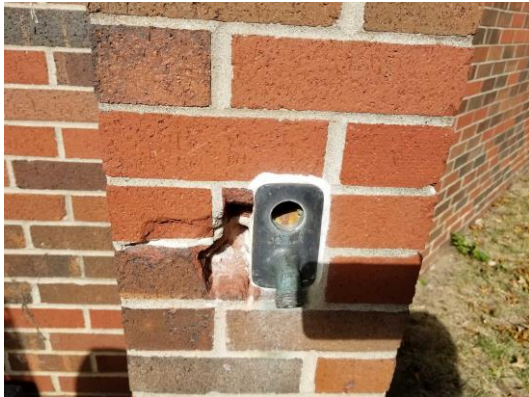
Damaged Brick at old hose bib

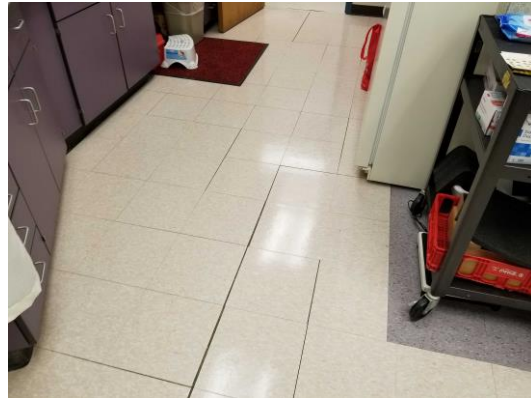
VCT Flooring issues

- Corridors have VCT floors and 12" x 12" acoustical ceiling tiles and surface mounted lighting and painted plaster or gypsum board walls. Flooring, lighting and ceilings need improvements.

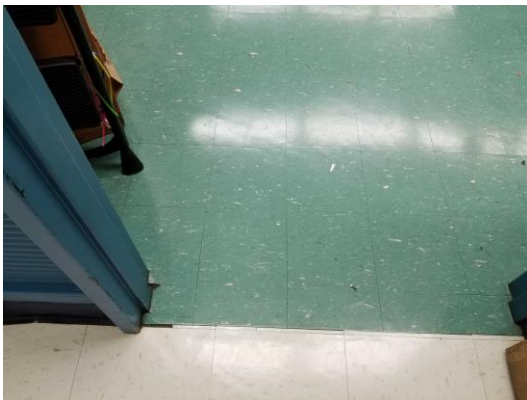
Original 9x9 floor tile

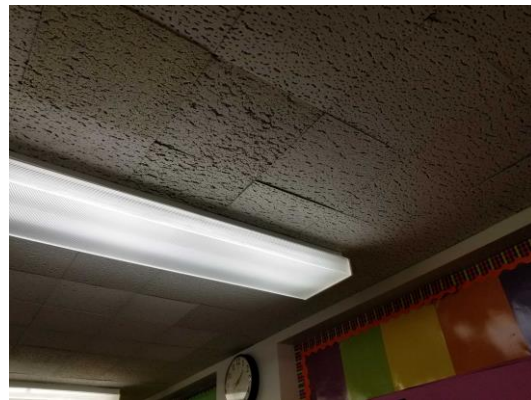
12x12 ceiling tile and surface lighting

- Classrooms have carpet square floors, 12" x 12" ceiling tiles and surface mounted lighting and painted plaster or gypsum board walls. Lighting and ceilings need improvements.

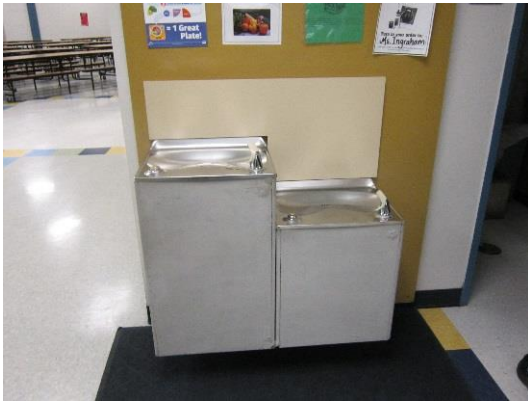
Inaccessible drinking fountains.

- Additional Updates required to bring systems up to current codes:
 - Several water coolers and plumbing fixtures are not ADA compliant and need to be replaced.

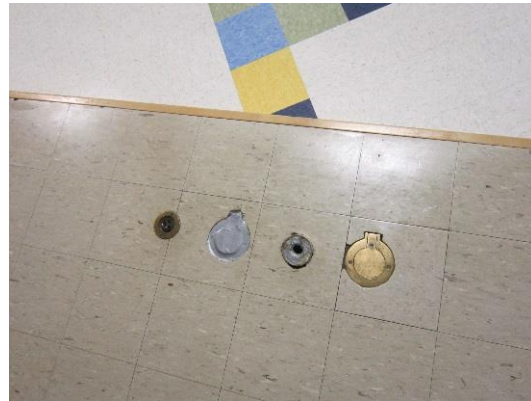
Stage power not operational.

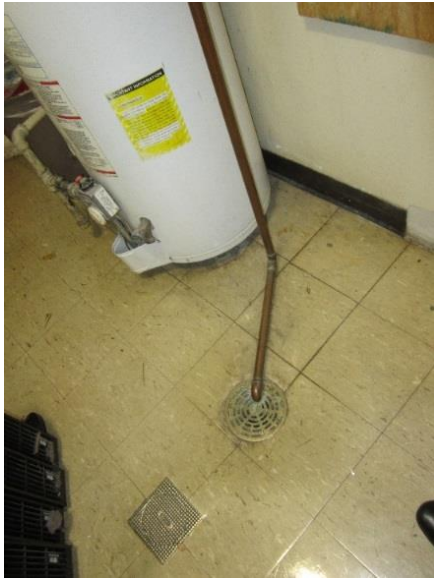
Water heater & drain in same closet as Data Rack.

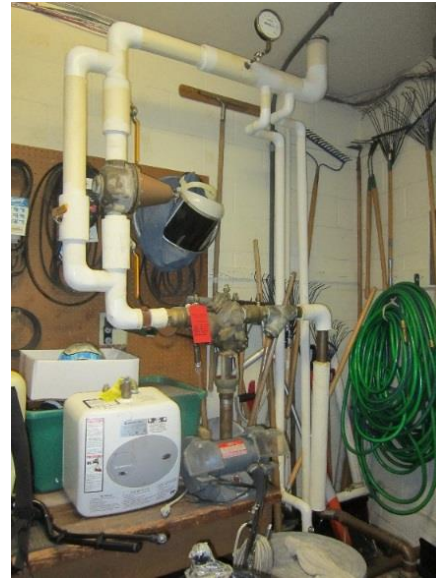
Water service impedes on work area.

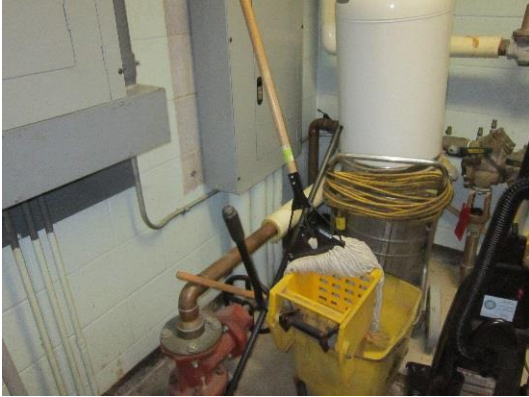
Water service installed in required clearance of panelboard.

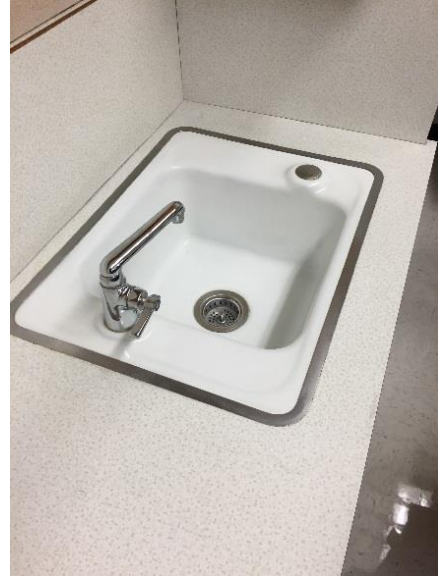
Classroom sink, no hot water.

- All classrooms shall be provided with a sink that has domestic hot and cold water in the classroom.
 - Replace non-ADA compliant plumbing fixtures.

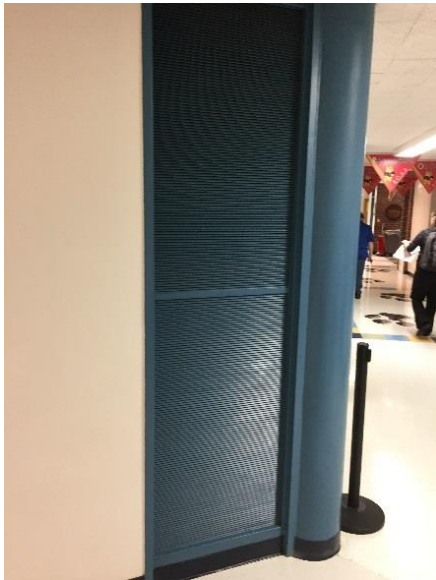
Corridor being used as return air path.

- The rooftop unit serving the kitchen has recently been replaced.
 - Return air path for the rooftops is through the corridor.
- Controls Systems
 - A full BMS control system is currently installed to serve all HVAC equipment.

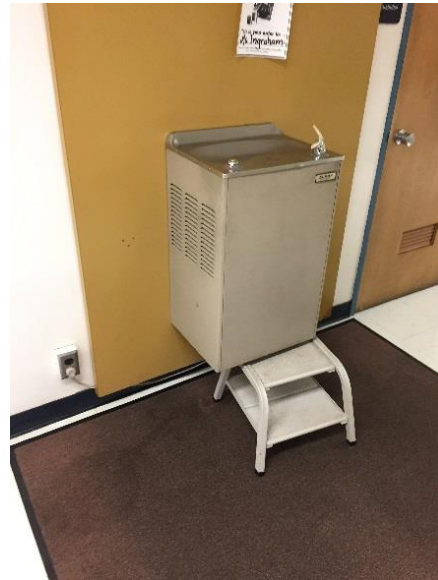
Non-ADA water cooler.

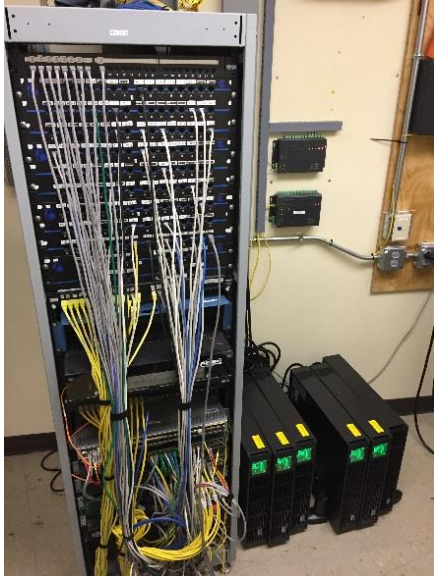
No dedicated mechanical equipment for data room.

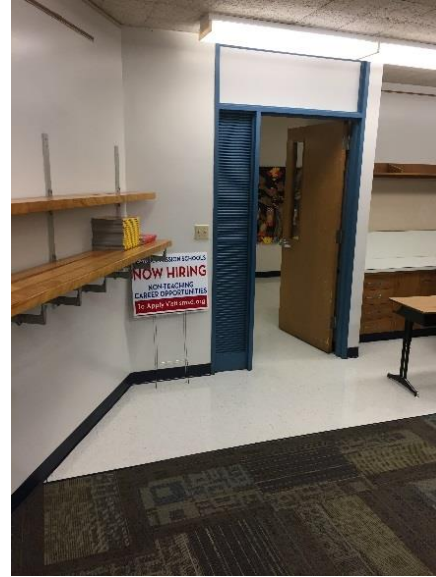
Return air transfer from classroom to corridor.
