# Property Assessment Report

## John Diemer Elementary School

# SHAWNEE MISSION SCHOOL DISTRICT JOHN DIEMER ELEMENTARY SCHOOL BUILDING SUMMARY IMAGES

### BUILDING SUMMARY REPORT

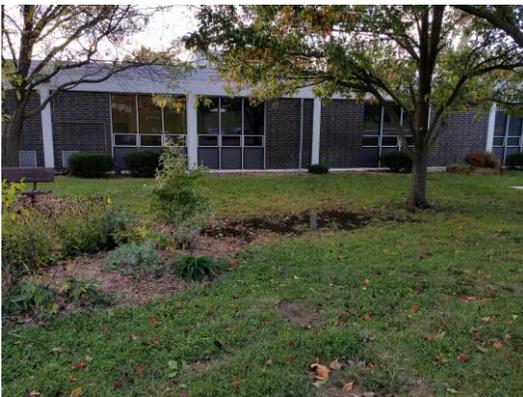
Ponded water

- North of north playground equipment - water stands & is always wet.
- Appears to be low spot in front drive at entry doors.
- Long flat area along drive in front of school do not allow for good drainage.
- During heavy rains, moisture will enter the school.

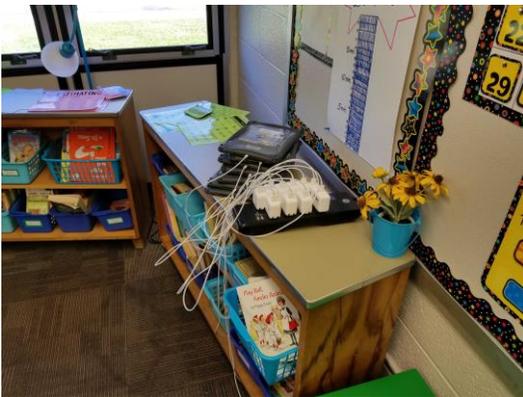
Lack of outlets for charging of devices

- Technology infrastructure is in place for the 1 to 1 initiative set forth by the district, but there is a lack of electrical outlets for charging of devices.

- Energy Metering added to all electrical equipment. May require replacement of main service panel.
- Additional receptacles added throughout classrooms.

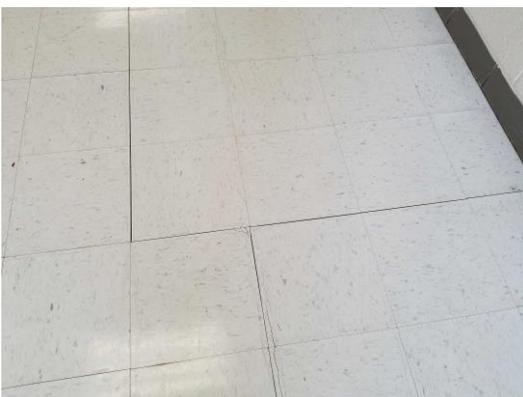
VCT flooring issue

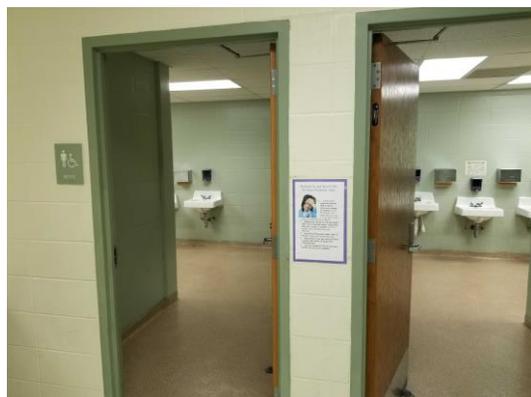
Line of sight issues at restrooms

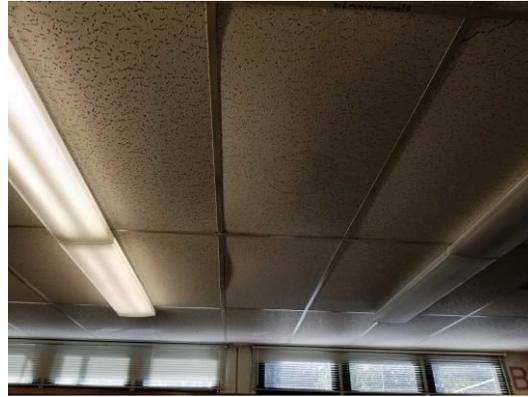
Ceiling tile, surface mounted lights and roof leak

- Roof construction is low slope modified bitumen roofing and in fair condition. A majority of the roof system was replaced in 2010 and is under a manufacturer's warranty until 2030. Several stained ceiling tile caused by roof leaks were observed during the walk through.
- Exterior walls are face brick and painted concrete structure.
- Exterior windows and doors are aluminum framed, have insulated glass and appropriate hardware.

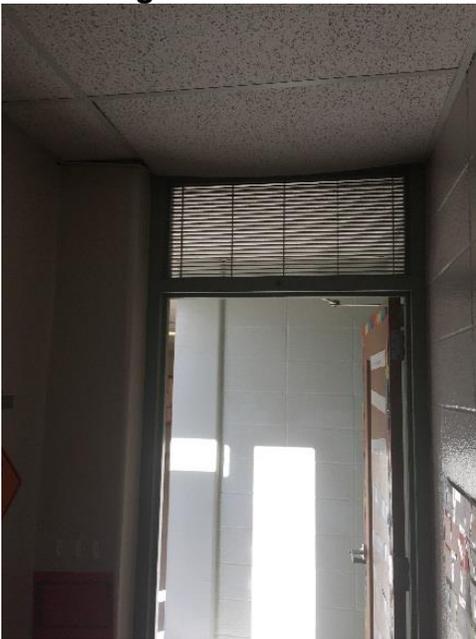
Classroom transfer air to corridor for Building circulation.

- The building is not equipped with a fire sprinkler system.
- Corridors appear to be used as transfer air and air circulation throughout the building. Exit corridors are not allowed to be used as plenums / ducts per International Mechanical Code.

- Exit corridors cannot be used as air passageway.
- Add emergency boiler shutdown to existing boiler systems
- Provide minimum ventilation per current codes to each classroom.
- Energy recovery will be required when minimum ventilation rates are brought up to code.
- Fire sprinkler system would have to be installed.

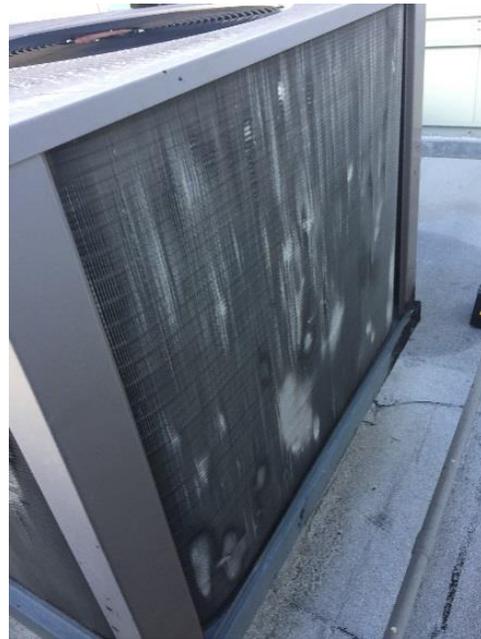
Damage to condenser coil fins.

- Rooftop units were either 10 years old or 20 years old. Typical life span of a rooftop unit is 15 years. Majority of rooftop unit's condenser coil fins are damaged, which limits performance and efficiency. Rooftops use R-22 refrigerant which is a refrigerant that is phased out making it difficult to repair the refrigerant systems.
- The majority of the classrooms are being conditioned from unit ventilators fed from the 2-pipe system. If teacher is too hot or too cold they turn off the unit ventilator which does not allow any outside air into the classroom.
- Select classrooms contained ceiling fans.
- Rooftop unit serving kitchen has been replaced with in the last 2 years.
- Library had a portable dehumidifier, leading us to believe there are humidity issues in the space.

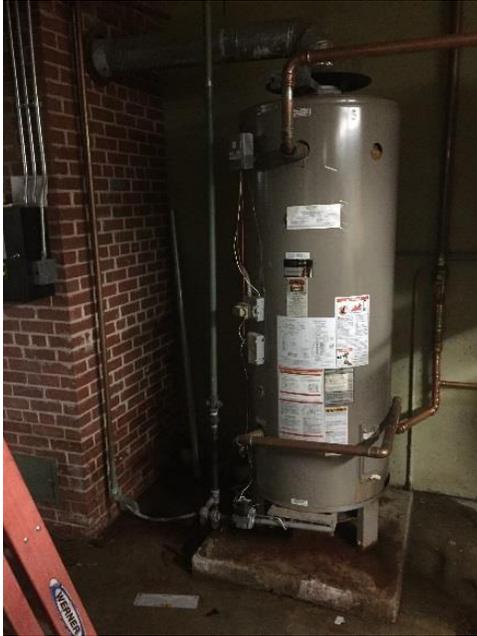
Domestic water piping not insulated  
In mechanical room.

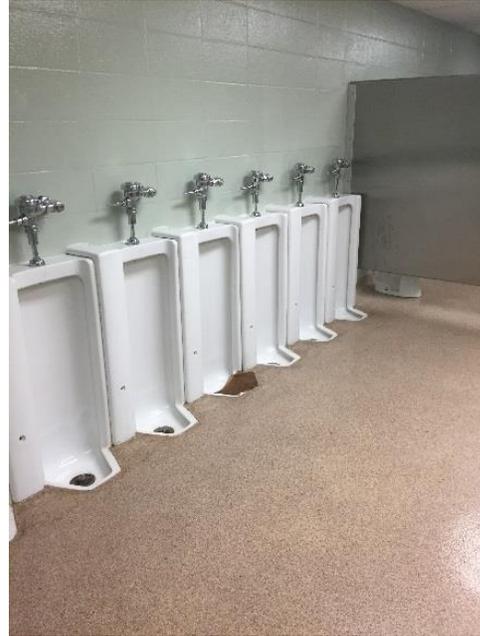
Floor mounted water closets and urinals.

- Majority of restrooms contained floor mounted water closets and floor mounted urinals. None of the lavatories had ADA under sink protection.
- The nurse area does not have a shower – accessible or otherwise.

- Replace all faucets and flush valves with Toto sensor devices.
- Add accessible roll-in shower for the Nurse Area.
- Hot water recirculation line shall tie into hot water line with-in 3 feet of every hand washing sink.
- All classrooms shall be provided with a sink in the classroom.
- Replace majority of water closets with new wall-mounted water closets.

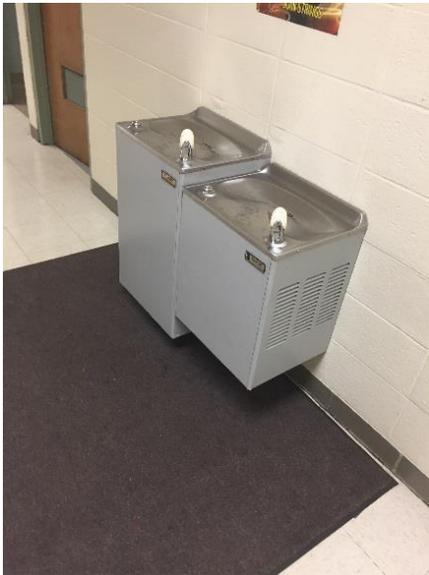
Inaccessible water cooler.

- Several water coolers and plumbing fixtures are not ADA compliant and need to be replaced
- All handwashing sinks will need to have thermostat mixing valves installed to limit maximum water hot water temperature to 110°F.

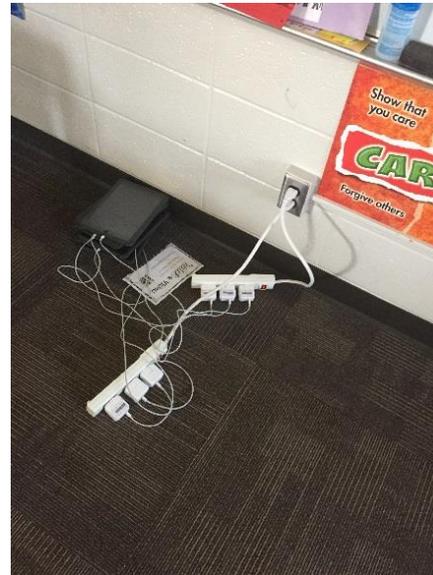
Not enough receptacles in classrooms.

- Building is fed from an underground service located at the back of the building.
- Extension cords and power supplies were common in classrooms due to insufficient quantities and locations of electrical receptacles.
- Power systems appeared to have available space and spare for future improvements, depending on scope. However, should a different HVAC system be installed, the electrical service would likely require an upgrade.

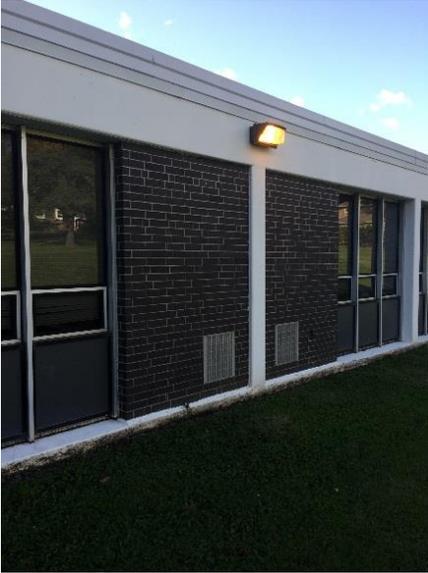
Poor exterior lighting for security purposes

- Basement Electrical and Mechanical room illumination was not sufficient to see or maintain equipment.
- Exterior illumination did not appear sufficient. There was no dedicated parking lot lighting. Wall mounted light fixtures were aged and lenses were significantly yellowed.
- A few of the classrooms have been updated to have vacancy sensors. The majority of the building has surface mounted T8 fluorescent light fixtures.

- Electrical
  - All receptacles to be replaced with tamper resistant devices.
  - Additional Exterior lighting to ensure sufficient illumination.

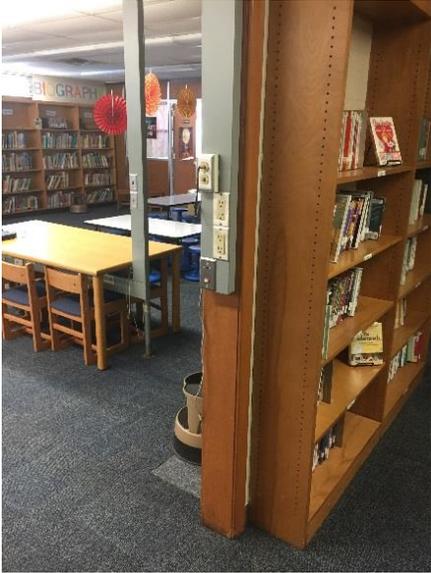
Surface mounted electrical power.

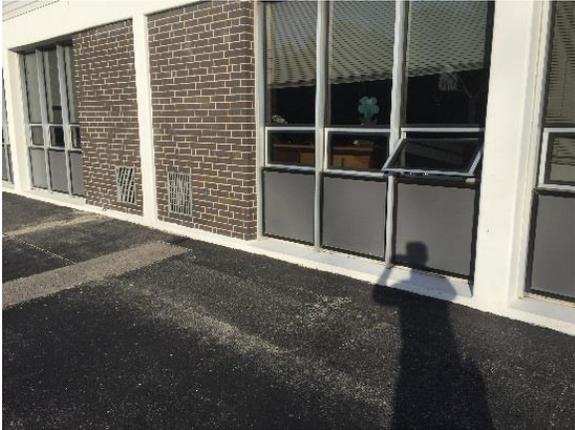
Operable window left open.

- The majority of the classrooms have operable windows. Operable windows make it difficult for the mechanical equipment to control humidity levels. With large amounts of untreated outside air, this may cause high humidity levels and can lead to moisture problems.
