Property Assessment Report  
Shawnee Mission Northwest High School  
12701 W 67th St, Shawnee, KS 66216

## Evaluation - Shawnee Mission Northwest HS

Dec. 27, 2018

# SHAWNEE MISSION SCHOOL DISTRICT SHAWNEE MISSION NORTHWEST HIGH SCHOOL BUILDING SUMMARY REPORT

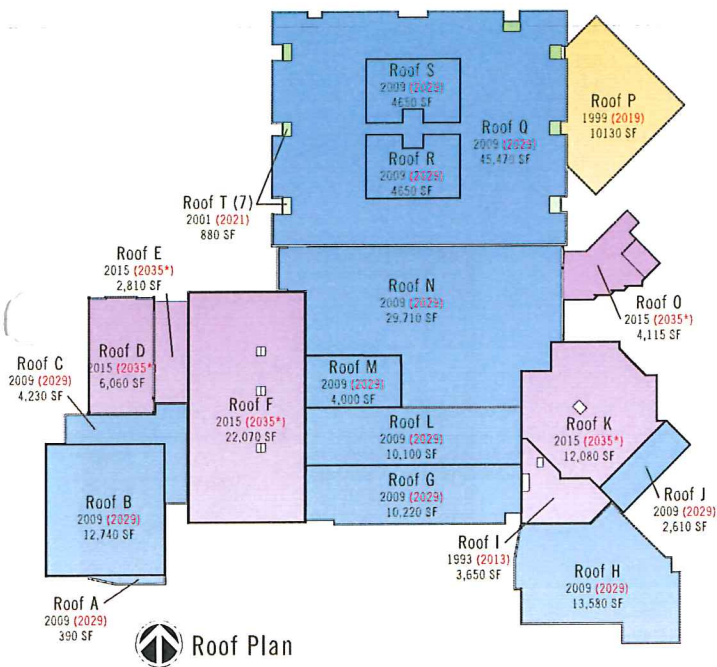
- Roofs P  
Tamko 103 / 91 squares  
February 1999 (20 year) **2019**
- Roofs T  
Tamko 103 / 21 squares  
October 2001 (20 year) **2021**
- Roofs A,B,C,G,H,J,L,M,N,Q,R,S  
Tamko 109FR / 1,314 squares  
August 2009 (20 year) **2029**
- Roofs D,E,F,I,K,O  
Derbigum / 536 squares  
2015 (20 Year) **2035\***

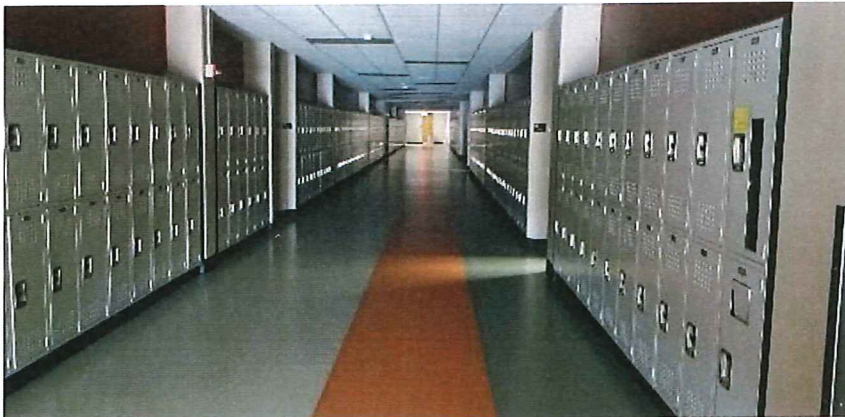
Corridor with seamless flooring

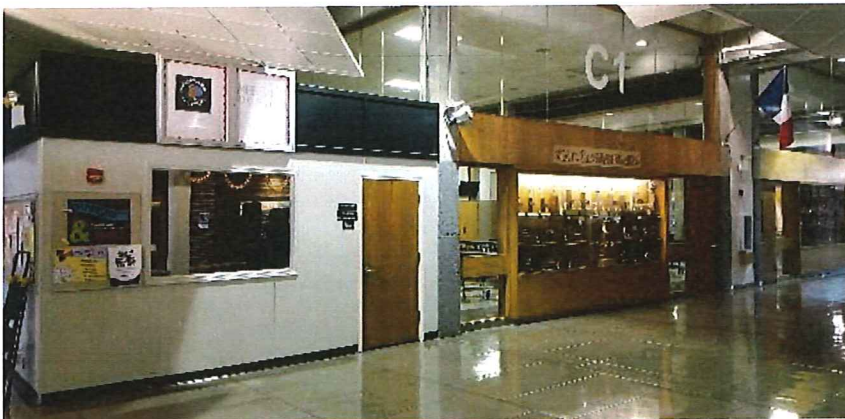
Corridor with polished concrete floor

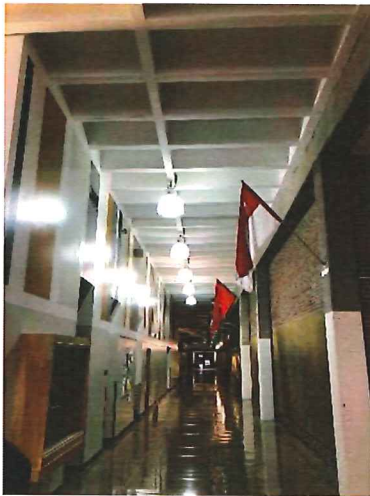
Corridor Light Fixtures.

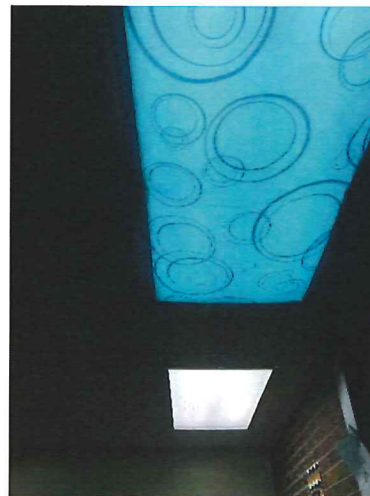
Classroom Light Fixtures.

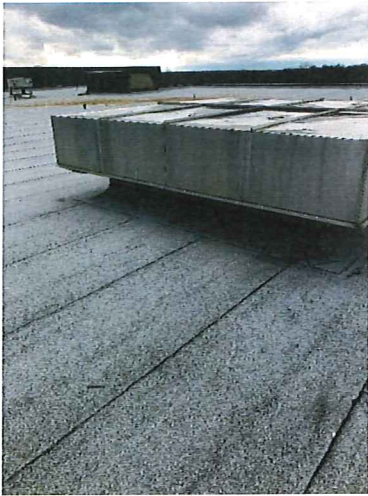
Leaking Roof Hood

- Air handler serving main gym also serves lower level offices and wrestling room.
  - Water leaking through gravity relief ventilation hoods.
  - Replacement of pool equipment might help some with the condensate issues at the pool space.

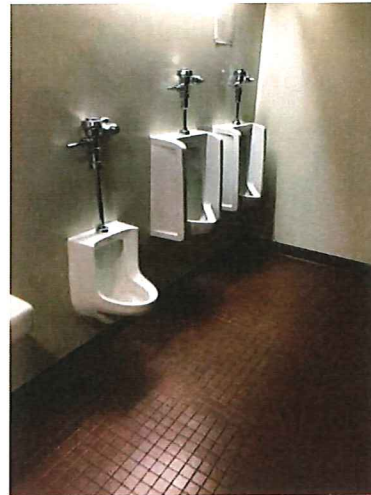
Toilet Fixtures

- Replace majority of water closets and urinals with new wall-mounted fixtures.

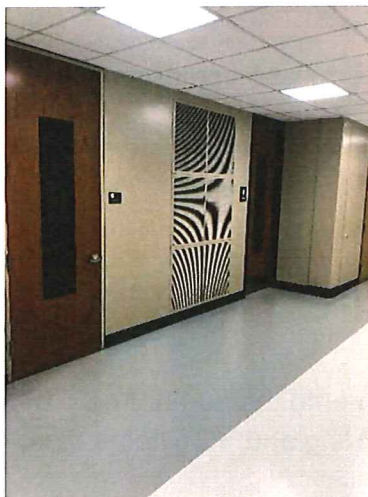
Return Air Grill in Corridor

- Air Handlers have had issues with coils leaking.
  - Chiller shuts off on high head loss multiple times a summer.
  - Corridors are used as a return air path. Some doors have transfer grilles in them for transfer air.

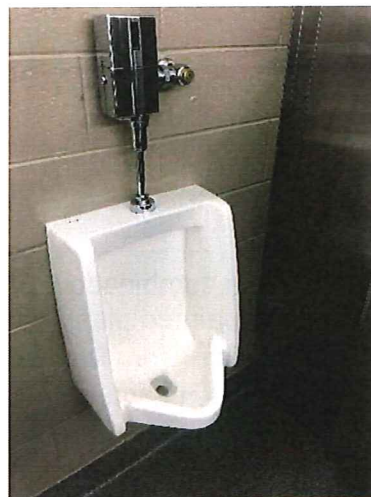
Updated Plumbing Fixture
