Property Assessment Report

Shawnee Mission North High School

7401 Johnson Dr, Overland Park, KS 66202

SHAWNEE MISSION SCHOOL DISTRICT SHAWNEE MISSION NORTH HIGH SCHOOL BUILDING SUMMARY IMAGES

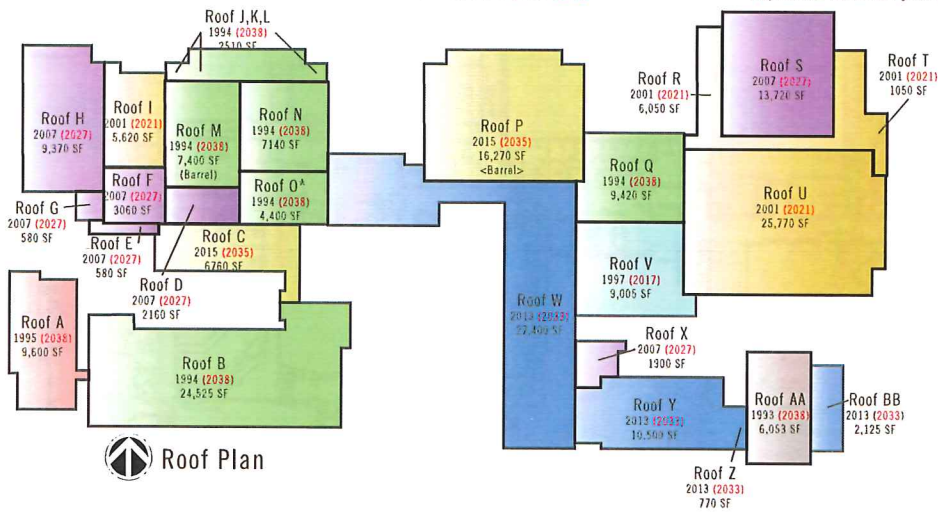
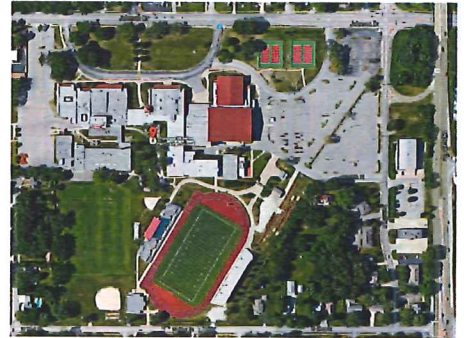
ROOF ASSESSMENT | A1

Derbigum / 420 squares
October 1993 (20 year) 2038</p> <p>Roofs Q
Tamko 103 / 90 squares (Library)
October 1997 (20 year) 2017</p> <p>Roofs B,J,K,L,M,N,O*,V
Derbigum / 628 squares
November 1994 (20 year) 2038</p> <p>Roofs A
Derbigum / 96 squares
March 1995 (15 year) 2038</p> | <p>Roofs I,R,T,U
Tamko 103 / 340 squares (Gym & L. Theater)
October 2001 (20 year) 2021</p> <p>Roofs D,E,F,G,H,S,X
Tamko 103
2007 (Missing) 2027</p> <p>Roofs W,Y,Z,BB
GAF Ruberoid/GAFGLAS Diamond / 397 squares
Pledge NDL
August 2013 (20 year) 2033</p> <p>Roofs C,P
Derbigum
September 2015 (20 year) 2035</p> |

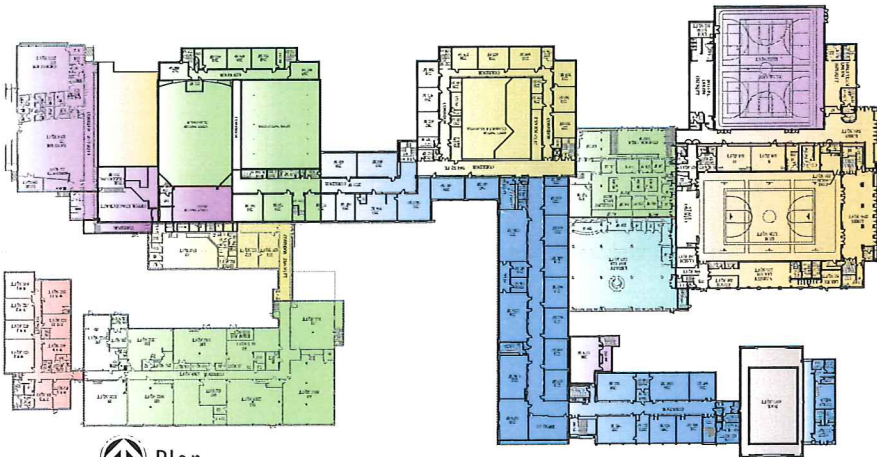
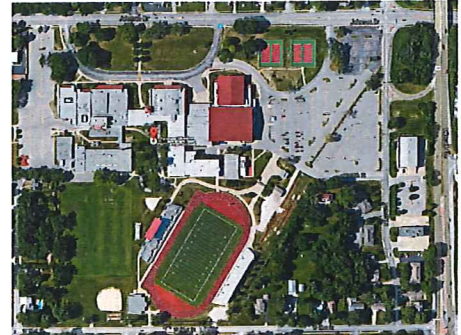
ROOF ASSESSMENT | A2

<p>Roofs AA Derbigum / 420 squares October 1993 (20 year) 2038</p> <p>Roofs Q Tamko 103 / 90 squares (Library) October 1997 (20 year) 2017</p> <p>Roofs B,J,K,L,M,N,O*,V Derbigum / 628 squares November 1994 (20 year) 2038</p> <p>Roofs A Derbigum / 96 squares March 1995 (15 year) 2038</p>	<p>Roofs I,R,T,U Tamko 103 / 340 squares (Gym & L. Theater) October 2001 (20 year) 2021</p> <p>Roofs D,E,F,G,H,S,X Tamko 103 2007 (Missing) 2027</p> <p>Roofs W,Y,Z,BB GAF Ruberoid/GAFGLAS Diamond / 397 squares Pledge NDL August 2013 (20 year) 2033</p> <p>Roofs C,P Derbigum September 2015 (20 year) 2035</p>
---	---

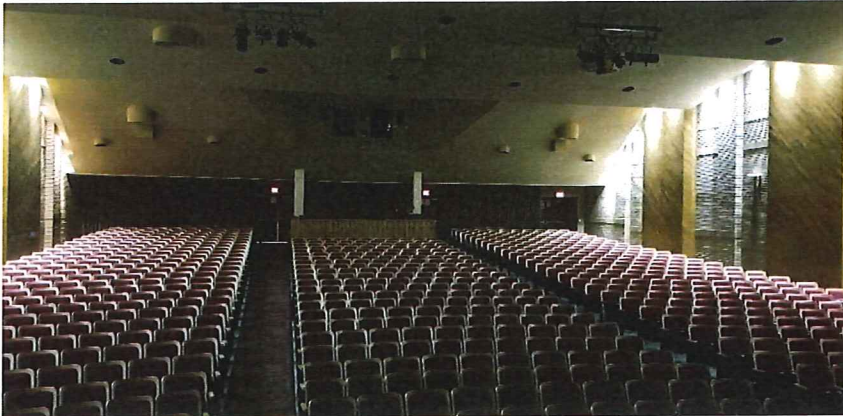
Performing Art Center

- Cafeteria has VCT flooring, plaster walls, 2'x4' ceiling tiles and recess lighting, all in good condition.
- Theater has plaster ceilings, exposed brick and wood paneling walls. Seating is in need to repair.

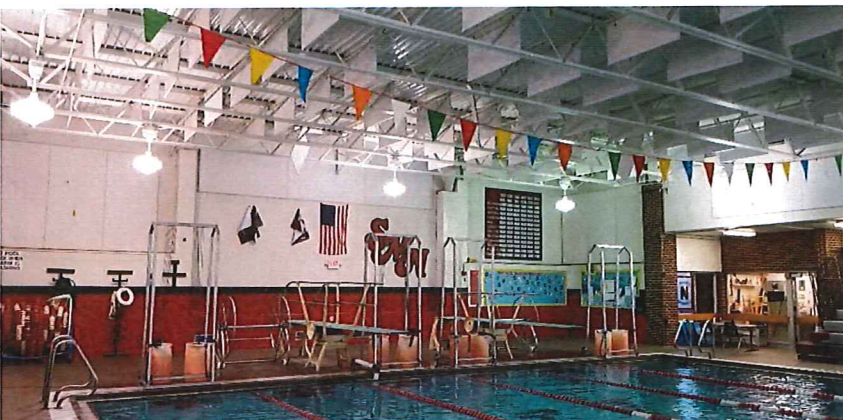
Pool

- Swimming pool has a sealed concrete floor, painted CMU walls and exposed structure ceilings. Steel lintels are rusting out around this area do to the corrosive nature of the pool chemicals and set for repair / replacement in 2019.

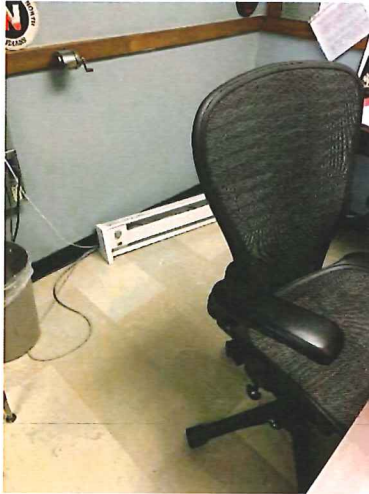
Heater.

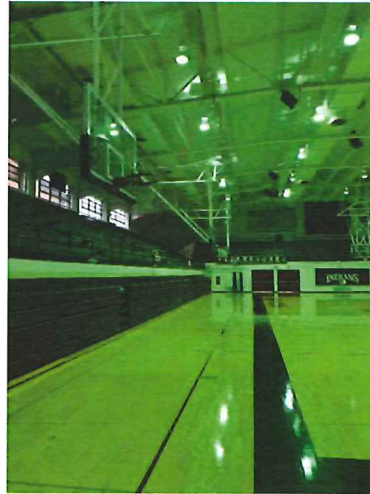
Gym Lighting.

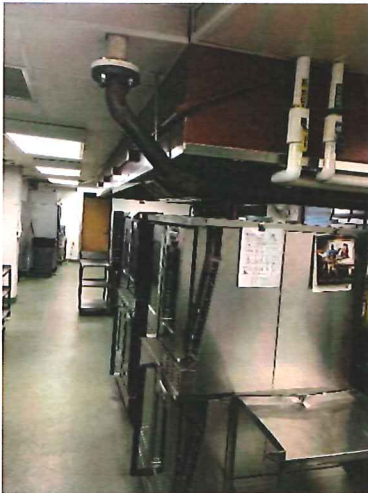
Kitchen Hood

- Kitchen mechanical equipment is old and needs to be replace.
- Pool mechanical equipment didn't appear to be functioning properly because doors were open to outside and to inside adjacent spaces. This space should be isolated from the rest of the building with doors closed and proper mechanical system that would help eliminate moisture and corrosion issue to adjacent rooms near the pool.

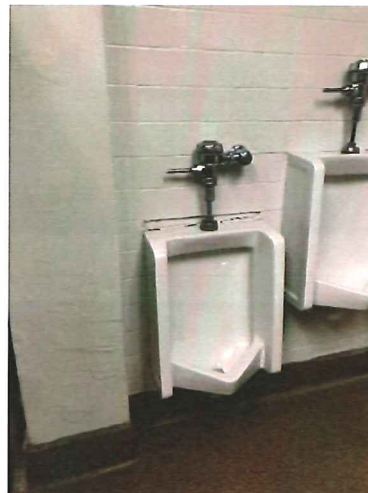
Plumbing Fixture

- Additional Updates required to bring systems up to current SMSD Standards:
 - Replace all faucets and flush valves with Toto sensor devices.
 - Hot water recirculation line shall tie into hot water line with-in 3 feet of every hand washing sink.
 - Replace majority of water closets and urinals with new wall-mounted fixtures.

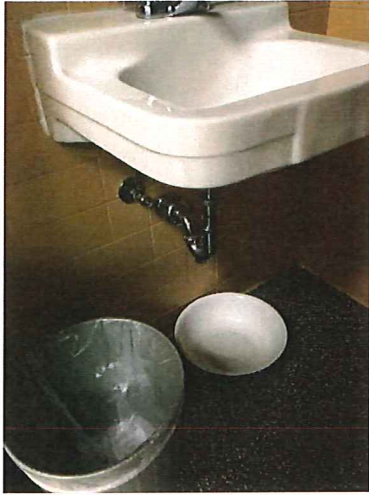
Leaking Sink

- Majority of water coolers were not ADA compliant but there were a couple bottler filling stations added.
- Location where old lavatory is leaking and a bowl is located under sink to catch any water that drips.
