Property Assessment Report

Shawnee Mission Instructional Support Center

9700 W 96th St, Overland Park, KS 66212

SHAWNEE MISSION INSTRUCTIONAL SUPPORT CENTER

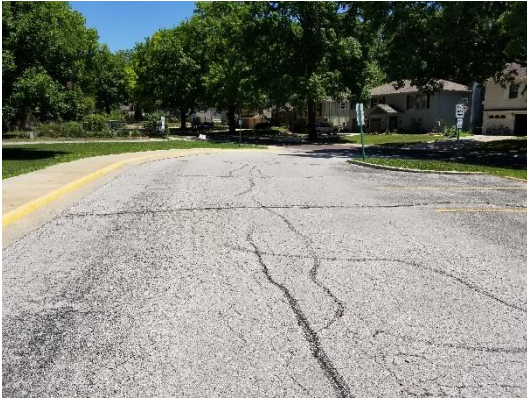
Alligatored Asphalt

- All pavement areas need full depth repairs and overlay.

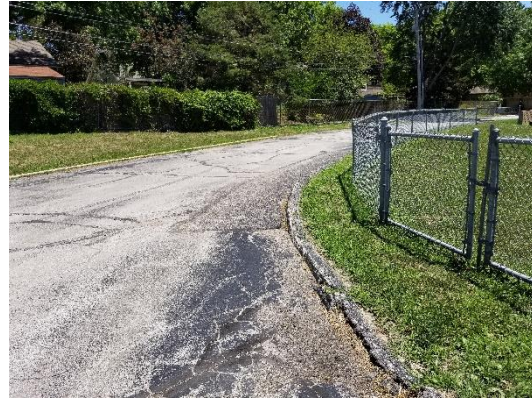
Deteriorated asphalt and curbing

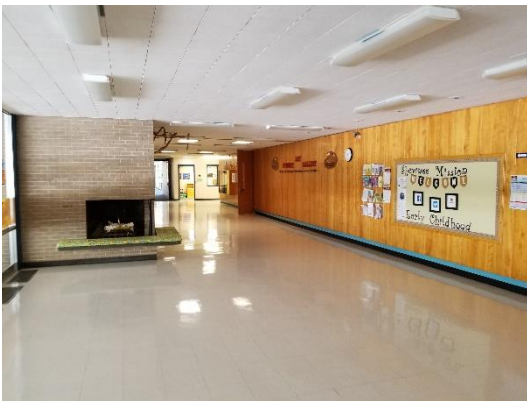
Entry Vestibule – No Secure Entry

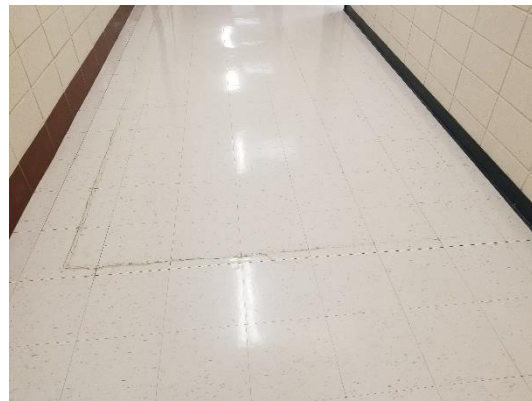
VCT Flooring issues / Floor Settlement

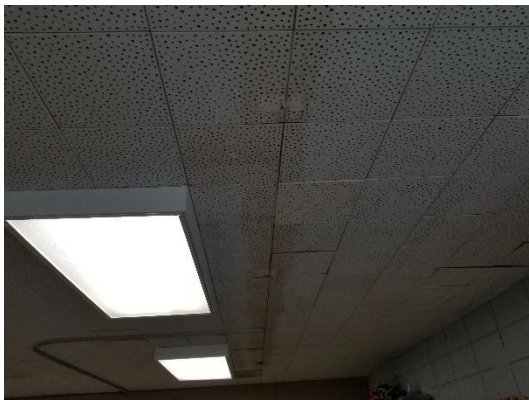
Water Damaged ceilings

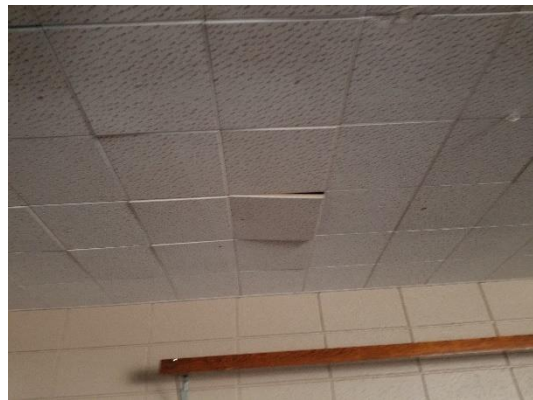
Loose 12x12 ceiling tiles

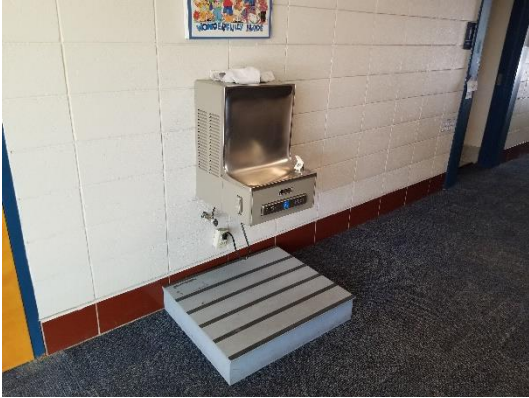
Inaccessible drinking fountains.

- The nurse area does not have a shower – accessible or otherwise.
- Additional Updates required to bring systems up to current codes:
 - Several water coolers and plumbing fixtures are not ADA compliant and need to be replaced.

- the classroom.
- Replace non-ADA compliant plumbing fixtures.

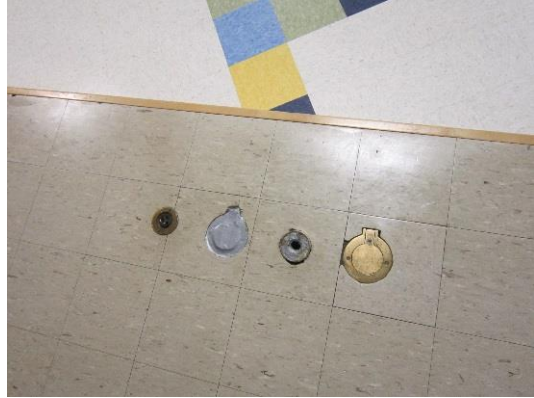
Stage power not operational.

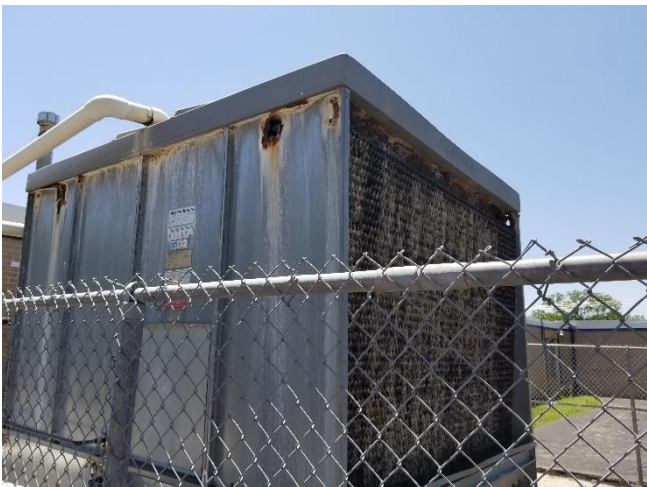
Chiller in need of significant repairs or replacement

- System Descriptions
 - The majority of the building is served by chiller / boiler systems.
 - The chiller is in need of immediate repair / replacement
 - Controls Systems, pneumatic and should be updated to meet district standards
 - Not all classrooms were provided with dedicated thermostat controls. Several classrooms were served from one unit and shared thermostats which can cause student and teacher discomfort.
- Additional Updates required to bring systems up to current codes:
 - Provide minimum ventilation per current codes to each classroom.
 - Energy recovery will be required when minimum ventilation rates are brought up to code.
- Additional Updates required to bring systems up to current SMSD Standards:
 - HVAC equipment efficiencies shall be increased.
 - Each classroom shall be provided with its own thermostat.
 -

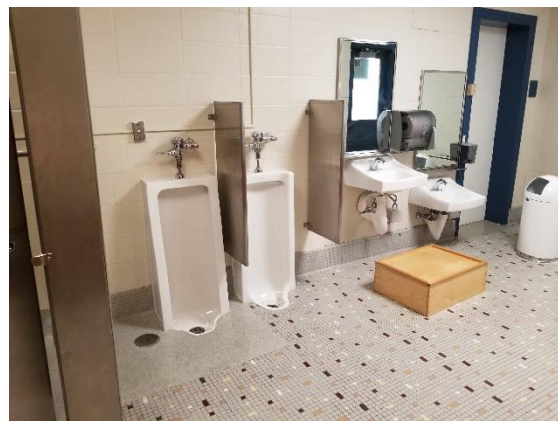
Restroom Fixtures

- Water Supply
 - Water pressure seem to be sufficient.
- Roof Drains
 - Roof drains appeared to discharge to internal drains.
- Some restroom groups appeared to have been updated with new fixtures, wall and floor finishes and were in poor condition.

- Replace all faucets and flush valves with Toto sensor devices.
 - Add accessible roll-in shower for the Nurse Area.
 - Hot water recirculation line shall tie into hot water line with-in 3 feet of every hand washing sink.

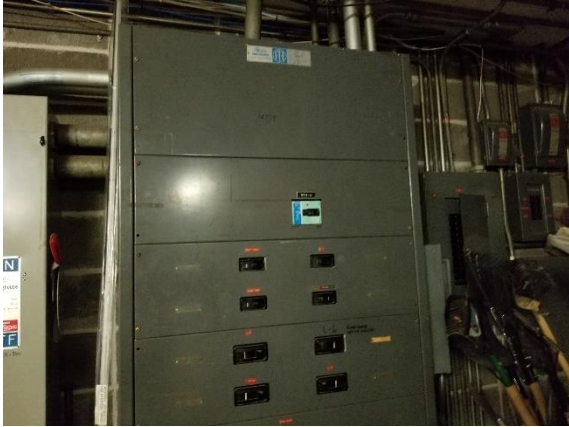
Outdated Electric MDP

- Intercom system – None
 - Data systems – None
- Additional Updates required to bring systems up to current SMSD Standards:
 - Electrical
 - Energy Metering added to all electrical equipment. May require replacement of main service panel.

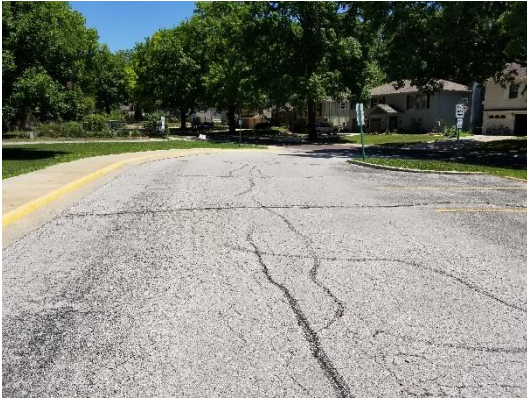
Alligatoring Asphalt

- All pavement areas need full depth repairs and overlay.

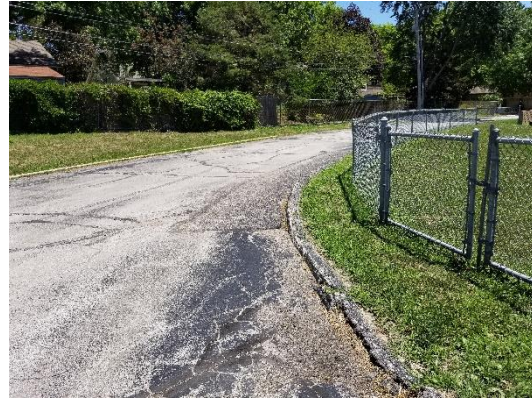
Deteriorated asphalt and curbing

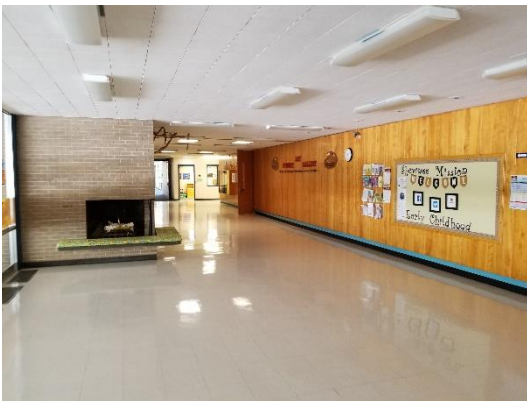
Entry Vestibule – No Secure Entry

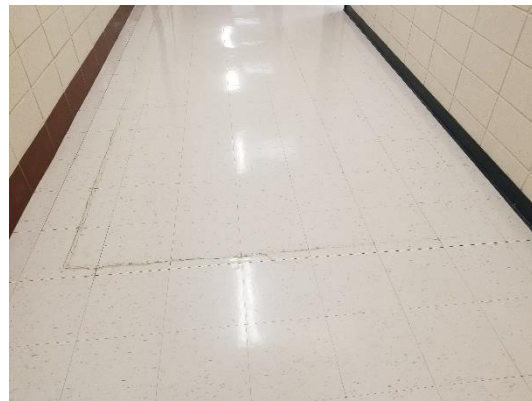
VCT Flooring issues / Floor Settlement

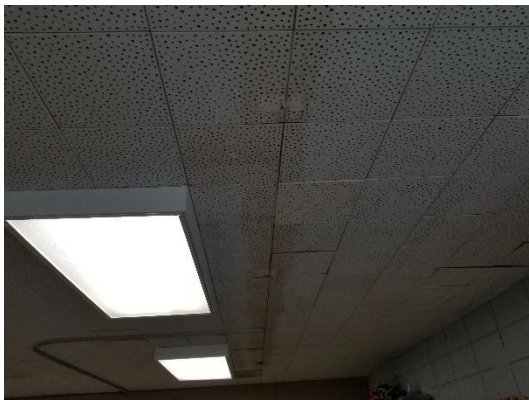
Water Damaged ceilings

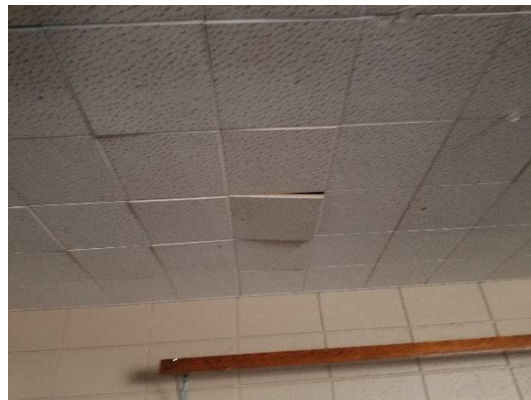
Loose 12x12 ceiling tiles

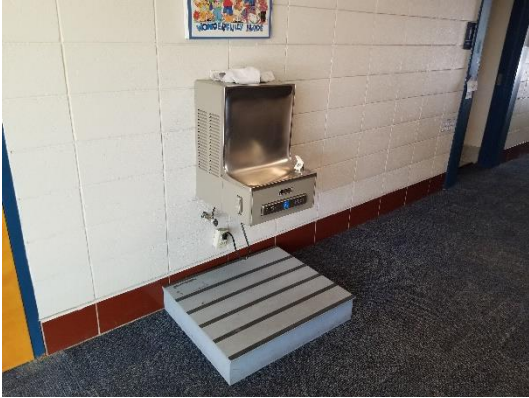
Inaccessible drinking fountains.

- The nurse area does not have a shower – accessible or otherwise.
- Additional Updates required to bring systems up to current codes:
 - Several water coolers and plumbing fixtures are not ADA compliant and need to be replaced.

- the classroom.
- Replace non-ADA compliant plumbing fixtures.

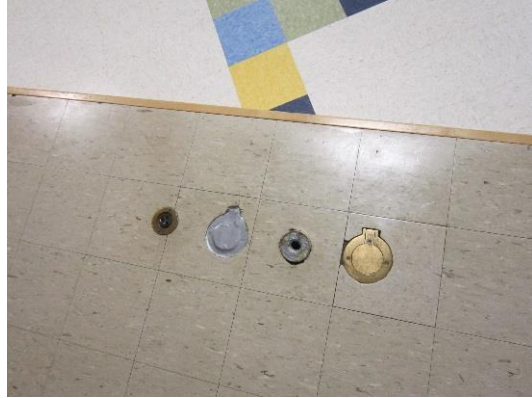
Stage power not operational.

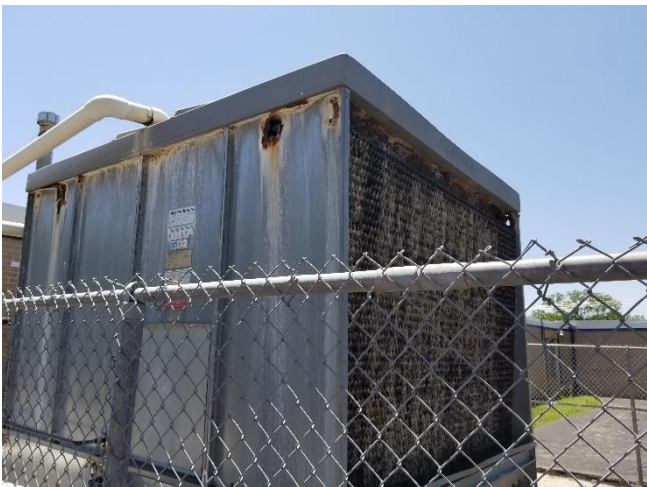
Chiller in need of significant repairs or replacement

- System Descriptions
 - The majority of the building is served by chiller / boiler systems.
 - The chiller is in need of immediate repair / replacement
 - Controls Systems, pneumatic and should be updated to meet district standards
 - Not all classrooms were provided with dedicated thermostat controls. Several classrooms were served from one unit and shared thermostats which can cause student and teacher discomfort.
- Additional Updates required to bring systems up to current codes:
 - Provide minimum ventilation per current codes to each classroom.
 - Energy recovery will be required when minimum ventilation rates are brought up to code.
- Additional Updates required to bring systems up to current SMSD Standards:
 - HVAC equipment efficiencies shall be increased.
 - Each classroom shall be provided with its own thermostat.
 -

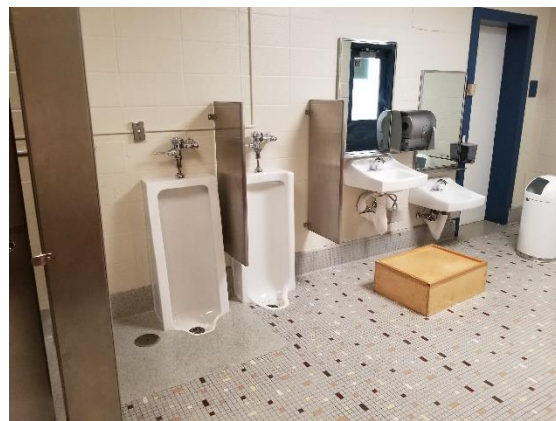
Restroom Fixtures

- Water Supply
 - Water pressure seem to be sufficient.
- Roof Drains
 - Roof drains appeared to discharge to internal drains.
- Some restroom groups appeared to have been updated with new fixtures, wall and floor finishes and were in poor condition.

- Replace all faucets and flush valves with Toto sensor devices.
 - Add accessible roll-in shower for the Nurse Area.
 - Hot water recirculation line shall tie into hot water line with-in 3 feet of every hand washing sink.

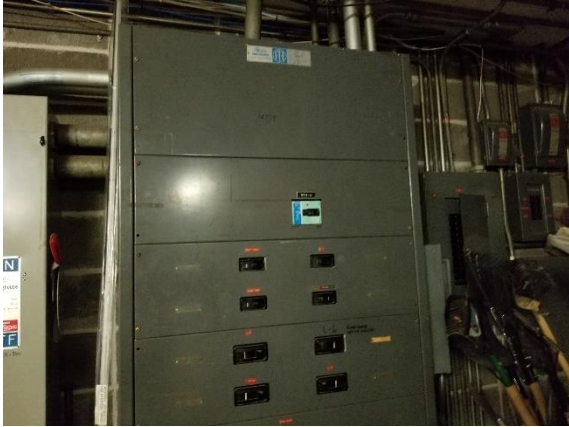
Outdated Electric MDP

- Intercom system – None
 - Data systems – None
- Additional Updates required to bring systems up to current SMSD Standards:
 - Electrical
 - Energy Metering added to all electrical equipment. May require replacement of main service panel.
