Property Assessment Report

Santa Fe Trail Elementary School

7100 Lamar, Overland Park, KS 66204

SHAWNEE MISSION SCHOOD DISTRICT SANTA FE TRAIL ELEMENTARY SCHOOL BUILDING SUMMARY IMAGES

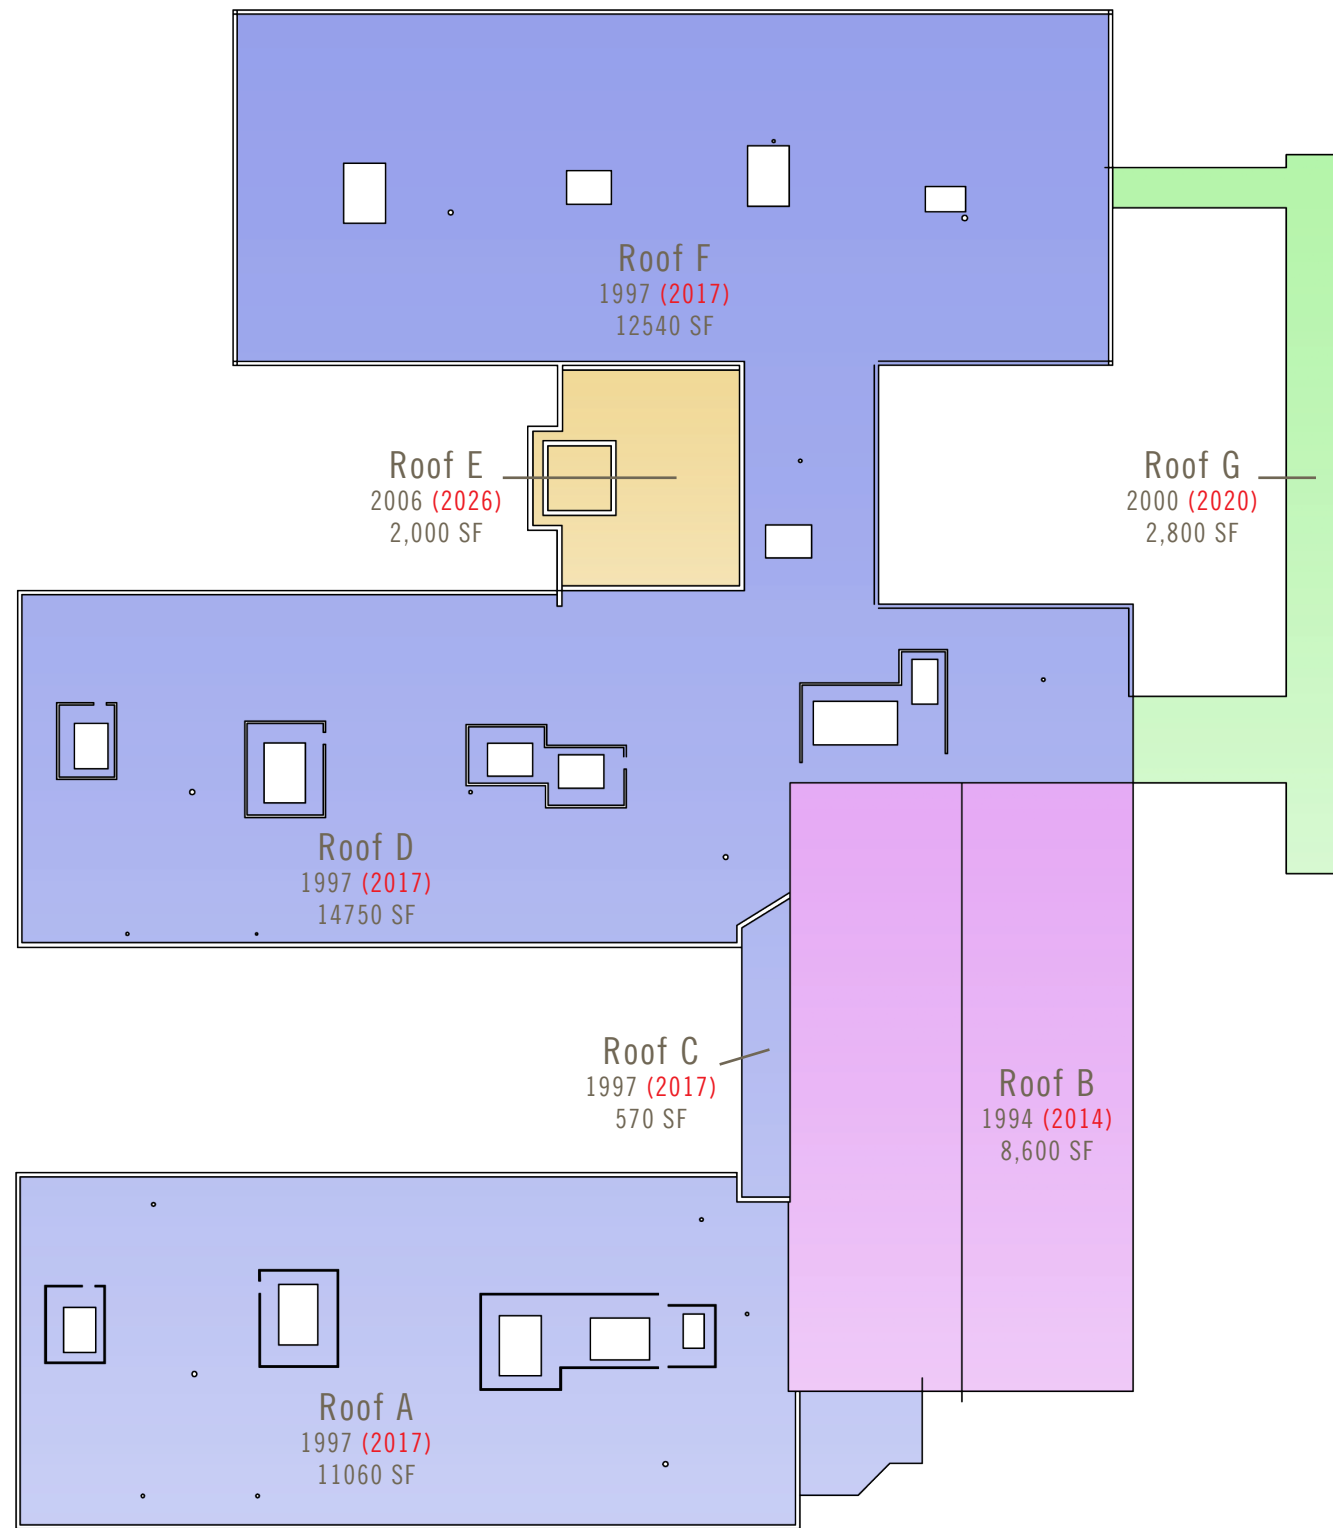
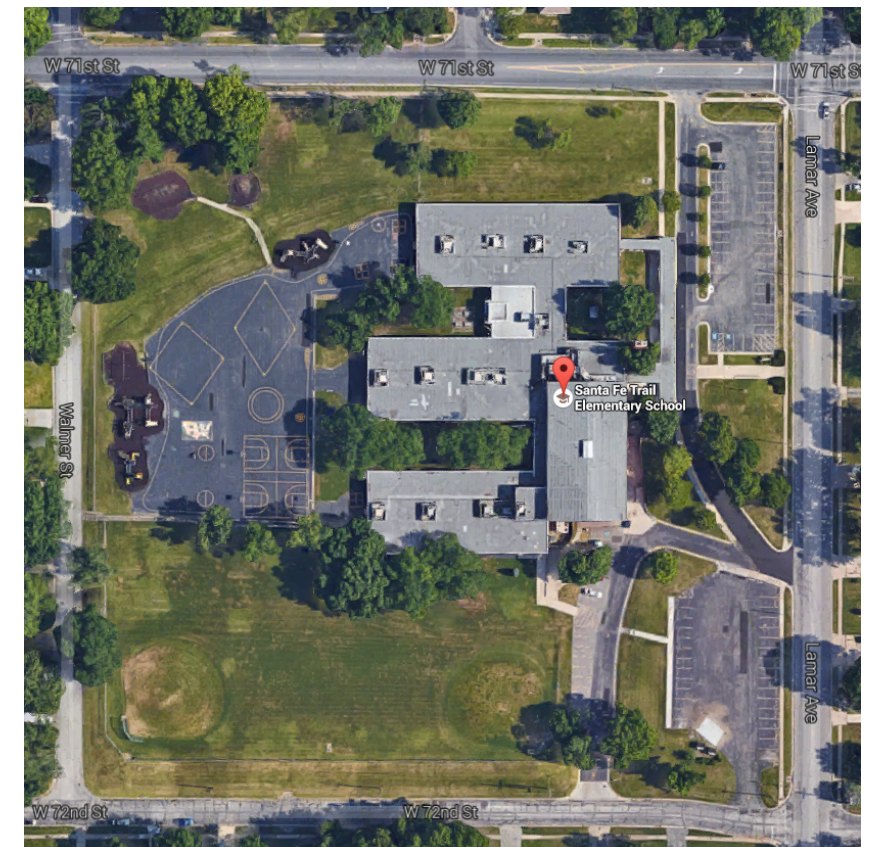
Roof Areas

- Roofs B (Gym)
Tamko 103 / 86 SQ.
August 1994 (20 year) **2014**
- Roofs A,C,D,F
Tamko 103 / 400 SQ.
October 1997 (20 year) **2017**
- Roofs G (Canopy)
Tamko 103 / 28 SQ.
October 2000 (20 year) **2020**
- Roofs E (Library)
Tamko 103FR / 20 SQ.
July 2006 (20 year) **2026**

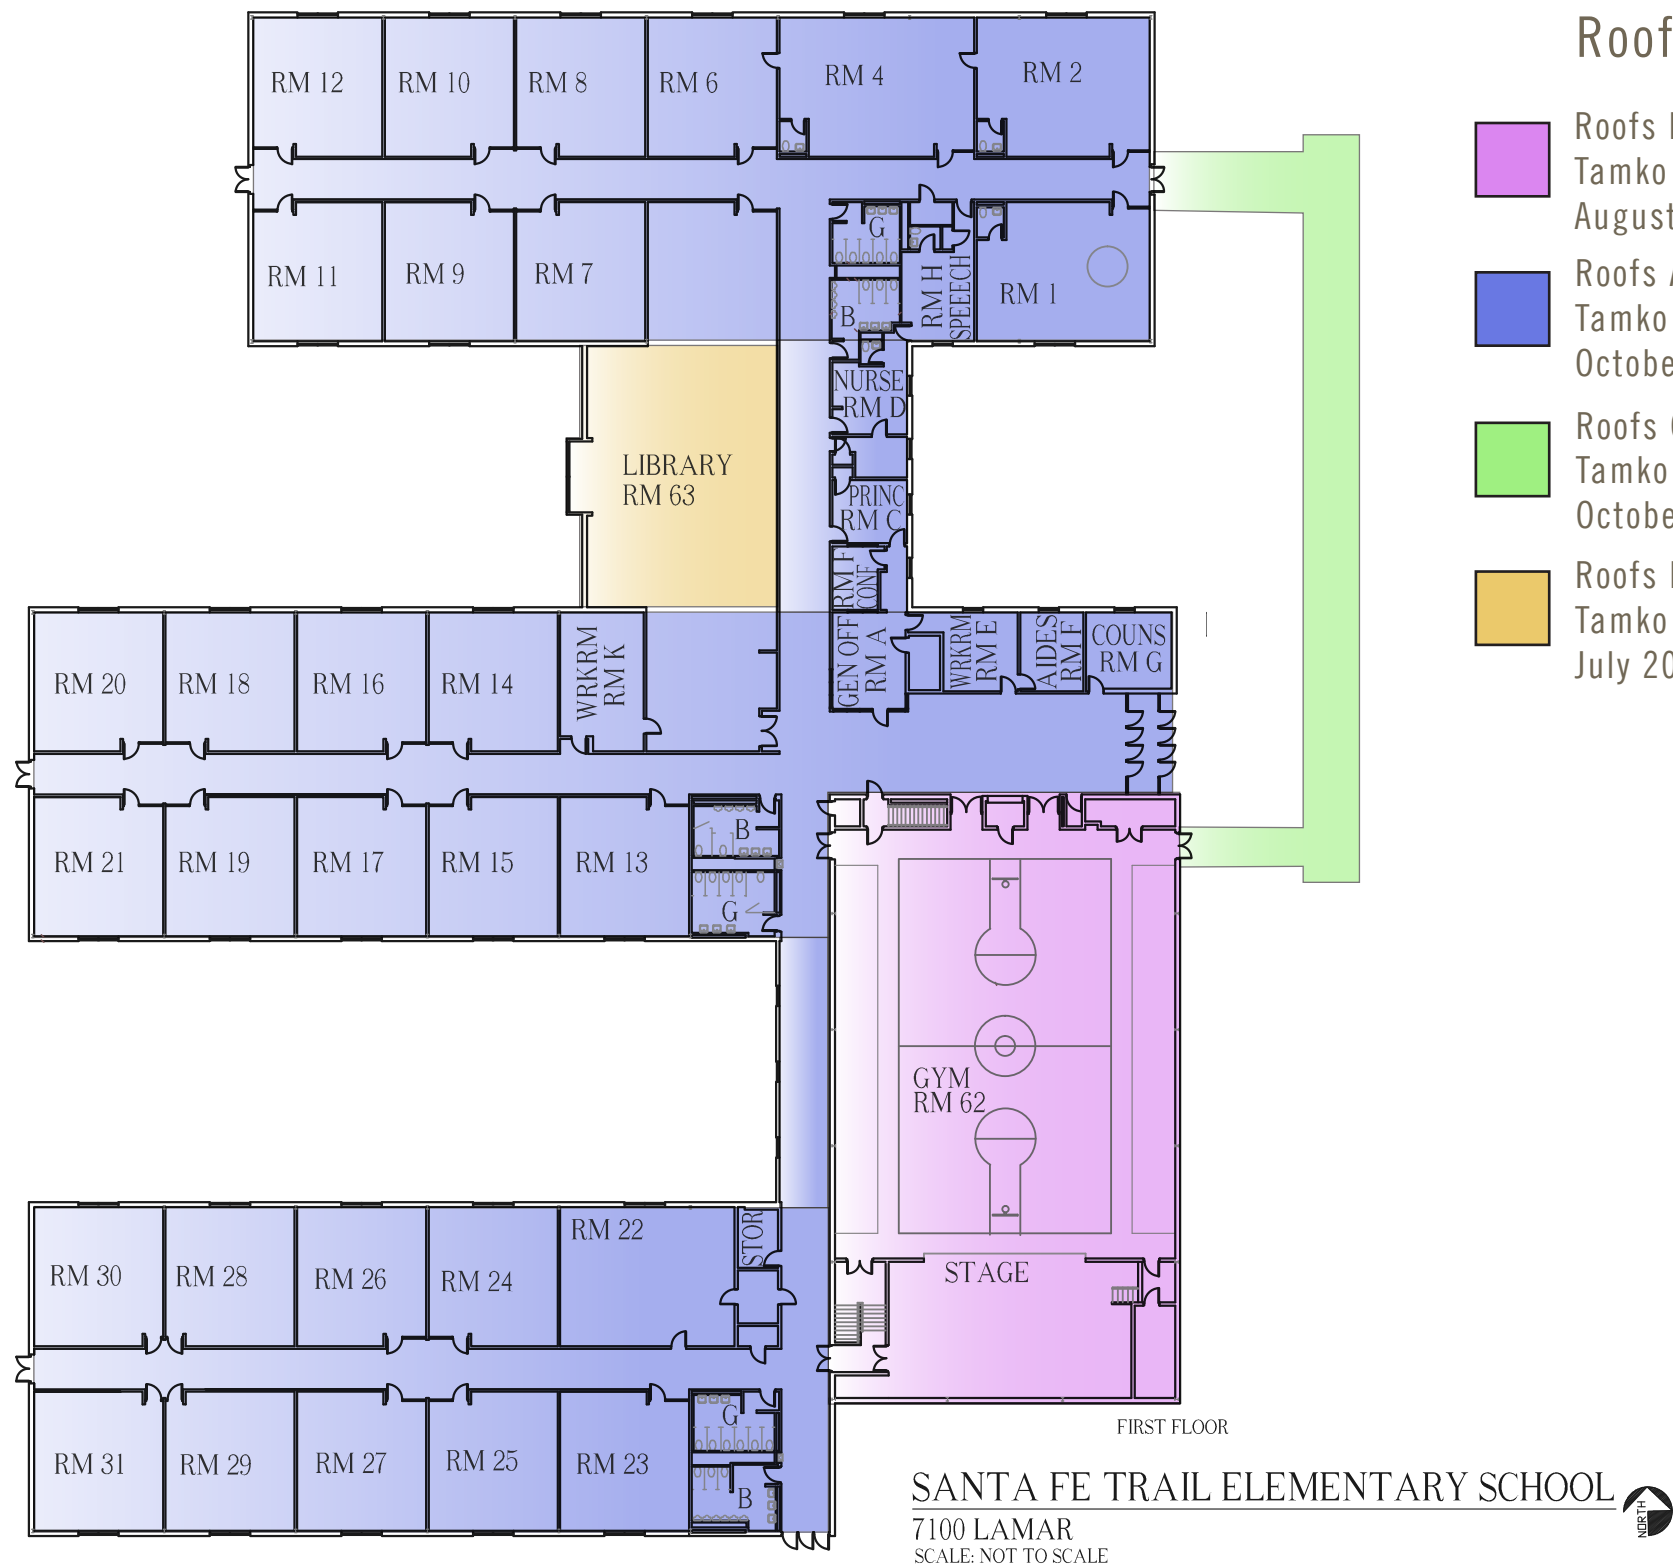
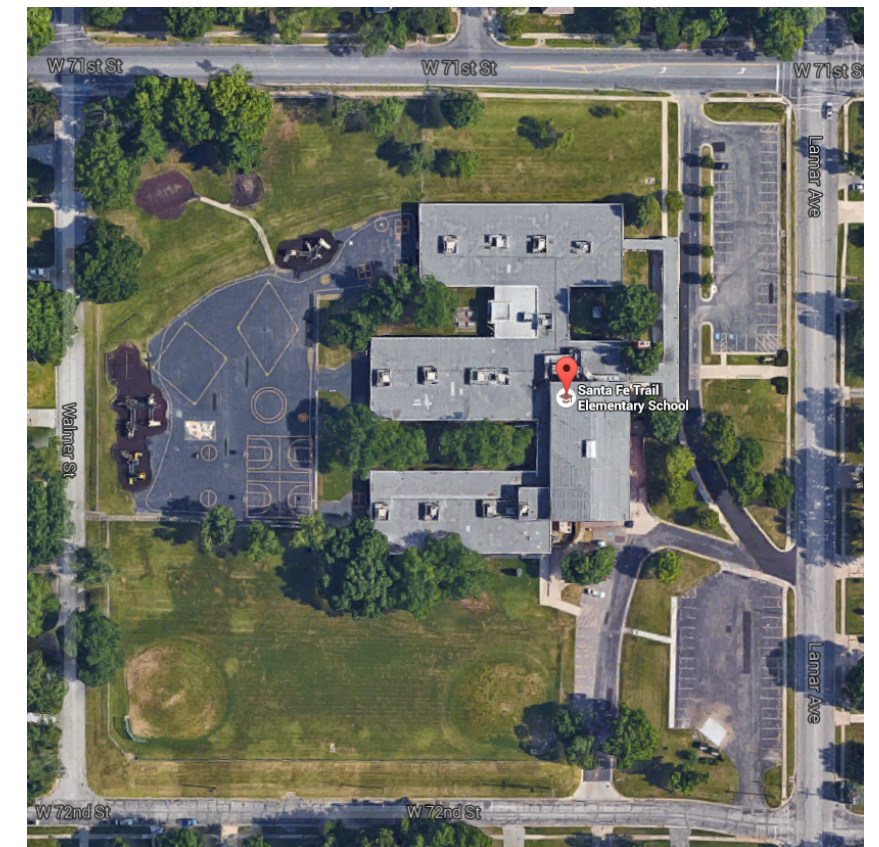
Roof Areas

- Roofs B (Gym)
Tamko 103 / 86 SQ.
August 1994 (20 year) **2014**
- Roofs A,C,D,F
Tamko 103 / 400 SQ.
October 1997 (20 year) **2017**
- Roofs G (Canopy)
Tamko 103 / 28 SQ.
October 2000 (20 year) **2020**
- Roofs E (Library)
Tamko 103FR / 20 SQ.
July 2006 (20 year) **2026**

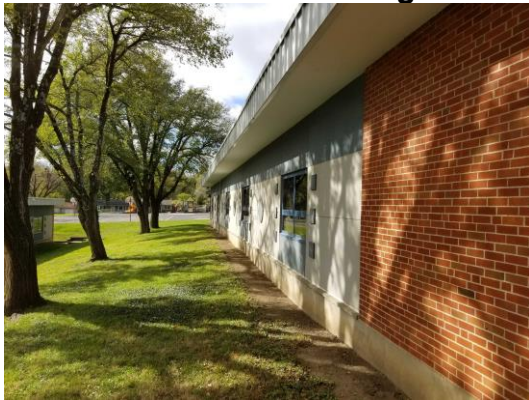
Facebrick and EFIS

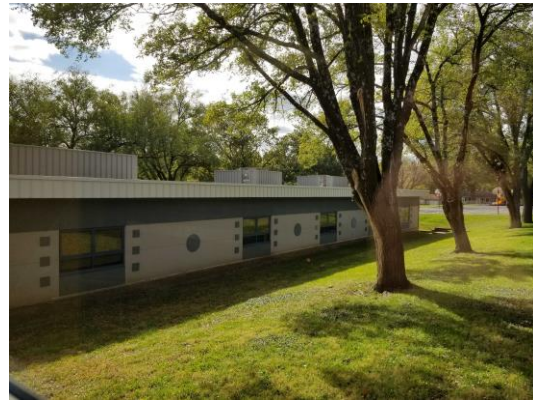
Typical exterior windows

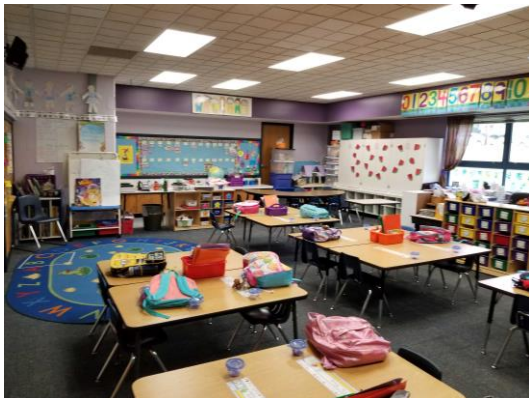
Typical classroom

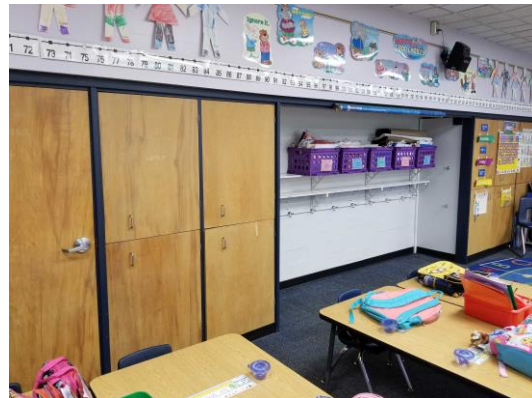
Classroom storage and cubbies

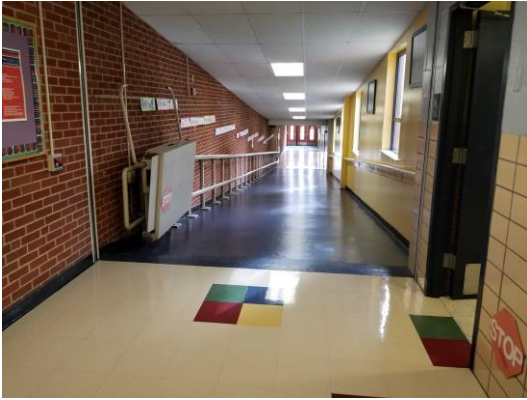
Corridor with VCT flooring

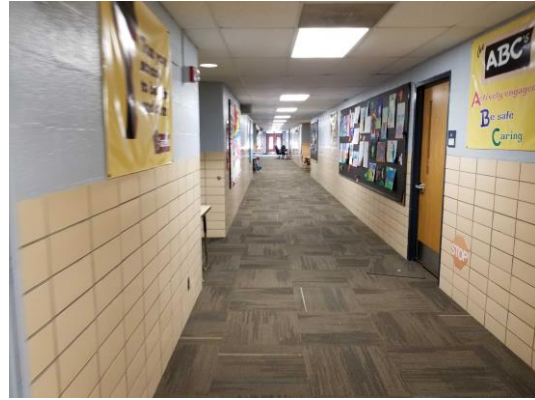
Corridor with carpet tile

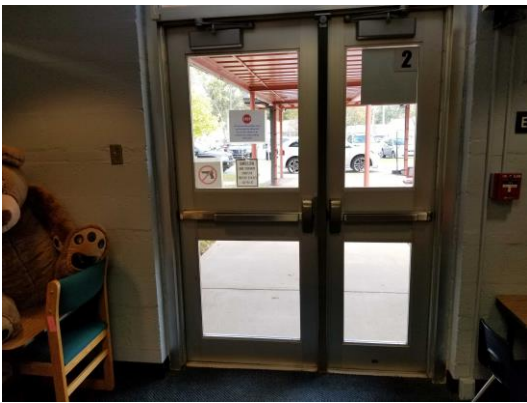
Aluminum exterior doors

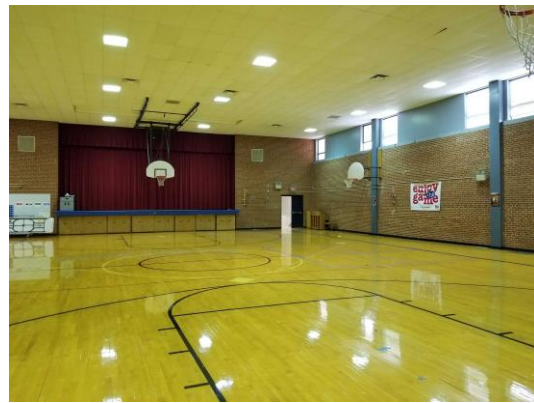
Gymnasium

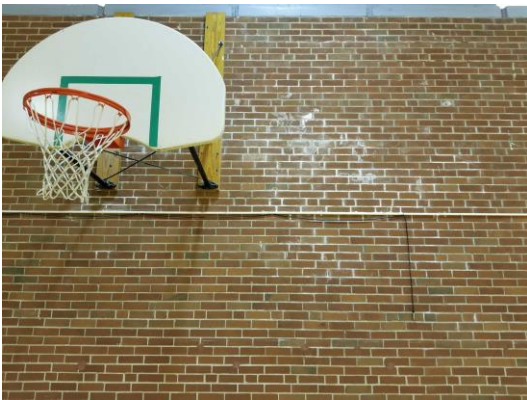
Efflorescence in gym

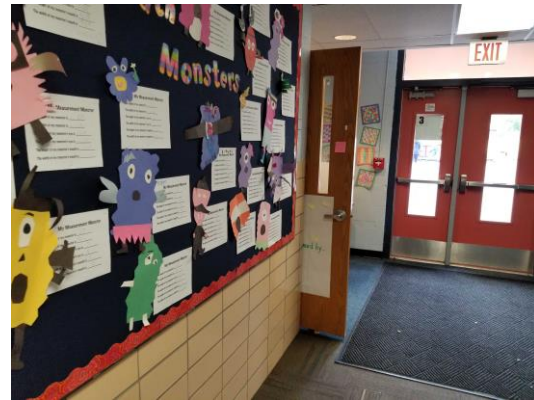
Classroom door encroaching on corridor

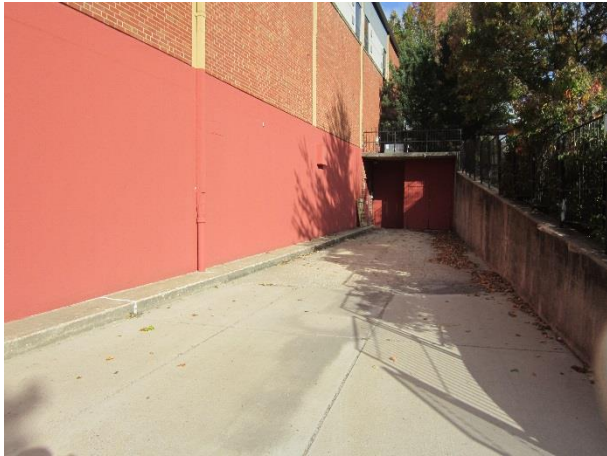
Additional exterior lighting recommended for security.

- Additional Updates required to bring systems up to current codes:
 - Electrical
 - All receptacles to be replaced with tamper resistant devices.
 - Additional Exterior lighting to ensure sufficient illumination.

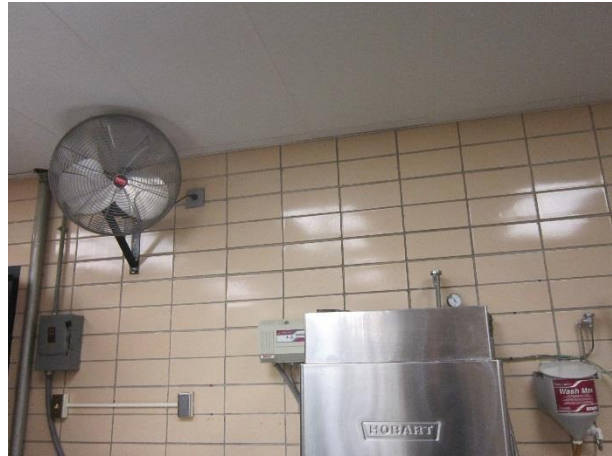
Dishwasher not vented.

- It appears that the majority of the rooftop units do not have humidity control.
 - Kitchen dishwasher did not have ventilation hood to remove heat and humidity from kitchen space.

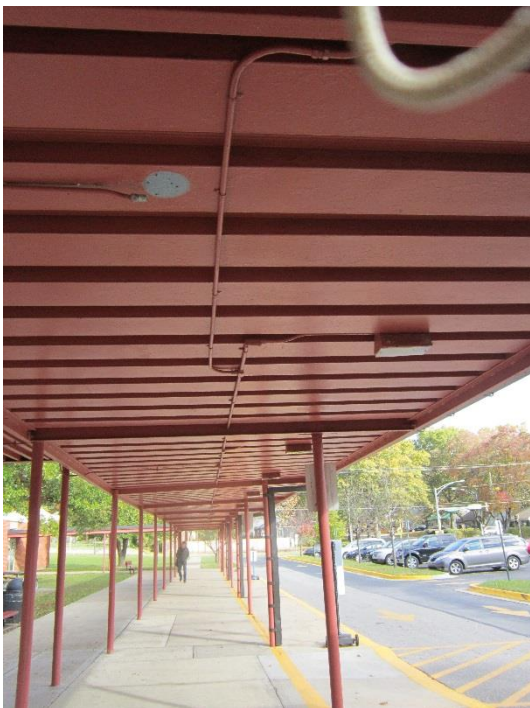
Exterior lighting in need of update & additional fixtures.

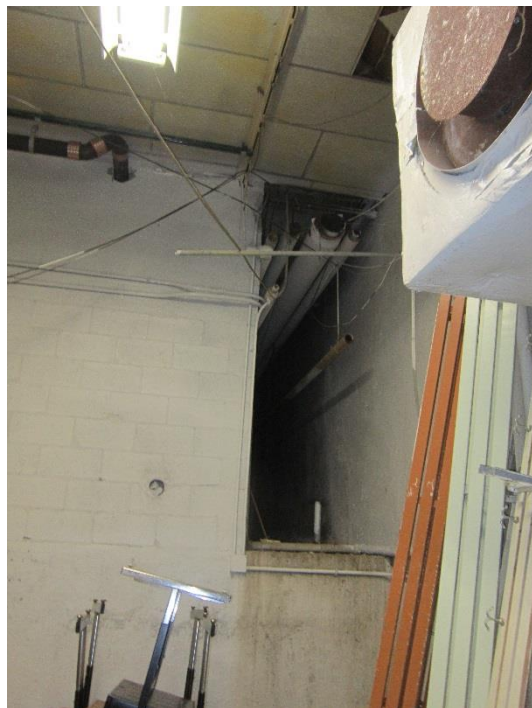
Original boiler & chiller system no longer in use.

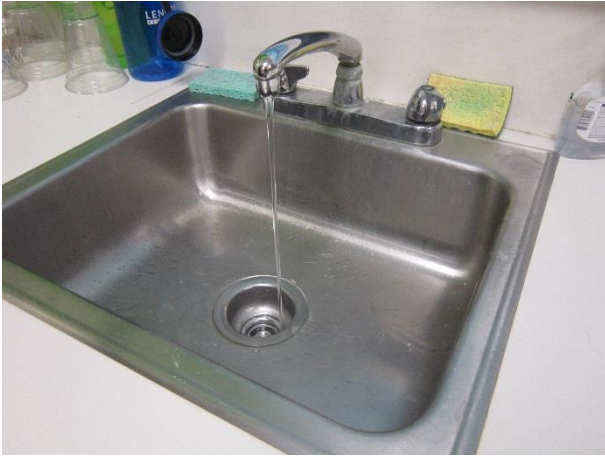
Hot water supply in classrooms has low pressure.

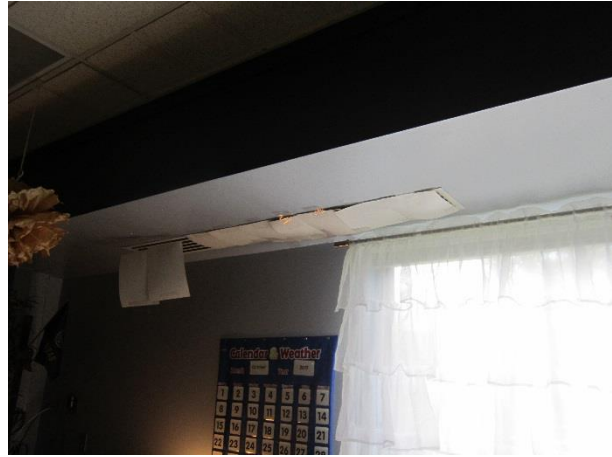
Classroom temperature & air flow issues.

- Controls Systems
 - A full BMS control system is currently installed to serve all HVAC equipment.
 - Not all classrooms were provided with dedicated thermostat controls. Several classrooms were served from one unit and shared thermostats which can cause student and teacher discomfort.

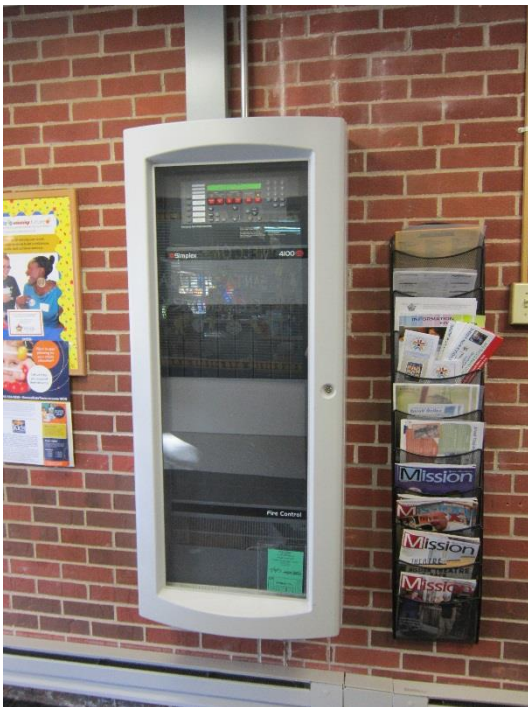
Updated fire alarm system
Capable of expansion to mass notification.

- Fire Alarm – Complete Replacement of all devices and control panels to support a mass notification system. Additional Smoke Detection may be required.

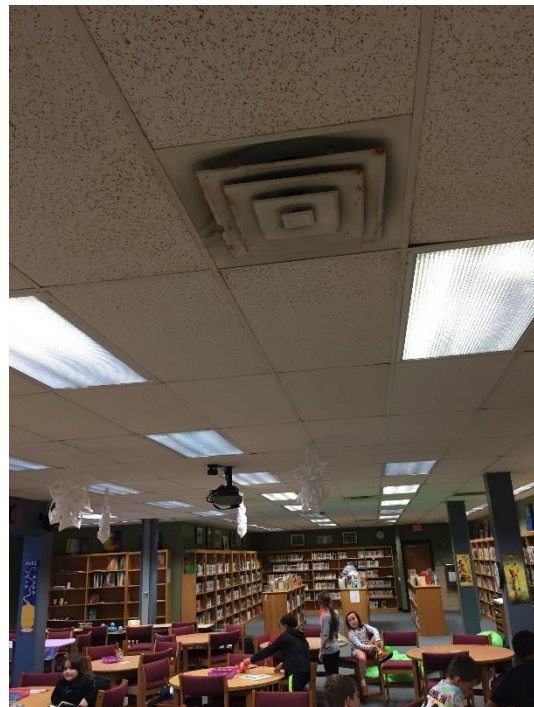
Supply diffuser rusting due to high humidity levels.

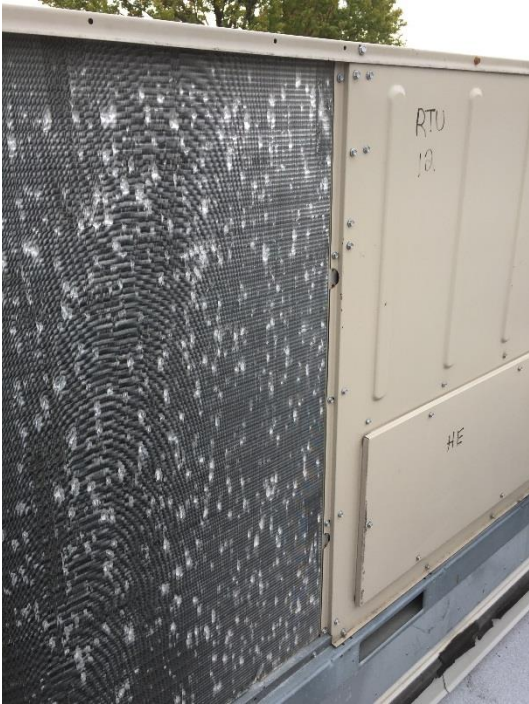
Damaged condenser coil fins.

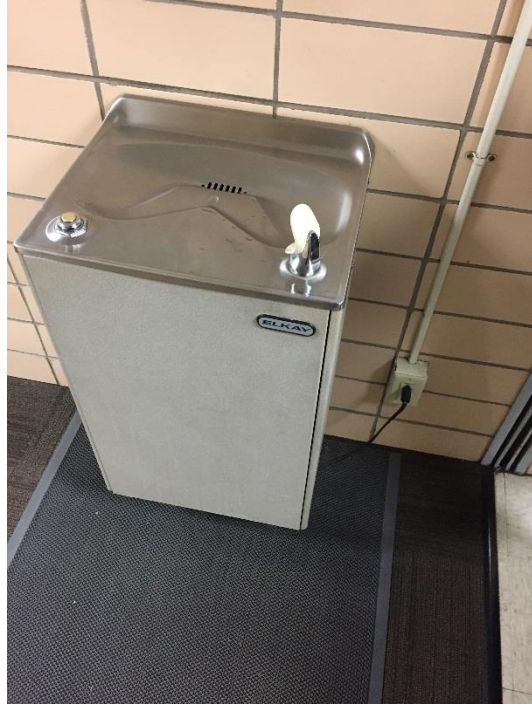
Non-ADA water cooler.

- Additional Updates required to bring systems up to current codes:
 - Several water coolers and plumbing fixtures are not ADA compliant and need to be replaced.

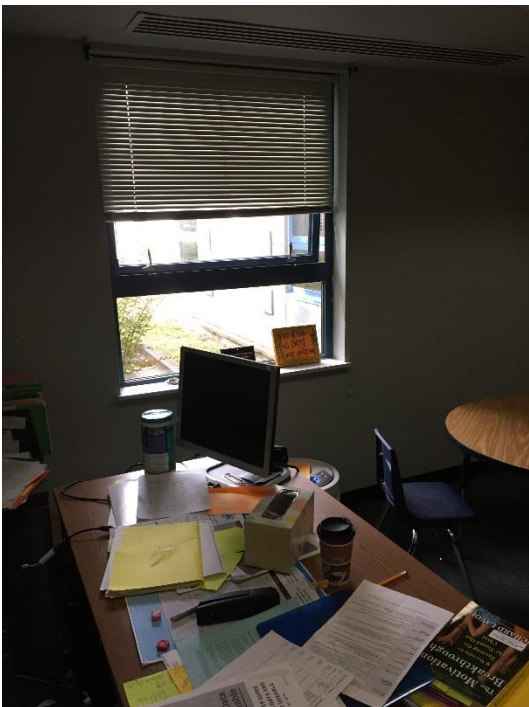
Operable window left open.

- The majority of the classrooms have operable windows. Operable windows make it difficult for the mechanical equipment to control humidity levels. With large amounts of untreated outside air, this may cause high humidity levels and can lead to moisture problems.

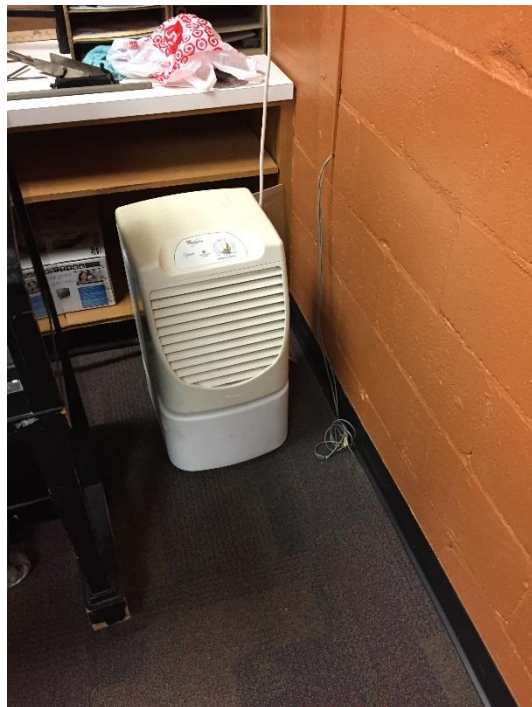
Portable dehumidifier.

- The majority of the classrooms had a portable dehumidifier in the space and some classrooms had ceiling tiles that appeared to be sagging most likely due to high humidity levels.
