Property Assessment Report

Westridge Middle School

9300 Nieman Rd, Overland Park, KS 66214

Evaluation - Westridge Middle School

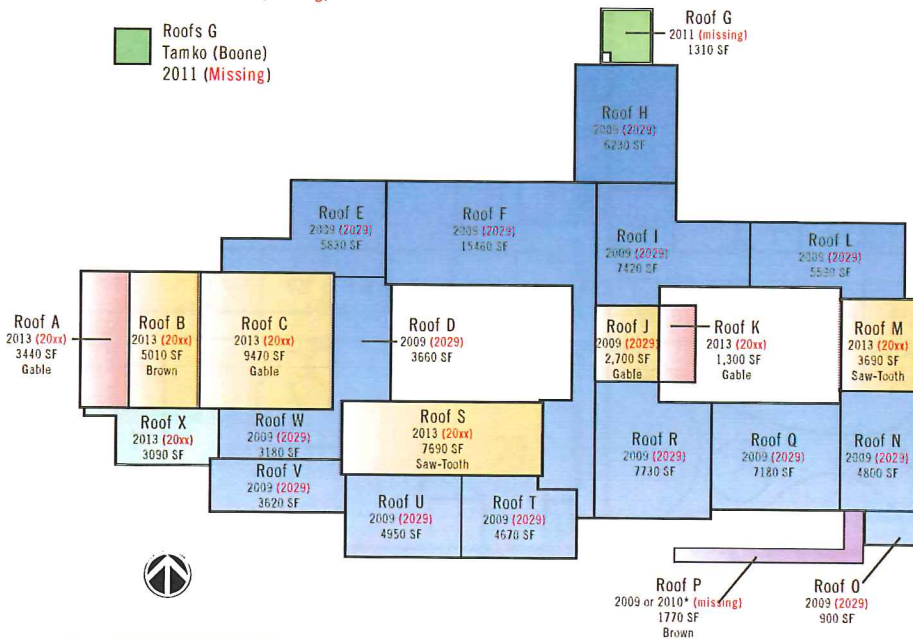
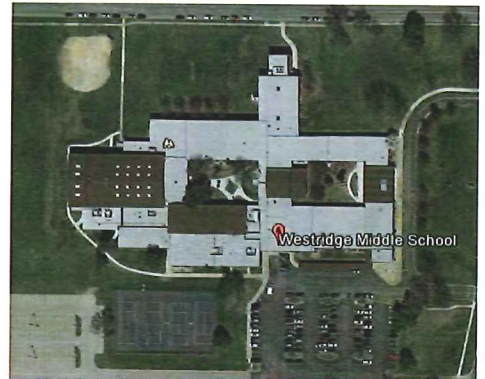
A1

White Roofs B,C,D,E,F,H,I,J,L,M,N,O,Q,R,S,T,U,V,W
Tamko 117FR M3 / 887 squares
Brown August 2009 (20 year) 2029

White Roofs A,K,X
Delta XXX
Brown 2013 (Missing) 20XX

Roof P
Tamko Brown
2008- 2010* (Missing)

Roofs G
Tamko (Boone)
2011 (Missing)

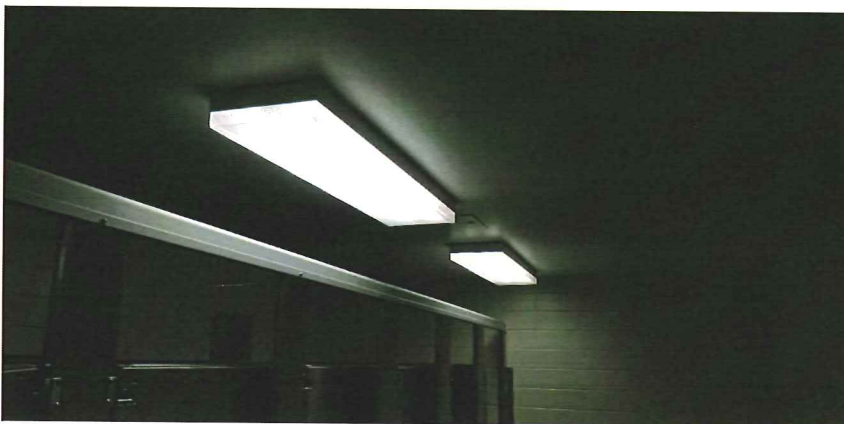
Bathroom ceilings

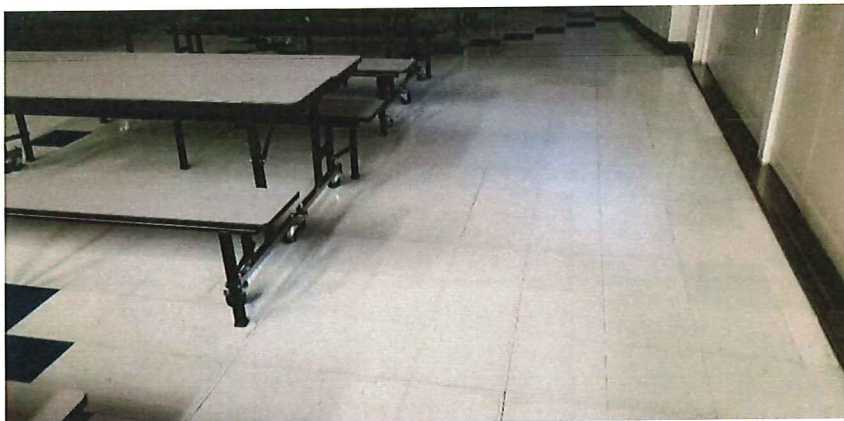
Floor tile

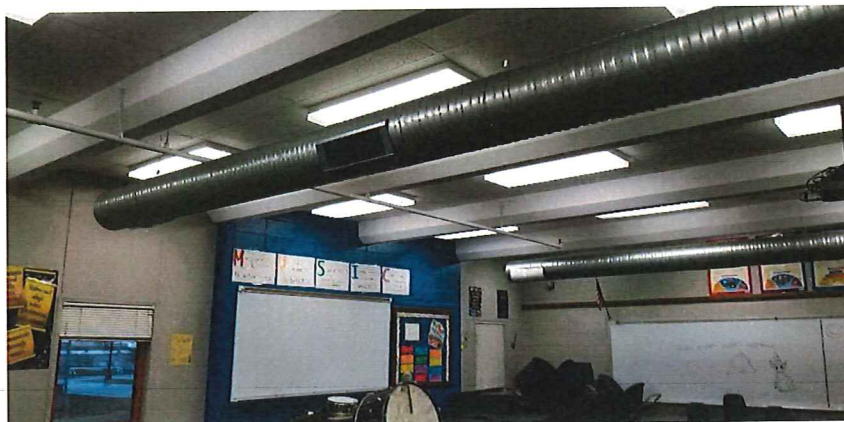
Classroom ceilings / lighting

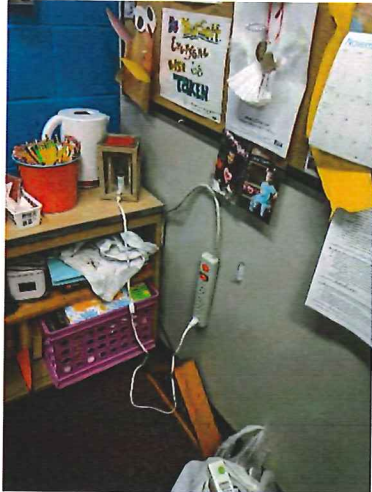
Power Strips

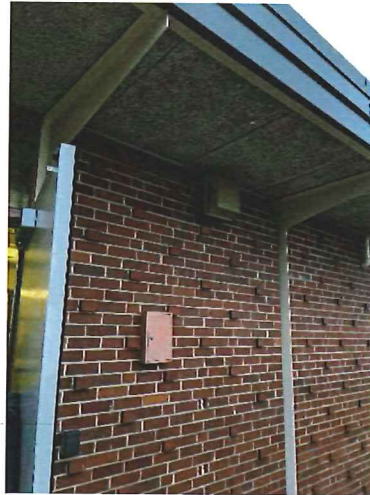
Exterior lighting

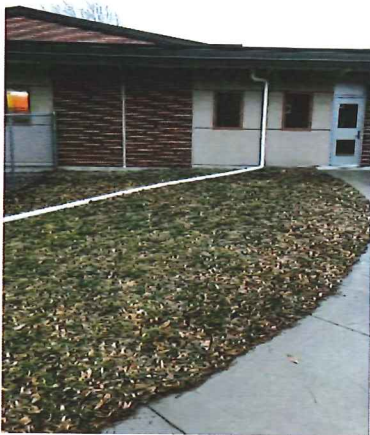
Roof Drainage

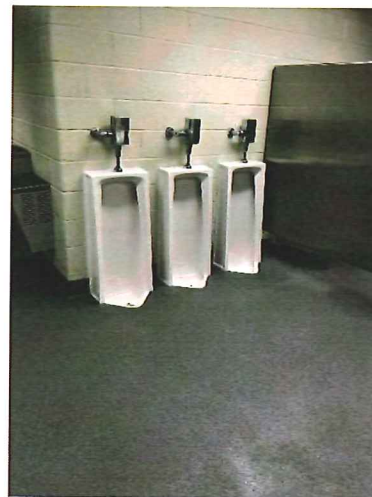
Urinals

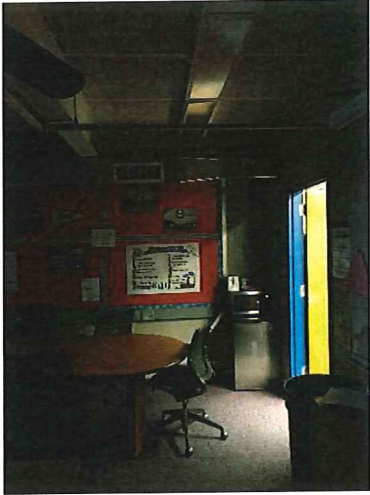
Exposed ductwork

- Not all classrooms have their own thermostat. 1 single zone rooftop unit may serve up to 4 classrooms.
- Some of rooftop units are ground mounted with exterior exposed ductwork.

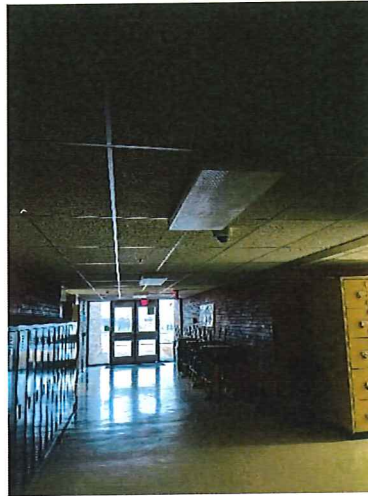
Surface lighting
