SHAWNEE MISSION HORIZONS HIGH SCHOOL

# **FACILITY EVALUATION**

# SUMMARY

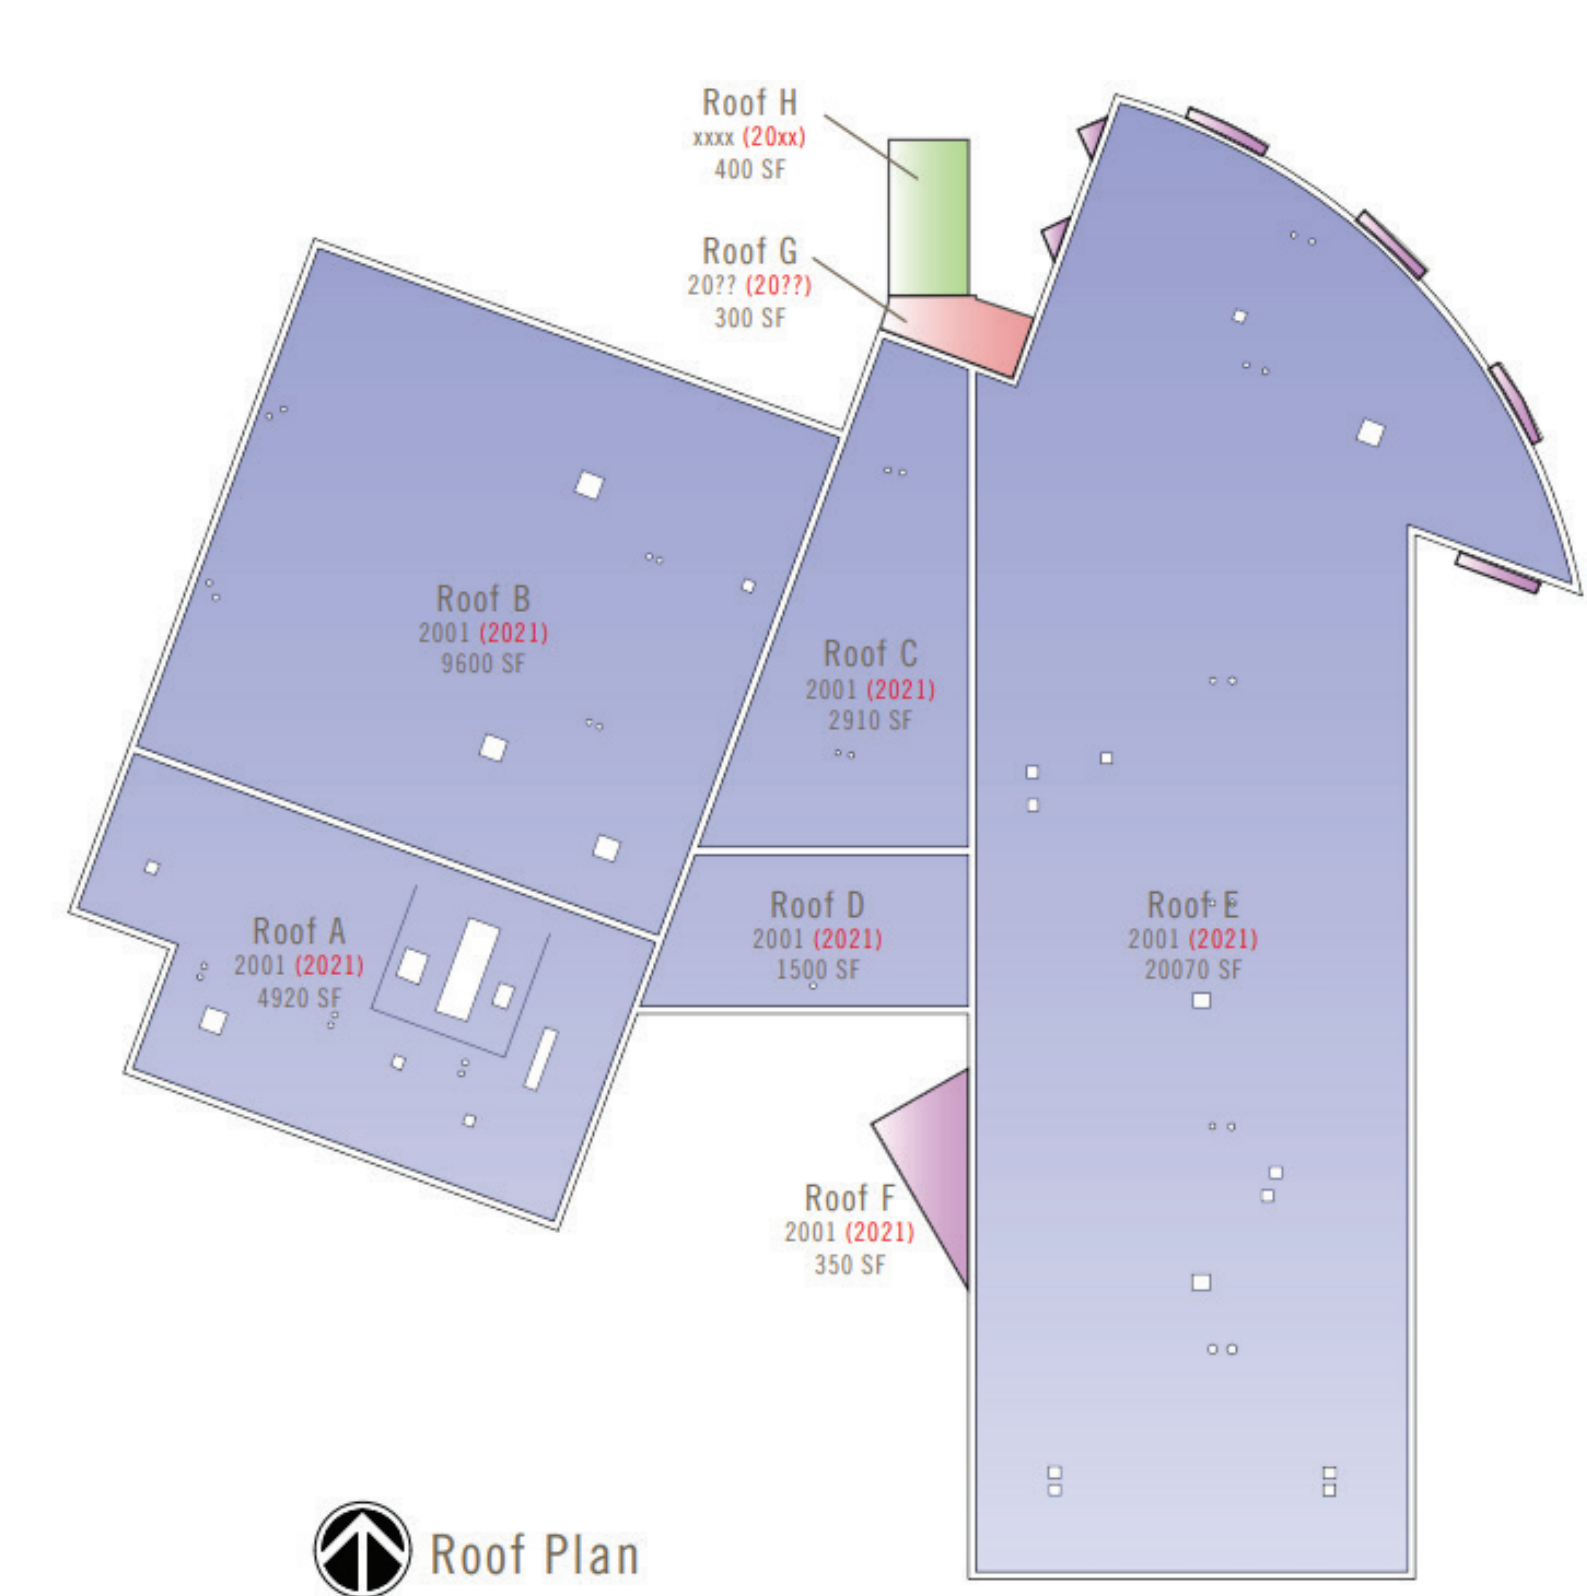
ROOF ASSESSMENT

- Roof Areas**
- Canopy Roof H  
SBS Mod. Bit. Membrane  
2011-2013 (Missing)
  - Roofs A,B,C,D,E  
Tamko 103FR / 394 sq.  
April 2001 (20 year) 2021
  - Roofs G  
Tamko 103FR  
2011-2013 (Missing)
  - Roofs F  
Standing Seam Metal Roof  
2001 (20 year) 2021

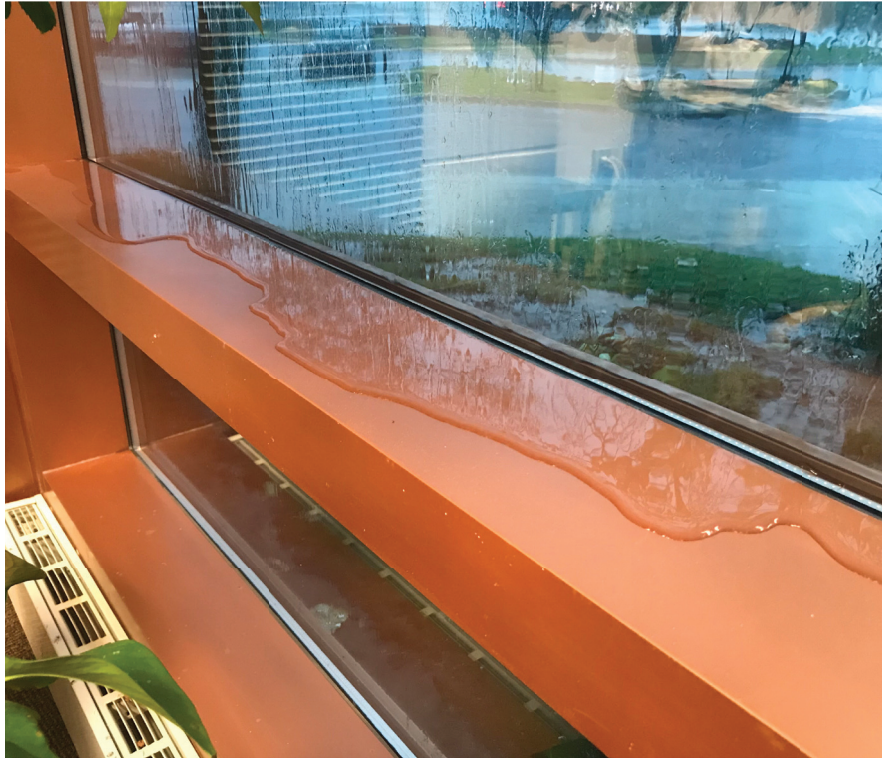
Projection windows have been a constant leaking issue.

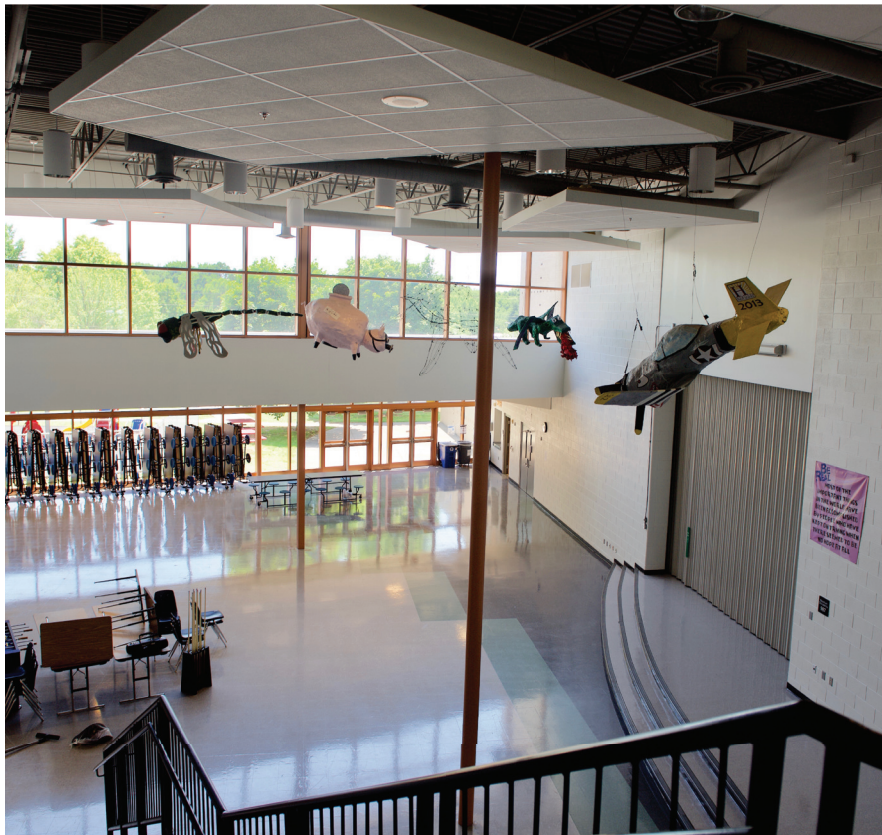
Common space is below the front entrance level. Stage is rarely used. Bright and open space.

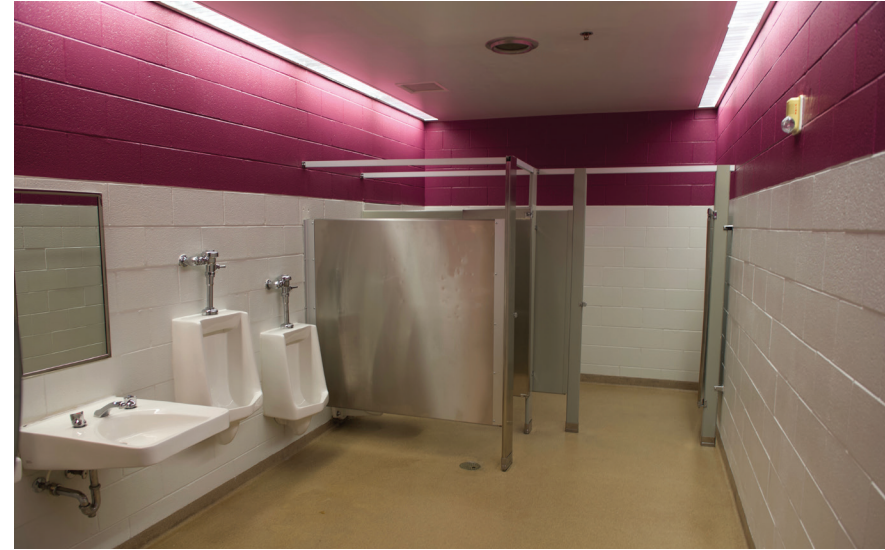
Toilet fixtures and partitions are in good shape and well maintained.

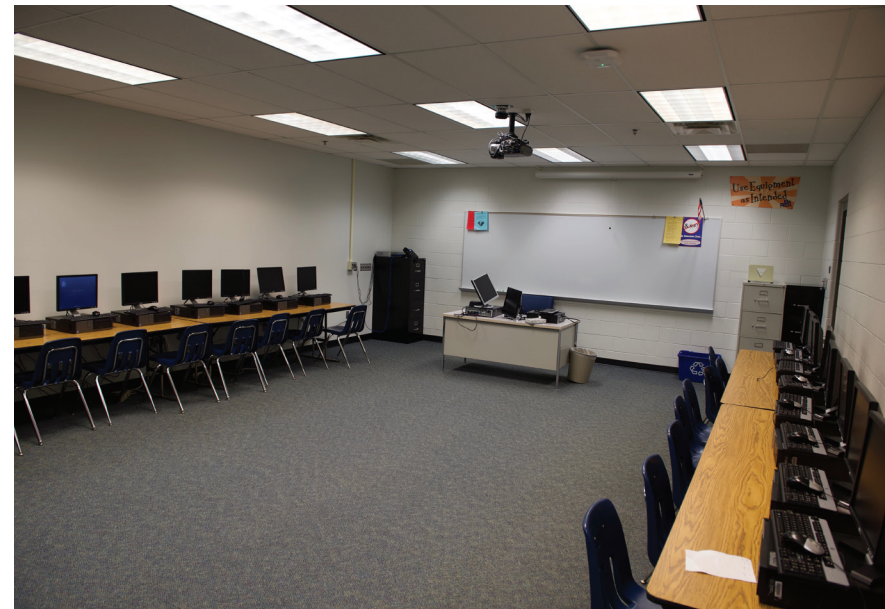
Computer lab is dark and lacks a sense of place, updated furniture and layout would improve the space.

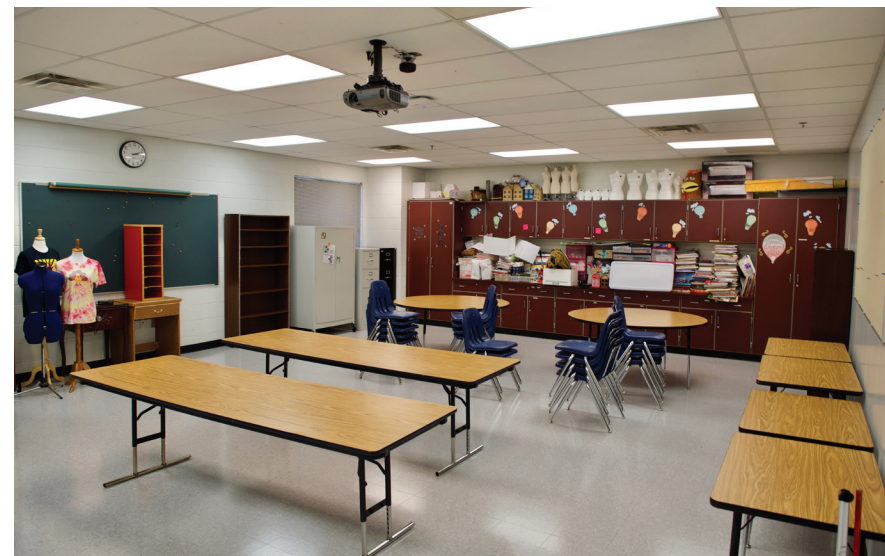
Classroom is adequately sized and has a variety of types of furniture.

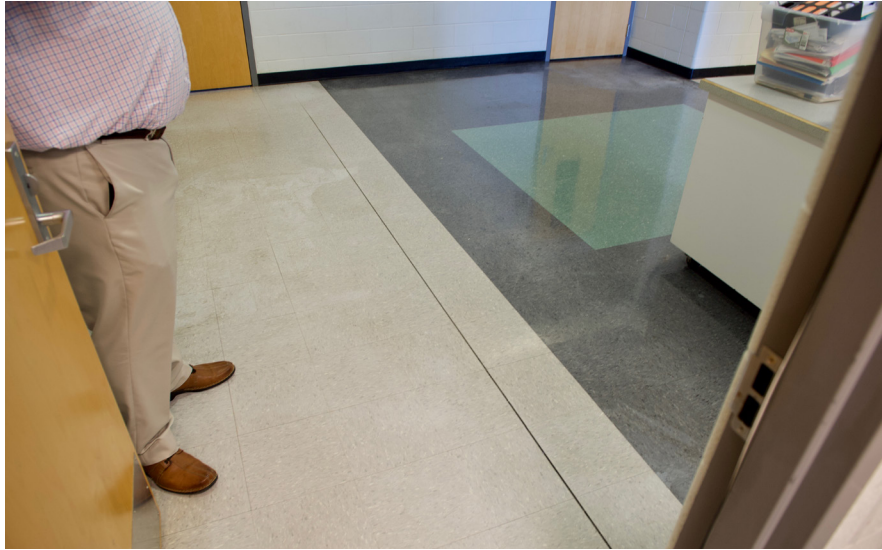
Separation in the floor tiles in this location may indicate movement in the structure or an expansion joint.

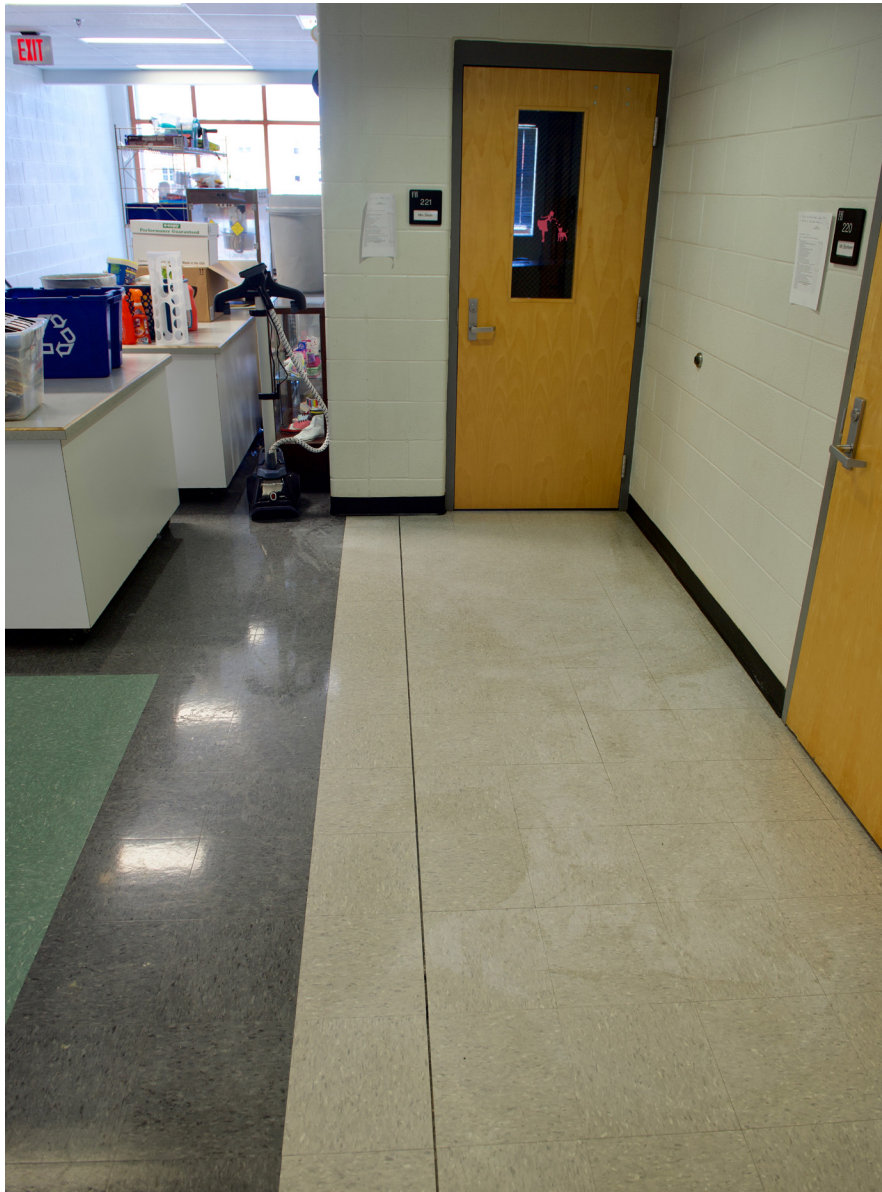
Separation in the floor tiles in this location may indicate movement in the structure or an expansion joint.

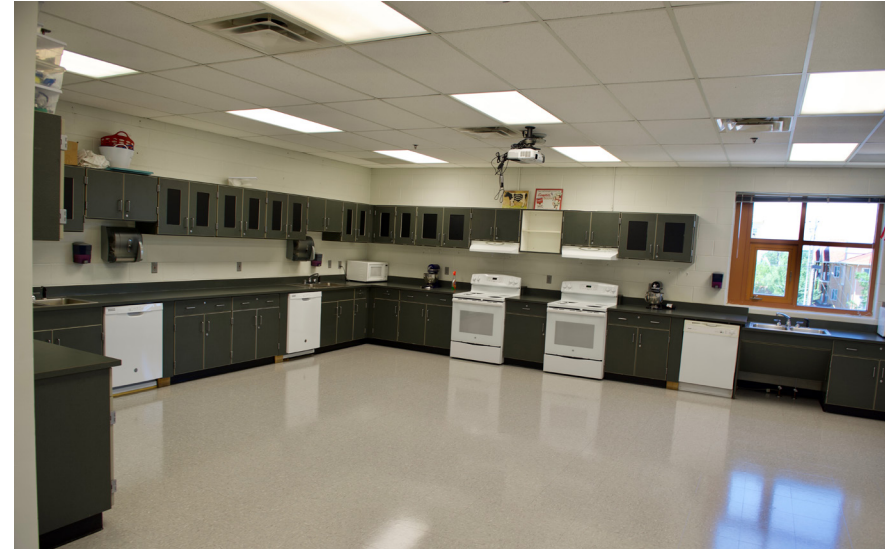
FACS Classroom is large and well lit. ADA station is provided.

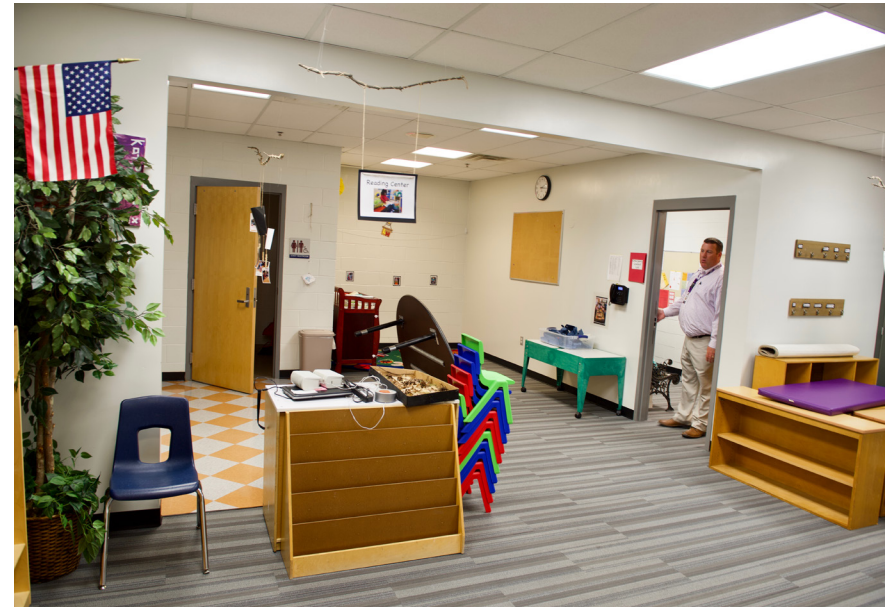
Early Childhood needs a secure direct entrance.

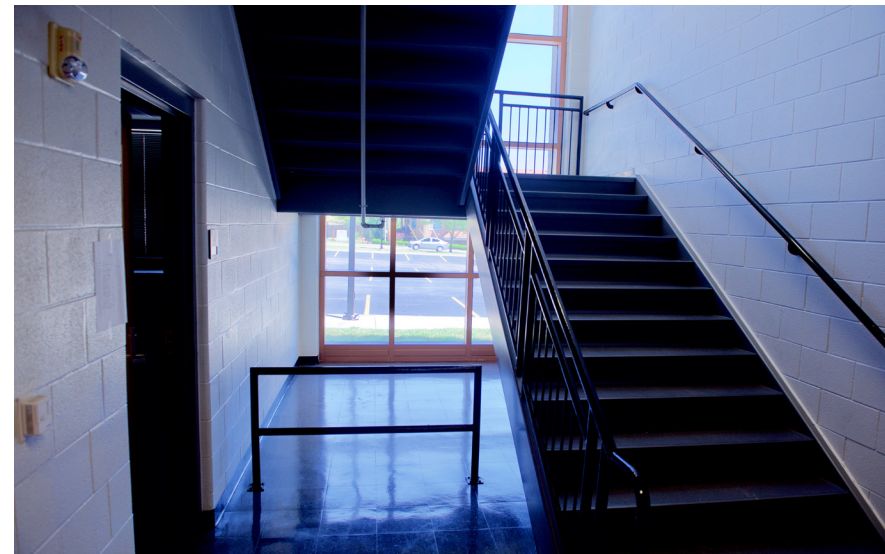
Stair design doesn't allow for access to the east parking lot.

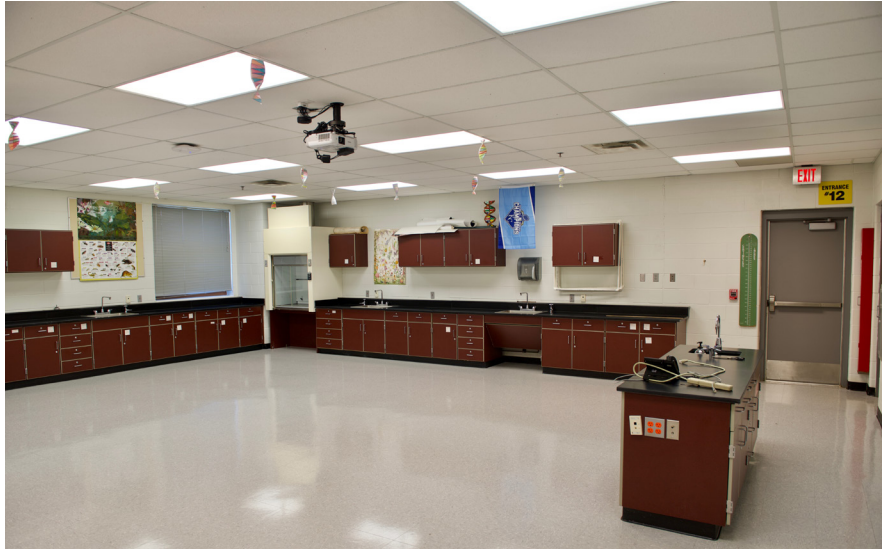
Science rooms are adequately sized and equipped.

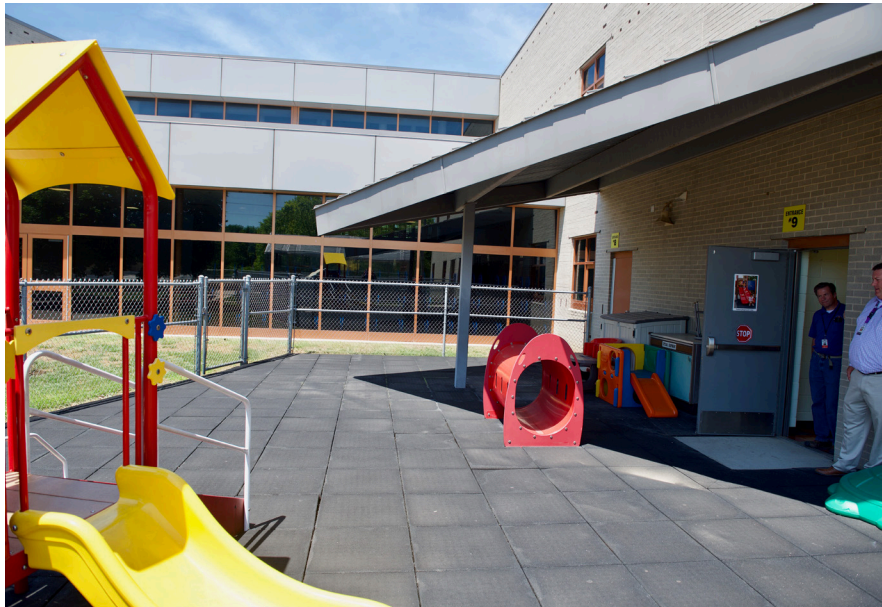
Early Childhood play area is across the corridor from the classroom and is open to the main common space.

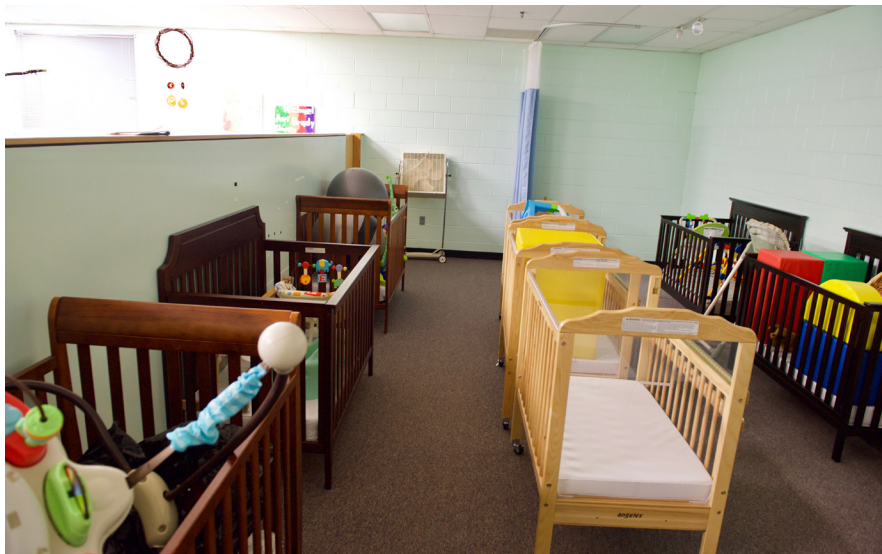
Early Childhood cribs are behind a half height wall for privacy but allows for observation.

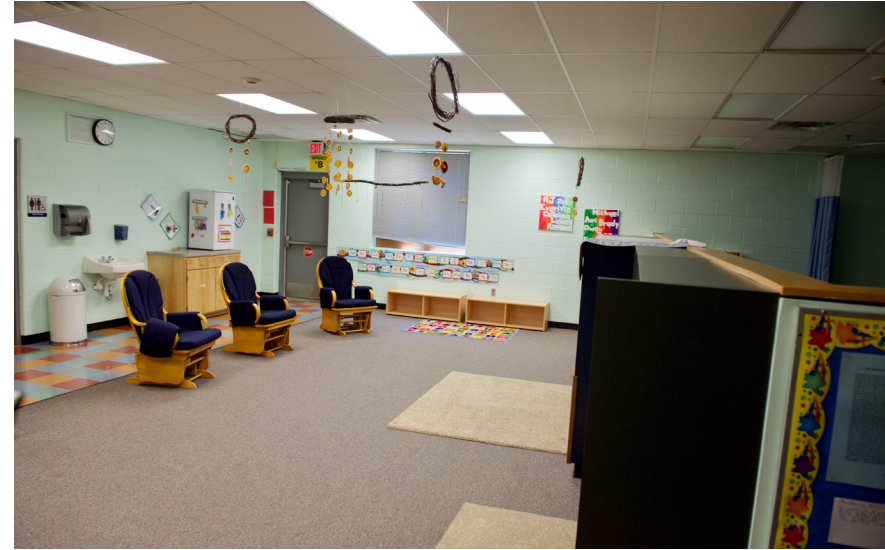
Other side of early childhood crib room with feeding chairs.

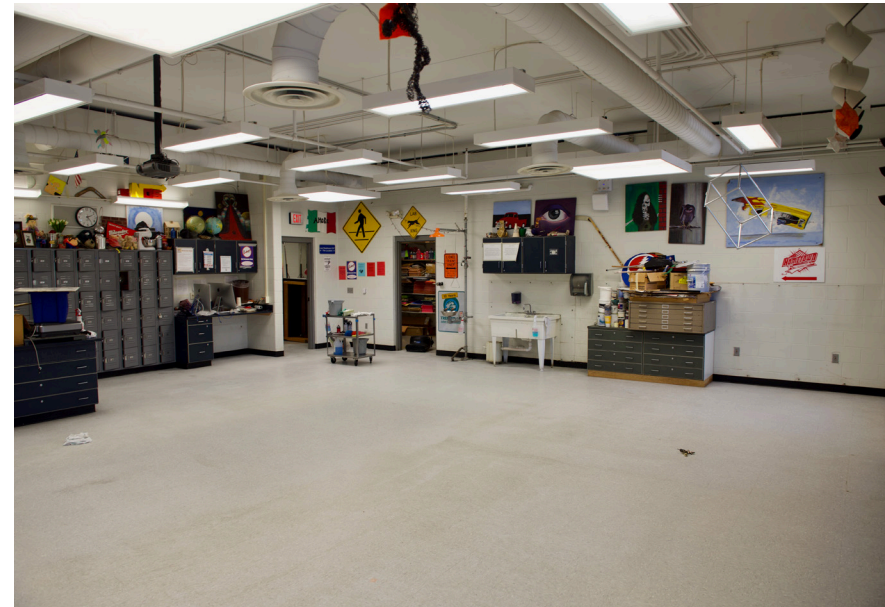
Art room is adequately sized and equipped.

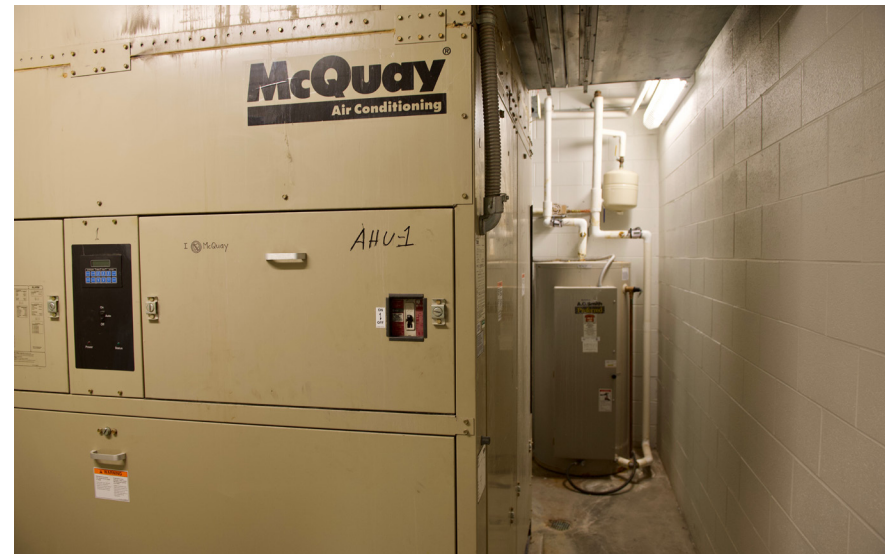
Mechanical system is in good shape but cooling tower has issues with shutting down that should be addressed.

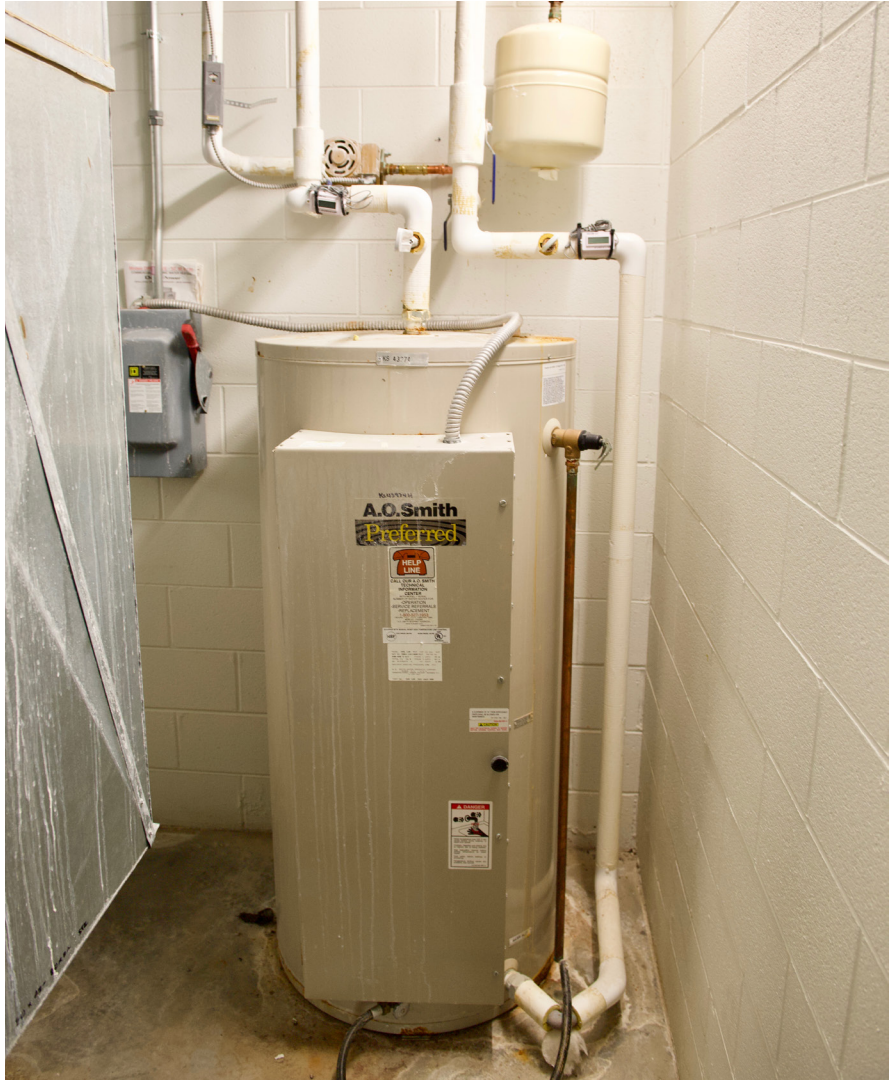
Hot water tanks may be nearing end of life.

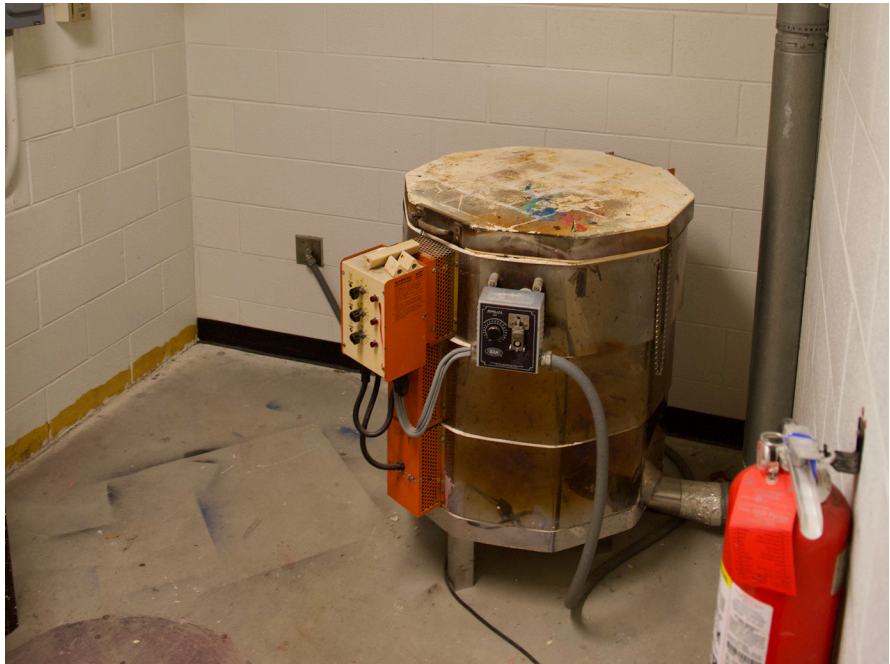
Art Room Kiln room is properly ventilated and adequately sized.

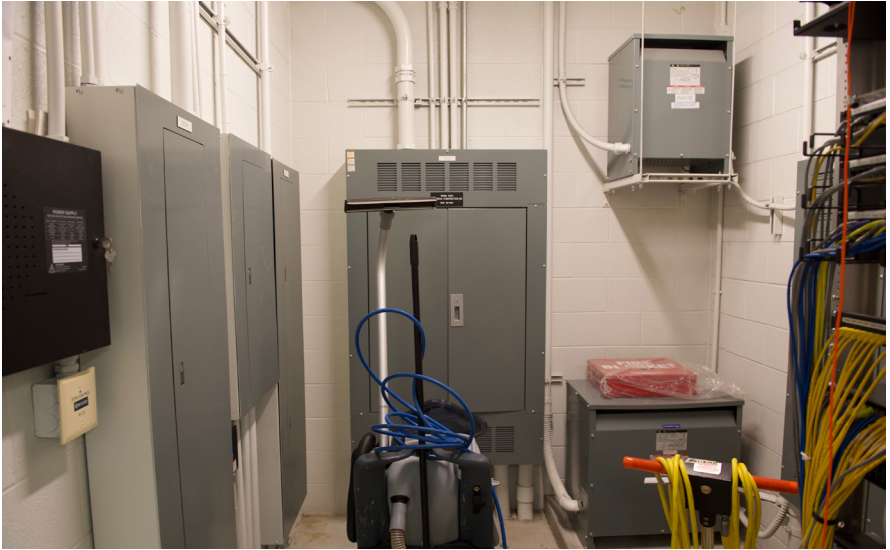
Electrical and Data share same room, no security for data.

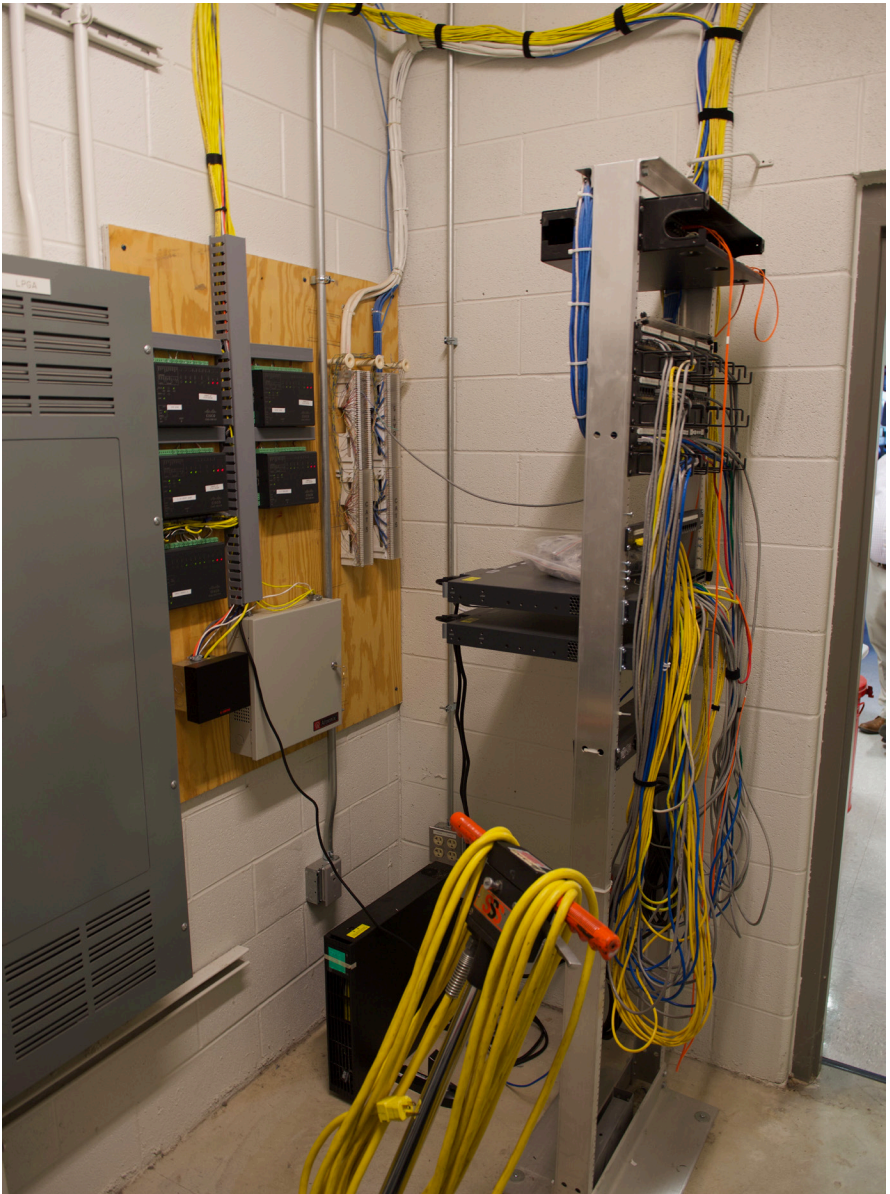
Data Rack and Phone patch board.

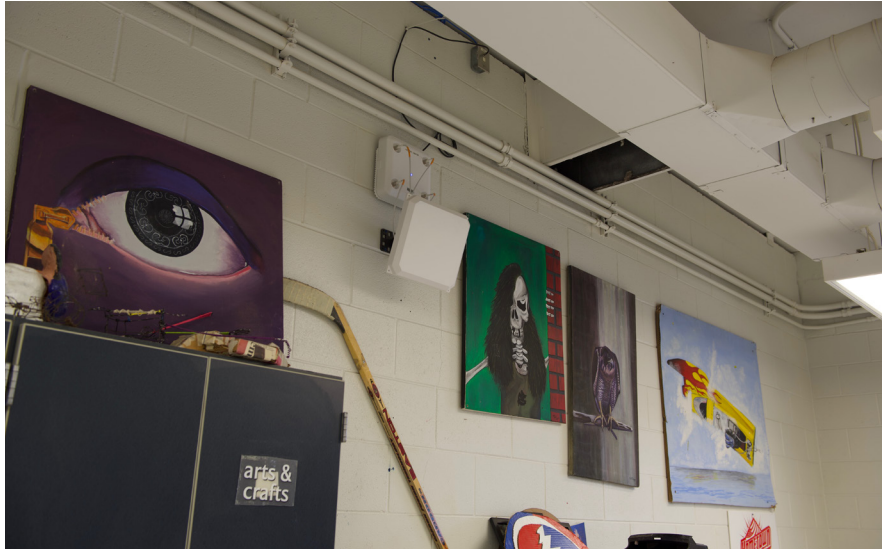
Wifi Network goes off line and has blind spots in the building.

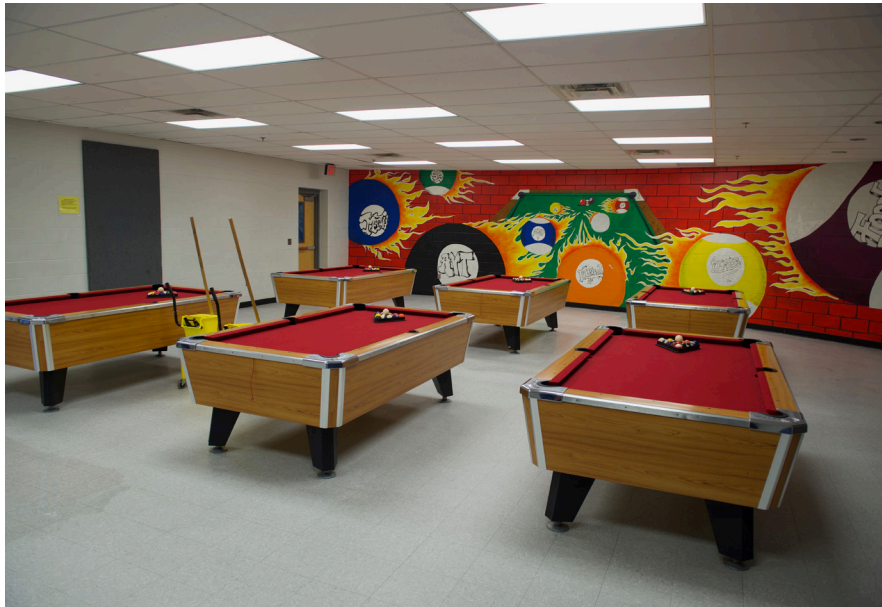
Student Recreation room is in good shape and size.

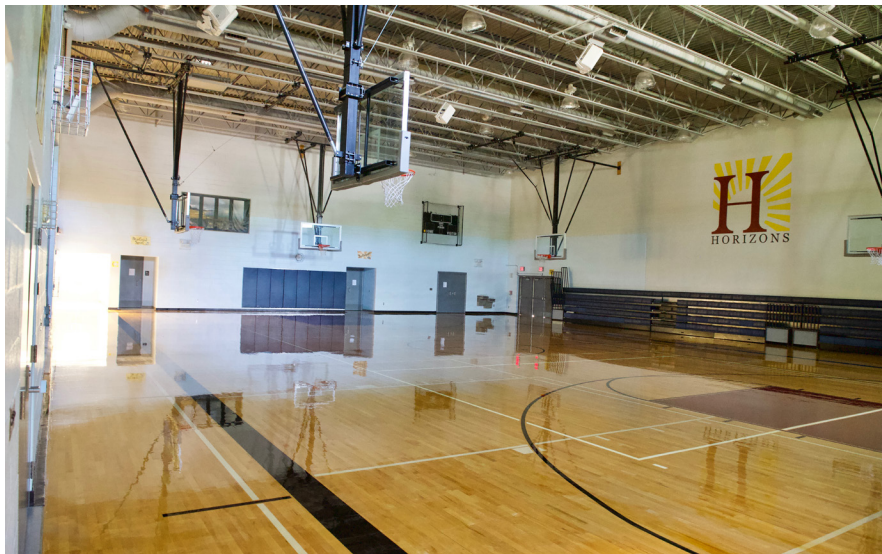
Gymnasium is adequately sized and in good shape. Bleachers are large enough for events being held. Floor was recently refinished.

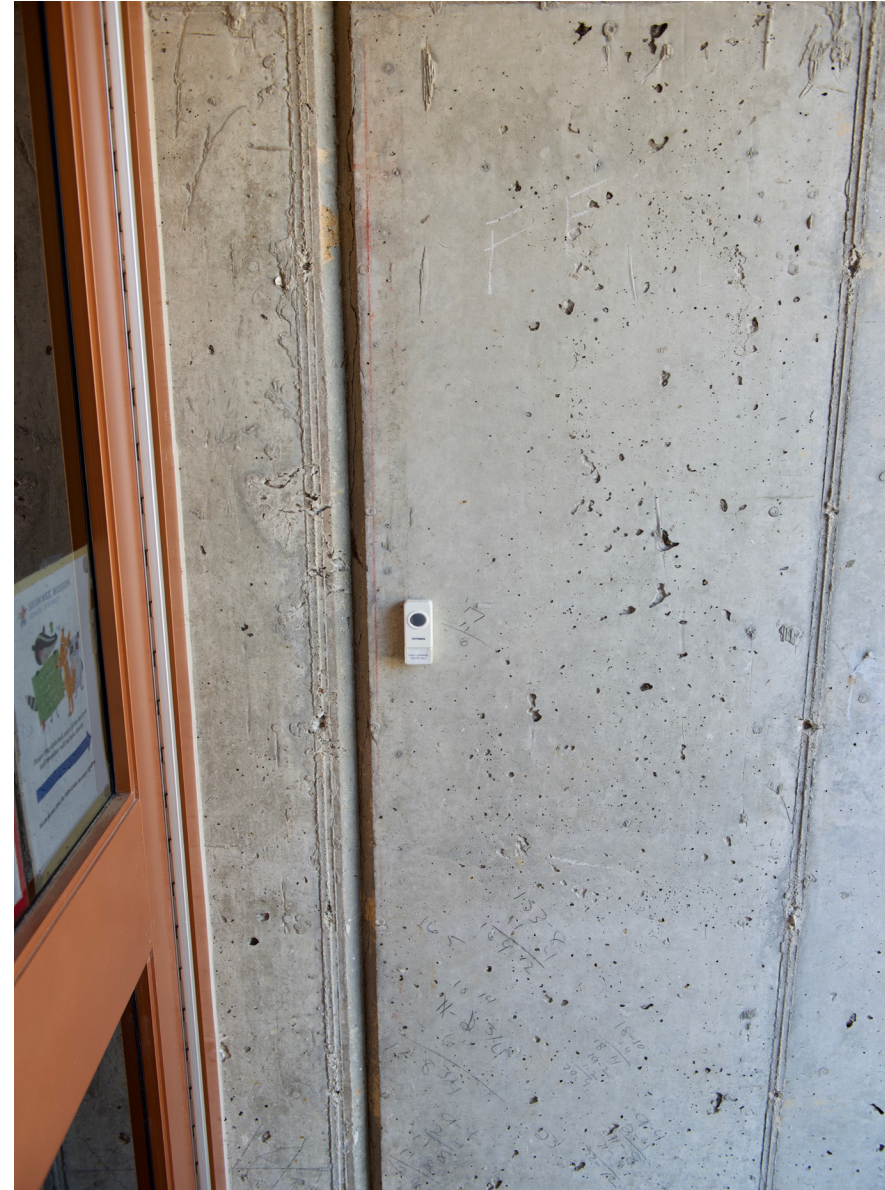
East parking lot (student & early childhood) entrance is not well monitored and students open the doors for visitors or other students.

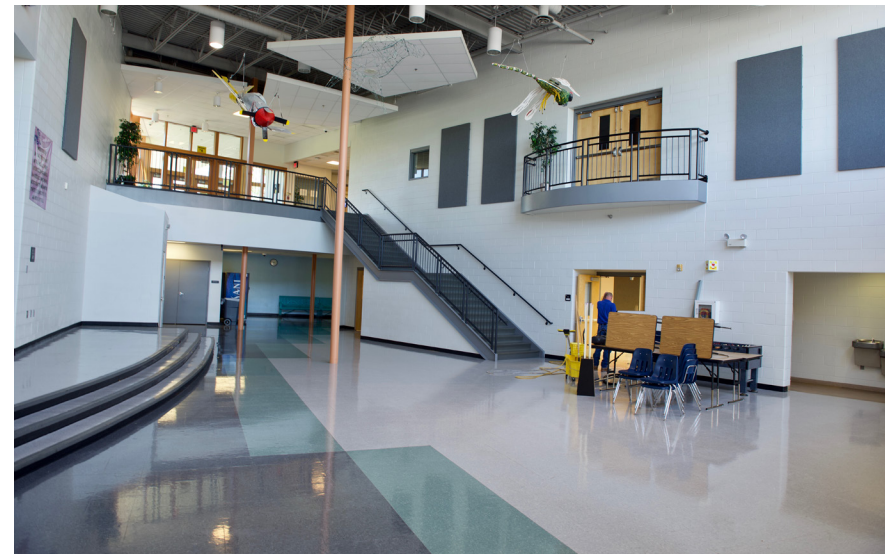
Commons space with little used stage and unneeded balcony from the teachers lounge.

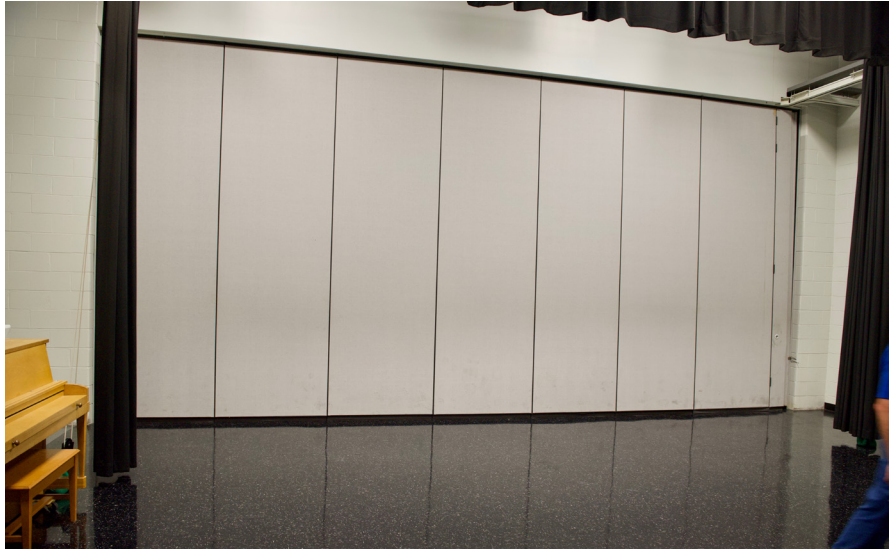
Doors from stage to cafeteria are rarely used.

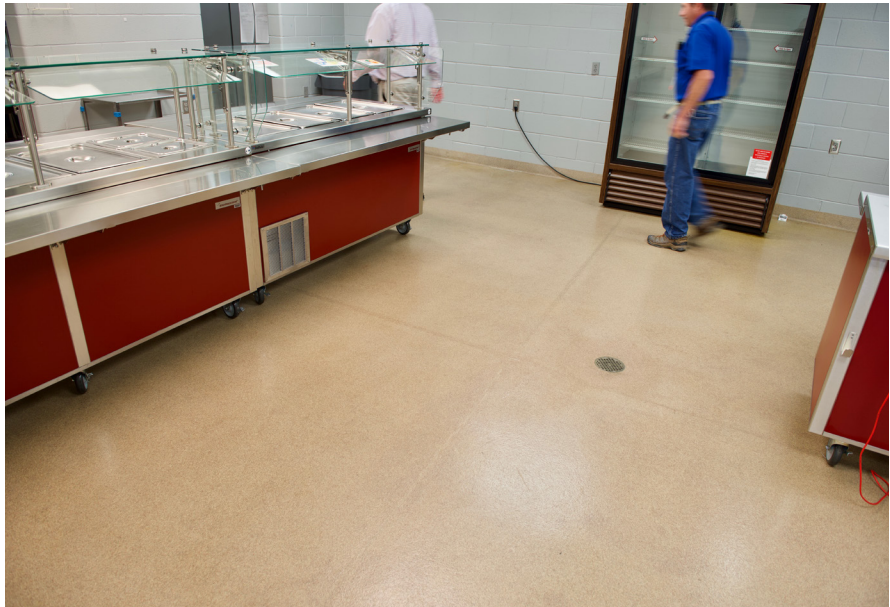
Kitchen floor is in good shape, but controls joints do telegraph through and should be monitored for potential failure in the future.

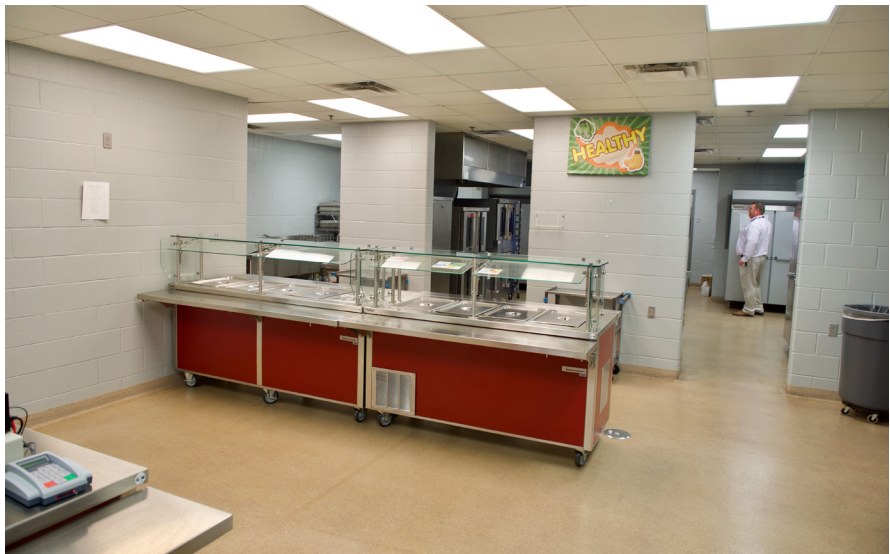
Kitchen and scramble are adequately sized and equipped.

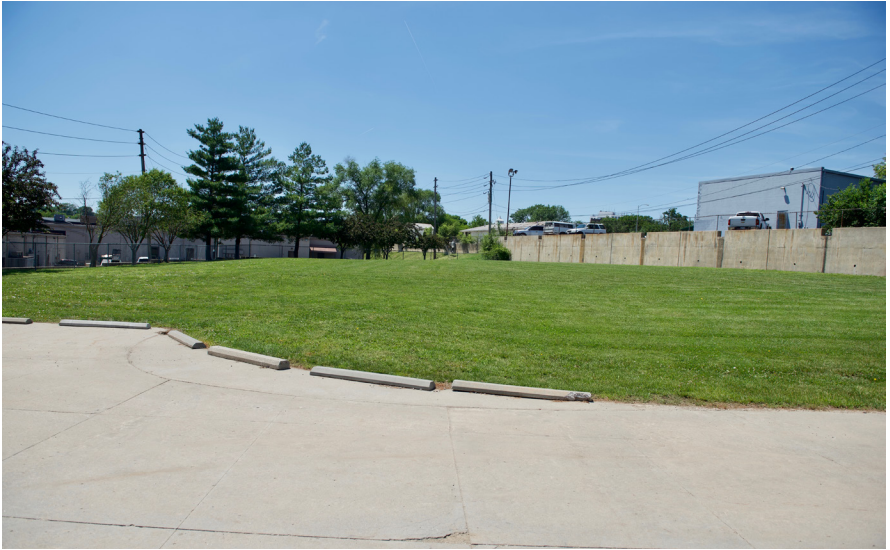
Play area for students, no backstop or other defined playing fields.

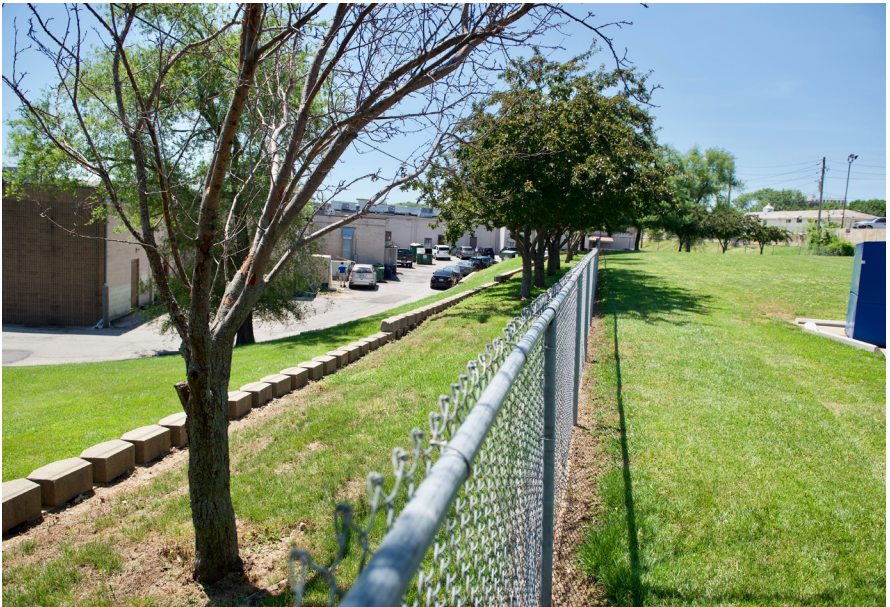
Steep slope beyond fence is difficult to mow and maintain.

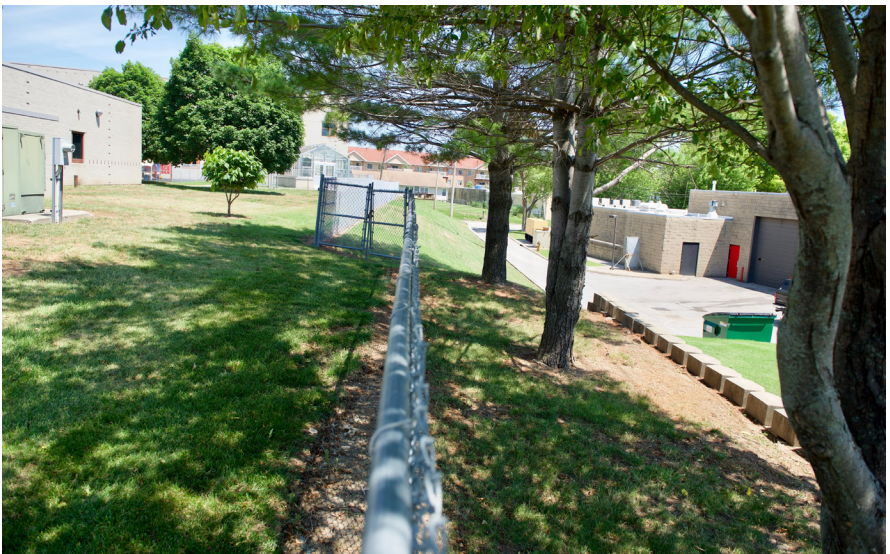
Steep slope beyond fence is difficult to mow and maintain.

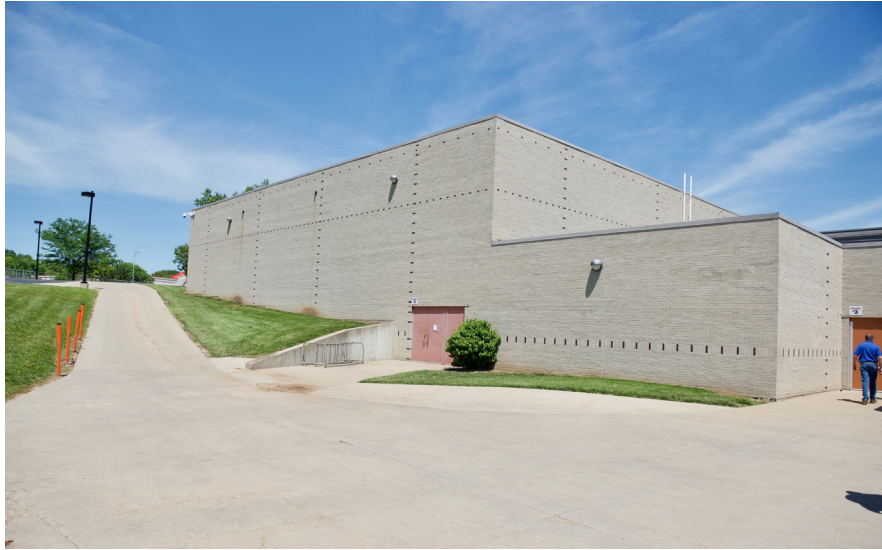
West service drive, Building exterior in good condition.

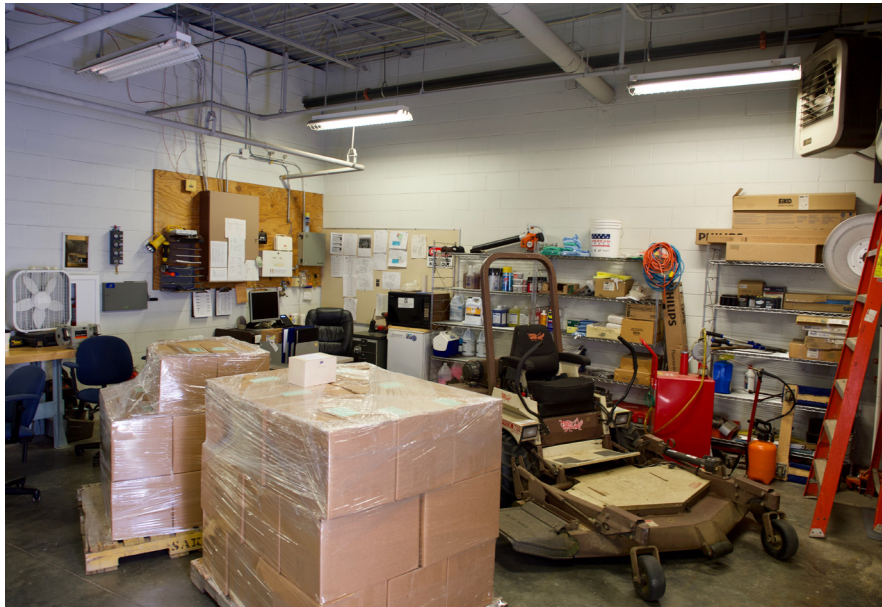
Janitorial storage and receiving is a little tight.

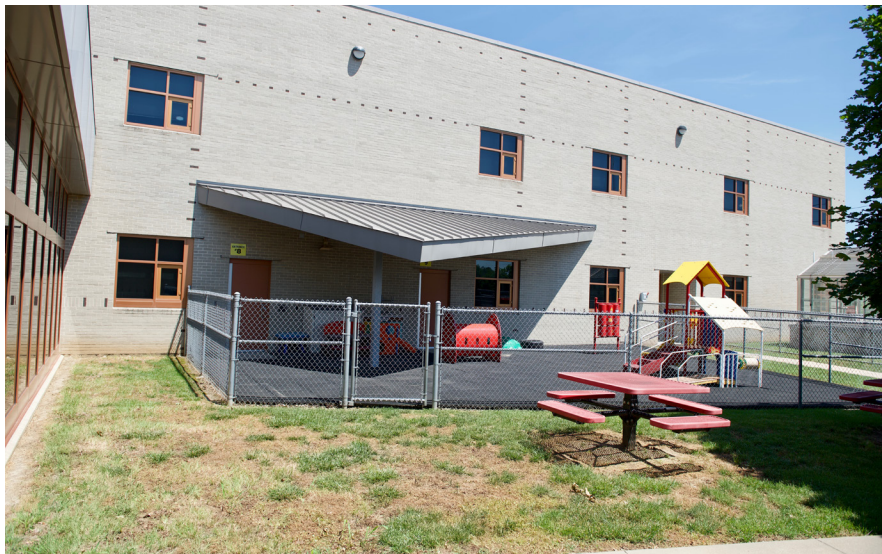
Early childhood playground is protected from the general public's view but does impact the space available for high school students outside of the commons.
