SHAWNEE MISSION HORIZONS HIGH SCHOOL

# **FACILITY EVALUATION**

# SUMMARY

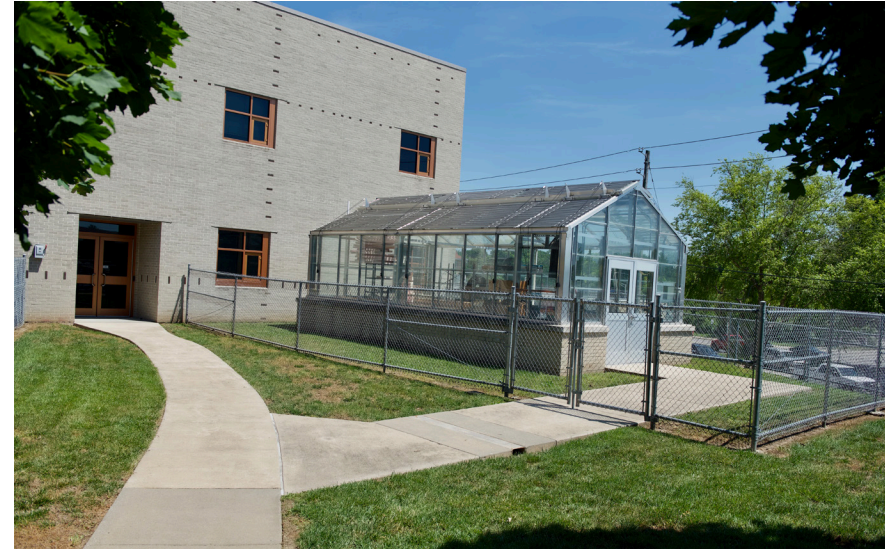
Greenhouse is rarely used and the controls need to be updated.

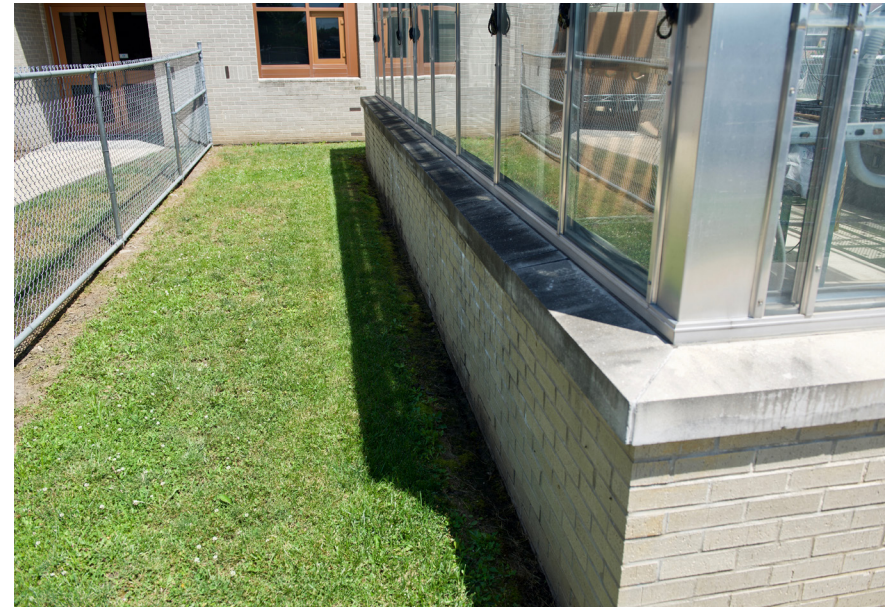
Some staining of the cast stone on the north elevation of the greenhouse.

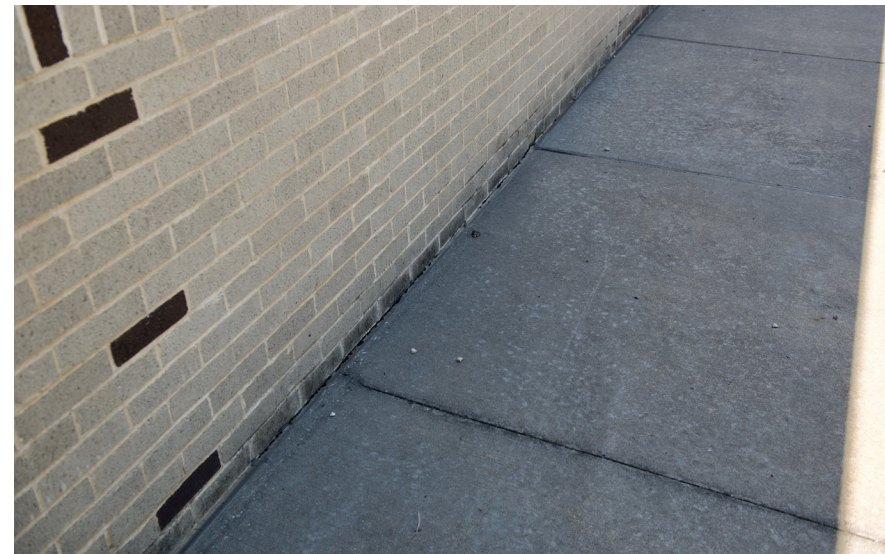
Some staining at the lowest brick along the sidewalk outside the common space.

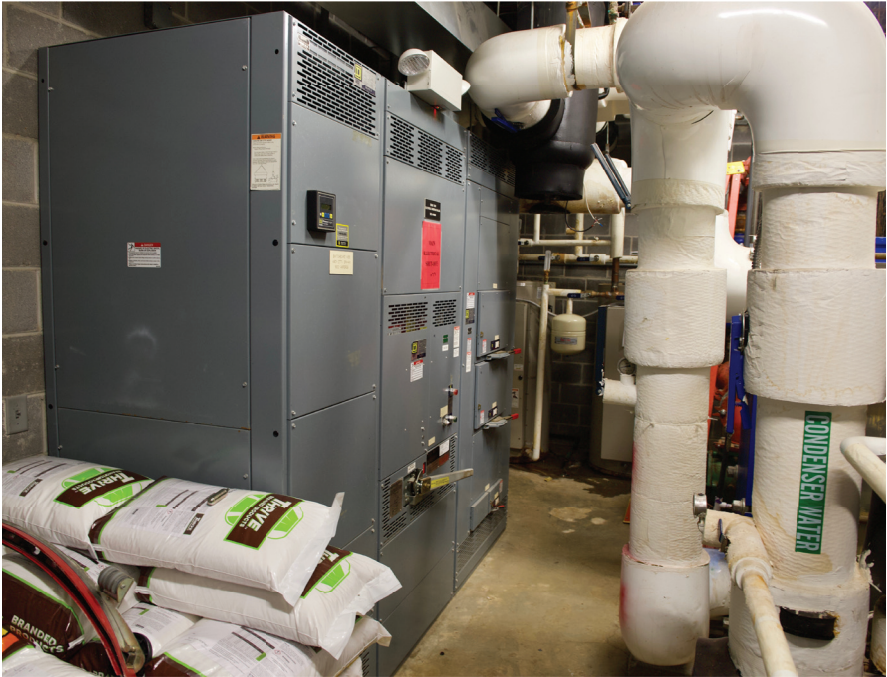
Electrical service is adequately sized and in good condition.

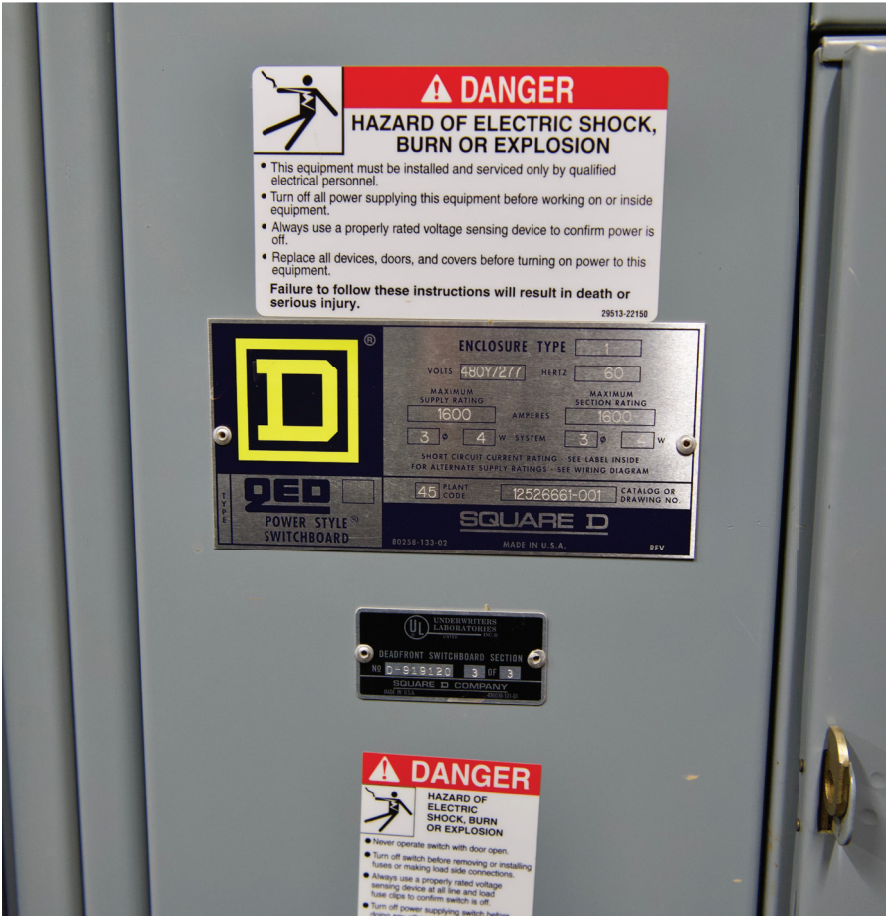
Electrical service is adequately sized and in good condition.

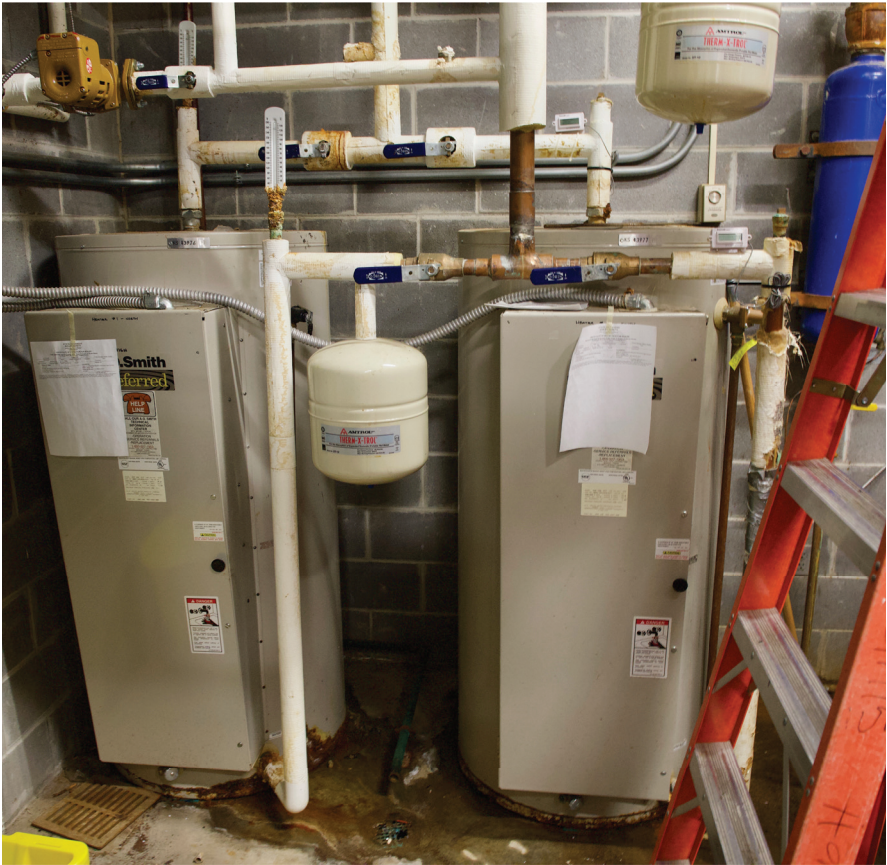
Boilers are in decent shape but may be nearing end of life in the next decade.

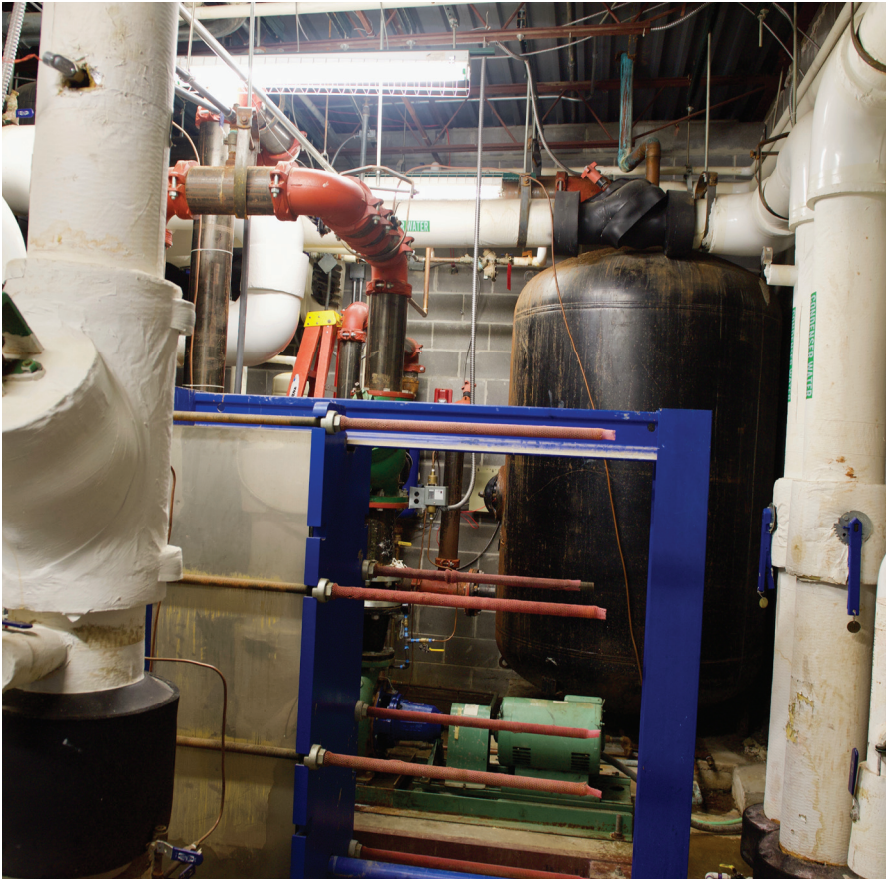
Cooling tower tank has a leak.
