Property Assessment Report

Trailridge Middle School

7500 Quivira Rd, Shawnee, KS 66216

Evaluation - Trailridge Middle School

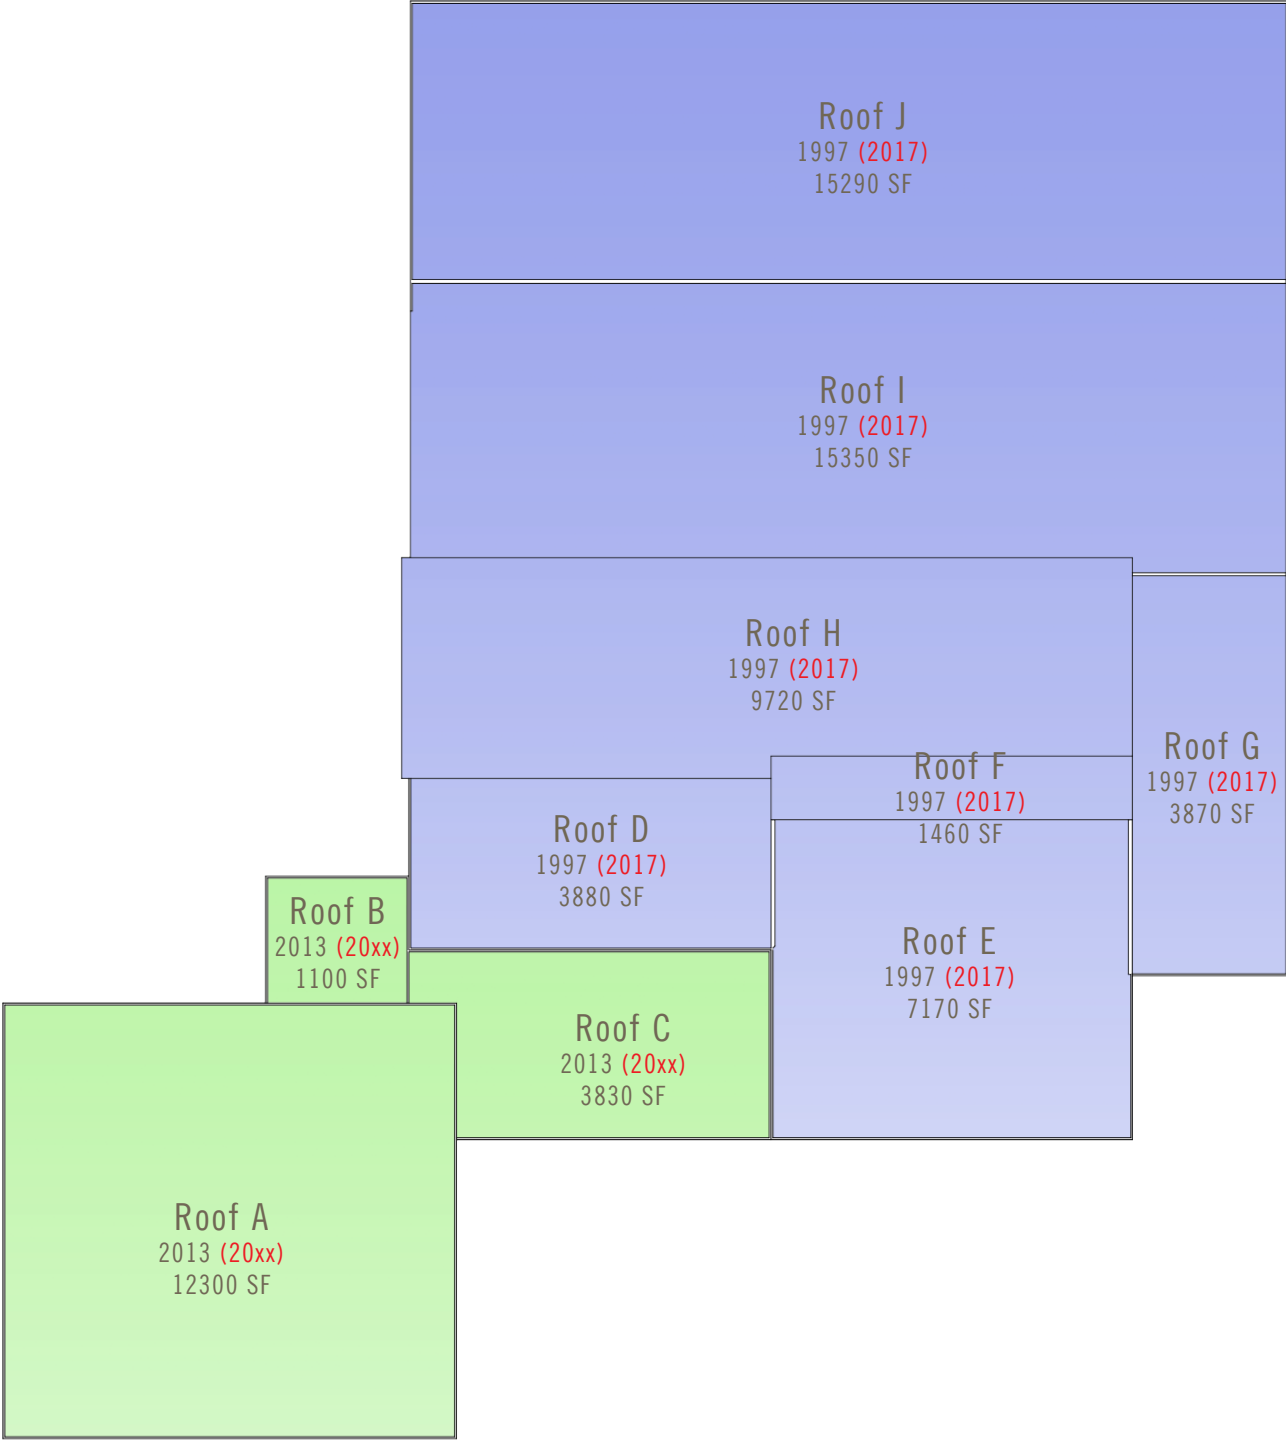
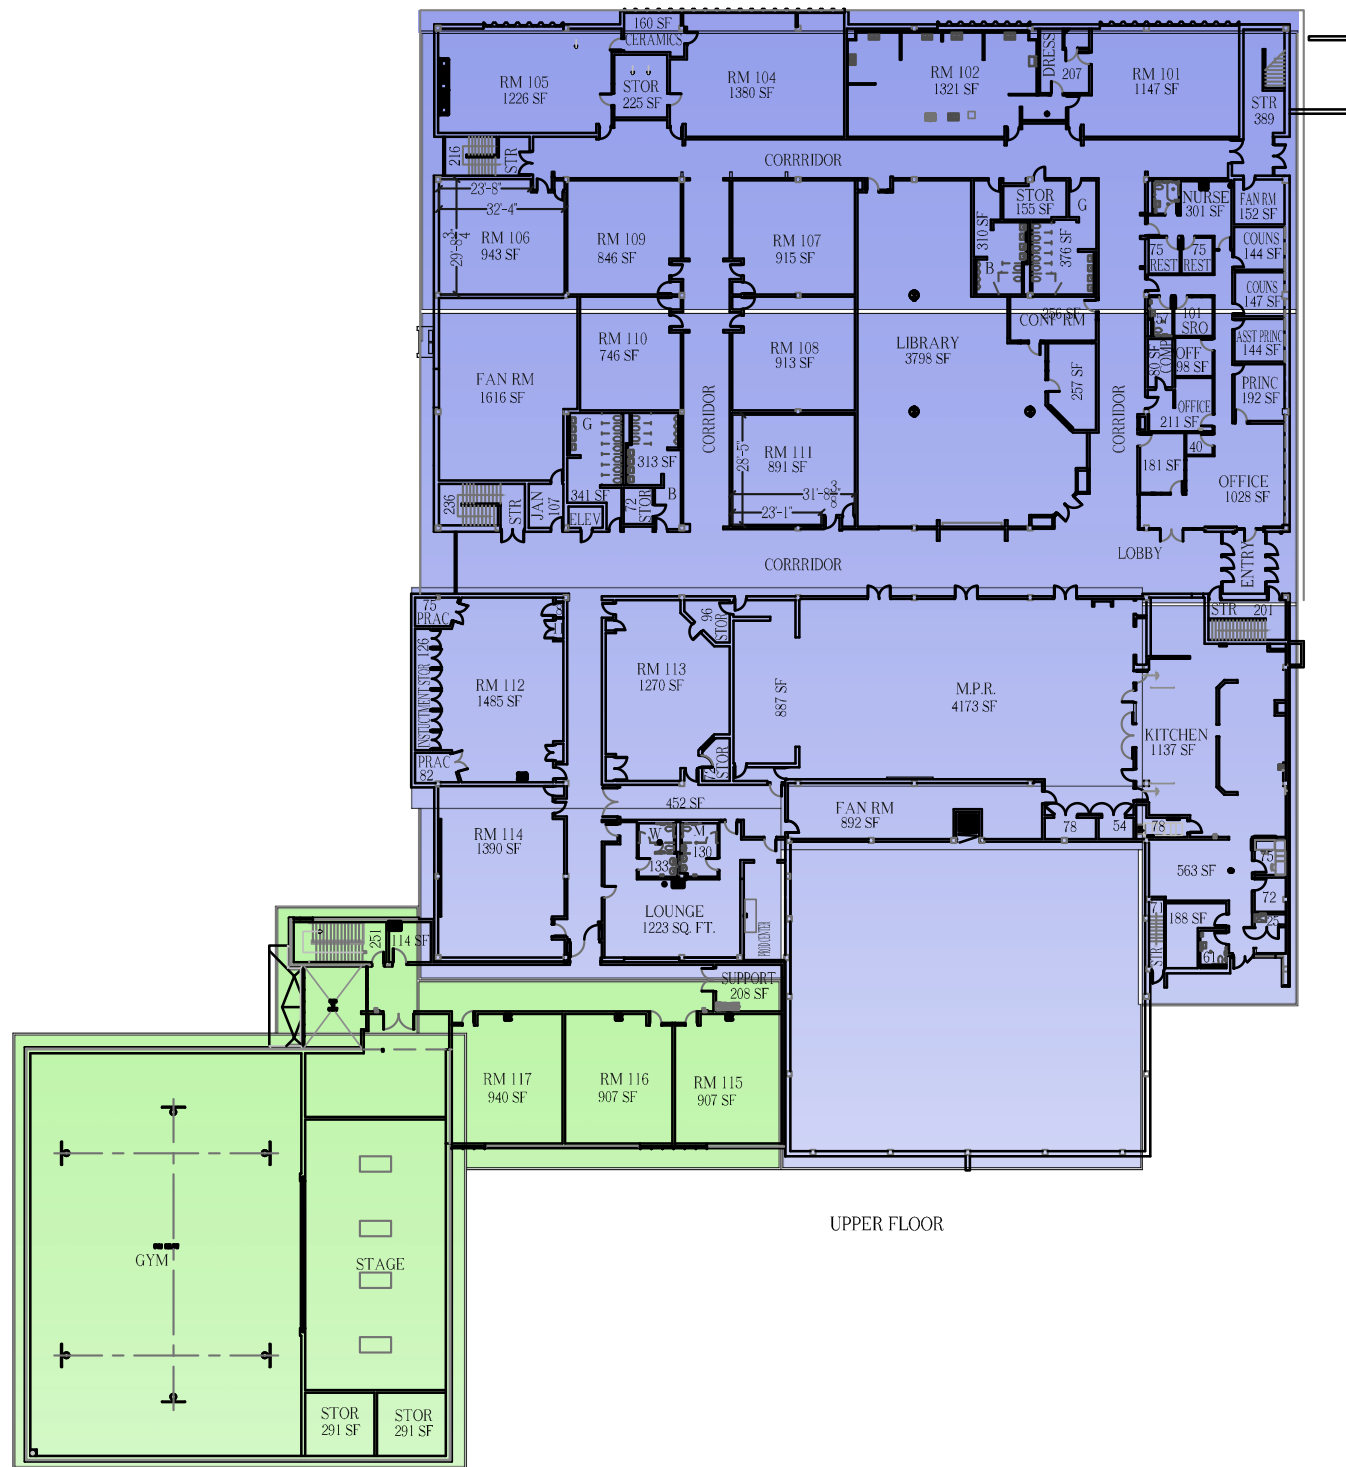
Roof Plan

- Roofs D,E,F,G,H,I,J
Tamko 103 / 622 squares
August 1997 (20 year) 2017
- Roofs A,B,C
GAF
2013 (Missing)

- Roofs D,E,F,G,H,I,J
Tamko 103
August 1997 (20 year) 2017
- Roofs A,B,C
GAF
2013 (Missing)

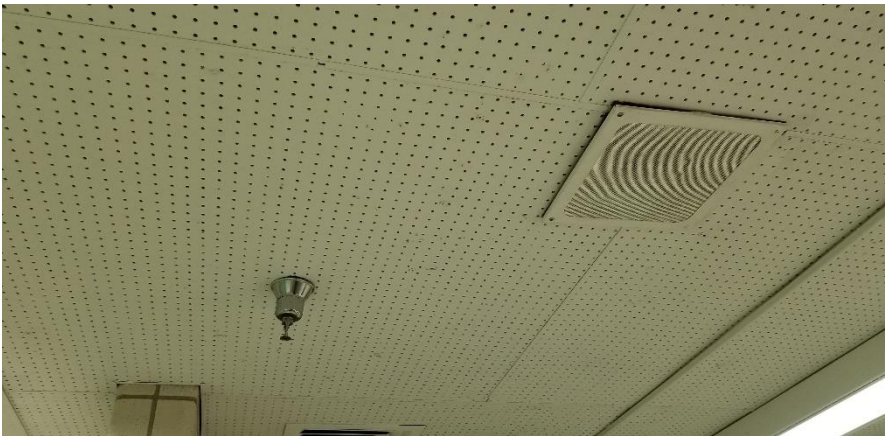
Bathroom ceilings

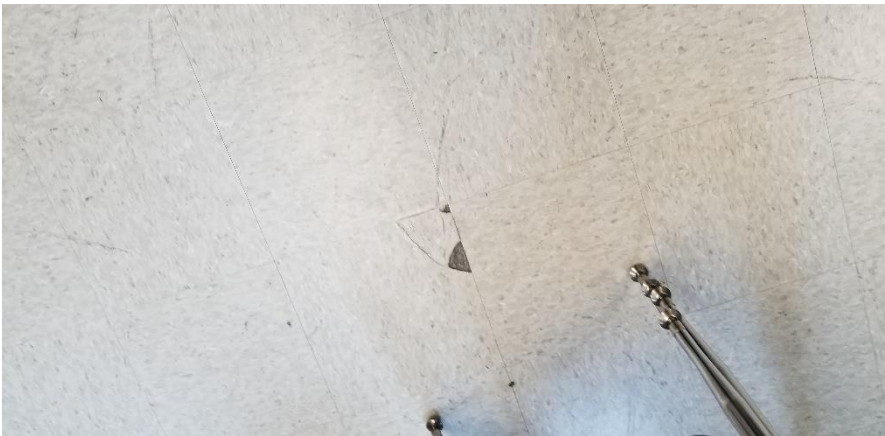
Floor tile

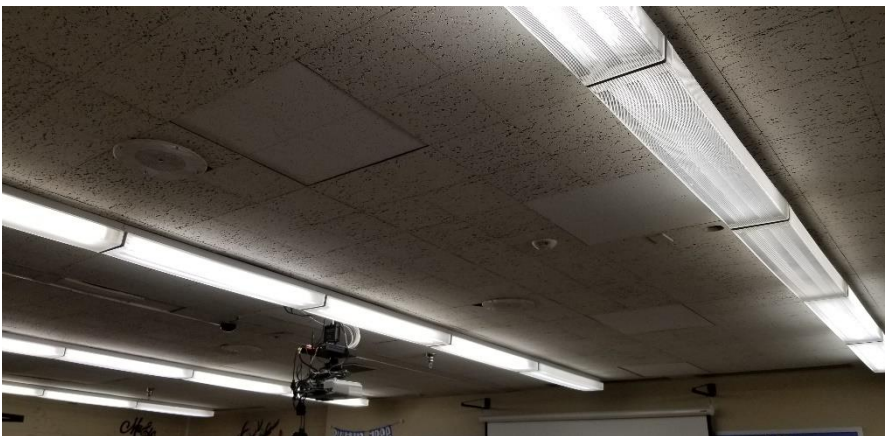
Classroom ceilings / lighting

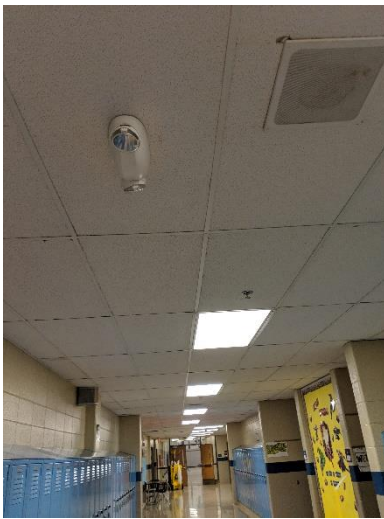
Emergency Lighting

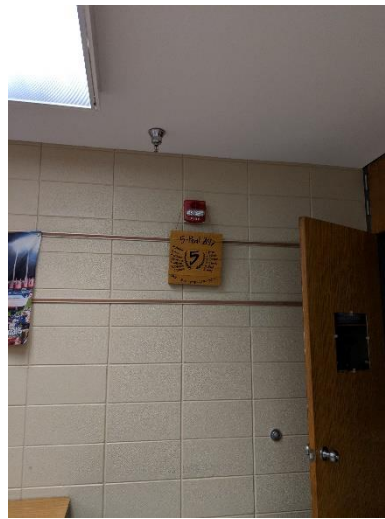
Fire Strobe.

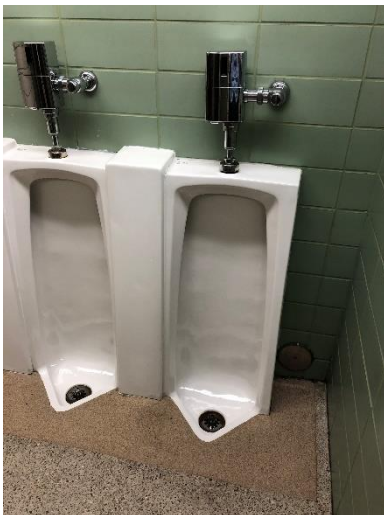
Urinal

- Replace majority of water closets and urinals with new wall-mounted fixtures.

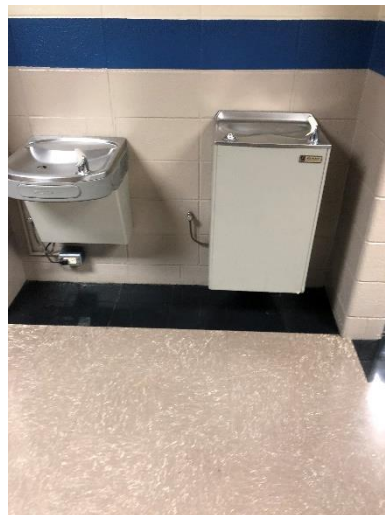
Drinking Fountains

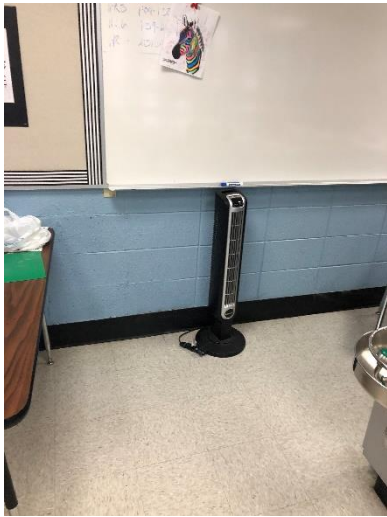
Fan for circulation

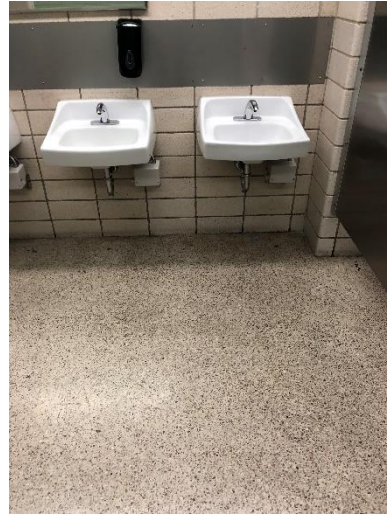
Plumbing Fixture

- Additional Updates required to bring systems up to current SMSD Standards:
 - Replace all faucets and flush valves with Toto sensor devices.
 - Hot water recirculation line shall tie into hot water line with-in 3 feet of every hand washing sink.
