TOMAHAWK ELEMENTARY

# FACILITY EVALUATION

TOMAHAWK  
ELEMENTARY

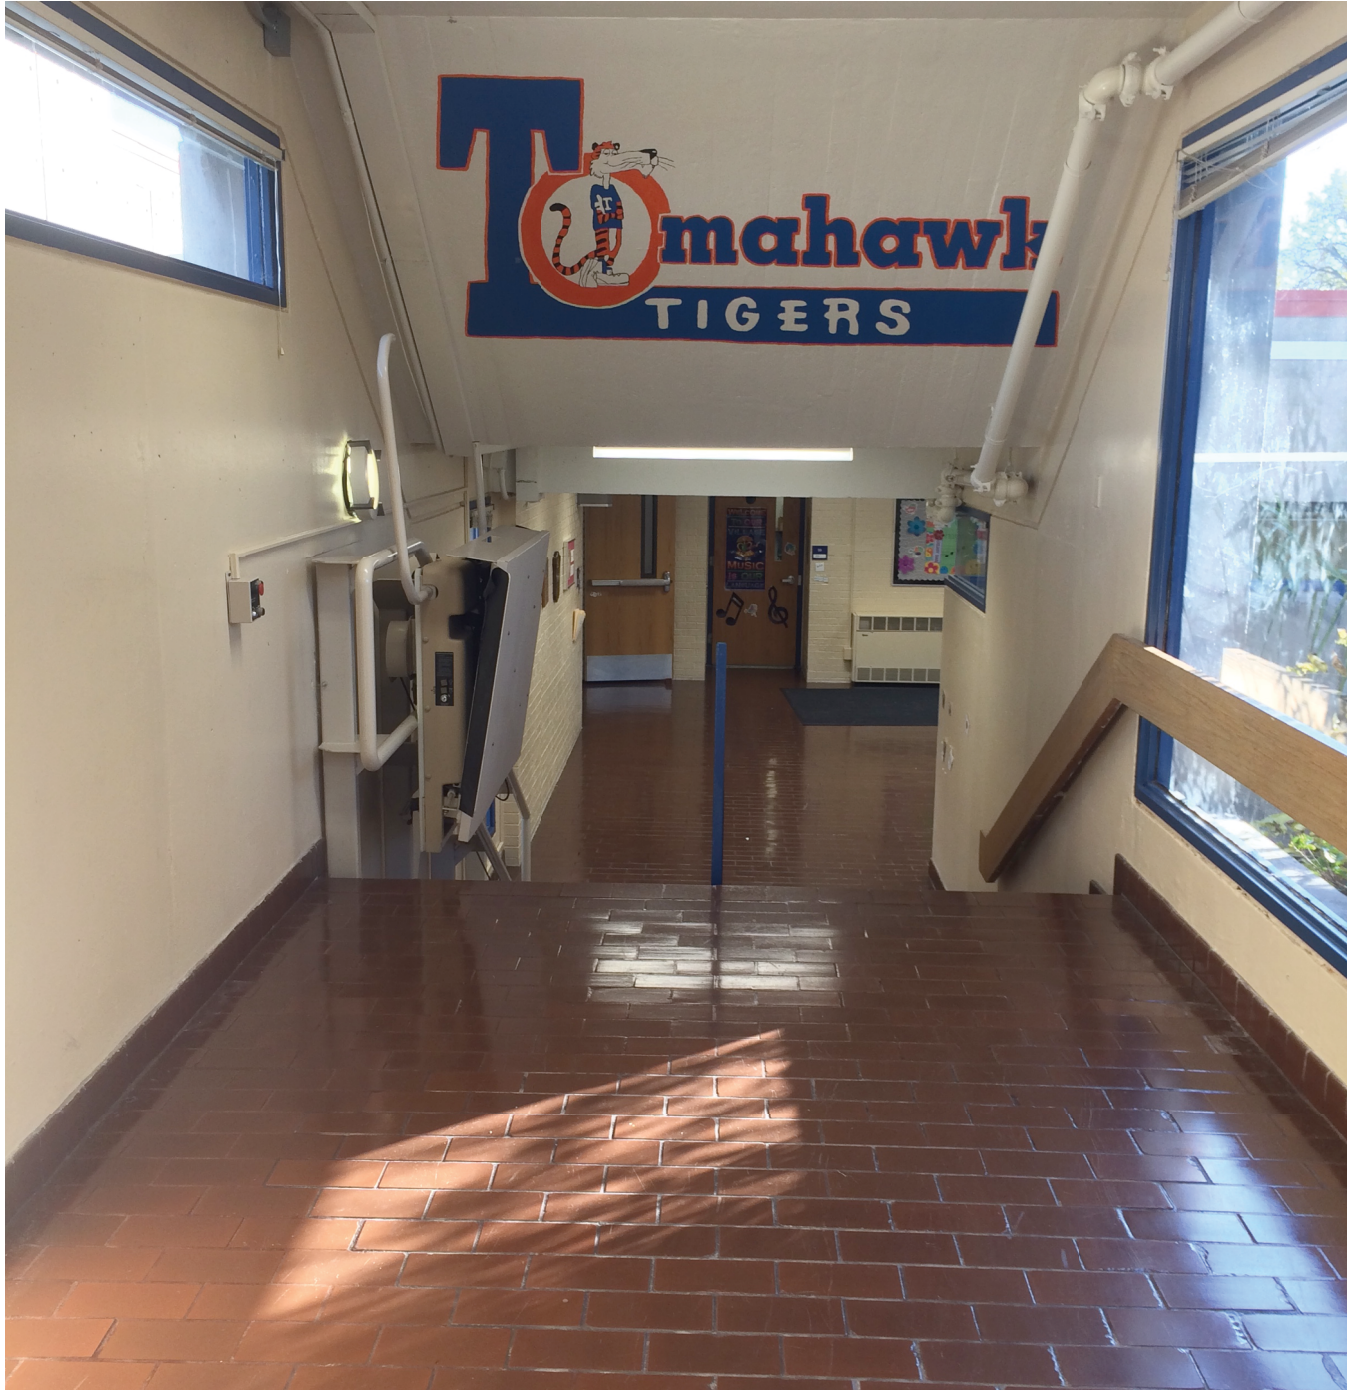
Corridors have low ceilings (8'-0" a.f.f.). Surface mounted light fixtures. Chair lift at steps. Exposed pipes and conduits. Ceramic tile floors

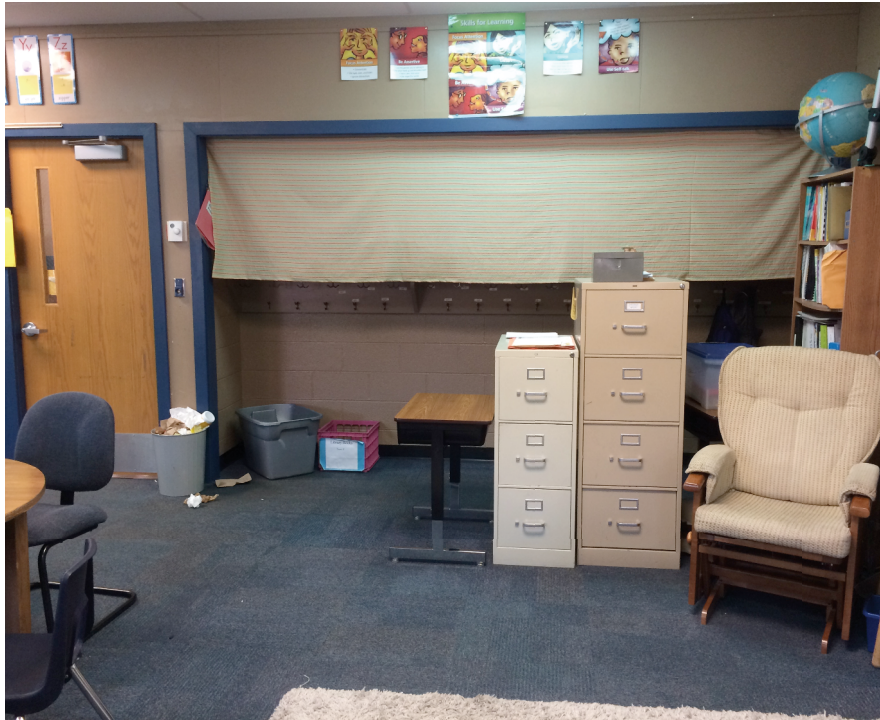
No cubby storage for students in the 1st thru 6th Grade classrooms, only coat hooks close together for coats and back packs. Need built in casework with doors to hide the clutter. Classrooms need different types of desks, tables and furniture for various teaching methods.

In the SPED/SLC classrooms the open bookshelves are covered with curtains. The clutter is too distracting for the students with Autism. The SLC students are learning verbal skills. Visual aids and pictures are used. Smaller areas with movable screens/walls are needed to provide some privacy for alone time for SLC students. There are only 5 students per SLC class along with teachers and para professionals.

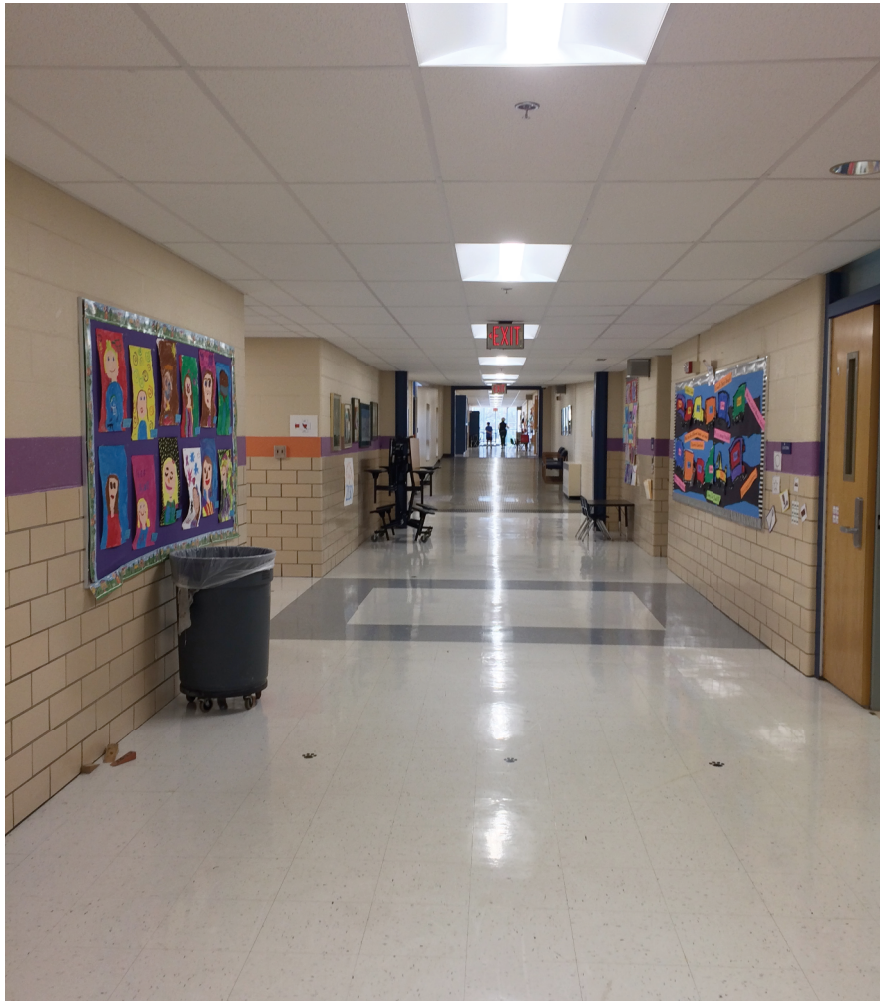
Corridors have VCT flooring requiring maintenance. Walls are concrete masonry units with glazed block on lower part of wall. Some doors swing into corridors.

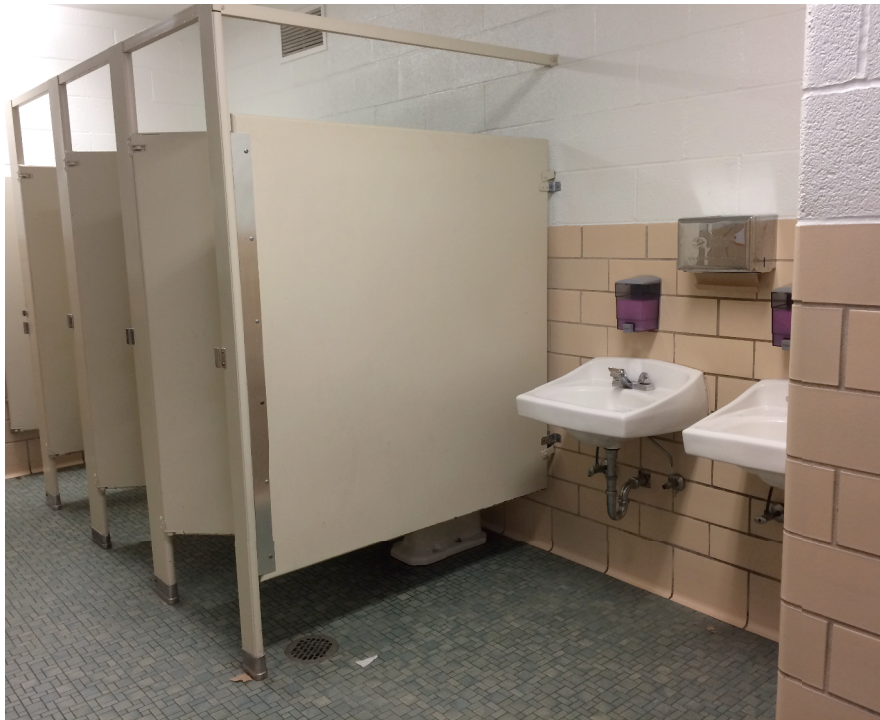
Student toilet rooms need updating. Most of them are not ADA accessible. No mirrors.

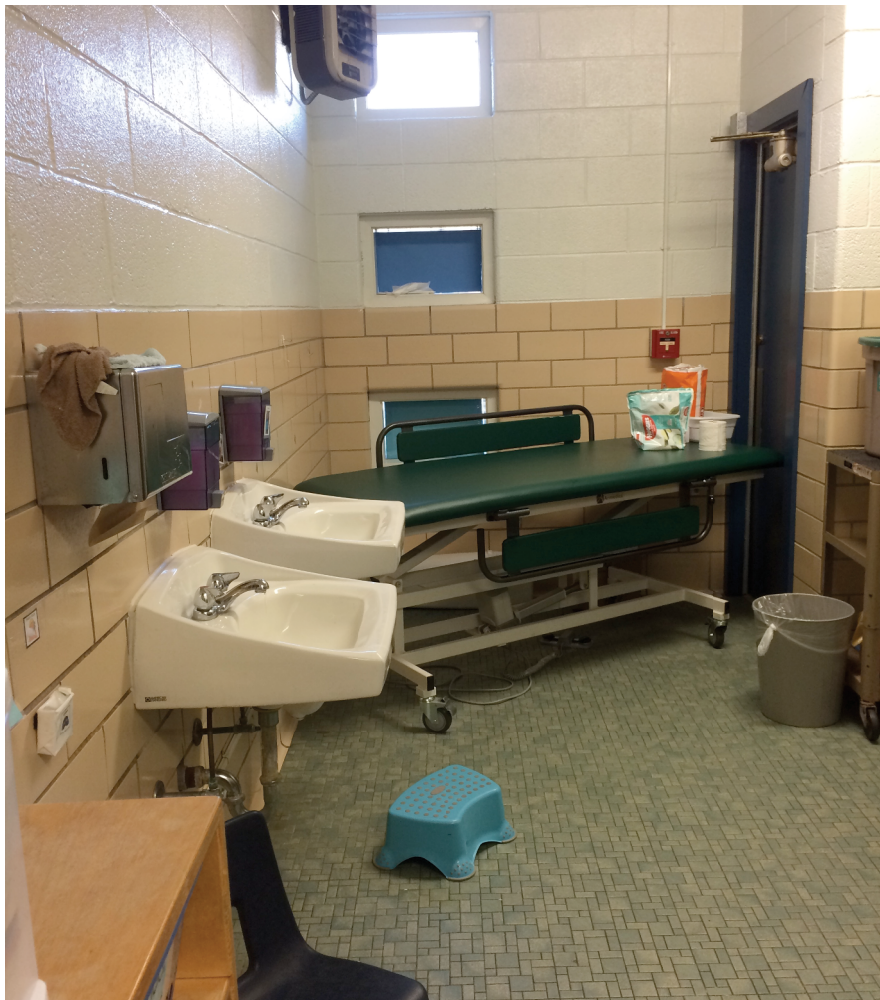
SLC toilets need changing stations and closer proximity to the actual classroom for toilet training of the younger students. The outside door is not desirable.

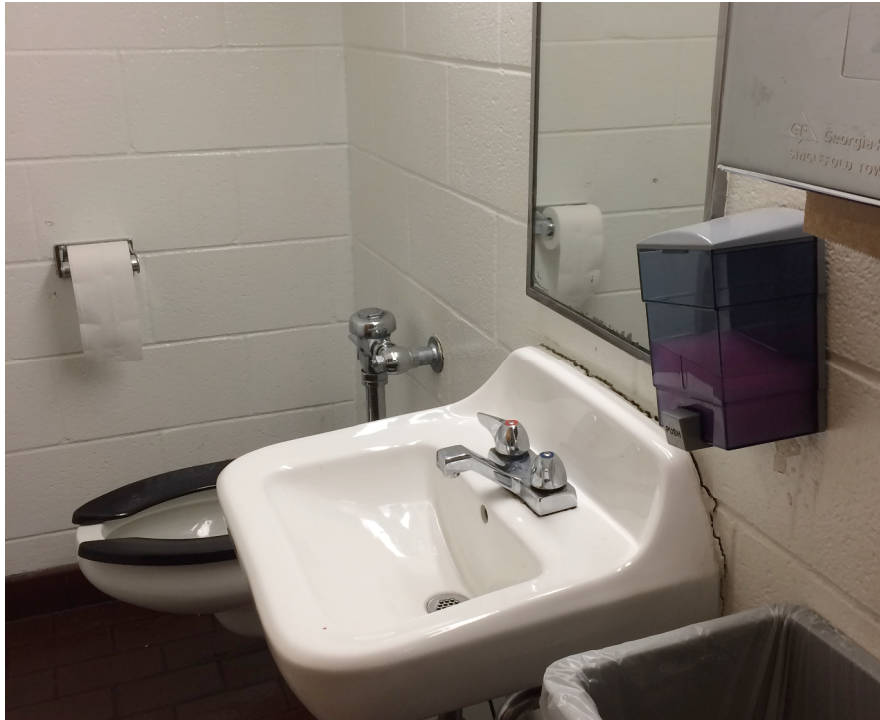
Staff toilets need updating. Not ADA accessible.

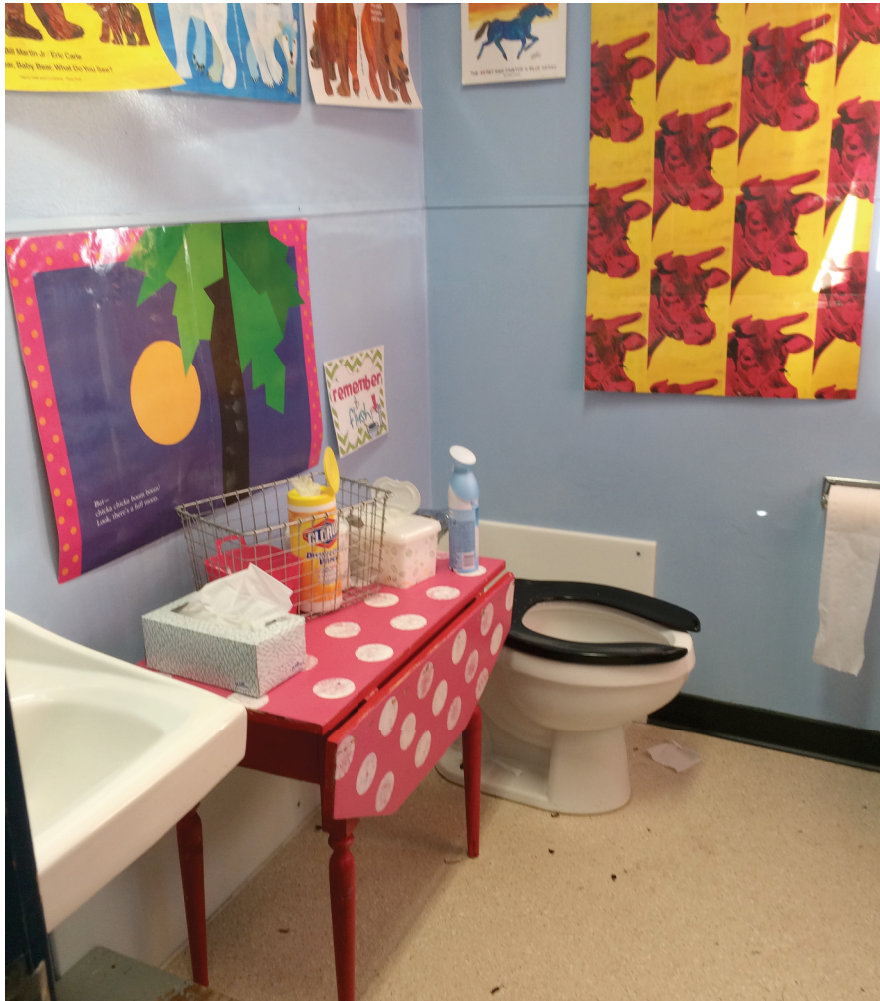
Kindergarten toilet, no grab bars for ADA accessibility.

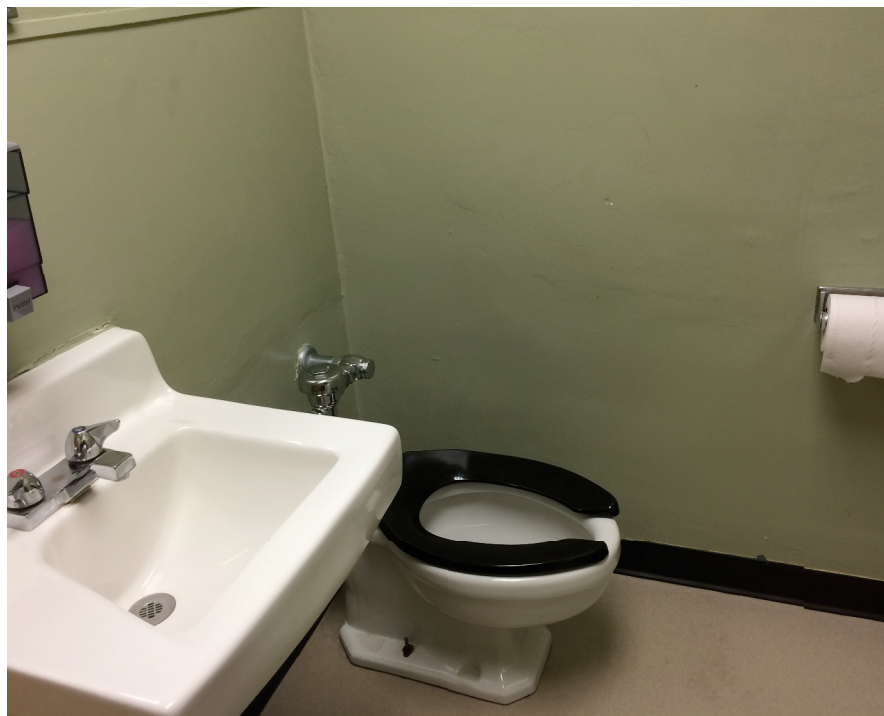
Nurse toilet not ADA accessible.  
No shower.

- Replace all faucets and flush valves with Toto sensor devices.
- Add accessible roll-in shower for the Nurse Area.
- Hot water recirculation line shall tie into hot water line with-in 3 feet of every hand washing sink.
- All classrooms shall be provided with a sink in the classroom.
- Replace majority of water closets and urinals with new wall-mounted fixtures.

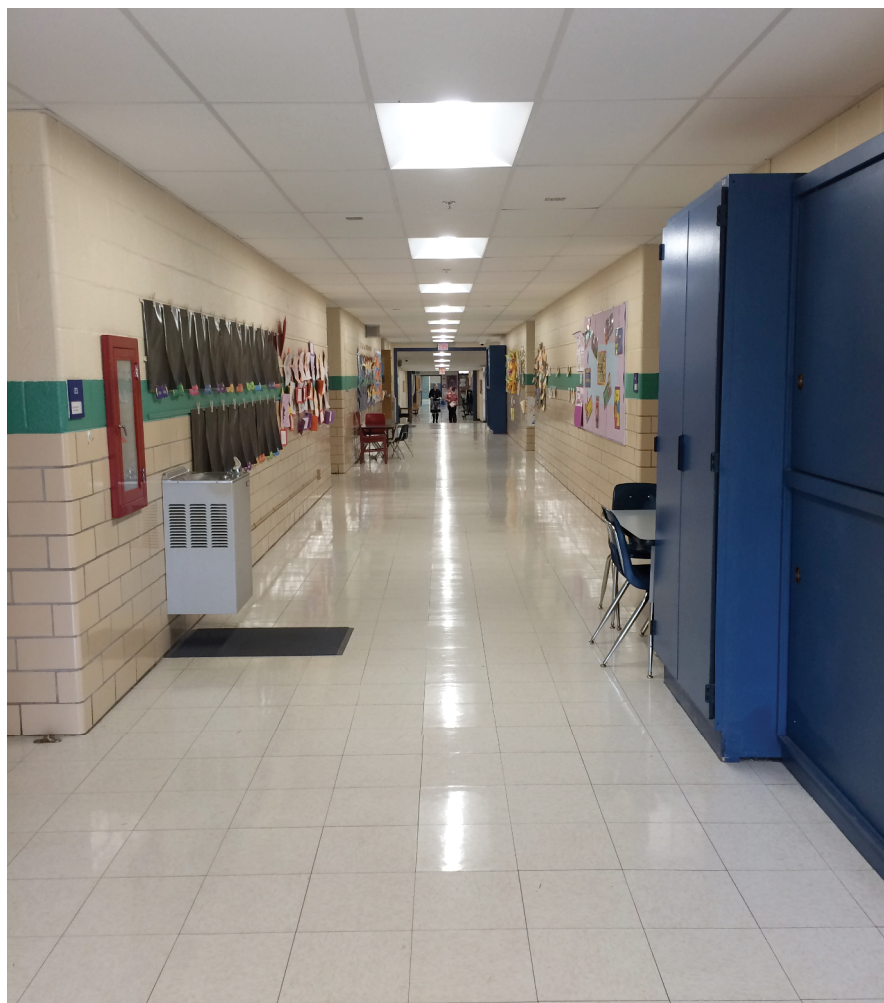
Drinking fountains protruding  
into Corridors more than allowed  
by ADA. Need to verify if storage  
cabinets protrude more than 4"  
into corridor exiting.

- Several water coolers and plumbing fixtures are not ADA compliant and need to be replaced.
- All handwashing sinks will need to have thermostat mixing valves installed to limit maximum water hot water temperature to 110°F.

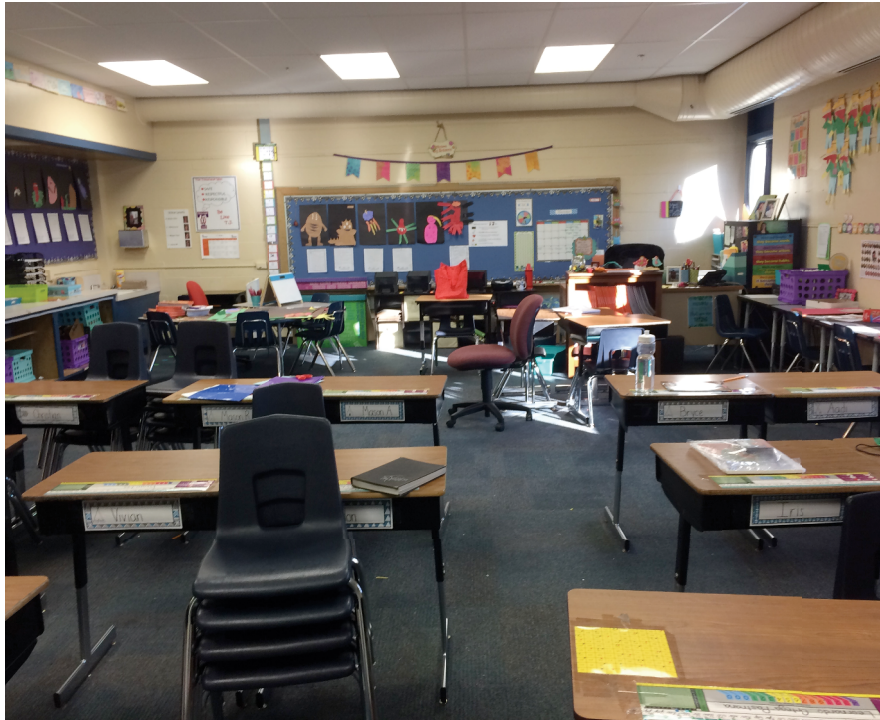
Classrooms with traditional desks. Need different casework and furniture to allow for various methods of teaching instruction. Large exposed ductwork added in one of the schools renovation projects.

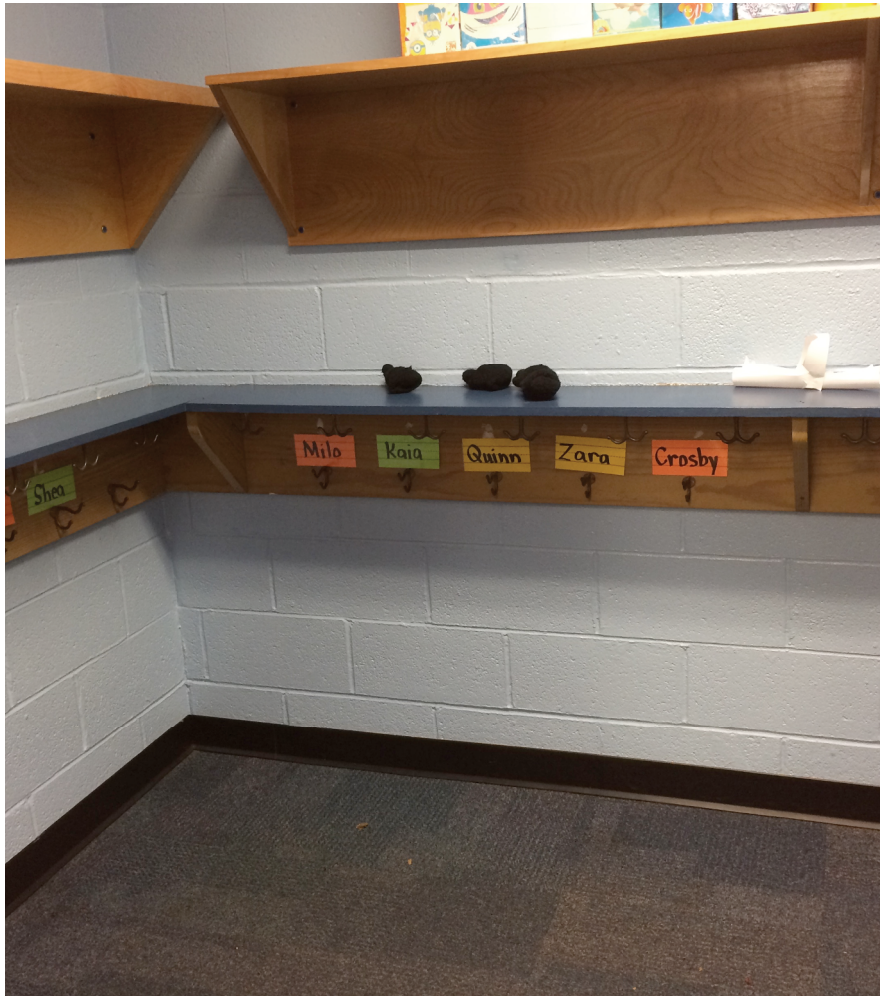
Kindergarten rooms have coat hooks for backpacks and coats. There are no individual cubbies per school district standards.

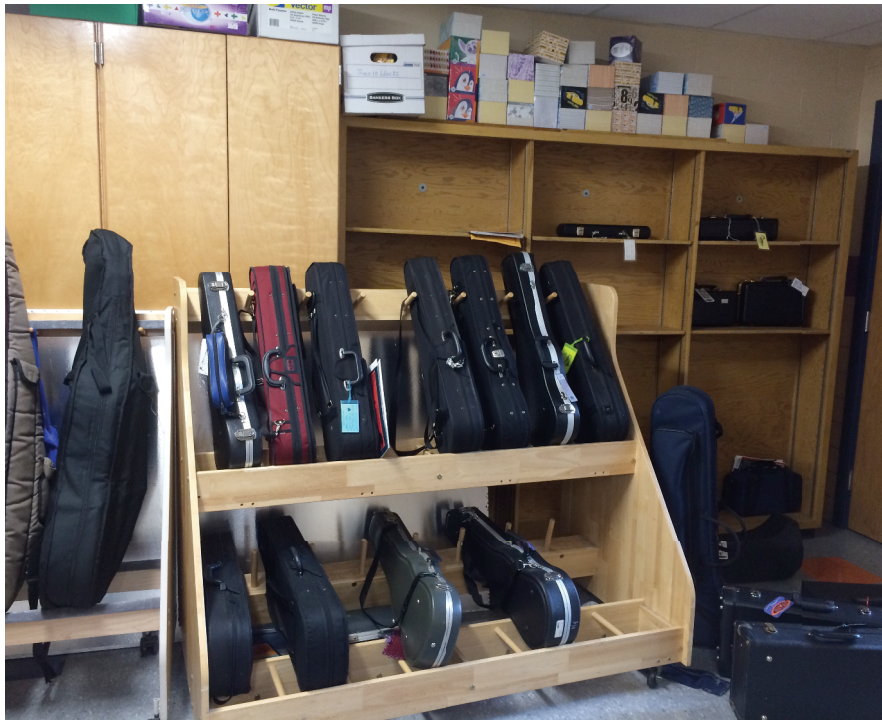
Instrument storage clutters the corridors.

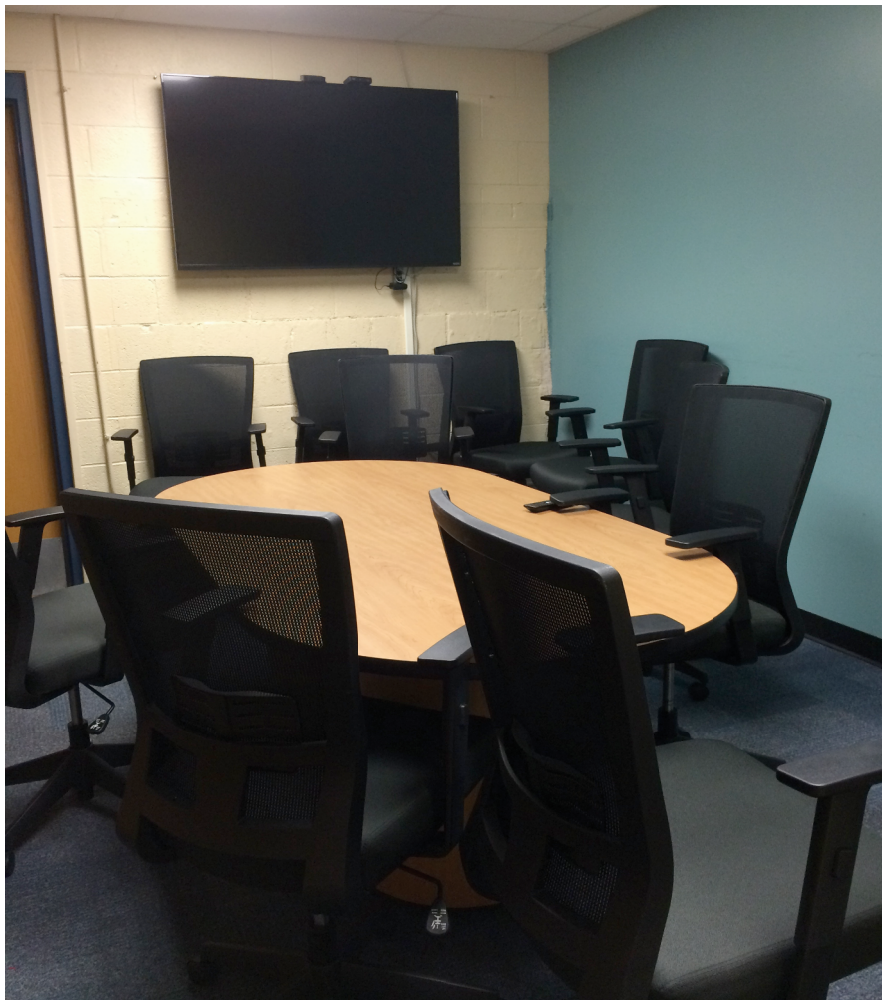
Need larger staff conference room. Can't fit all of the staff in this room at the same time.

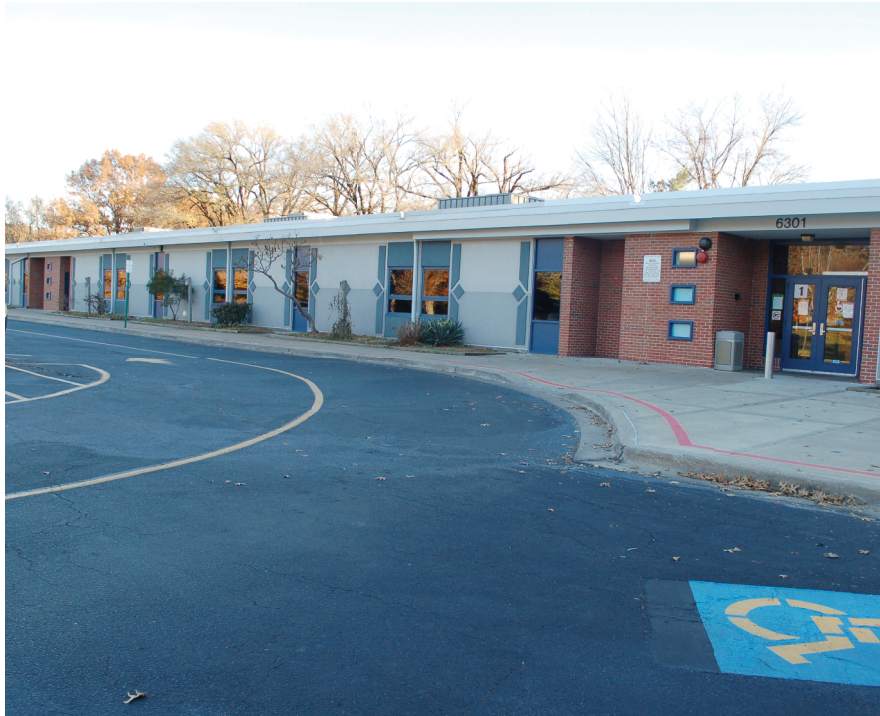
Main entry not easily recognizable as an entry.

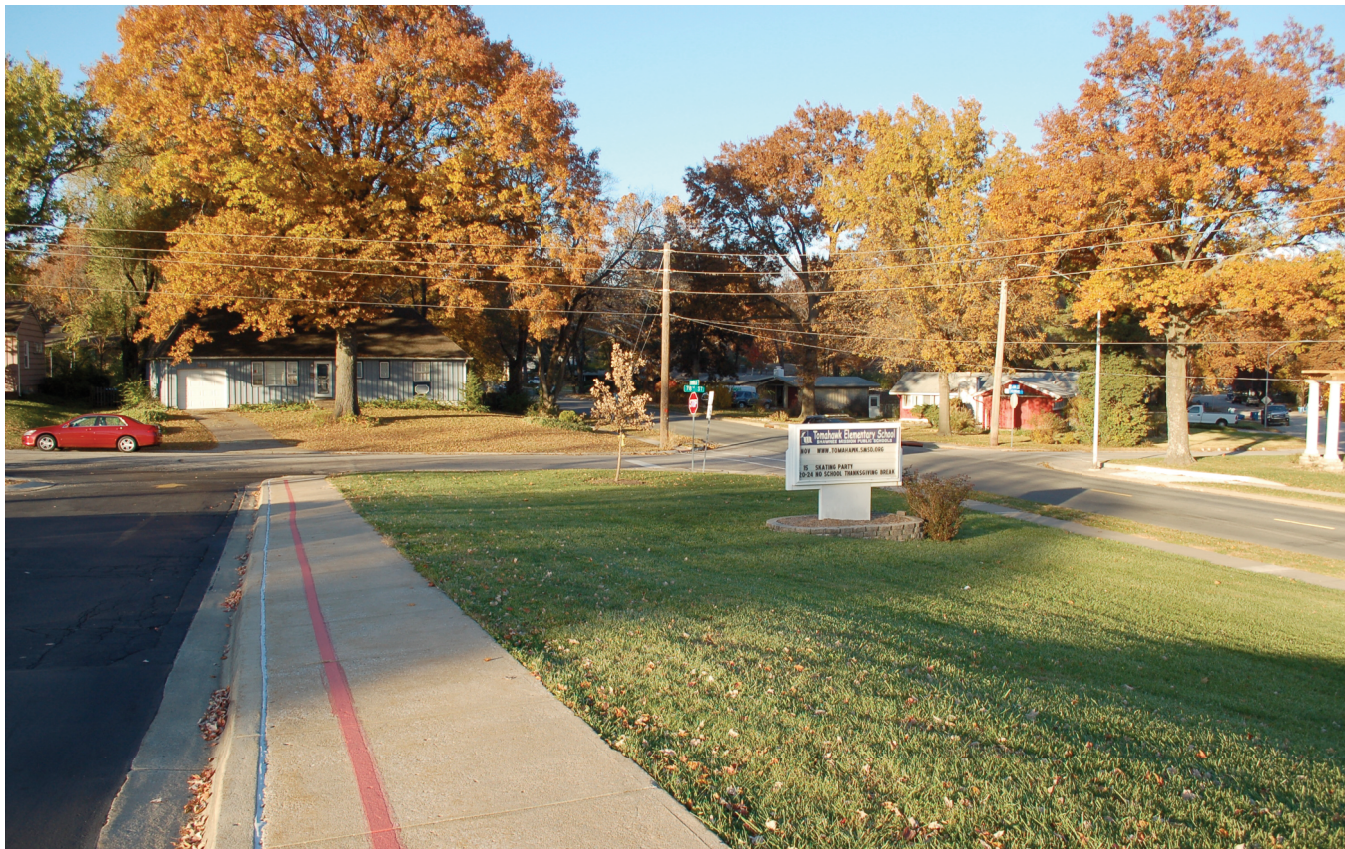
Need a crosswalk at Lamar and 78th Street, but the cities of Overland Park and Prairie Village couldn't agree on location and configuration. Students are supposed to use crosswalk at Lamar and 79th Street (further south) where there is a school crossing guard. Instead they cut across street at Lamar and 78th instead. Principal has concerns for student safety.

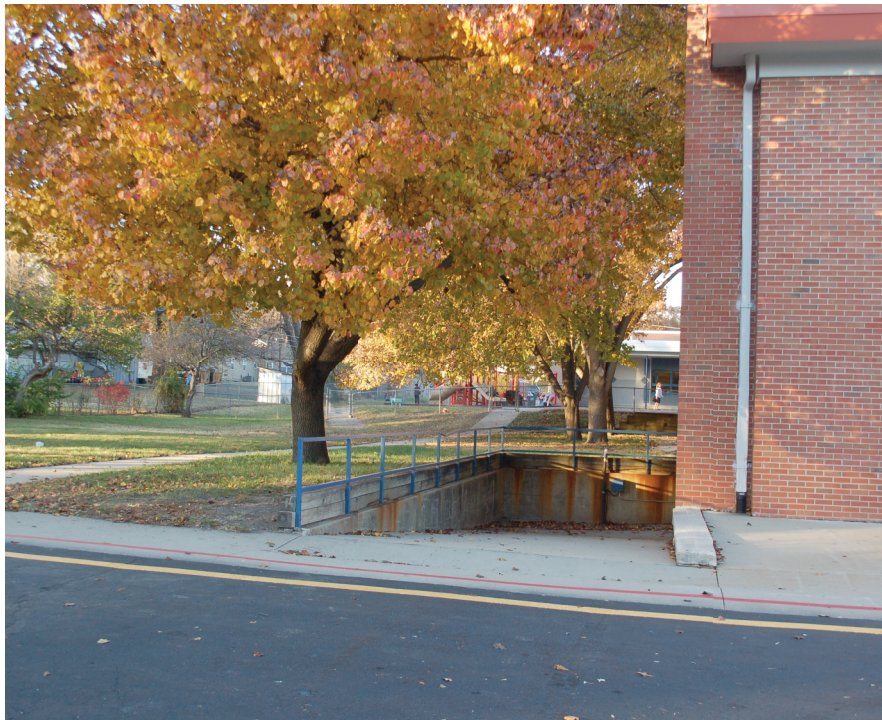
Ramp down to Maintenance/Tractor room has one drain that requires a sump pump when it rains. When power goes out the Tractor room and adjacent 5th Grade corridor is flooded because the sump pump doesn't work. Rust stains at railing/retaining wall is unsightly. There are 3 other window wells with similar drains in this classroom wing.

7. There is an exterior ramp access to the Tractor room that slopes down. The drain at the bottom of the ramp uses a sump pump to pump out the water when it rains. If they lose power the area fills up with water and floods the Tractor room and adjacent 5th Grade corridor. The Principal said this area has flooded twice in the past 3 years. There is also a lot of rust stains at the steel guardrail and concrete retaining wall.

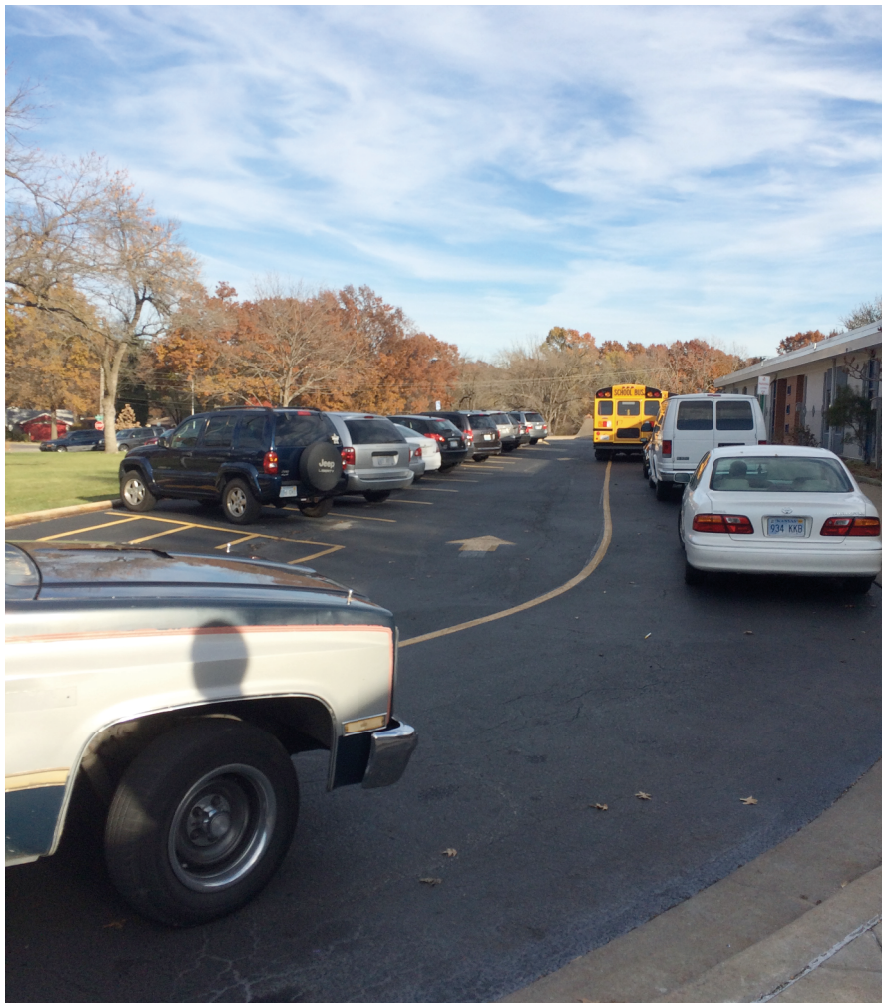
Parent pick up in the afternoon occurs on the north side of the school. There are also small SLC busses. The busses leave a few minutes before the vehicles. Vehicles back up onto 78th Street creating traffic issues

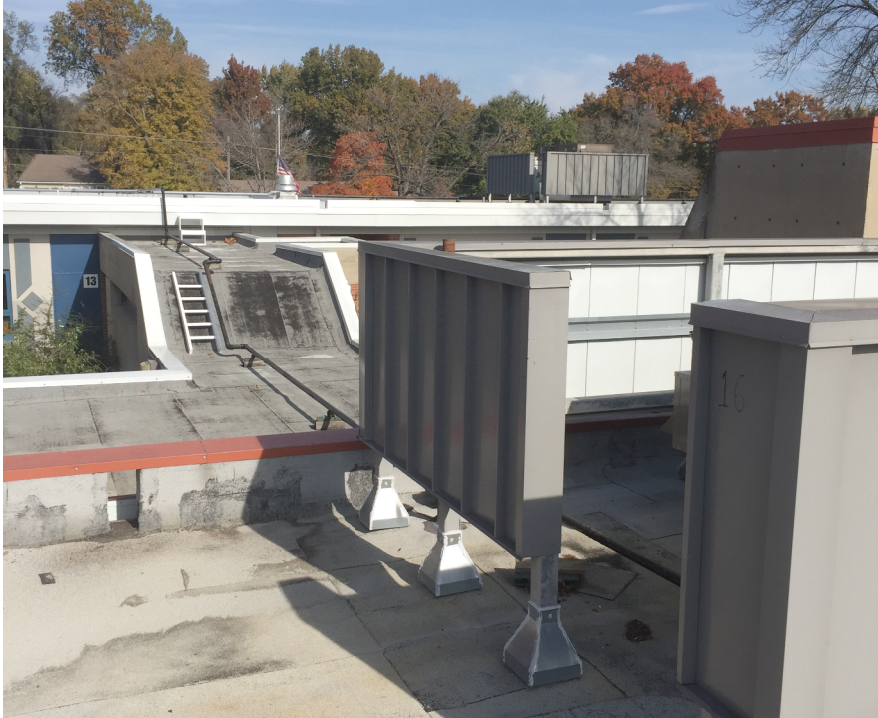
People climbing on roof where the connecting building steps up. Rust stains on roof membrane need to be maintained. Other stains indicate water ponding.

40. Boiler Room: Access to old underground tunnels used for original piping.
  41. MFEC accessed the roof. There were RTU screens, built up asphalt roof, exposed piping, roof drains and overflow scuppers. Roof has evidence of water ponding, rust stains and patch areas.

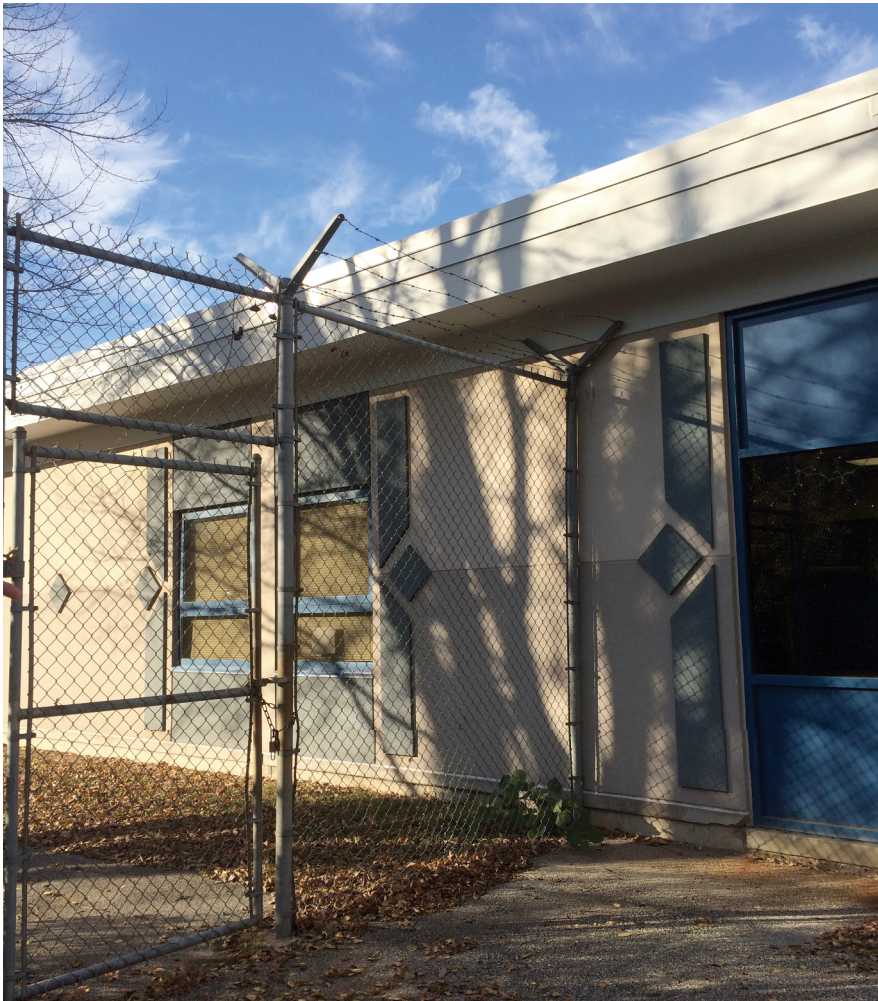
Courtyard has unsightly razor wire at chain link fence. Principal would like to get rid of it. It was installed to keep people from climbing on the roof inside courtyard, creating a security concern.

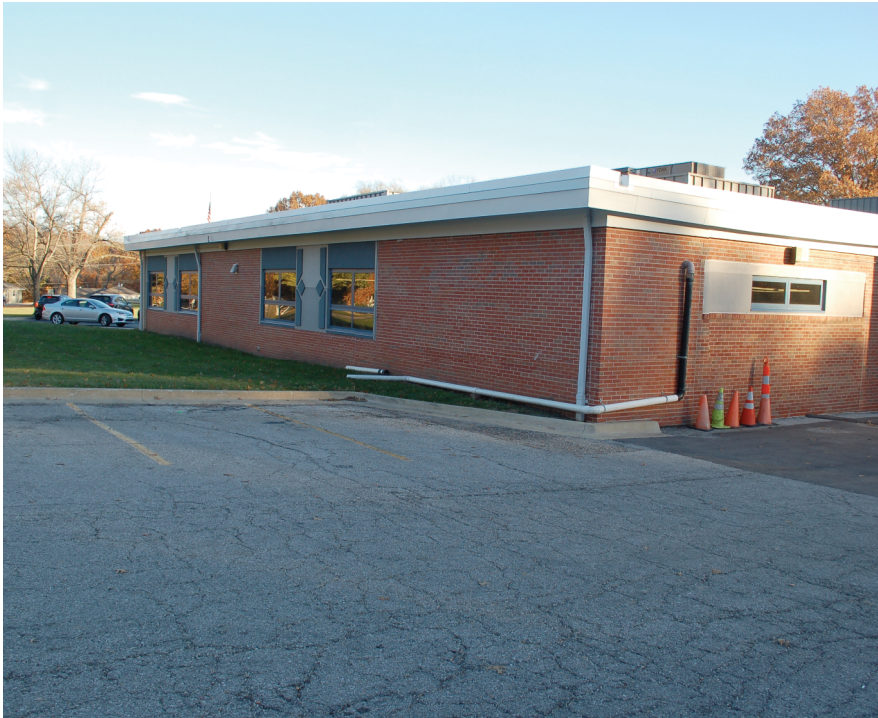
The overlapping exposed downspouts on northwest corner need to both connect to storm sewer system.

- Roof drains are discharged to grade by down spouts and not piped to storm sewer. This causes drainage issues around the building. Overflow scuppers are provided.

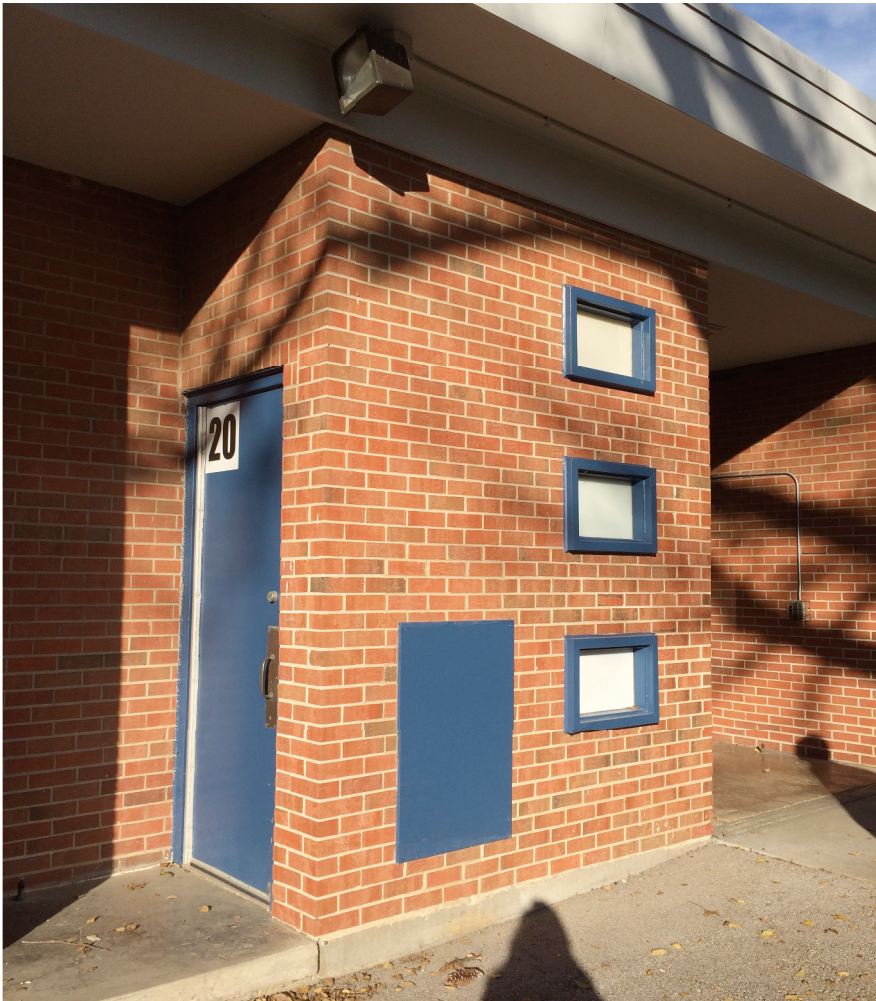
Exterior doors from the Boys/ Girls toilets are not needed. Students exit the building without being monitored which creates a security concern.

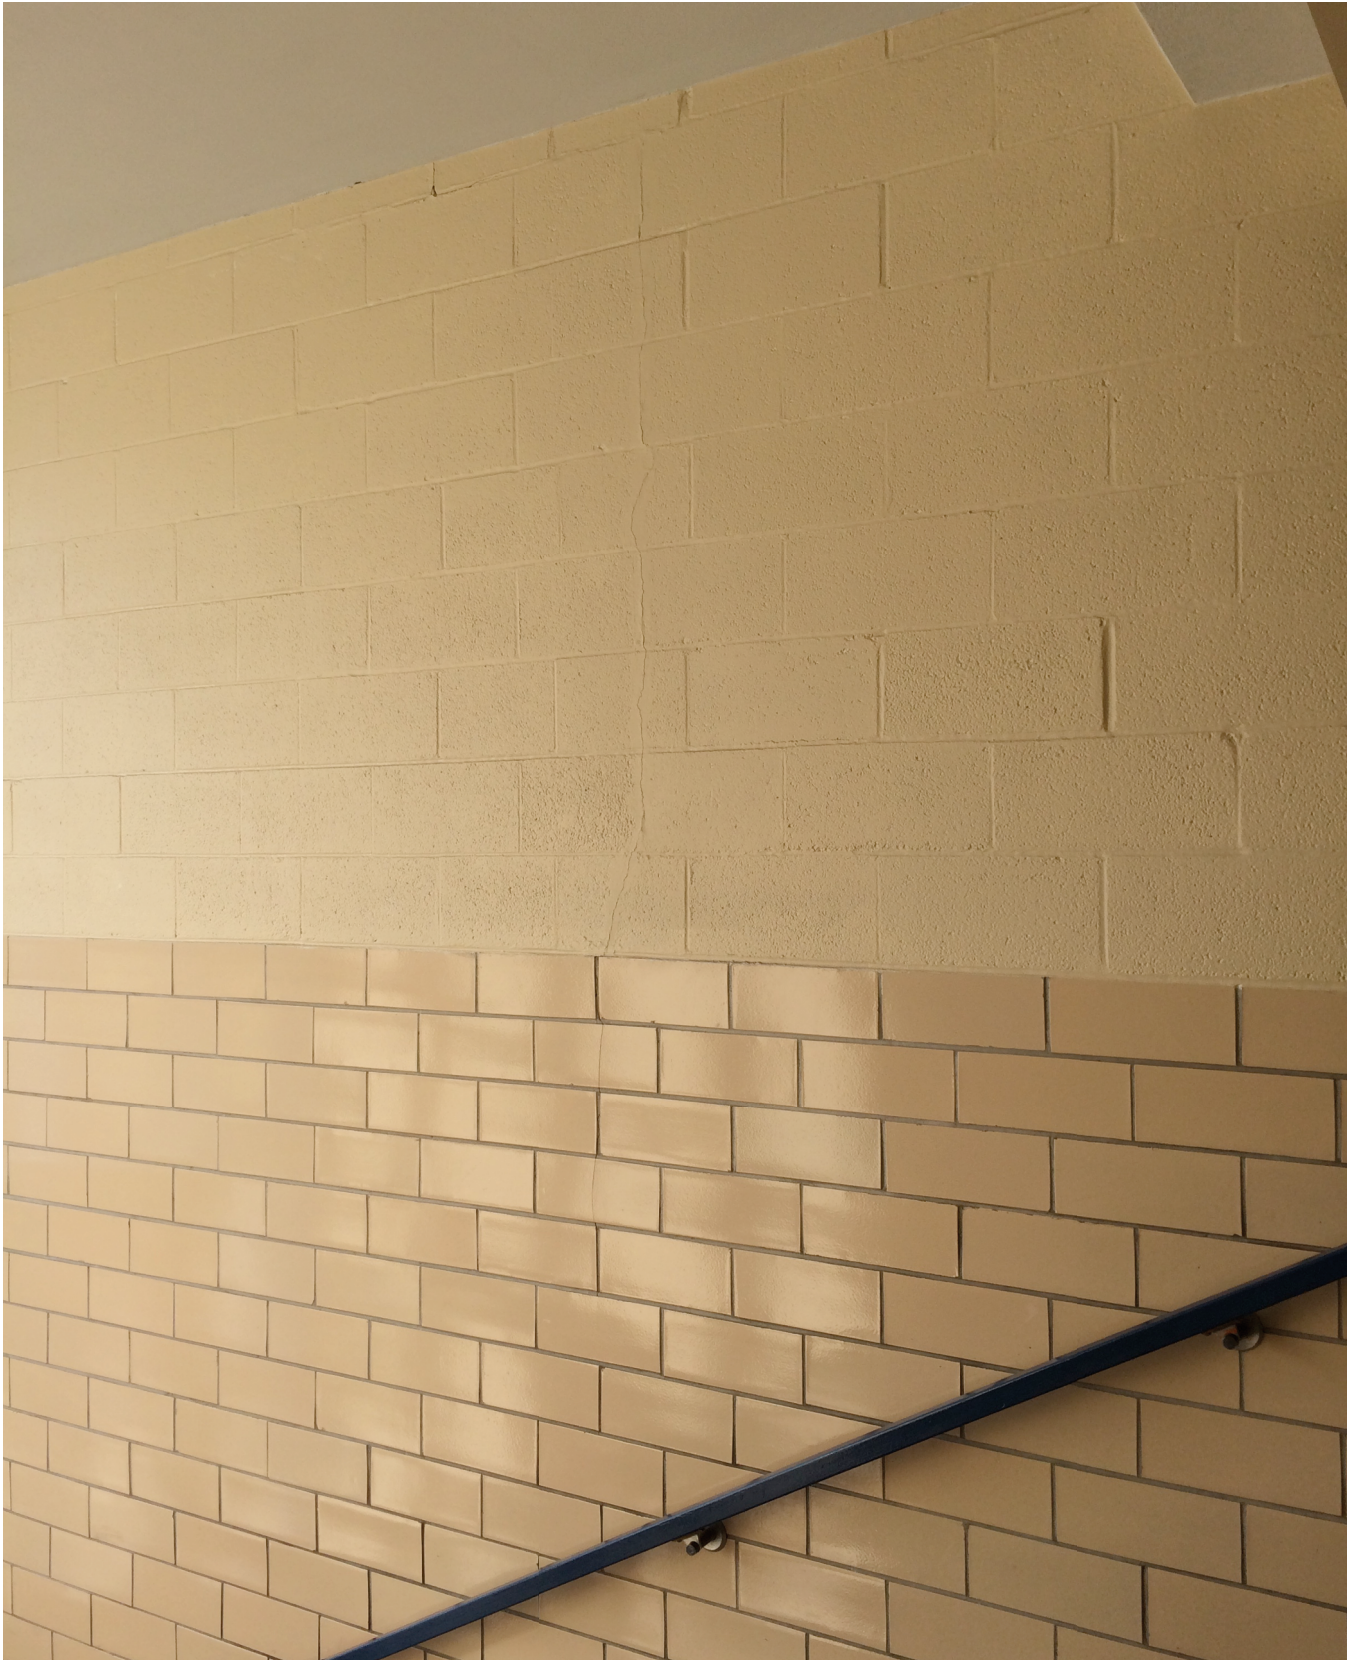
Visible vertical cracks at stair wall masonry need to be evaluated.

38. There is some visible vertical wall cracks at stair wells in the glazed block.
  39. No elevator, but a couple of chair lifts at gym and one corridor.

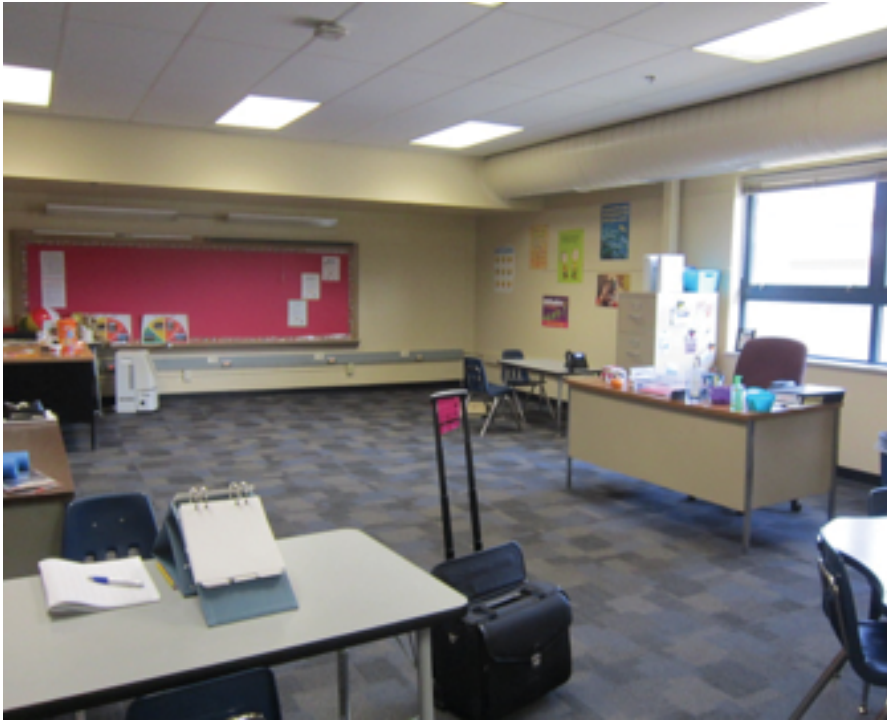
Dehumidifier running in space to reduce humidity

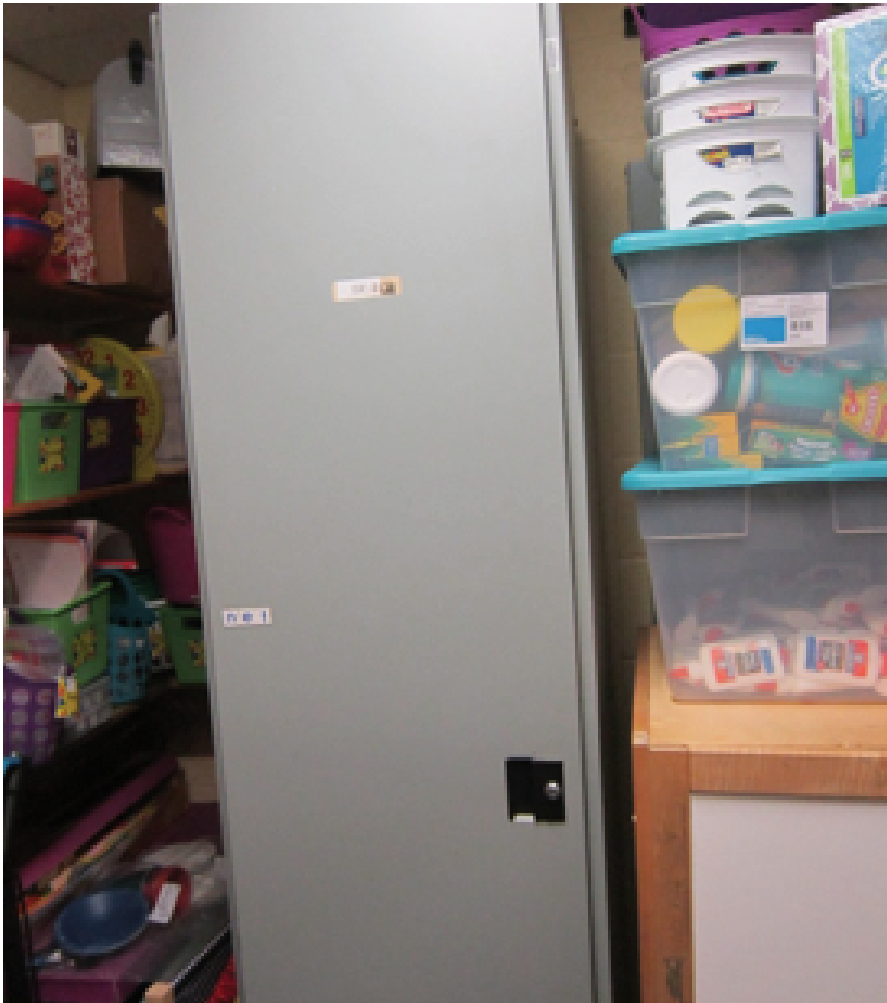
Data closet in storage room

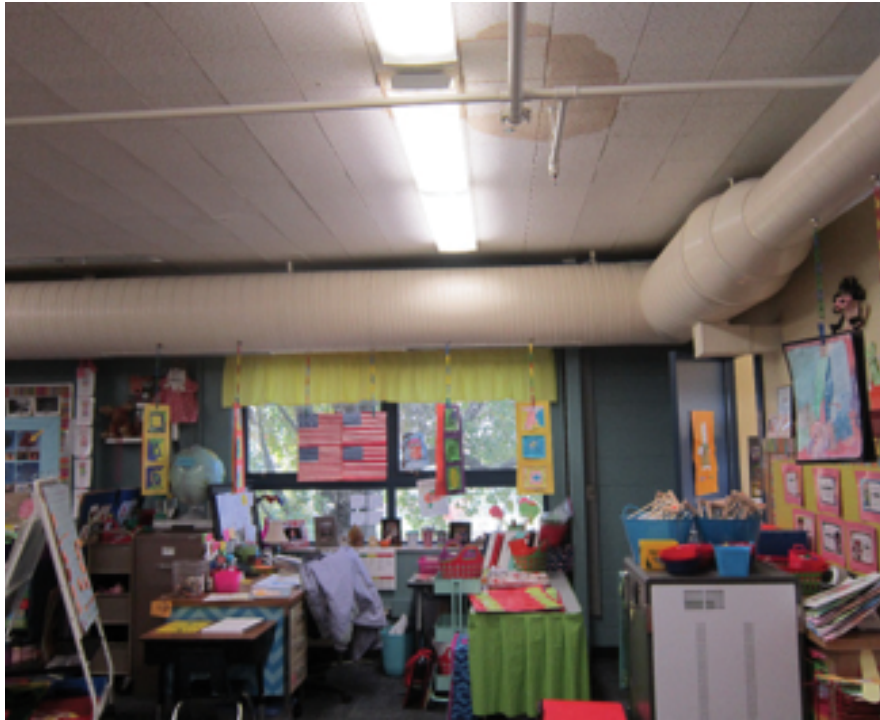
Ductwork exposed in classroom  
& ceiling water damage
