TOMAHAWK ELEMENTARY

# FACILITY EVALUATION

TOMAHAWK  
ELEMENTARY

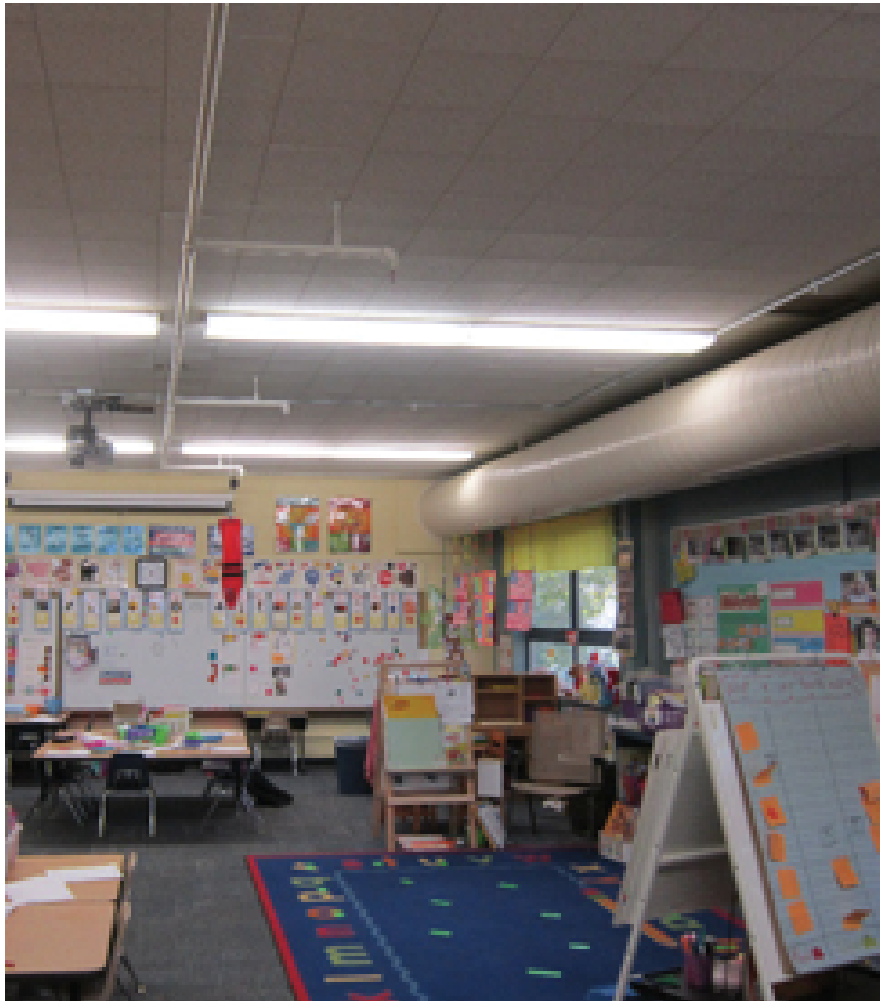
Exposed ductwork and sprinkler  
system in classroom space

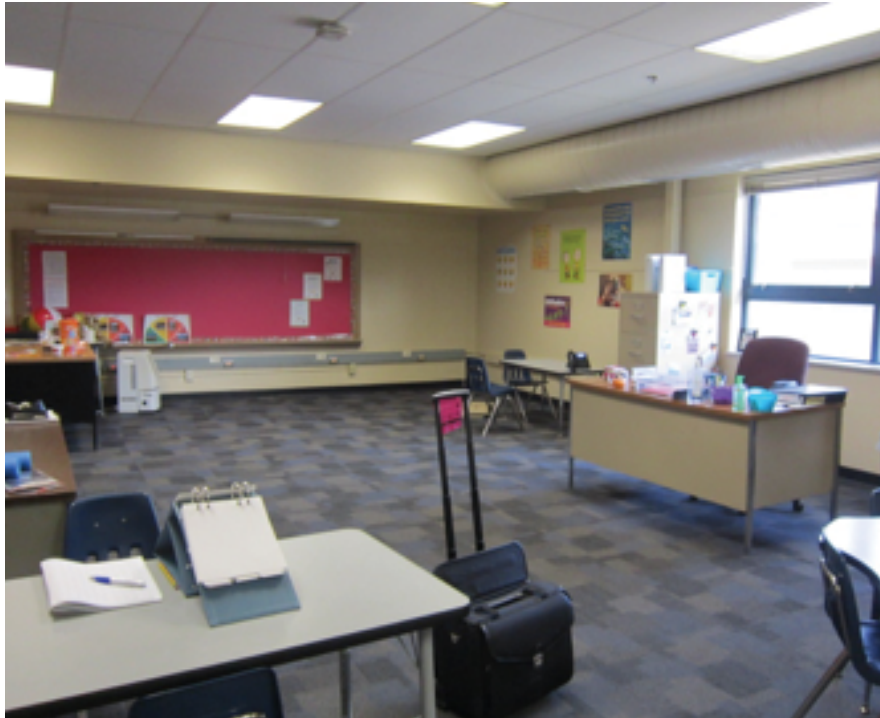
Dehumidifier running in space to reduce humidity

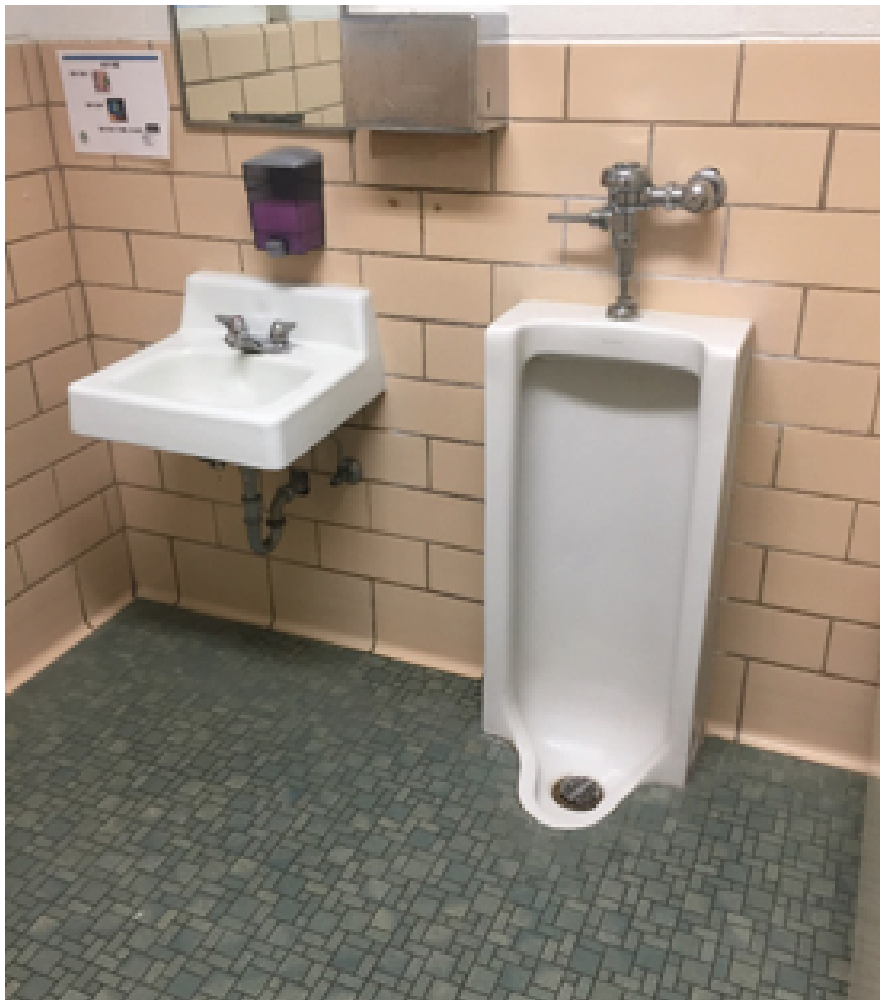
Floor mounted plumbing fixtures

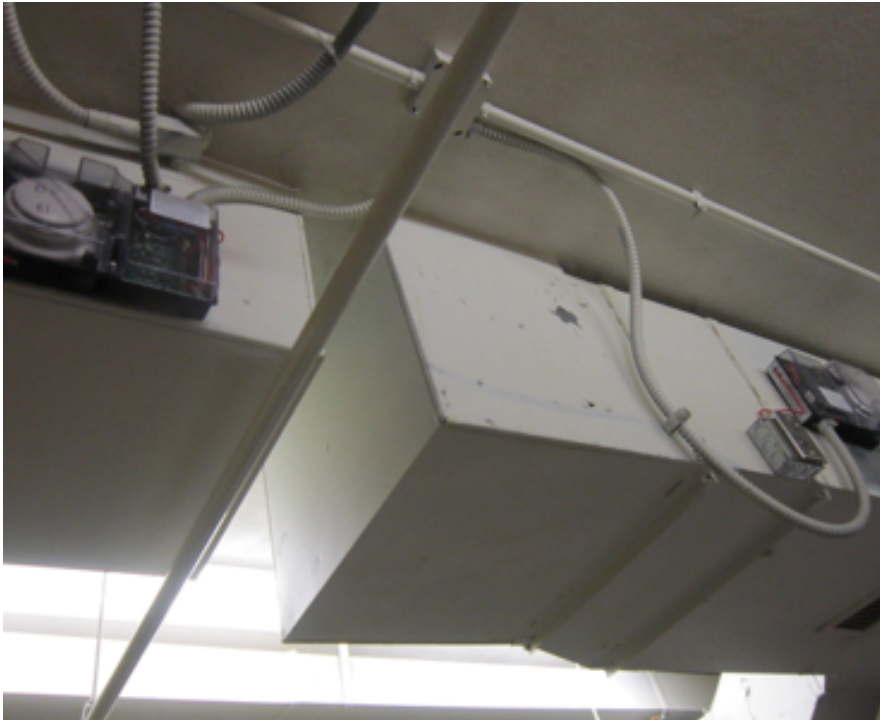
Smoke Detection on  
HVAC equipment

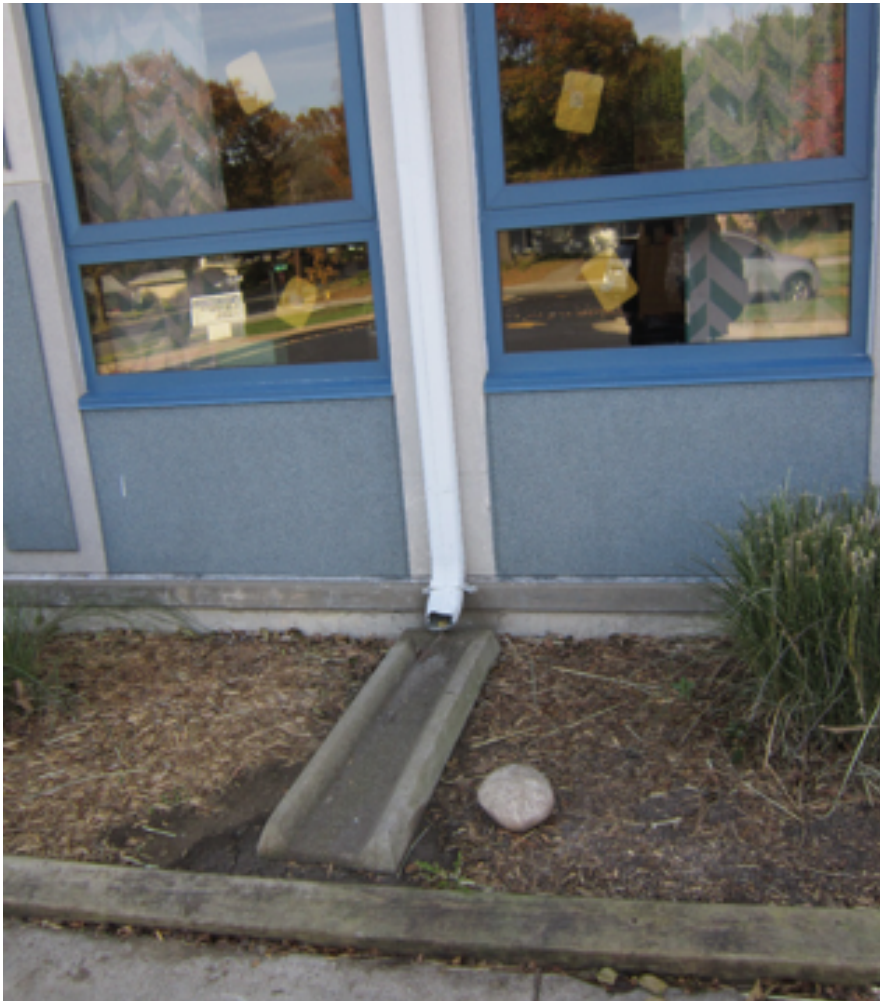
Roof drainage discharge on sidewalk

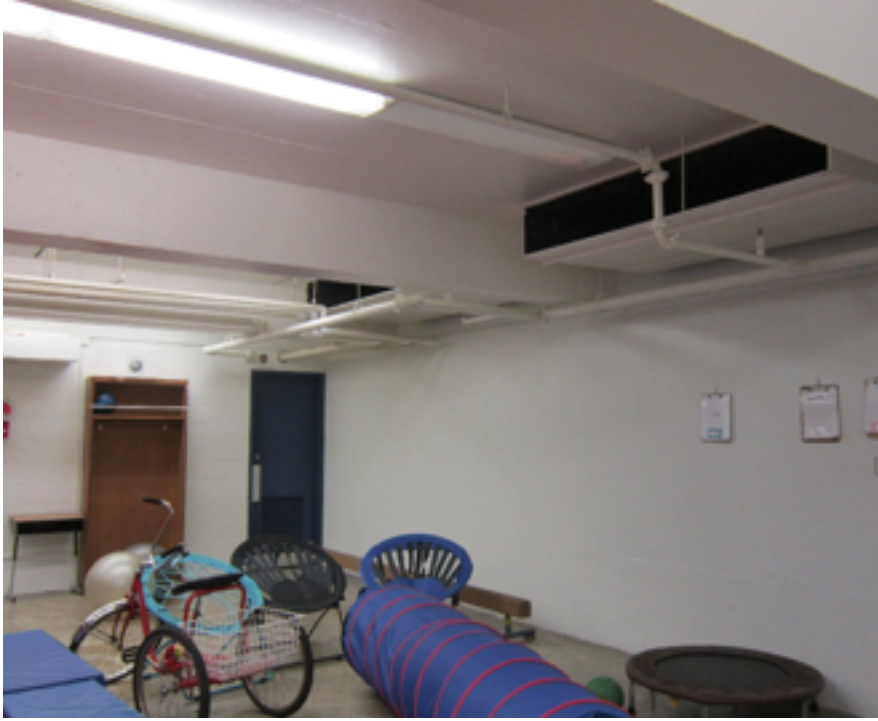
Piping and Ductwork exposed in lower level storm shelter. Space utilized for sensory space.
