RUSHTON ELEMENTARY

FACILITY EVALUATION

OVERALL SUMMARY

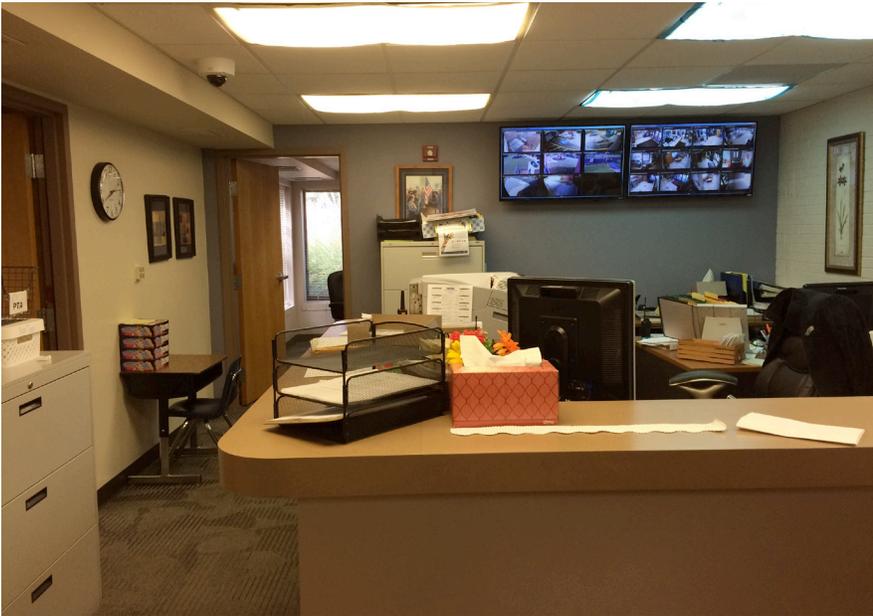
Small Administration Reception area has no waiting chairs for visitors or students.

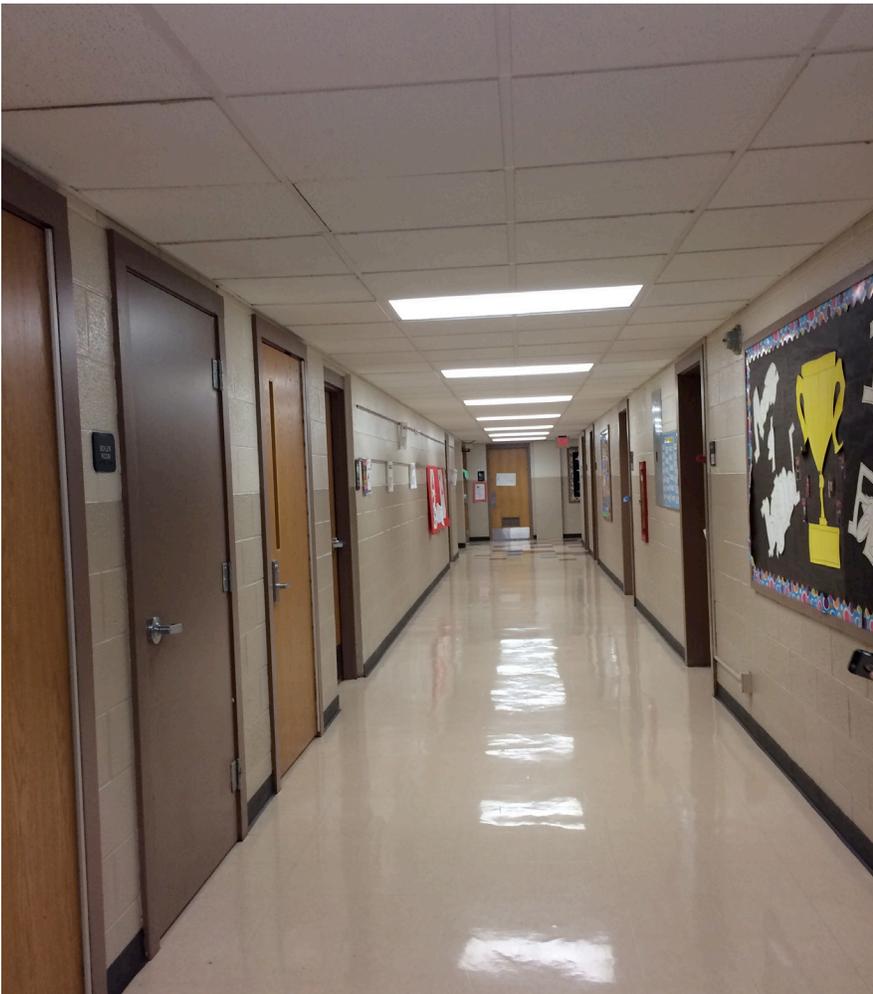
Corridors with low ceilings (7'-5" a.f.f.). Doors swinging into Corridor. VCT flooring requires maintenance. No common areas for students to meet.

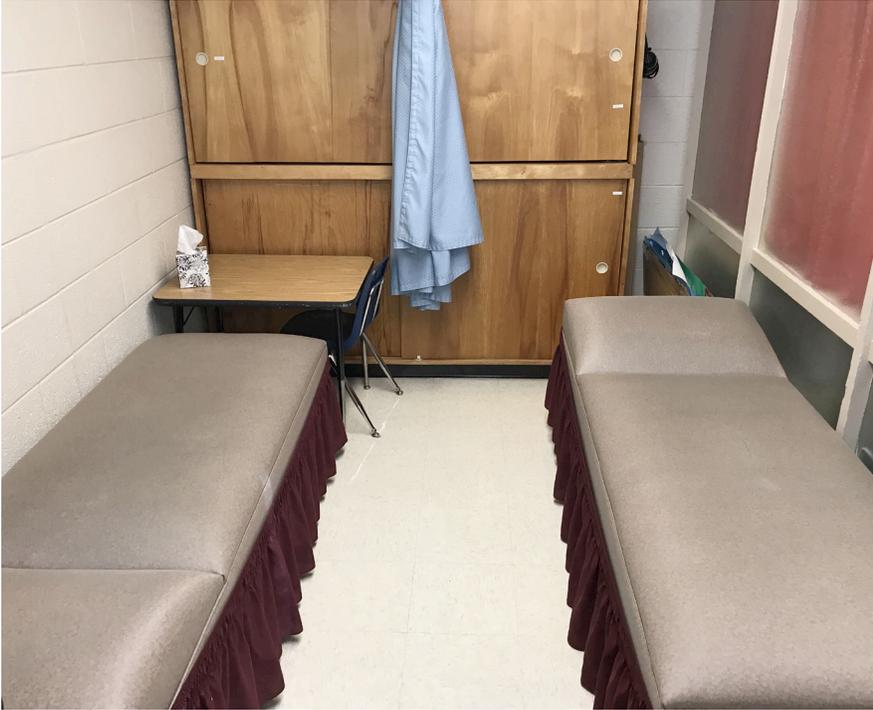
No shower in Nurse's area for kids.

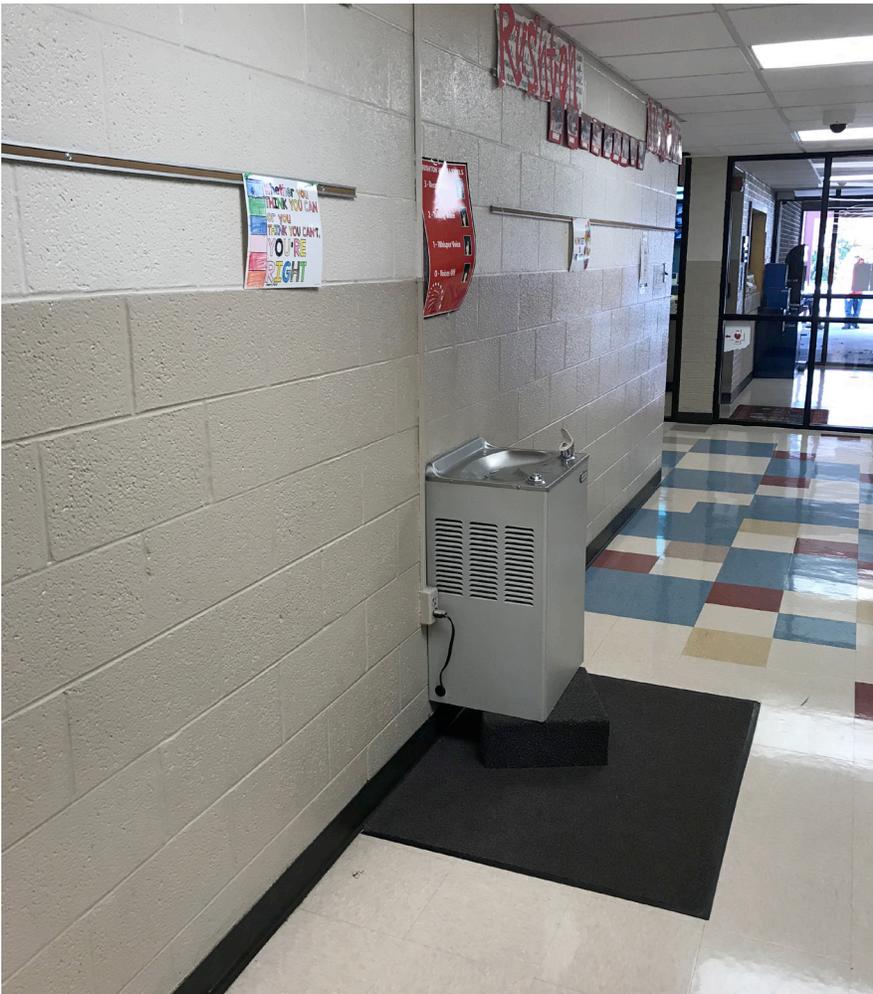
Drinking fountains protruding into Corridors more than allowed by ADA.

7. No roof access. Maintenance staff has to use a loose ladder to get on the roof.
8. Security cameras don't cover all hallways.
9. Drinking fountains protrude into hallway clearances, against ADA guidelines.

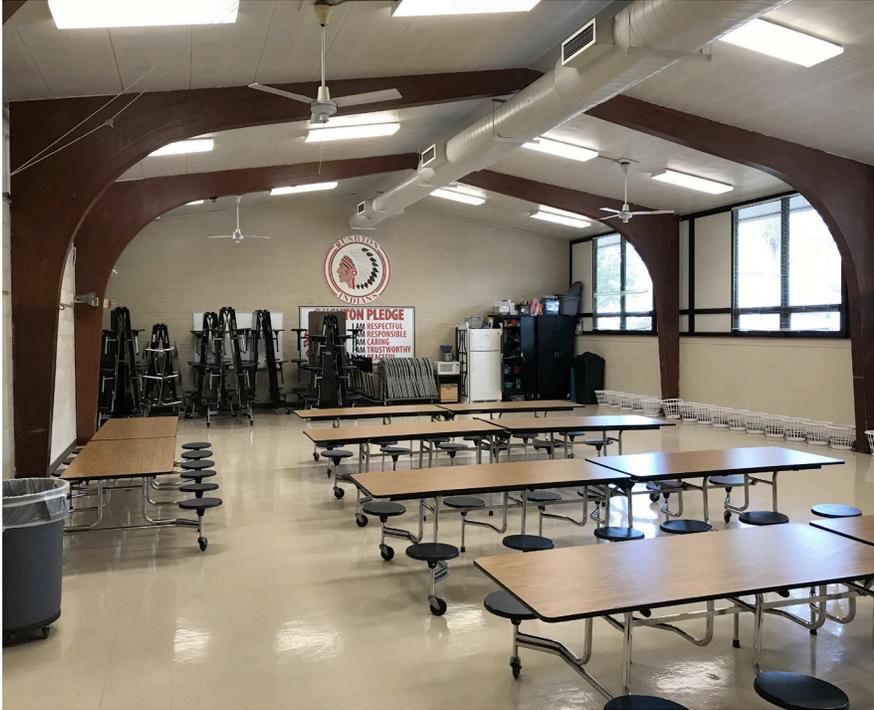
Small Cafeteria- A long Lunch period extends from 11:00 to 1:15. There are 75 to 100 kids per lunch period. Constant loud background noise from the HVAC unit.

- Rooftop unit serving Cafeteria. Noise from unit is excessive.
 - Rooftop units were either 10 years old or 20 years old. Typical life span of a rooftop unit is 15 years. Majority of rooftop unit's fin are damaged, which limits performance and efficiency.

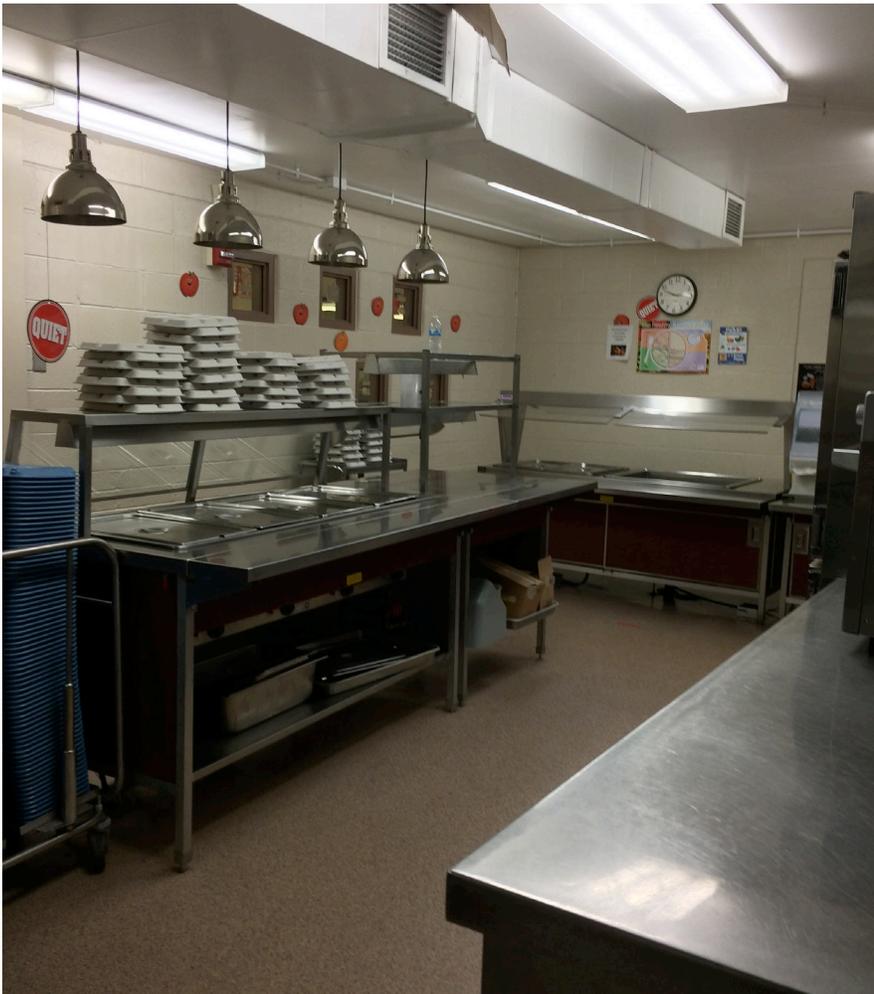
Small kitchen/serving area. Exposed ductwork directly over food areas.

- **Head clearance in kitchen area felt limited. Ductwork and piping were exposed in Kitchen and Serving Areas.**
- **Observations regarding code deficiencies are in reference to the current 2012 IBC code series adopted by local jurisdictions. Should local jurisdictions adopt codes newer than the 2012 IBC, additional updates may be required to building systems. Items of note include:**

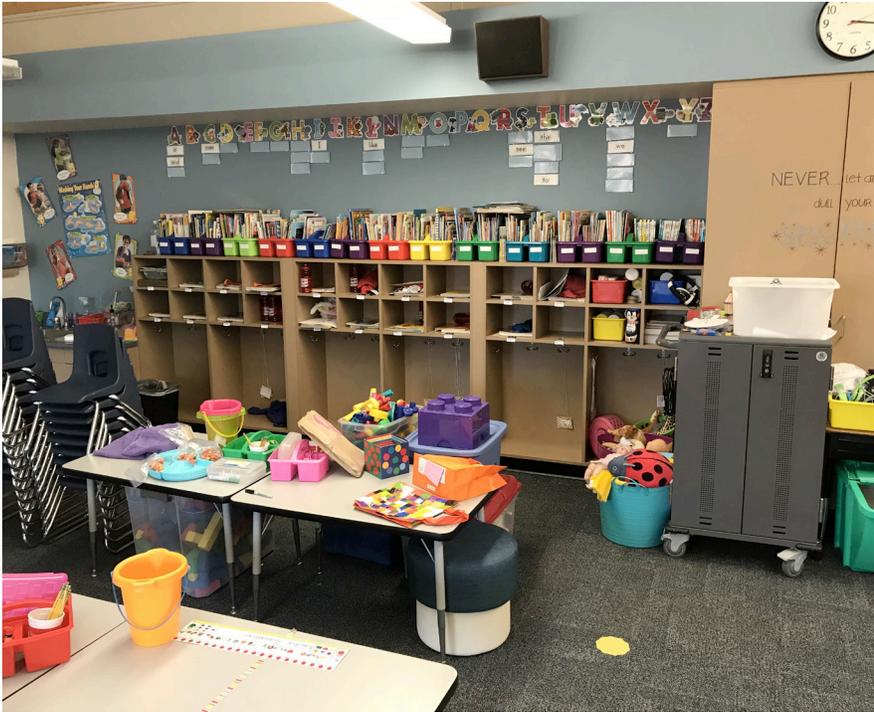
Typical Classroom: 24 shared cubbies. Need to be one cubby per student. Rooms have 709 s.f. which is smaller than most other schools in the district that have a minimum of 850 to 900 s.f.

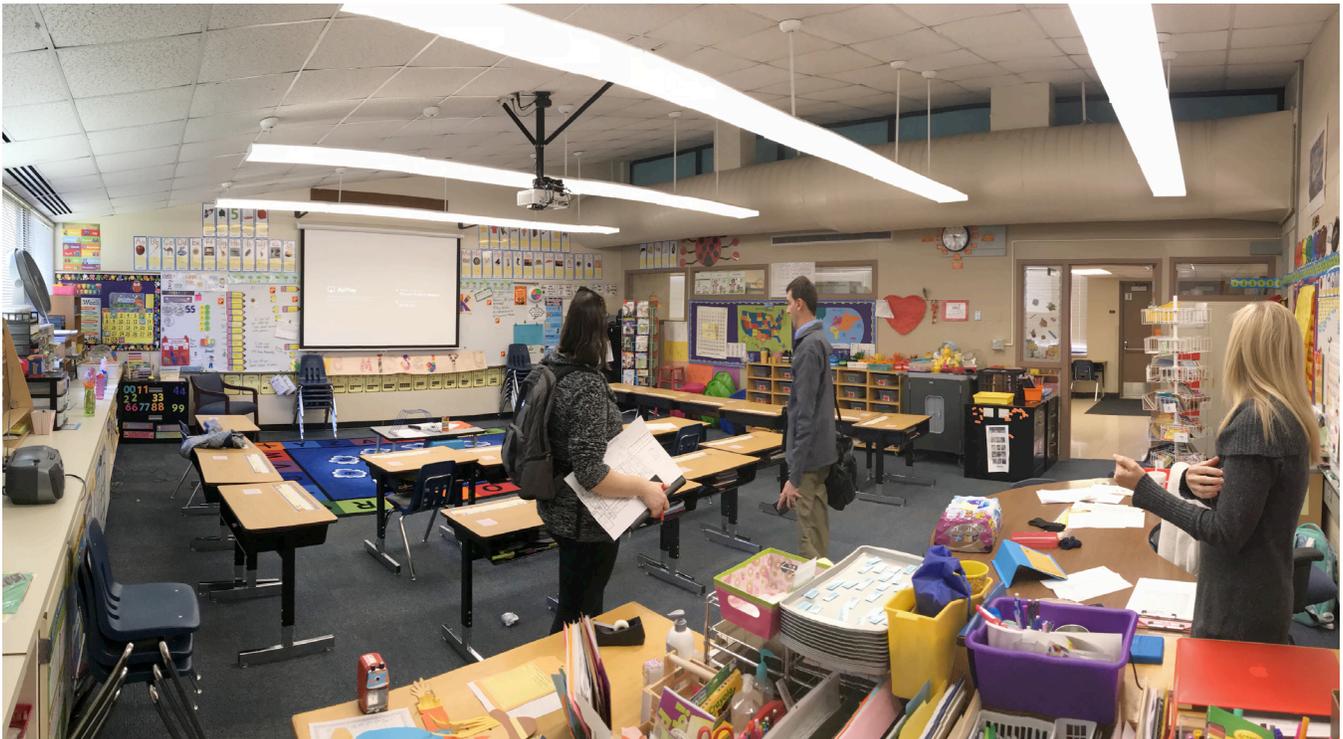
Small classrooms (709 s.f.) with traditional desks. Need different furniture types to allow for various teaching instruction. HVAC moisture problem is causing drooping ceiling tiles. High clerestory windows are covered up and large mechanical ductwork also blocks the clerestory windows.

- **At least one classroom had a portable dehumidifier in classroom and ceiling tiles were visibly sagging most likely due to high humidity levels.**
- **Additional Updates required to bring systems up to current codes:**

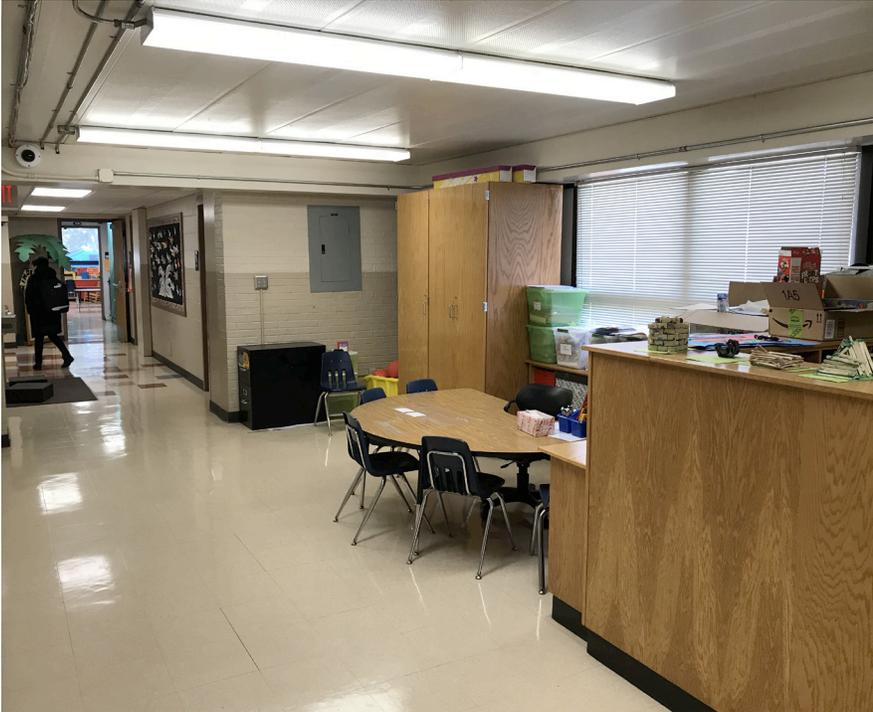
Corridor break out spaces have a lot of wasted space that could be used more efficiently. The wood cubbies are too high, prevents visibility behind them. A kidney shaped table can be used as small break out space but Principal said students using the space are distracted by people walking by. Need updated lighting fixtures.

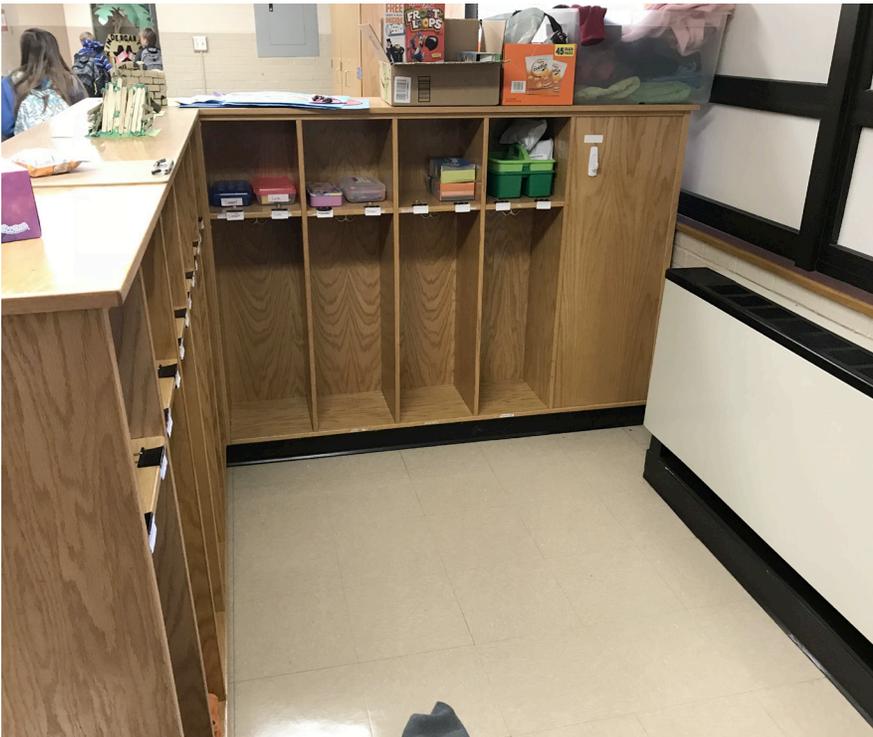
Corridor break out spaces with extra storage. The cubbies are not needed since each classroom has them in the room. These cubbies are too high. Bad visibility allows kids to hide from staff.

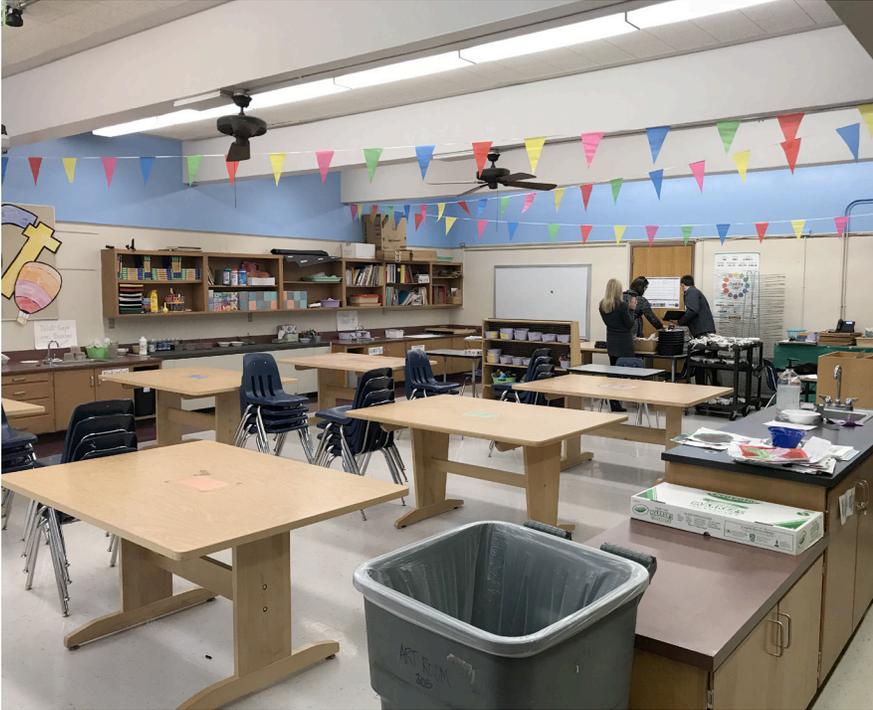
Art Room used as storm shelter so it has no windows for natural light. The Special Ed Resource room also has no windows.

18. Social Worker office next to Nurses area with connecting door. It has exposed electrical panels and conduit on outside wall.
19. Art Room is also a storm shelter so there are no windows. Adequate size room with casework, stainless steel sinks, wood tables and ceiling fans.

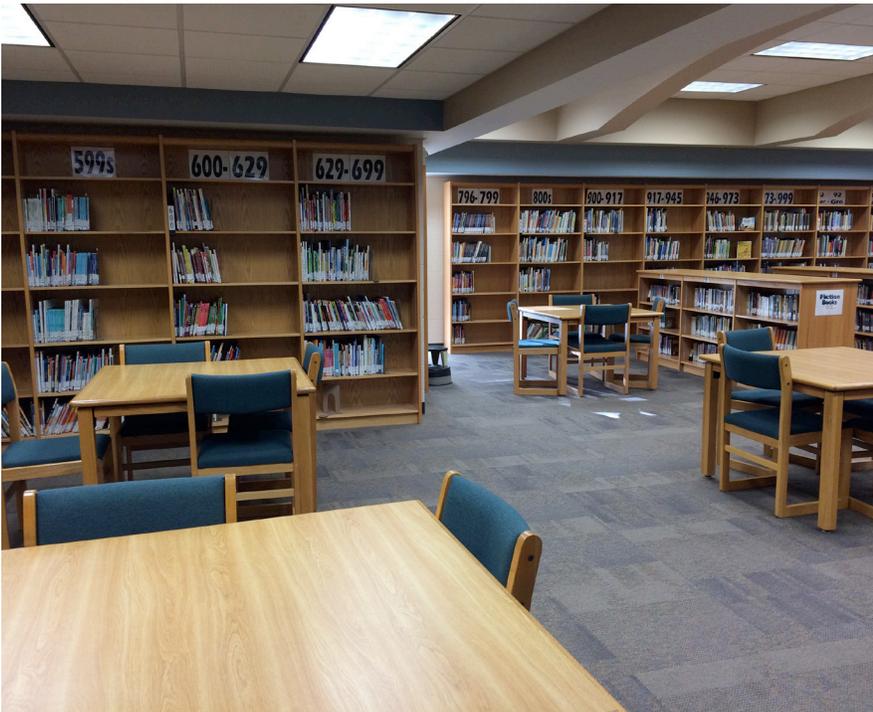
Library needs more natural light. There are no teaching areas in the layout.

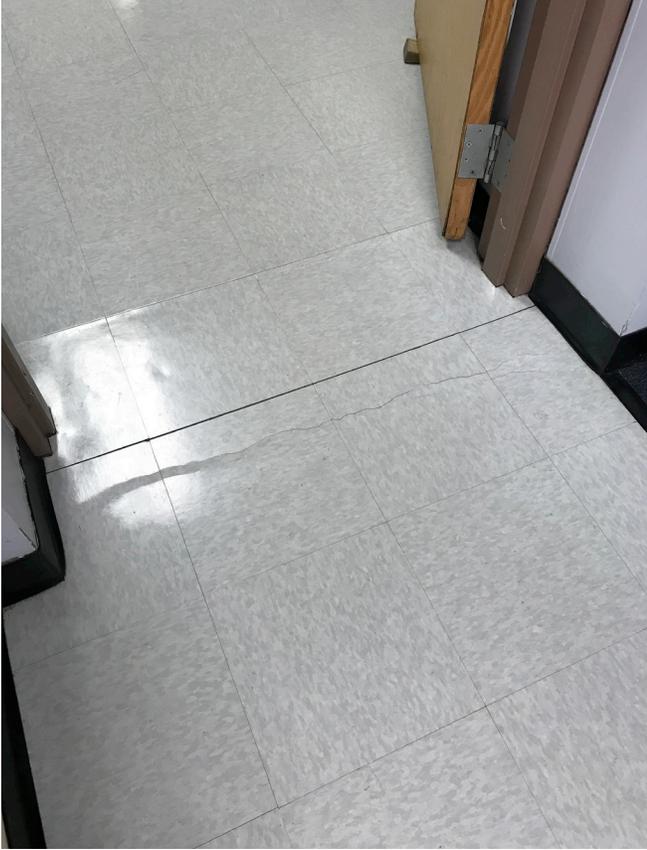
VCT flooring with cracks and unlevel surface for walking.

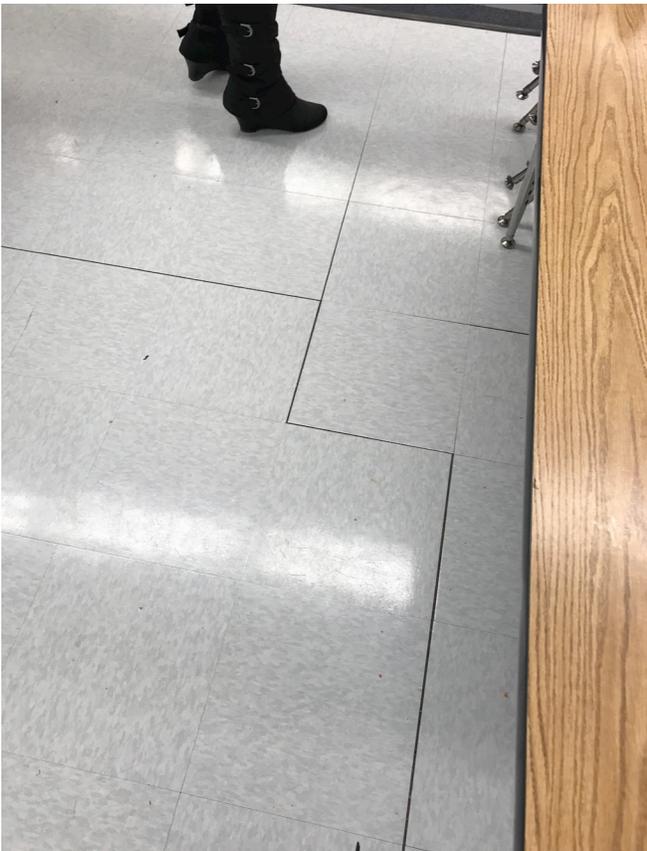
VCT flooring has large gaps in between the tiles.

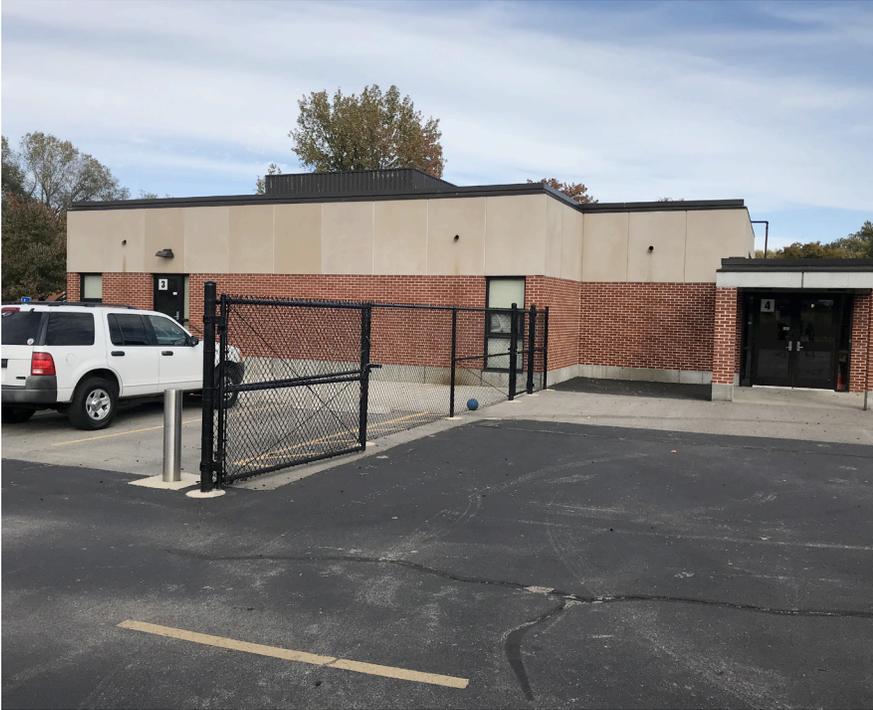
Students in a gym assembly have to come out of these exterior doors, walk through the playground over to the exterior doors to the classroom wing to get to their classes. The corridors are too crowded to walk directly to their classrooms inside the building. Playgrounds too close to drop off areas.

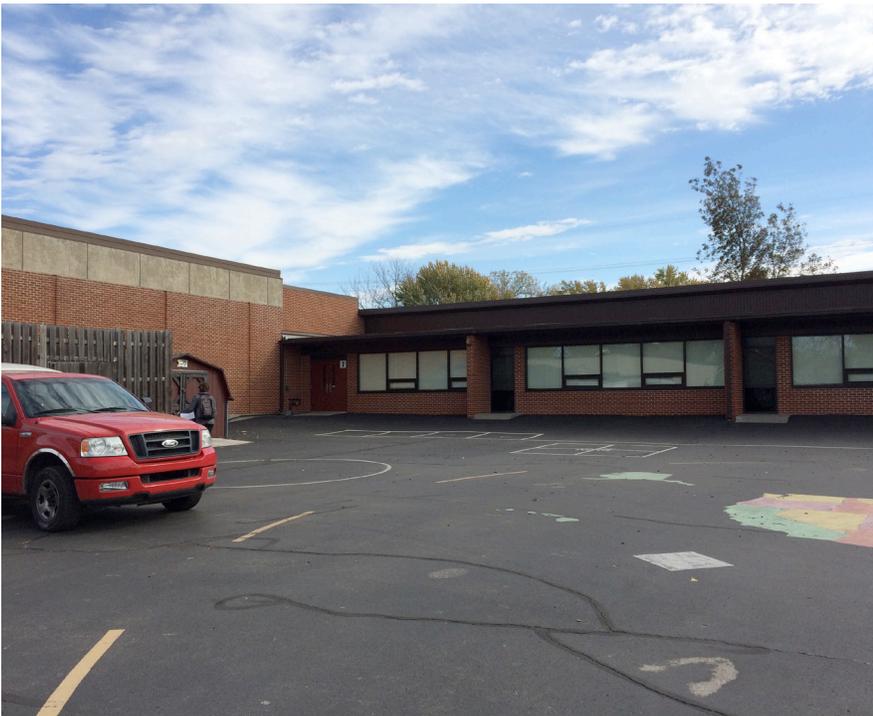
Playground adjacent to parking and drop off areas.

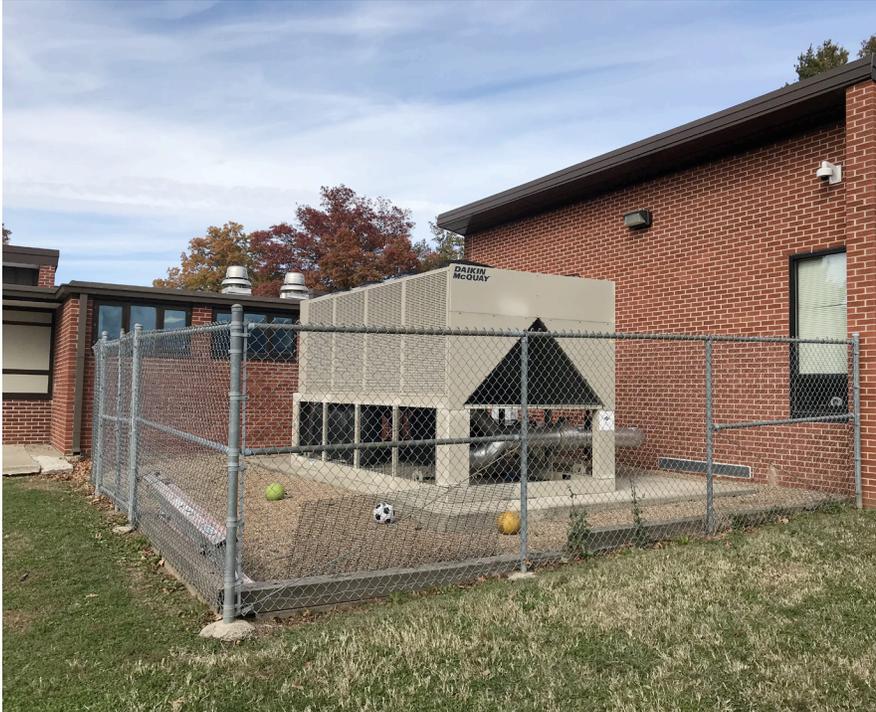
Playground balls are being thrown into the HVAC fence enclosure due to the close proximity to the playgrounds. Roof is accessed with a loose ladder at brick wall west of HVAC equipment.

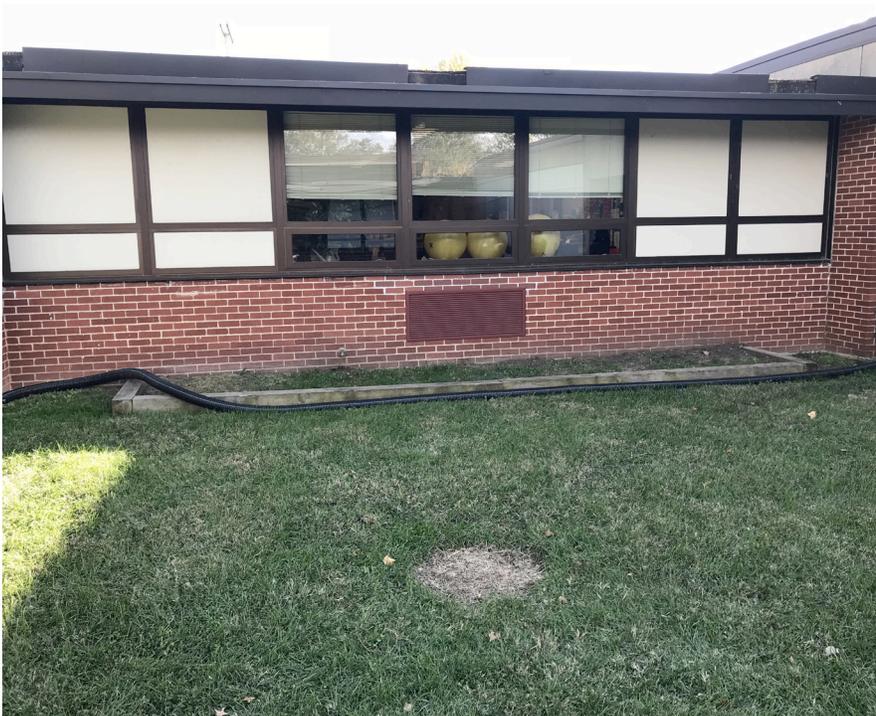
Courtyard drainage issues. Gutters and downspouts all drain into the courtyard. A downspout extender is being used to direct water away from wall.

- **Roof Drains**
 - Roof drains are drained to grade by down spouts and not piped to storm sewer. This causes drainage issues around the building.
- **Some restroom groups appeared to have been updated with new fixtures, wall and floor finishes and were in good condition.**

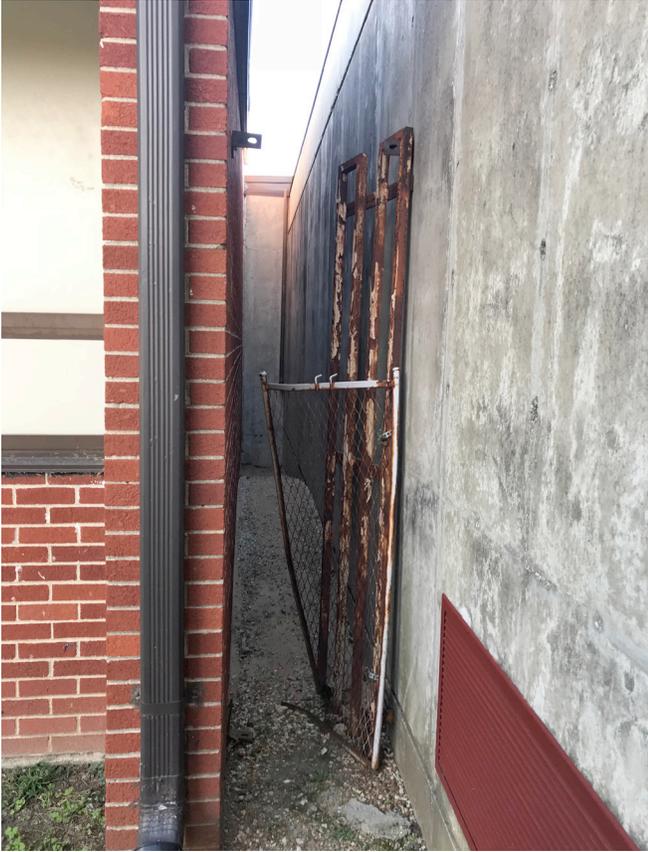
Exterior building: maintenance issues at brick and foundation walls.

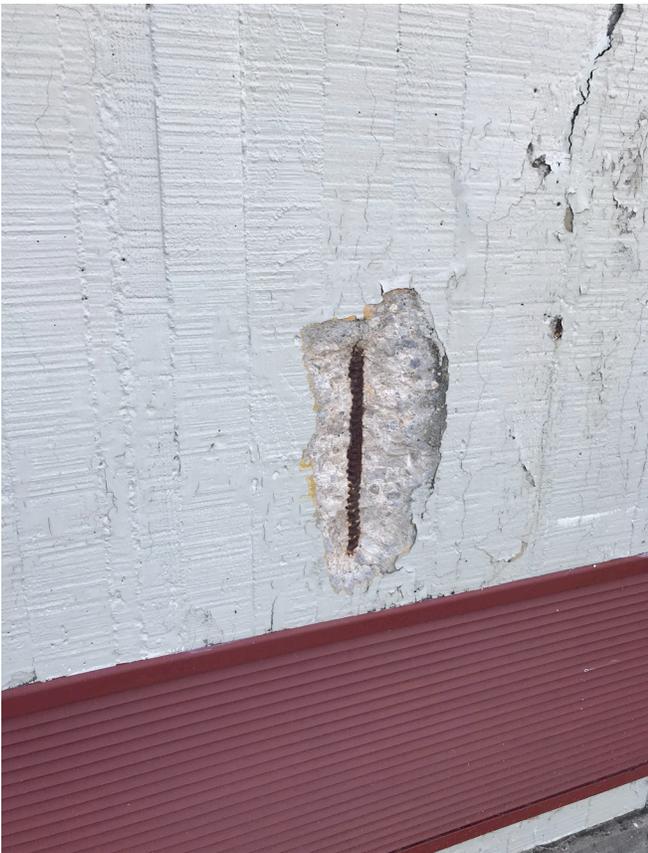
Concrete surface deterioration due to moisture issues.

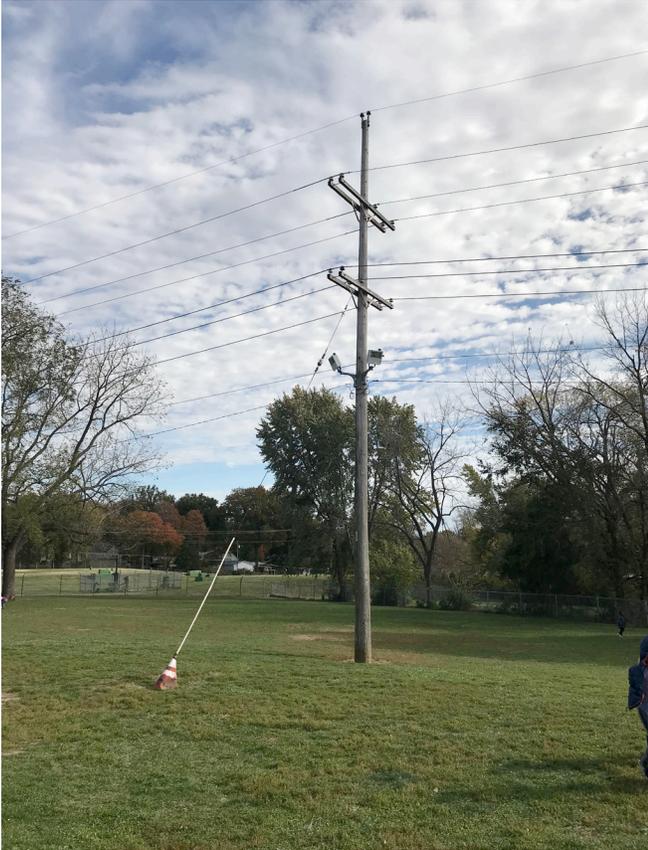
Overhead powerlines running through the playground areas. Guy wires are a tripping hazard.

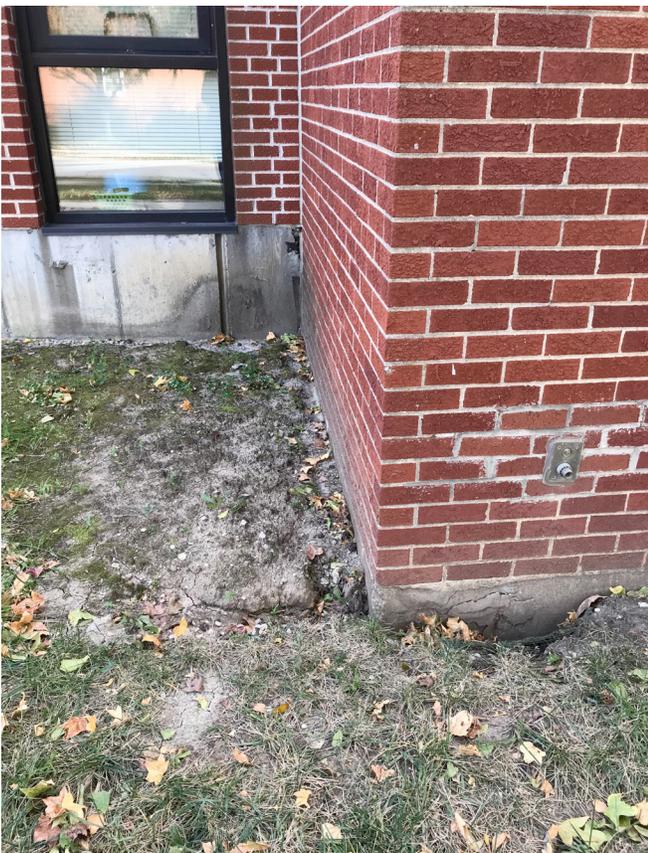
Exterior building: maintenance issues at brick and foundation walls.

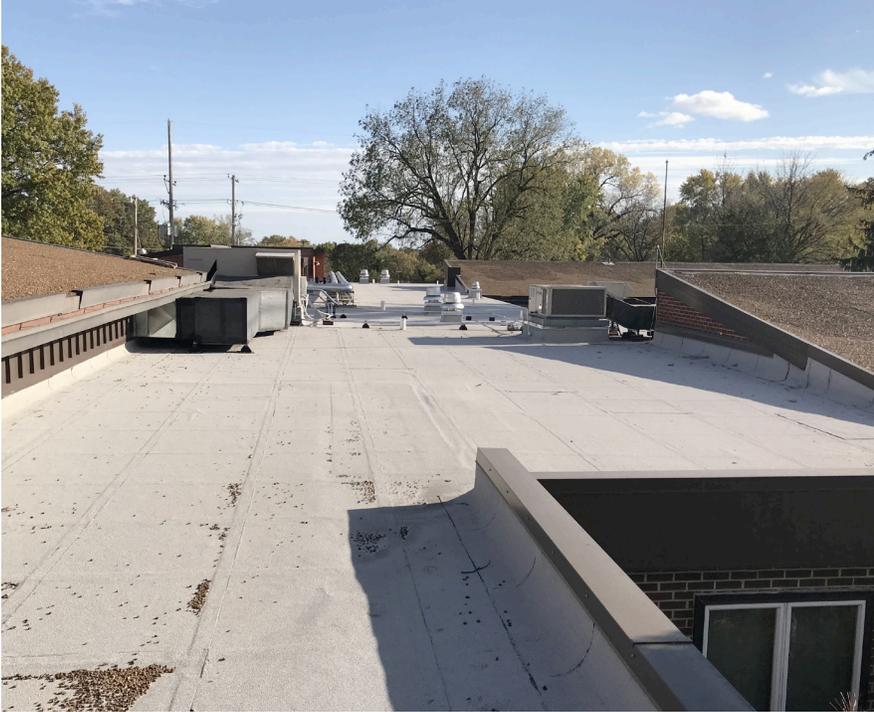
Gravel at ballasted roofs is washing away. No permanent roof access.

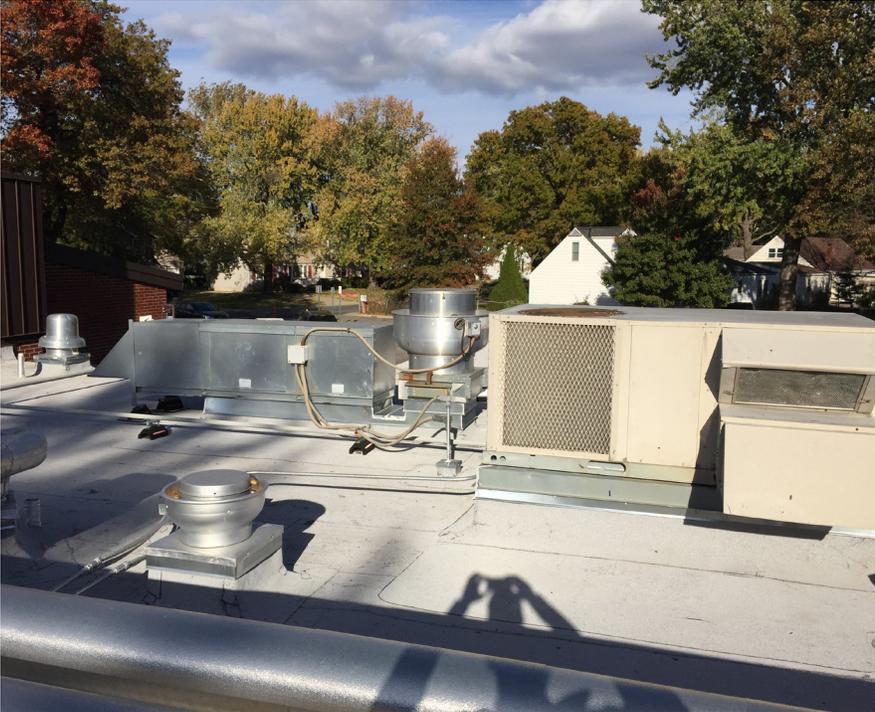
Distance from exhaust outlet to outside air intake should be a minimum of 10 feet does not appear to be

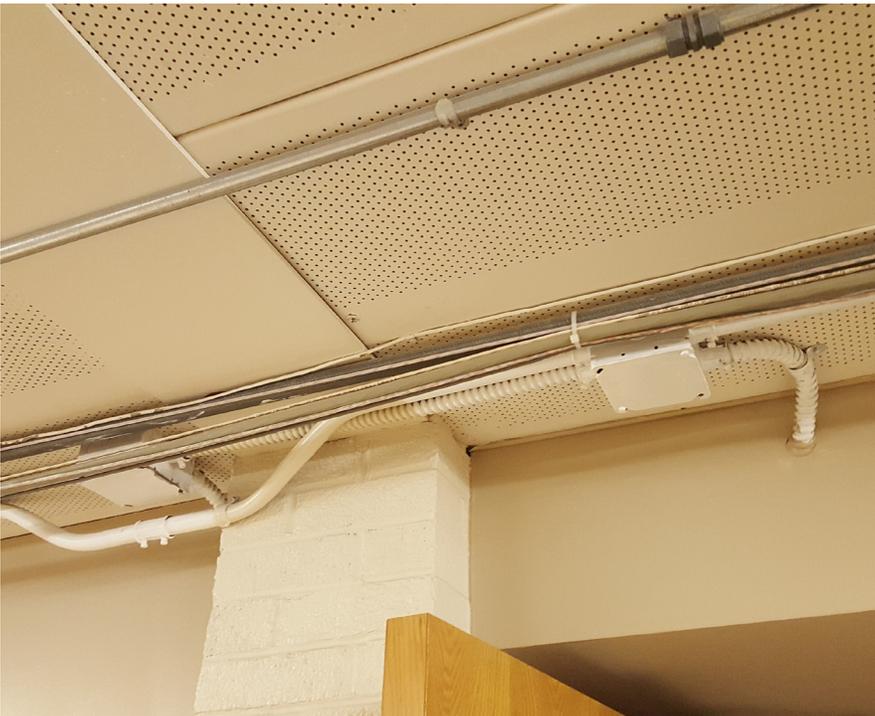
Hallway ceiling exposed conduits

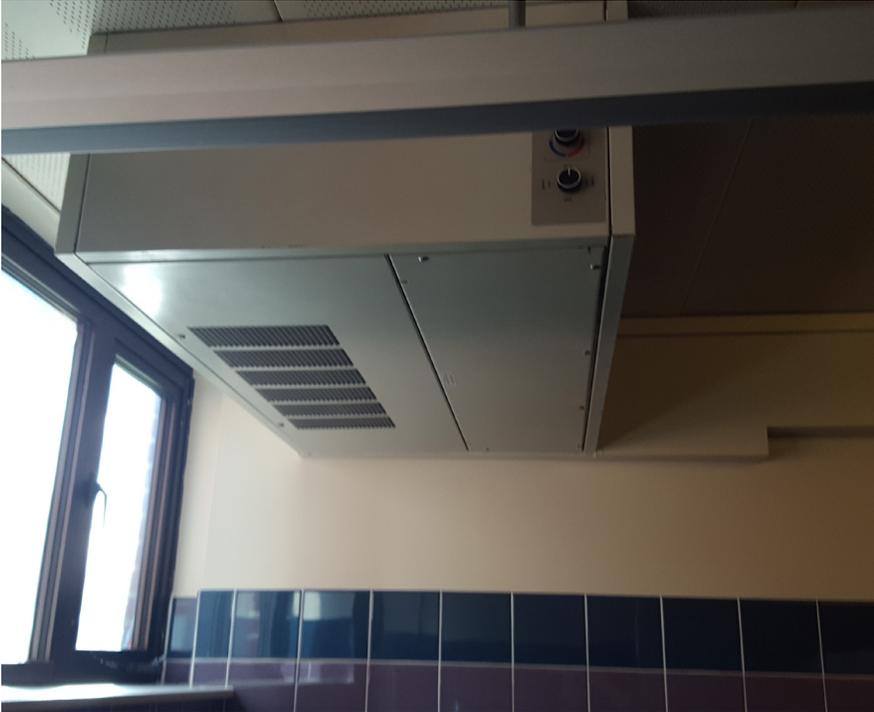
HVAC unit in restroom - accessible to students

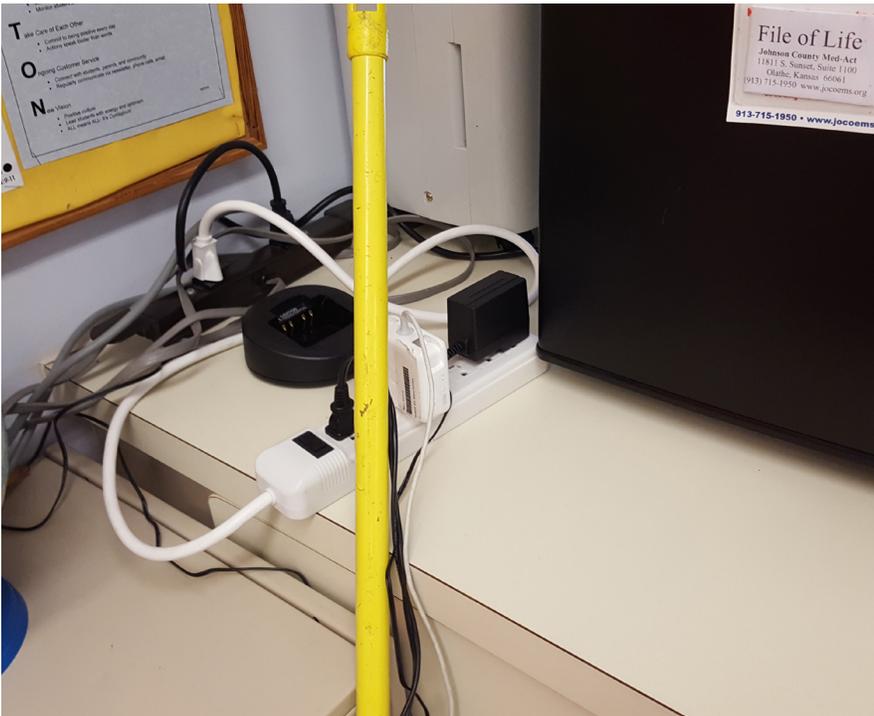
Insufficient electrical outlet quantities

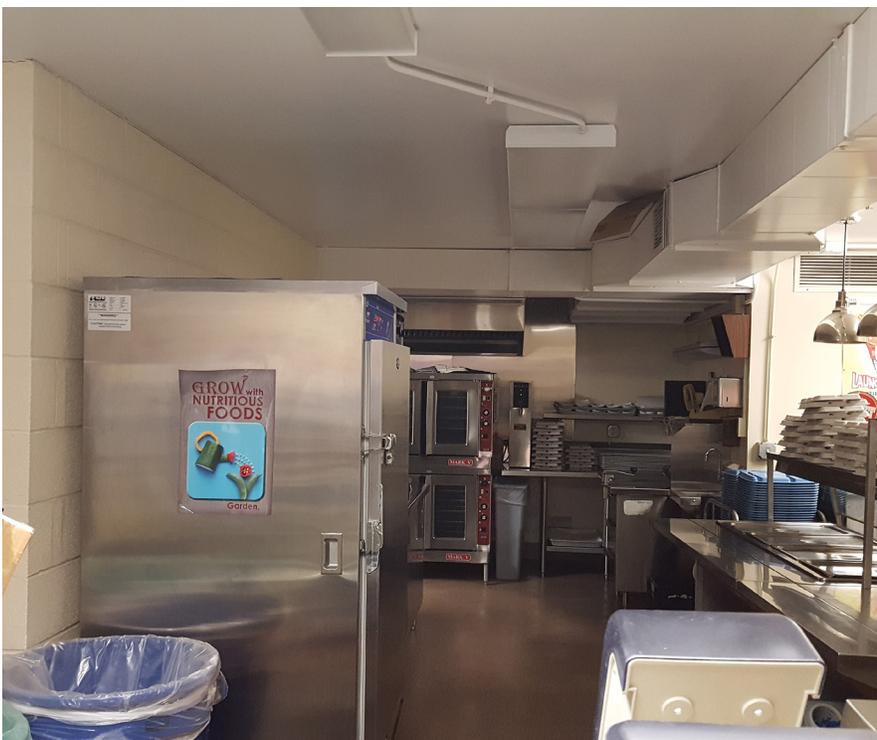
Low head clearance in Kitchen

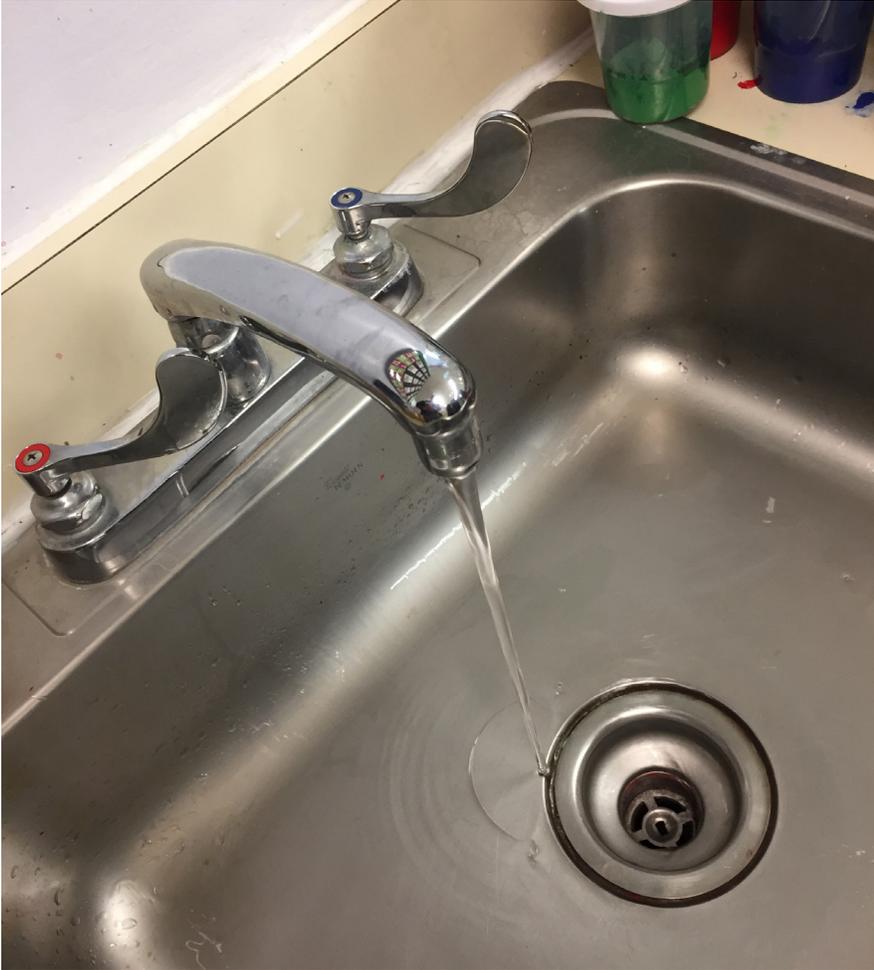
Low pressure for hot water supply from classroom sinks

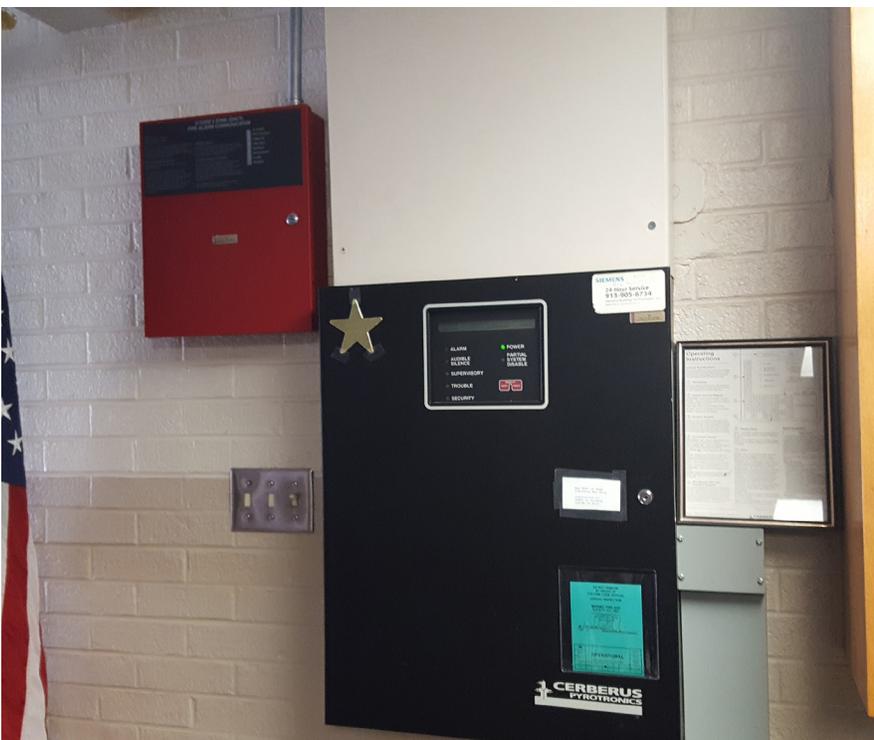
Main fire alarm control panel for outdated system

- Fire Alarm – Complete Replacement of all devices and control panels to support a mass notification system. Additional Smoke Detection may be required.

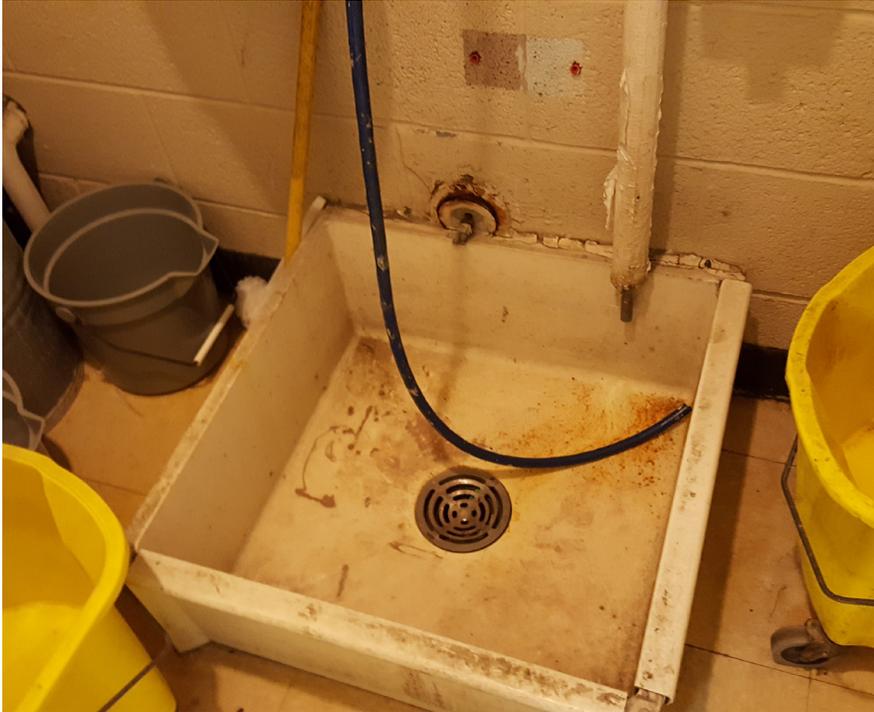
Mop sink deteriorated
recommend replacement

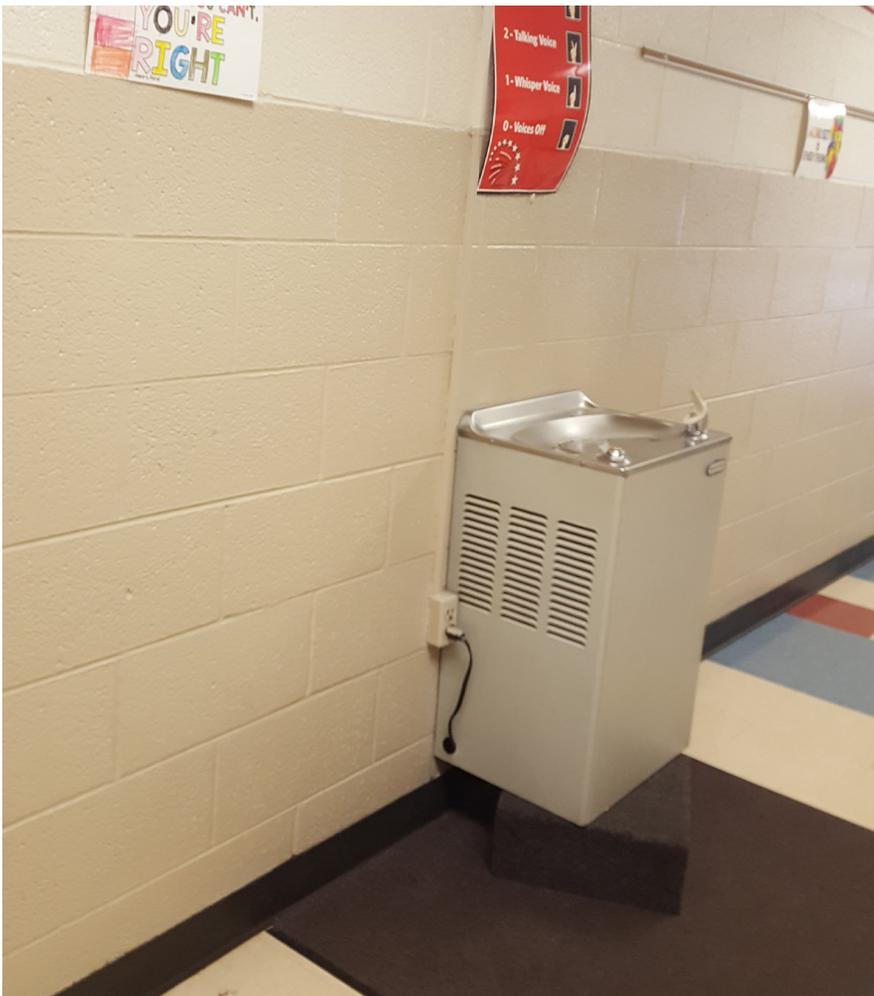
Non-accessible drinking fountain

- **Additional Updates required to bring systems up to current codes:**
 - Not all water coolers and plumbing fixtures are ADA compliant.
 - All handwashing sinks shall have thermostat mixing valve to limit maximum water hot water temperature to 110°F.
- **Additional Updates required to bring systems up to current SMSD Standards:**
 - Replace all faucets and flush valves with Toto sensor devices.
 - Add accessible roll in shower to Nurse Area.
 - Hot water shall be with-in 3 feet of every hand washing sink.
 - All classrooms shall be provided with a sink in the classroom.
 - Replace majority of water closets to wall mounted water closets.
