RUSHTON ELEMENTARY

FACILITY EVALUATION

OVERALL SUMMARY

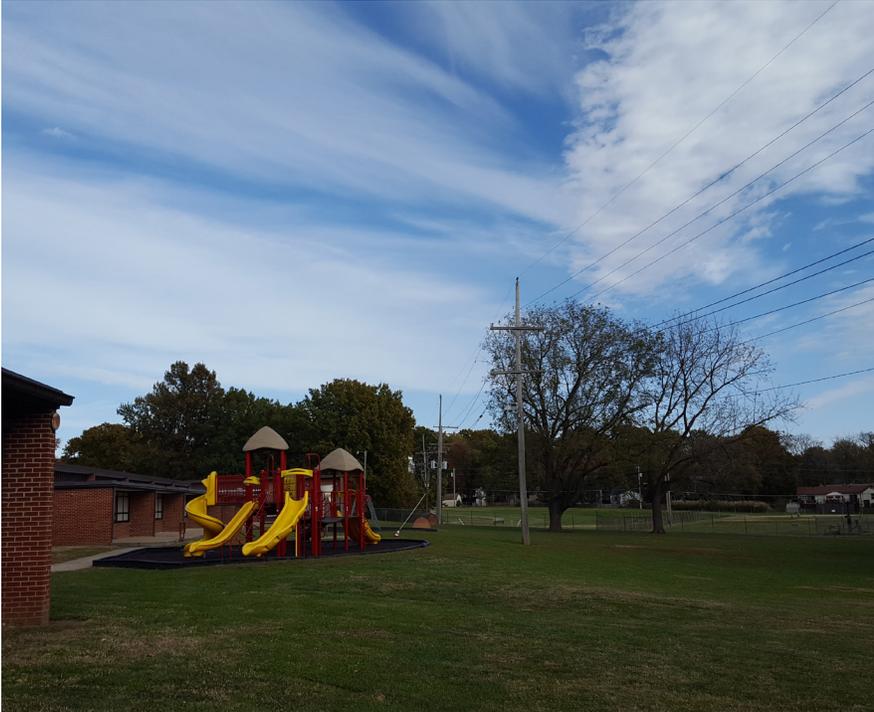
Overhead power lines above playground

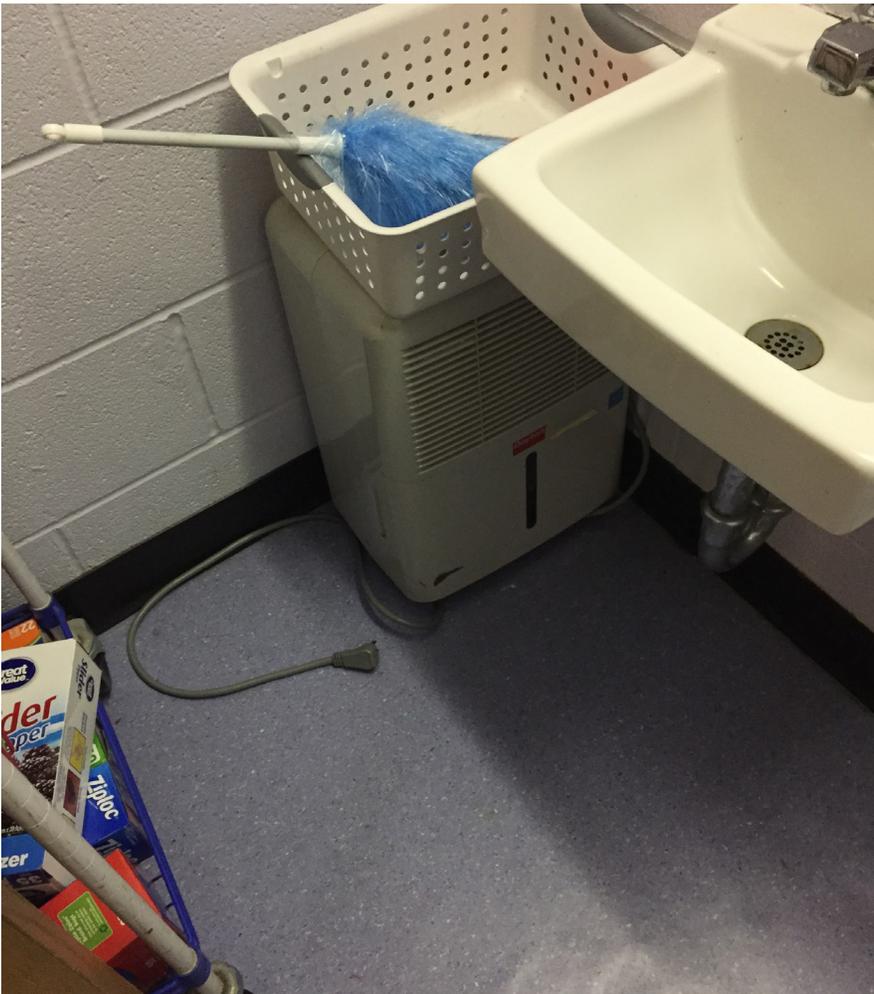
Portable dehumidification unit indicates high humidity levels

- Air Handler serving Newest Classroom wing often requires power reset and does not control humidity in the space to reasonable levels. Humidity has exceeded 60-70%.

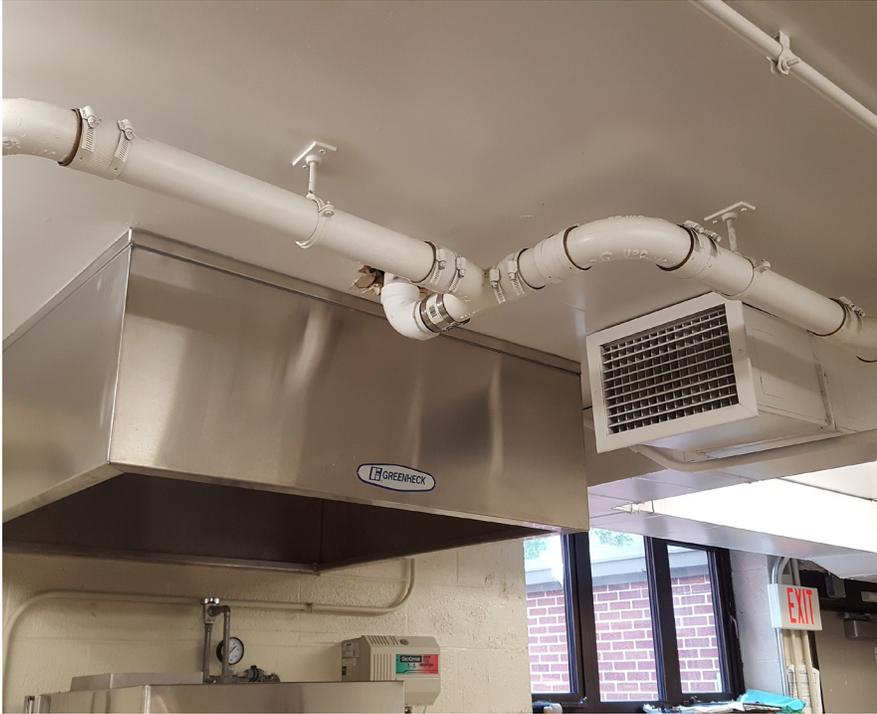
Sanitary vent piping near kitchen dishwasher

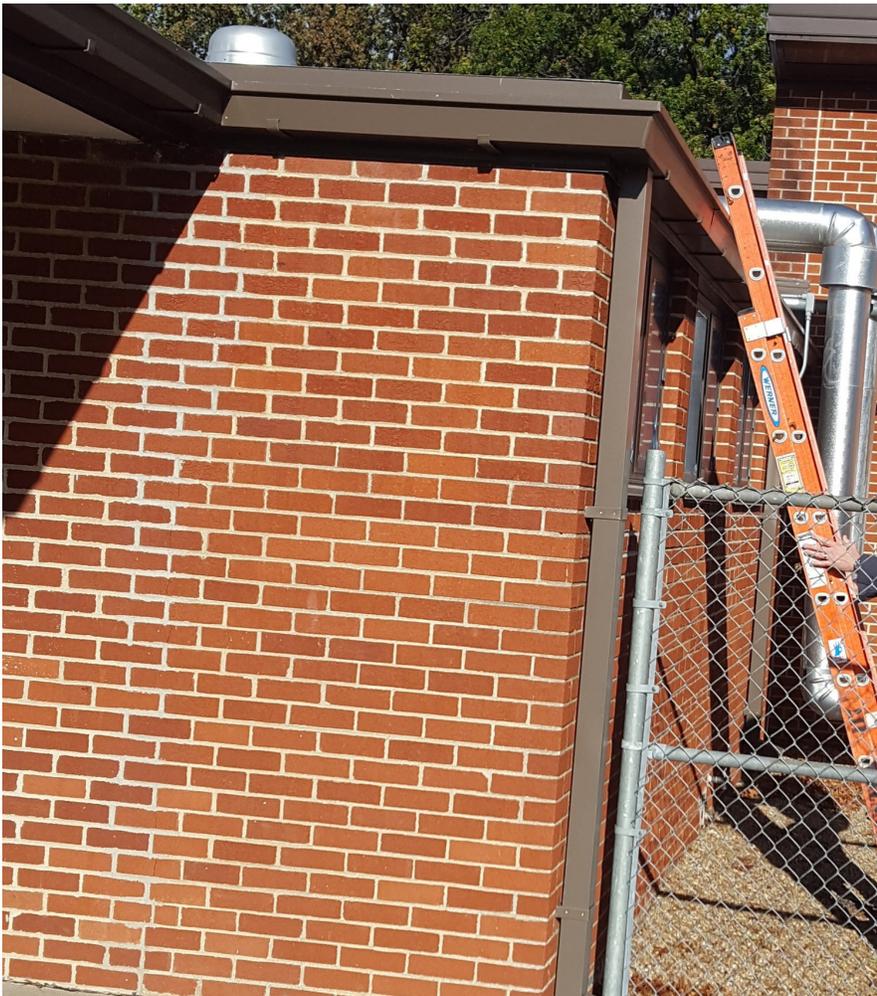
Roof Access is not permanent

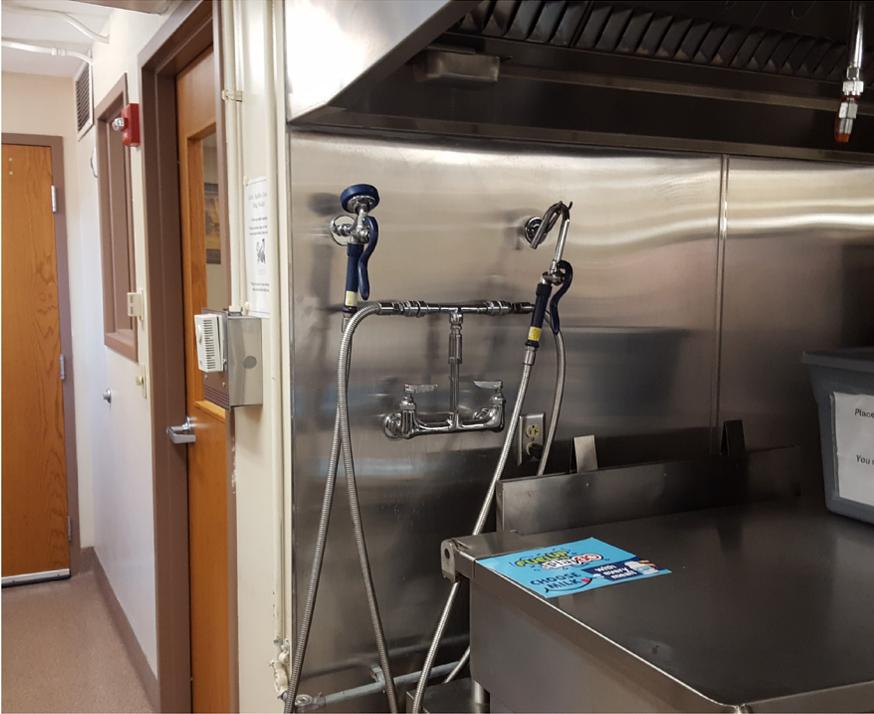
Thermostat near cooking line could cause false operation

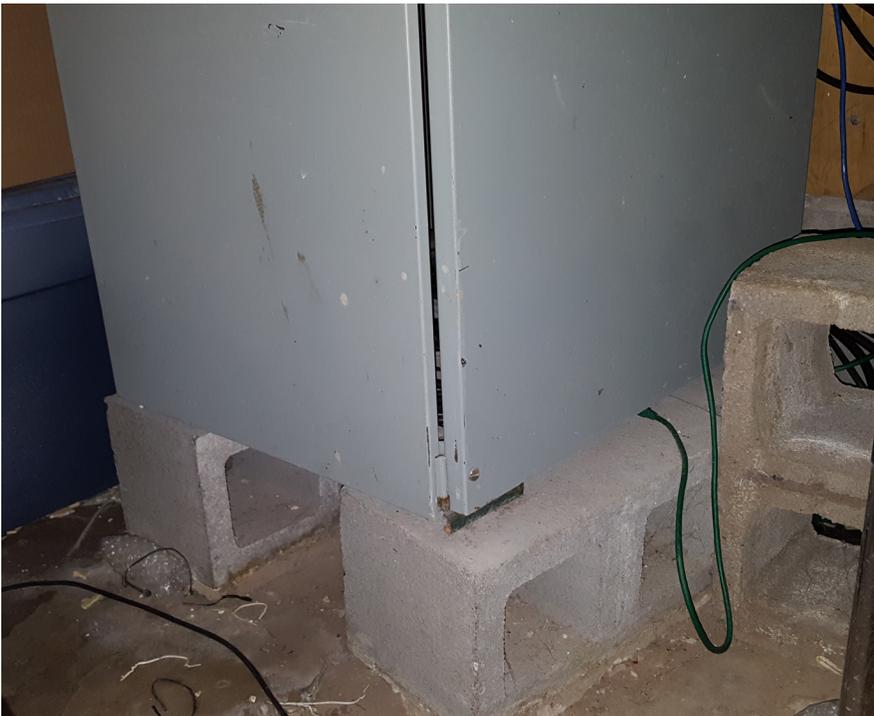
Data rack on blocks in basement that floods
