EAST ANTIOCH ELEMENTARY

# FACILITY EVALUATION

# OVERALL SUMMARY

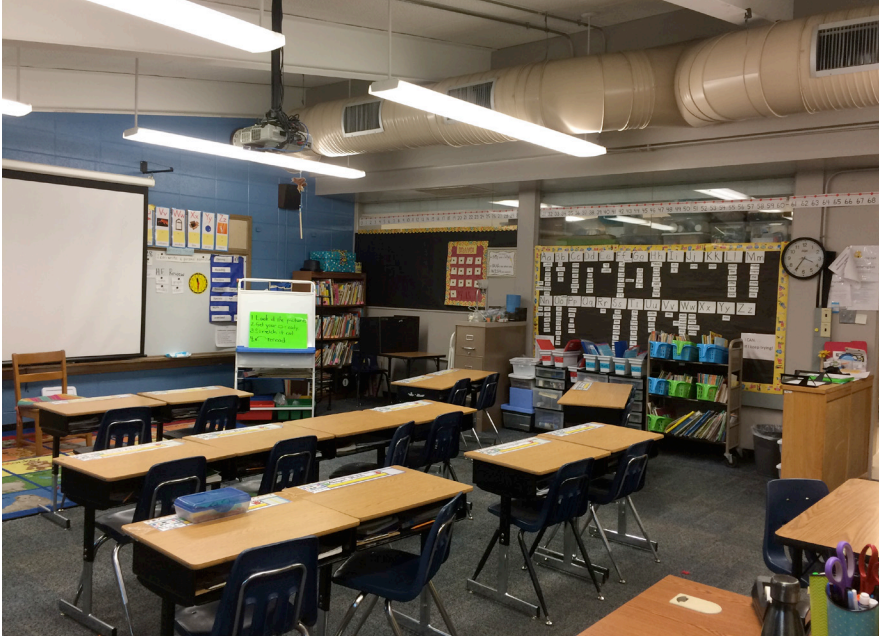
Exposed round ductwork blocks clerestory windows. Classrooms have traditional desks. Need different casework and furniture to allow for various methods of teaching instruction.

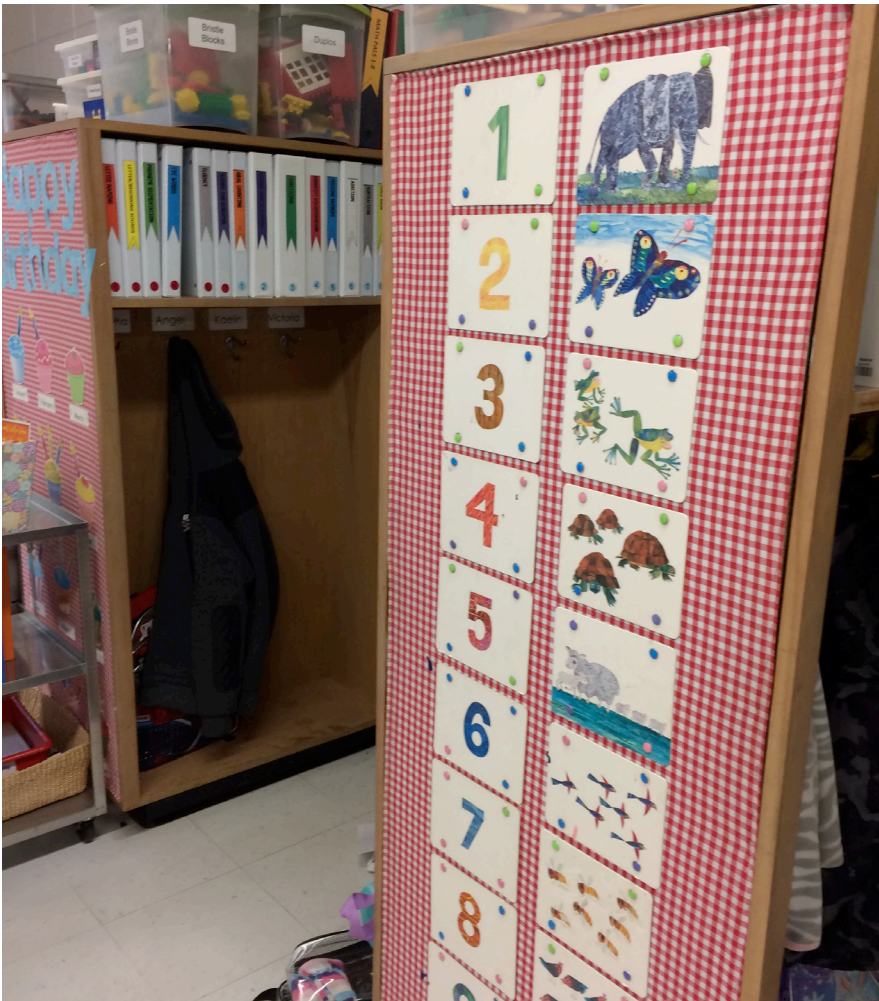
No individual cubby storage is provided in Kindergarten rooms, only coat hooks.

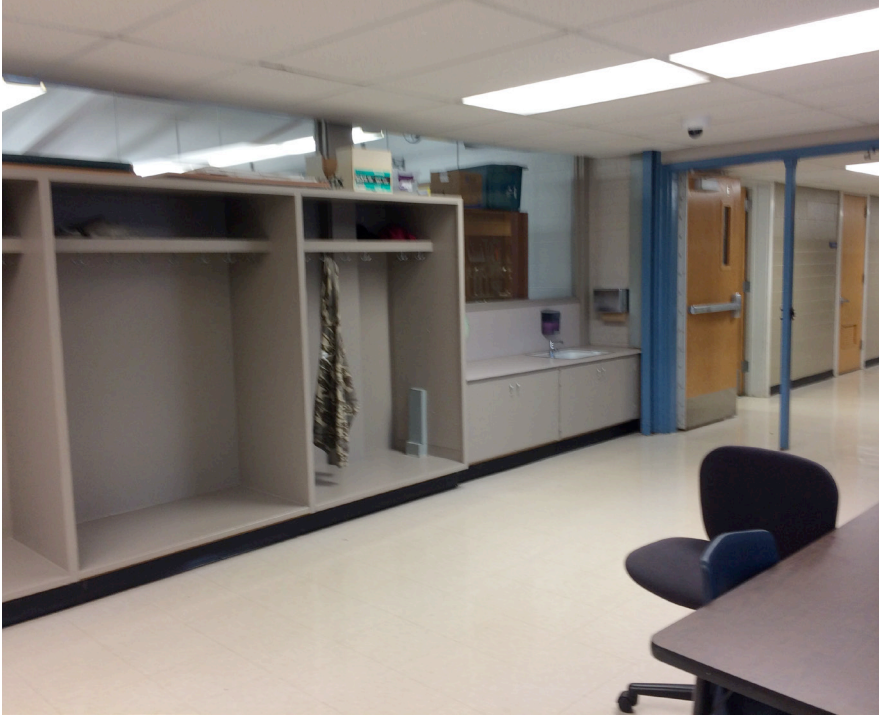
Coat hooks are provided in corridors in lieu of individual classroom cubbies at 1st thru 6th Grade classrooms.

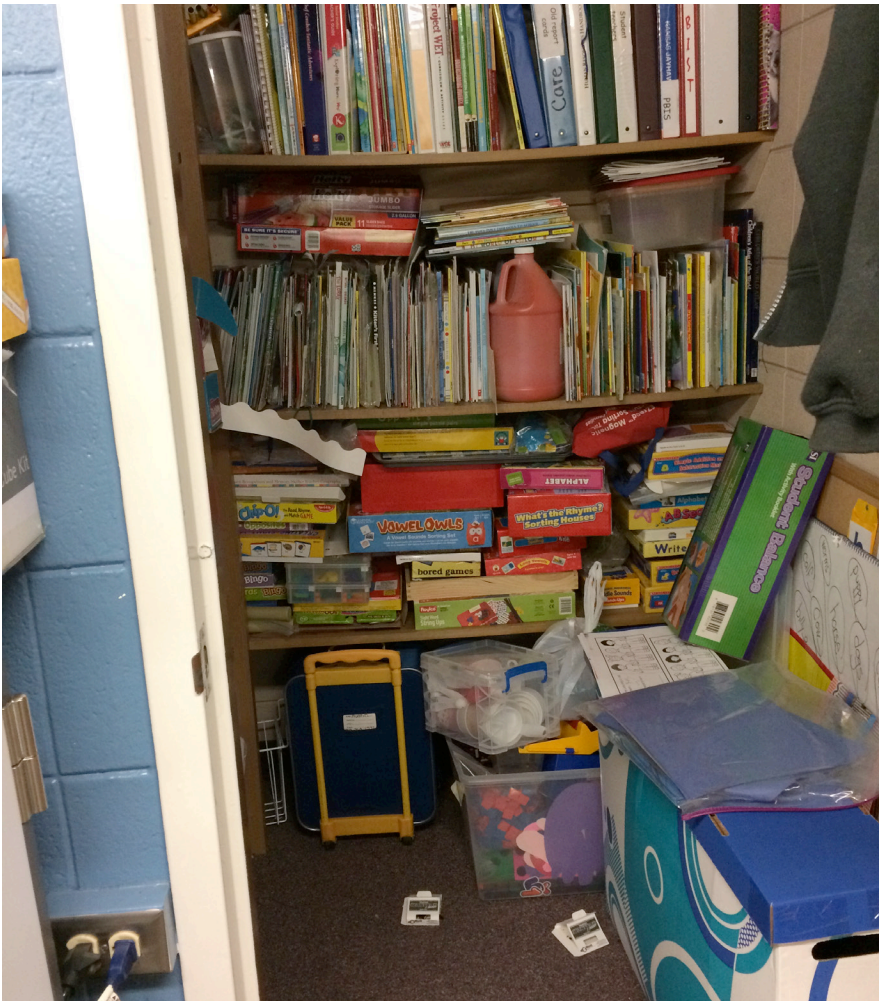
Kindergarten storage closet is too small.

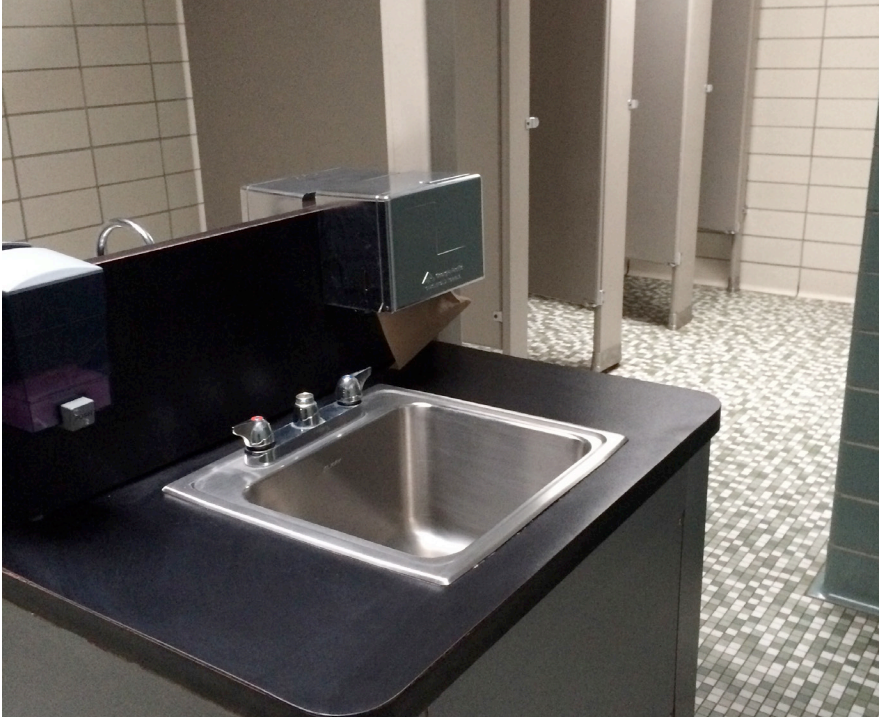
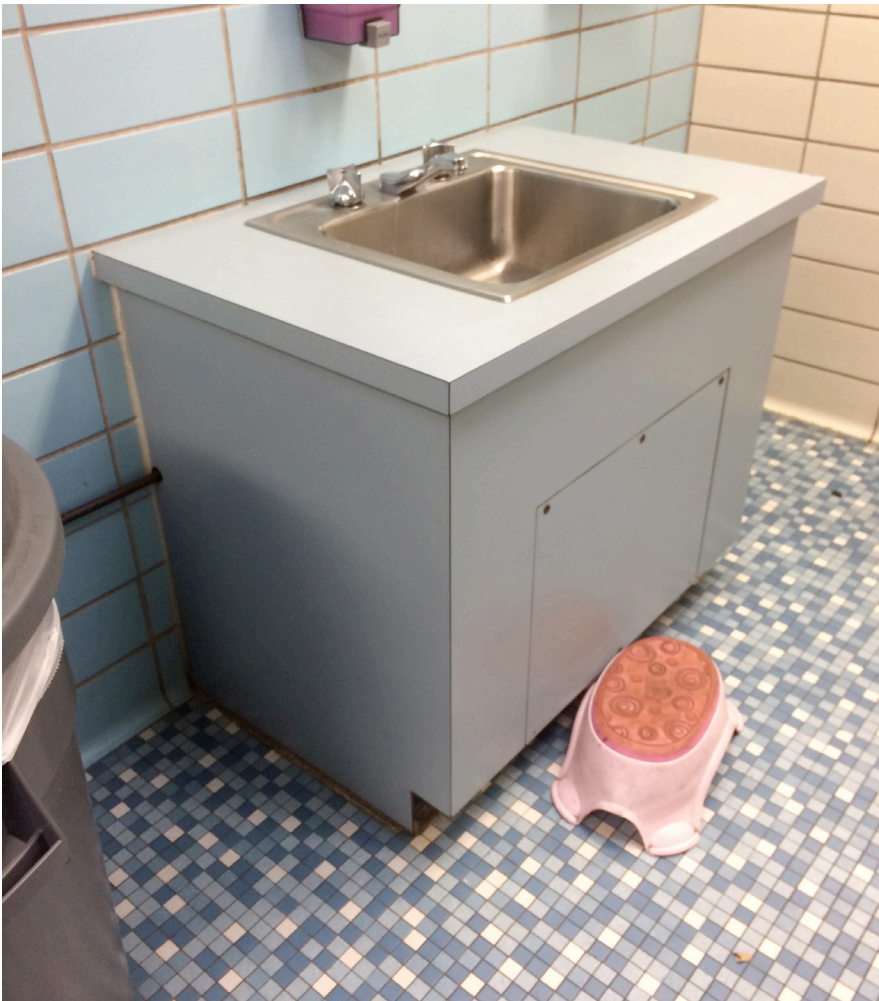
Student toilet rooms need updating. Most of them are not ADA accessible. No faucet on one side of the sink island. No mirrors. Plastic laminate countertops not typical in most Boys/Girls toilets.

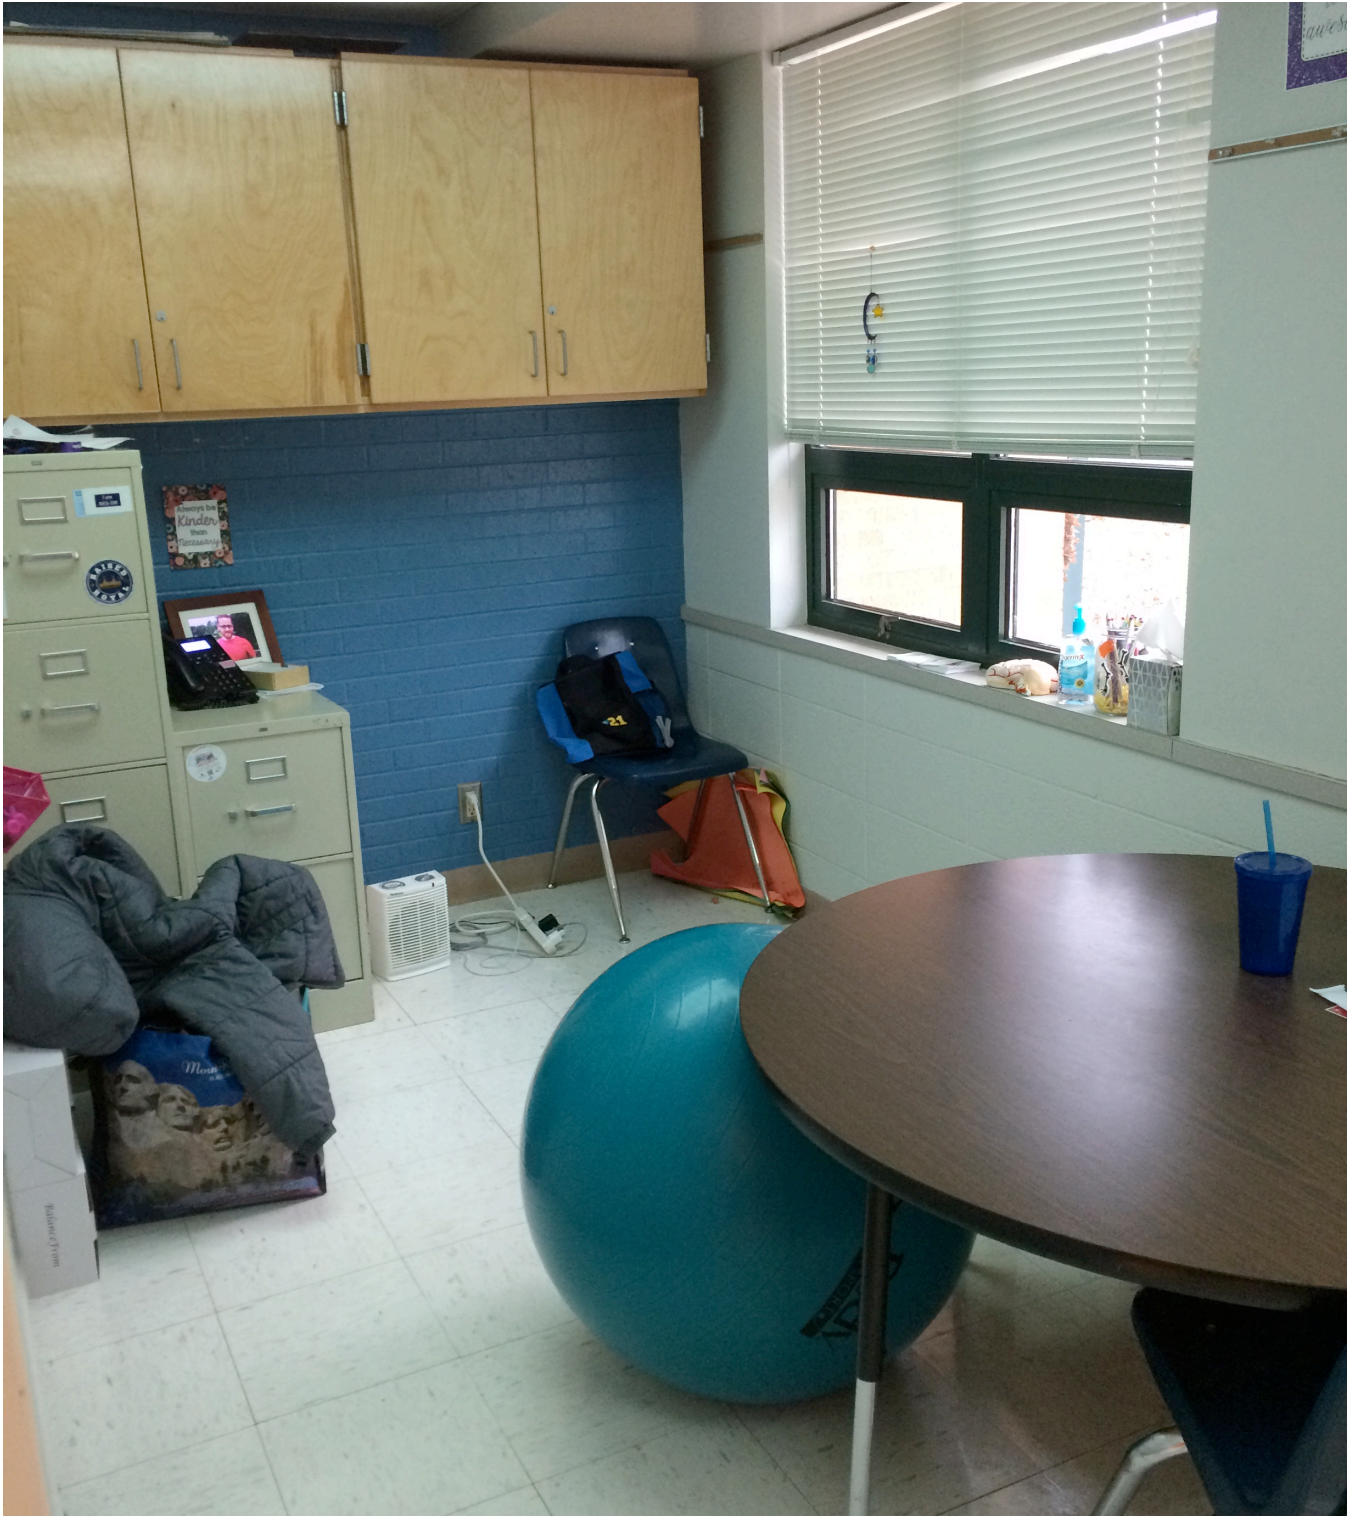
Small Social Worker room.

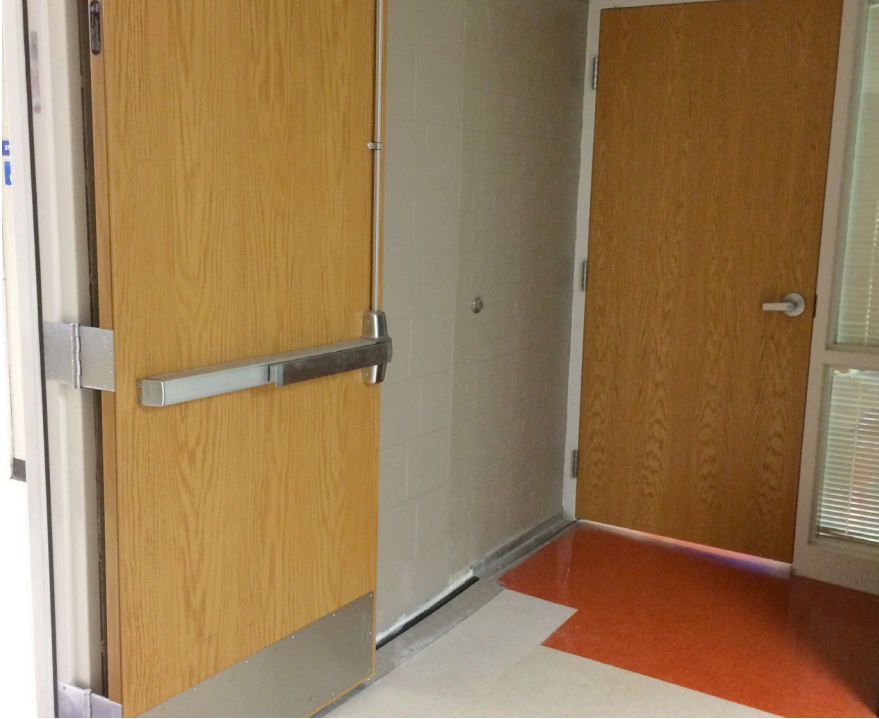
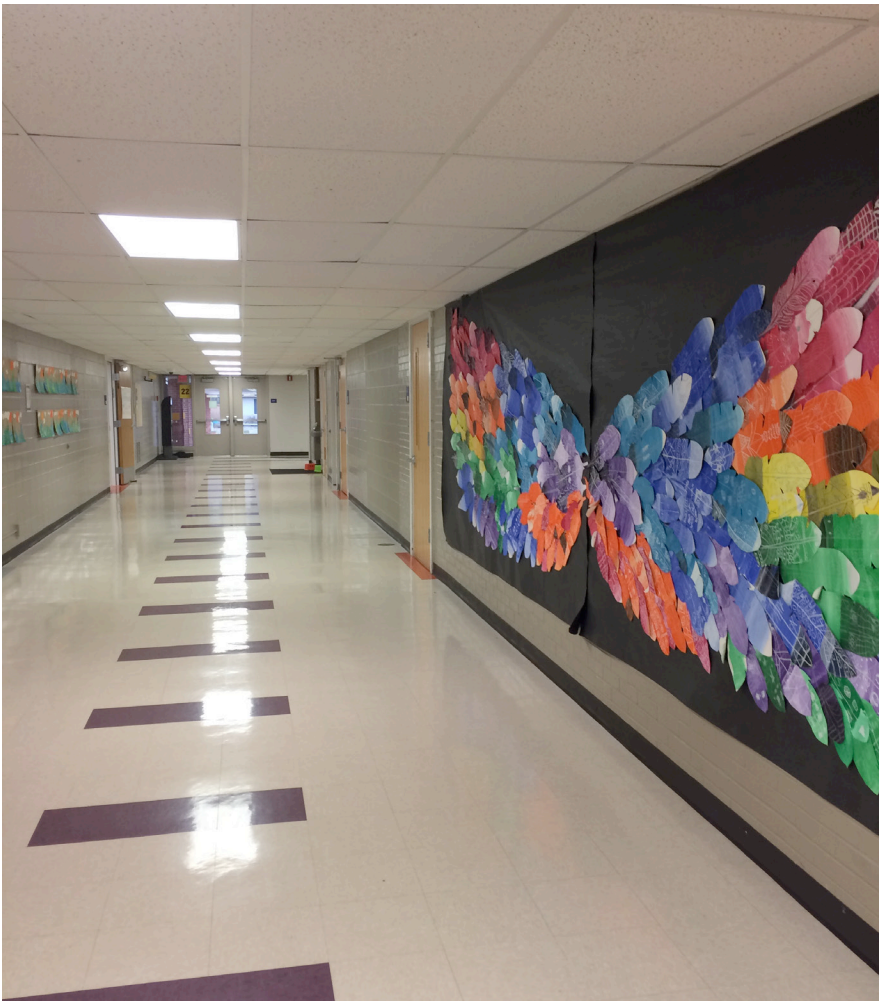
Corridor ceilings are only 7'-4" tall in some areas.

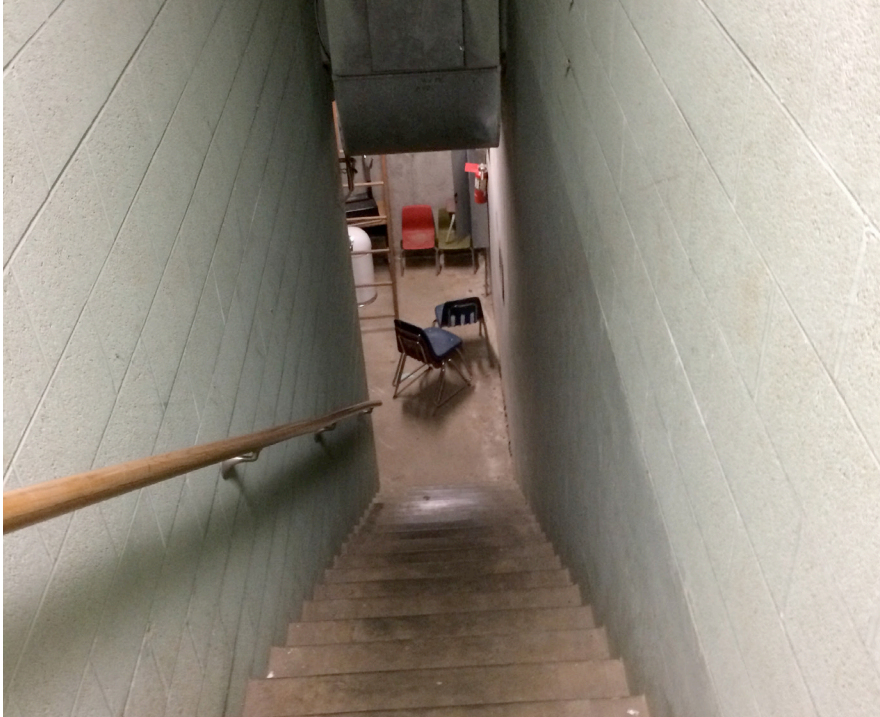
Steps to basement mechanical room too steep (7  $\frac{3}{4}$ " risers and 10" treads)

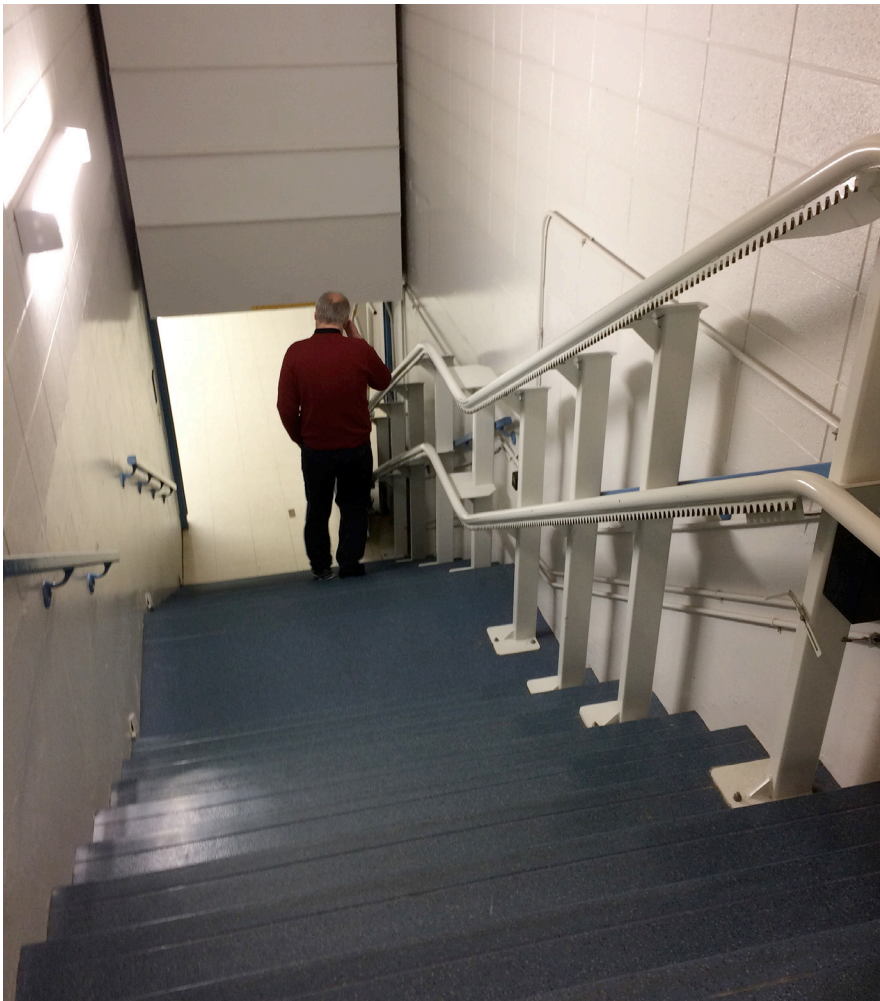
Chair lift at stairs to Storm Shelter Basement Music and Band rooms. No elevator.

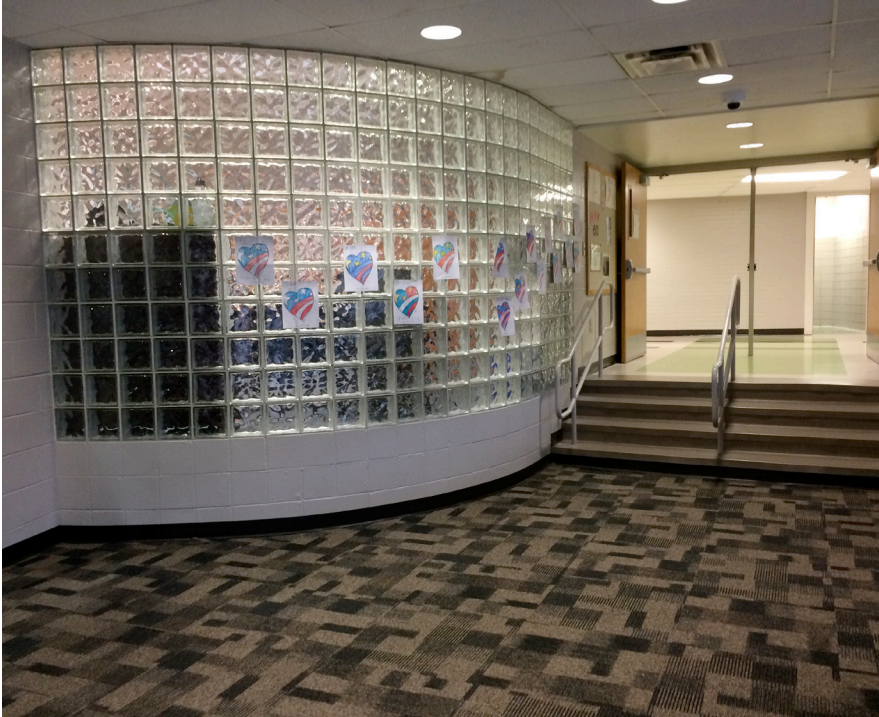
Steps to gym lobby have no chair lift.

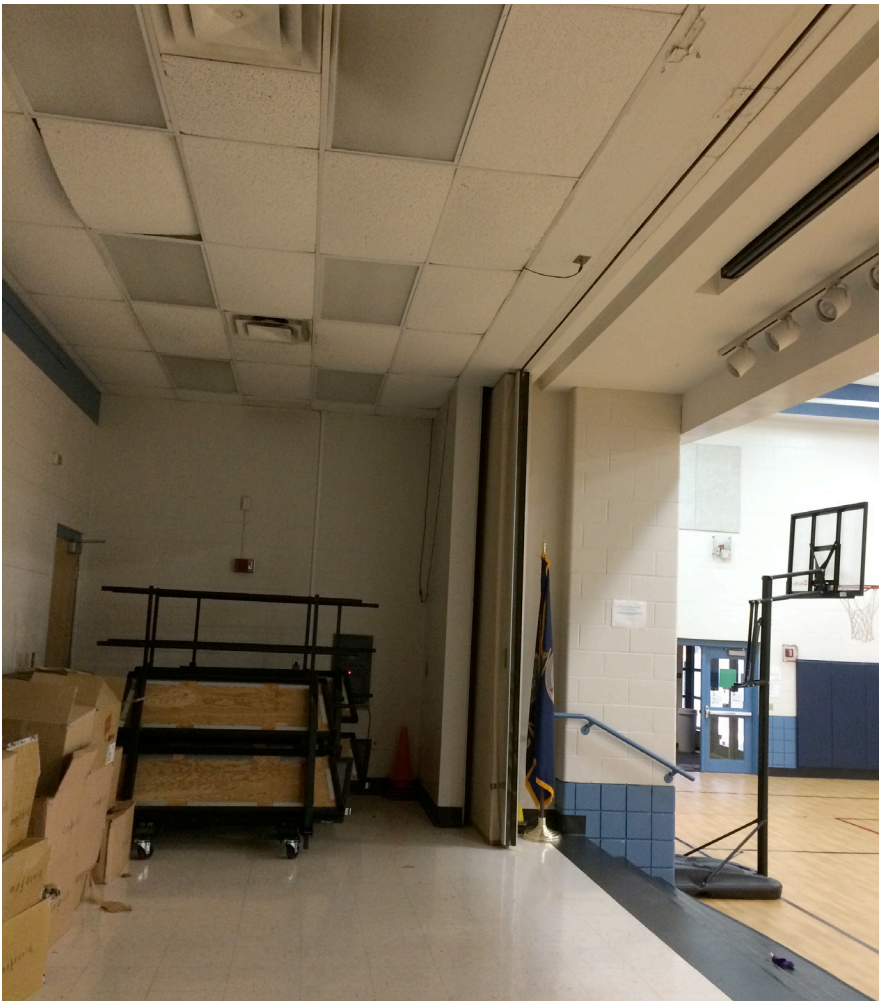
Stage: Droopy ceiling tiles as a result of humidity issue. Accordion door is used at stage to create a separate room when needed, but the acoustics are bad so the room is not used for a classroom.

Gym: 2 freestanding basketball goals not ideal. Ceiling hung crosscourt goals would be more desirable.

19. Stage has an operable partition, no curtains. The lay in ceiling tiles on stage are very droopy probably due to humidity problems. The room is not used for classroom because of the noisy gym.

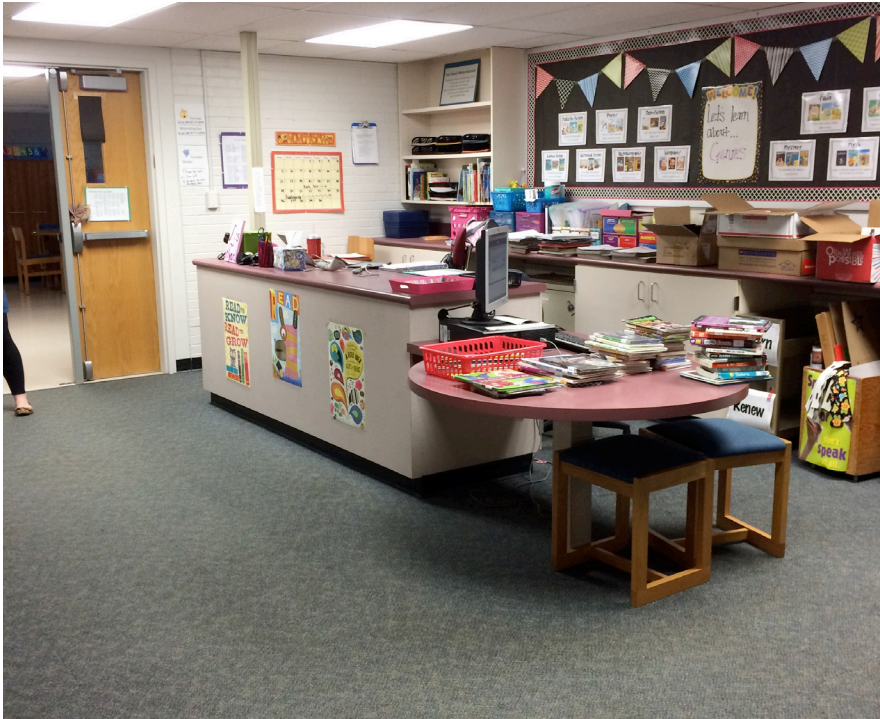
Library has no office or work room. Small check out desk.

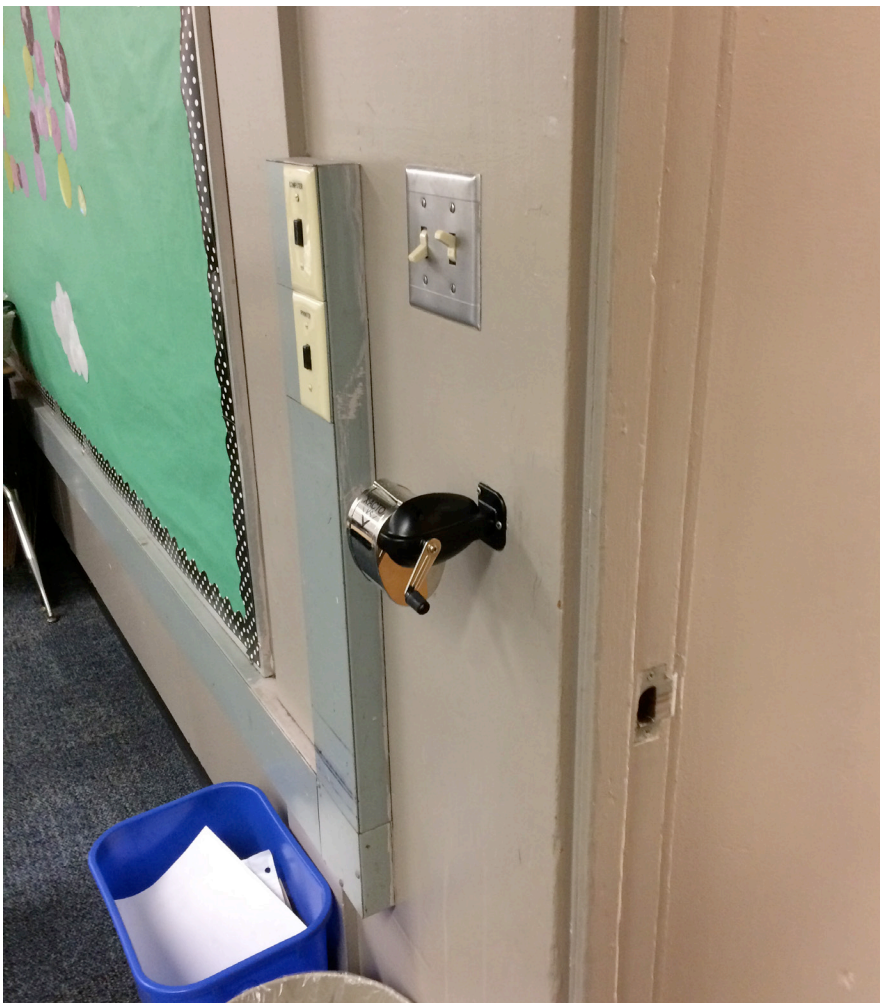
Exposed raceways in classrooms.

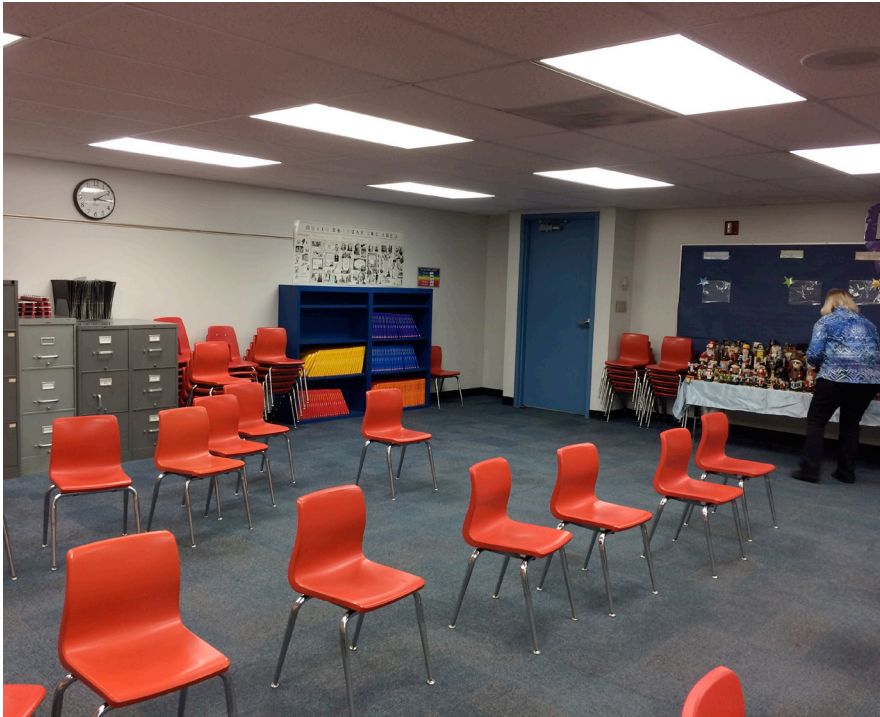
Music and Band rooms in basement have no windows because the space is designated as storm shelter.

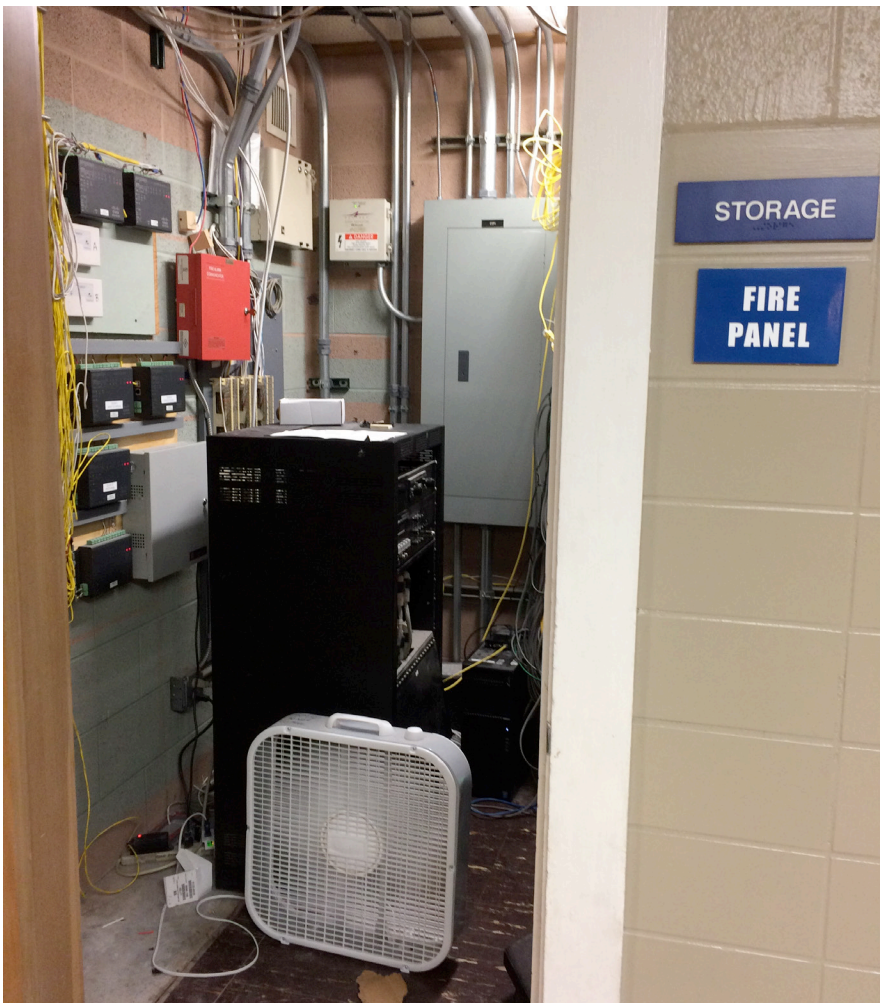
Fire Panel room has equipment that require a cooler space. The box fan is not adequate.

25. There are some data rooms that are not air conditioned (which is desirable for equipment). The maintenance staff has a floor fan in the Fire Panel room.

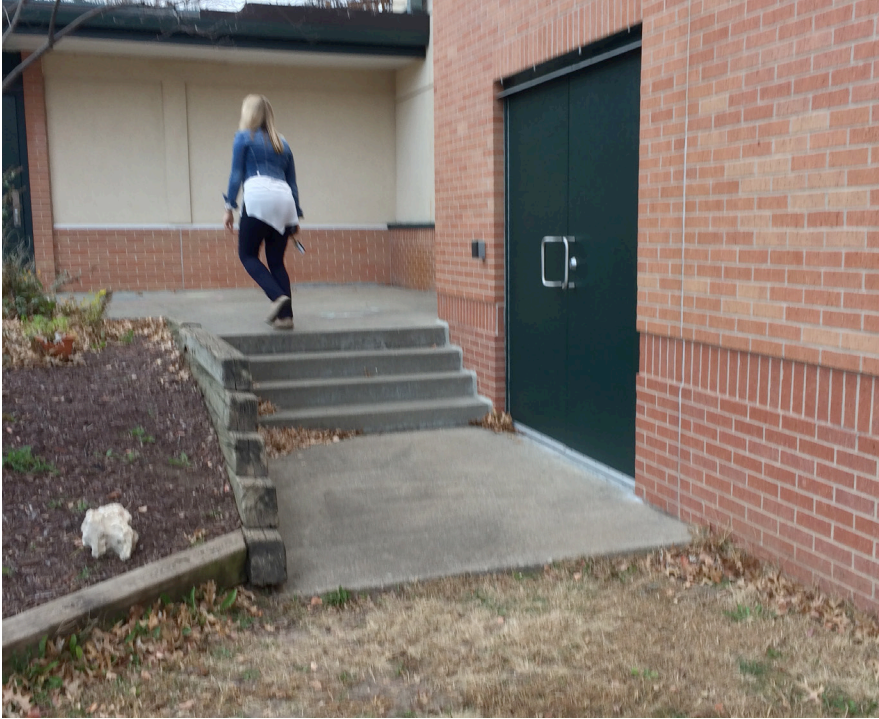
Water from the adjacent low roof dumps rain water in front of gym doors and water drains into the gym. Sidewalk outside gym doors needs an area drain.

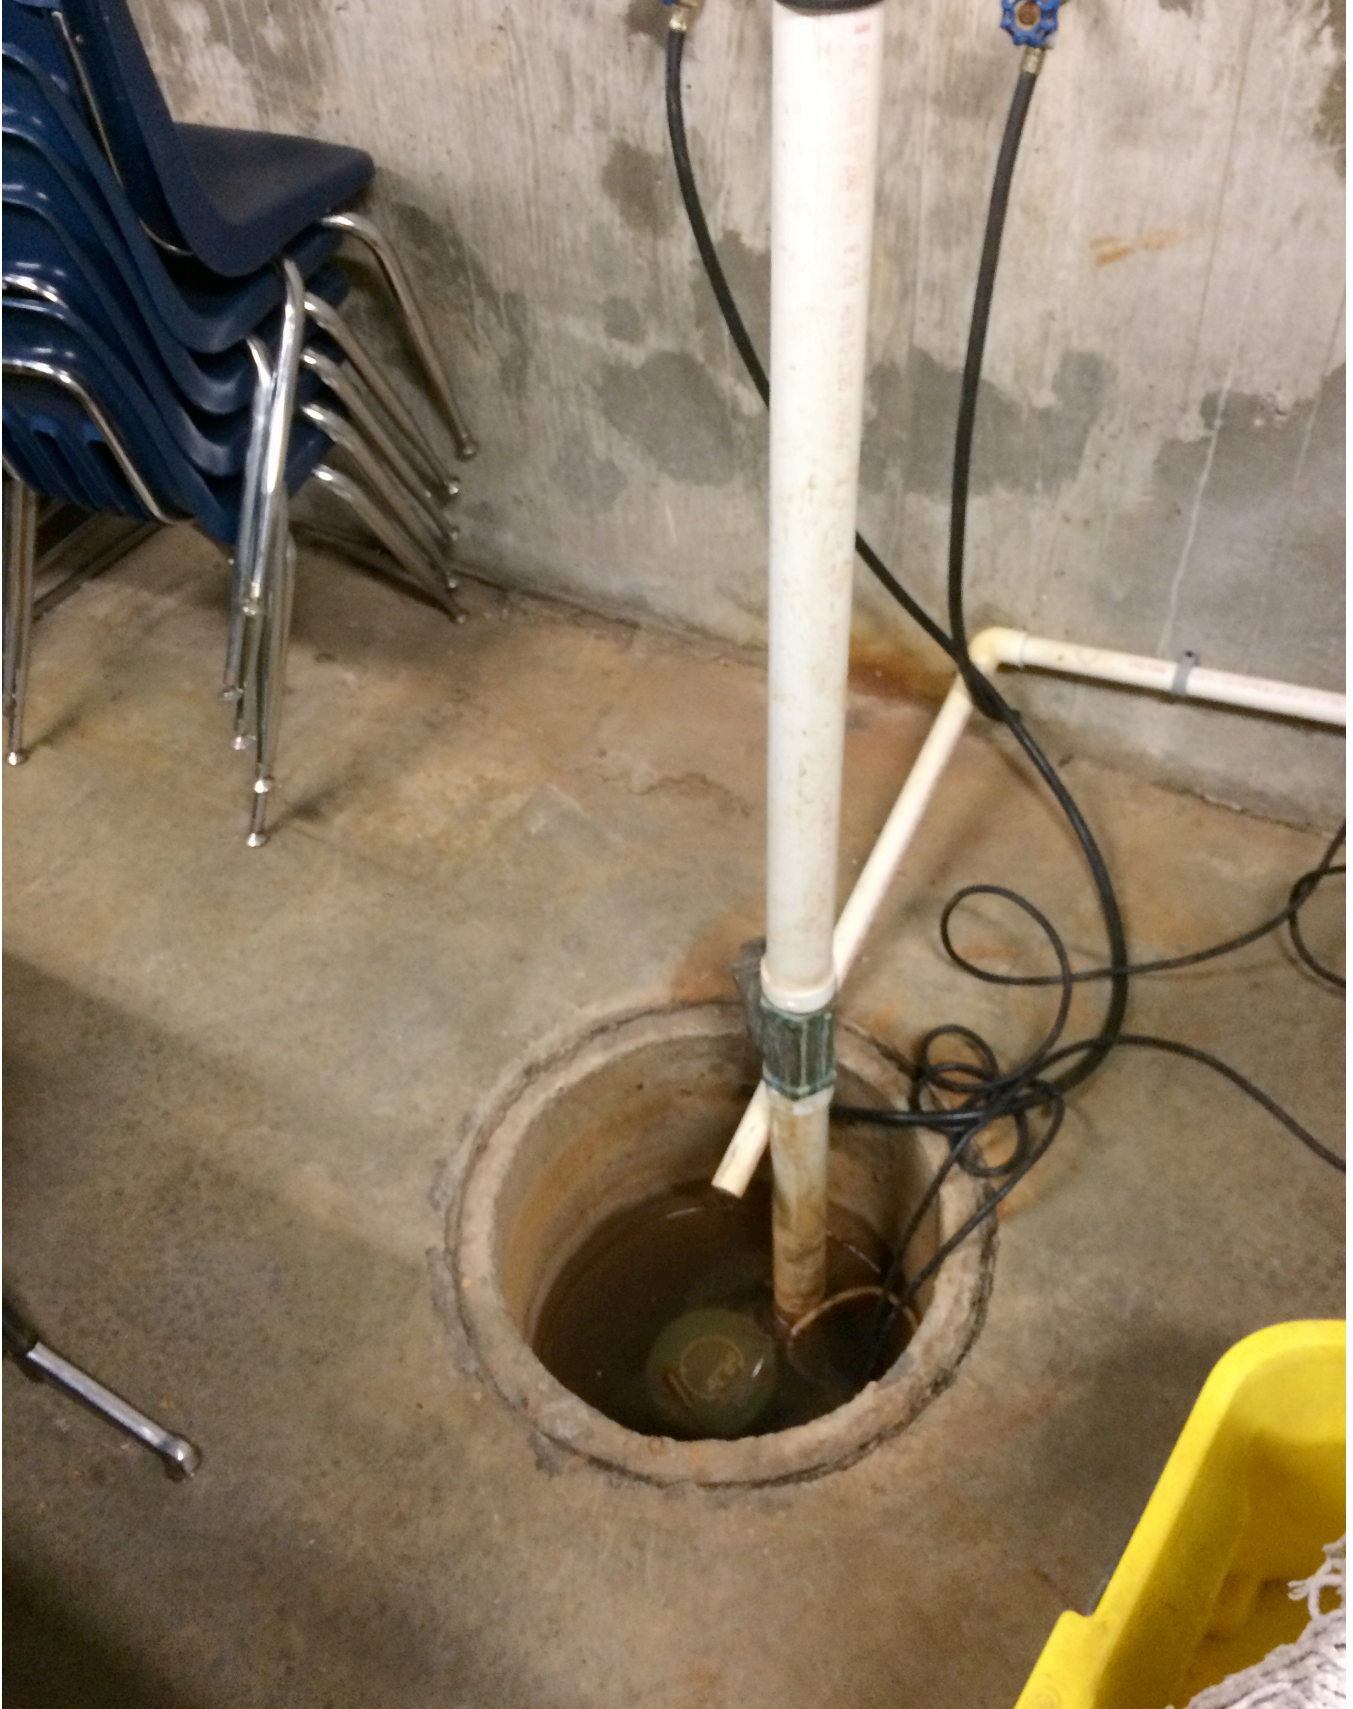
Broken sump pump at Basement Mechanical Room.

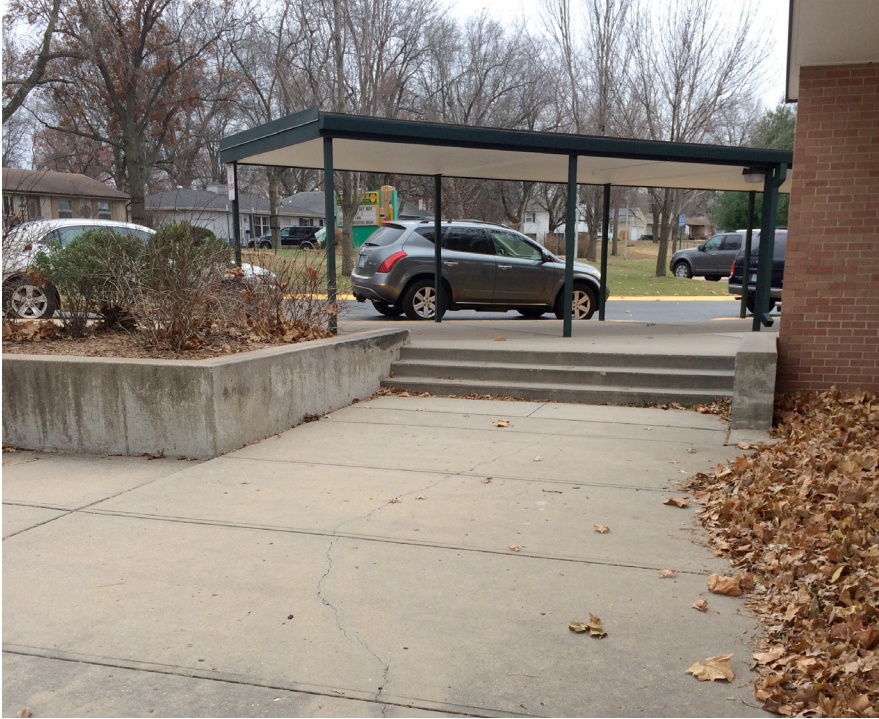
Parent pick up backs up onto Lowell Avenue during afternoon pickup.

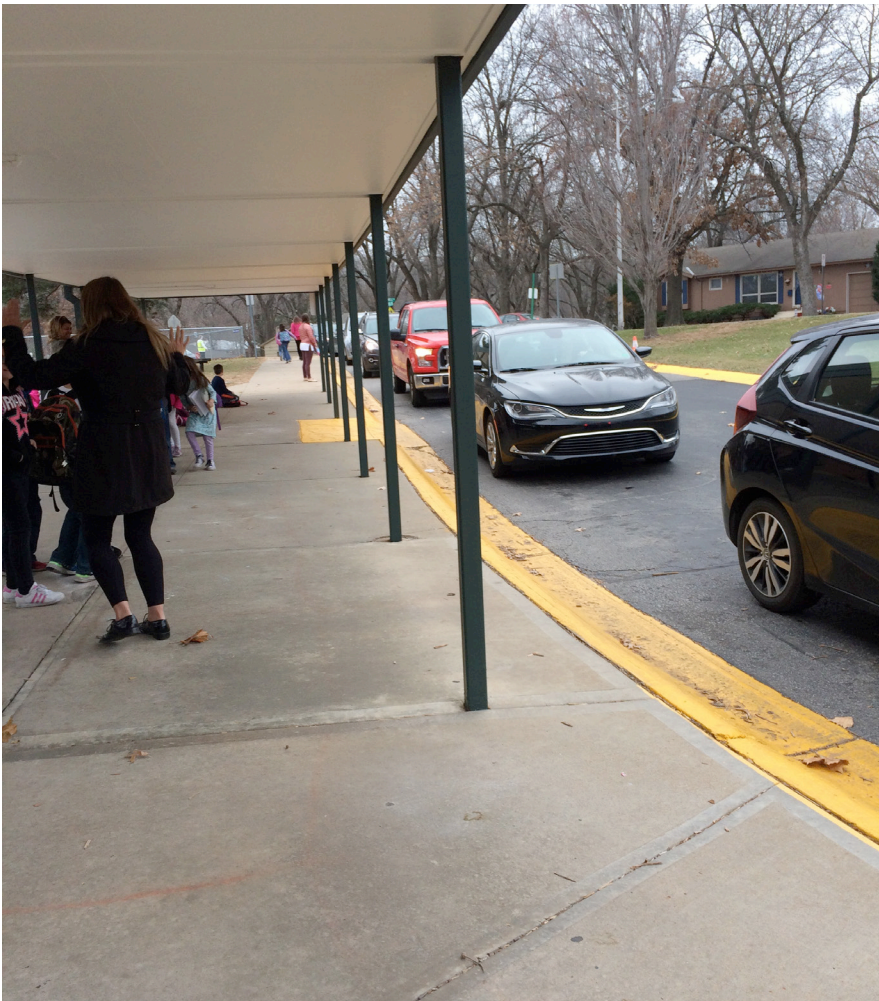
Parent pick up, queuing line backs up onto Lowell Avenue.

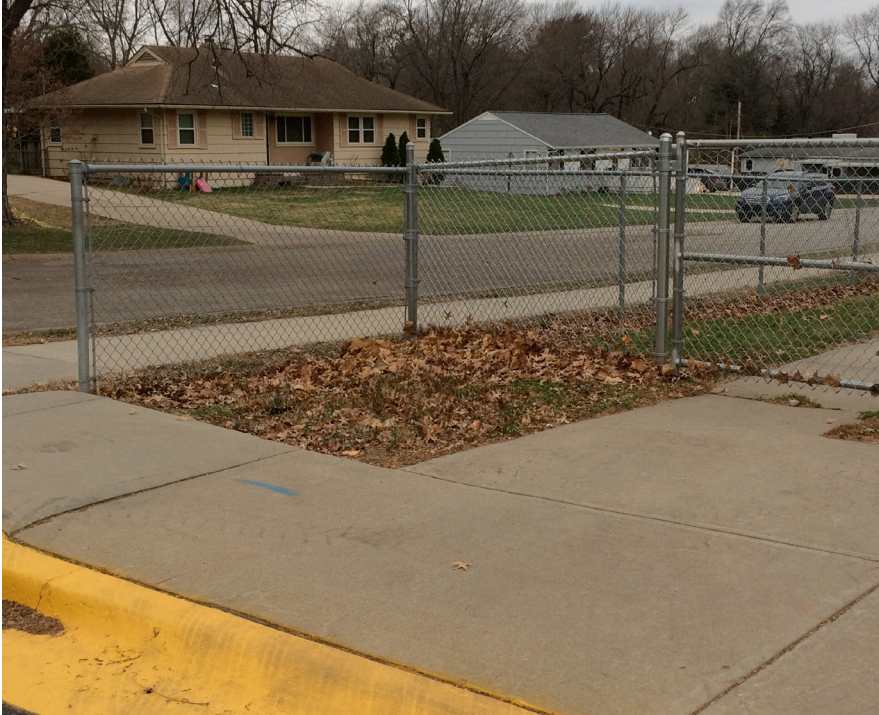
74th Street is dead end on the south side of school. Some parents pick up students there due to traffic on Lowell Avenue.

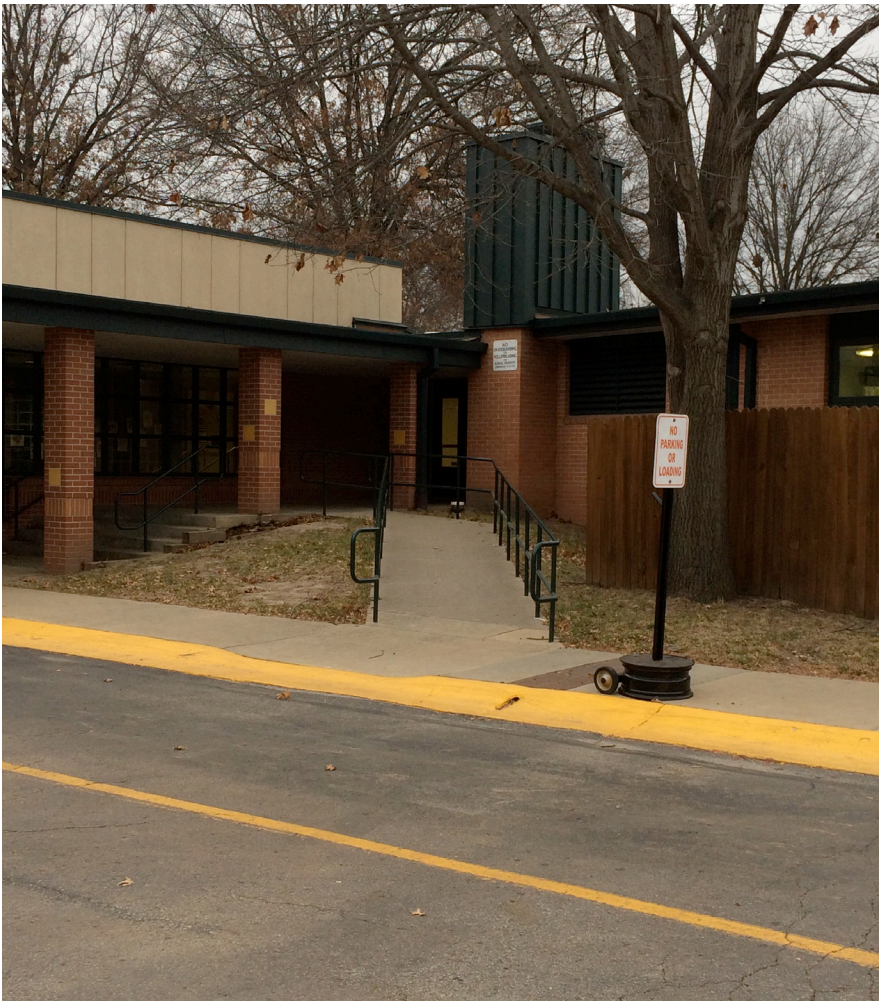
Water issues between top of ramp and adjacent door.

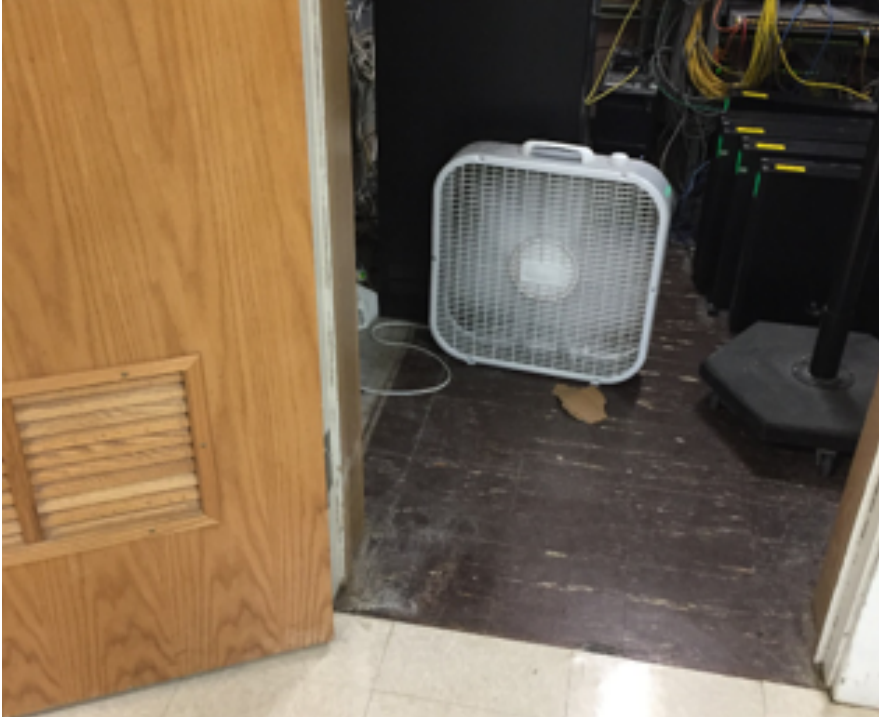
Cooling for data closet is a portable fan with louver in door

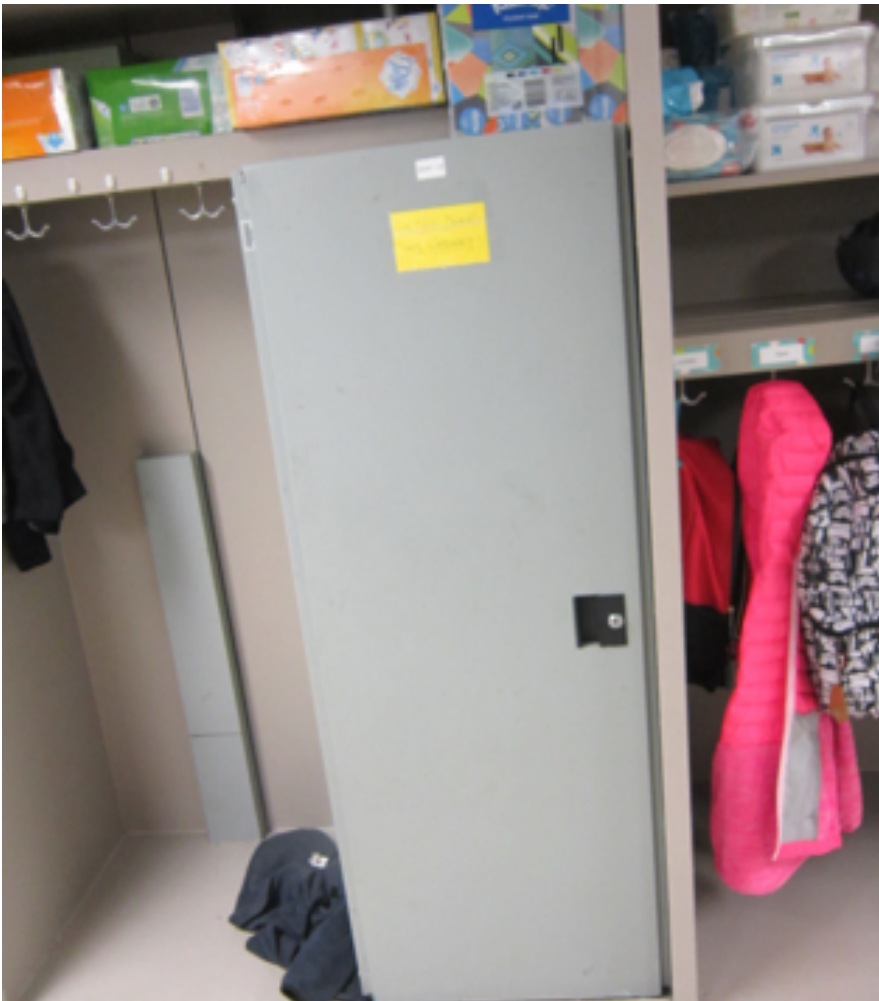
Data IDF in Corridor

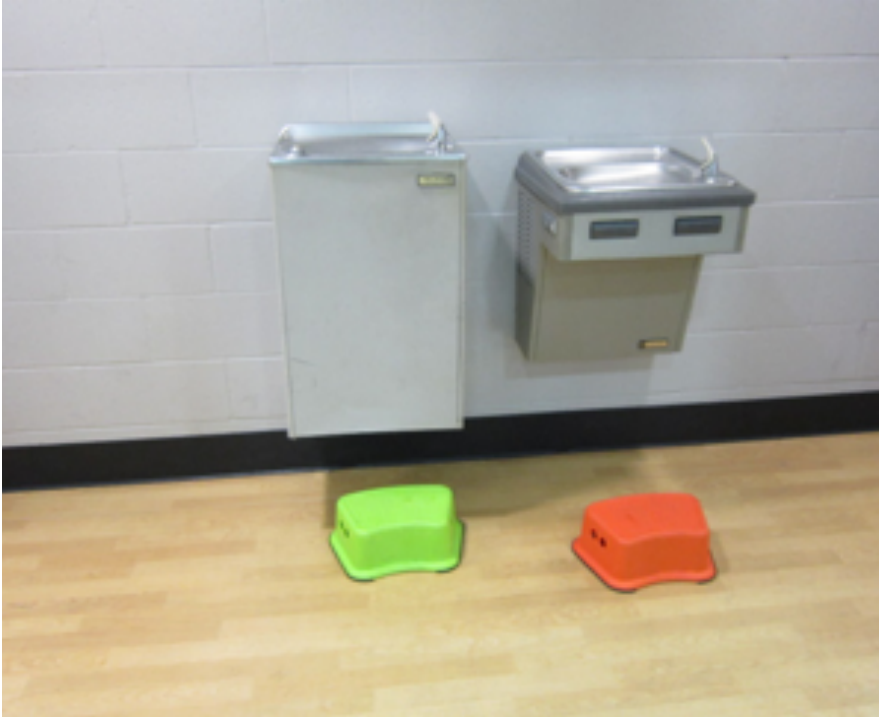
Drinking Fountains in Gym not easily accessible
