EAST ANTIOCH ELEMENTARY

# FACILITY EVALUATION

# OVERALL SUMMARY

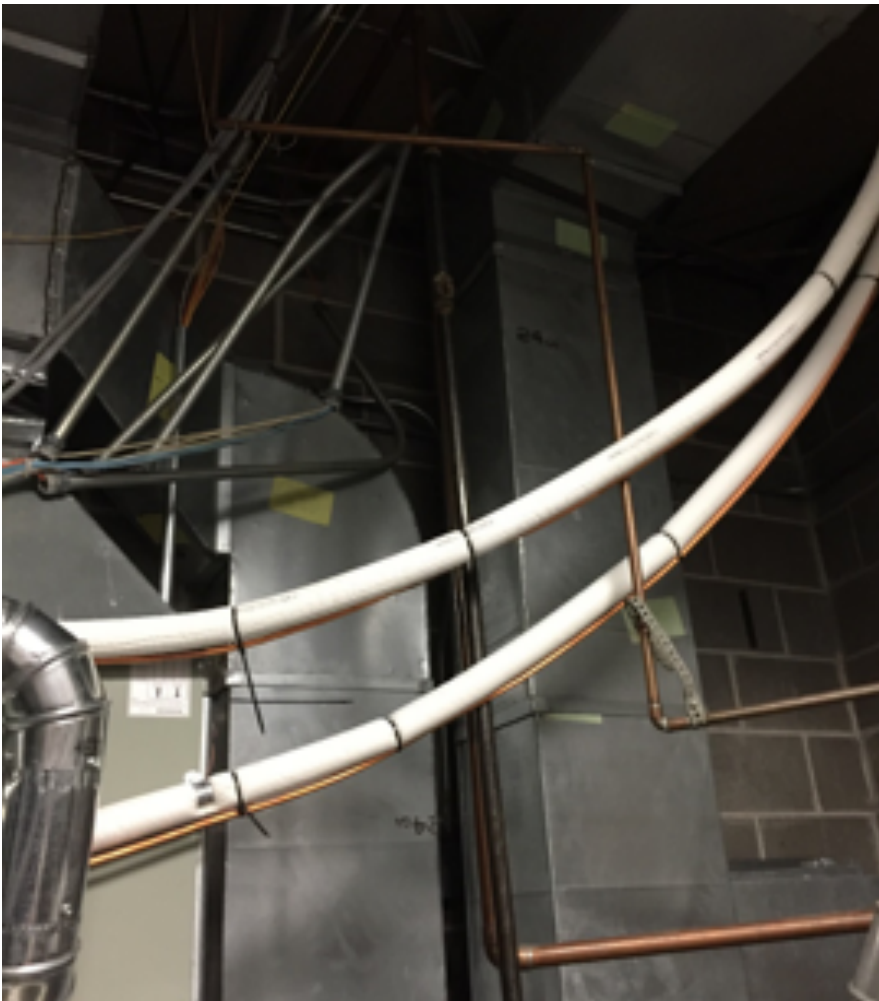
Domestic water piping not insulated

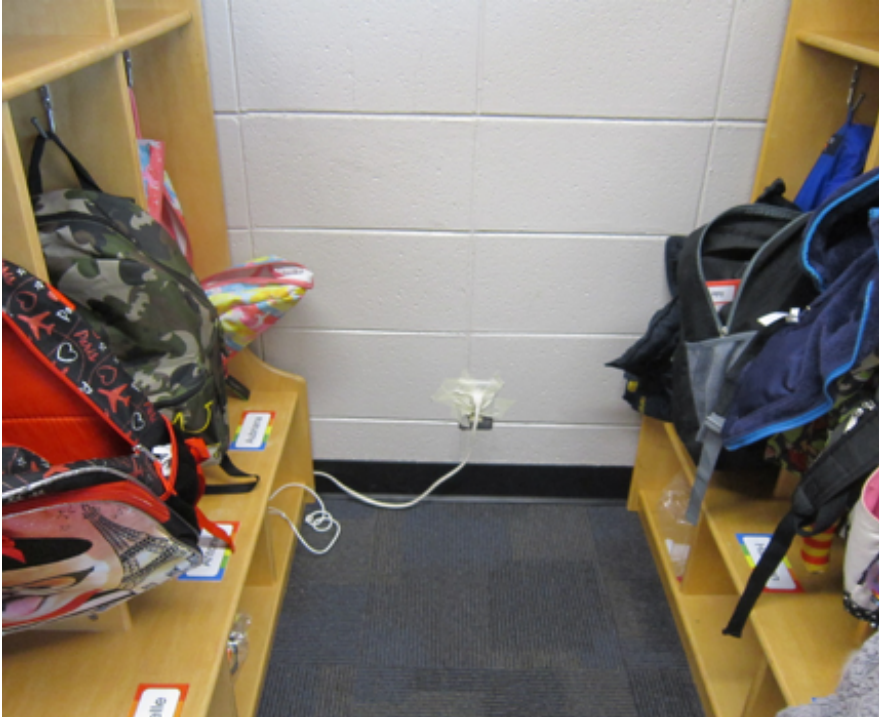
Electrical cord secured in place with tape

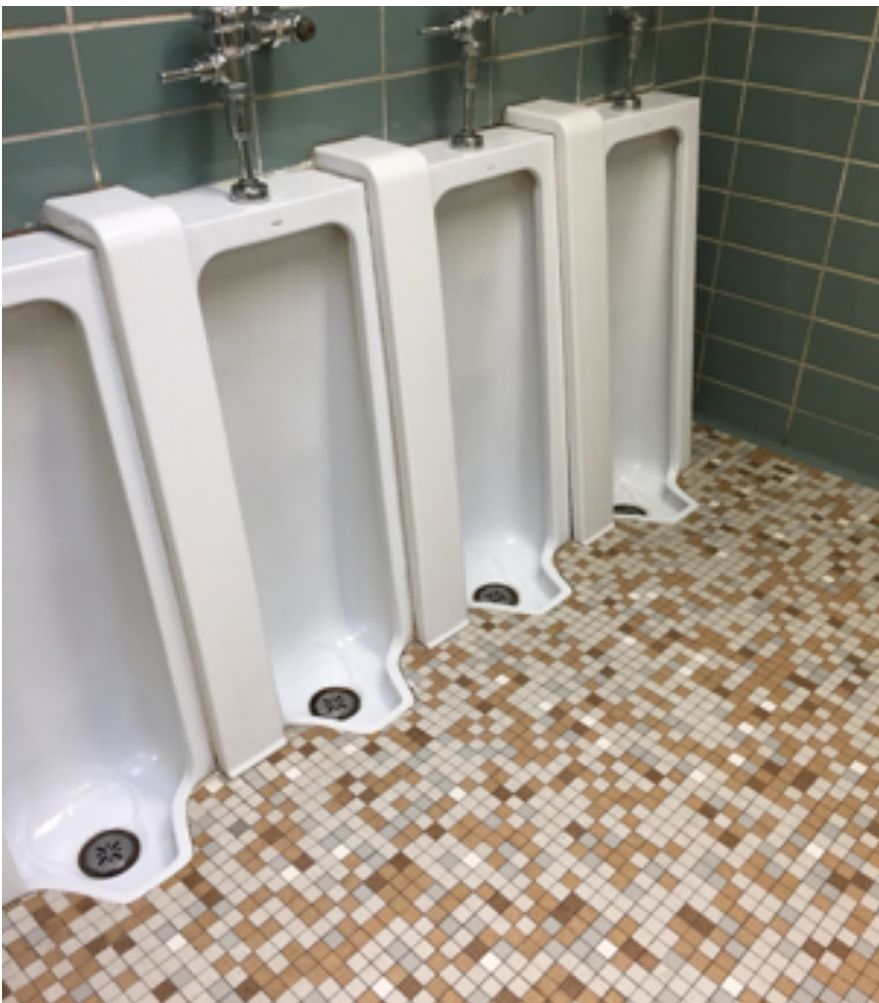
Floor mounted urinals

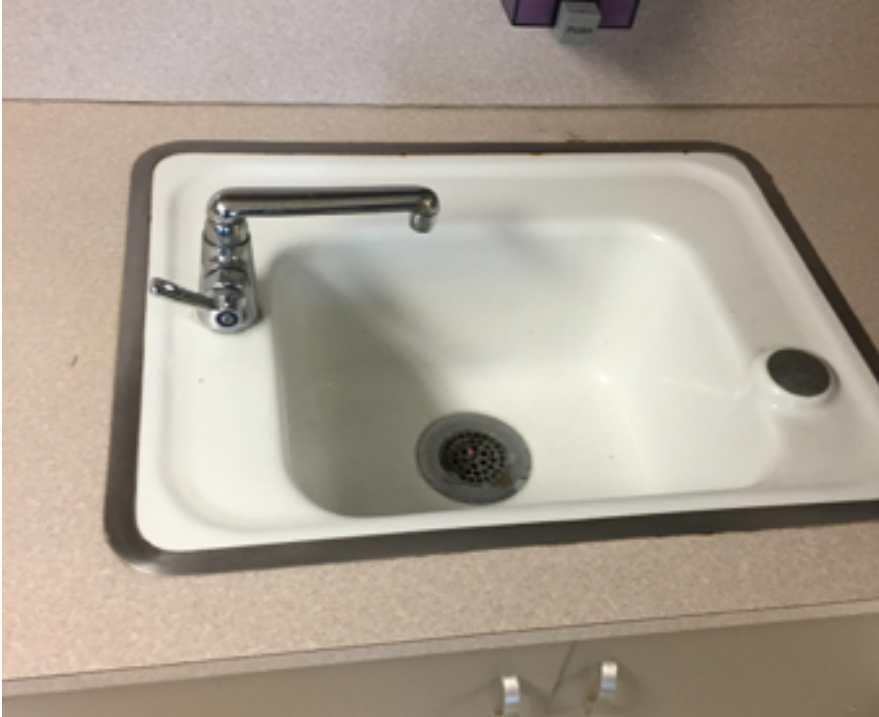
No hot water at classroom sink.

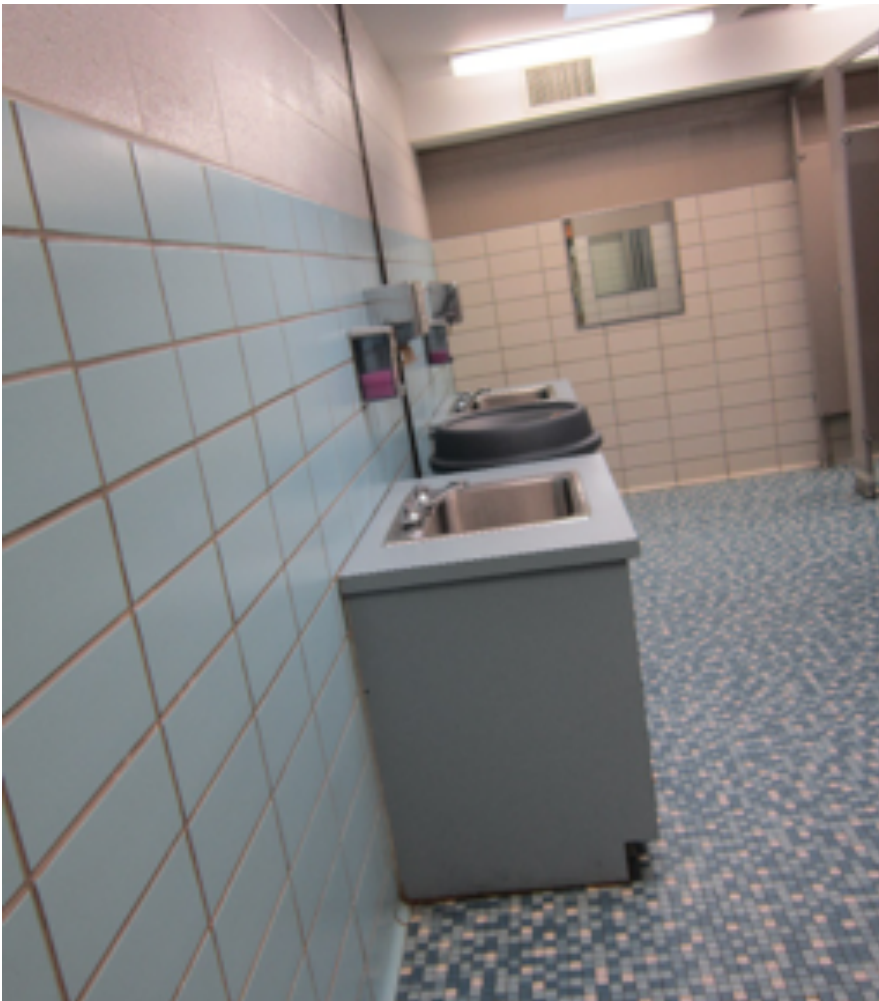
Lavatories not ADA Accessible  
and Exposed piping

- Several water coolers and plumbing fixtures are not ADA compliant and need to be replaced.
- All handwashing sinks will need to have thermostat mixing valves installed to limit maximum water hot water temperature to 110°F.

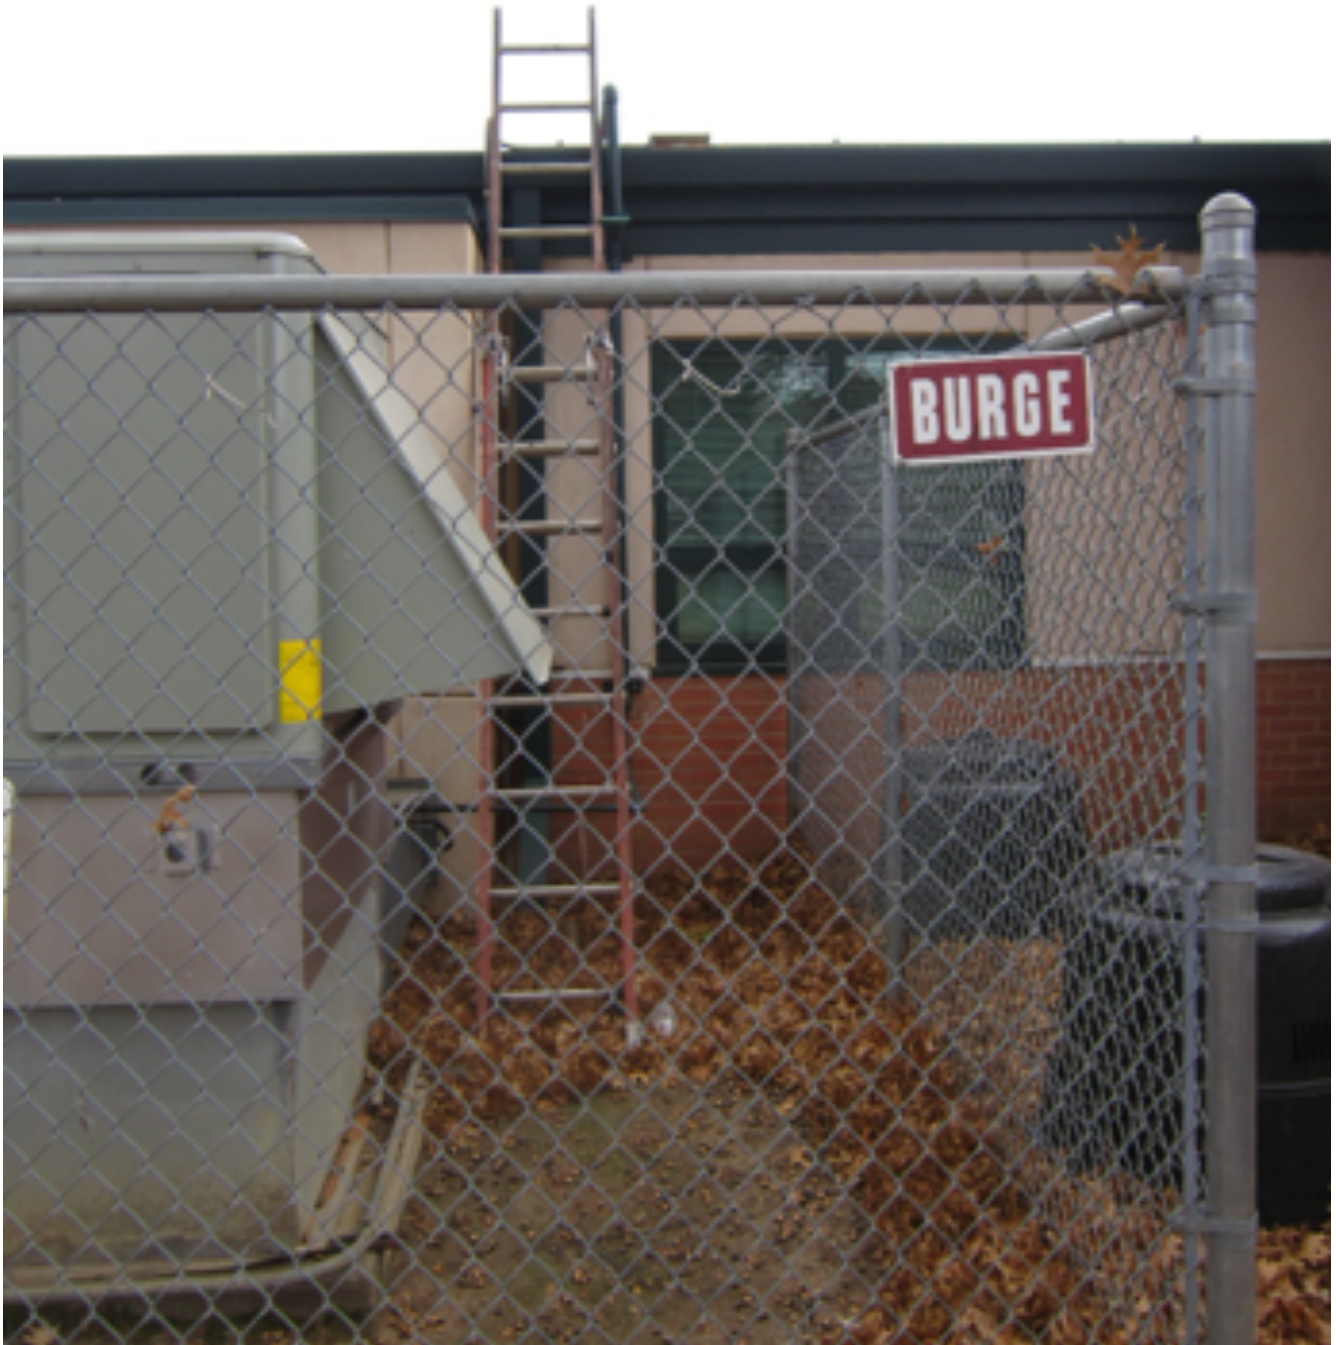
Roof Access

14. No Roof access from inside the building. Maintenance staff uses a loose ladder at the exterior walls to access roof.
15. Drinking fountains in corridors.
