BELINDER ELEMENTARY

# FACILITY EVALUATION

# OVERALL SUMMARY

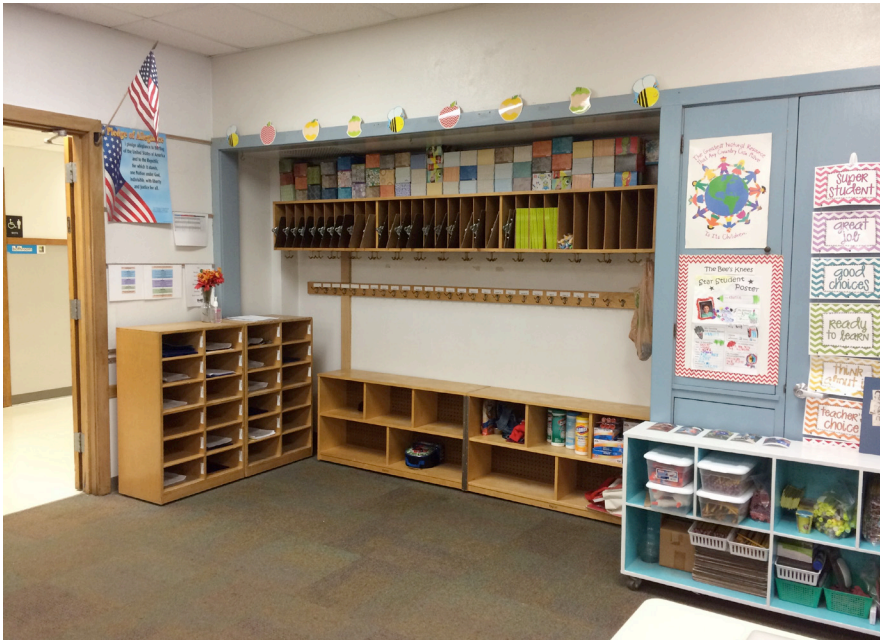
No cubby storage for students in the 1st Grade thru 6th Grade classrooms, only coat hooks close together.

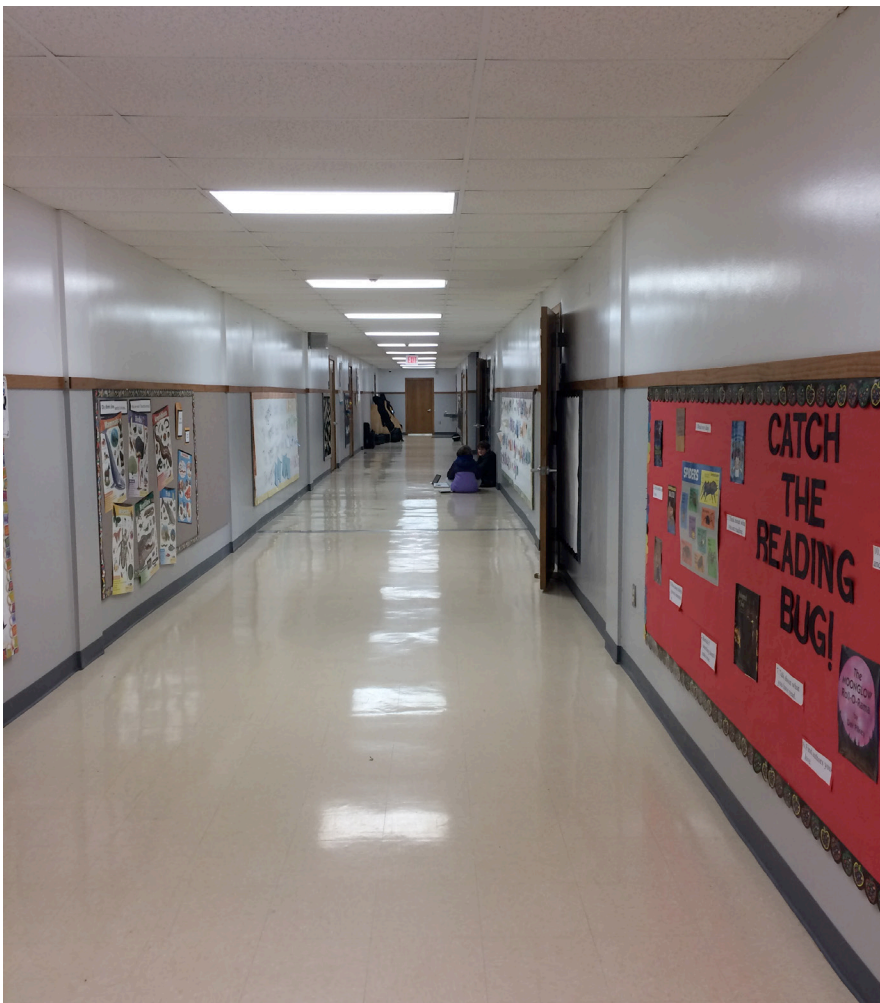
Corridors have low ceilings (8'-0" a.f.f.). Doors swinging into Corridor. Droopy ceiling tiles due to moisture issues. VCT flooring requires maintenance. No collaboration or common areas for students.

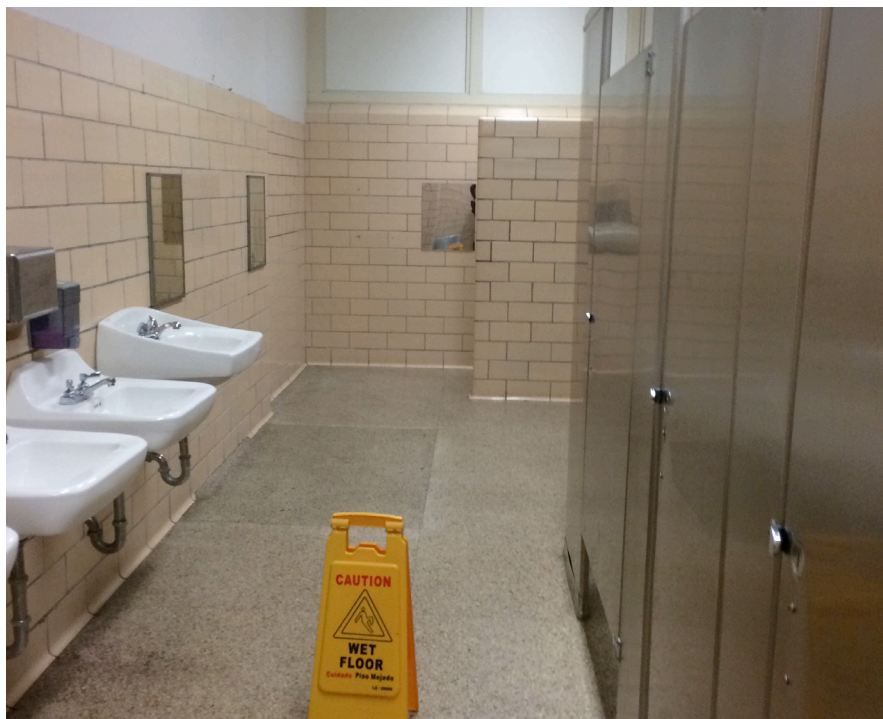
Student toilet rooms need updating.

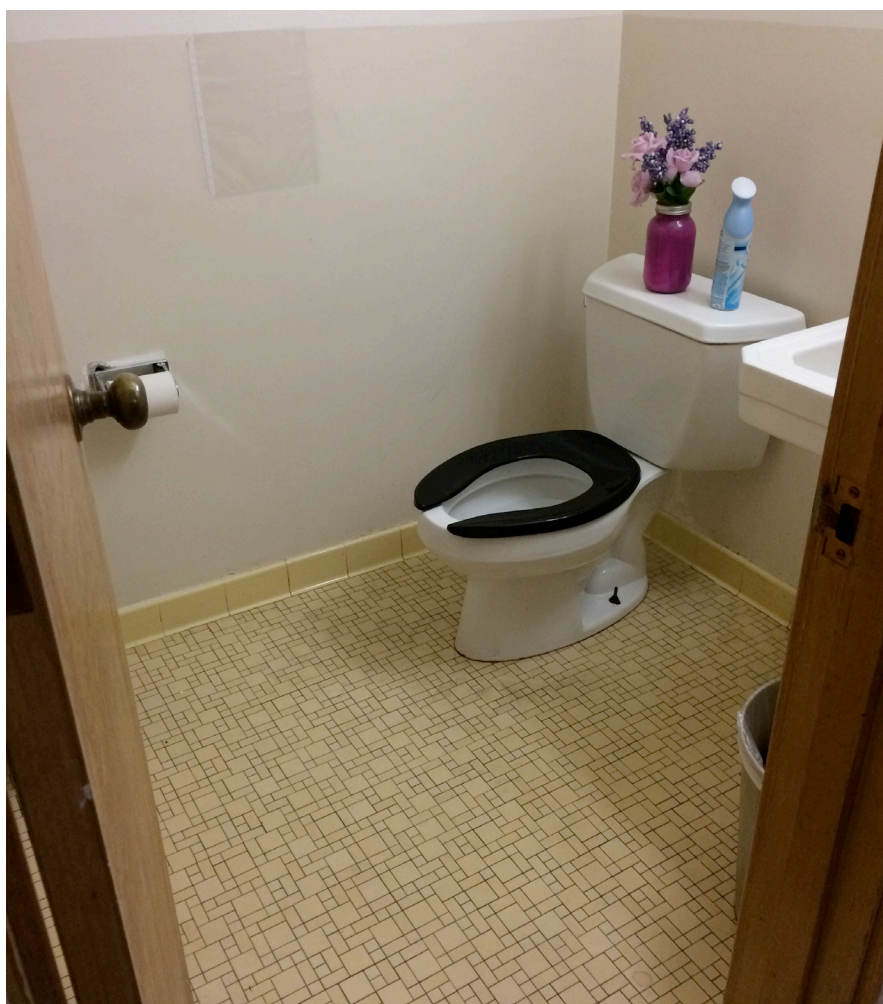
Staff toilets need updating.  
Not ADA accessible.

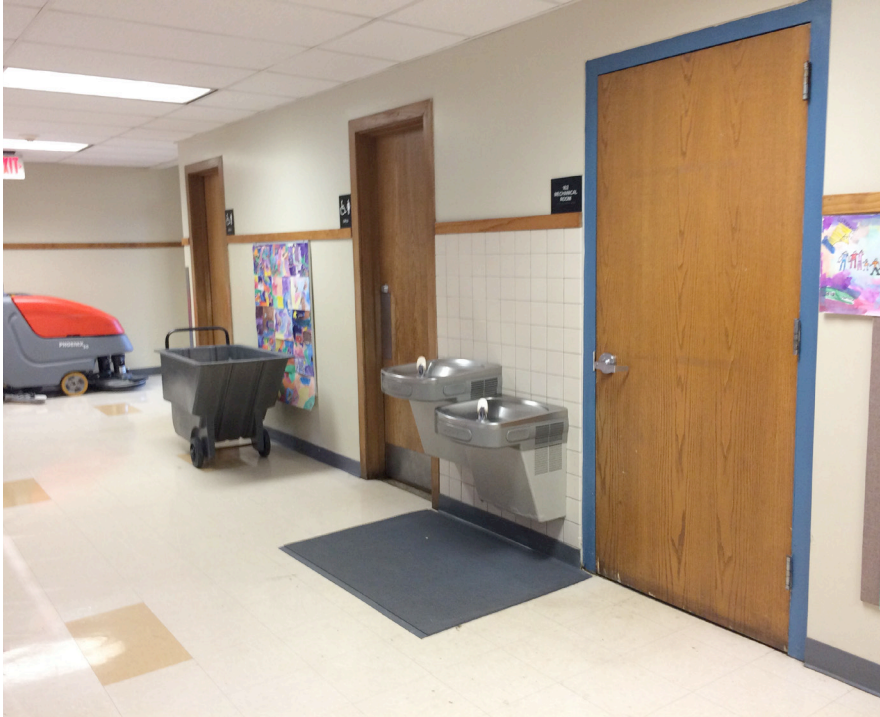
Drinking fountains protruding into Corridors more than allowed by ADA.

- **Additional Updates required to bring systems up to current codes:**
  - Several water coolers and plumbing fixtures are not ADA compliant and need to be replaced.

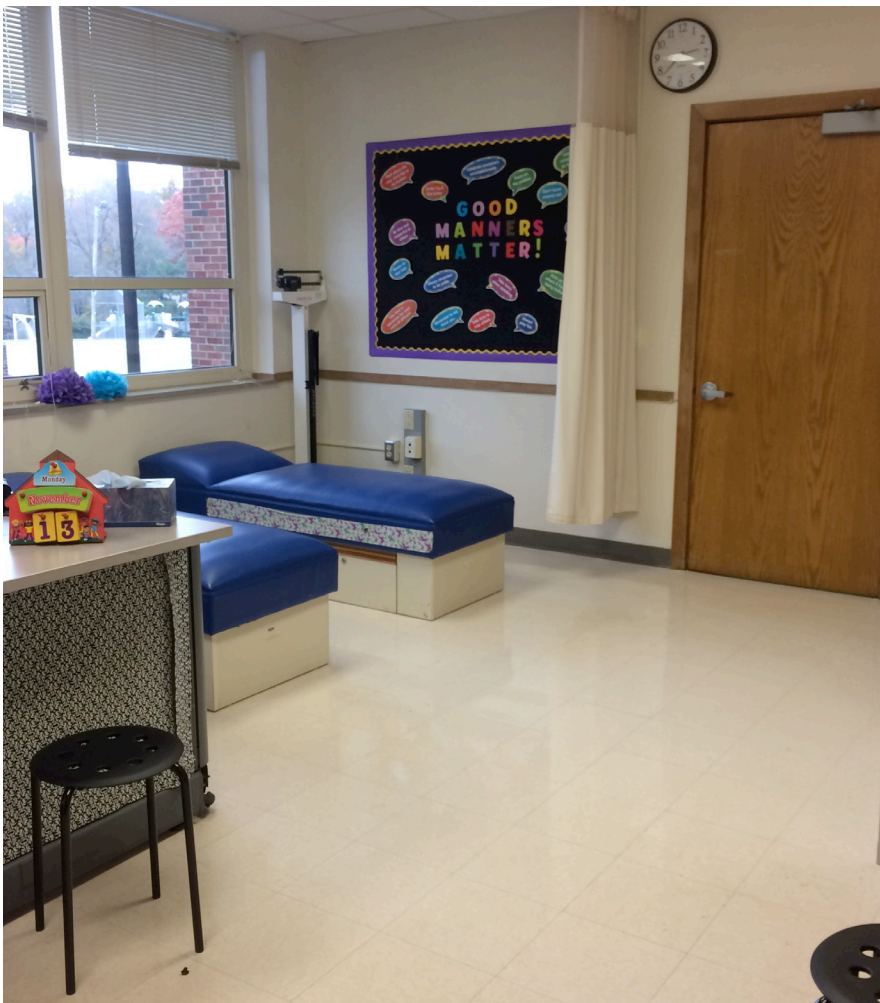
No shower in Nurse's area for kids.

- Replace all faucets and flush valves with Toto sensor devices.
  - Add accessible roll-in shower for the Nurse Area.
  - Hot water recirculation line shall tie into hot water line with-in 3 feet of every hand washing sink.

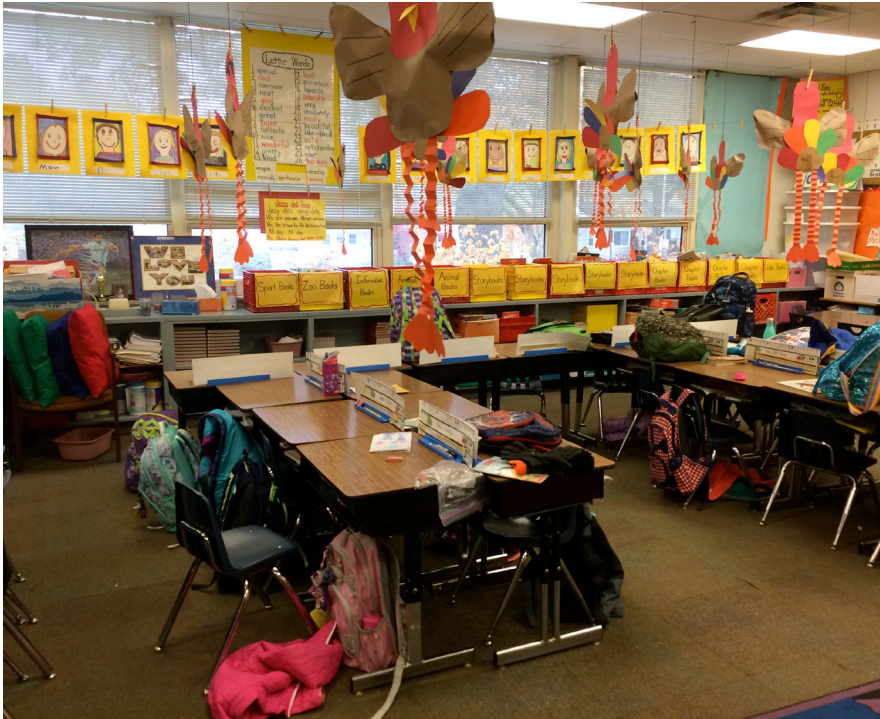
Classrooms with traditional desks. Need different casework and furniture to allow for various methods of teaching instruction.

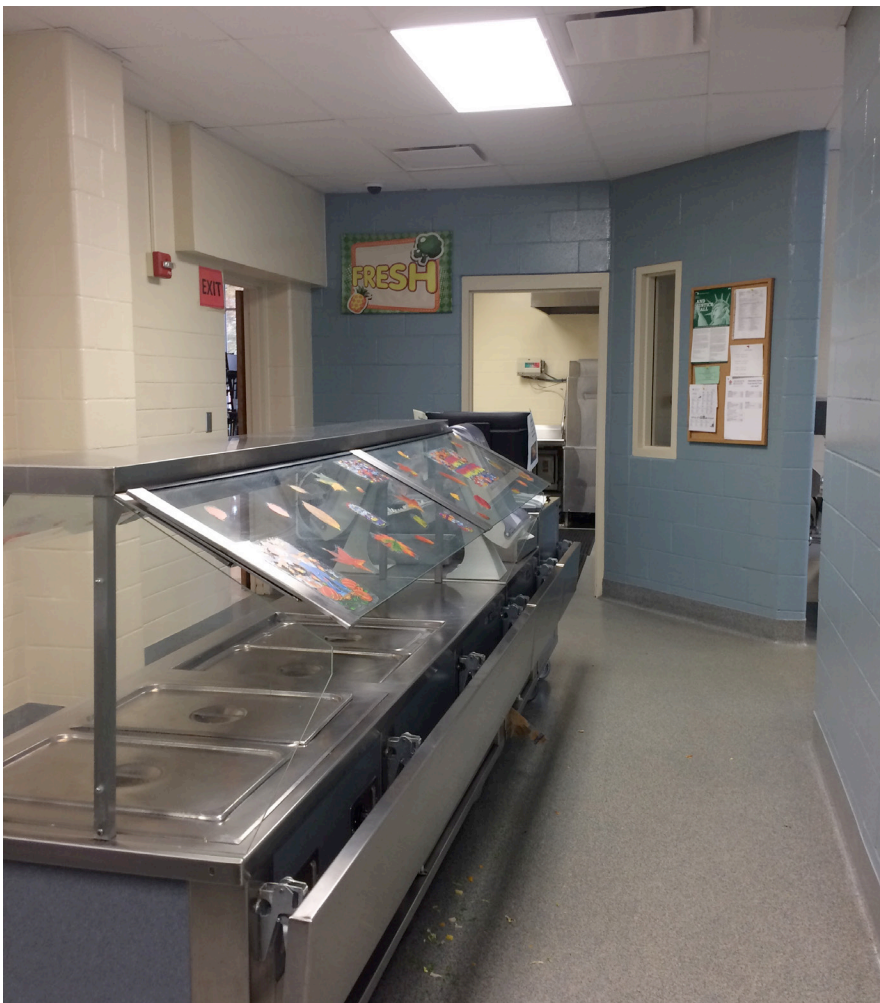
Small Kitchen/Serving line- A long Lunch period extends from 10:40 to 12:50.

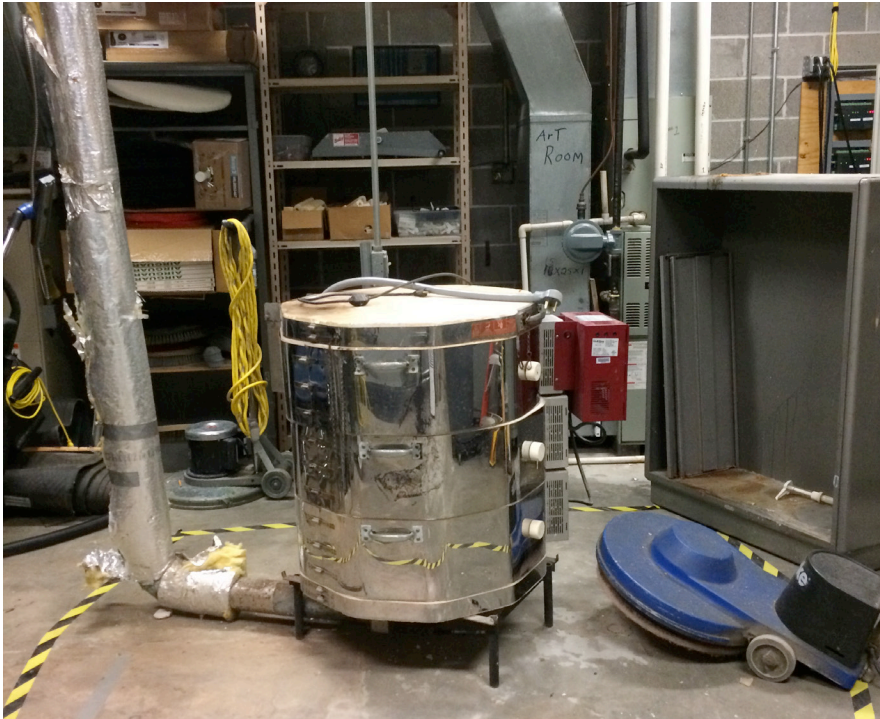
Kiln is located in Boiler room. Inconvenient for art students to access.

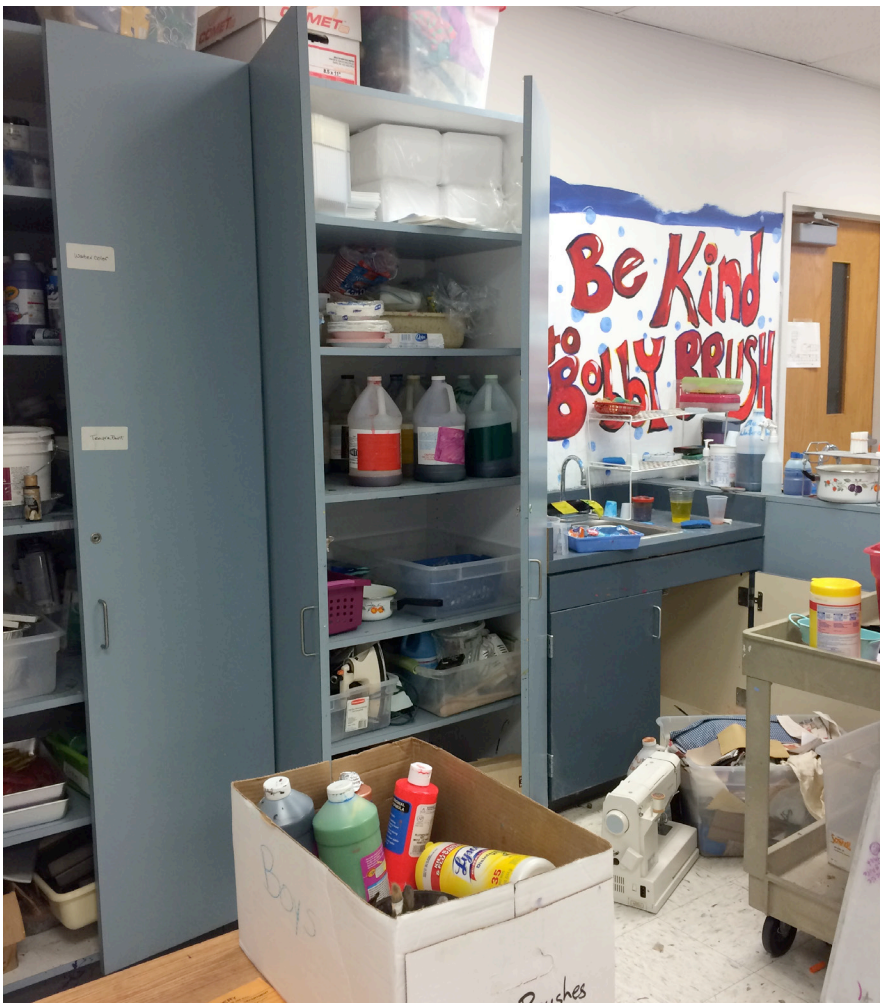
Art Room has unusable sink area, no countertop space.

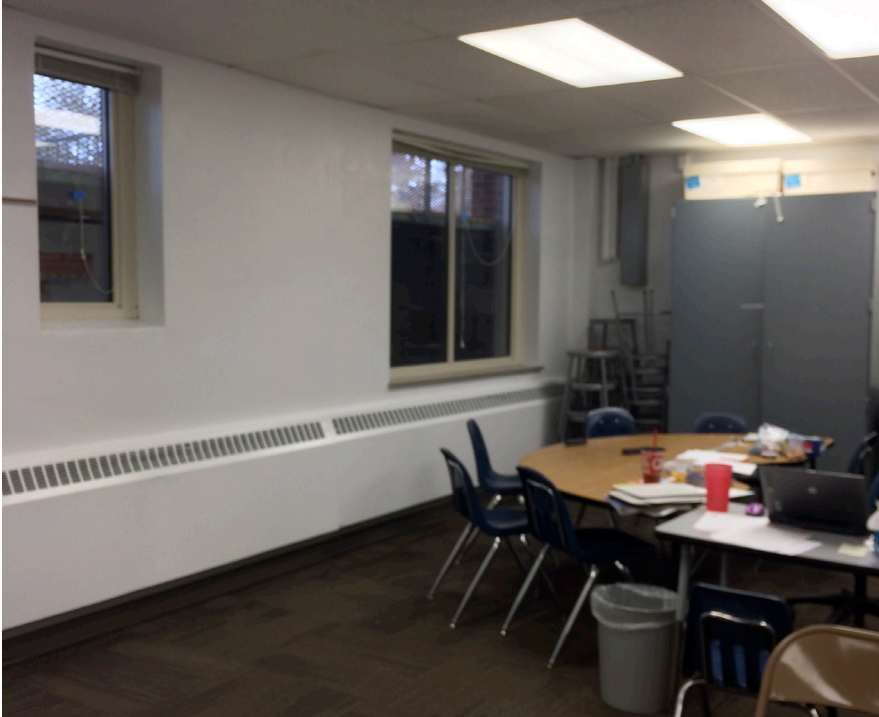
Band/Strings room located in lower level. Water issues have occurred. Window wells have steel cage on the glass. Room not large enough for this program.

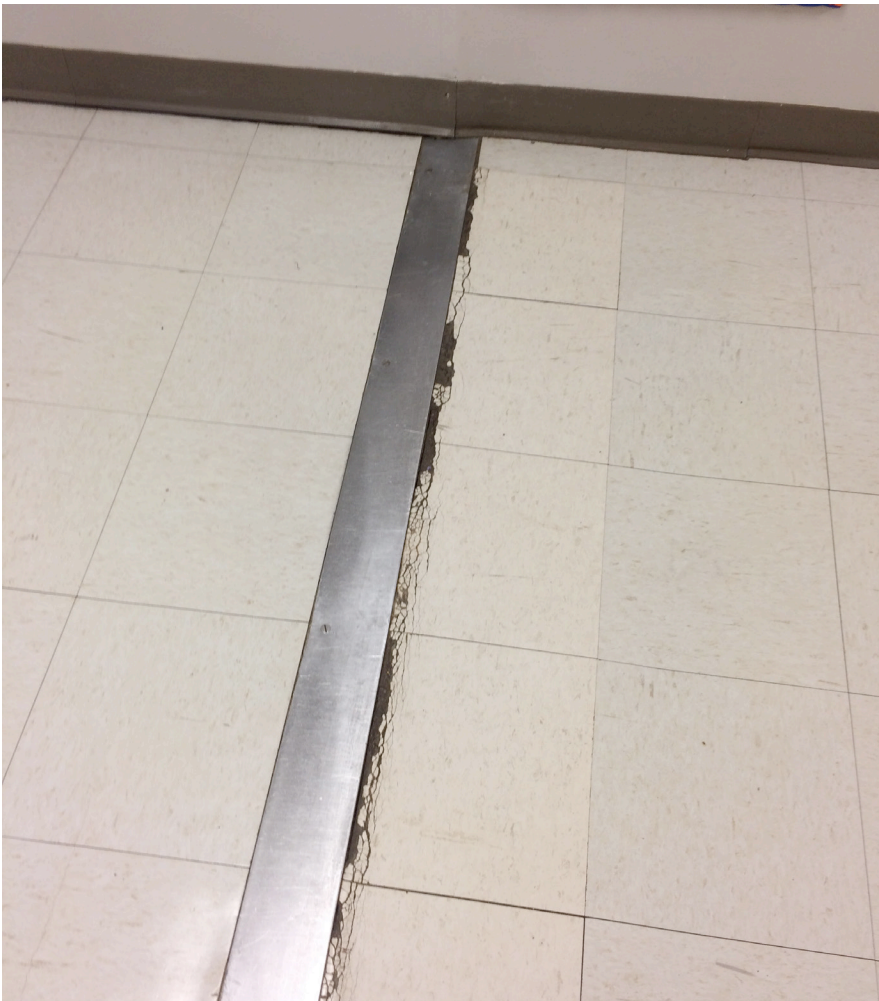
VCT flooring with cracks at expansion joints. There are also uneven surfaces at walls and ceilings. VCT flooring is a maintenance issue.

36. There is some broken VCT flooring at the building expansion joints in corridors.
37. New elevator in 2010.
38. Resource room on lower level.
39. MFEC accessed the roof. There were RTU screens, built up asphalt roof, exposed piping, brick boiler flue, roof drains, roof access ladders and lightning protection. Roof looks like it's been repaired/patched in several areas.

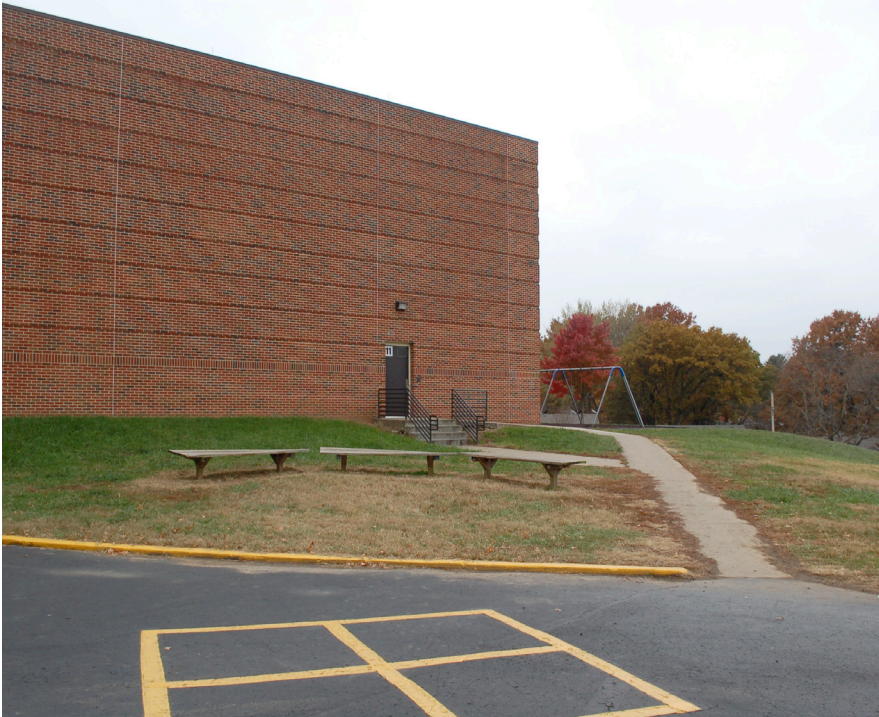
Both exterior doors at gym have steps outside so they are not ADA accessible.

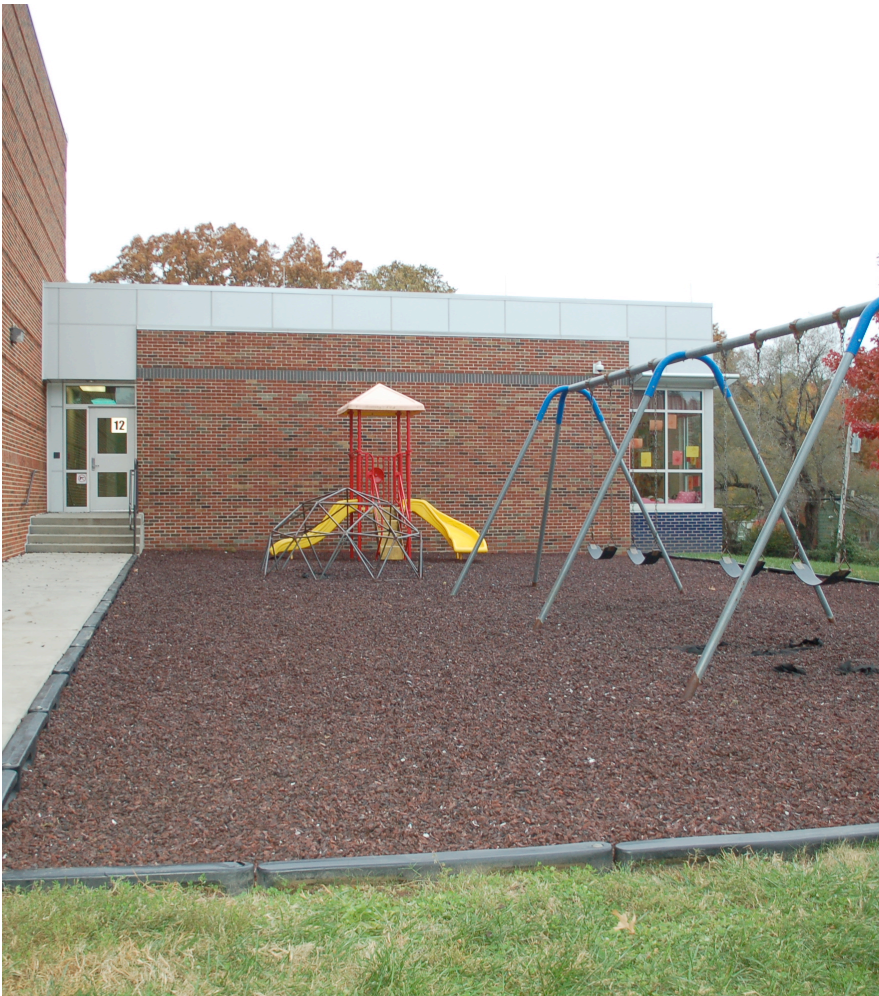
Exterior doors to playground not ADA accessible. Kindergarten playground location is hidden from view of staff members monitoring larger adjacent playground area. Kindergarten play equipment structure needs updating.

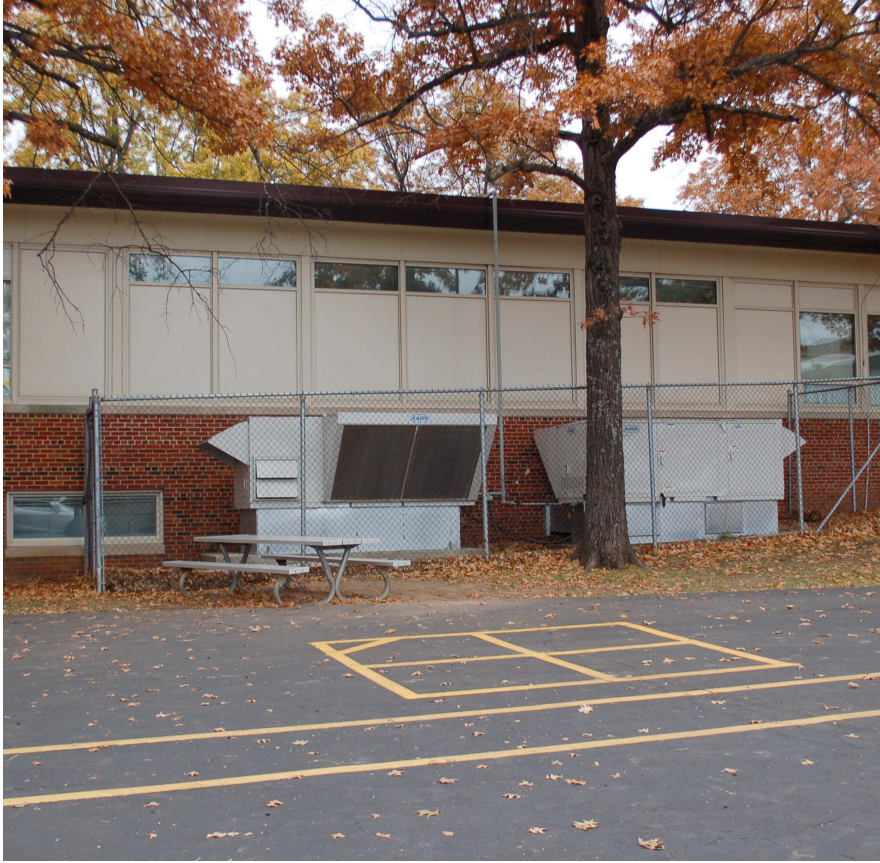
Noisy HVAC exterior unit adjacent to classroom windows.

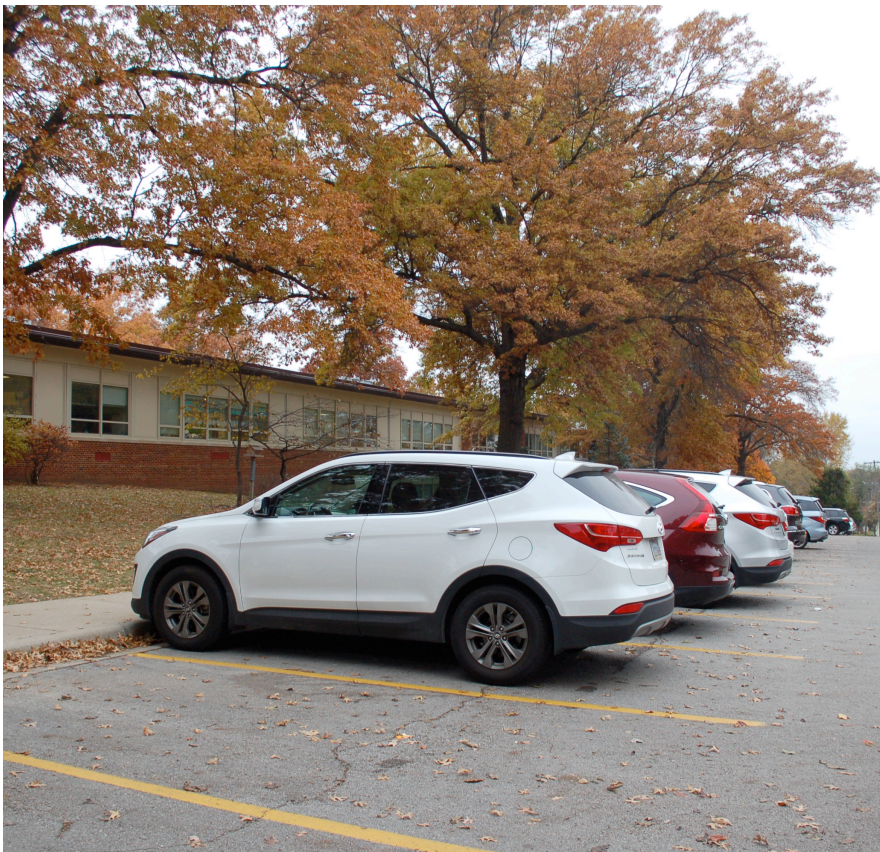
Off street parking causes traffic problems on Belinder Avenue. Parent pick up drive on south side isn't long enough and as a result cars spill out onto Belinder Avenue causing further traffic problems. Bus entry at north end of site is only one lane wide.

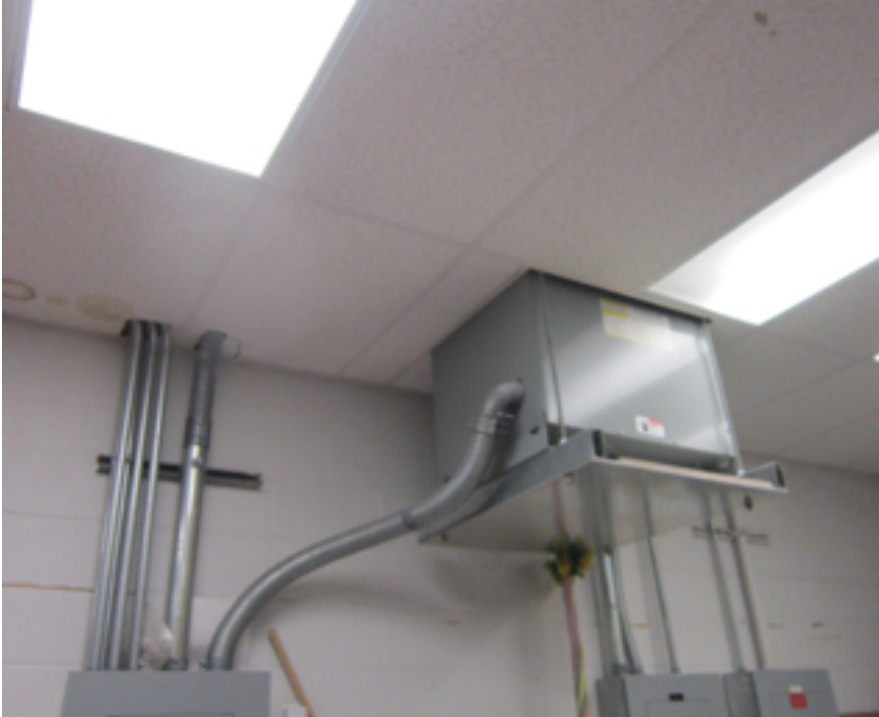
Electrical Transformer with Limited access due to ceiling installation

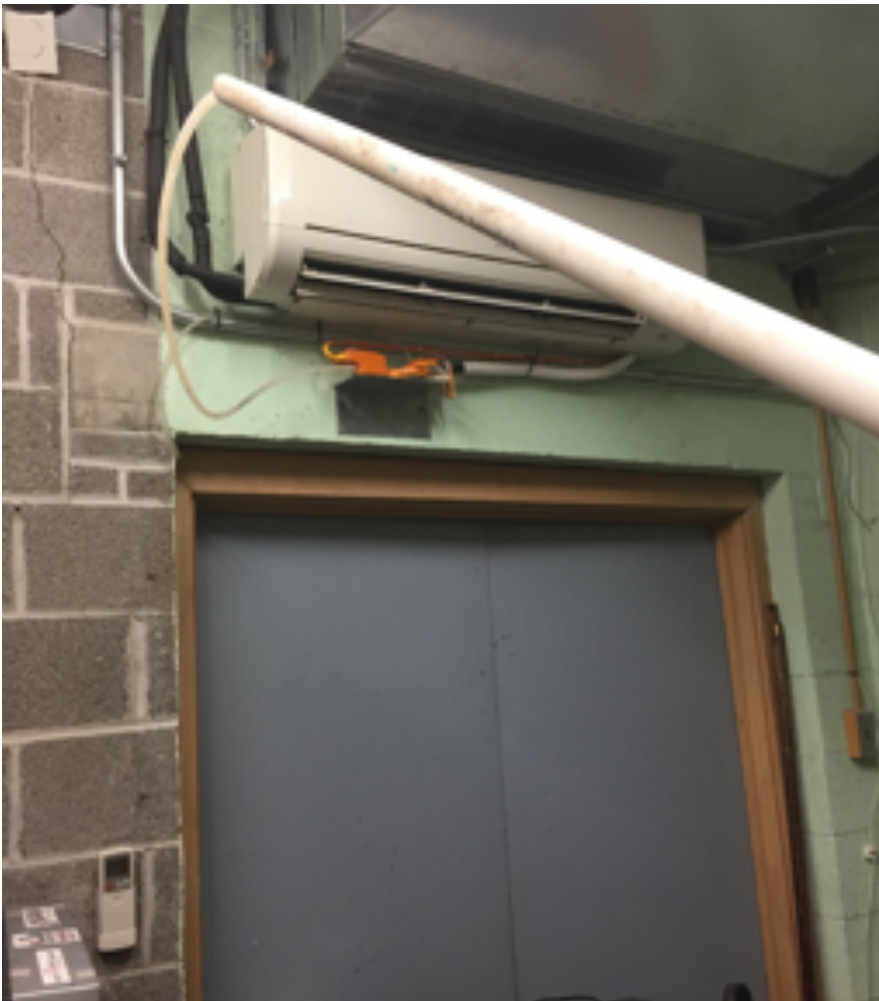
Condensate dangled across middle of the room

- Some classrooms contain ceiling fans. Some of these fans were operational, but many were not.
  - Ductless split system serves data room with data rack. However the condensate drain piping from unit is loosely hanging across the room.

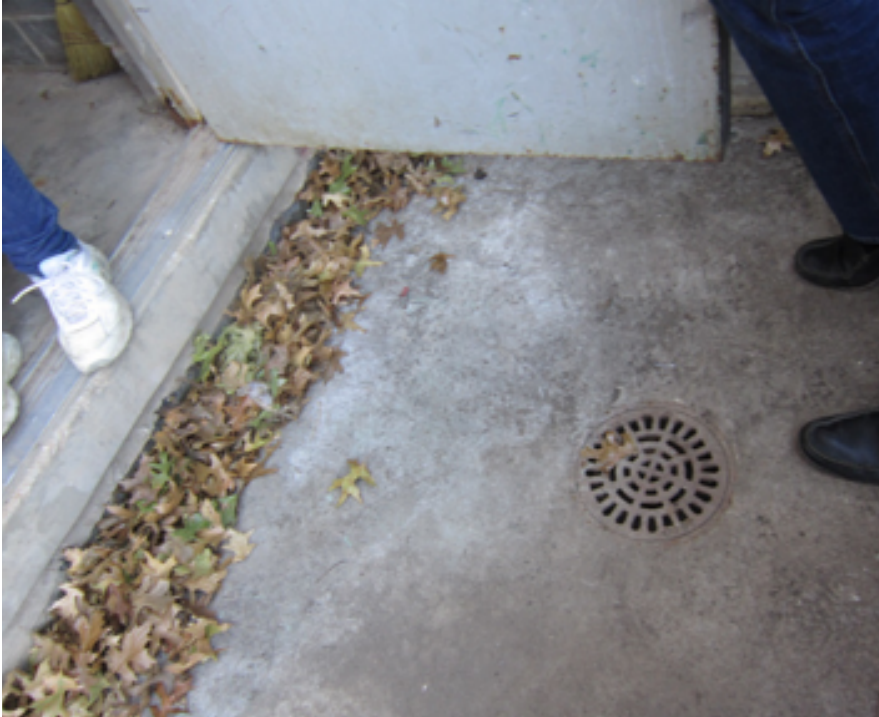
Exterior drain at mechanical room that clogs easily causing water inside building

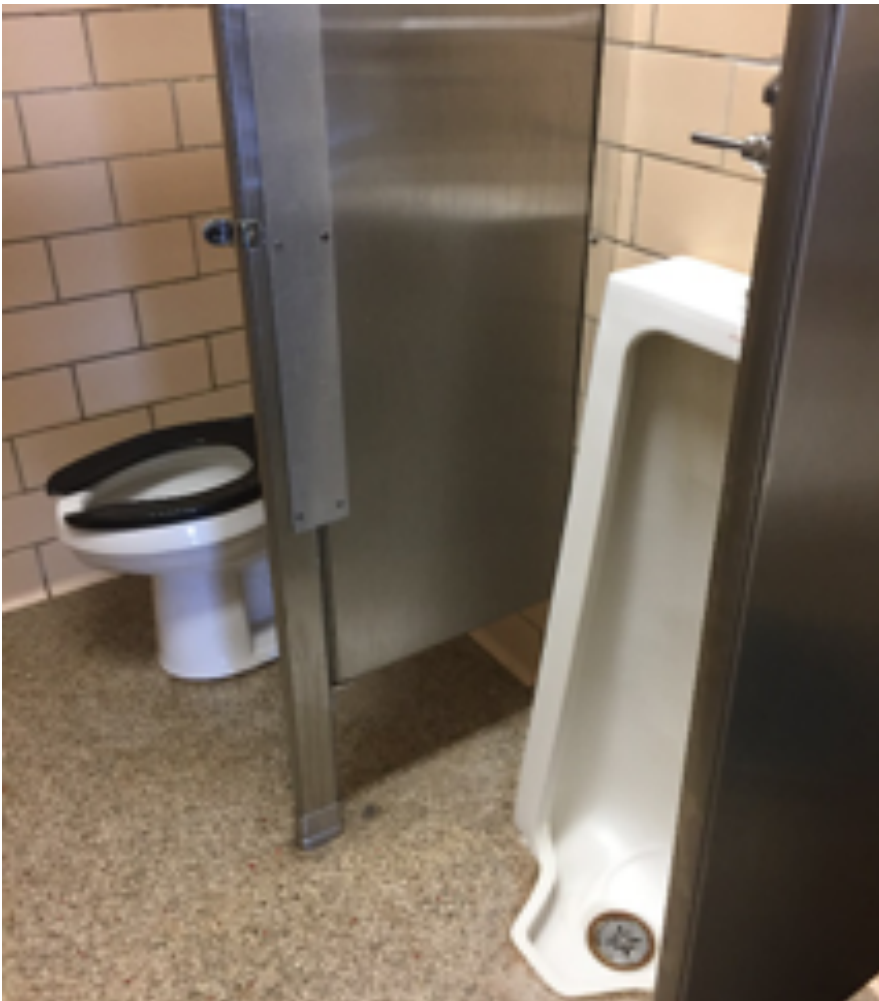
Floor mounted plumbing fixtures

- All classrooms shall be provided with a sink in the classroom.
  - Replace majority of water closets with new wall-mounted water closets.

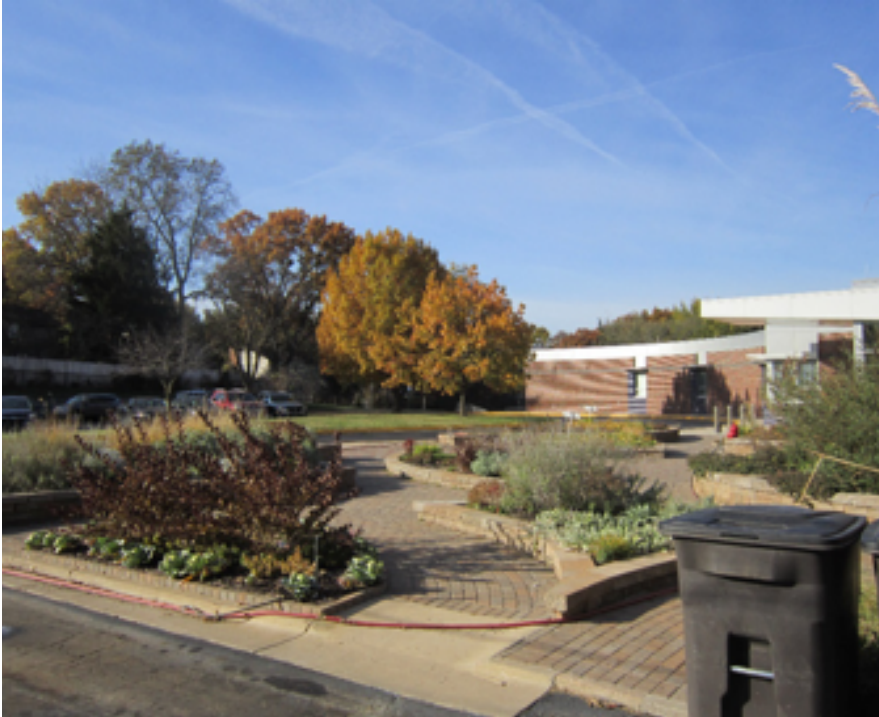
Exterior No parking lot lighting

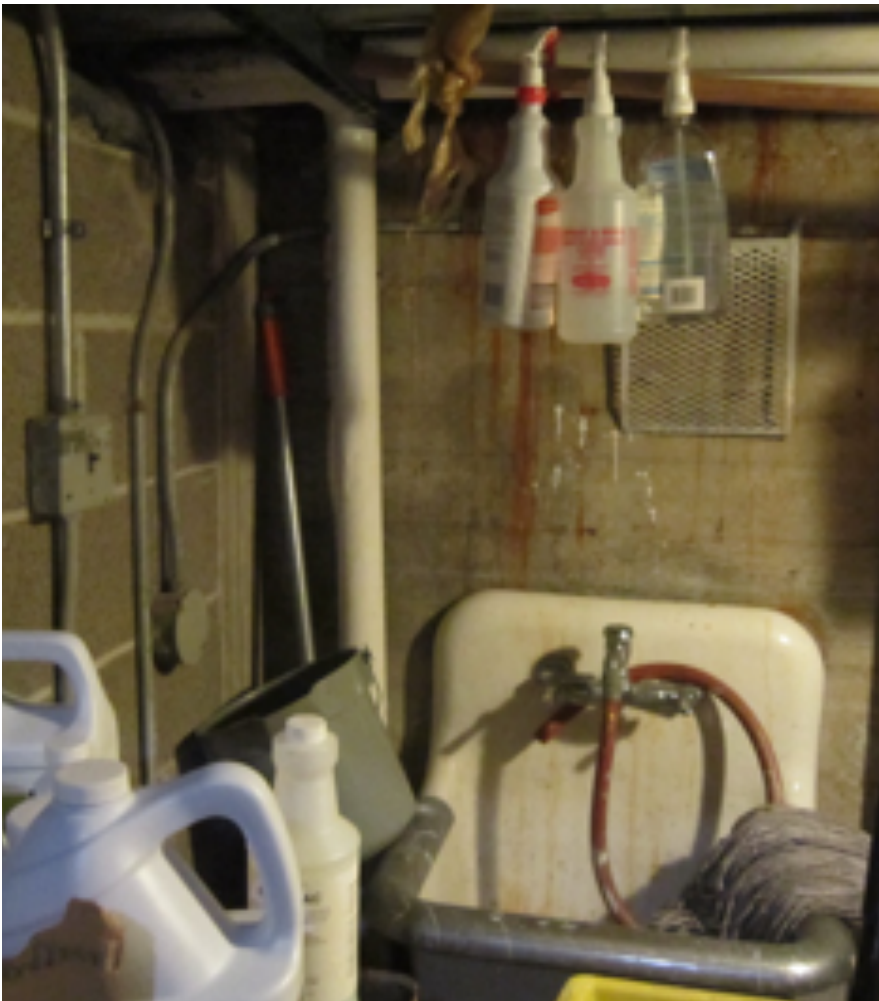
Janitor Closet without full head clearance

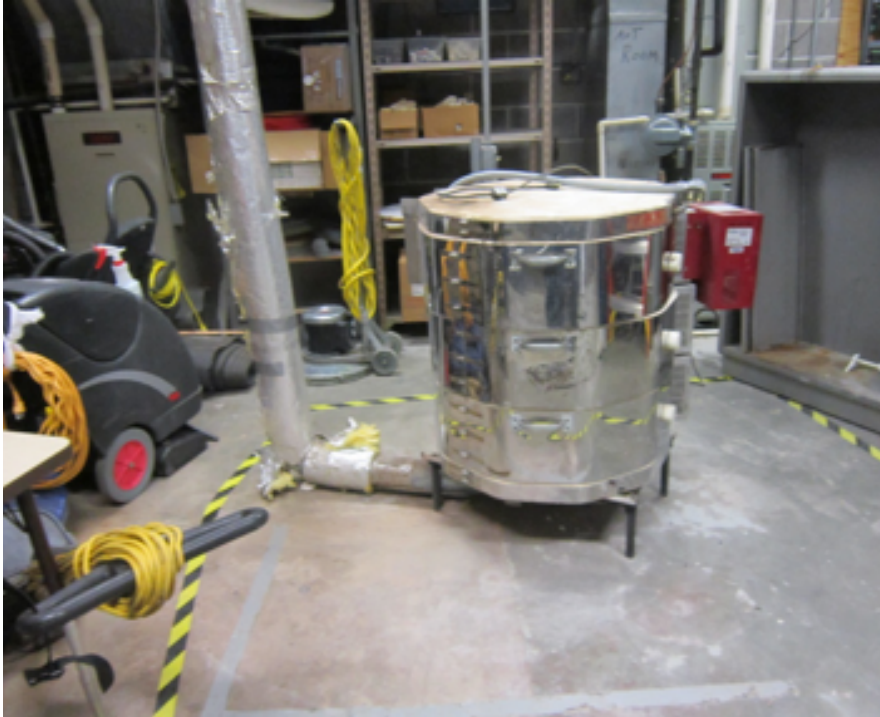
Kiln in Mechanical space in middle of room has inefficient use of space

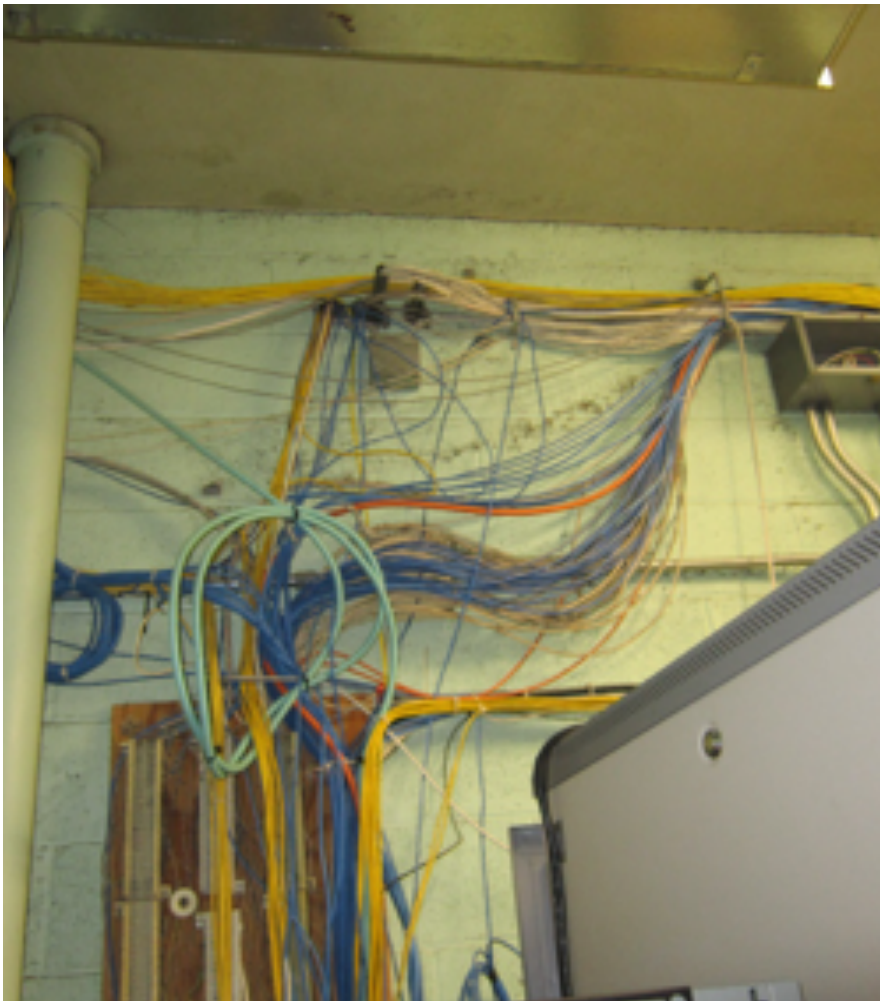
Network Cabling

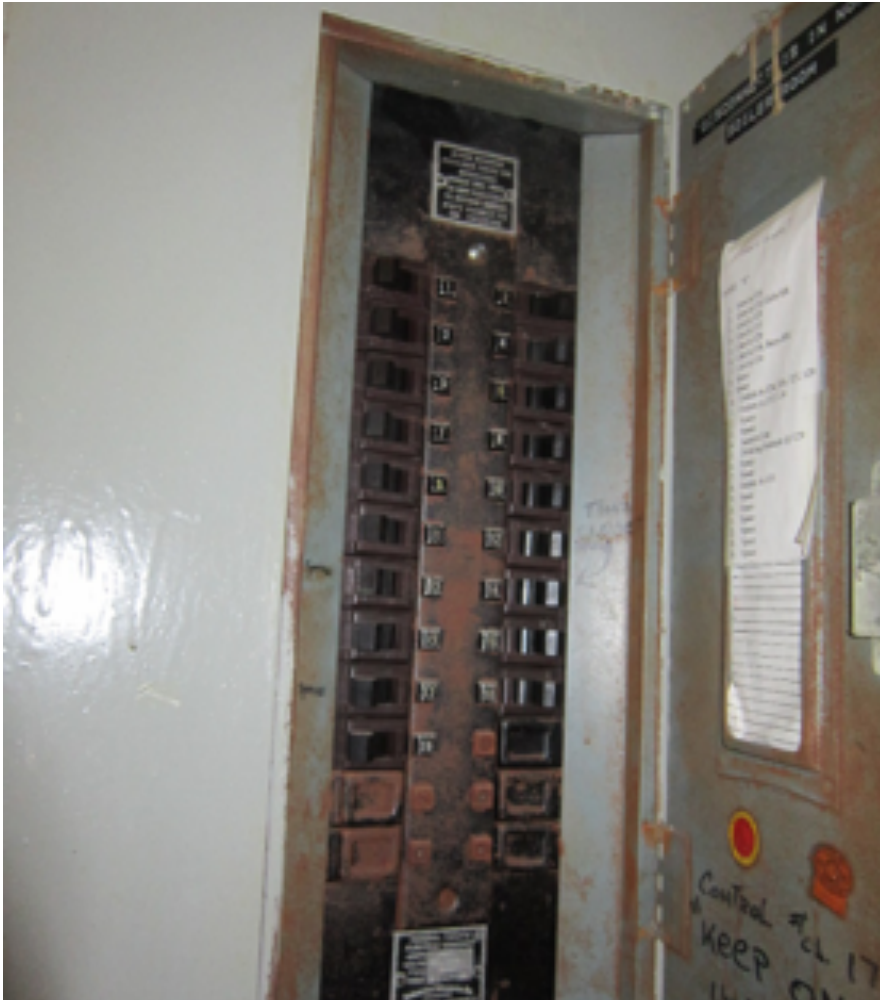
Old electrical panel with significant amount of rust

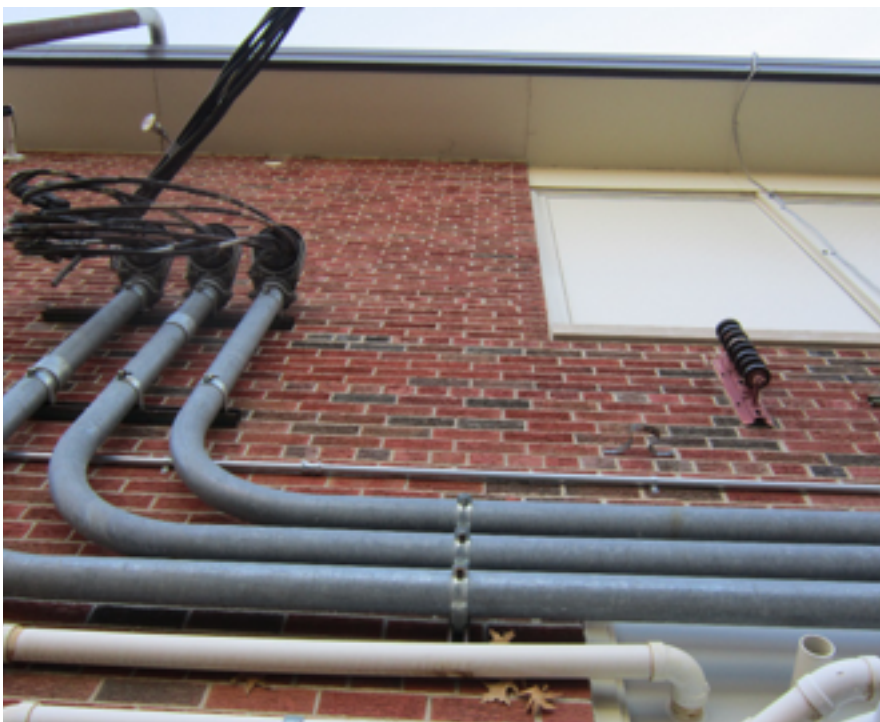
Overhead Electrical Service

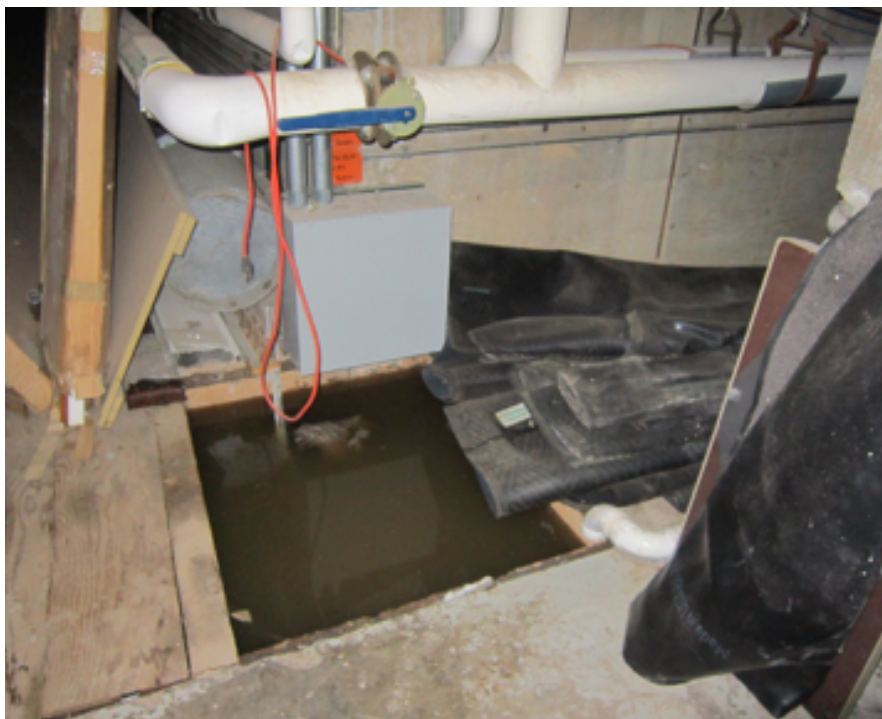
Sewer water backup

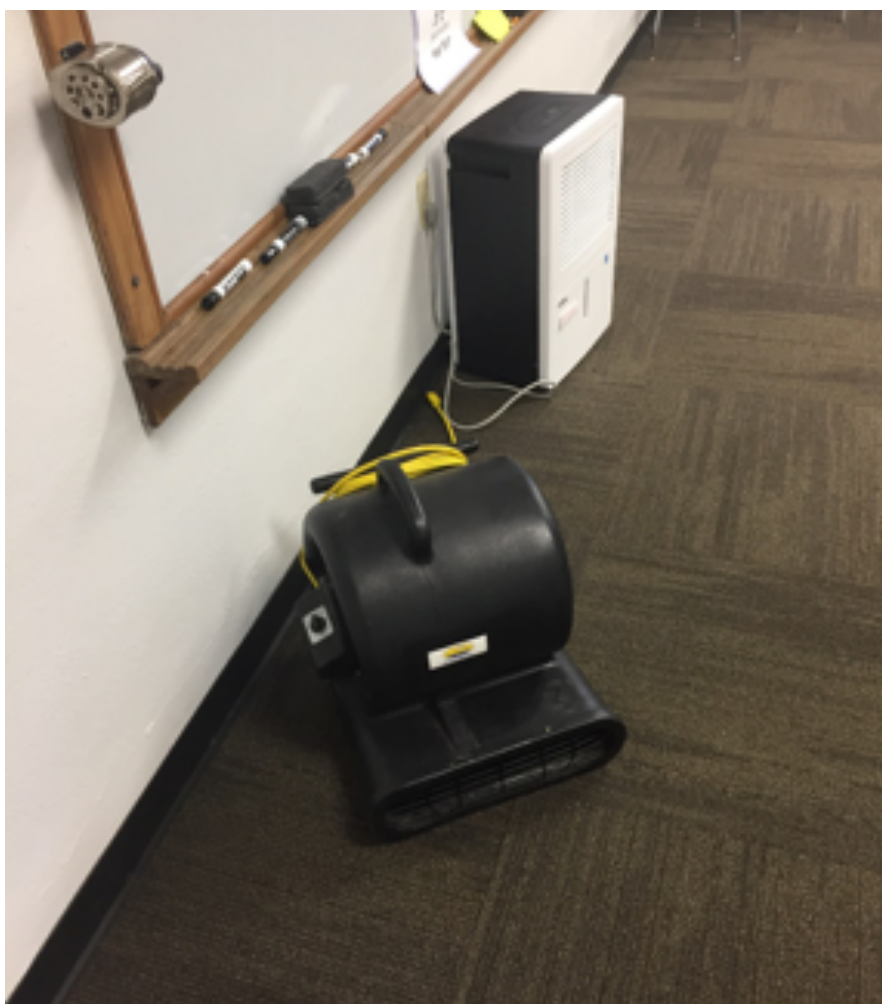
Portable dehumidifier and fan

- **One classroom on the lower level had a portable dehumidifier in the space. It appeared it was used mostly when poor drainage caused moisture problems in room.**

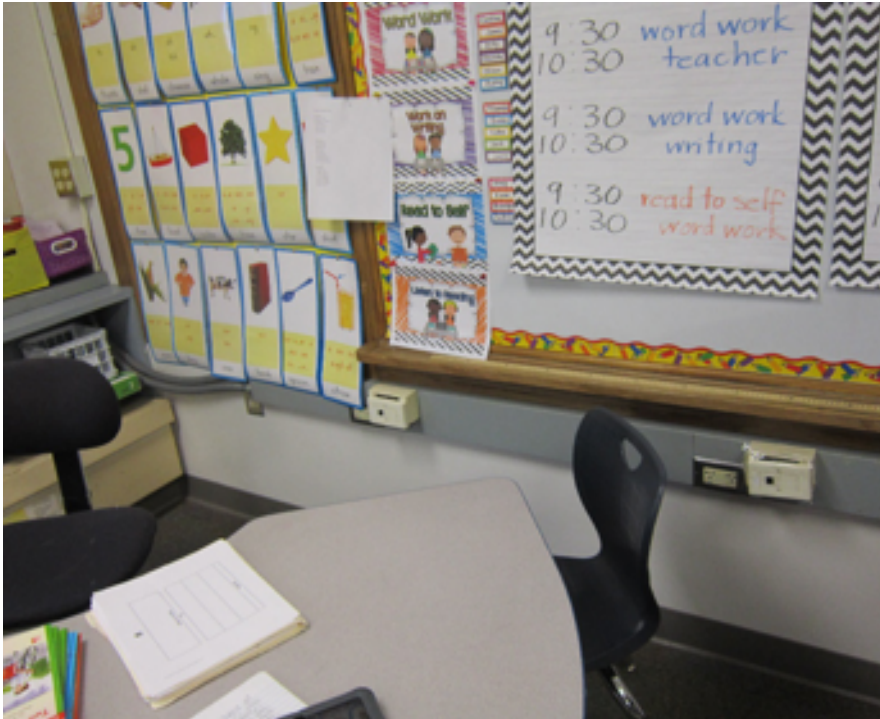
Surface electrical power.  
The typical classroom  
needs updating.
