BELINDER ELEMENTARY

# FACILITY EVALUATION

# OVERALL SUMMARY

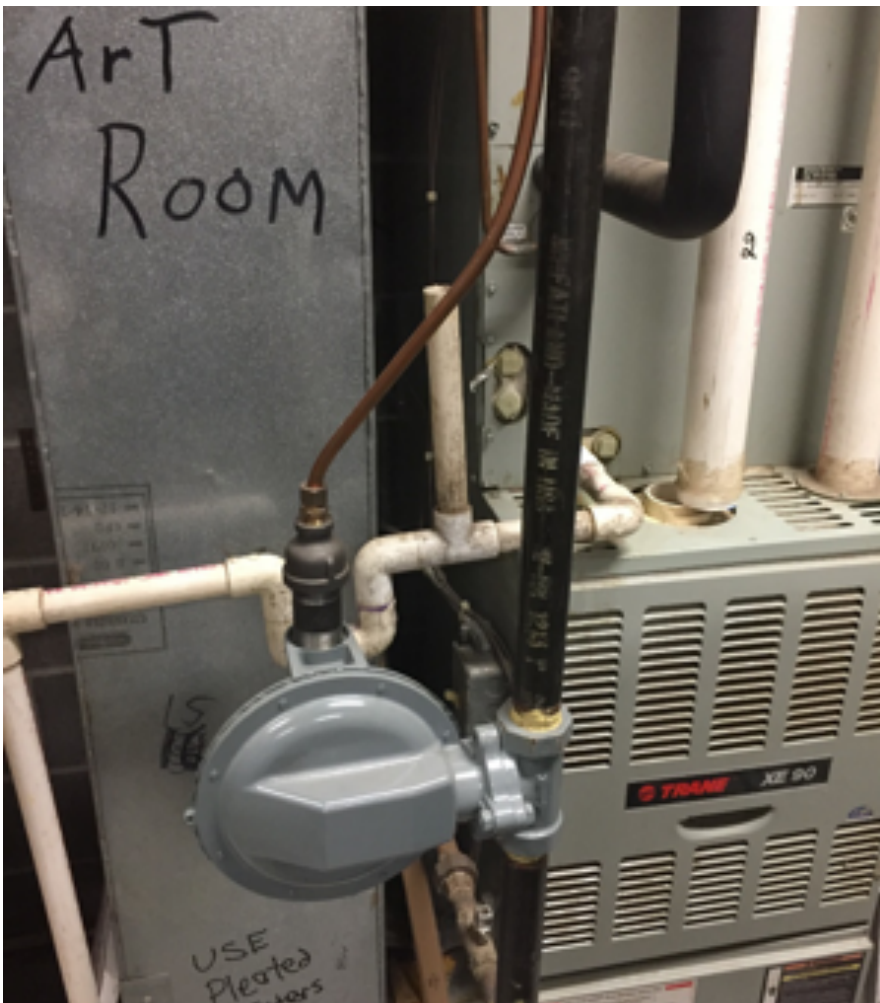
Split system serving Art  
Classroom. Exhaust not  
connected to unit.

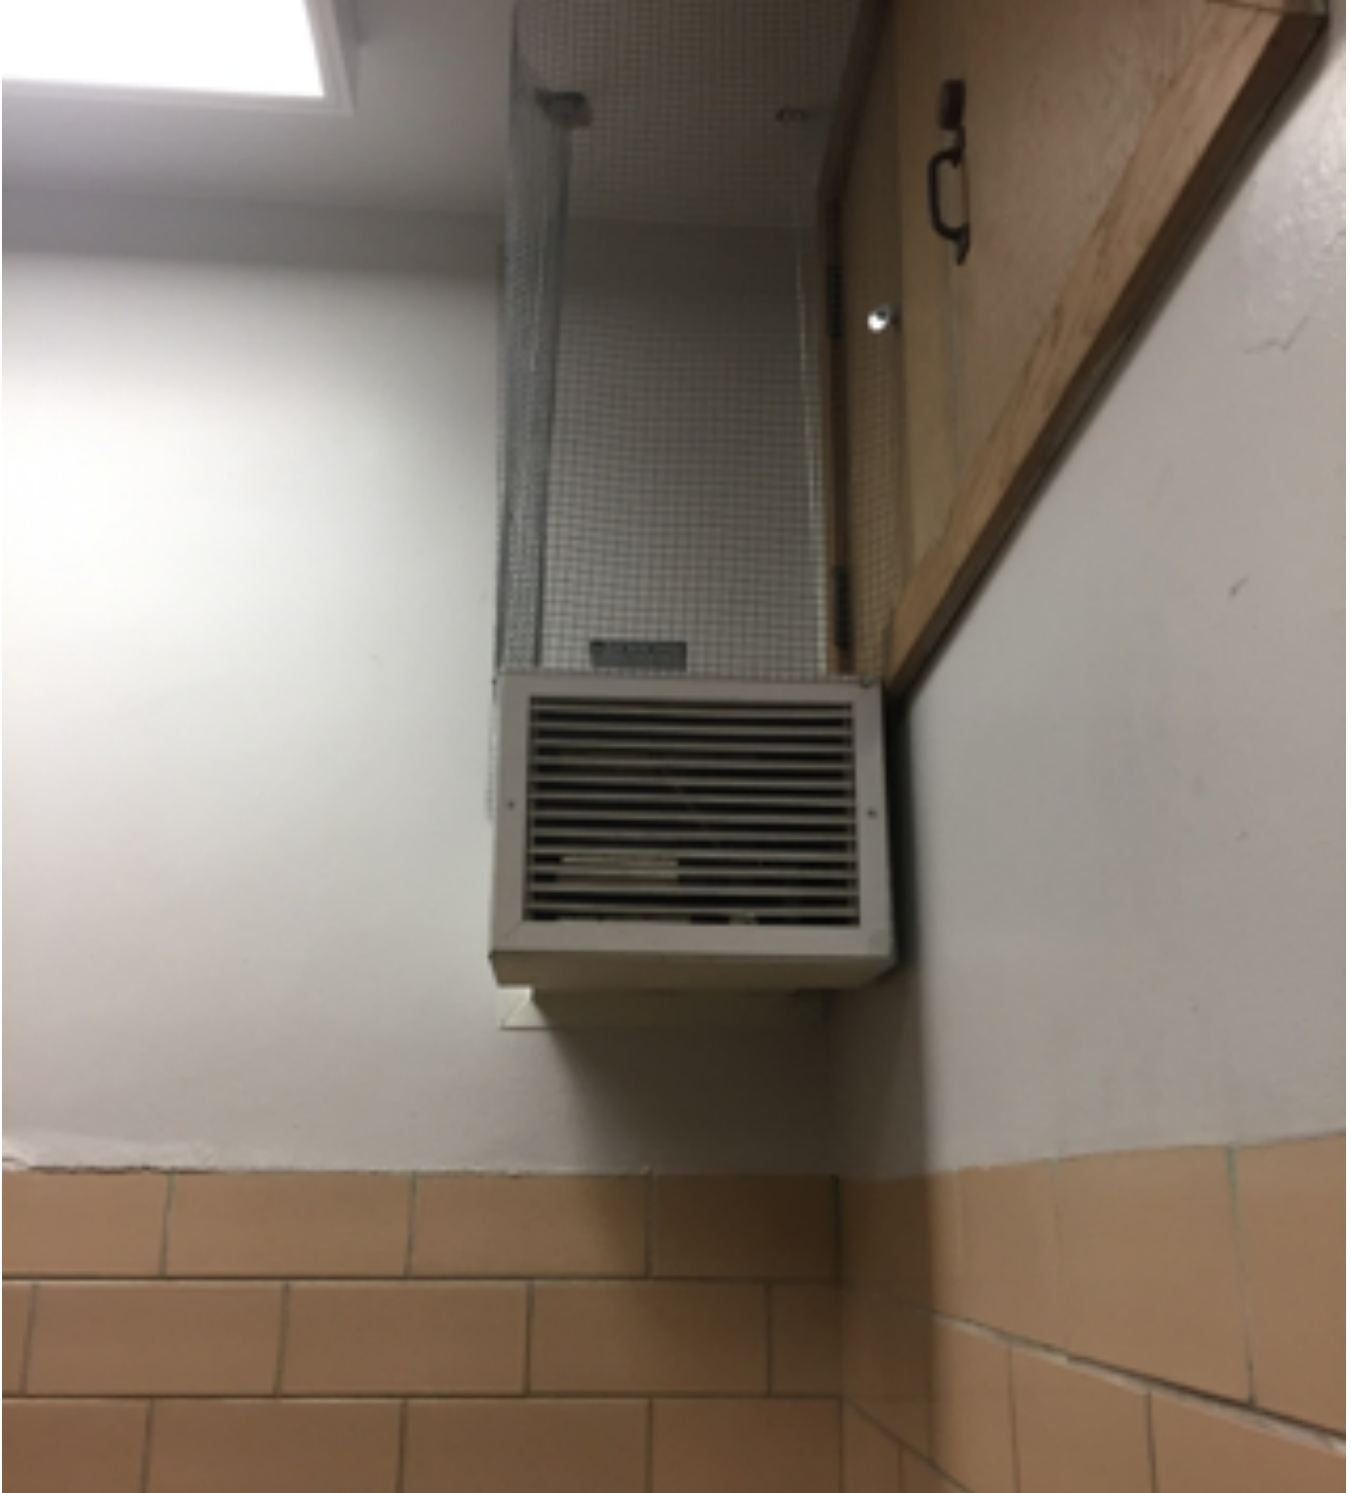
Transfer air from restroom to corridor.
