William Floyd UFSD

Little Red School House

Facility Evaluation Update

January 14, 2010

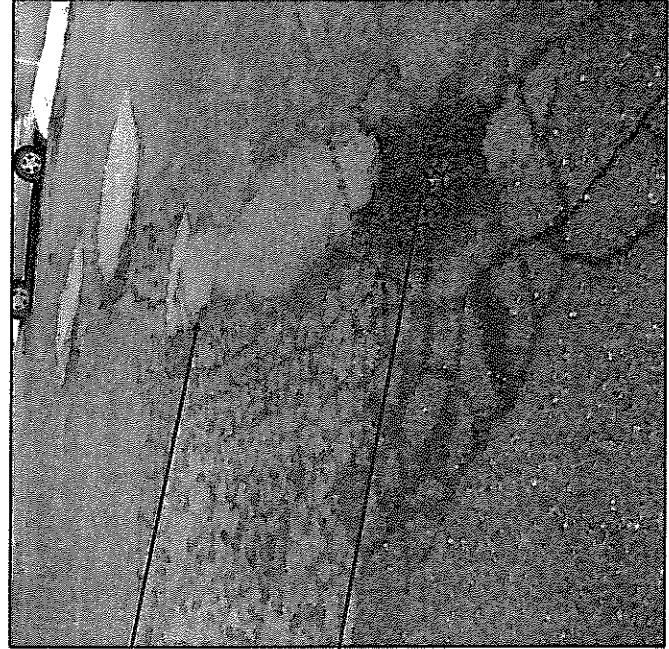
1.1	1	\$5,000	2011	\$5,300	Exterior Paved Areas: The existing asphalt paved parking area is has deteriorated. There are several areas in which the top asphalt coat is gone and the base material has deteriorated. (Potholes). Recommend Repair Potholes	\$5,300

1.2	3	\$70,000	2011	\$74,200	Exterior Paved Areas: related to above. The entire parking lot continues to deteriorate. Recommend Replace entire parking area			\$74,200

Damaged Asphalt Paving

Base material exposed

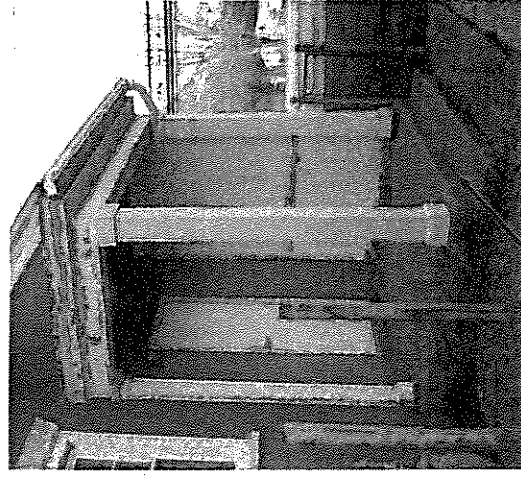
1.5	1	\$7,500	2011	\$7,950	Exterior Handrails: Org Bldg There are several locations in which exterior doors exit to a two step concrete area. A handrail on one side is required as per NYSED requirements	\$7,950		
Subtotal this page		\$115,000		\$121,900		\$20,150	\$18,550	\$74,200

Typical Steps without handrails

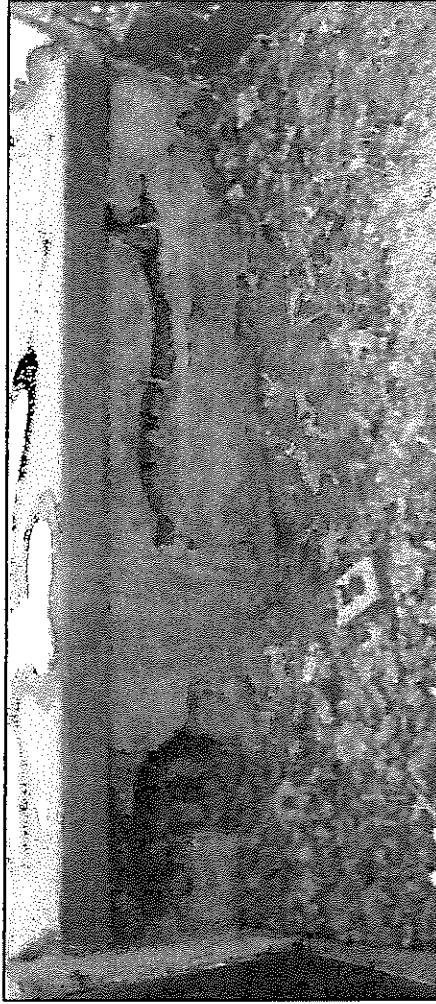
1.9	2	\$60,000	2011	\$63,800	Exterior Enclosure Heating Plant Addition: The heating plant for the addition is housed in a separate concrete structure which is partial below grade. The structure is in very poor condition.		\$63,800	
Subtotal Site		\$202,800		\$214,968		\$50,668	\$90,100	\$74,200

Addition structure that houses the Hot Air Furnace is structurally unstable.

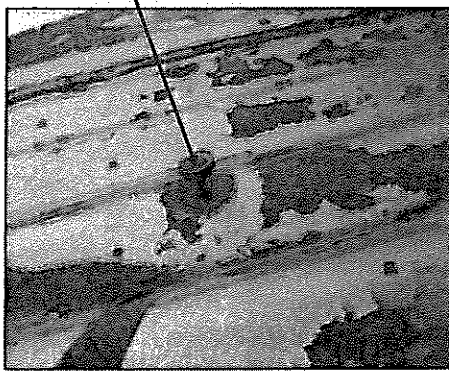
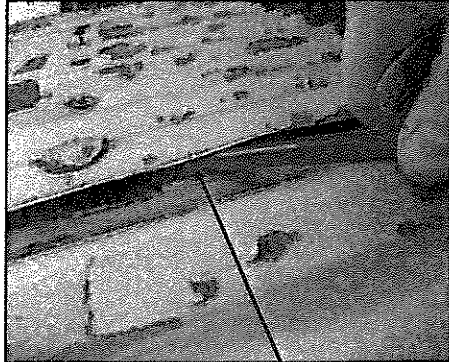
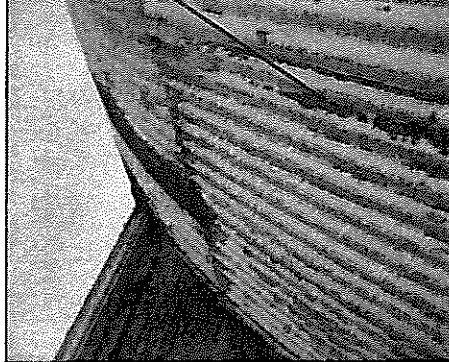
2.1	2	\$135,000	2011	\$143,100	<p>Roof: the original facility has an asphalt shingled system which is in good condition. There are several low slope (flat) areas which are a built-up system. There are not reported leaks; however the system mat is showing signs of deterioration. The Addition has a metal barrel vault, there are areas where the fasteners are rusting and the paint/coating is beginning to flak. <u>Recommendation:</u> All flat areas install new asphalt flood coat, on the barrel roof, remove the system and apply new standing seam system.</p>		\$143,100		
Subtotal		\$135,000		\$143,100		\$0	\$143,100	\$0

<p>Numerous loose fasteners which indicates roof system is not properly attached to structure which can result in blow off</p>		<p>Rusted and Pitted areas</p>			
				<p>Gap between the sheets</p>
