516 FACILITY CONDITION ASSESSMENT ACT EDUCATION CENTER

FACILITY CONDITION ASSESSMENT

17960 Monterey Rd. Morgan Hill, Ca 95037 | adultschool.mhusd.org

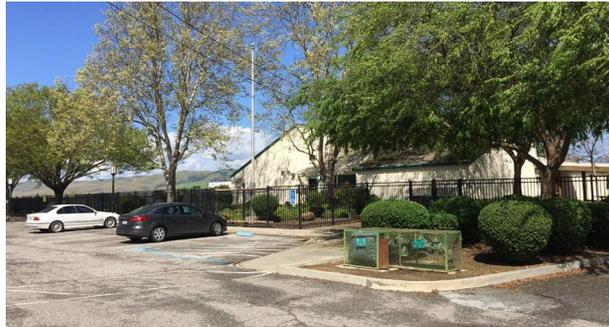
Parking

- Limited parking is available for students on-site.

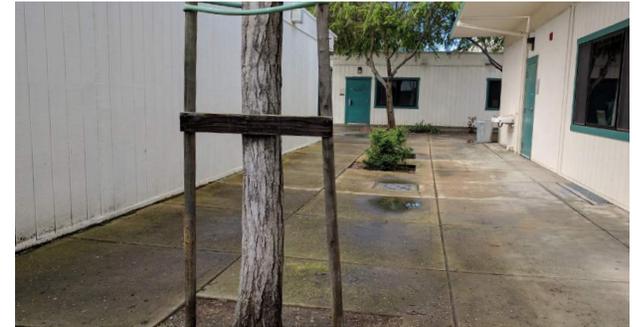
Typical Concrete Paving

- Concrete paving is in fair condition. Mild ponding was observed.

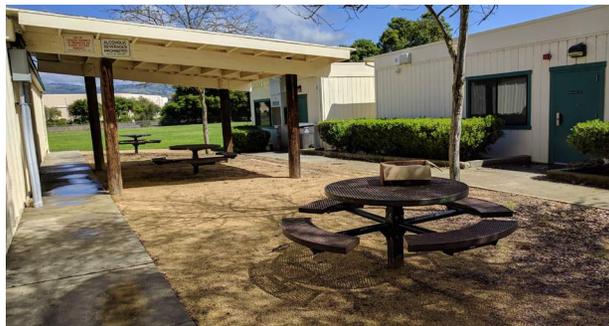
Outdoor Dining

- Outdoor eating area has decomposed granite
- Tree leaves are a nuisance for maintenance.

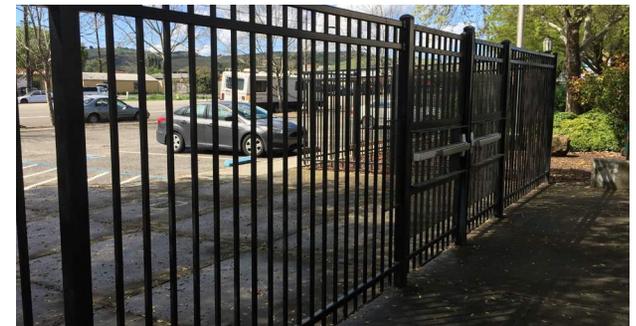
Security Fencing

- The existing fencing is only at the front of the campus. The rest of the campus perimeter remains open.

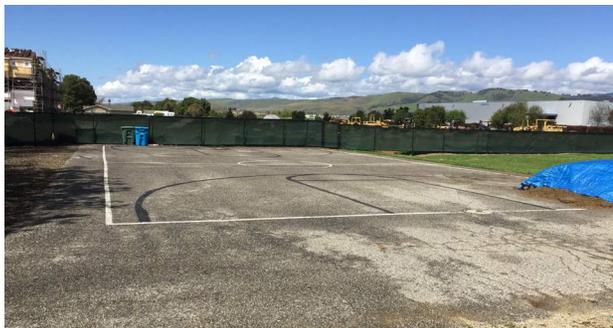
Hardcourts

- There is an AC pavement with basketball court outlines on the campus that is not used by the school. There are no outdoor basketball standards. The field is used by a local soccer group, and attendees park on the AC pavement.

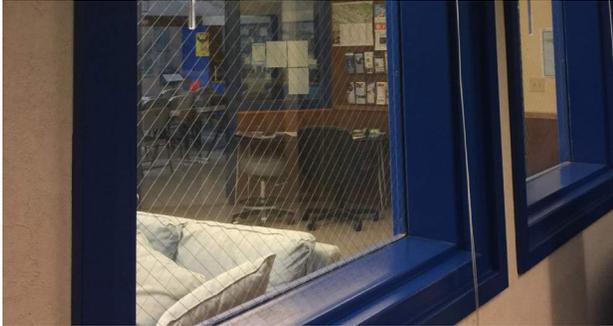
- Windows are original to the building.

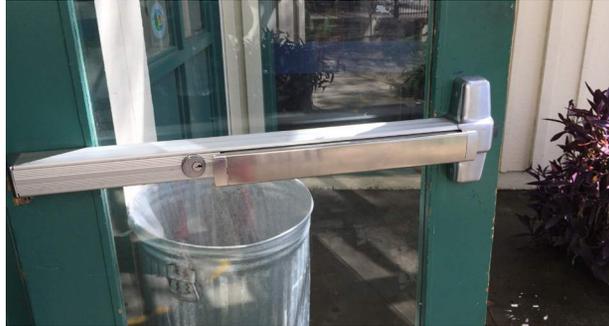
Exterior Door Hardware

- Doors are heavy with outdated hardware, particularly in the Central building.
- Keys availability for doors is questionable.

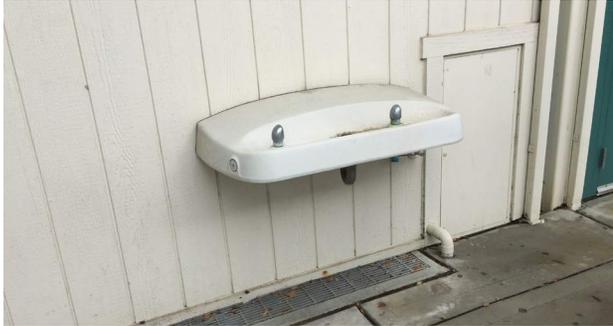
Drinking Fountain

- Drinking fountains are non-compliant.

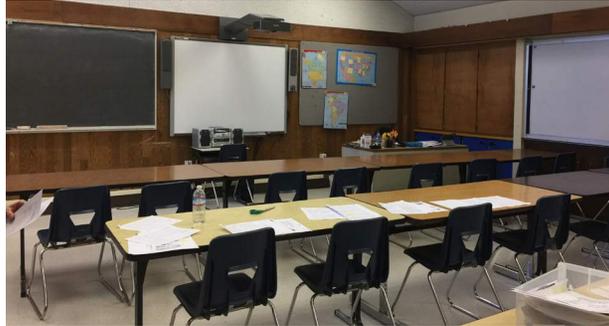
Typical Classroom

- Flooring in classrooms are damaged.
- There is an unknown odor in a couple of the classrooms.
- The ceilings in Central building are damaged.

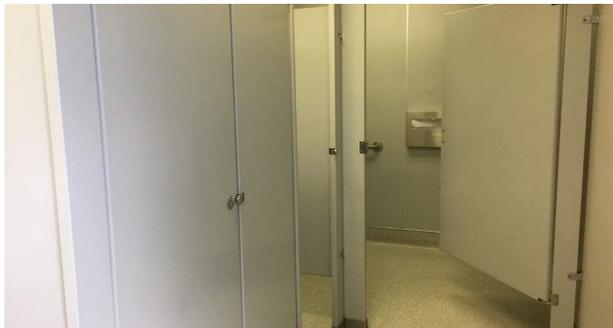
Restroom

- Finishes in the toilet rooms are in poor conditions. The flooring is warped or stained, the ceilings are damaged, and the toilet partitions have paint damage.
