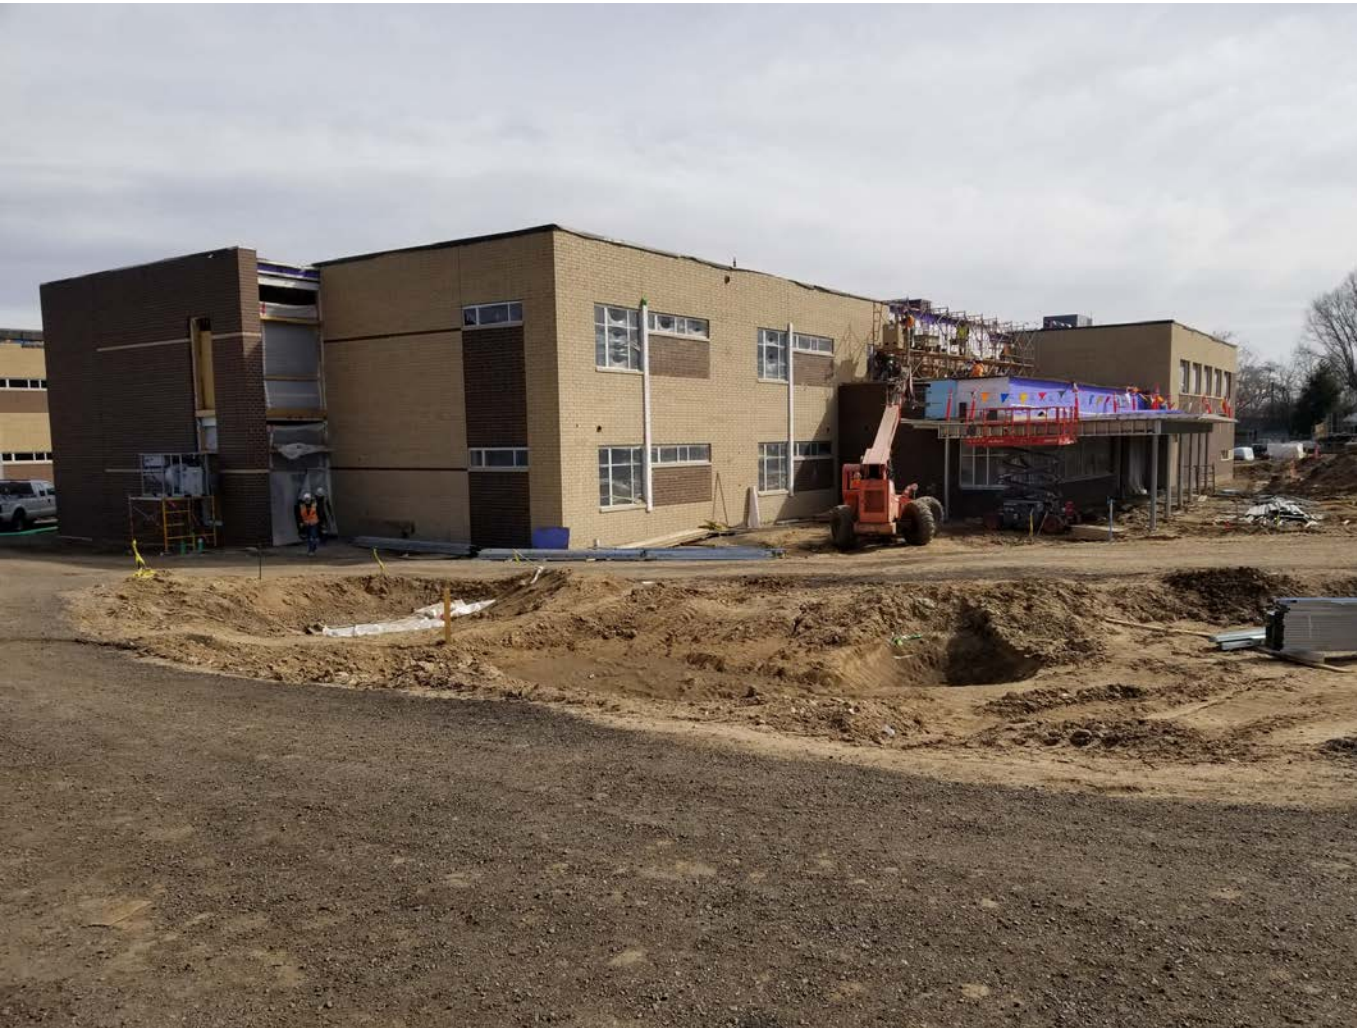
Front Entrance – Southwest Elevation; Roof work continues on awning

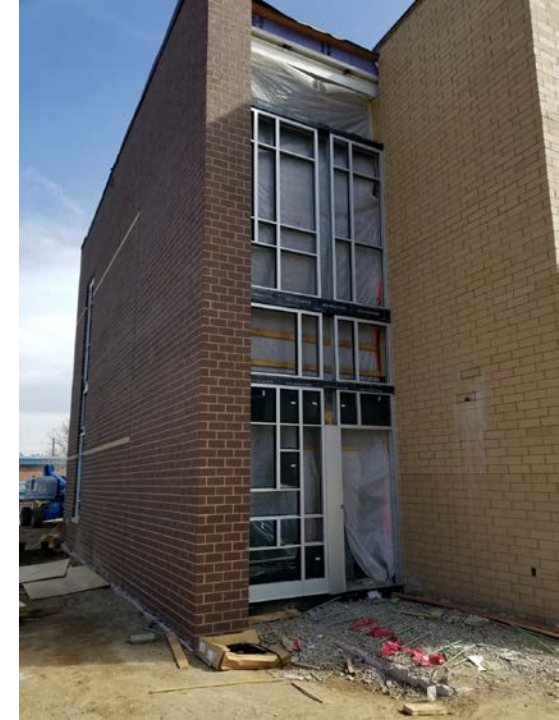
West Elevation; Frames installed on classroom wing staircases

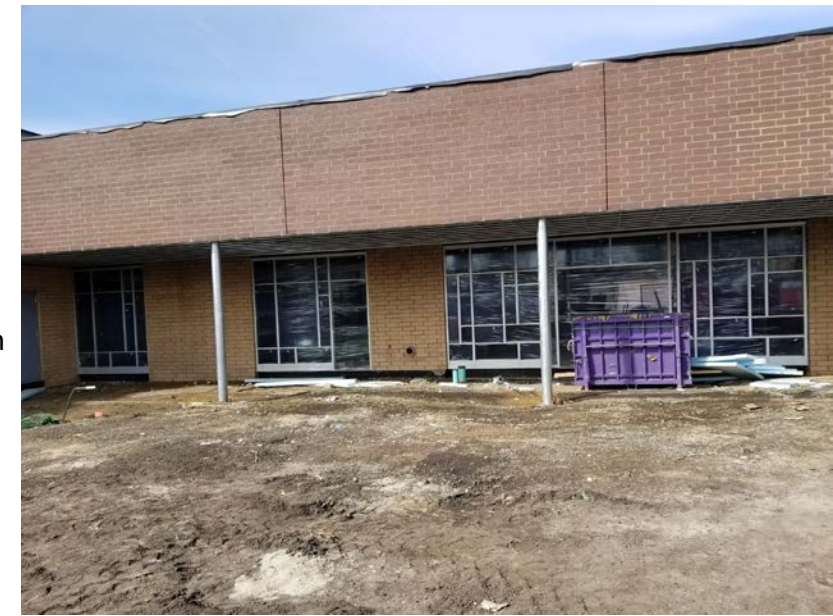
East Elevation; Frames installed in learning commons

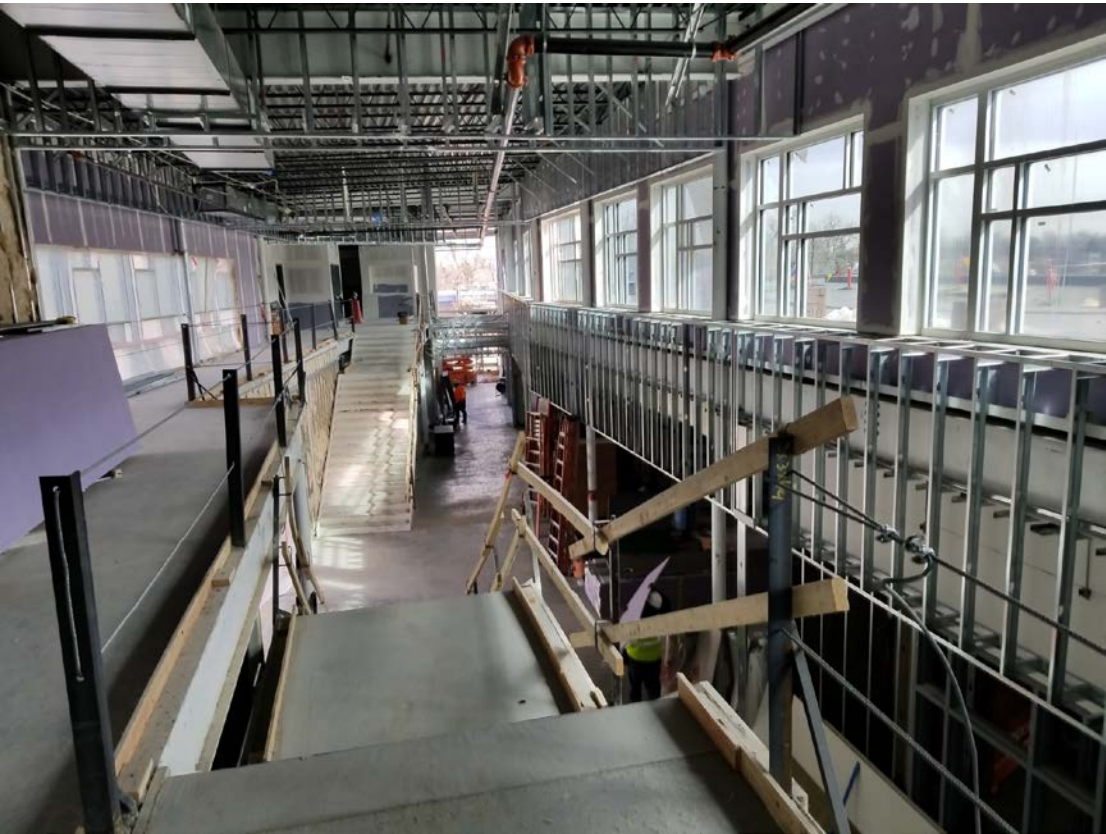
Grand Hall – North Facing View; Framing, mechanical, insulation and drywall install continues

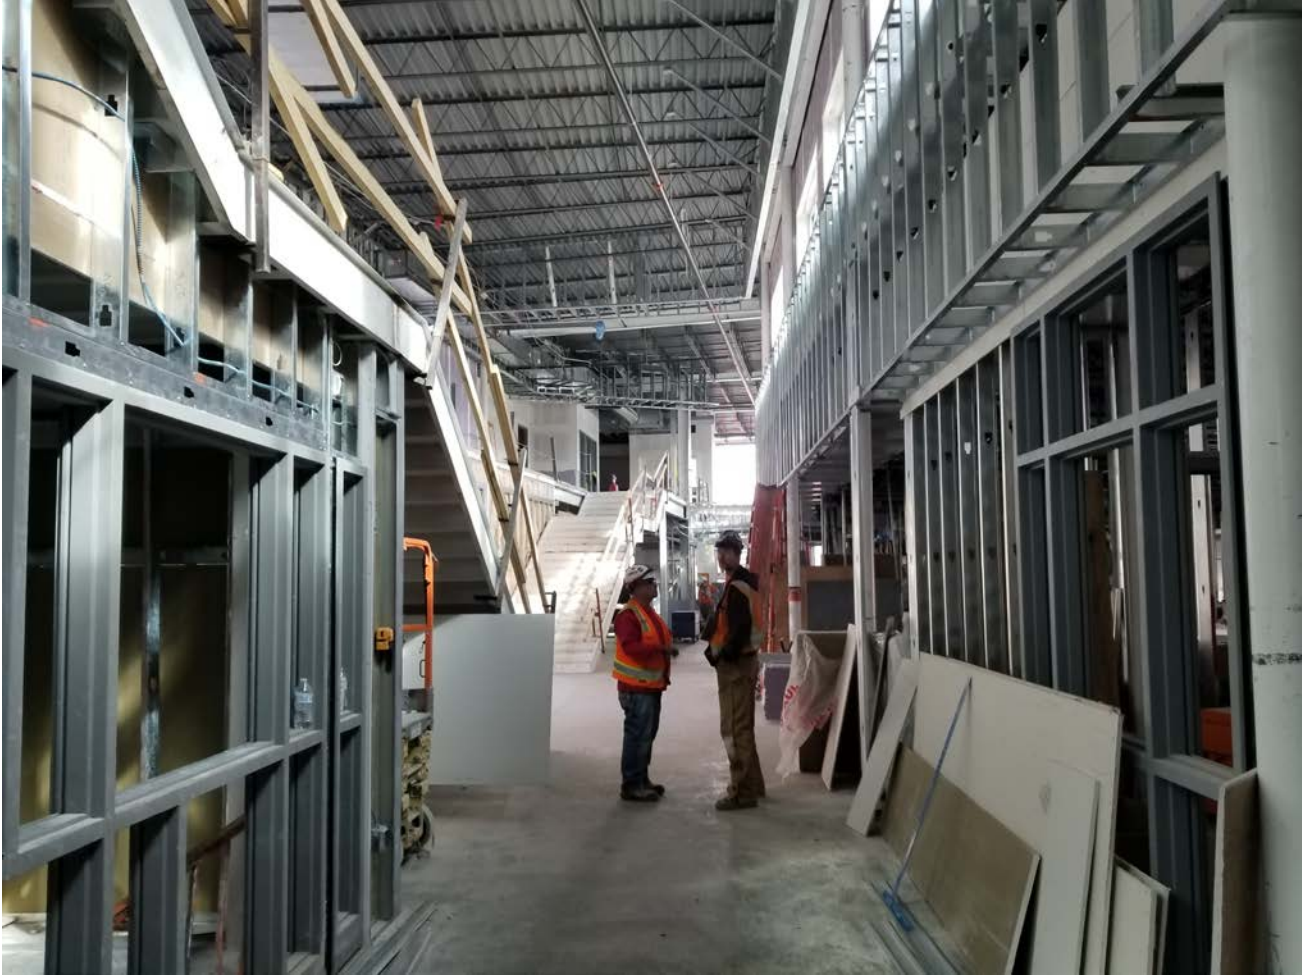
Grand Hall – North Facing View; Framing, mechanical, insulation and drywall install continues

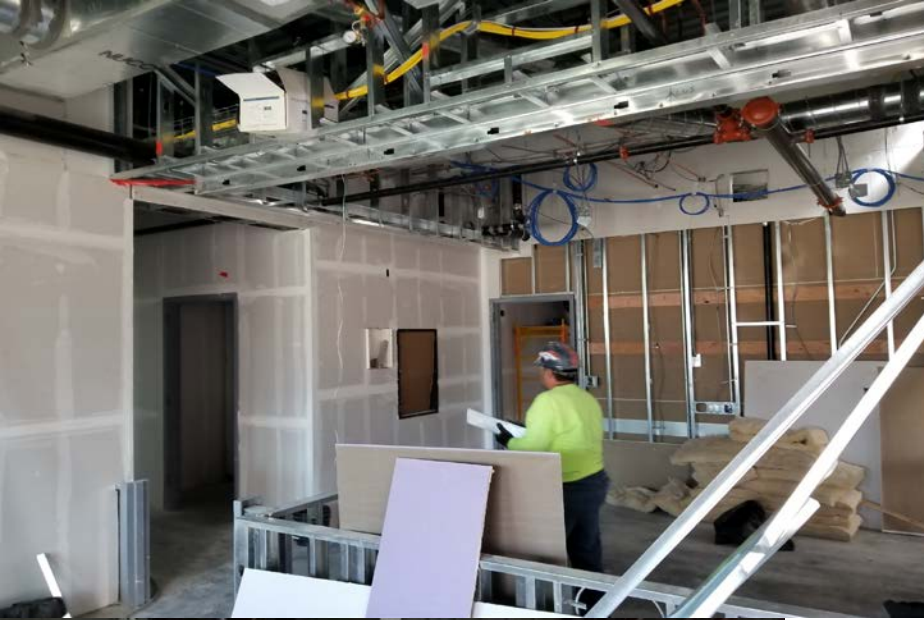
Reception Area – Electrical,
and drywall install continues

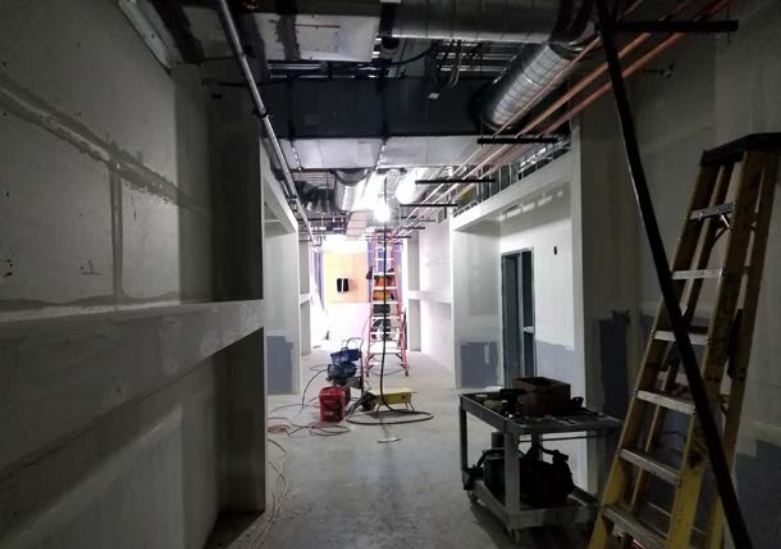
South Classroom Wing (lower level) – West Facing View;
mechanical work continues. Painting to begin soon

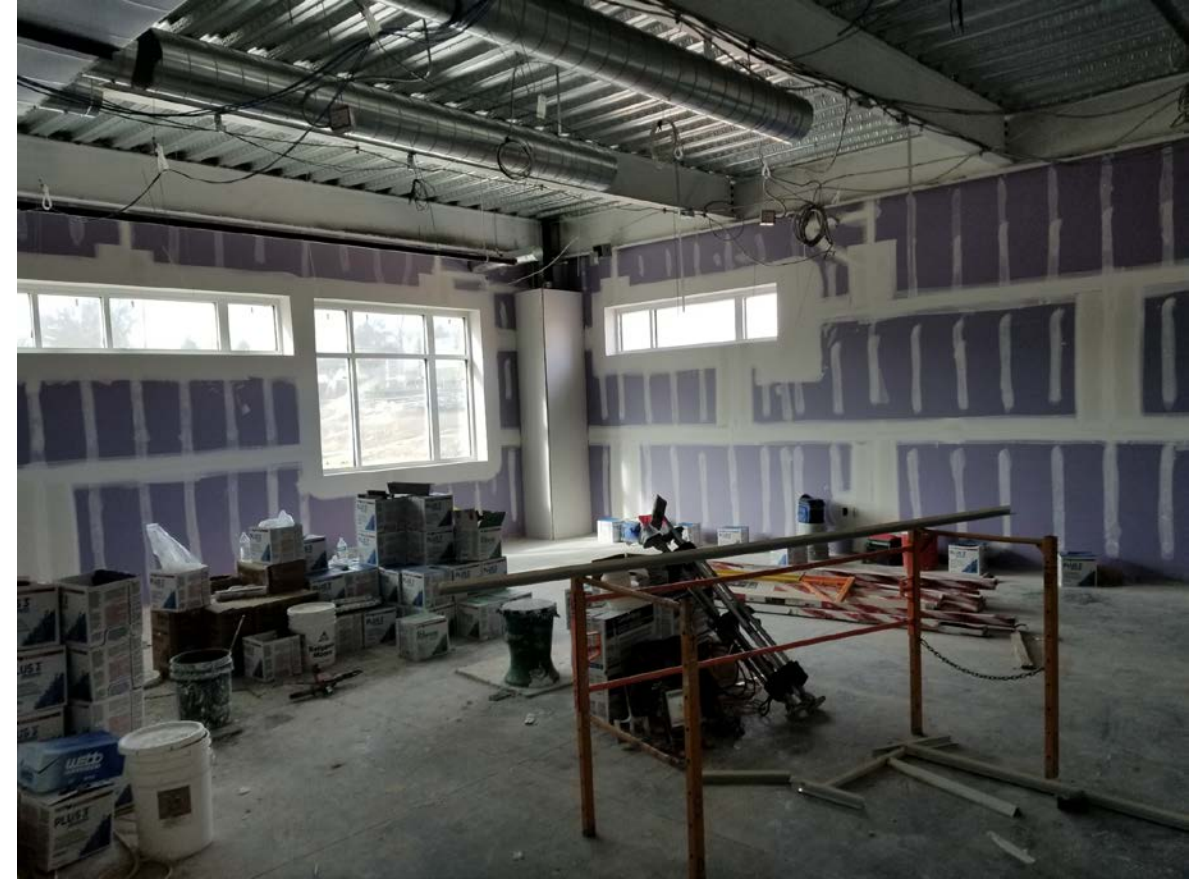
South Classroom Wing (lower level) – Classroom; drywall complete.
Painting to begin soon

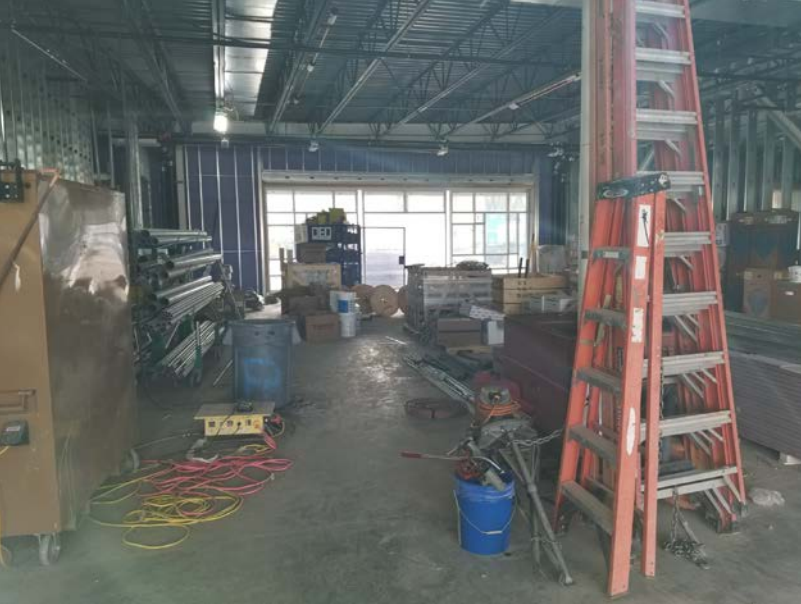
Learning Commons – Window frames newly installed. Framing and insulation of walls continue

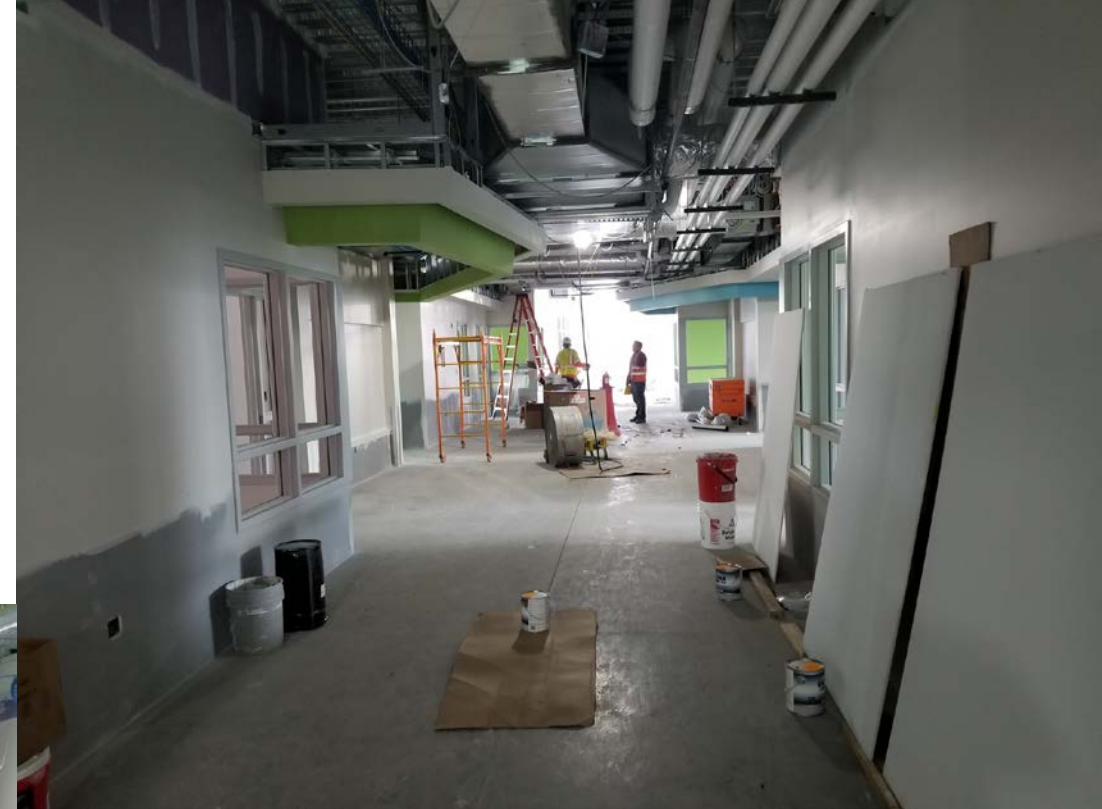
North Classroom Wing (lower level) – West Facing View; Painting continues

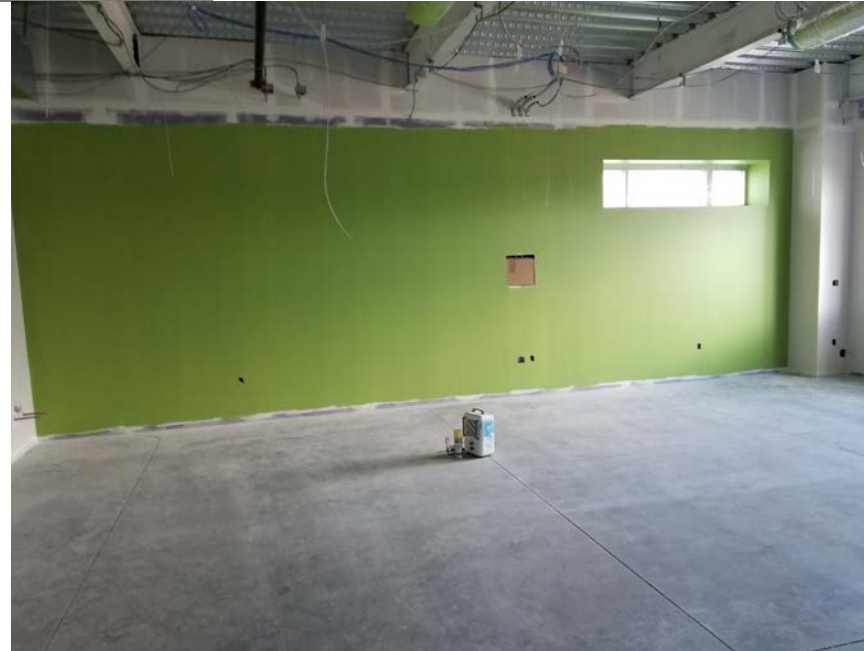
North Classrooms Wing – Classroom; Painting continues

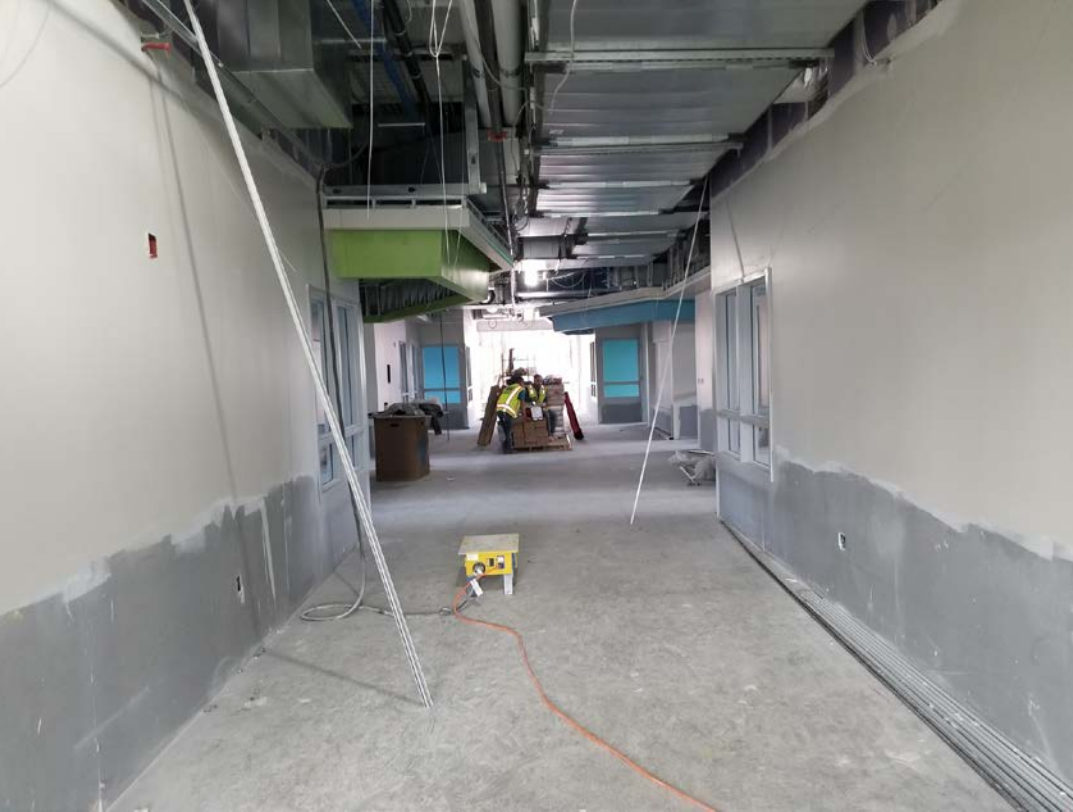
North Classroom Wing (upper level) – West Facing View; Painting continues

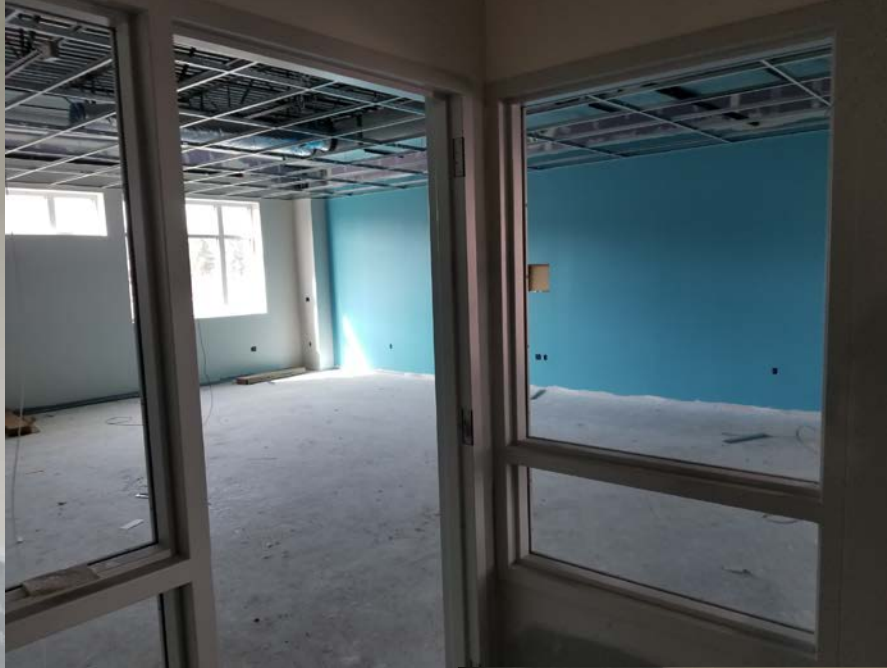
North Classroom Wing (upper level) – Classroom; Painting continues. Ceiling grid being installed

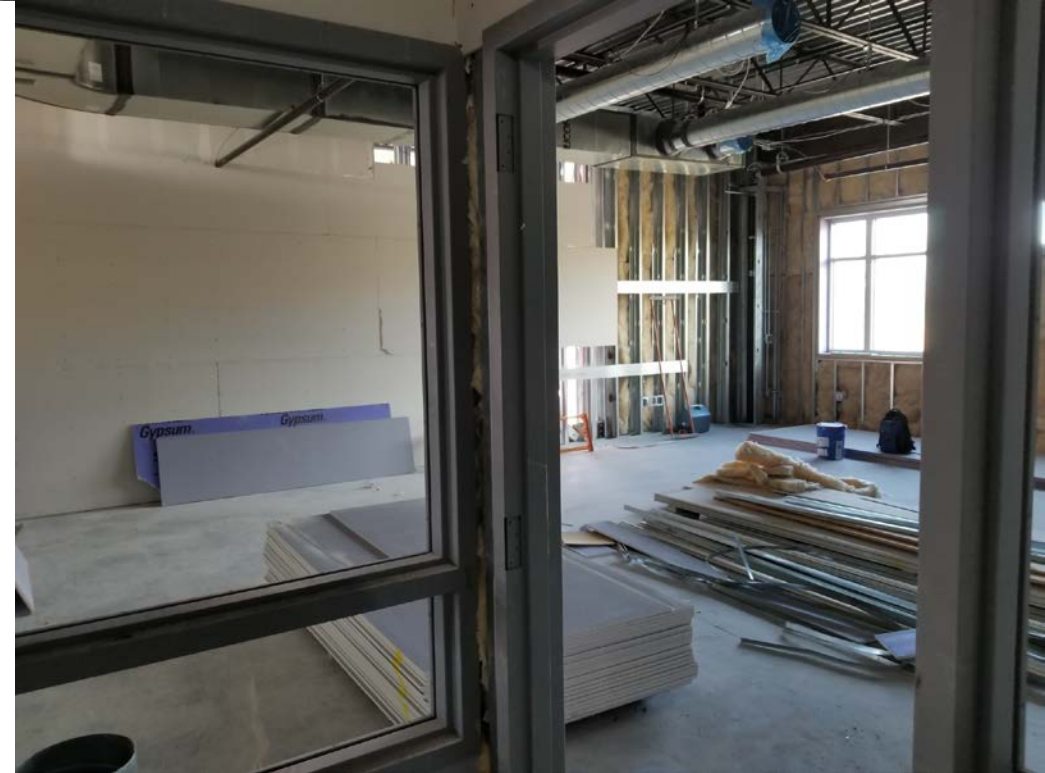
South Classroom Wing (upper level)
– Classroom; Drywall being installed
