CBRE April 2, 2018

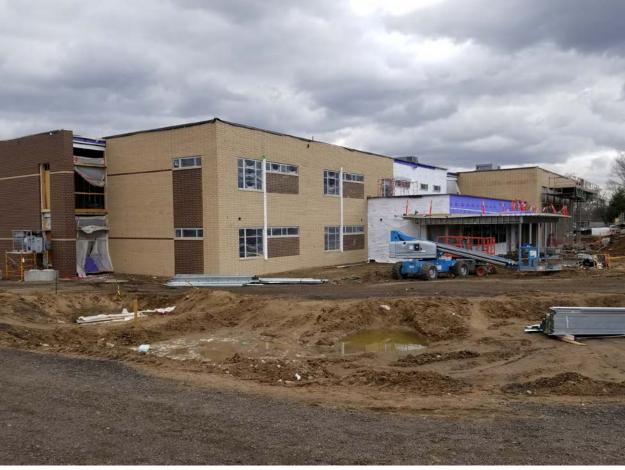
Front Entrance – Southwest Elevation; Brick, windows, and frames install continues

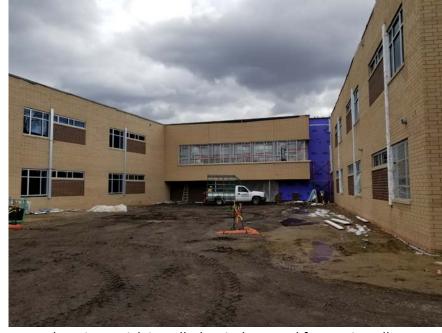
West Elevation; Brick installed. Windows and frames install continues

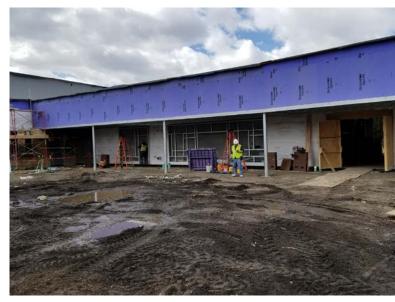
East Elevation; Brick, windows, and frames install continues

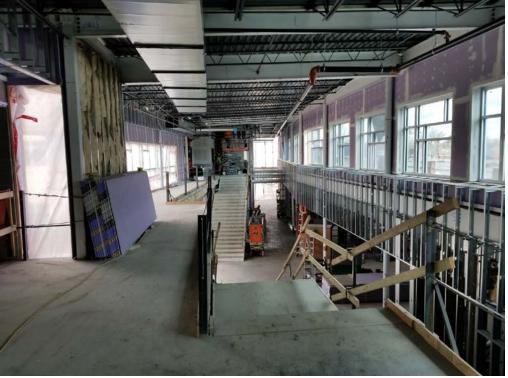
Grand Hall – North Facing View; Framing, mechanical, insulation and drywall install continues

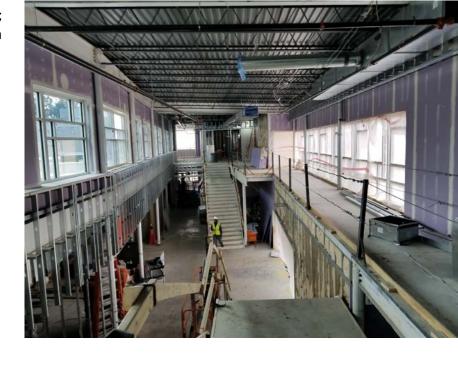
Grand Hall – South Facing View; Framing, mechanical, insulation and drywall install continues

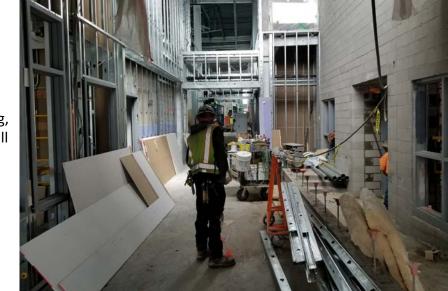
Grand Hall – North Facing View; Framing, mechanical, insulation and drywall install continues

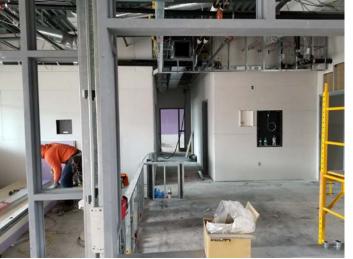
Office Area – Electrical, mechanical, insulation, and drywall install continues

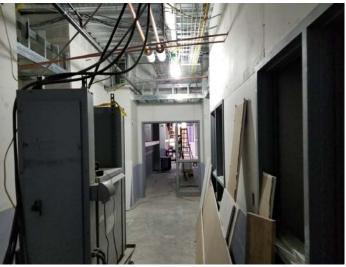
South Classroom Wing (lower level) – West Facing View; Insulation and drywall install continues

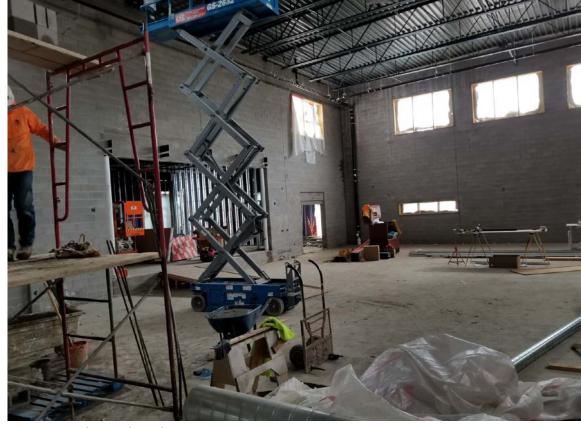
Gym - Mechanical work continues

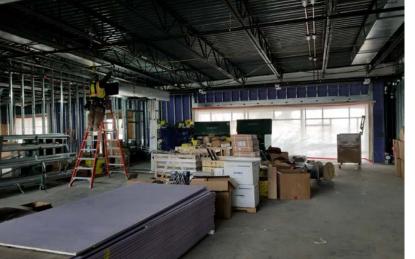
Kitchen and Cafeteria – Framing and insulation install continues

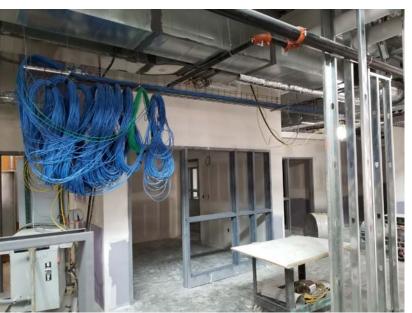
North Classrooms Wing - Conference Room - Data cabling being installed

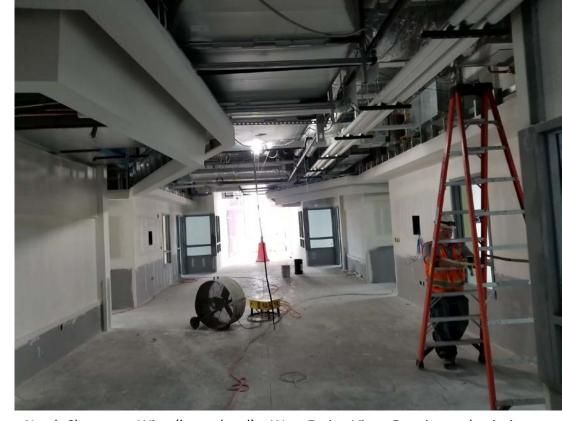
North Classroom Wing (lower level) – West Facing View; Framing and painting continues

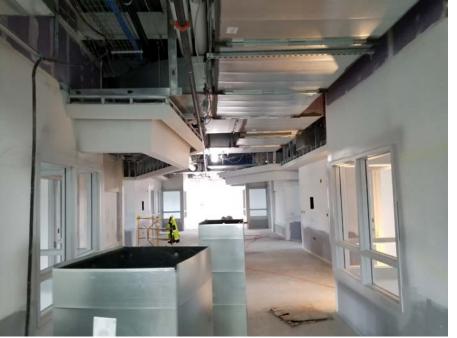
North Classroom Wing (upper level) – West Facing View; Drywall for soffit finishing, painting in progress

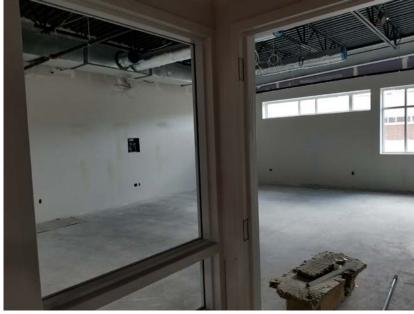
North Classroom Wing (upper level) – Painting in progress

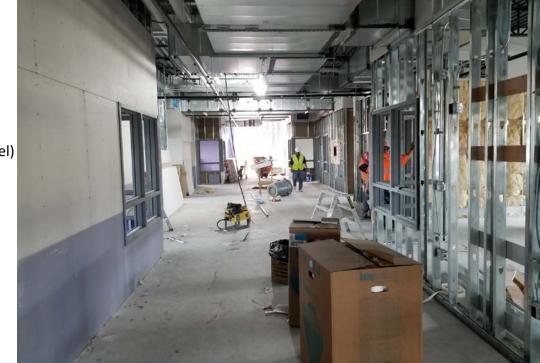
South Classroom Wing (upper level)

– West Facing View; Framing,
insulation, drywall, and window
frames install in progress
