CBRE April 23, 2018

CBRE GYM, OFFICE AREA & SOUTH CLASSROOM WING (L1)

CBRE CAFETERIA, COMMONS & NORTH CLASSROOM WING (L1)

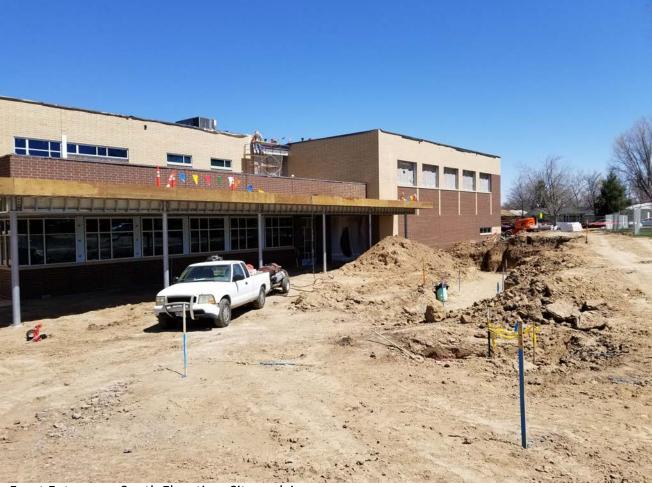
Front Entrance – South Elevation; Sitework in progress.

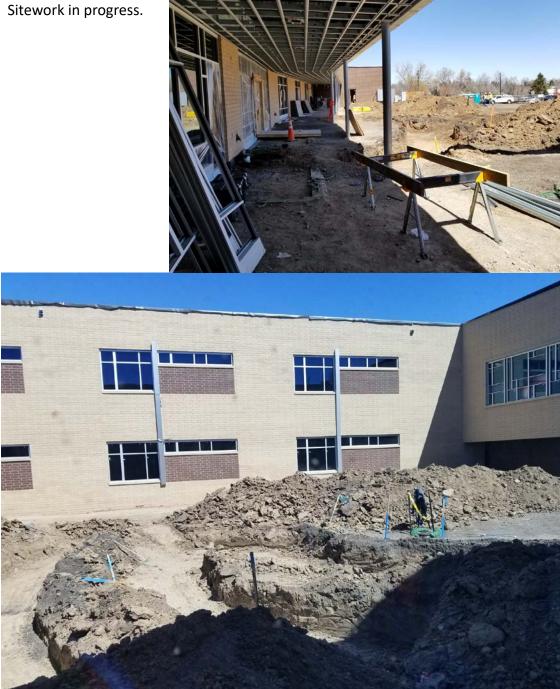
East Elevation -

Sitework in progress.

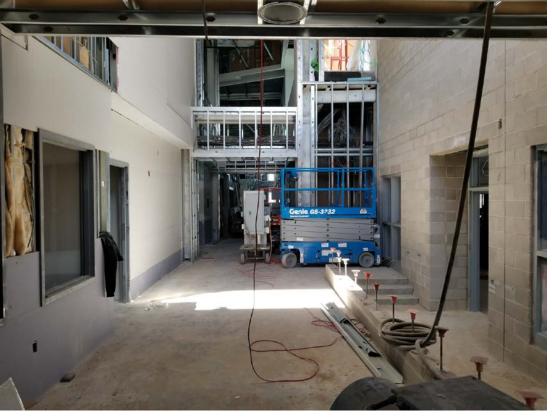
Grand Hall – North Facing View Adjacent to Gym; HVAC, electrical, insulation and drywall install continues.

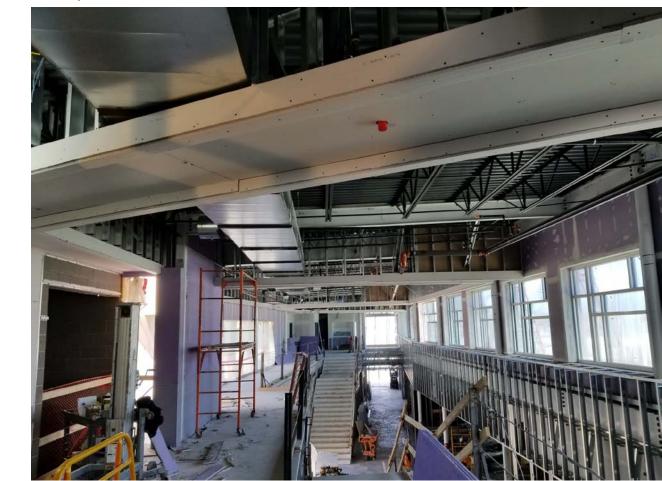
Grand Hall – North Facing View; HVAC, electrical, framing, insulation and drywall install continues.

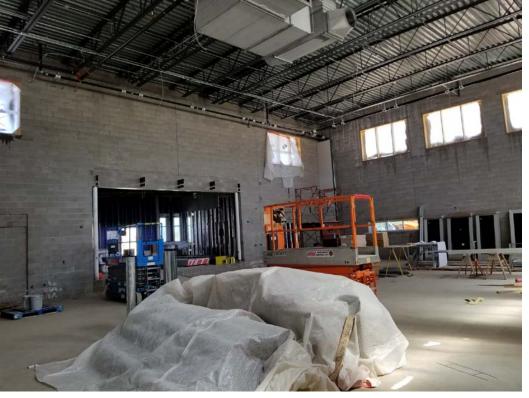
Gym – Framing install on stage/music room.

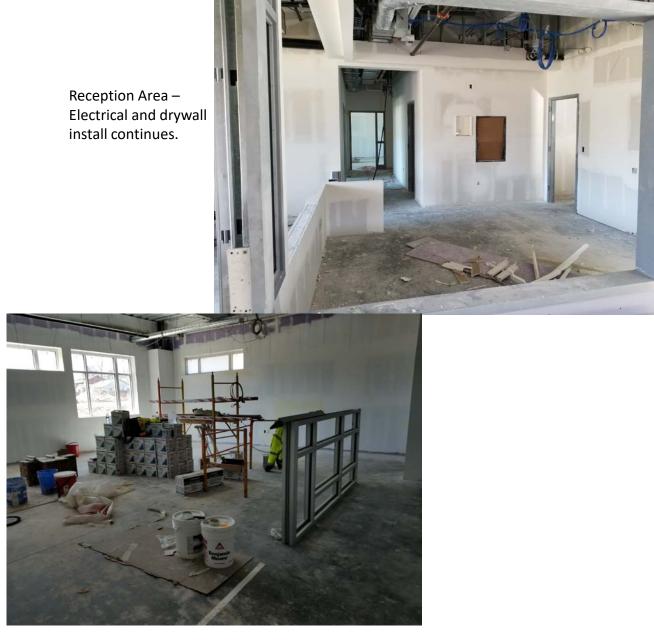
South Classroom Wing (lower level) –Painting in progress.

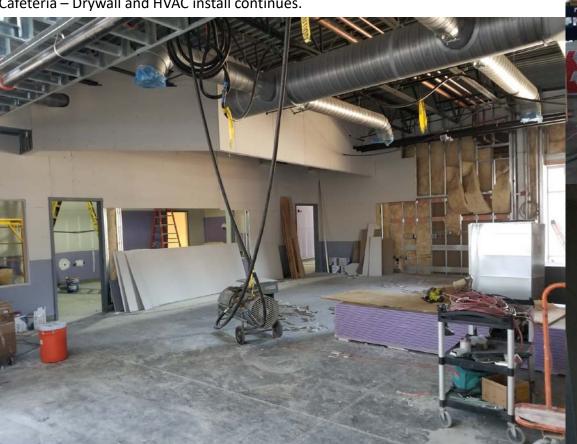
Cafeteria – Drywall and HVAC install continues.

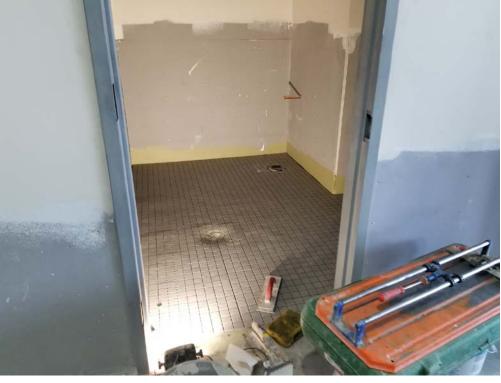
North Classroom Wing (upper level) – Teacher Restroom; Floor tile install.

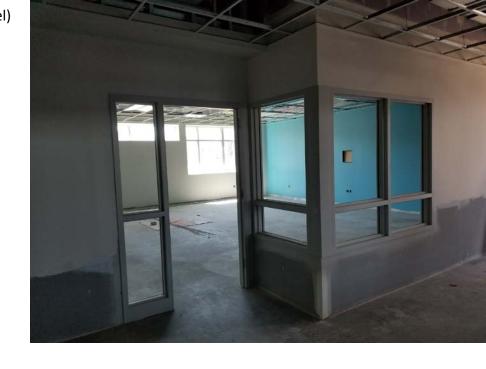
North Classroom Wing (upper level) – Classroom; Ceiling install and painting in progress.

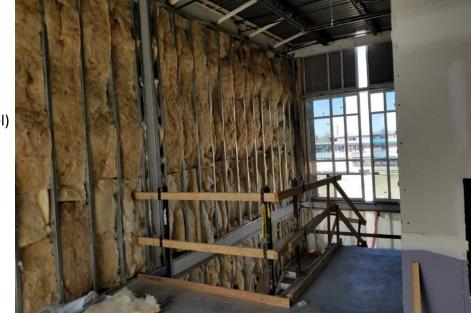
South Classroom Wing (upper level)

– Stairwell; Insulation and drywall install.
