Clayton Construction Report  
May 7, 2018

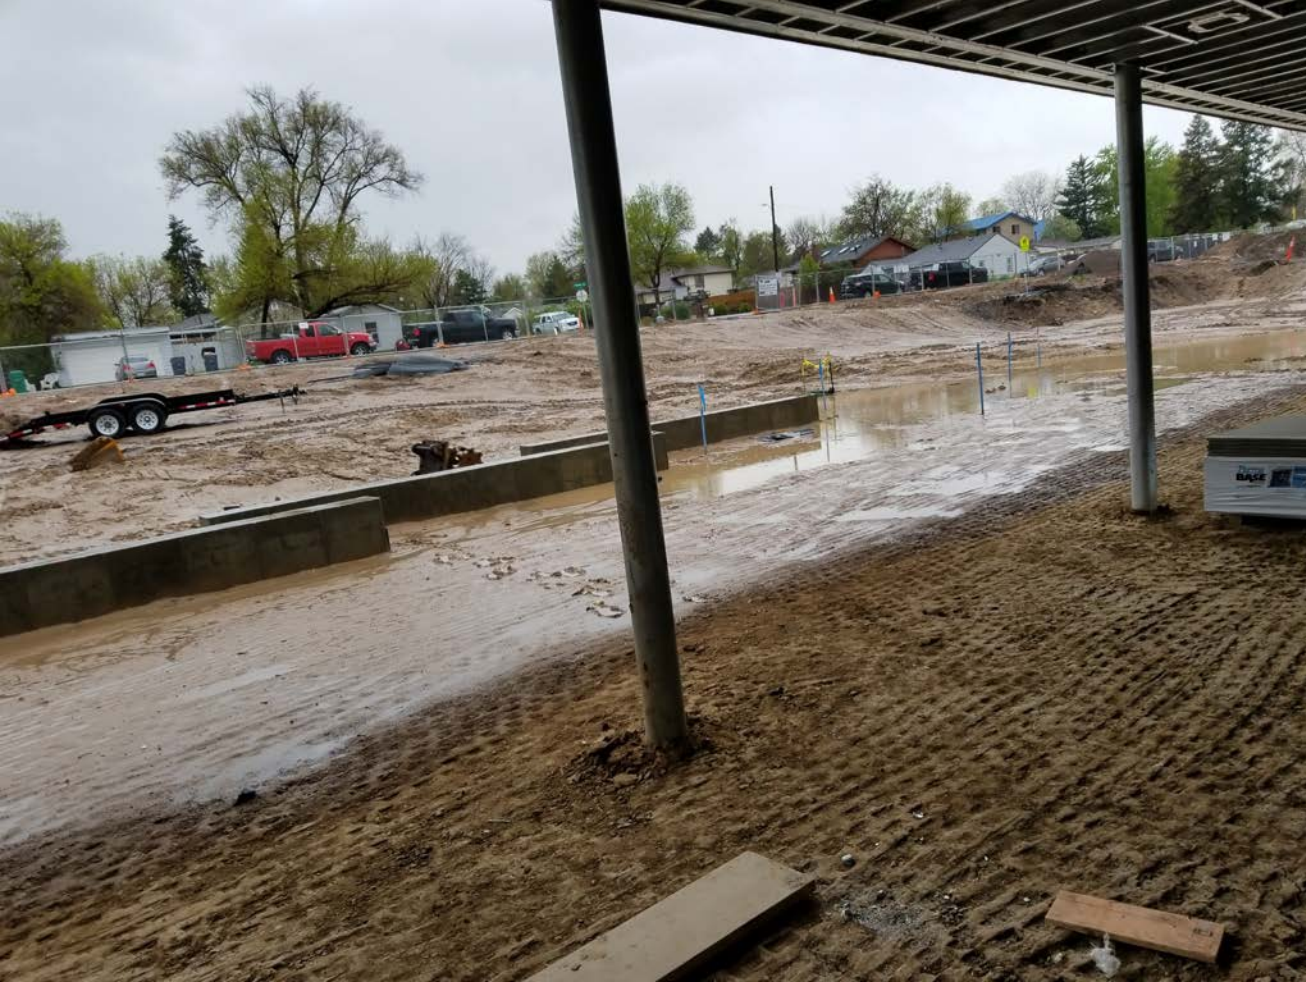
Front Entrance – South Facing View; Sitework continues.

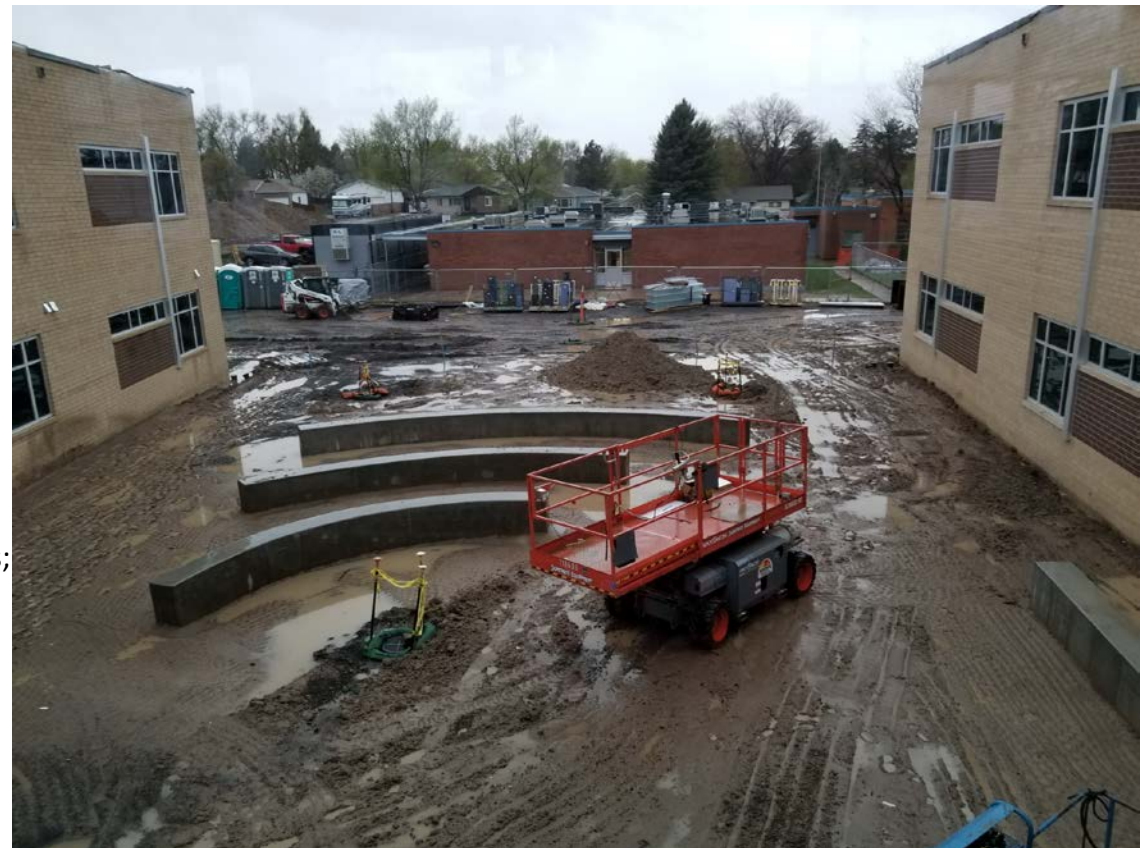
West Elevation – Plaza  
Between Classroom Wings;  
Sitework continues.

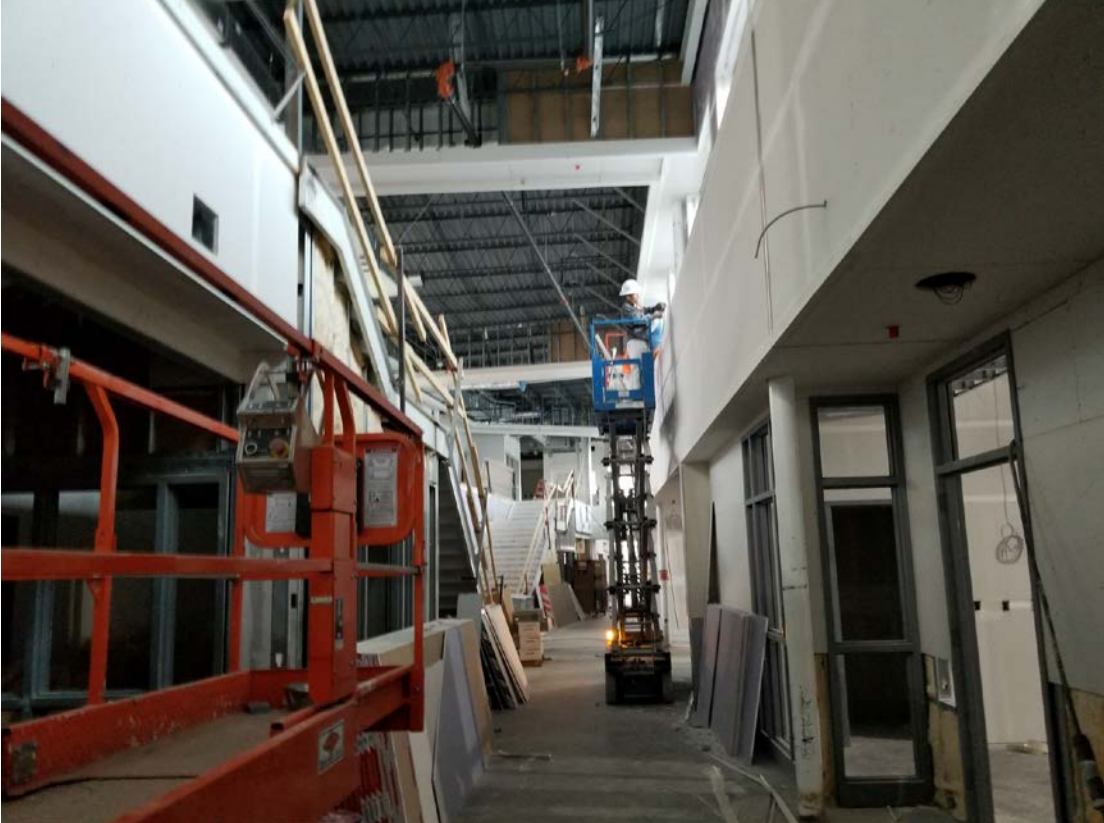
Grand Hall – North Facing View; HVAC, electrical, and drywall install continues.

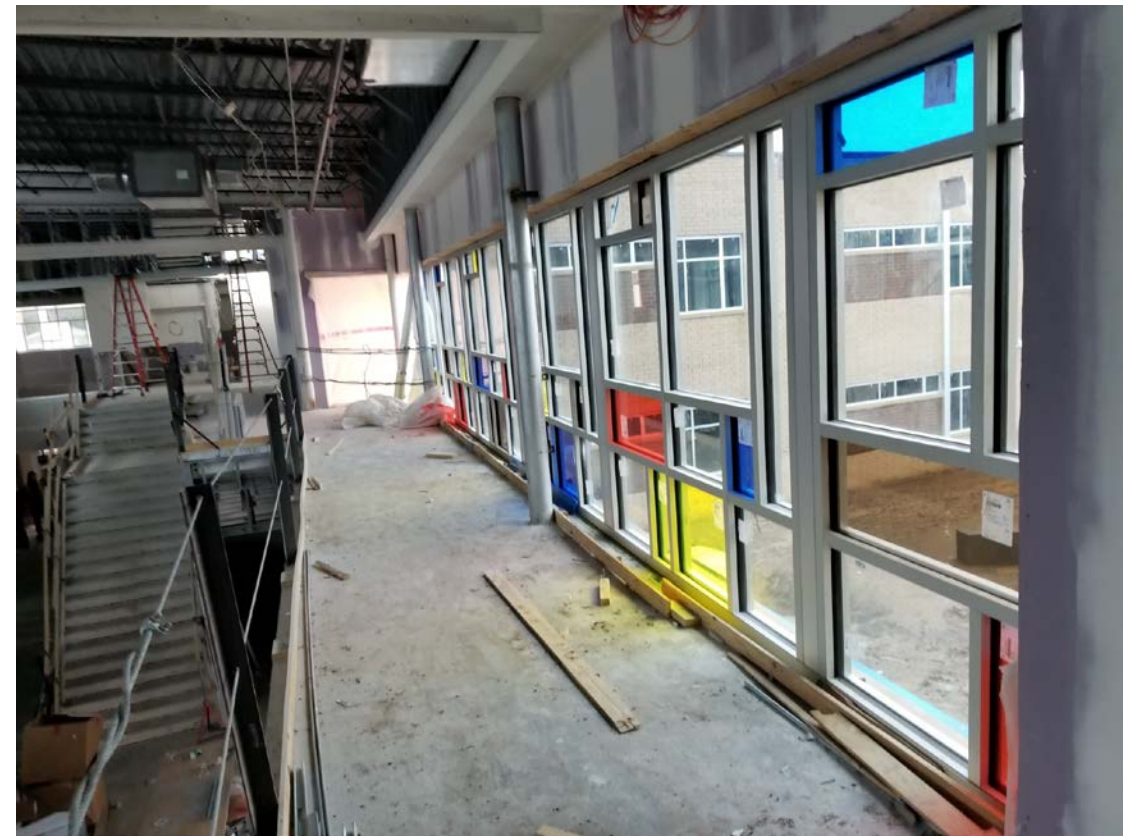
Grand Hall – South Facing View; 2<sup>nd</sup> Floor windows newly installed.

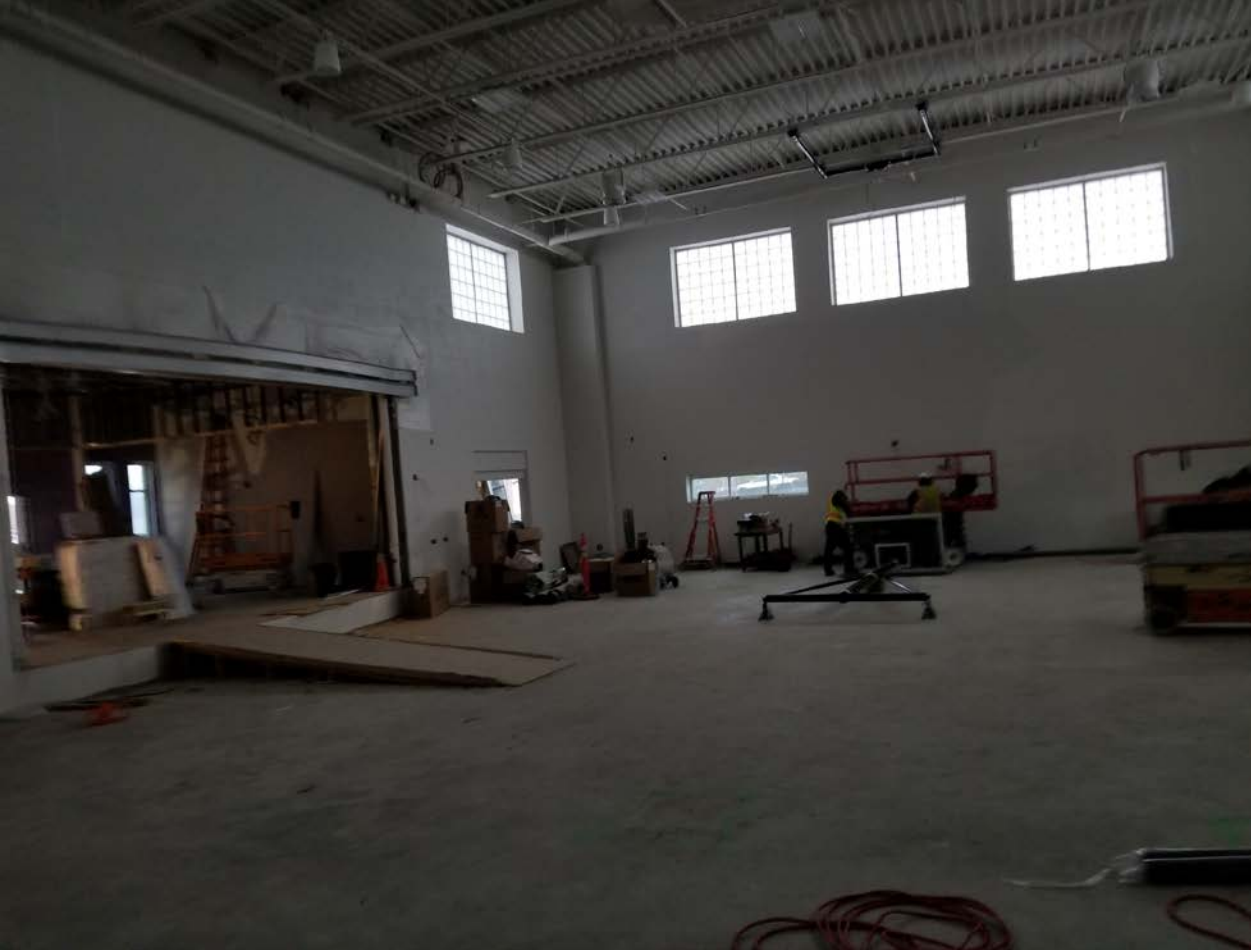
Gym – Painting in progress. Stage currently framing for drywall.

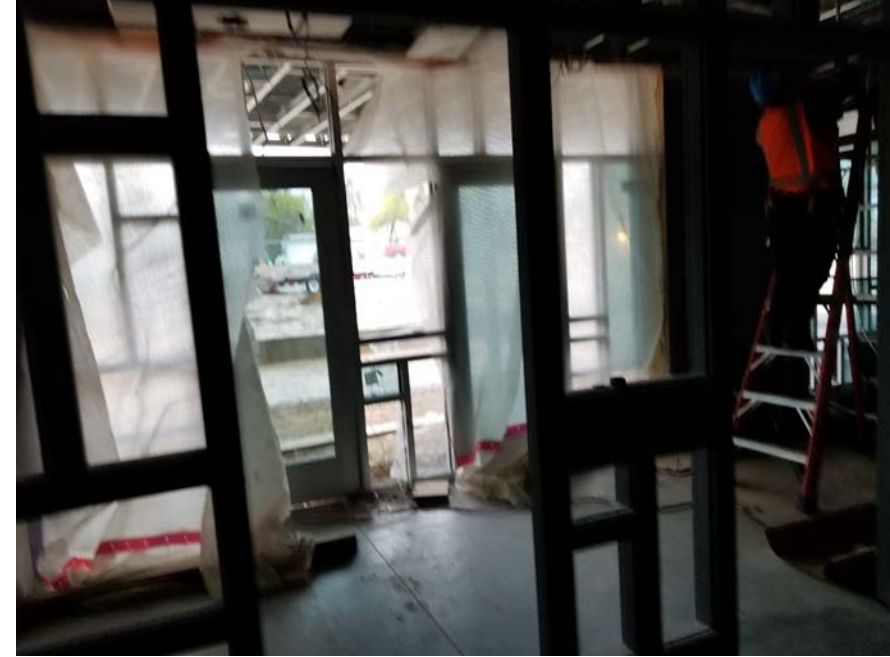
Main Entrance – Entry doors newly installed.

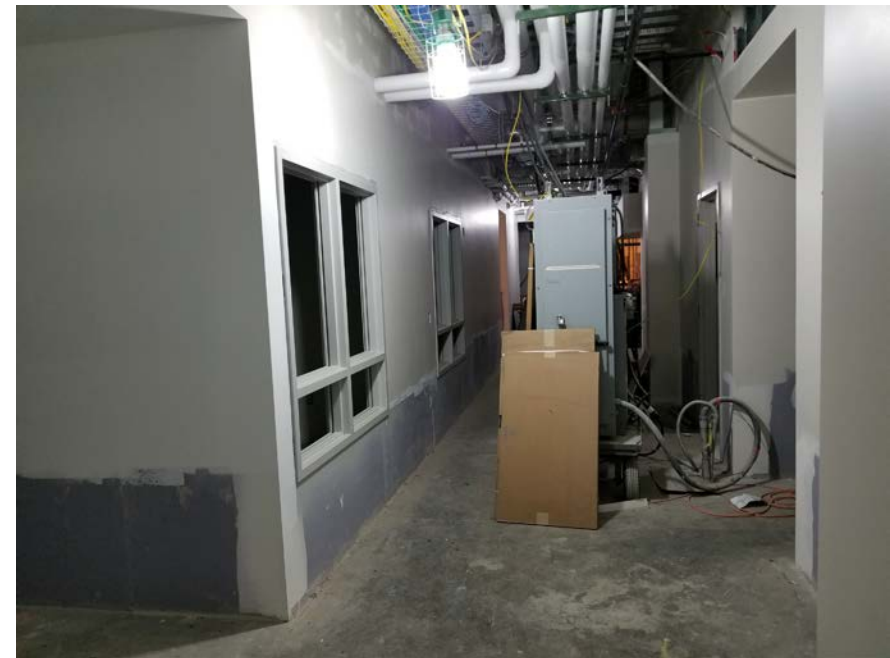
South Classroom Wing (lower level) – Tilework to begin soon.

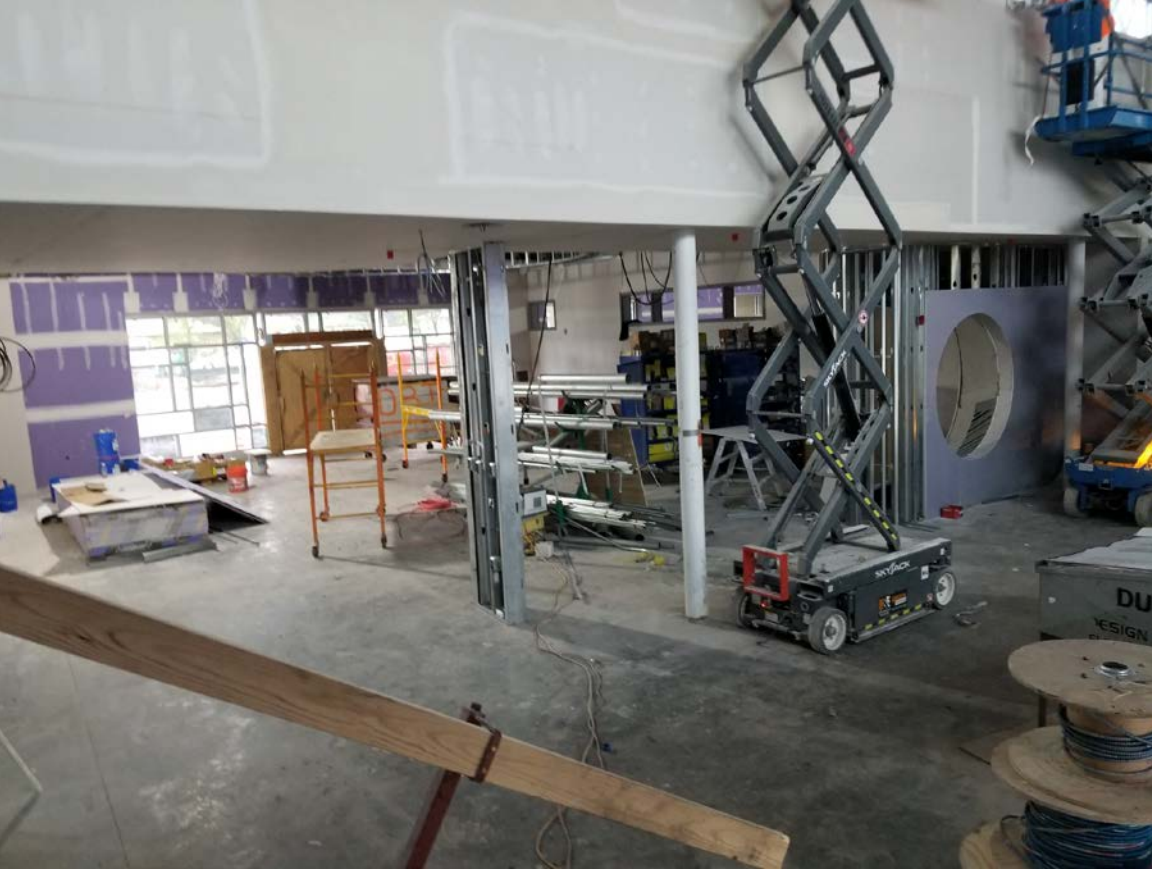
Learning Commons –Drywall install continues.

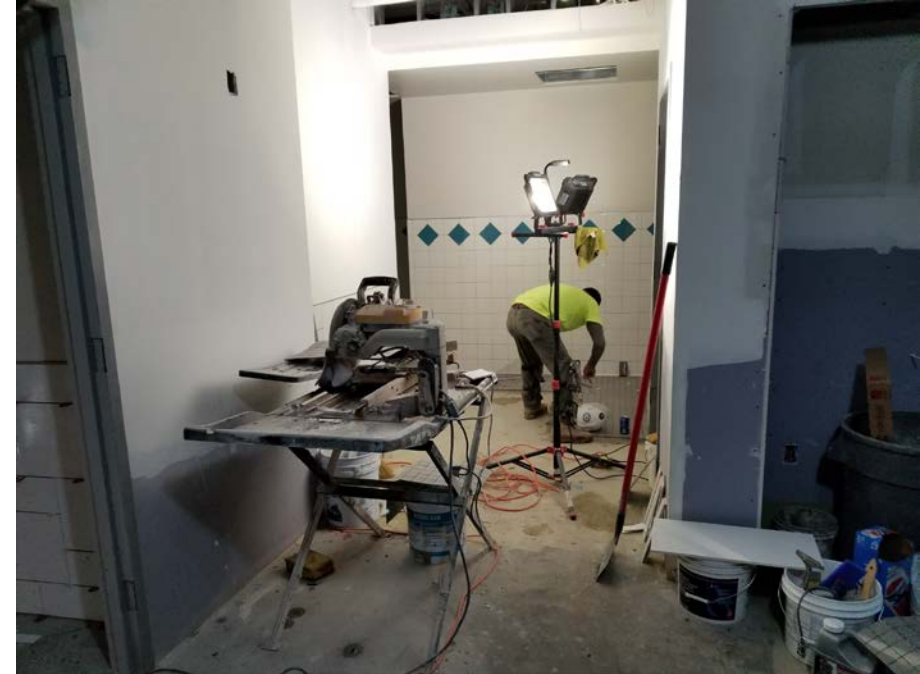
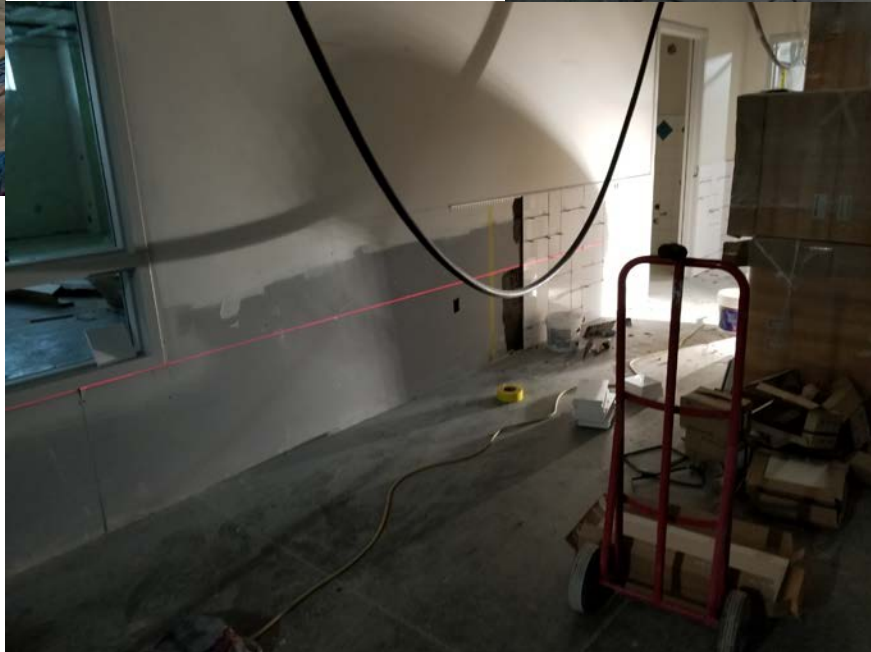
North Classroom Wing (lower level) – Wall tile install continues.

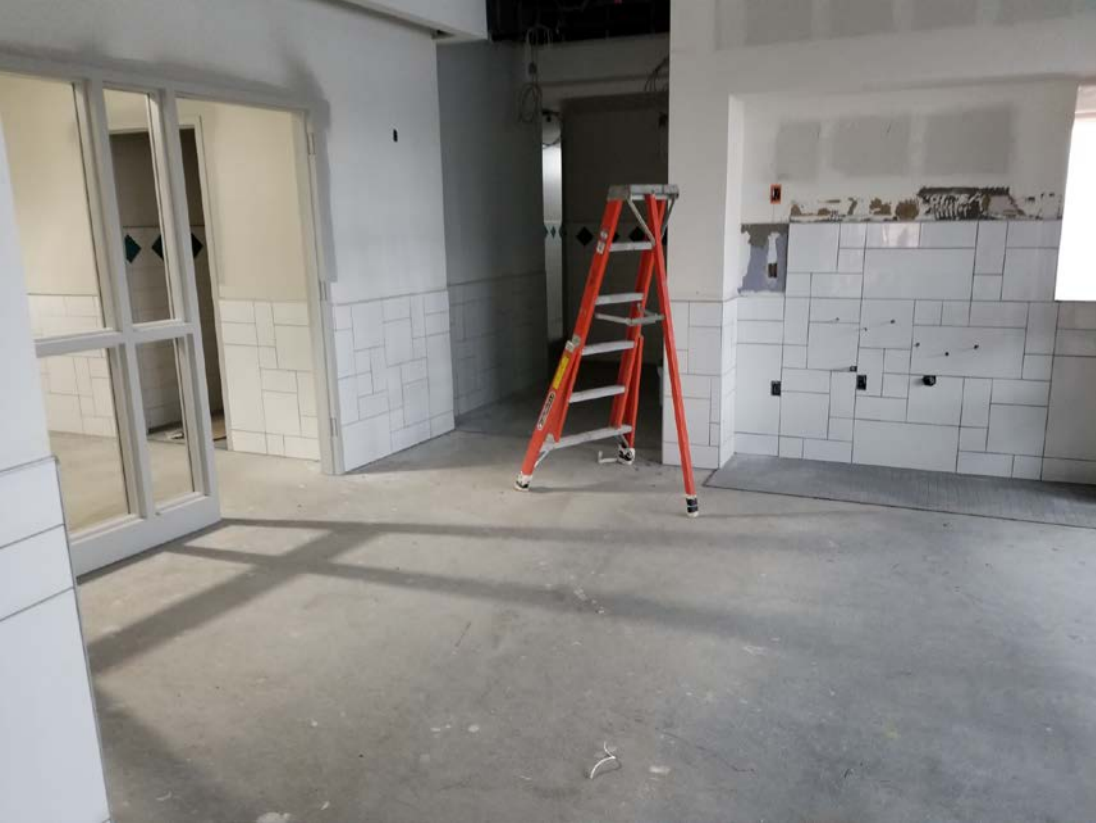
North Classroom Wing (upper level) – Wall tile install continues.

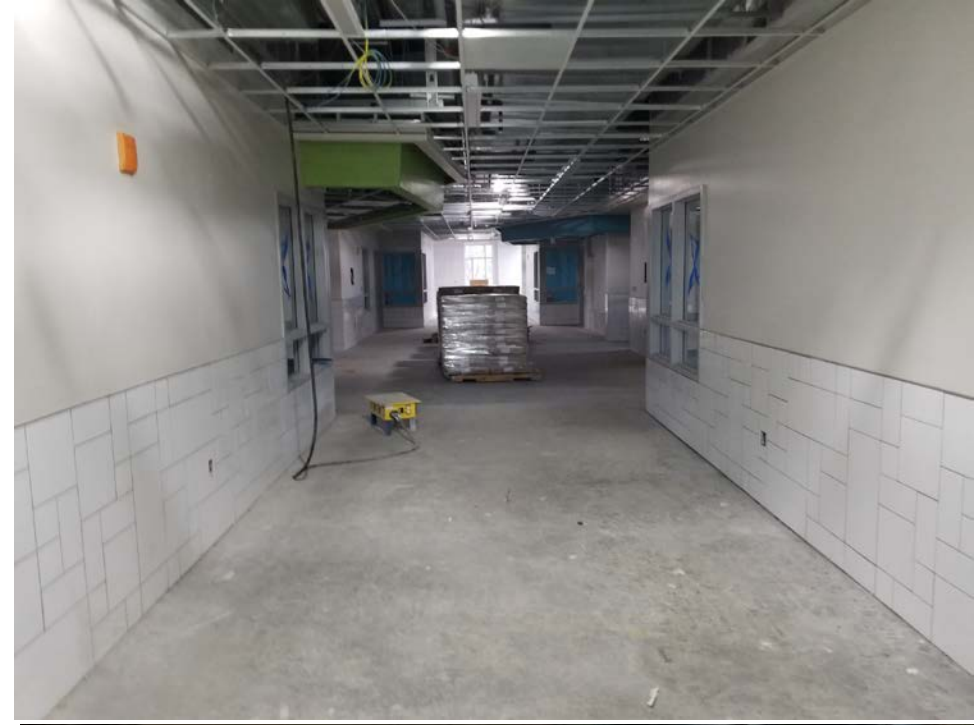
North Classroom Wing (upper level) – Light fixtures newly installed and wall tile complete.

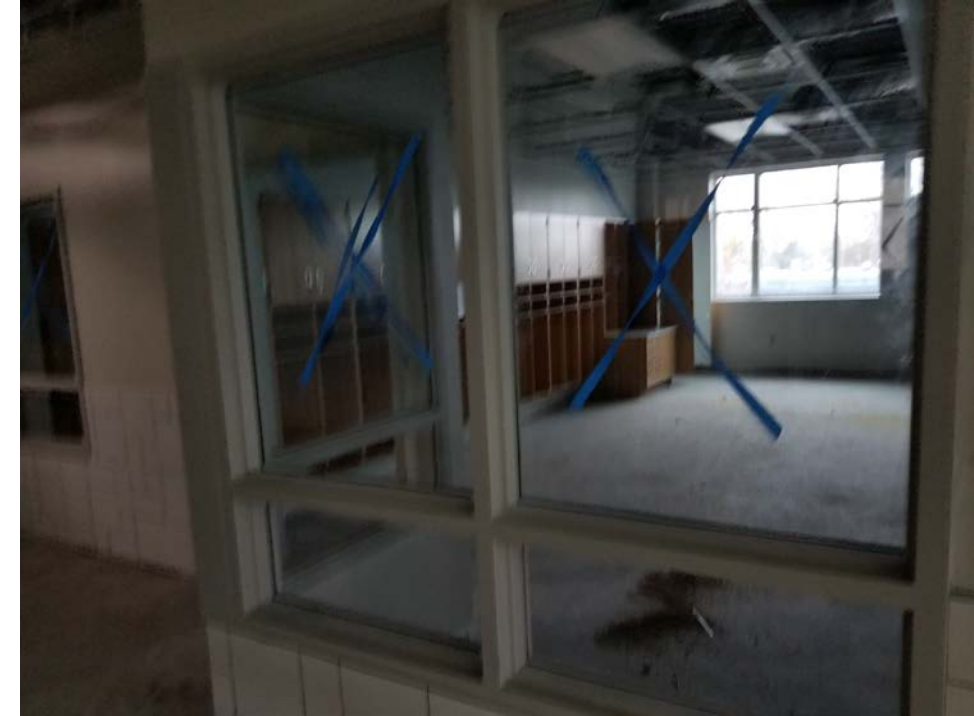
North Classroom Wing (upper level) – Glass in classroom newly installed.
