Maddox ECE Construction Report

April 16, 2018

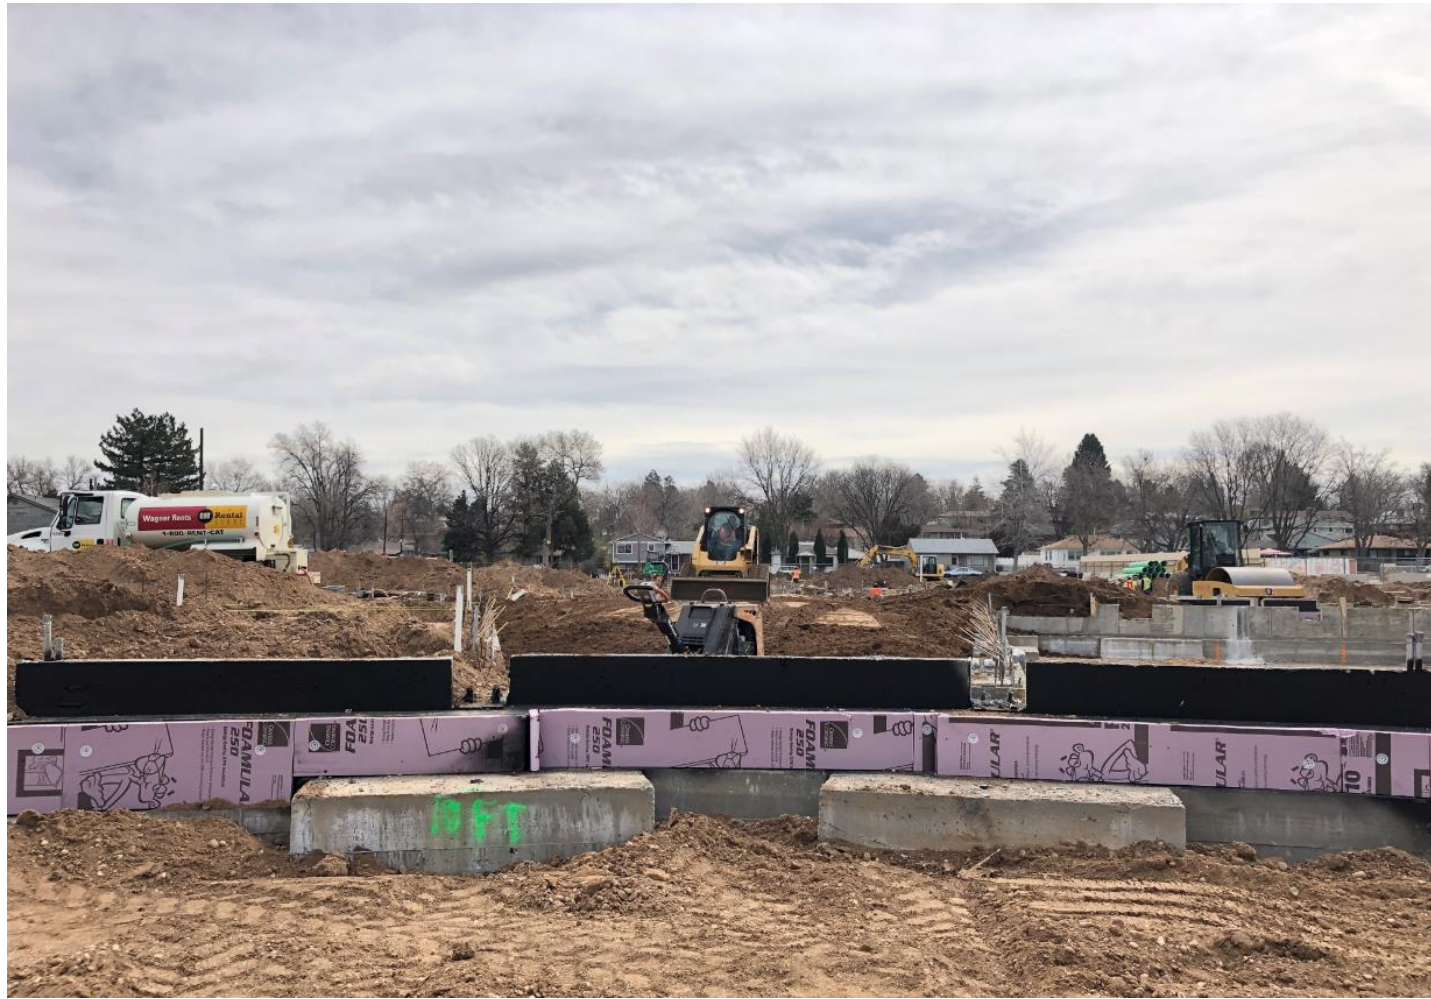
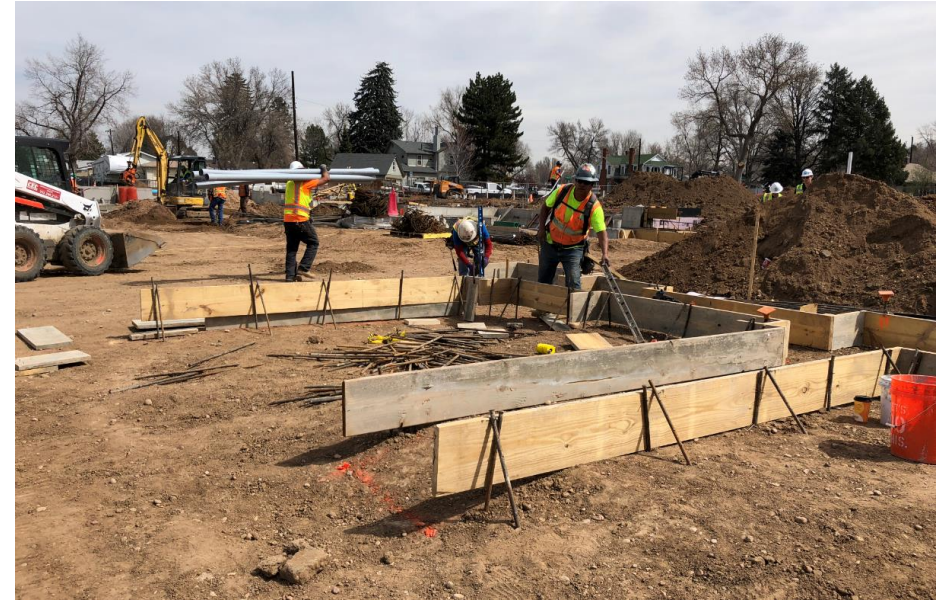
Looking East across building (left). Entry vestibule (right).

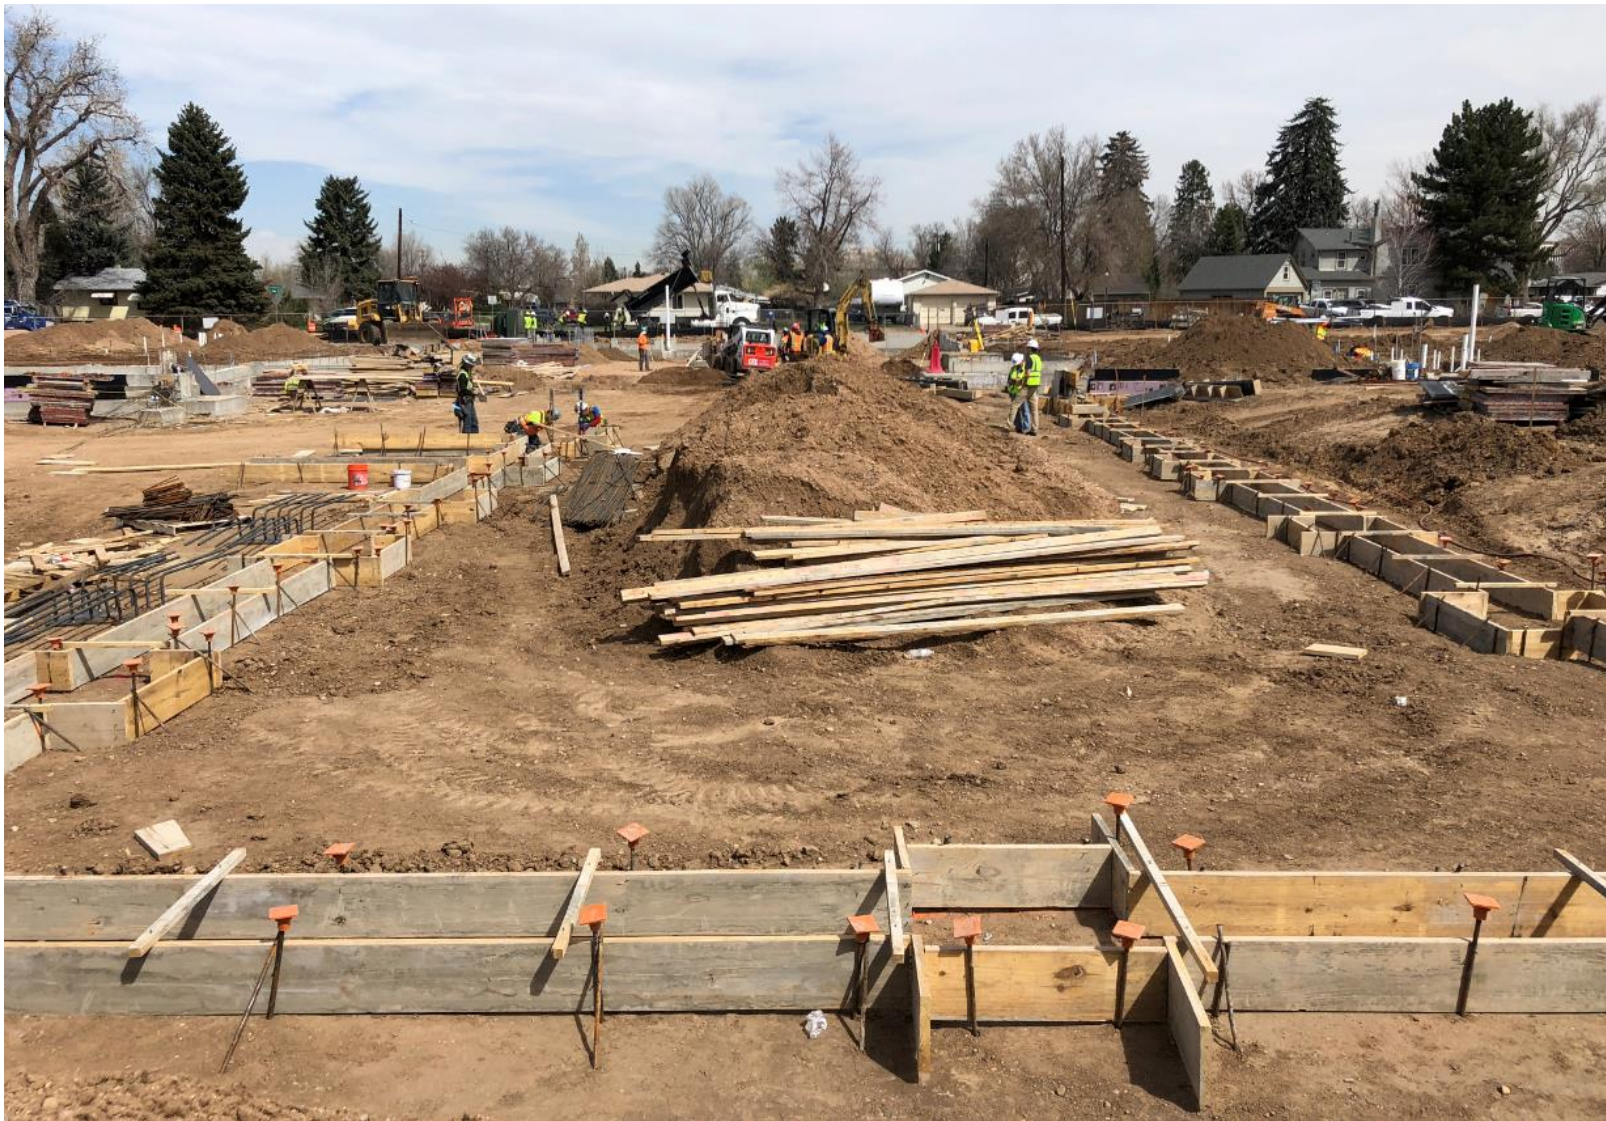
Forming South Central body.

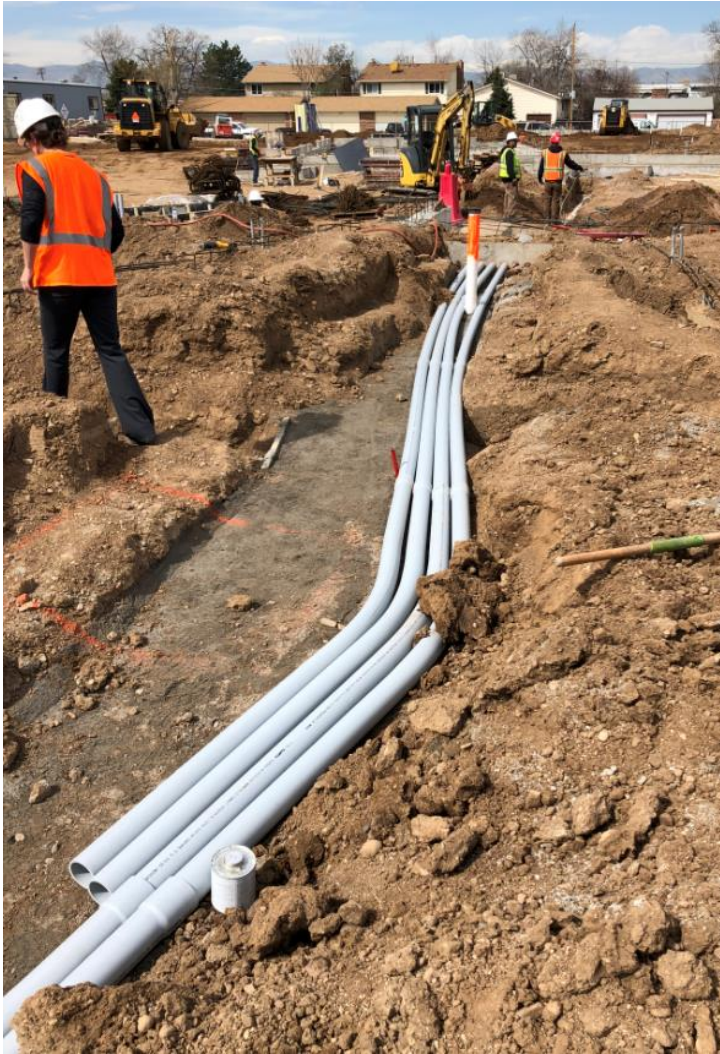
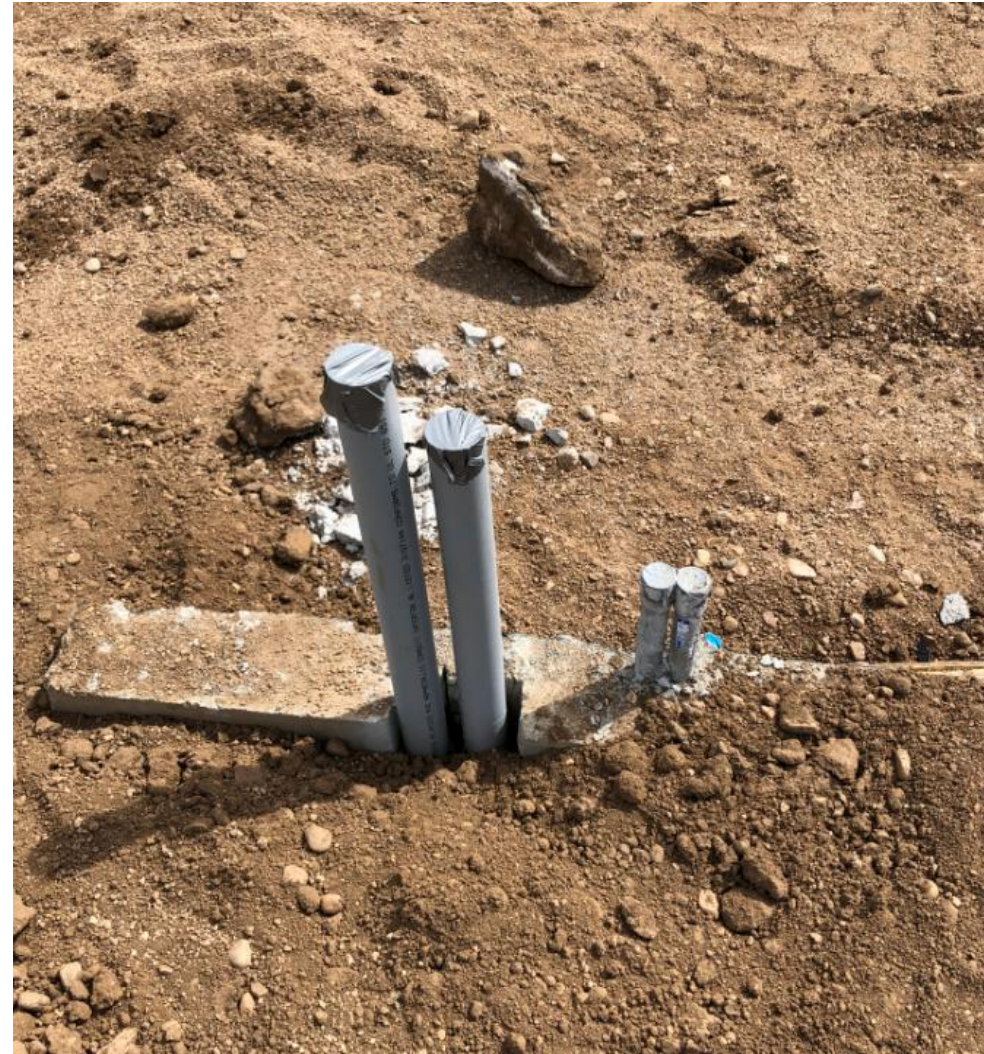
Underground IT conduit from MDF to Storage Rooms (left). IT conduit coming up to Teaching Wall (right).

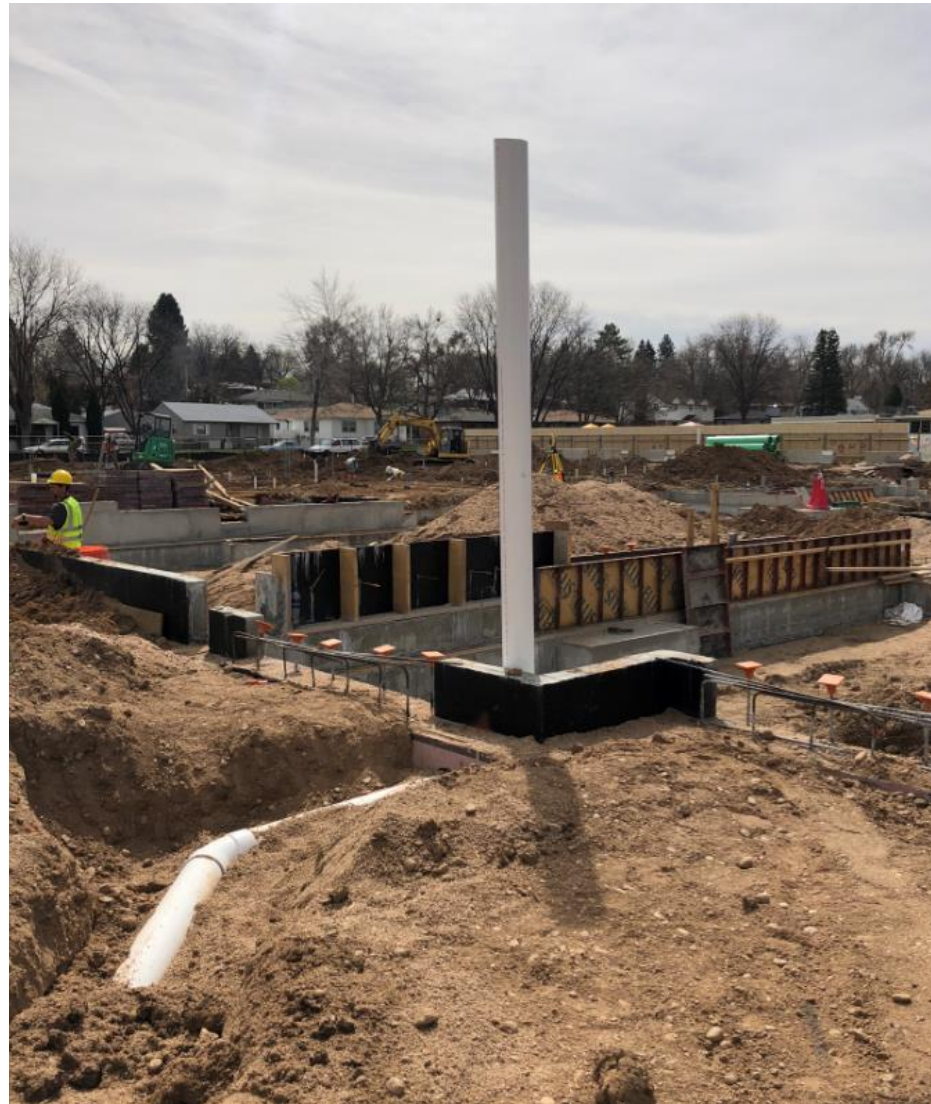
Roof drain to underground storm drain.

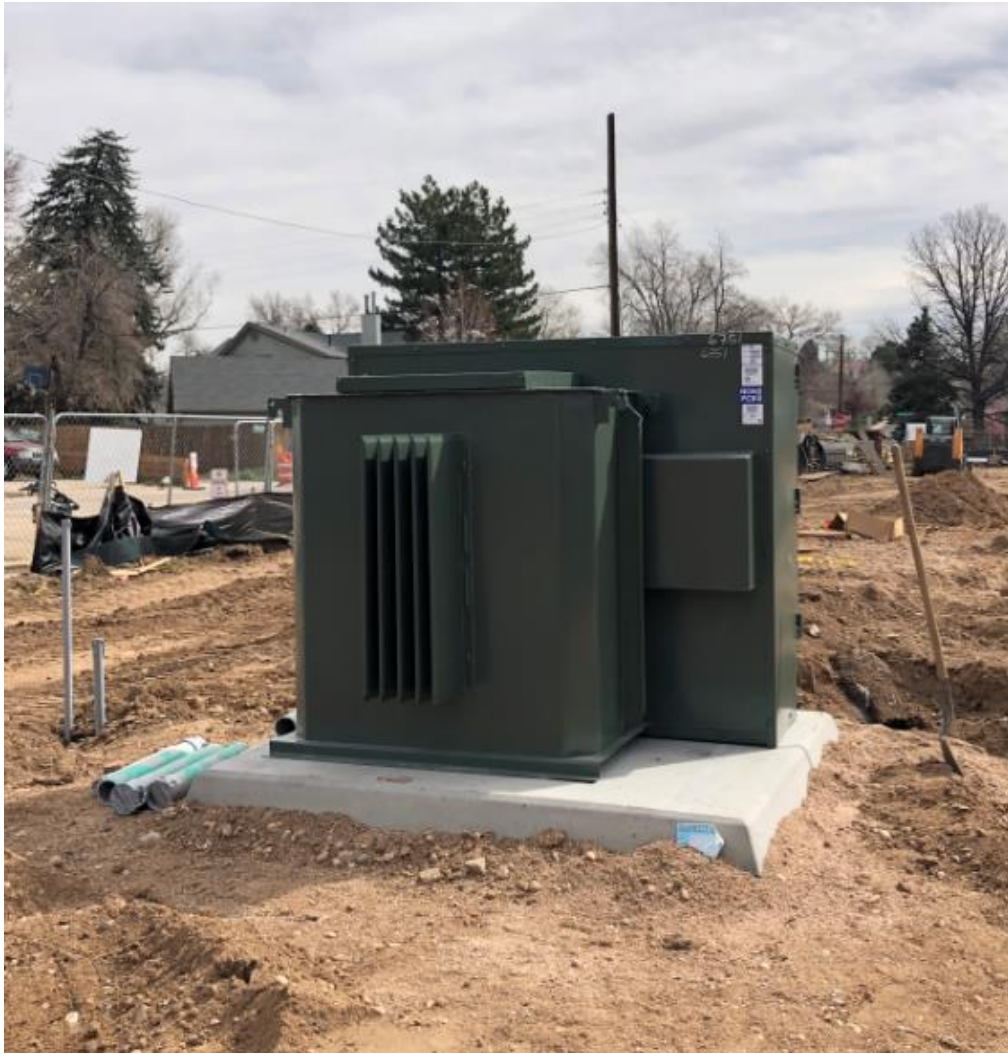
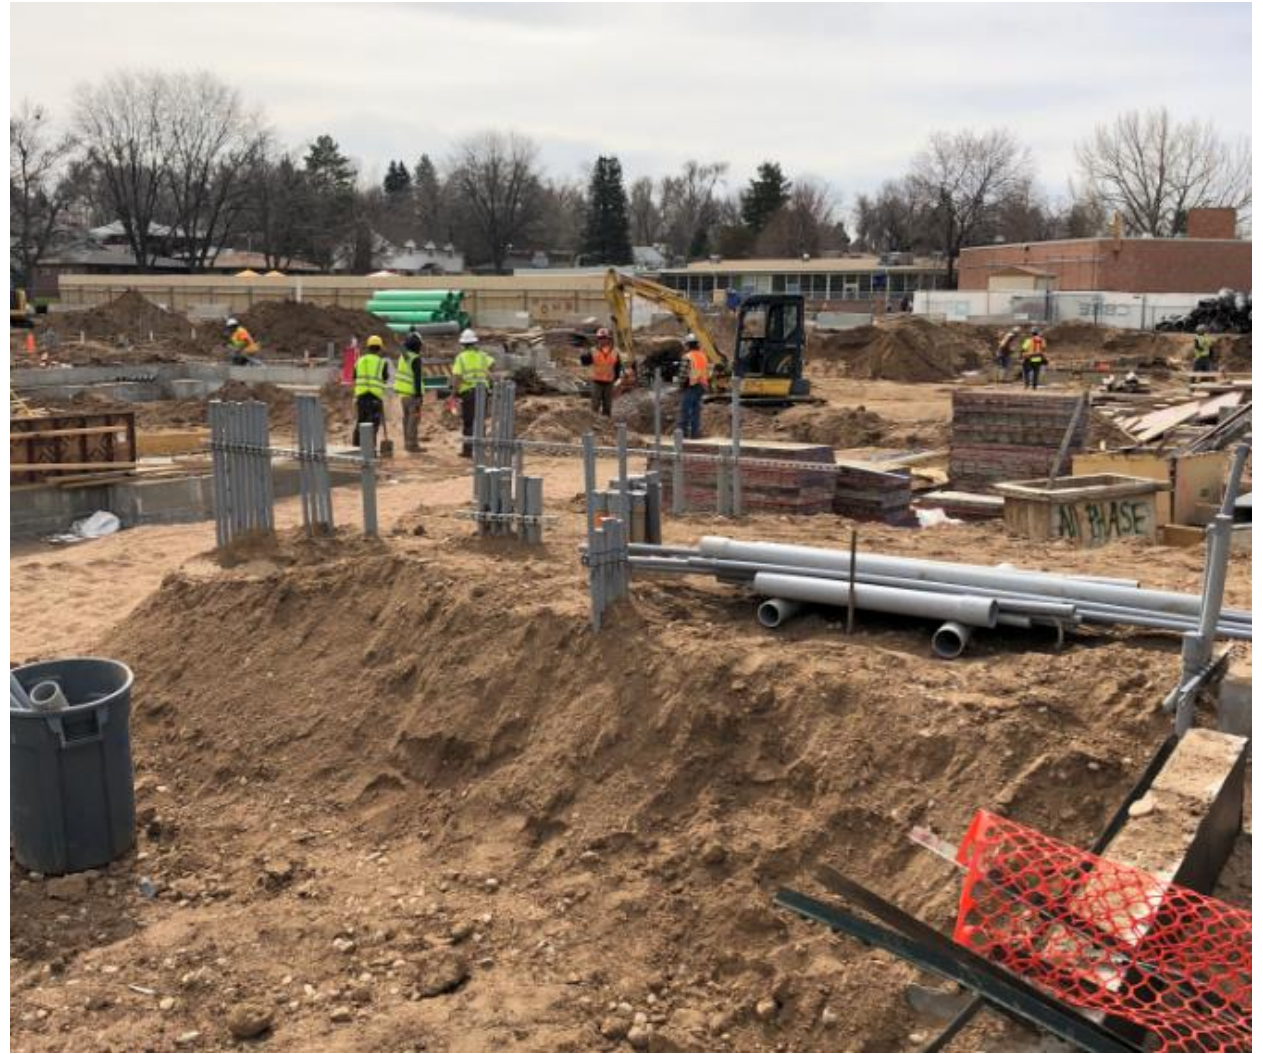
Transformer set (left). Conduit to Electrical room (right).

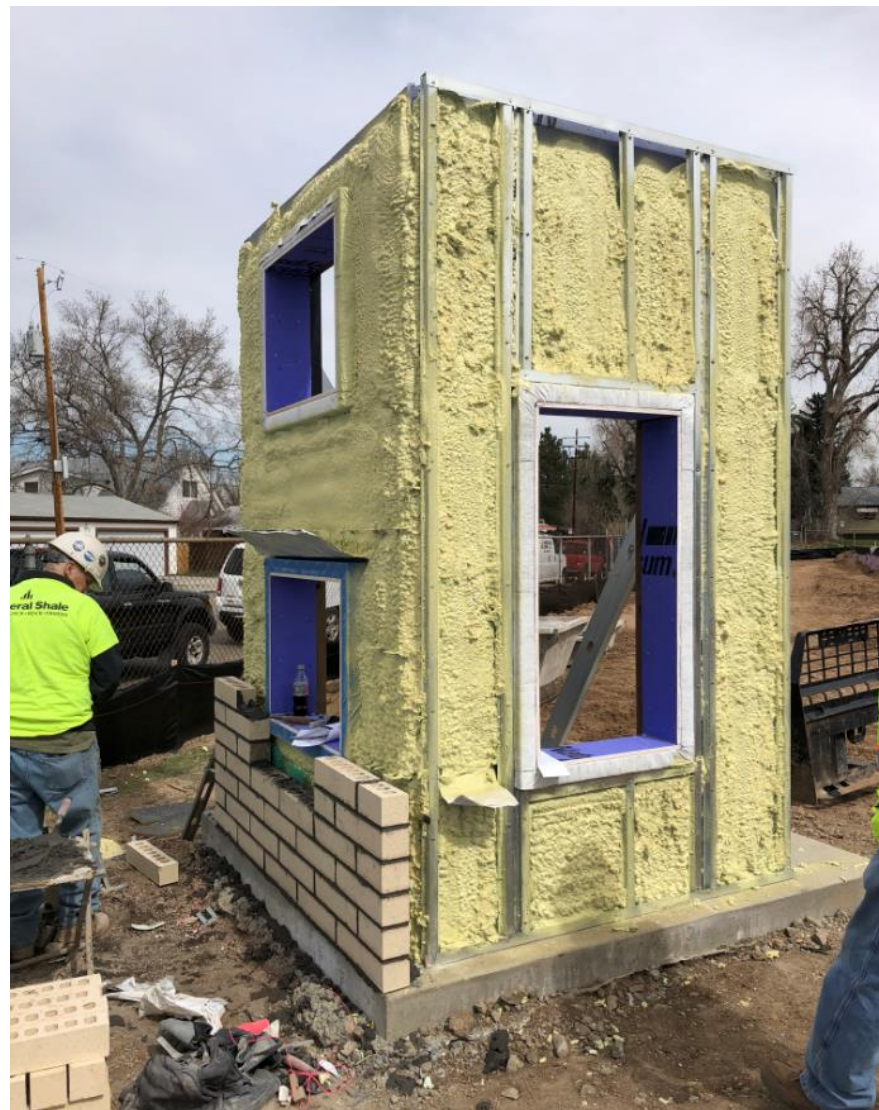
Mock up wall progression.
