Maddox ECE Construction Report May 7, 2018

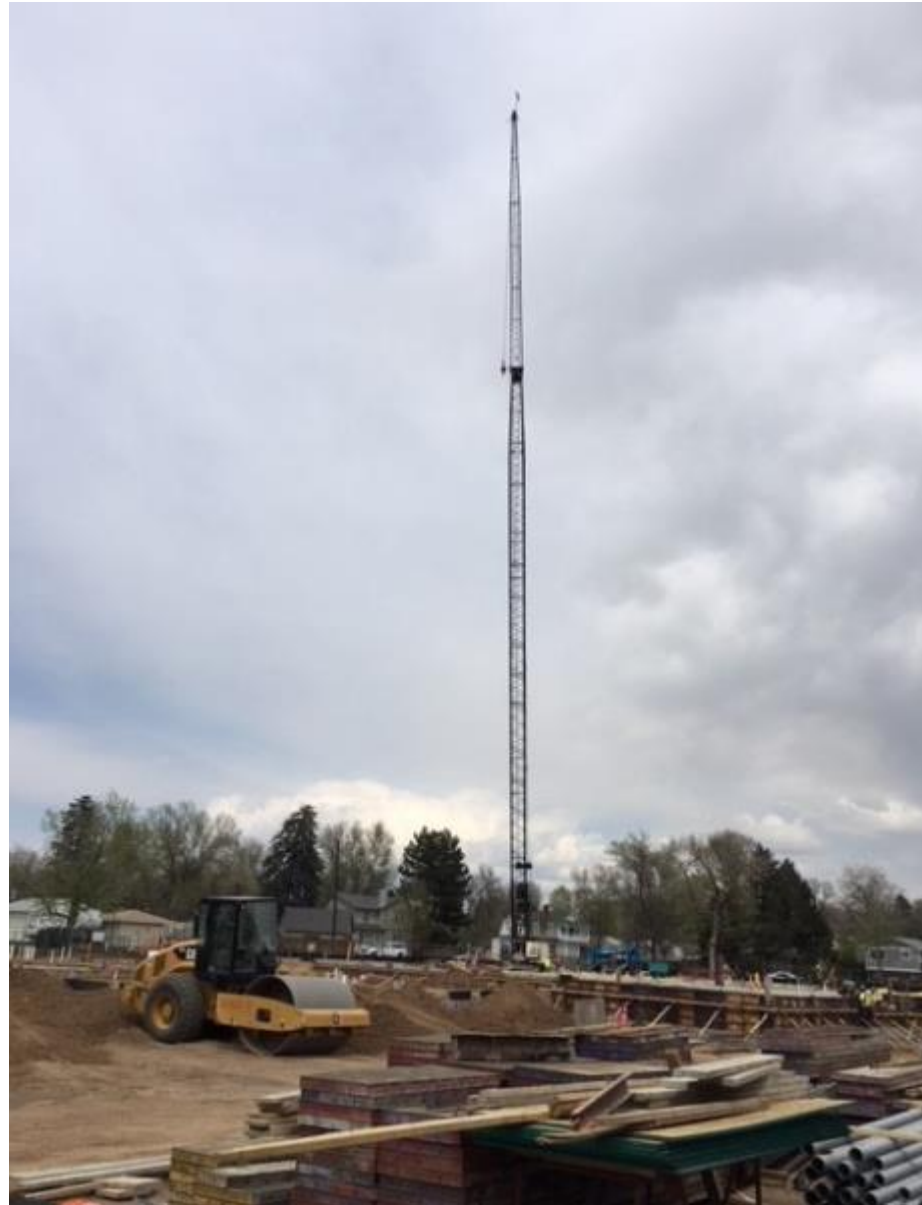
Crane has been erected to install steel.

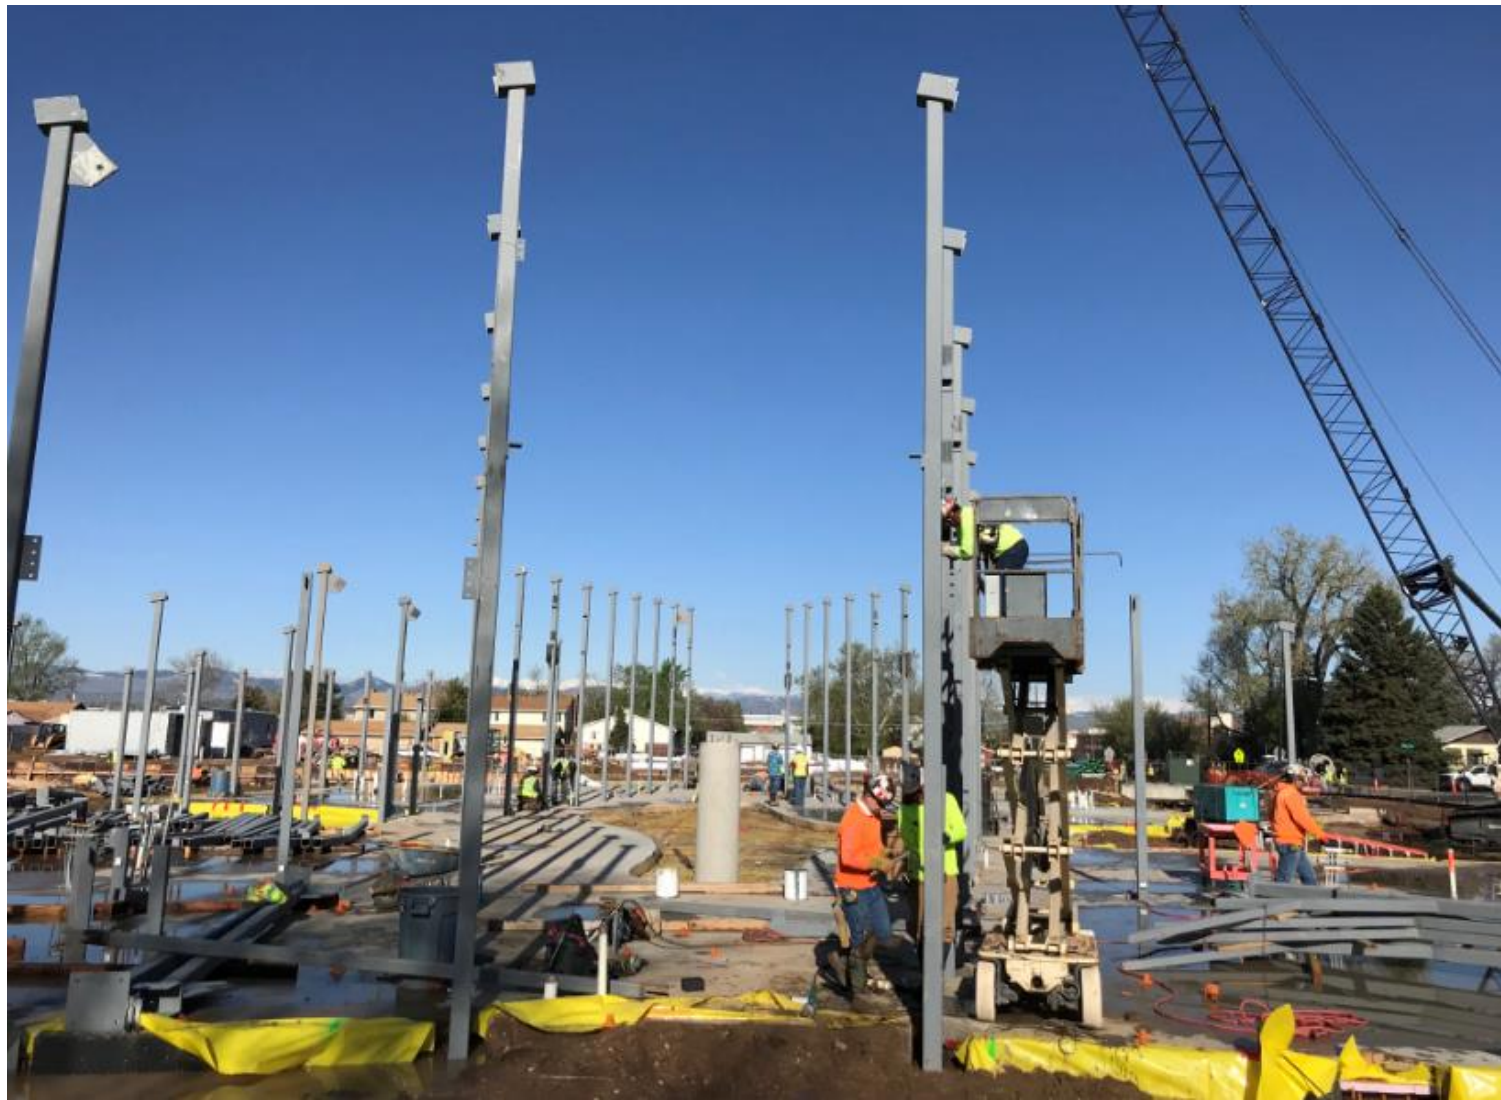
Looking West across building, steel columns installed.

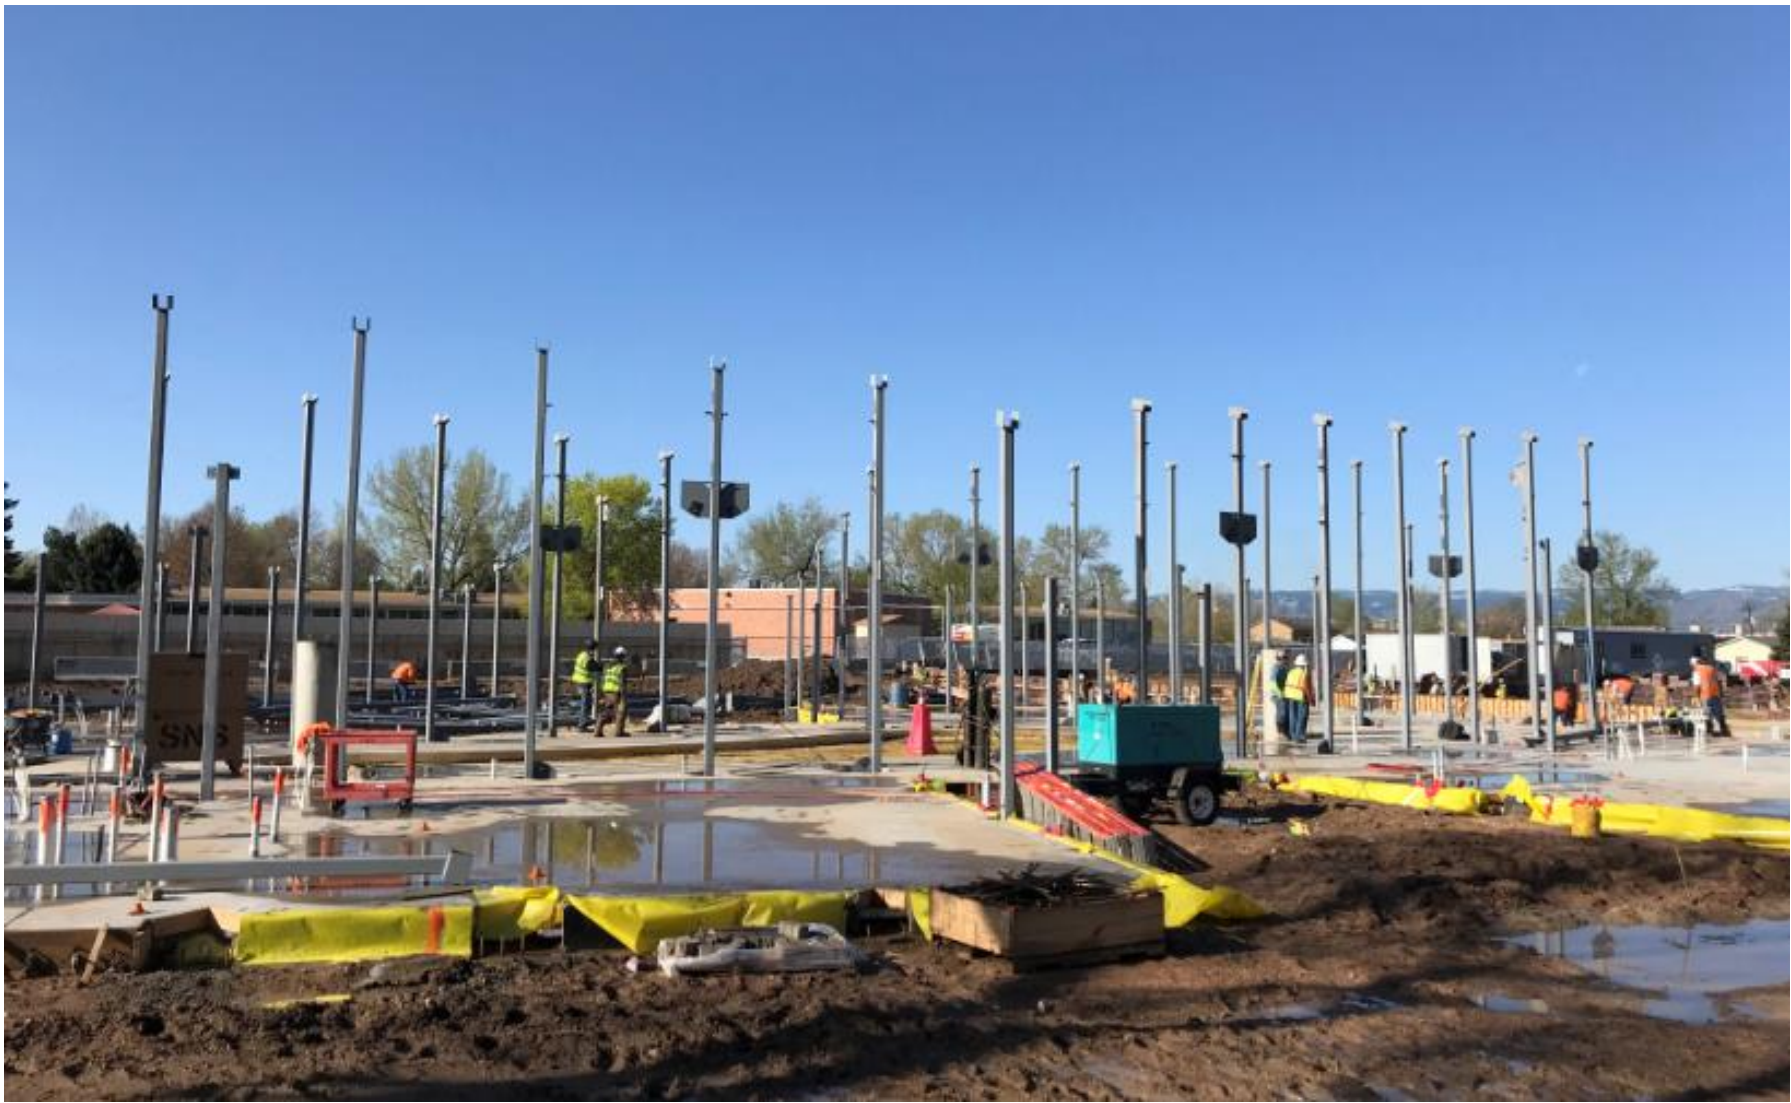
East wing with steel columns and floor slab.

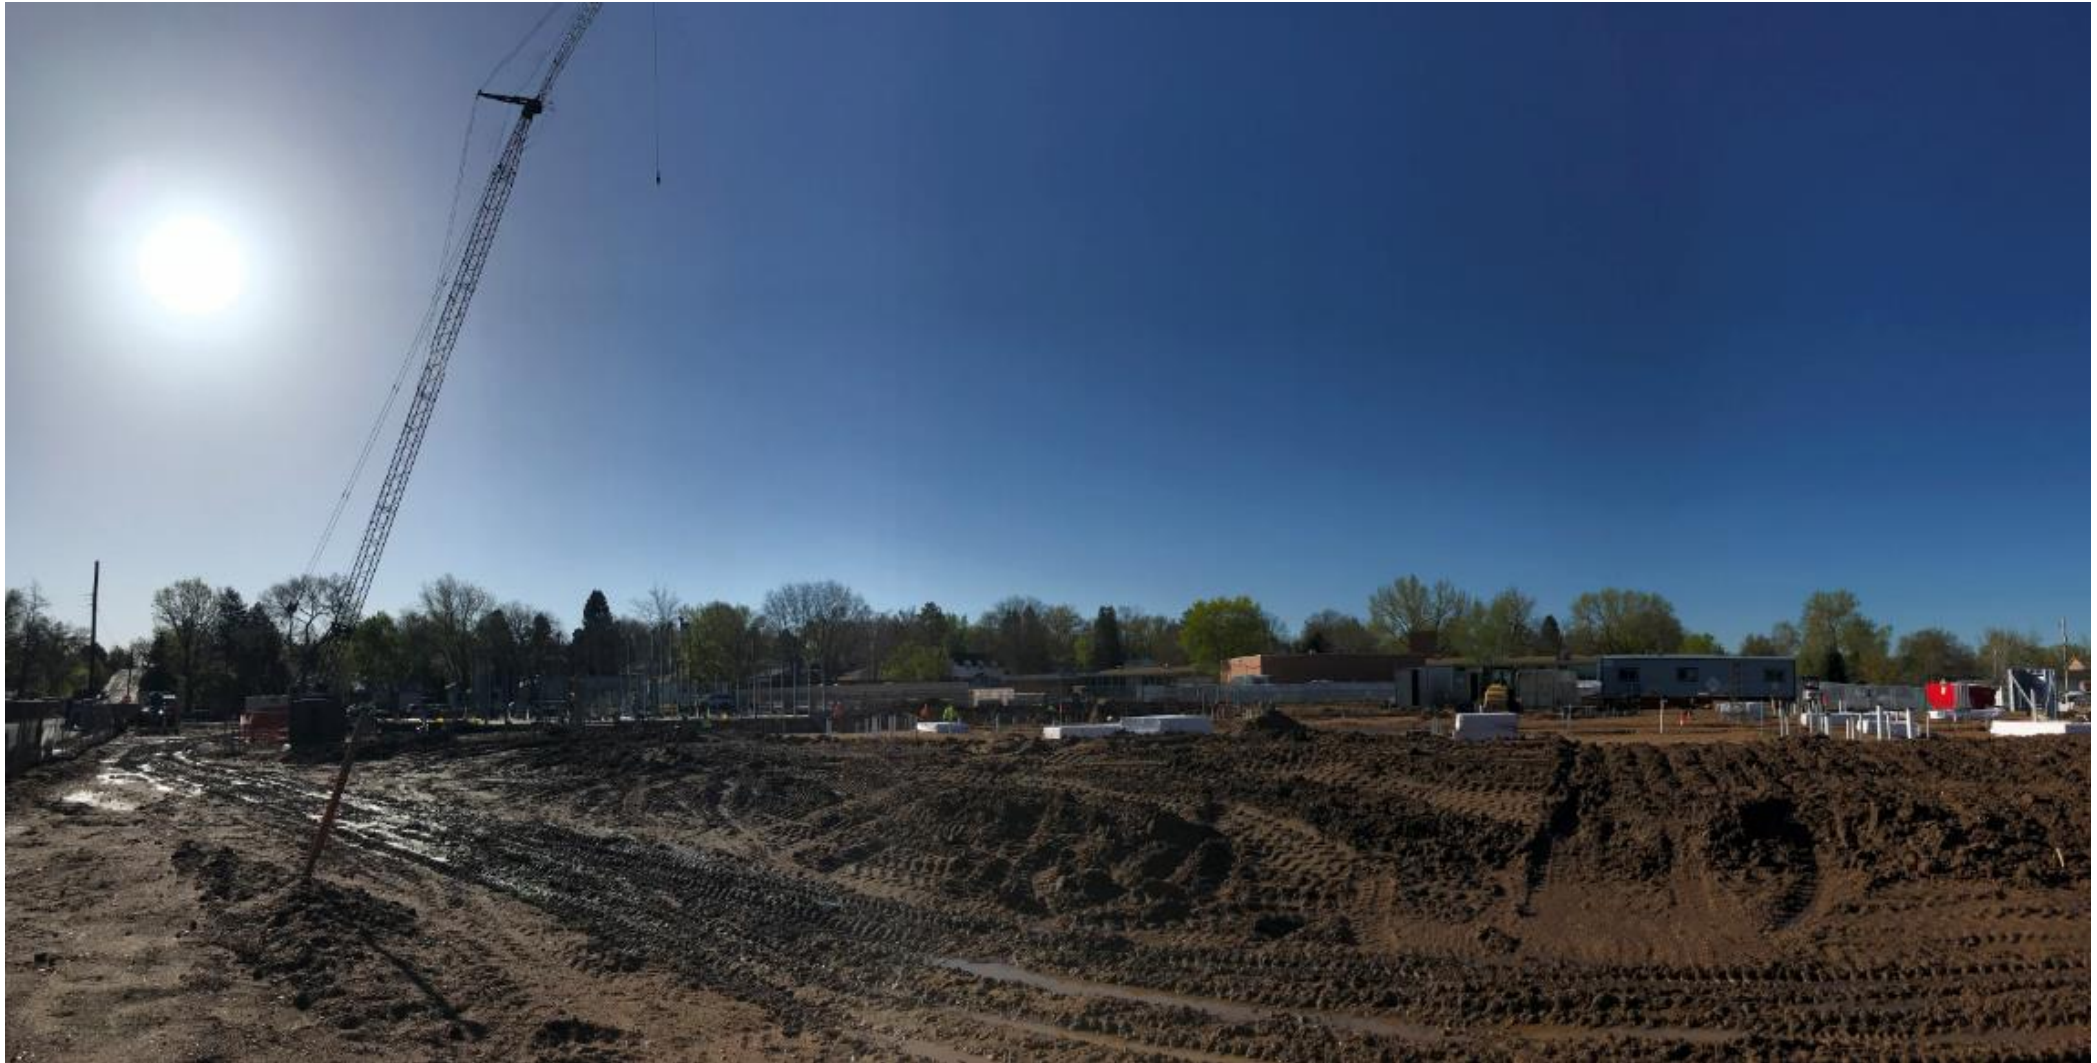
Looking South across entire building footprint.
