## Maddox ECE Construction Report

May 7, 2018

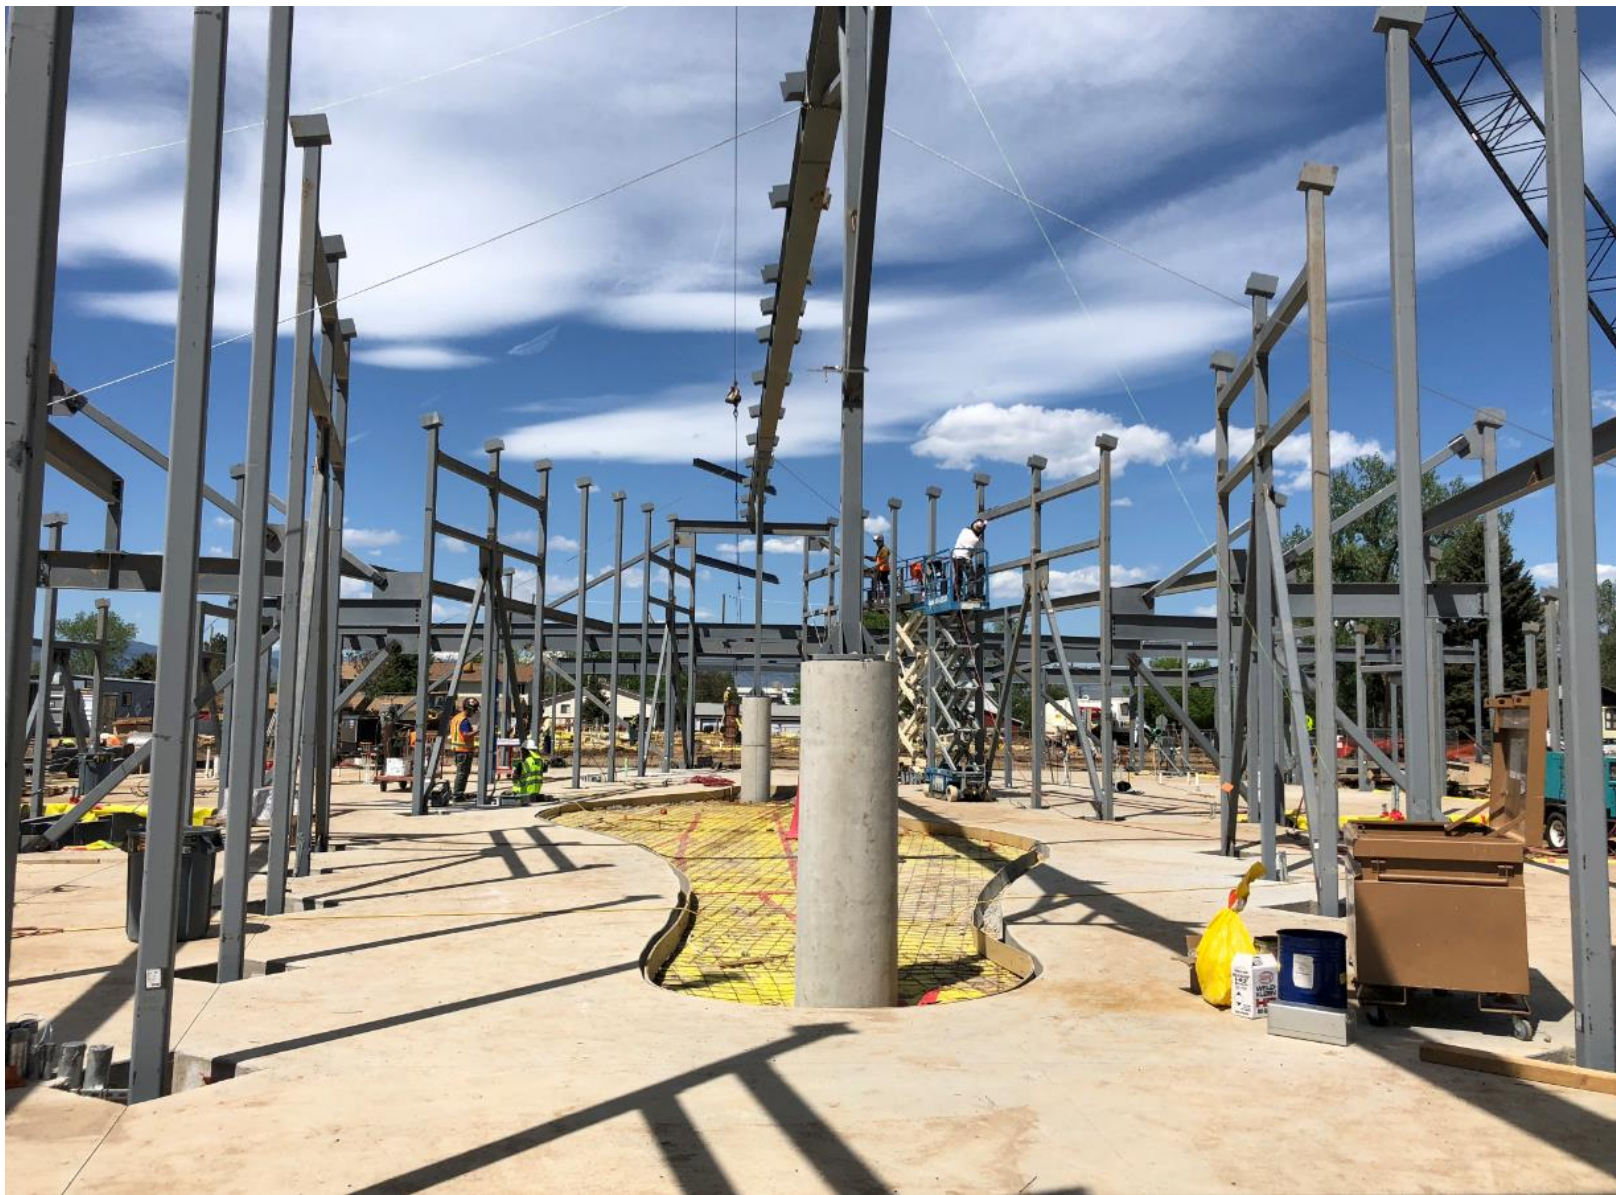
Looking West across East wing. Steel structure placed around indoor playground area.

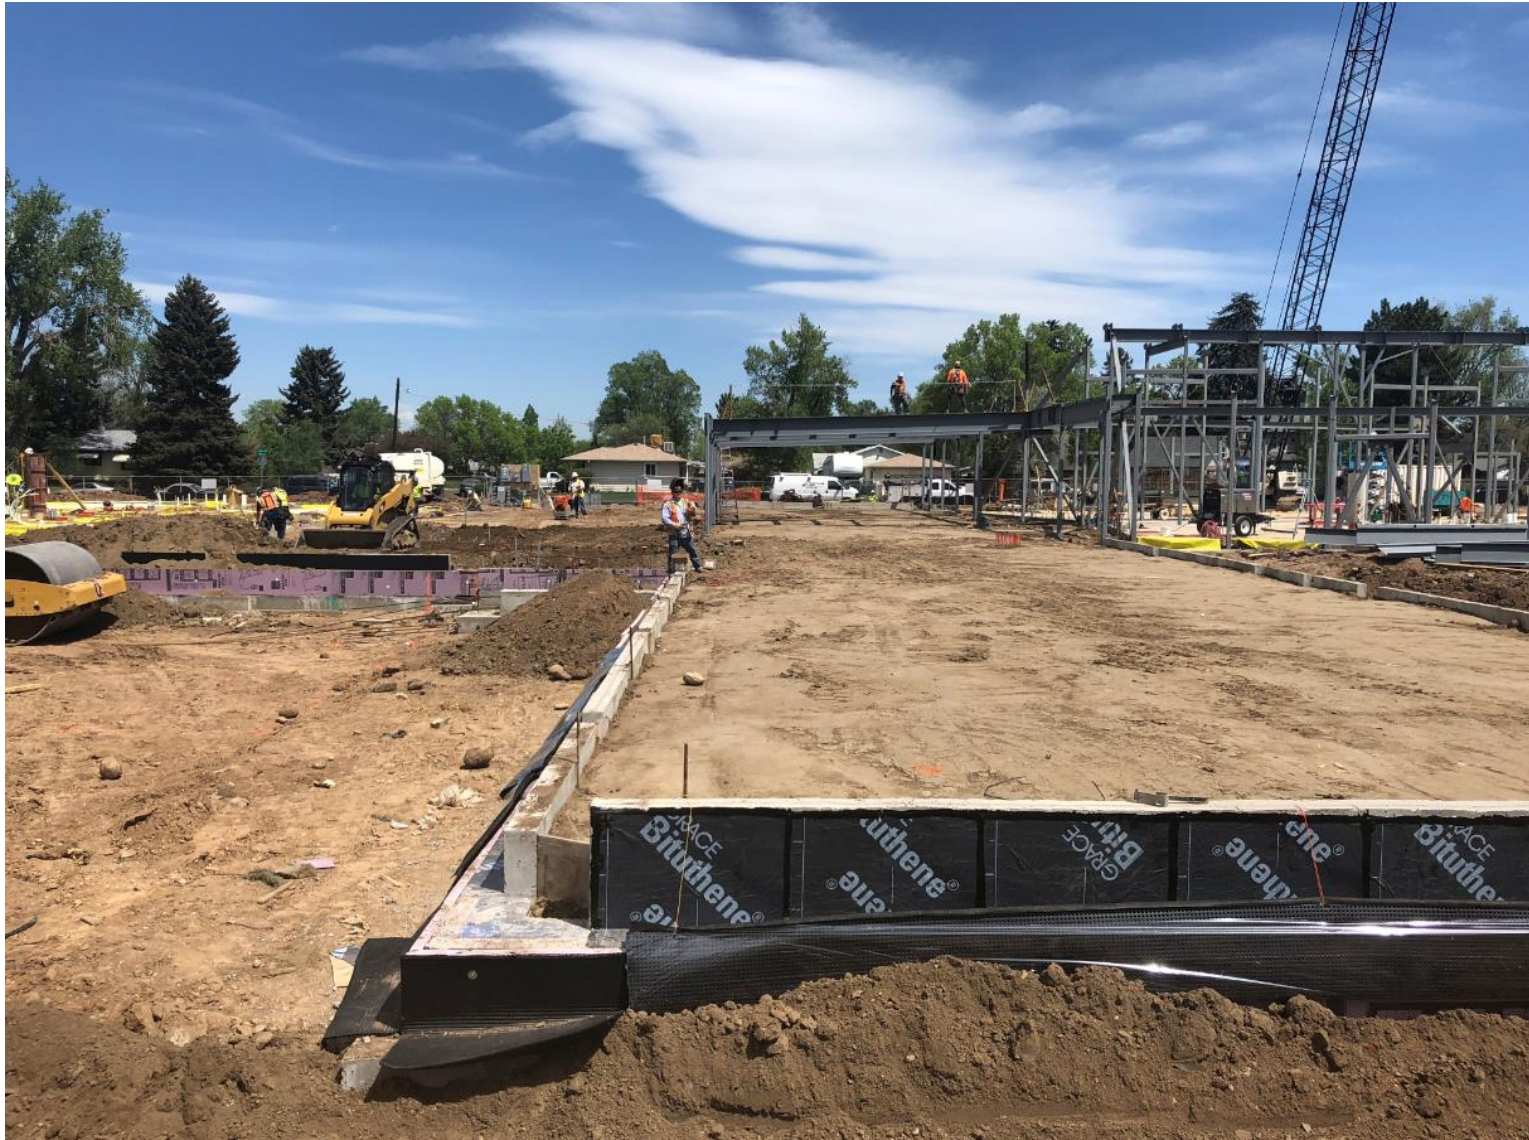
Looking North across central body.

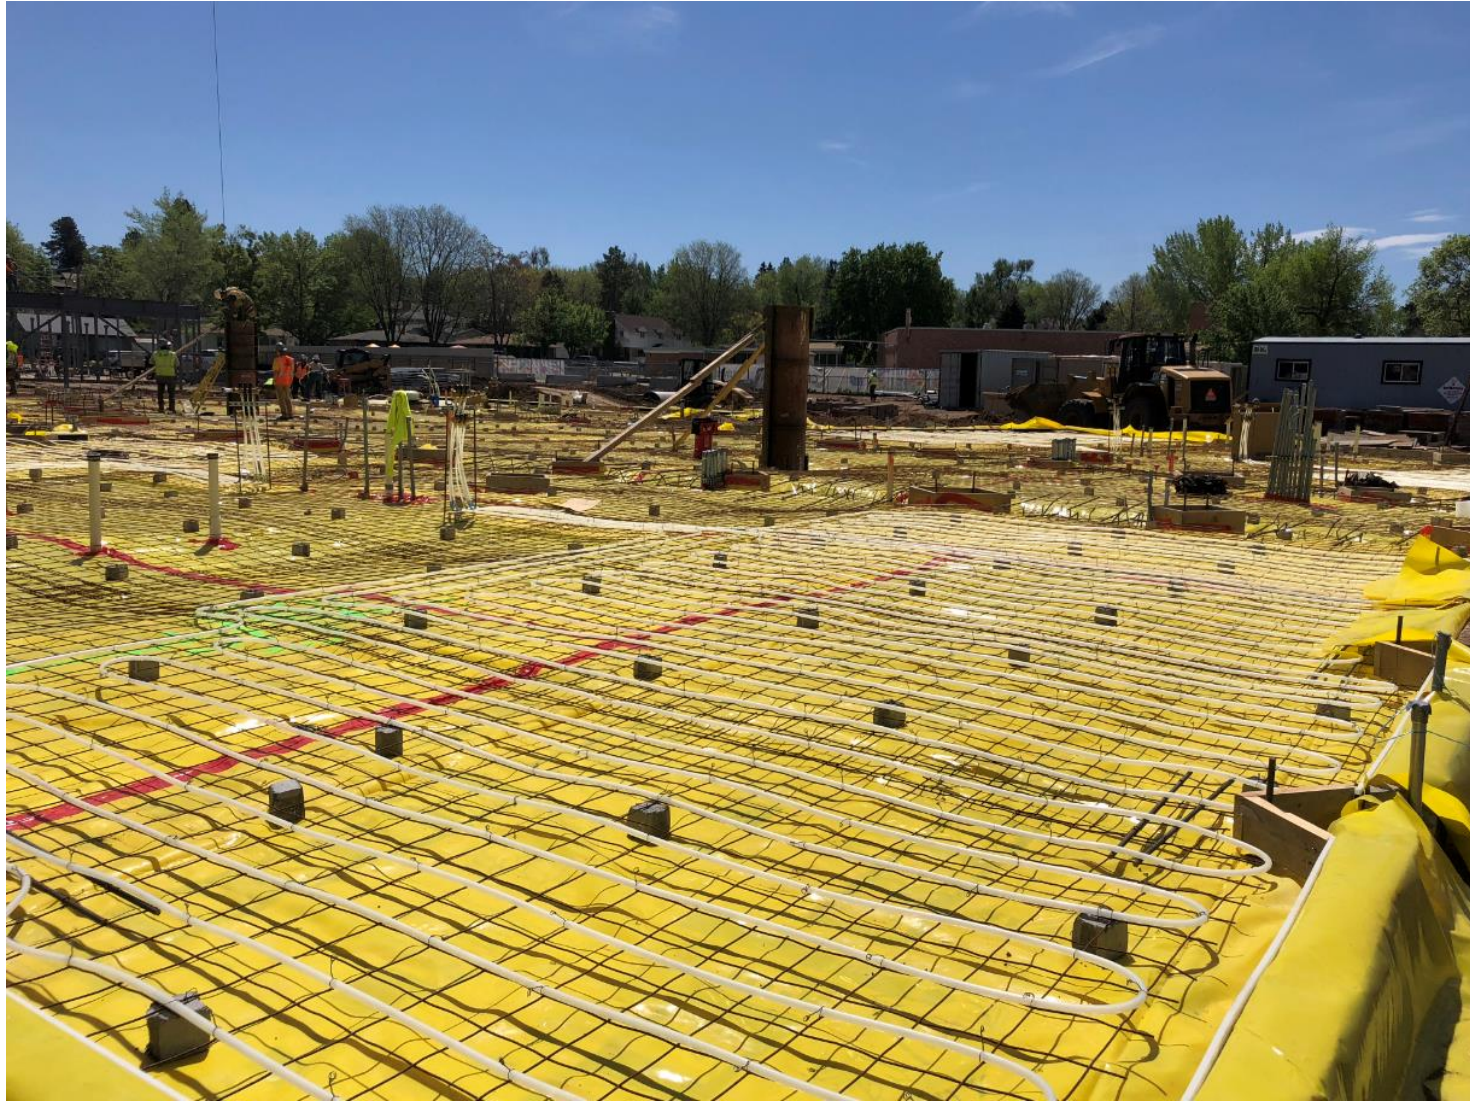
Vapor barrier and radiant heating installed on East wing.

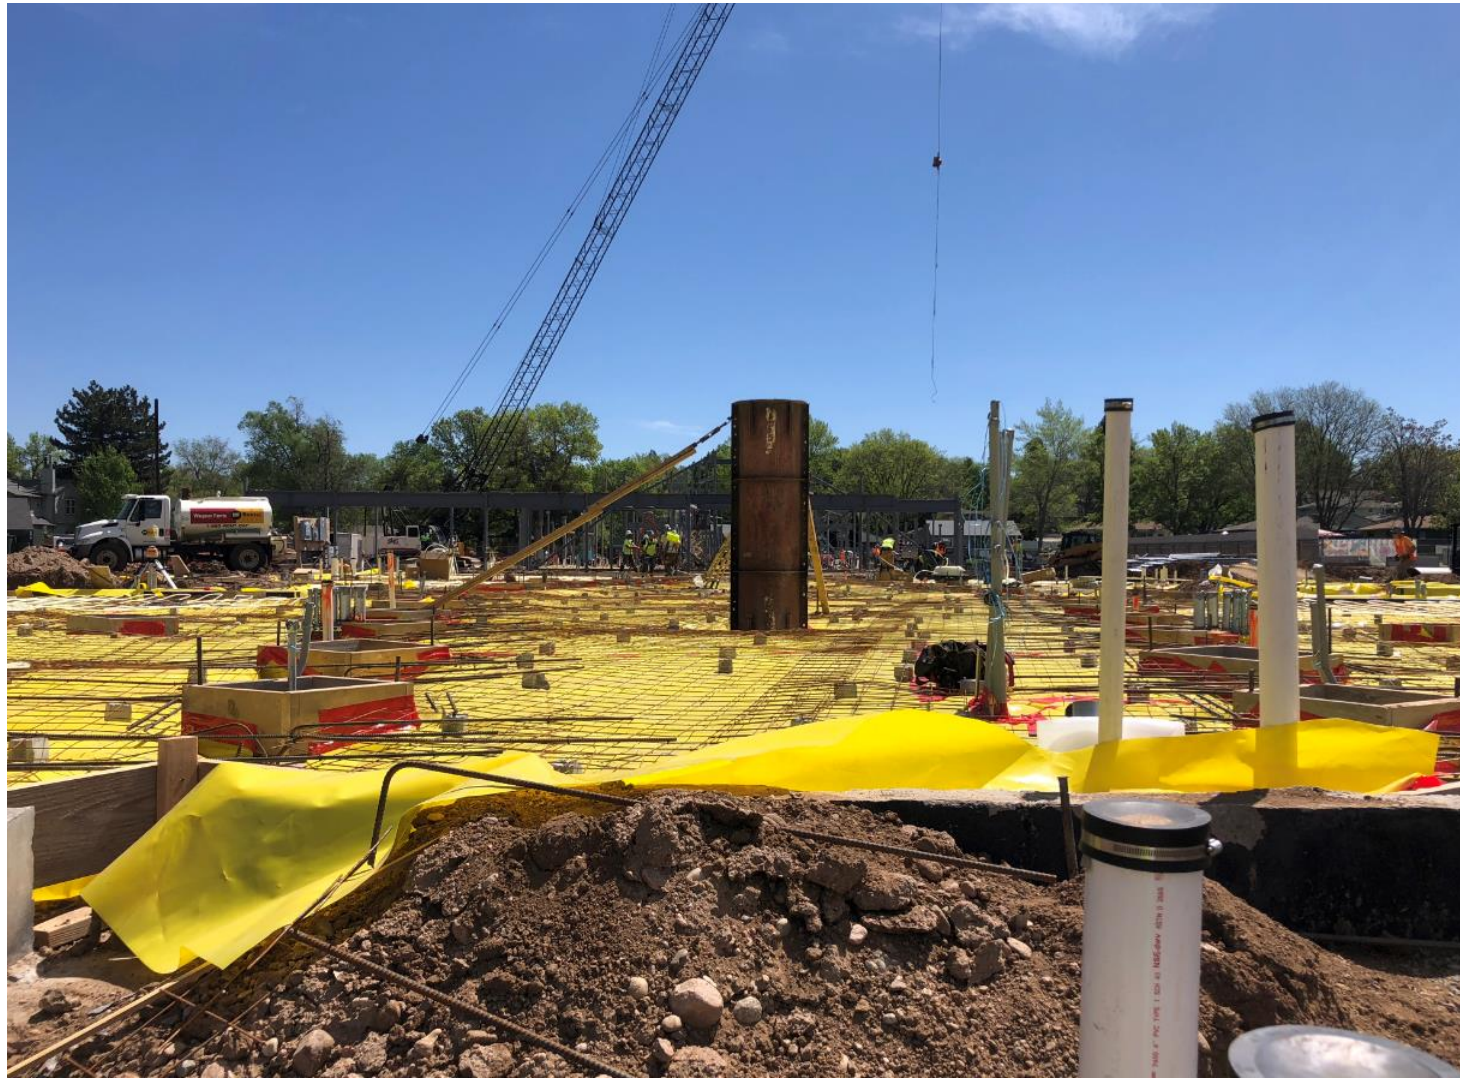
Looking East across building.

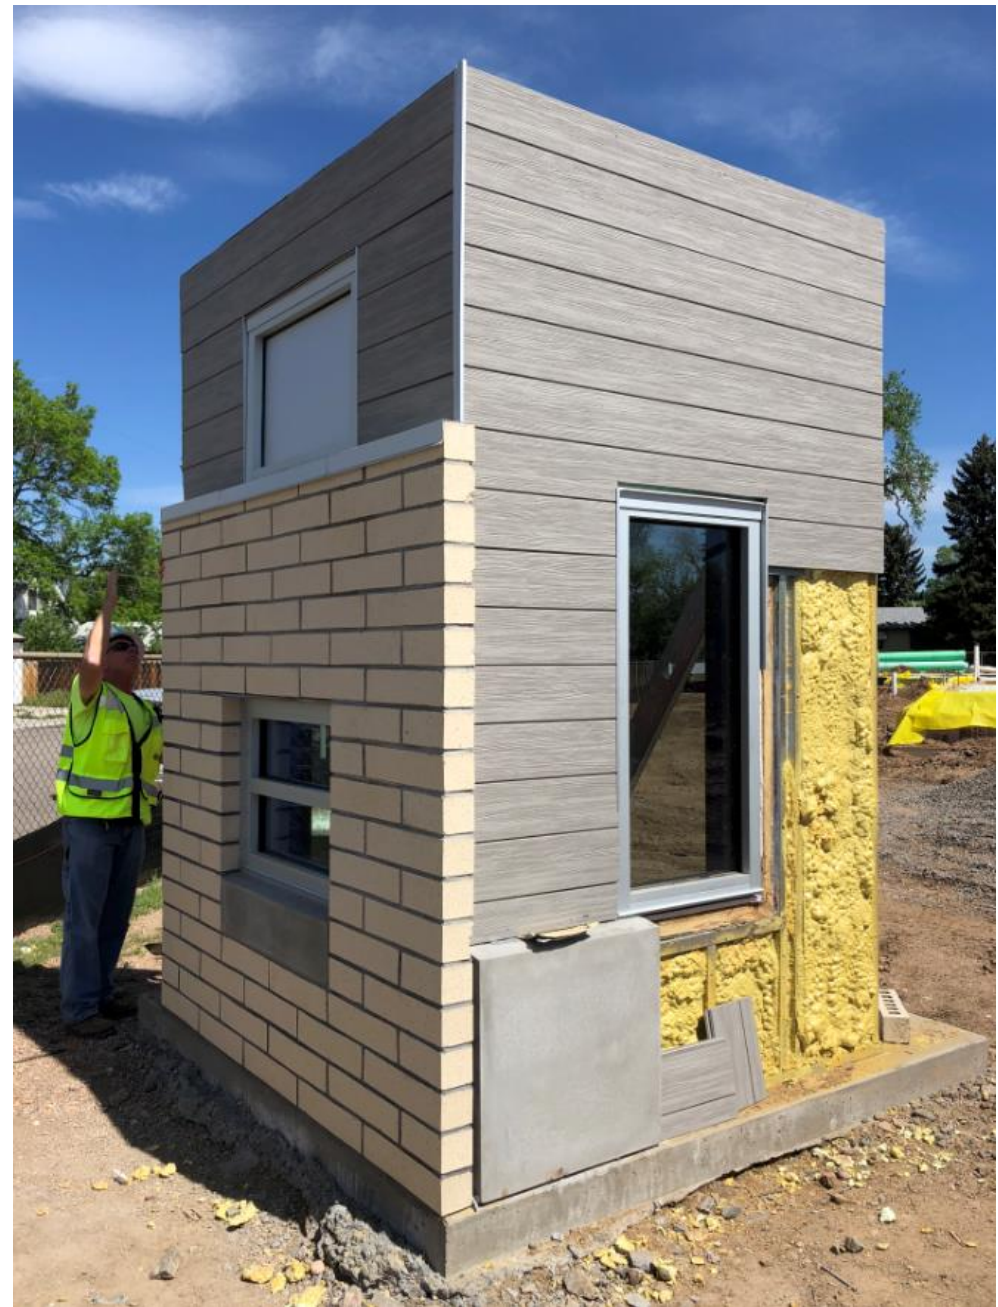
Mock-up wall progression.

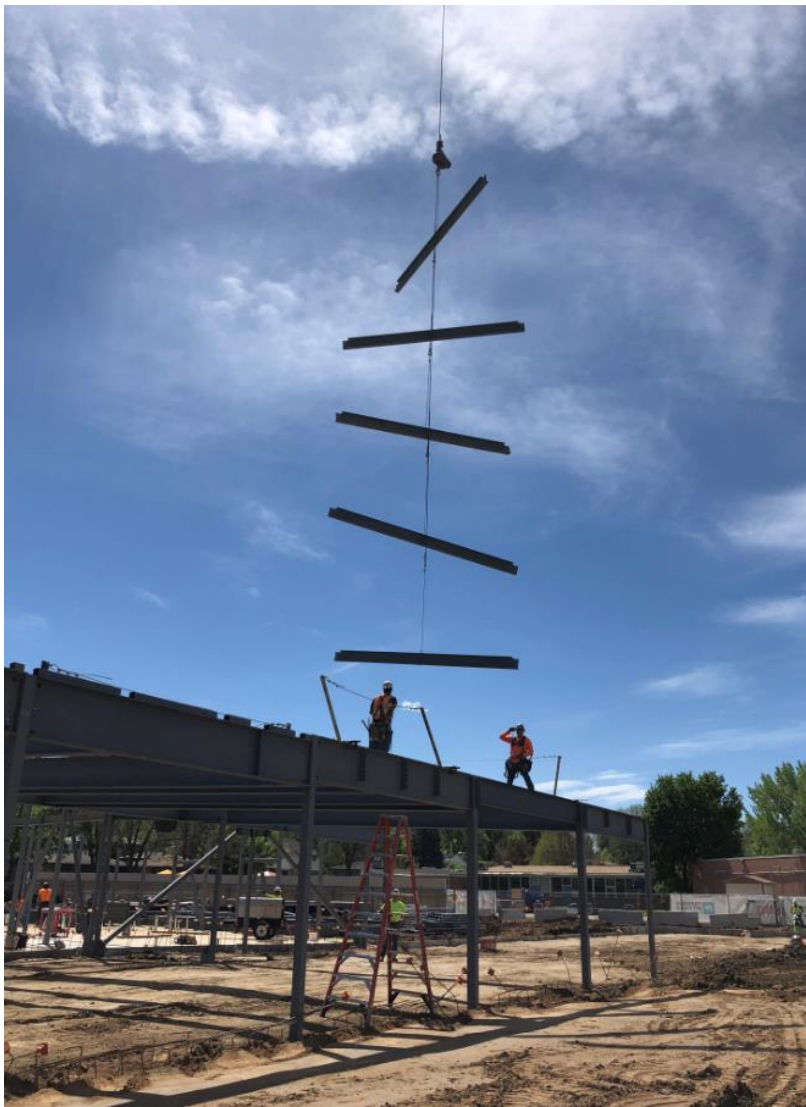
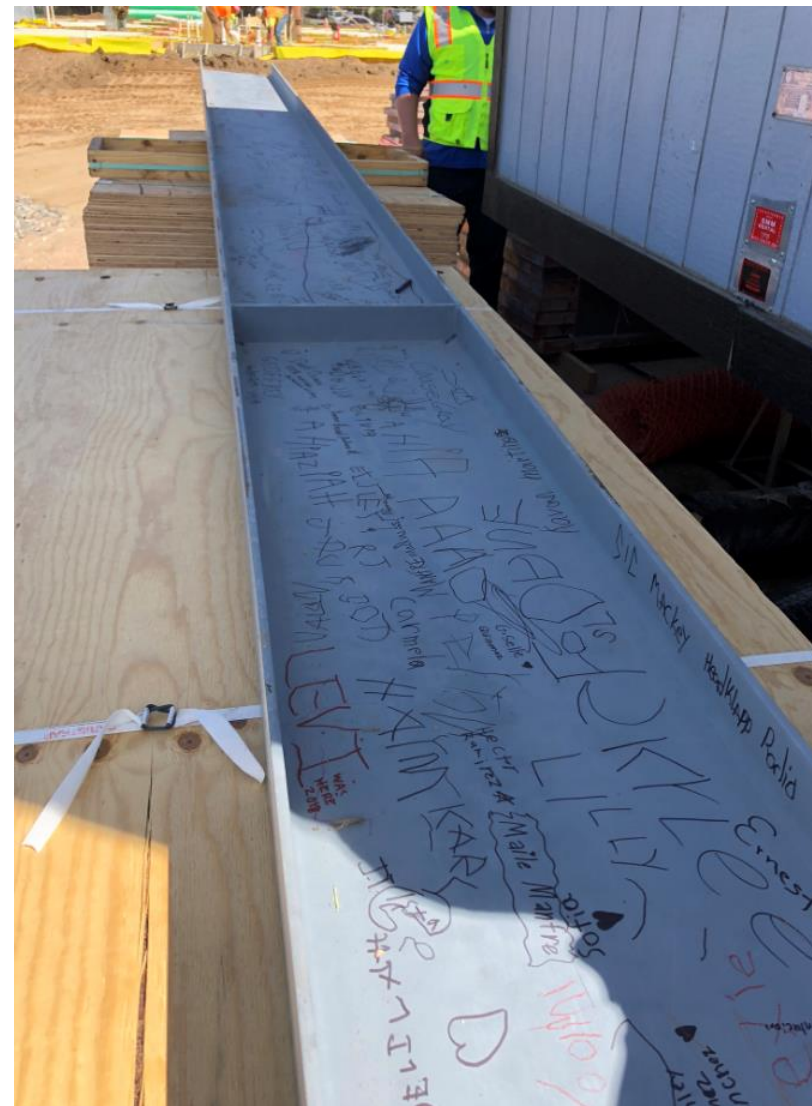
Lifting in beams with crane (left). Signed beam to be placed in Director's office (right).
