## Maddox ECE Construction Report May 7, 2018

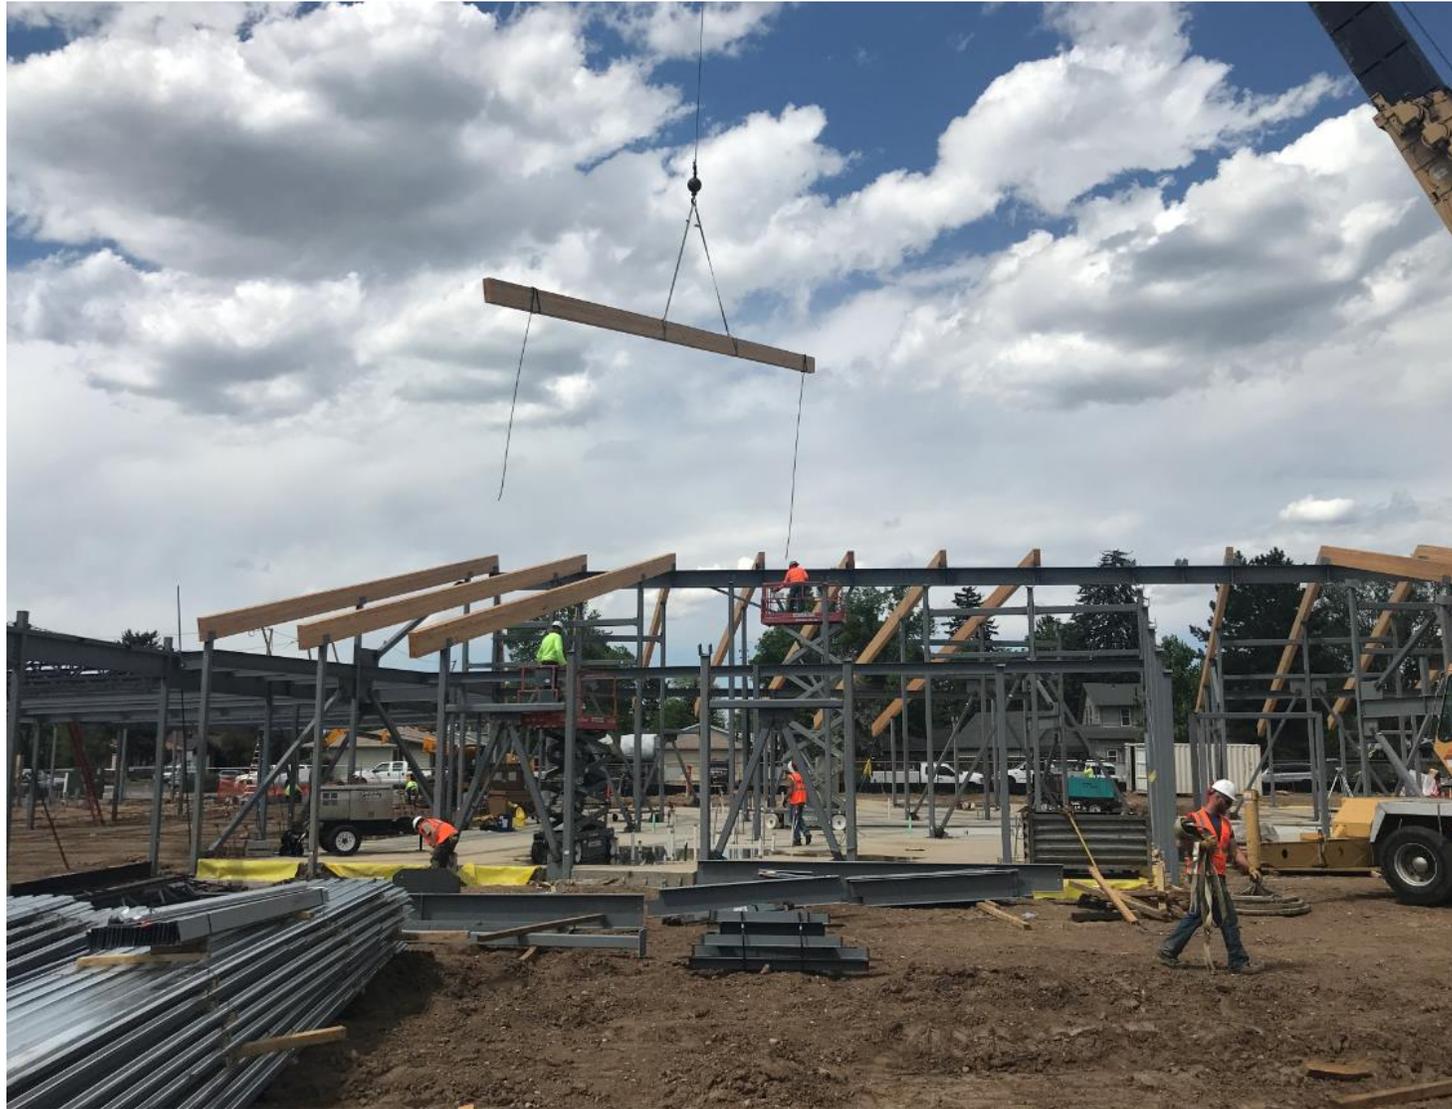
Glulam (glued laminated timber) beam installation.

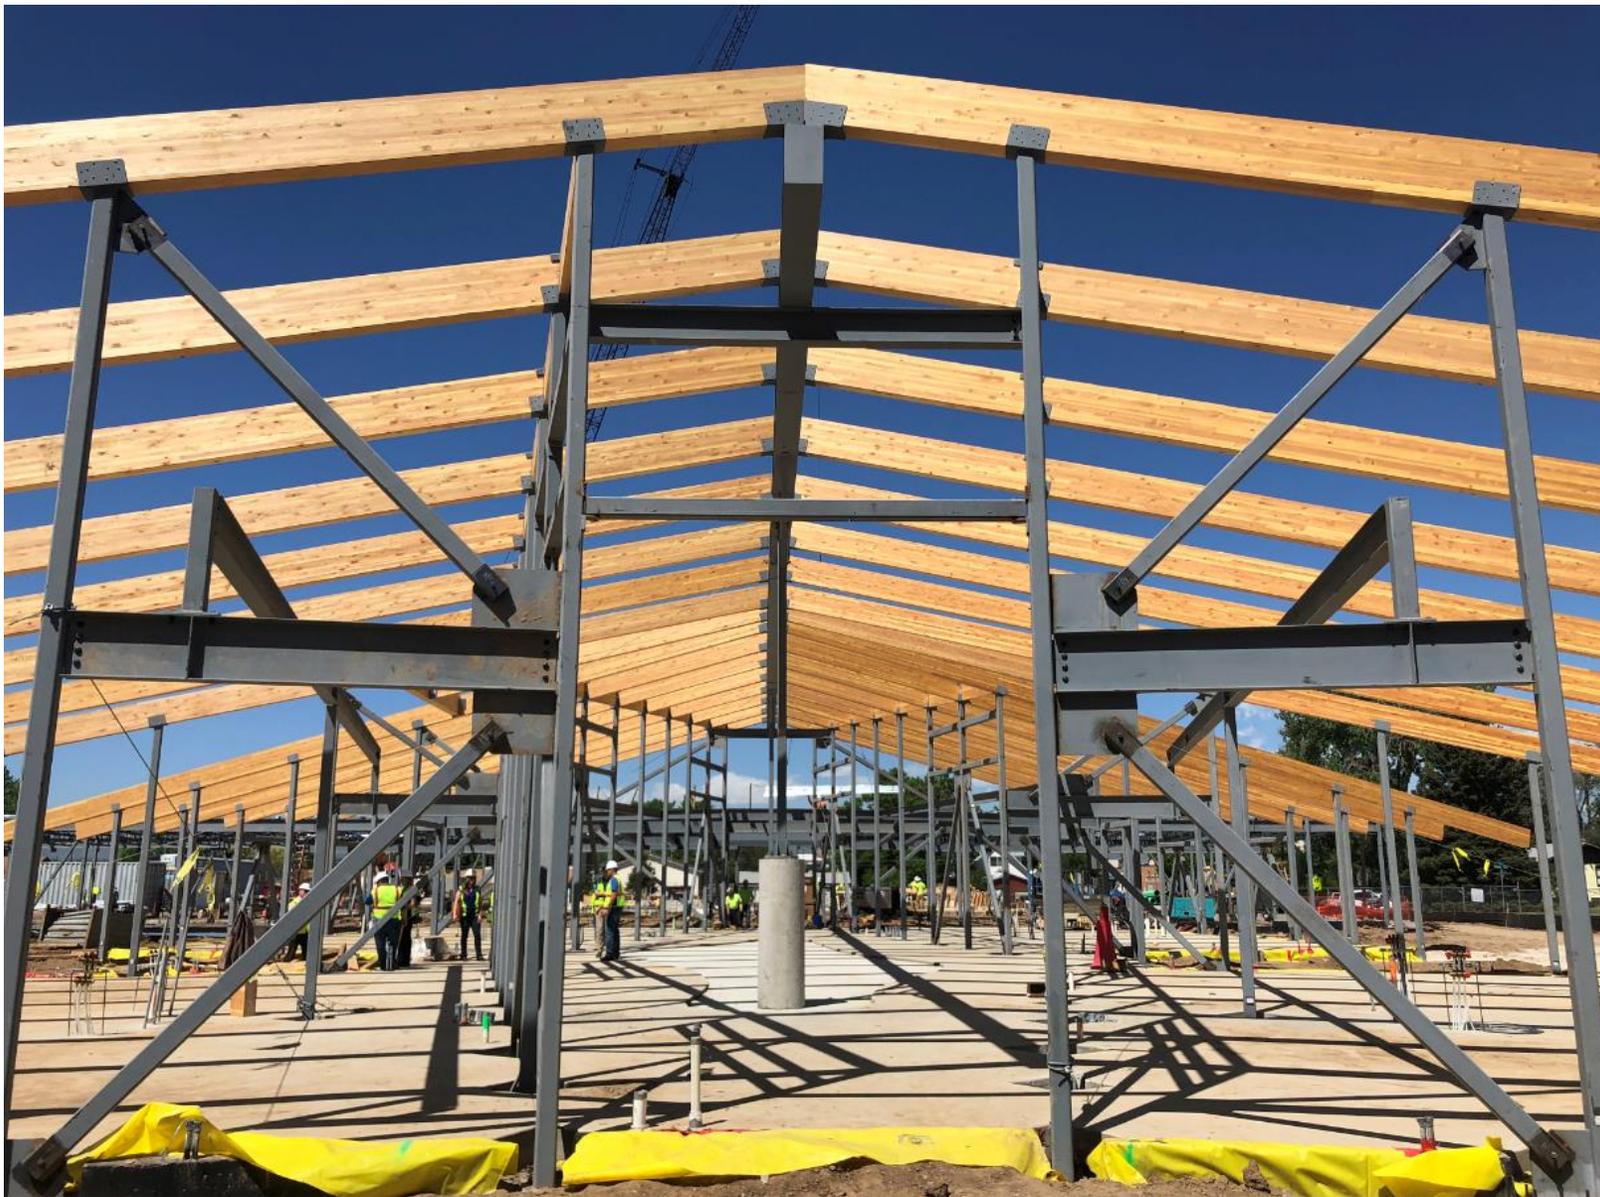
Looking West. Glulams installed on East wing.

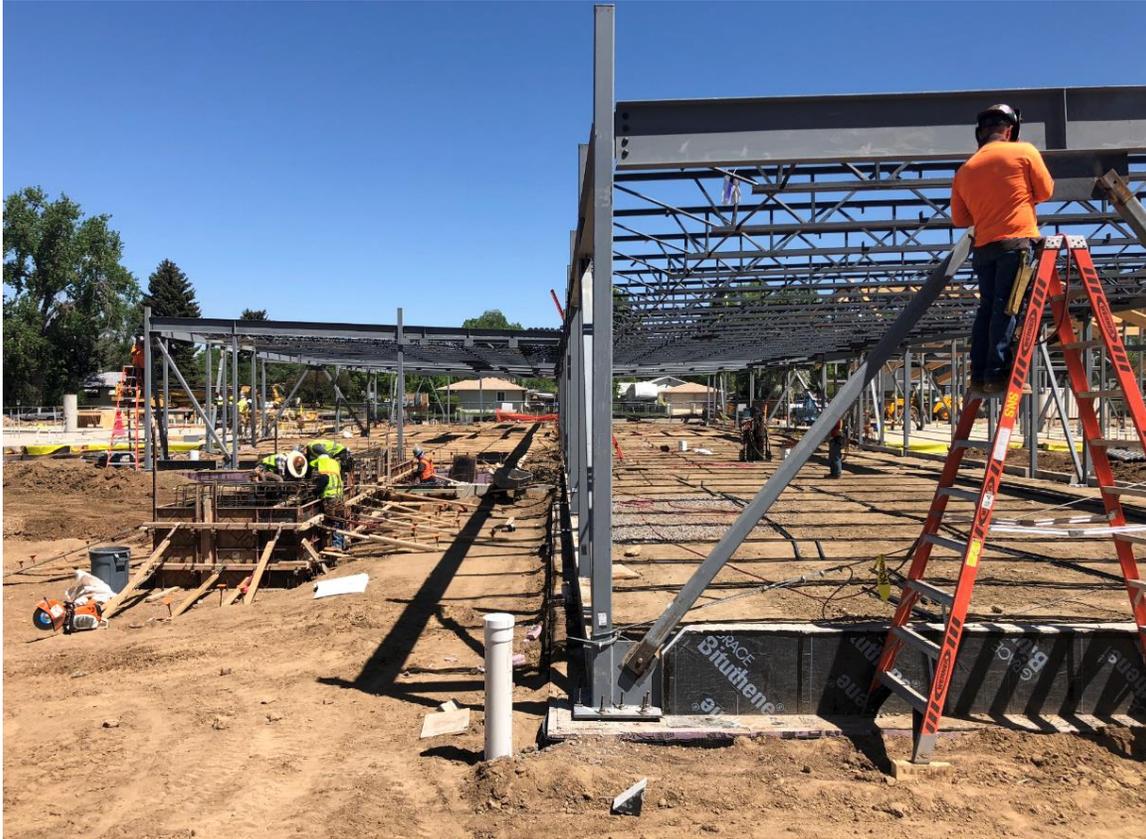
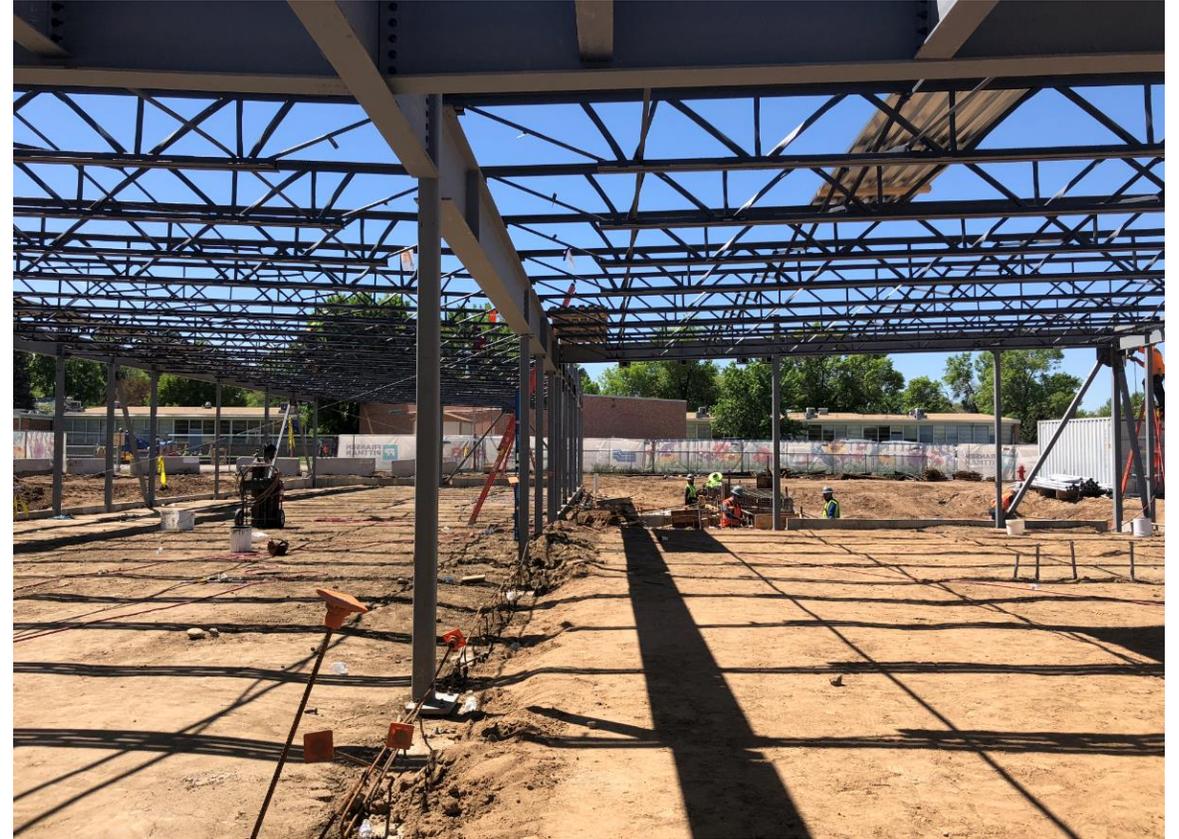
Looking North across central body (left). Interior of central body (right).

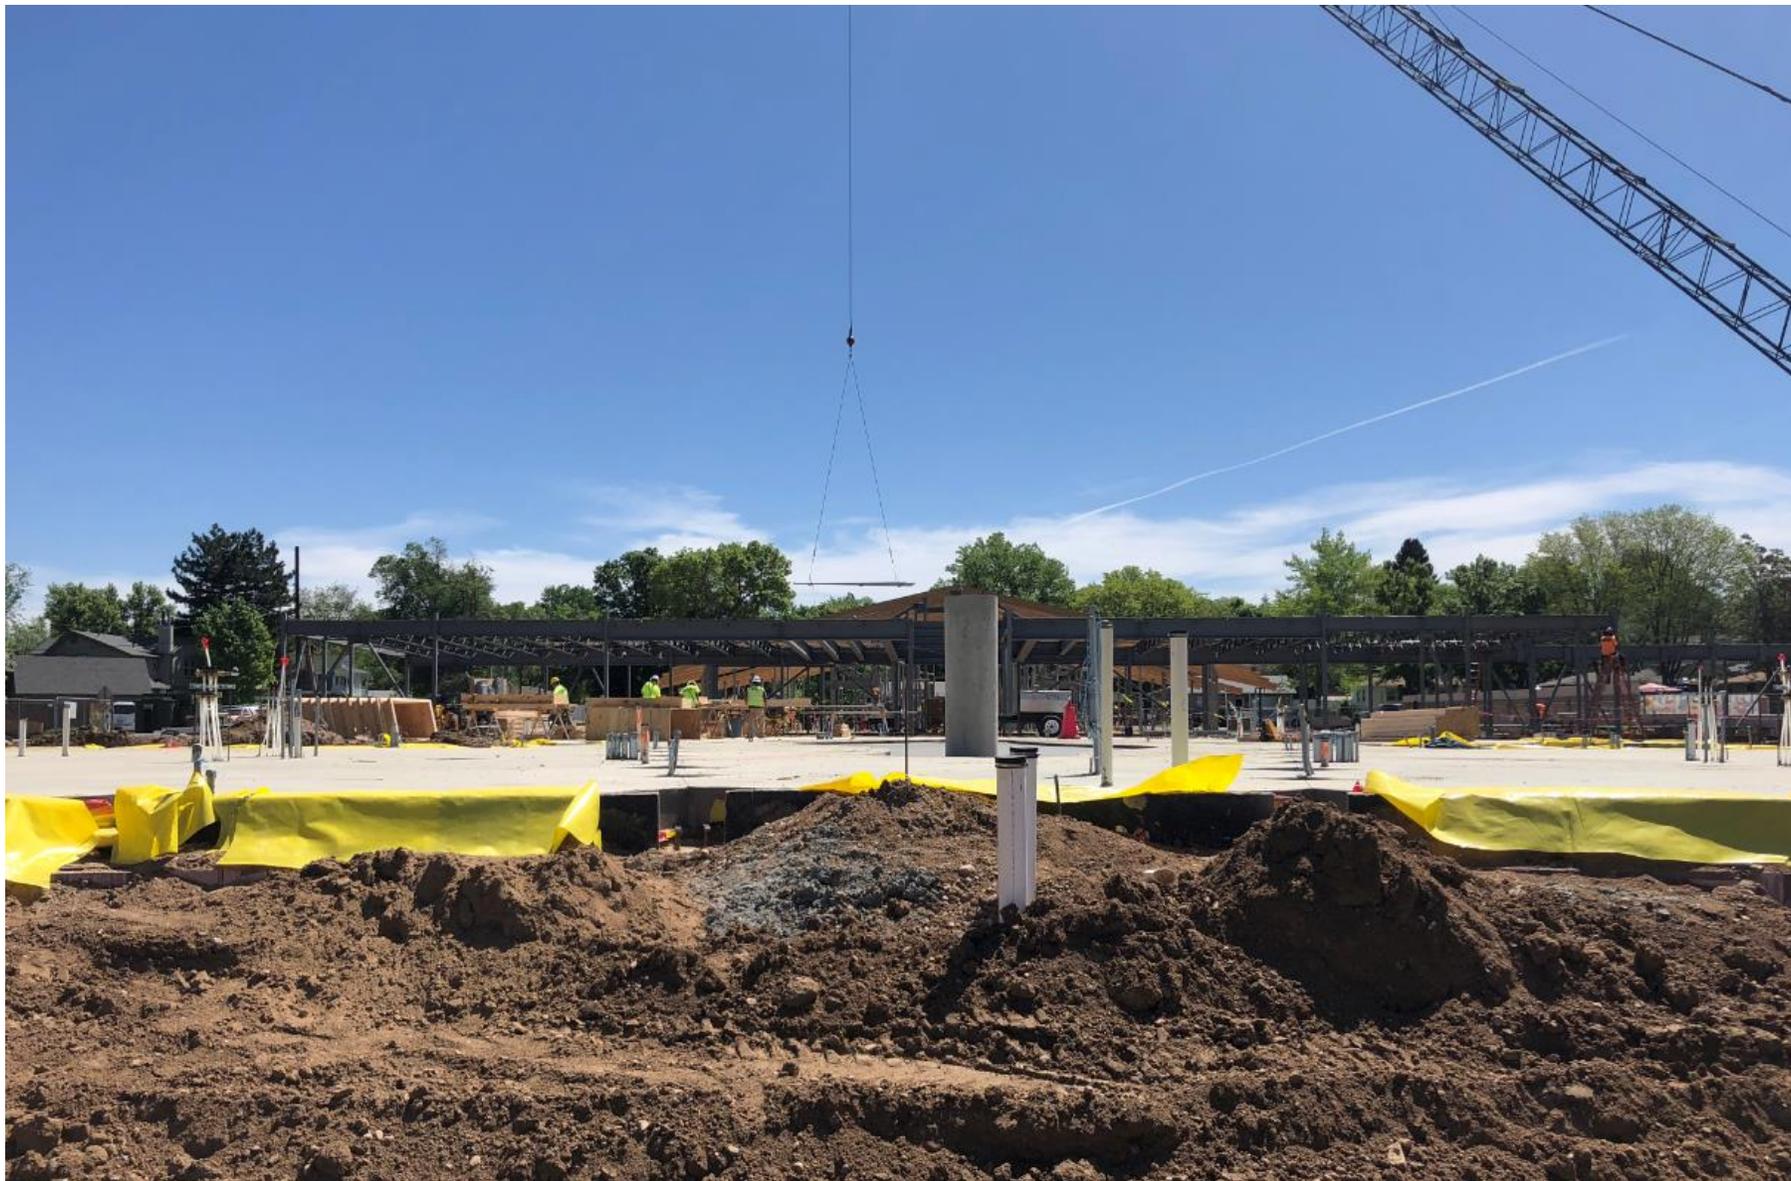
Looking East across building.

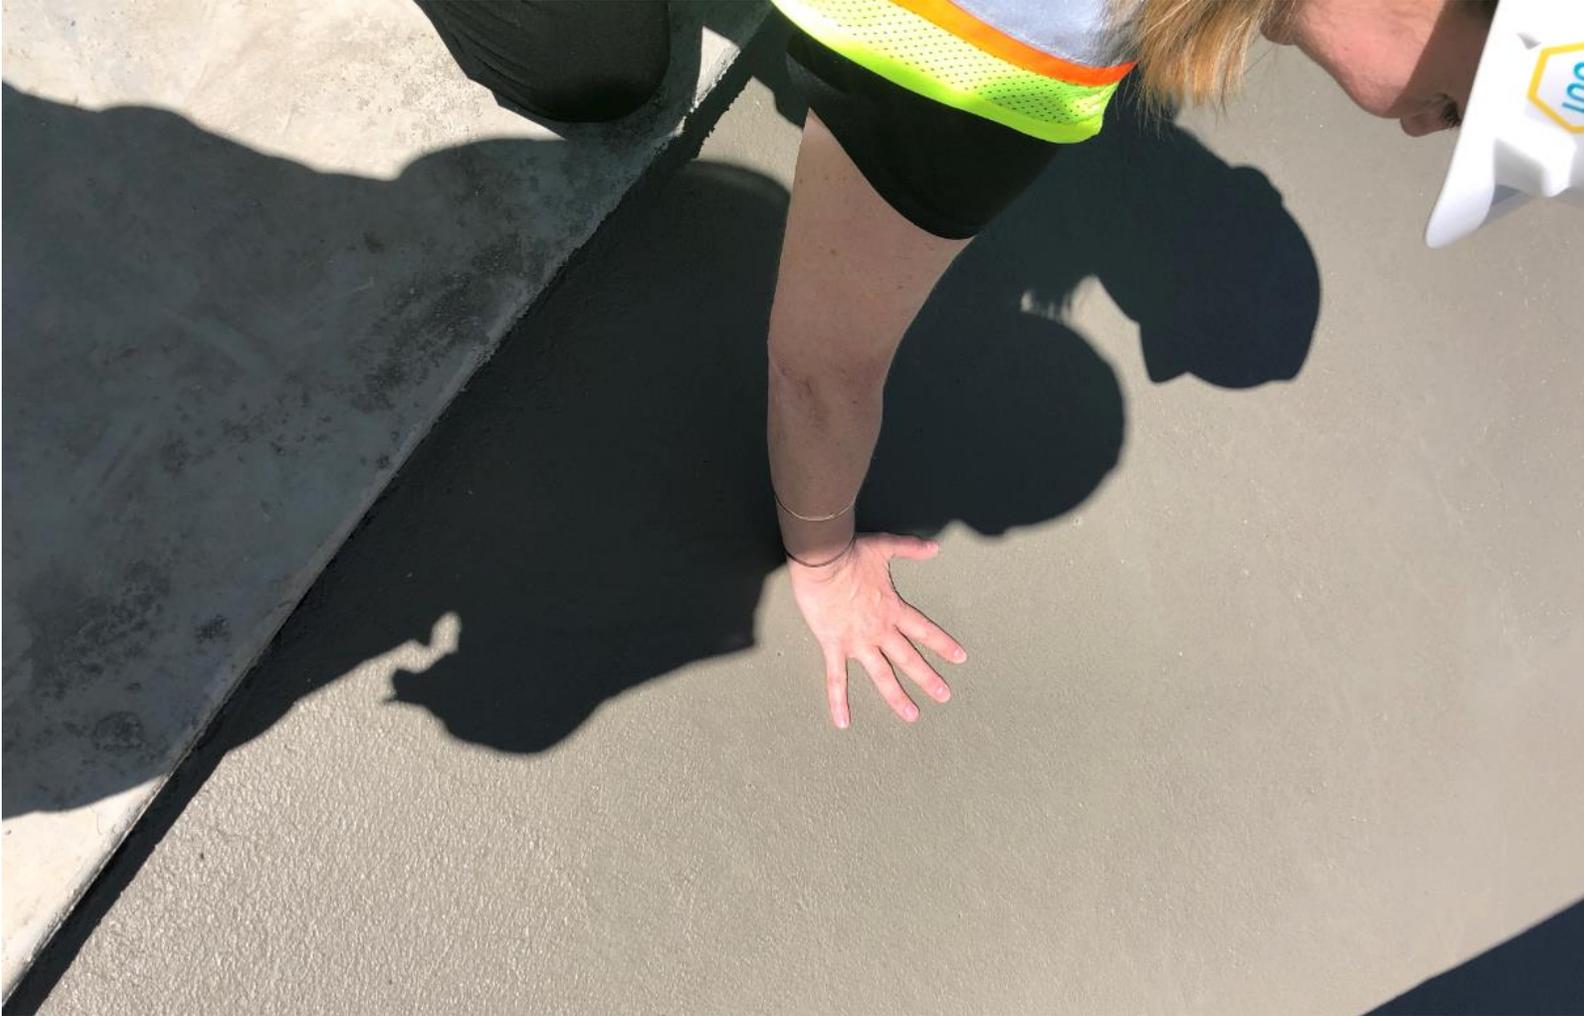
Leaving behind a few handprints.
