## Maddox ECE Construction Report June 18, 2018

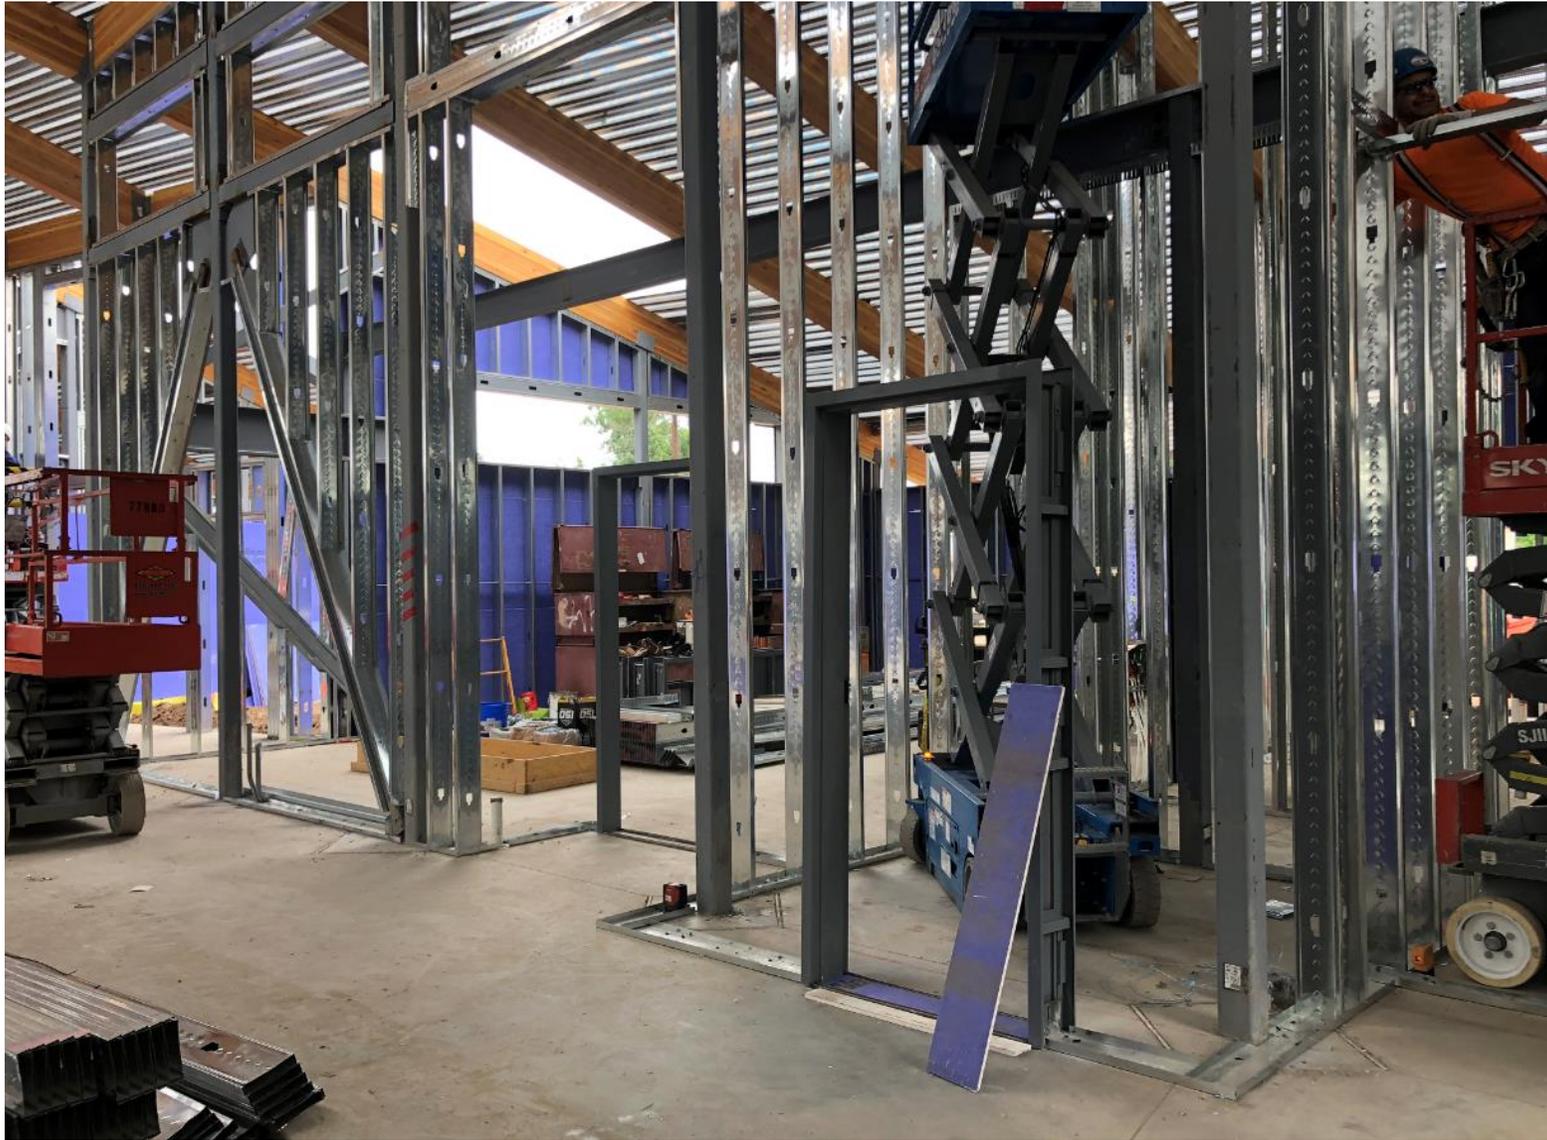
East classrooms being framed.

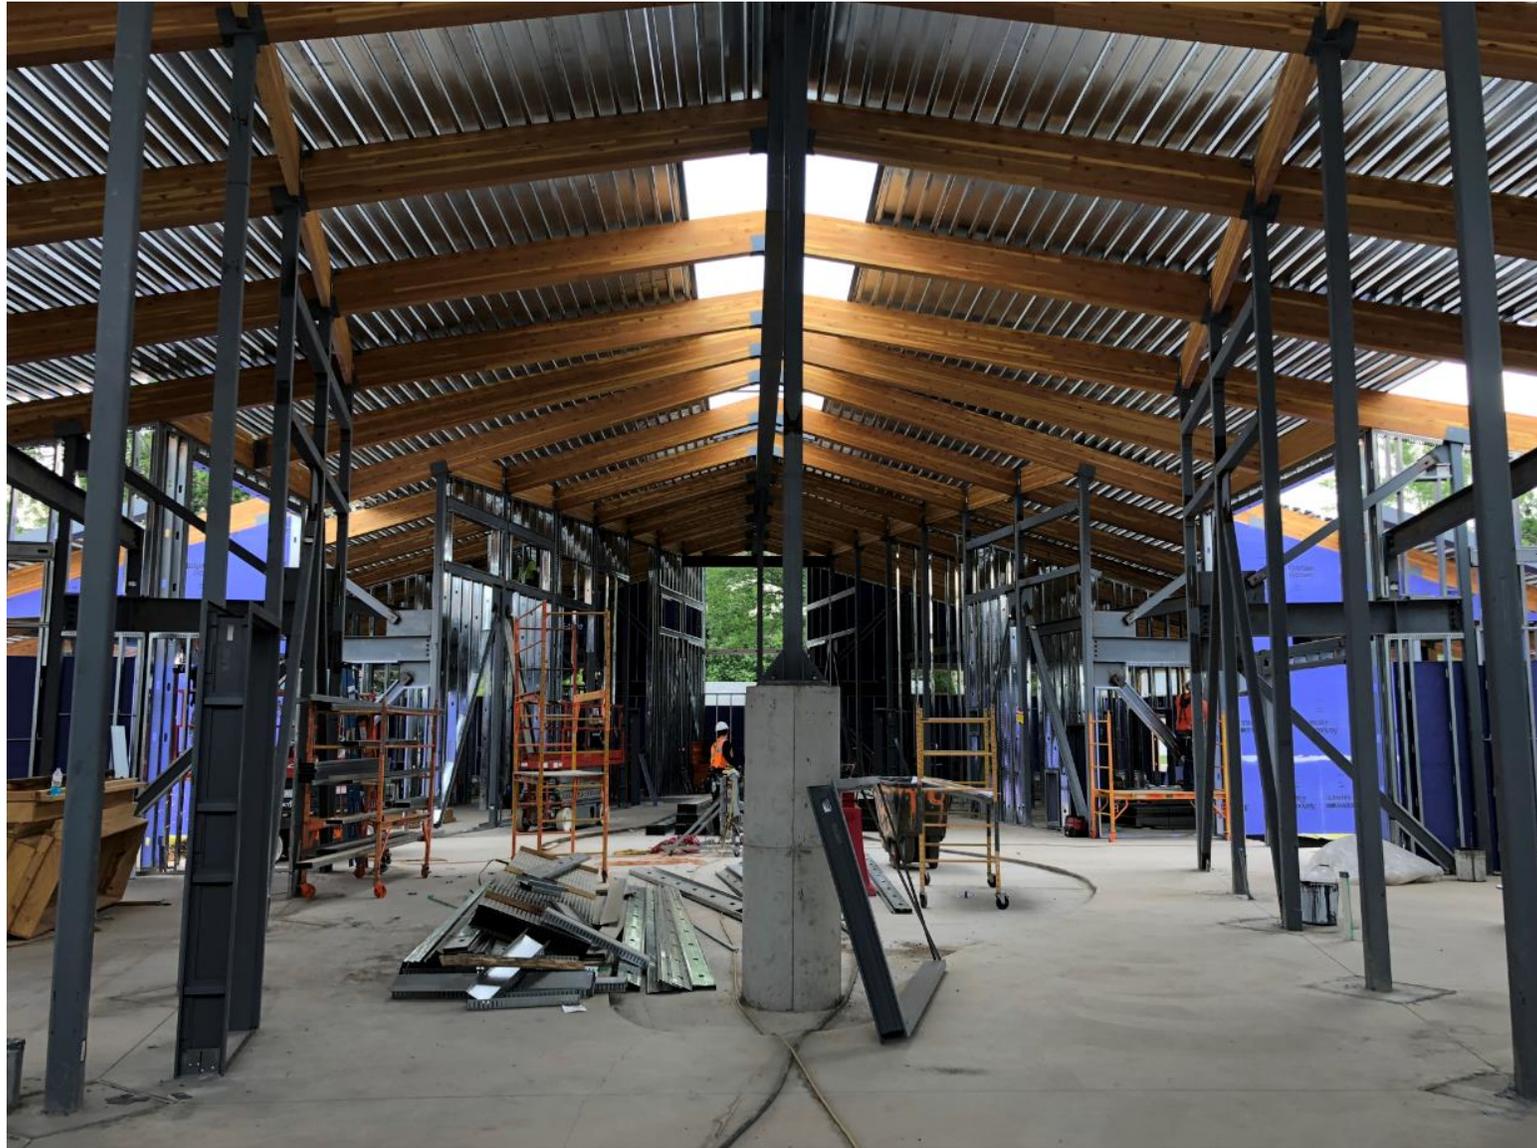
East wing.

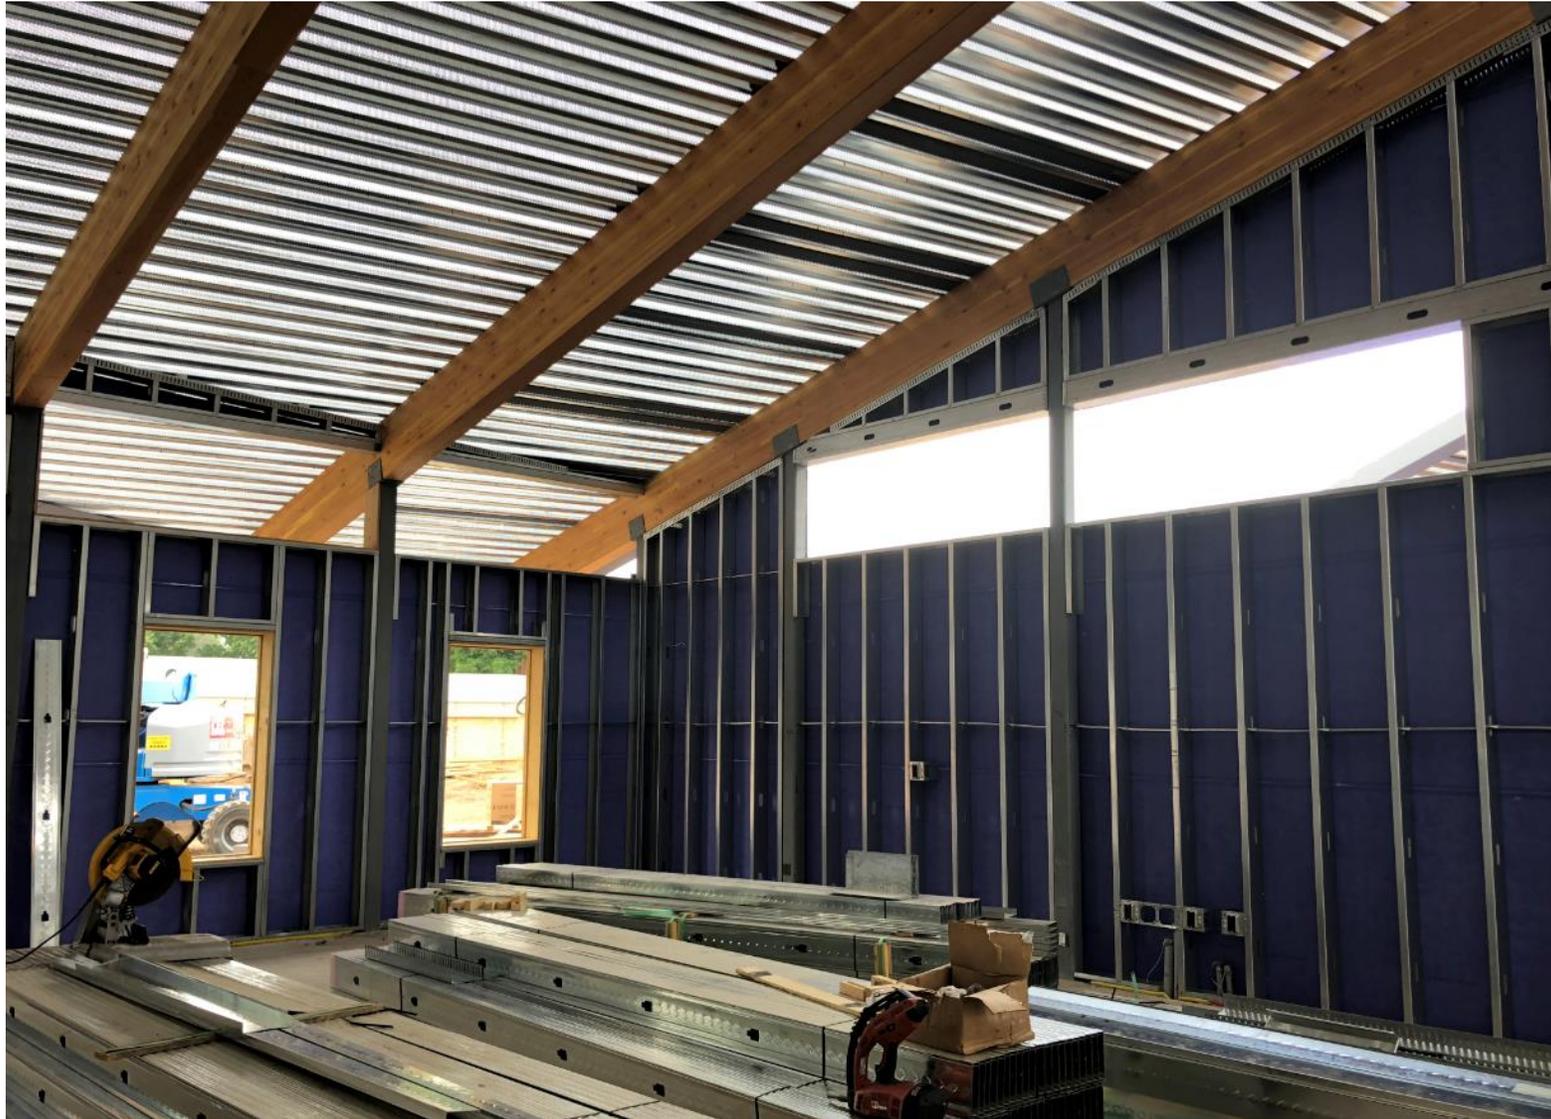
Windows framed.

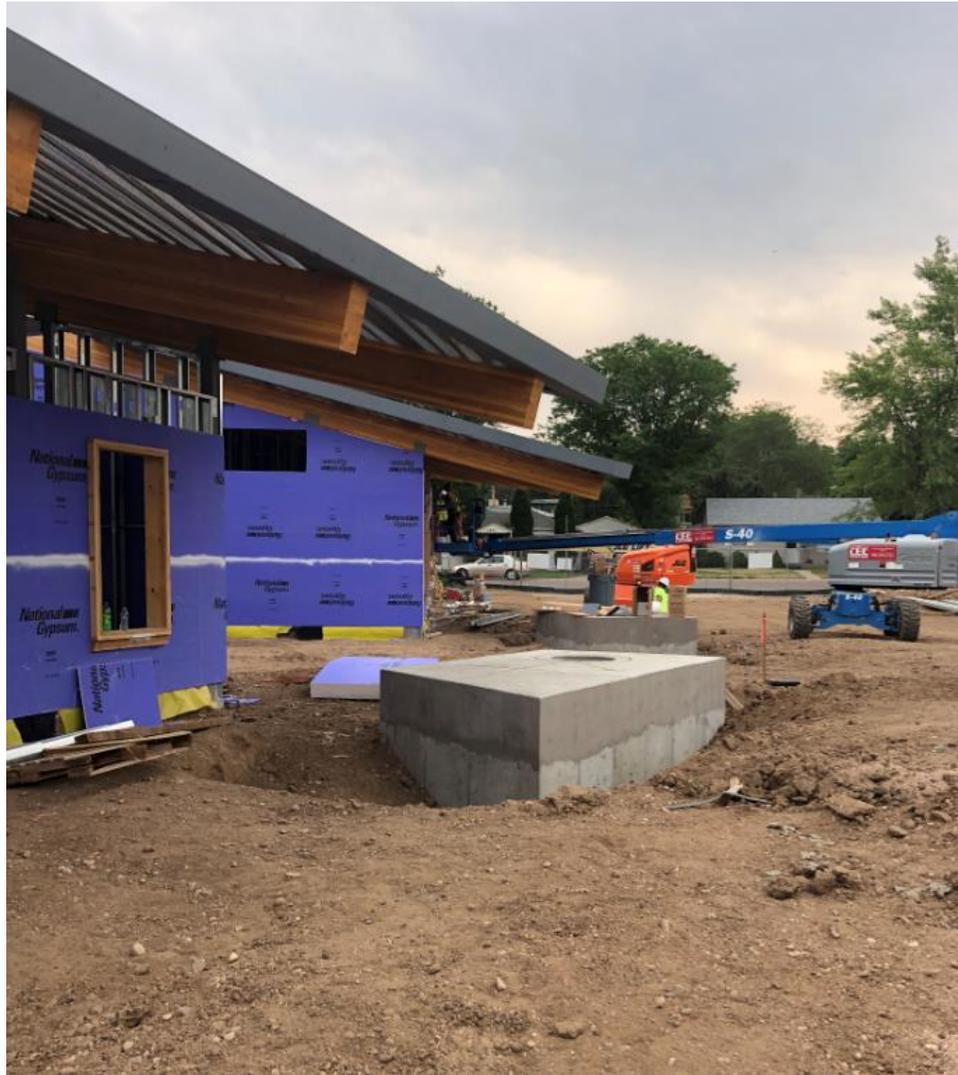
Rain chain/benches.

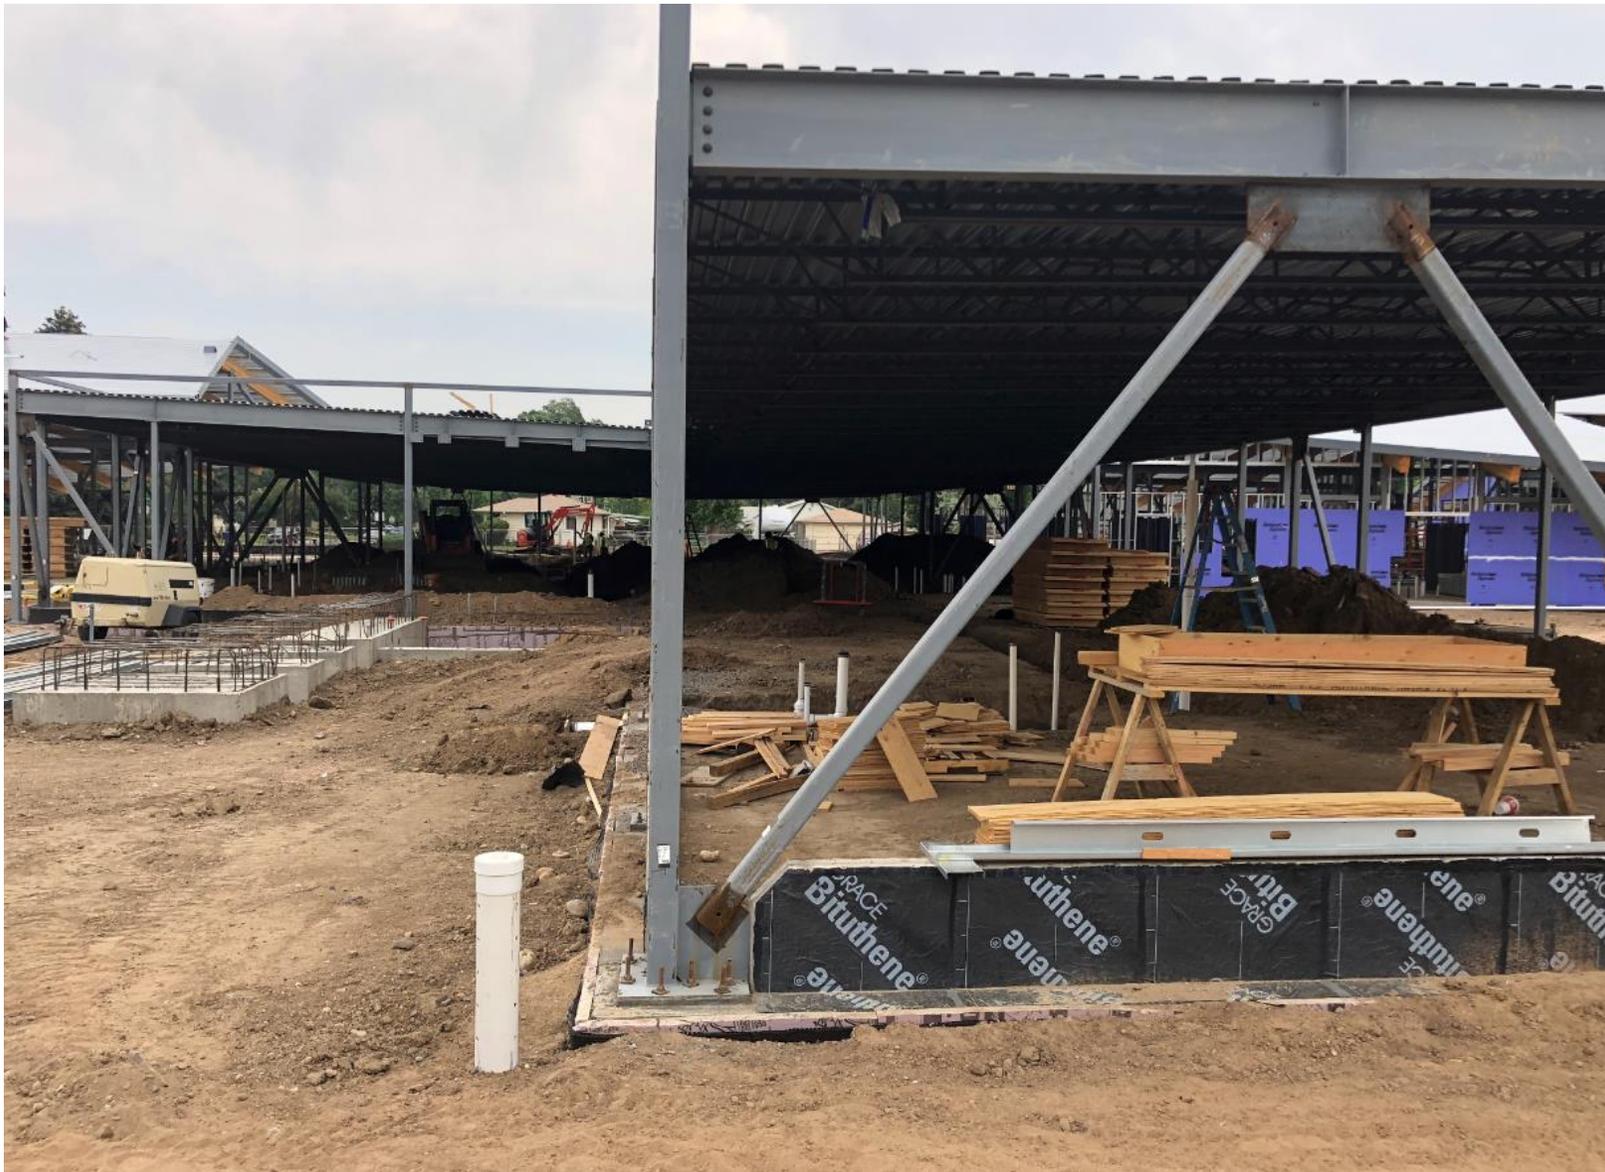
Central body, looking at main entrance area.

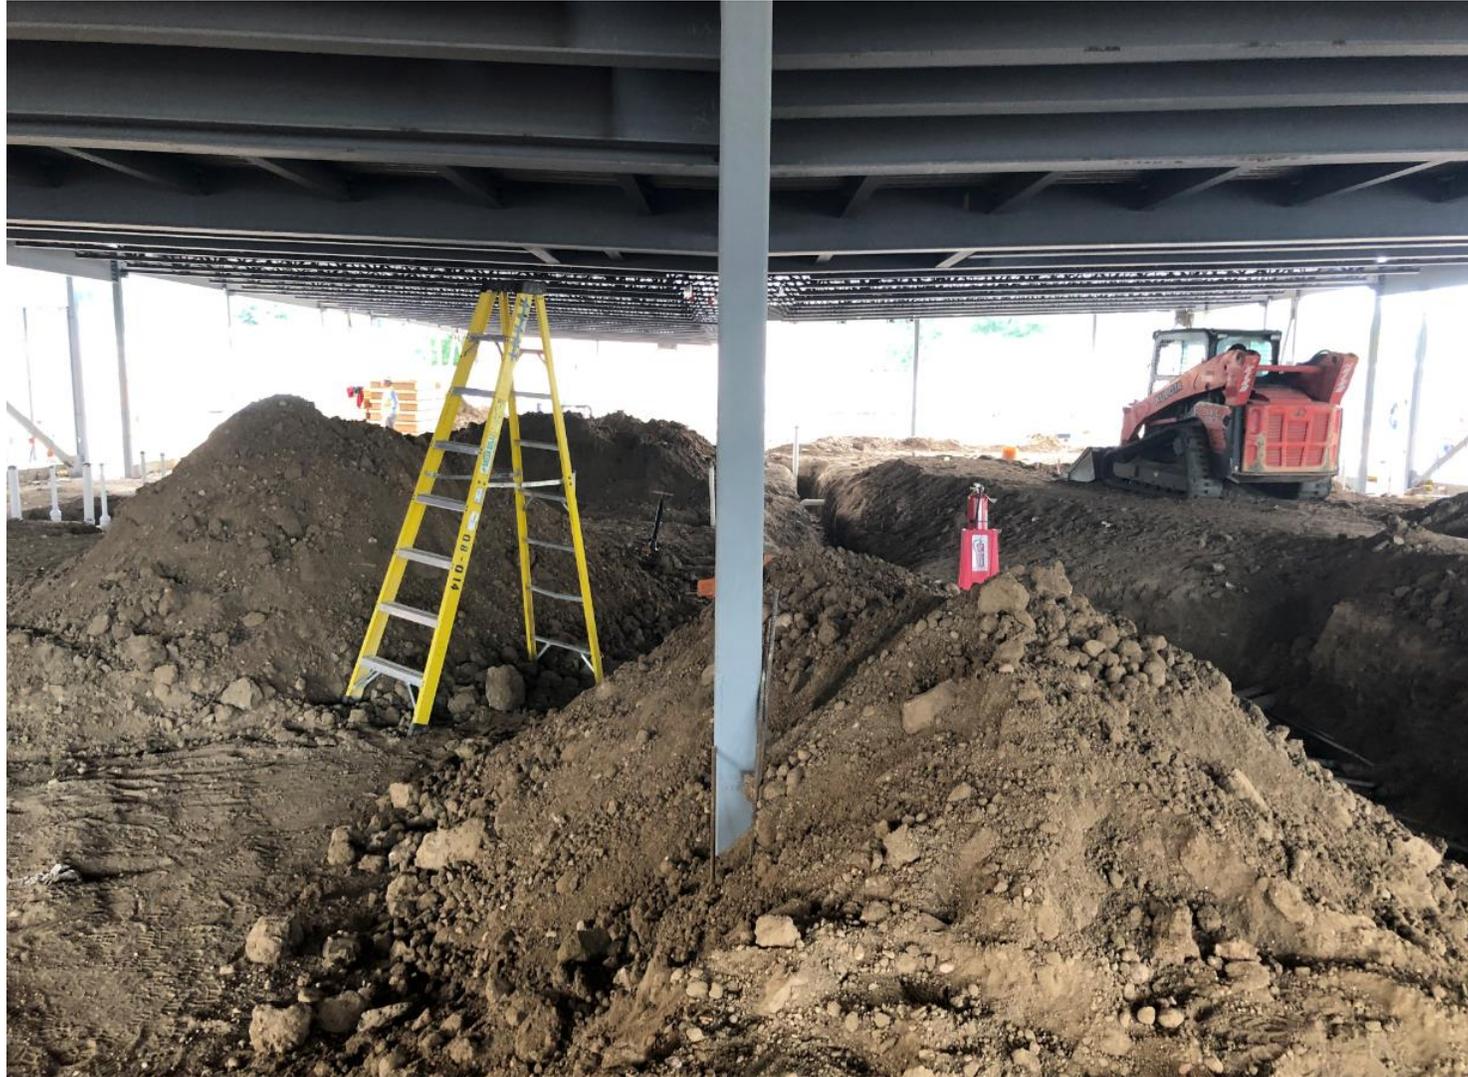
Looking North across central body. Plumbing trenches underway.
