Maddox ECE Construction Report

June 11, 2018

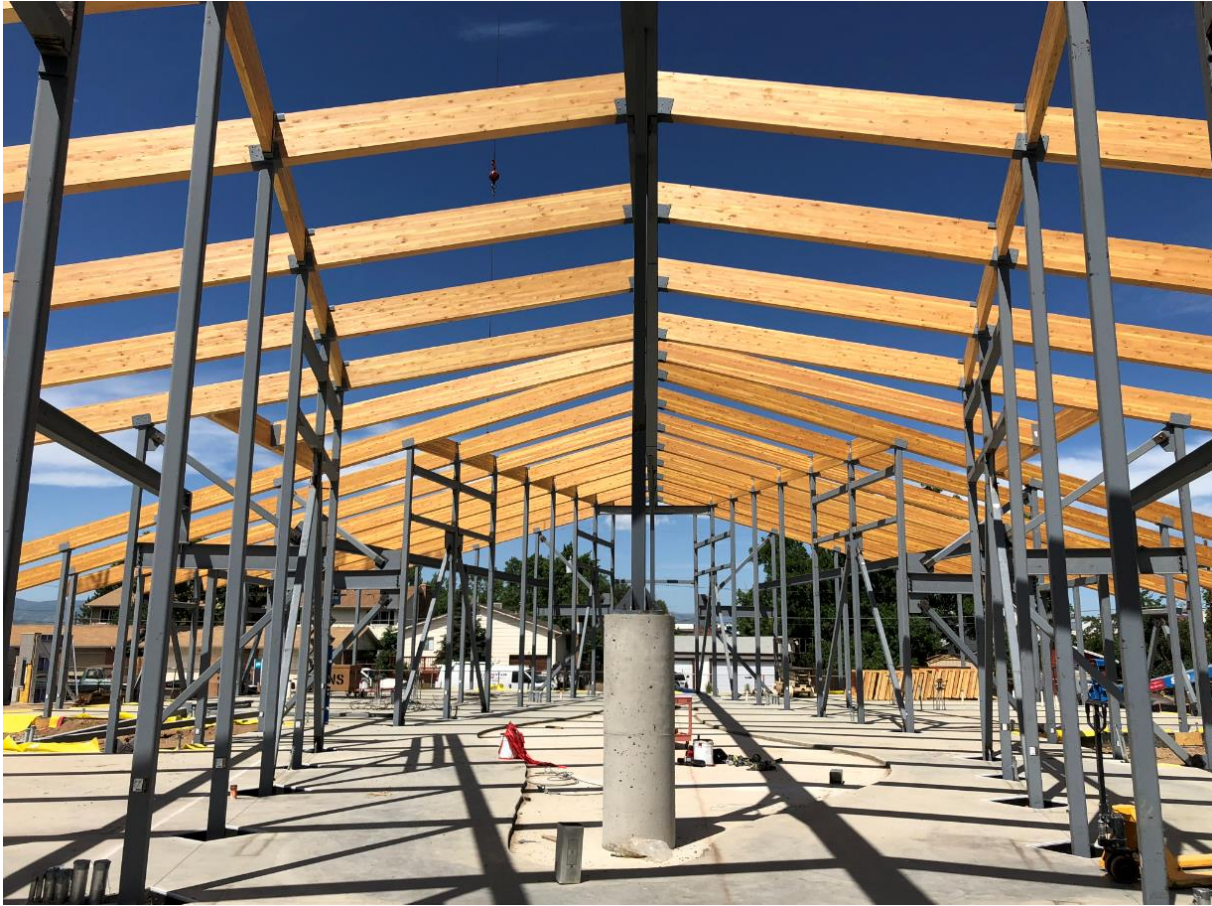
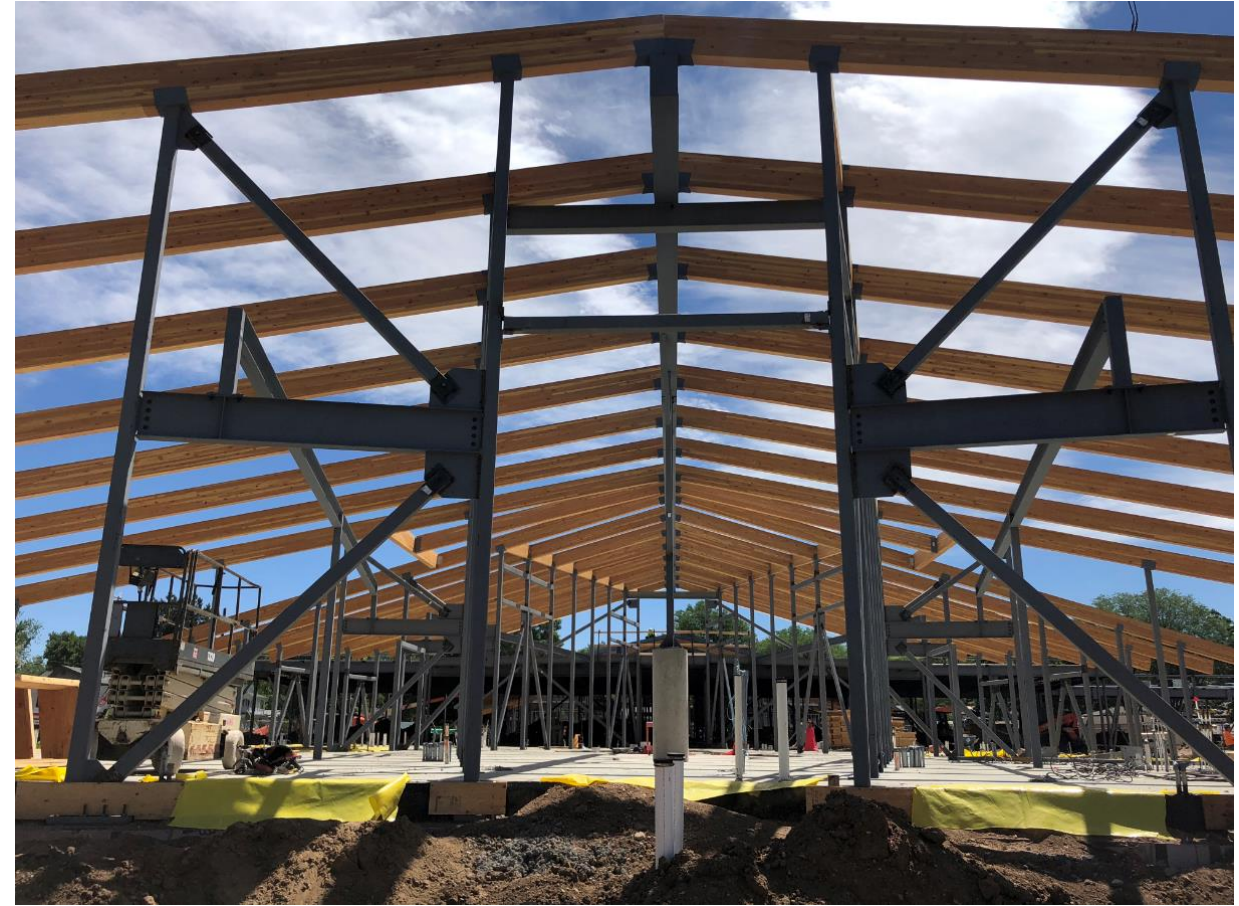
Looking across West wing.

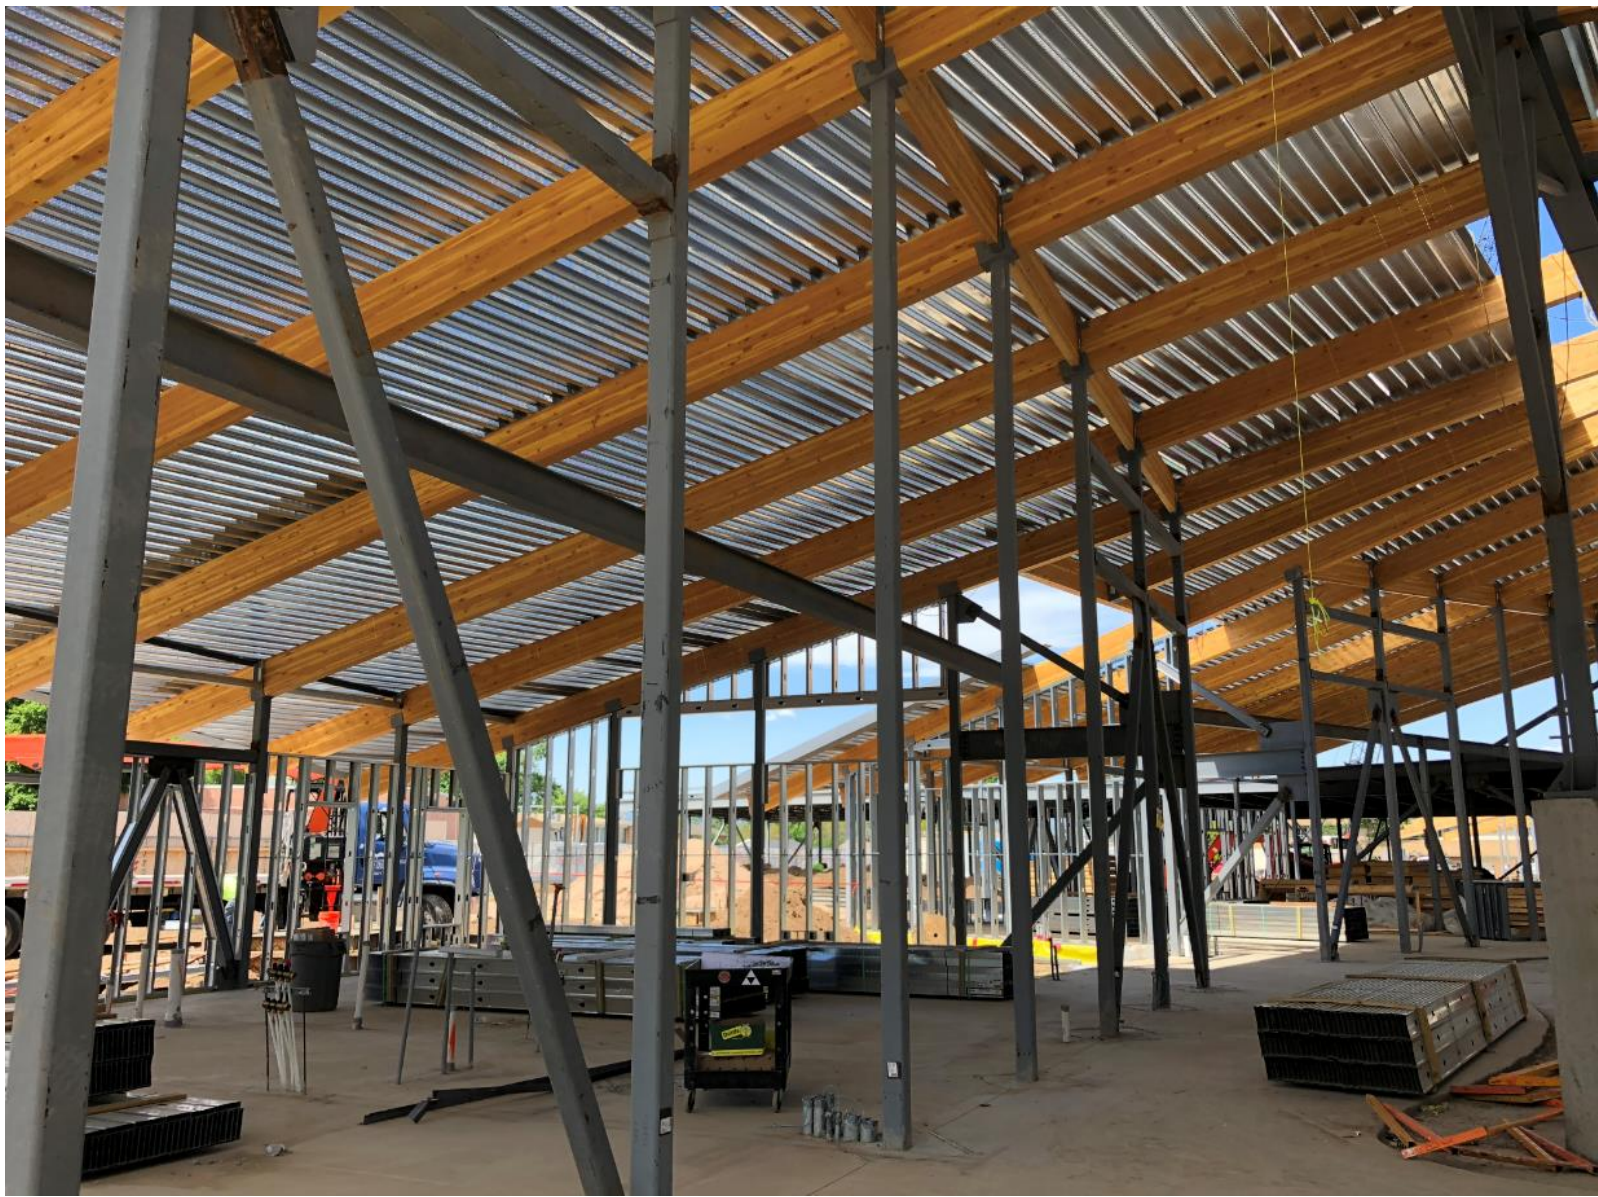
View of Southeast classrooms.

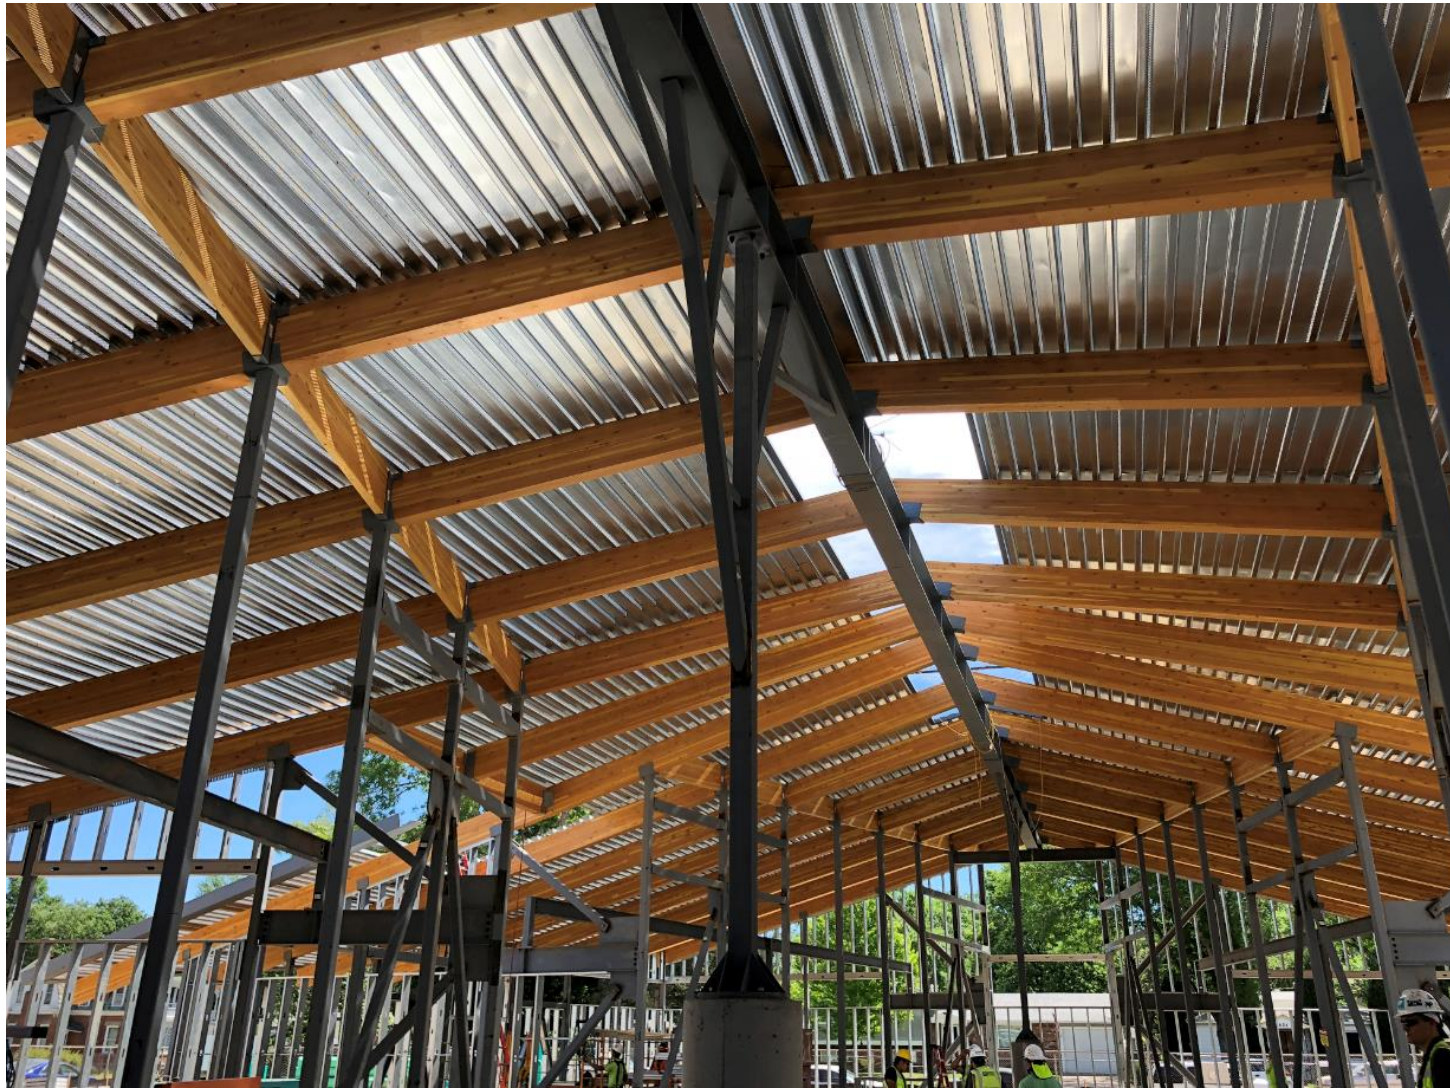
Acoustic deck installed on East wing.

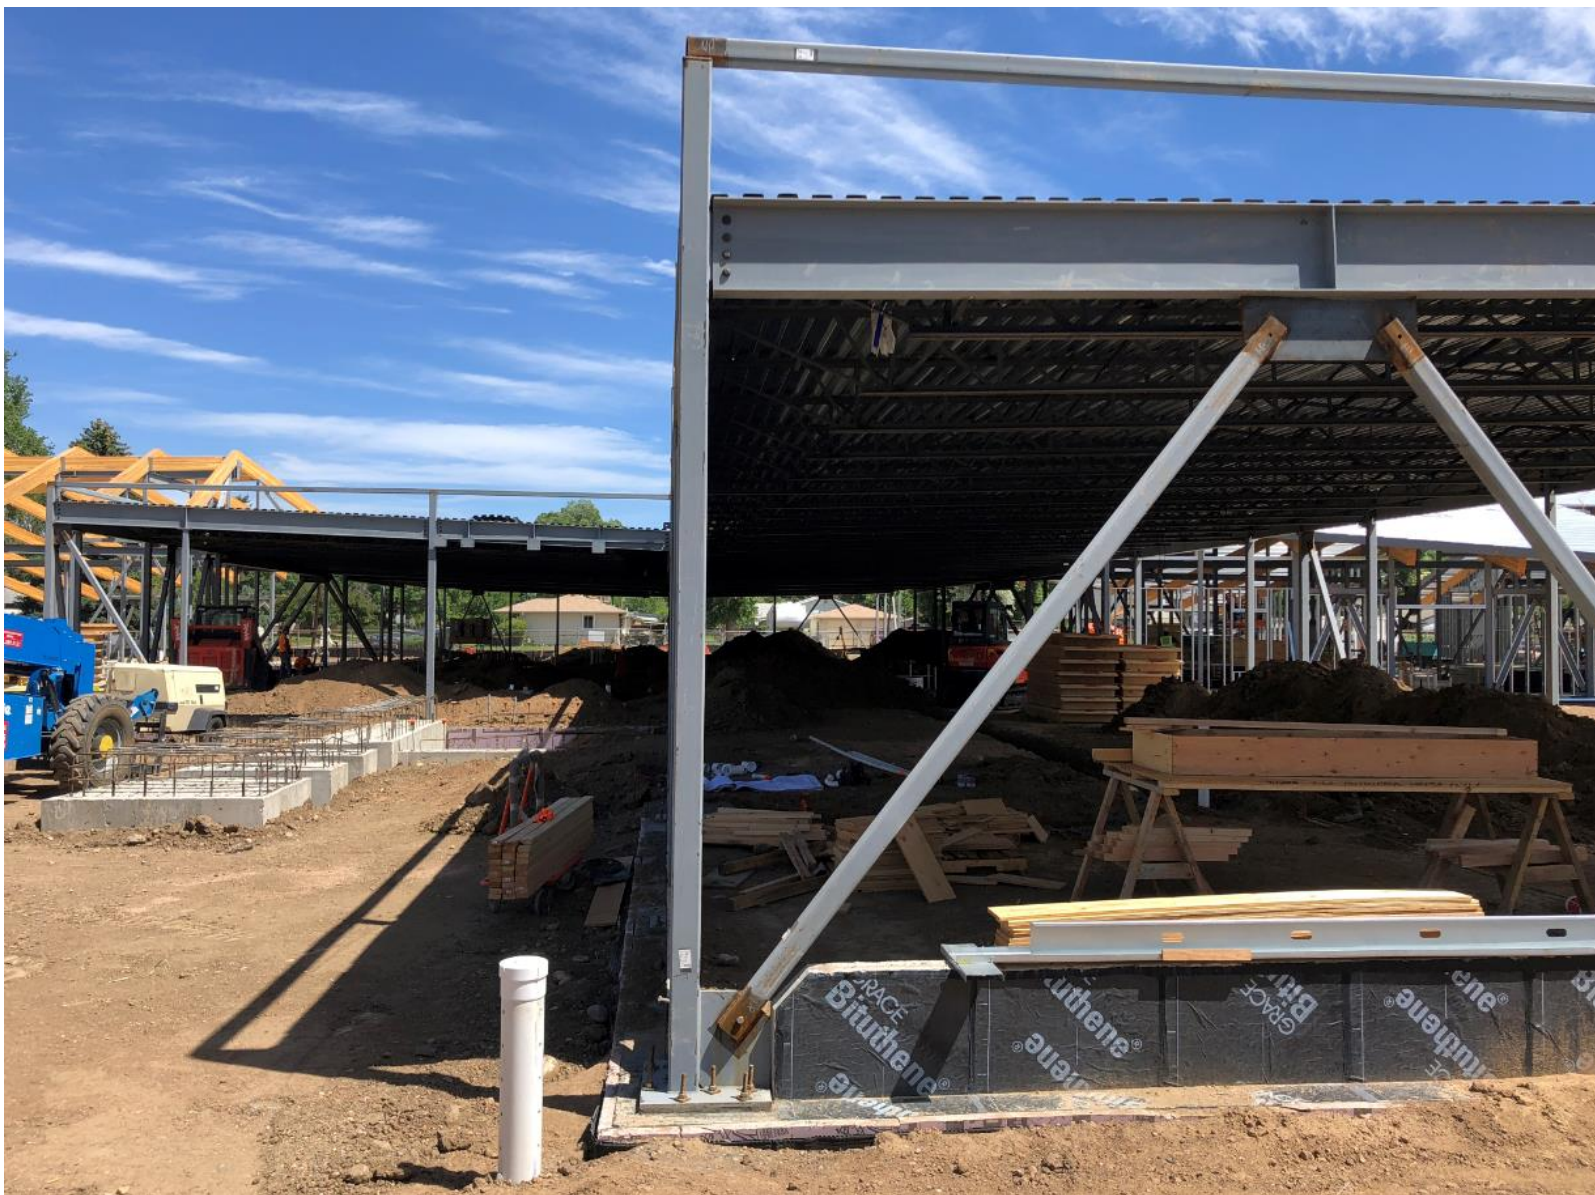
Central body, looking at main entrance area.

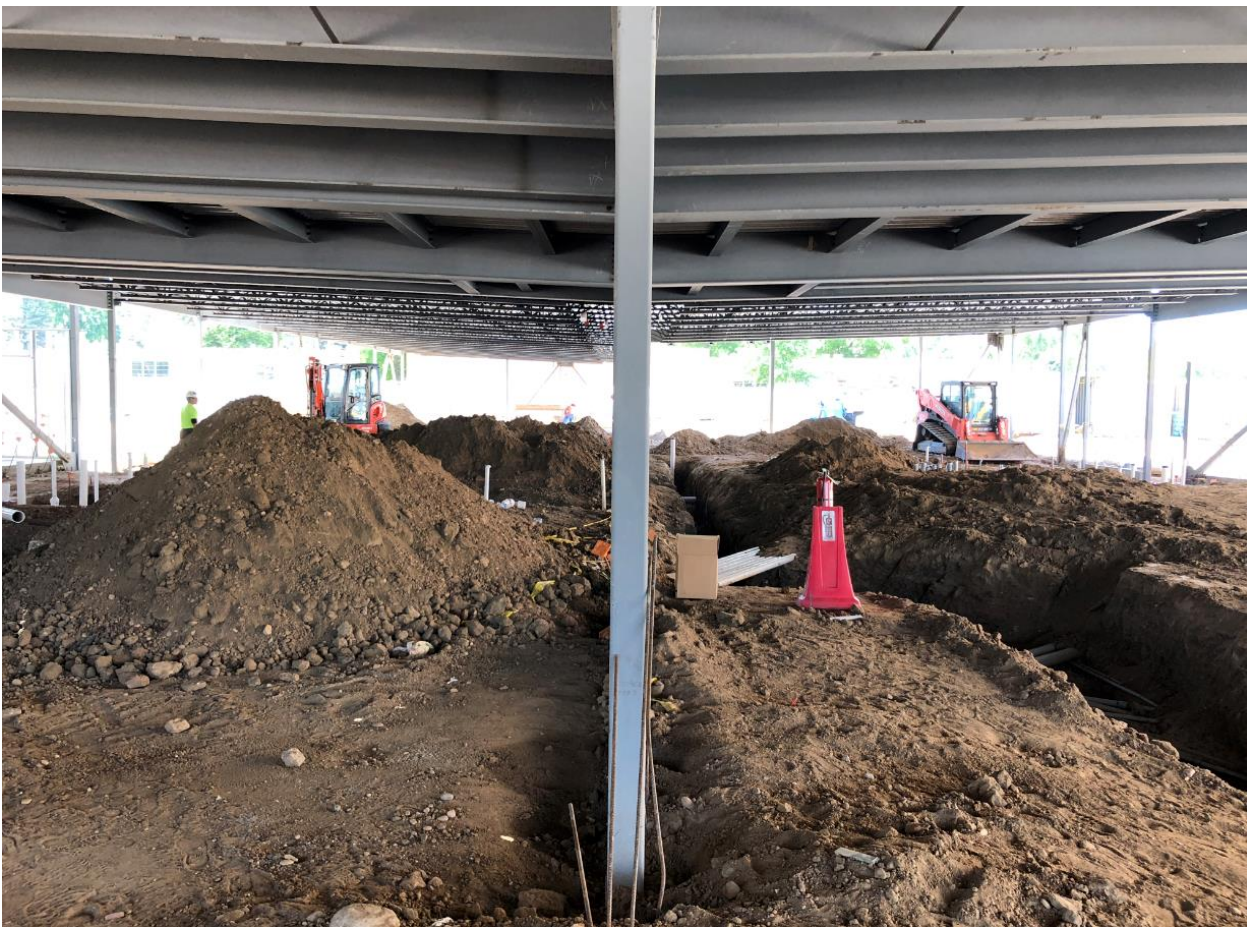
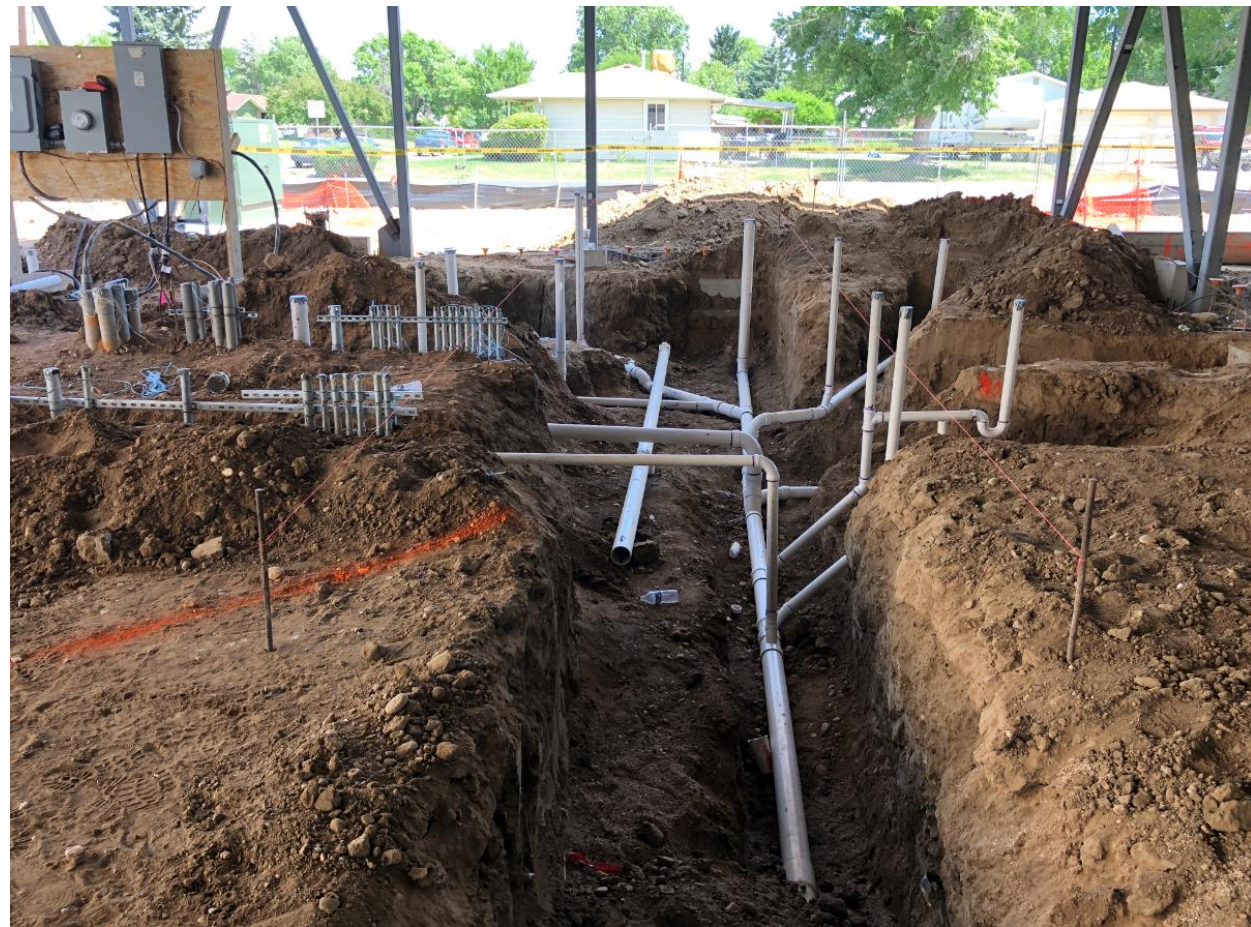
Looking North across central body. Plumbing trenches underway.
