Maddox ECE Construction Report

August 20, 2018

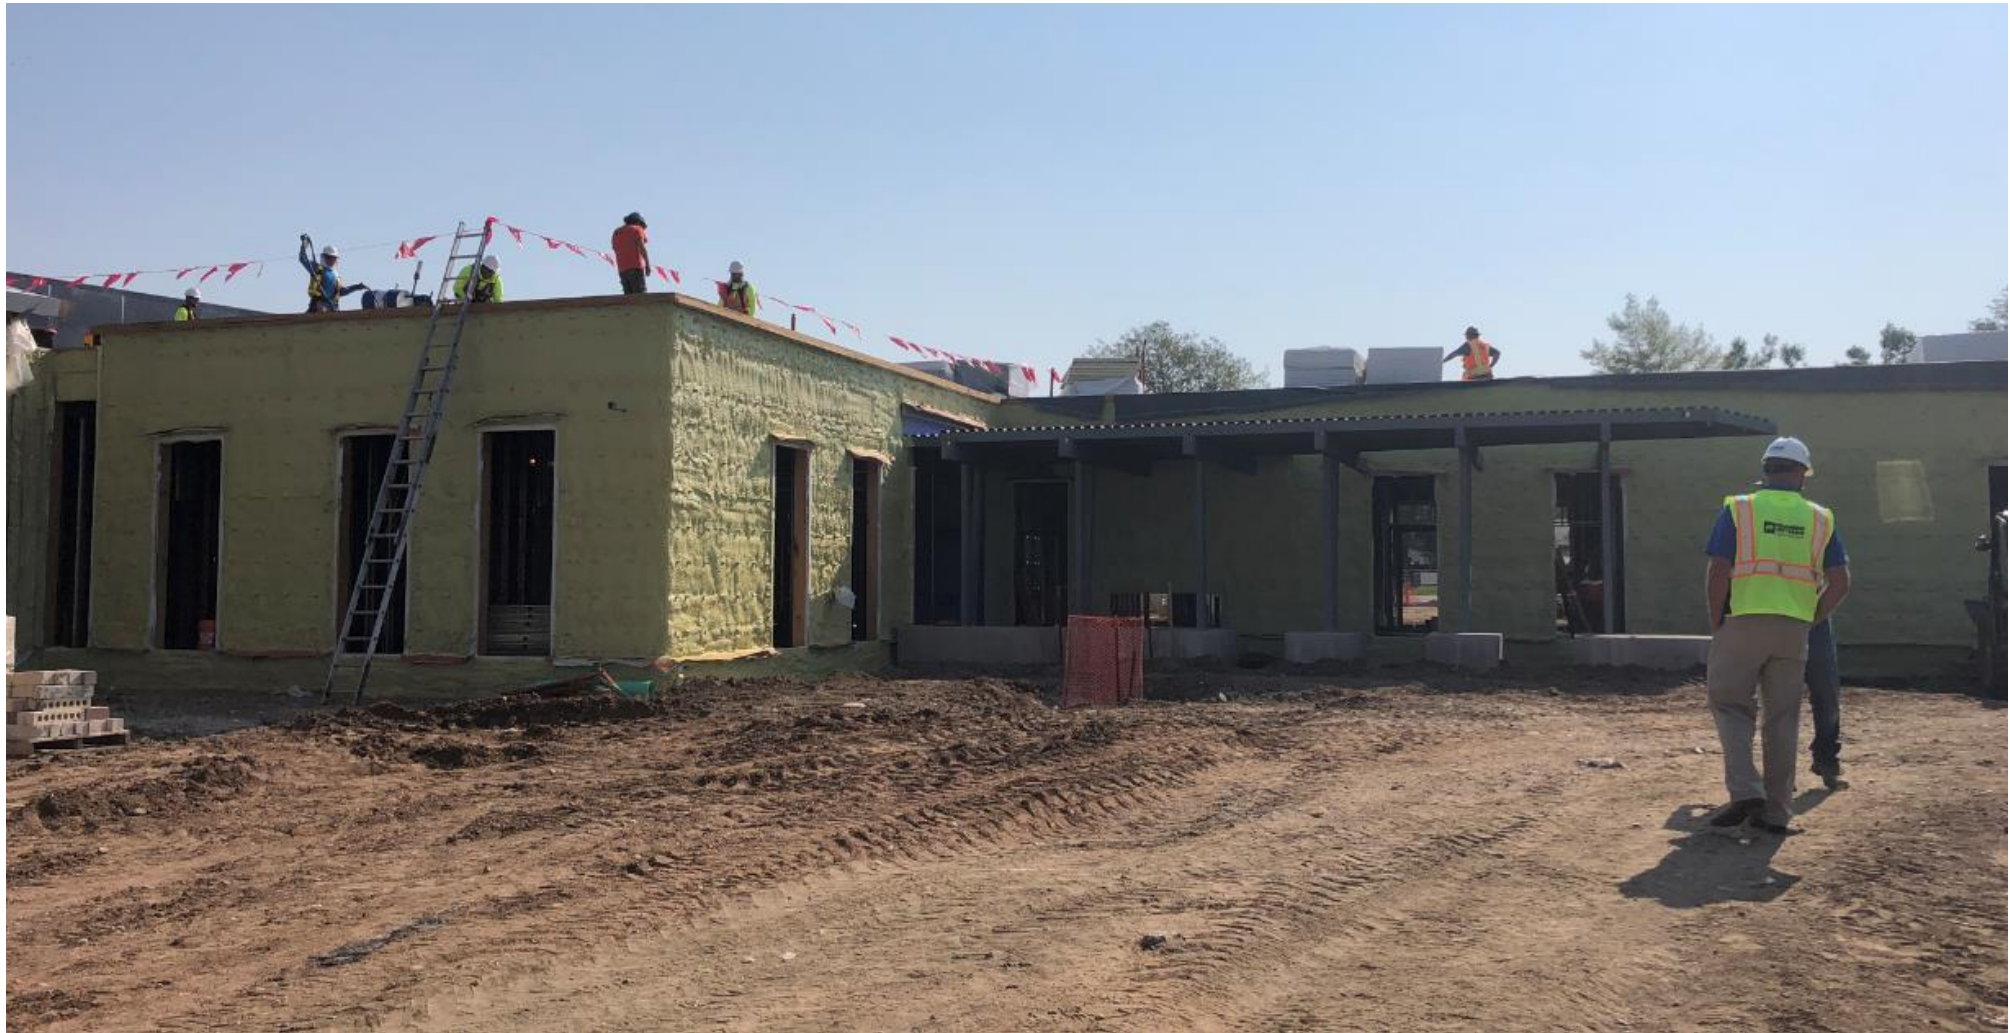
Main Entrance Area.

Soffits at Multipurpose Openings.

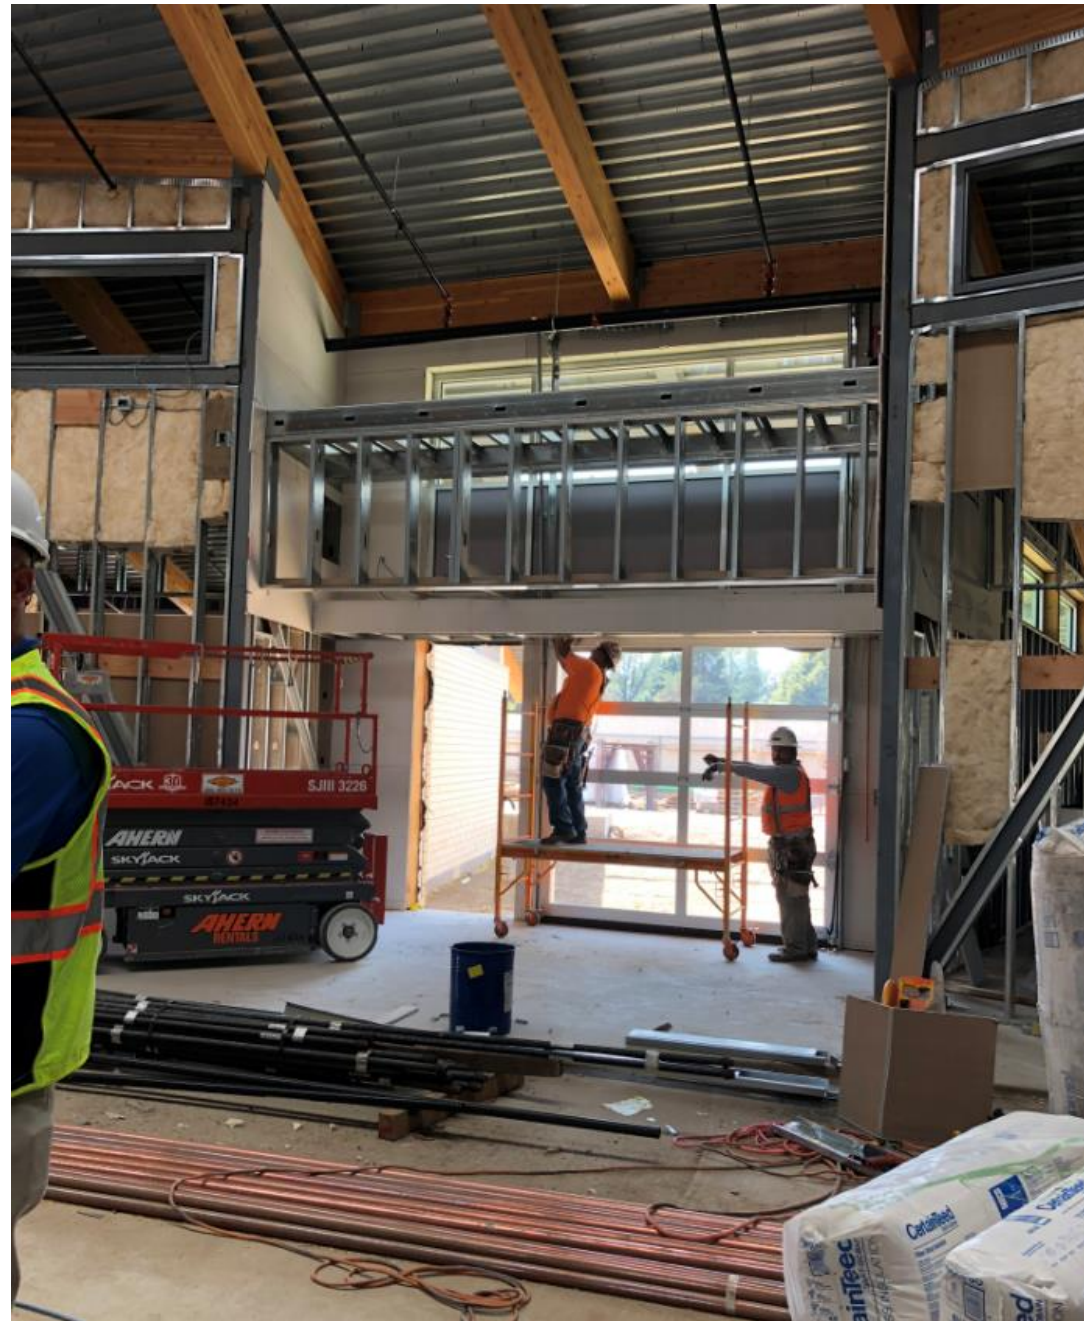
Insulation & Drywall
in East wing.
