Maddox ECE Construction Report

July 2, 2018

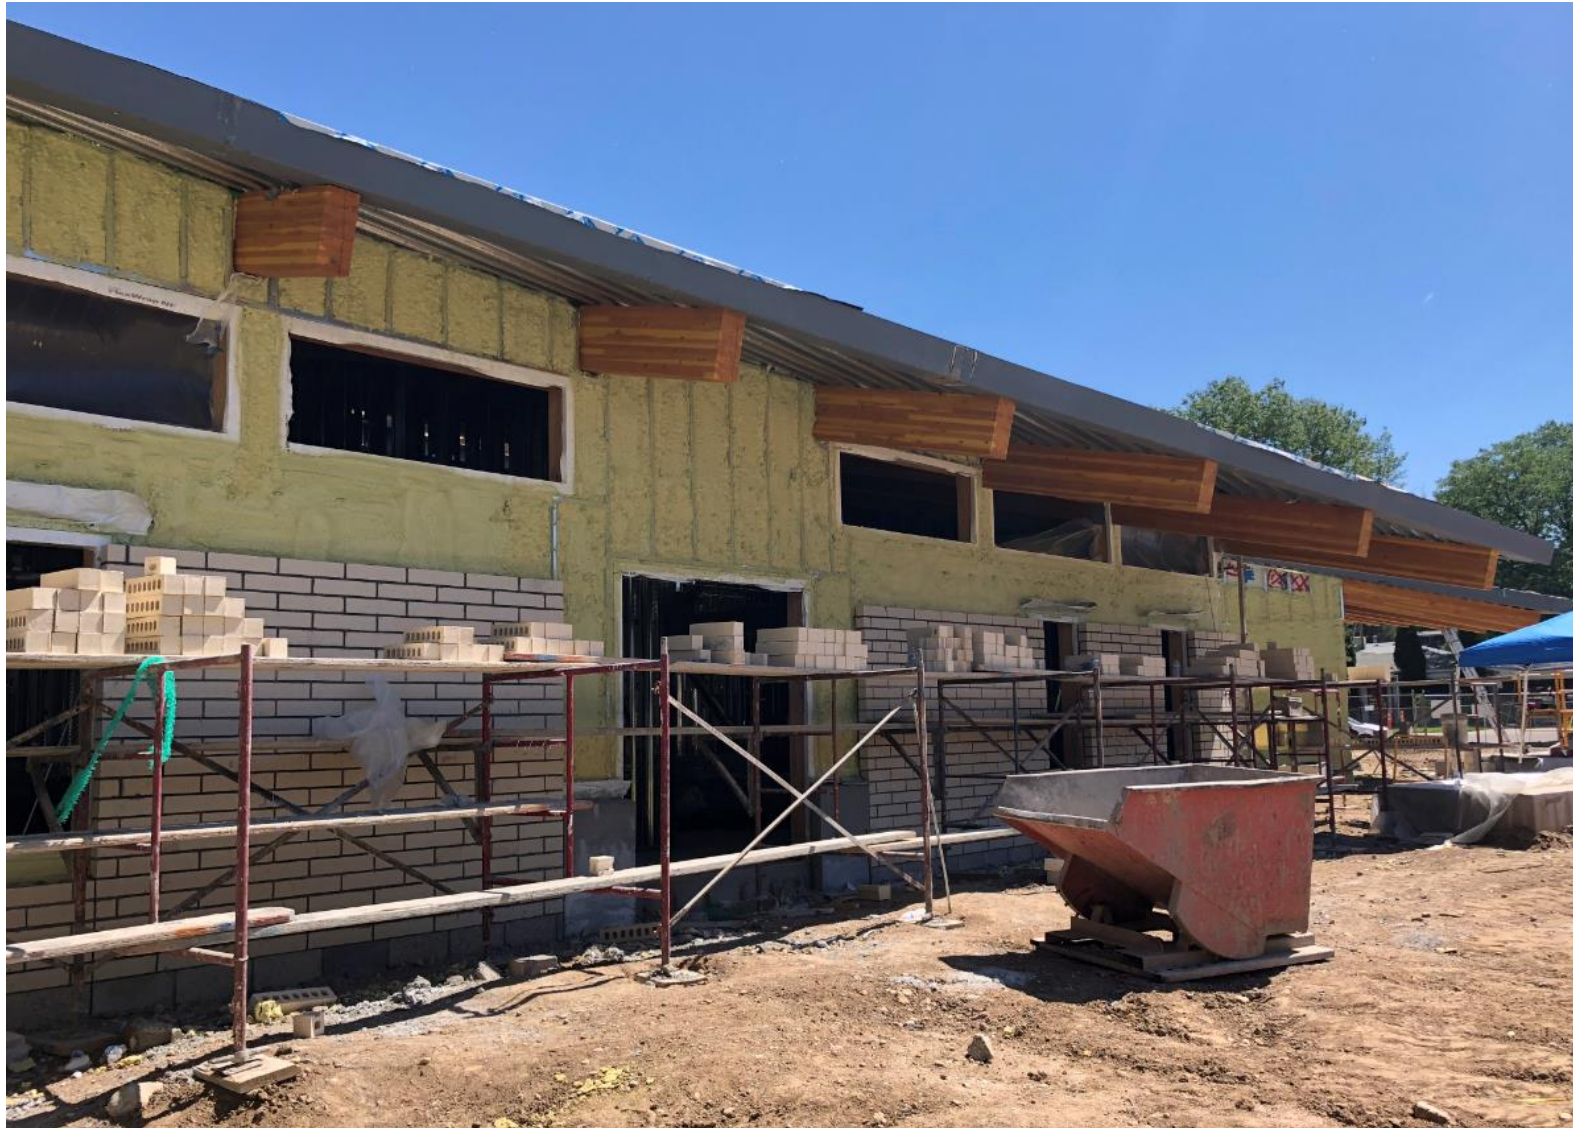
Brick being installed on East wing.

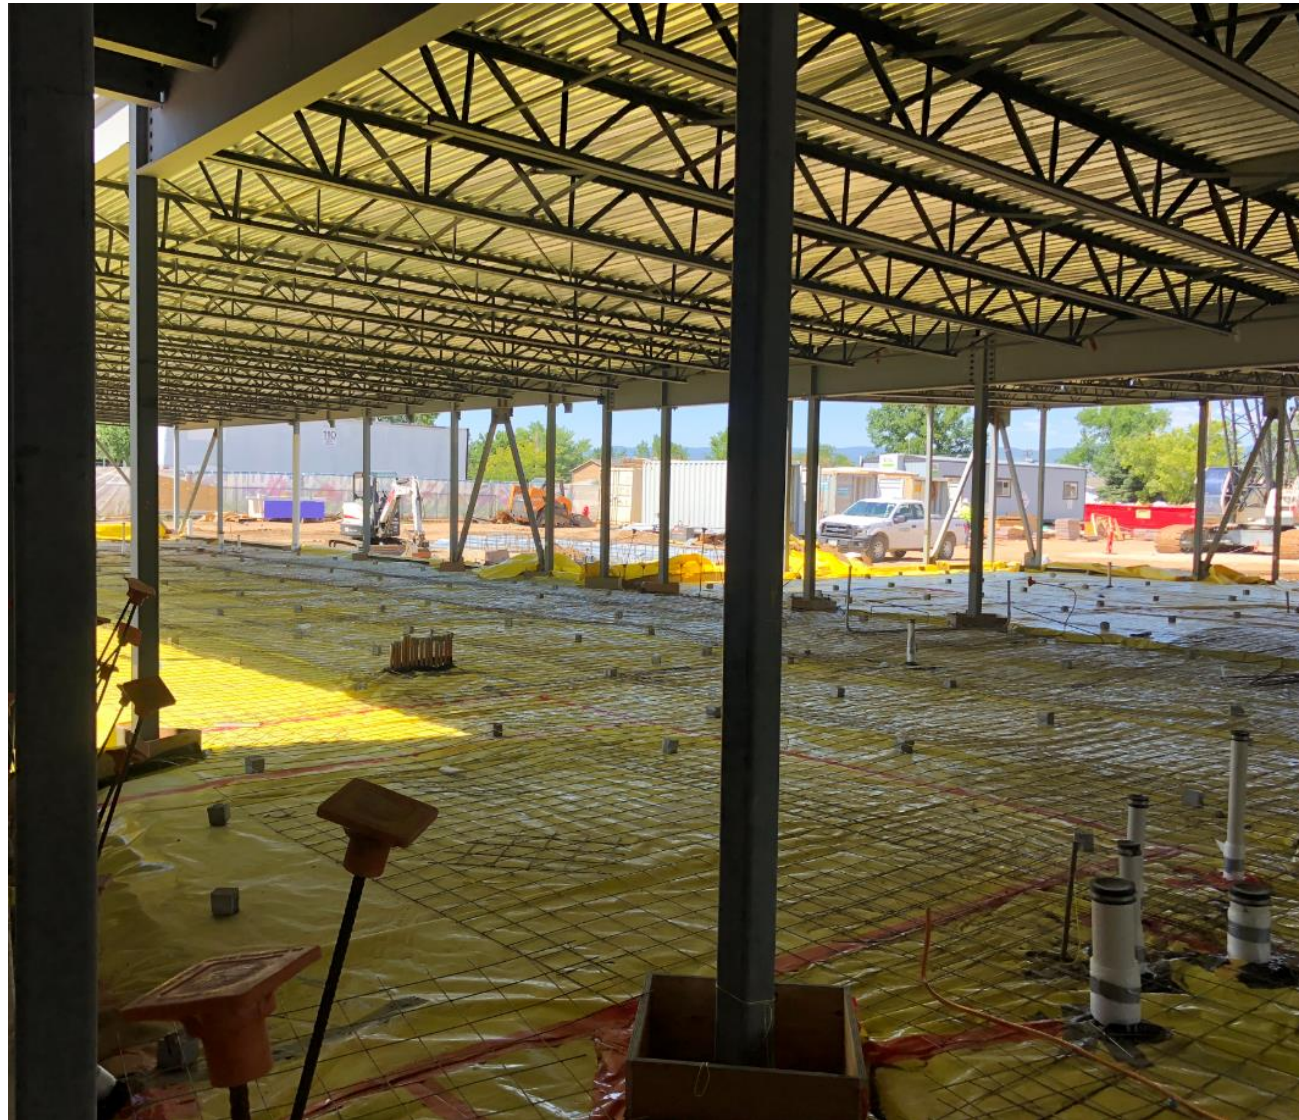
Almost ready to pour slab in Central body.
