Maddox ECE Construction Report

July 9, 2018

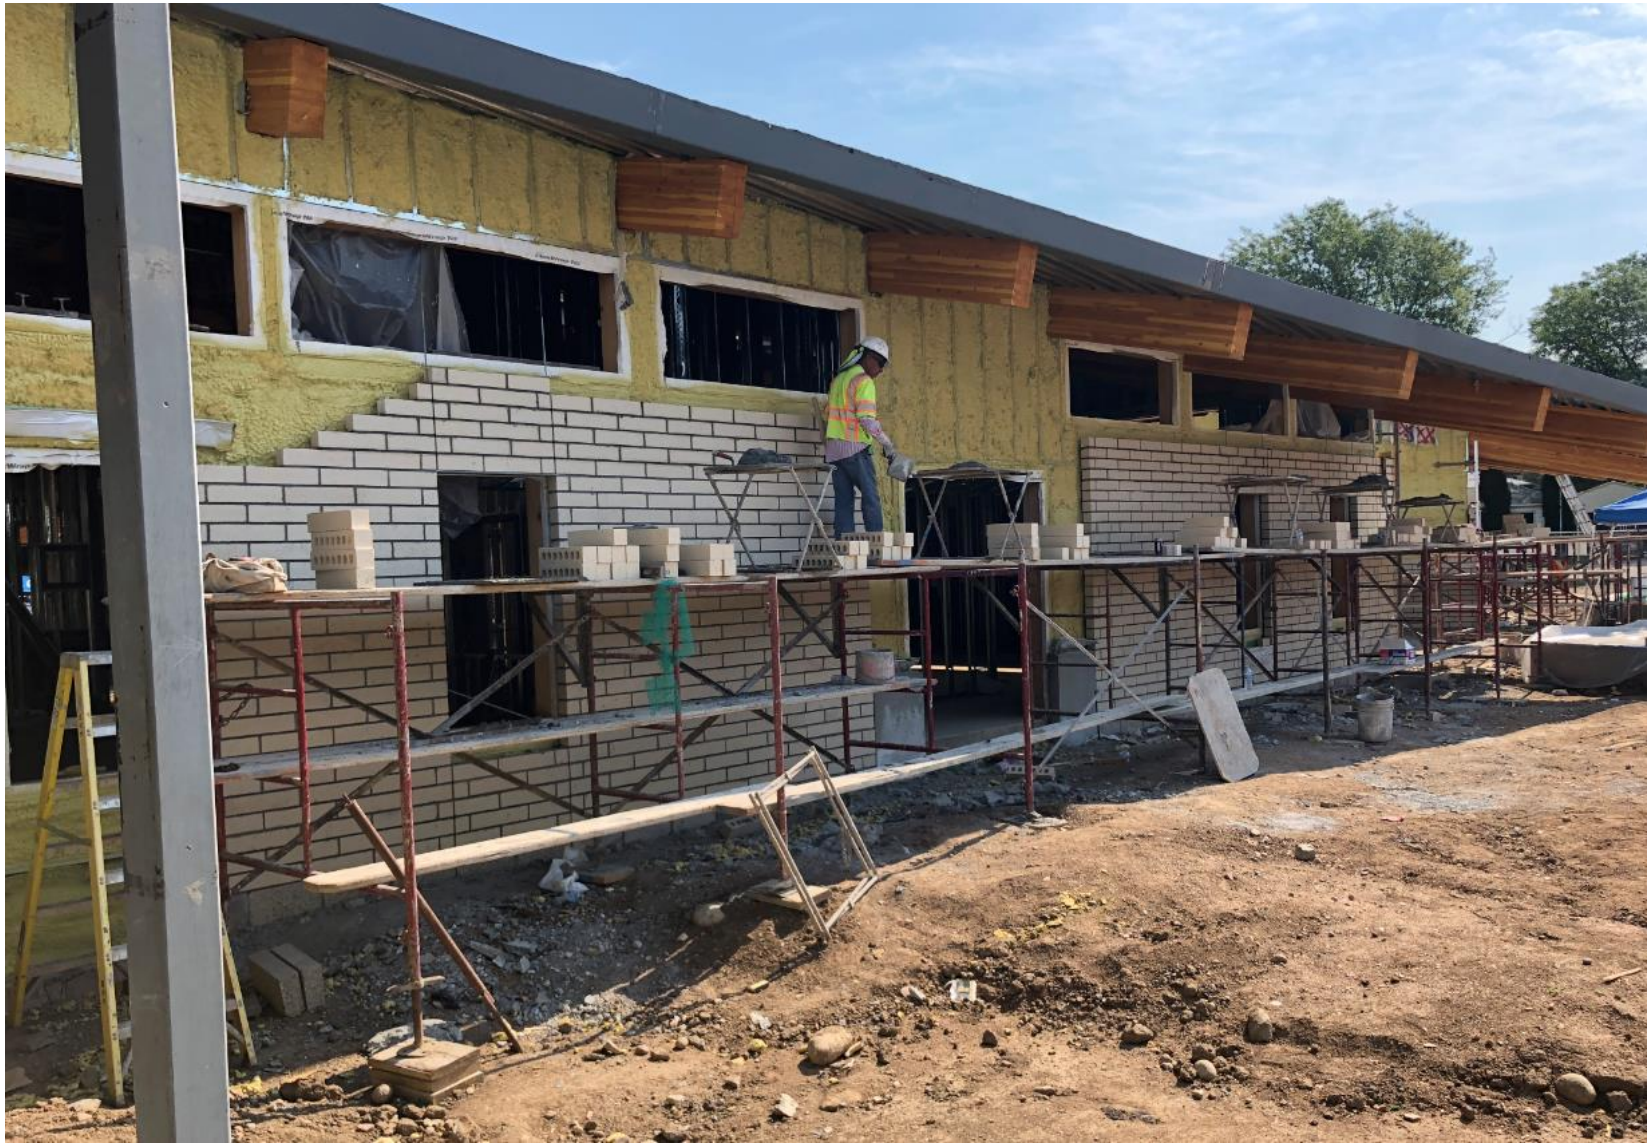
Brick being installed on East wing.

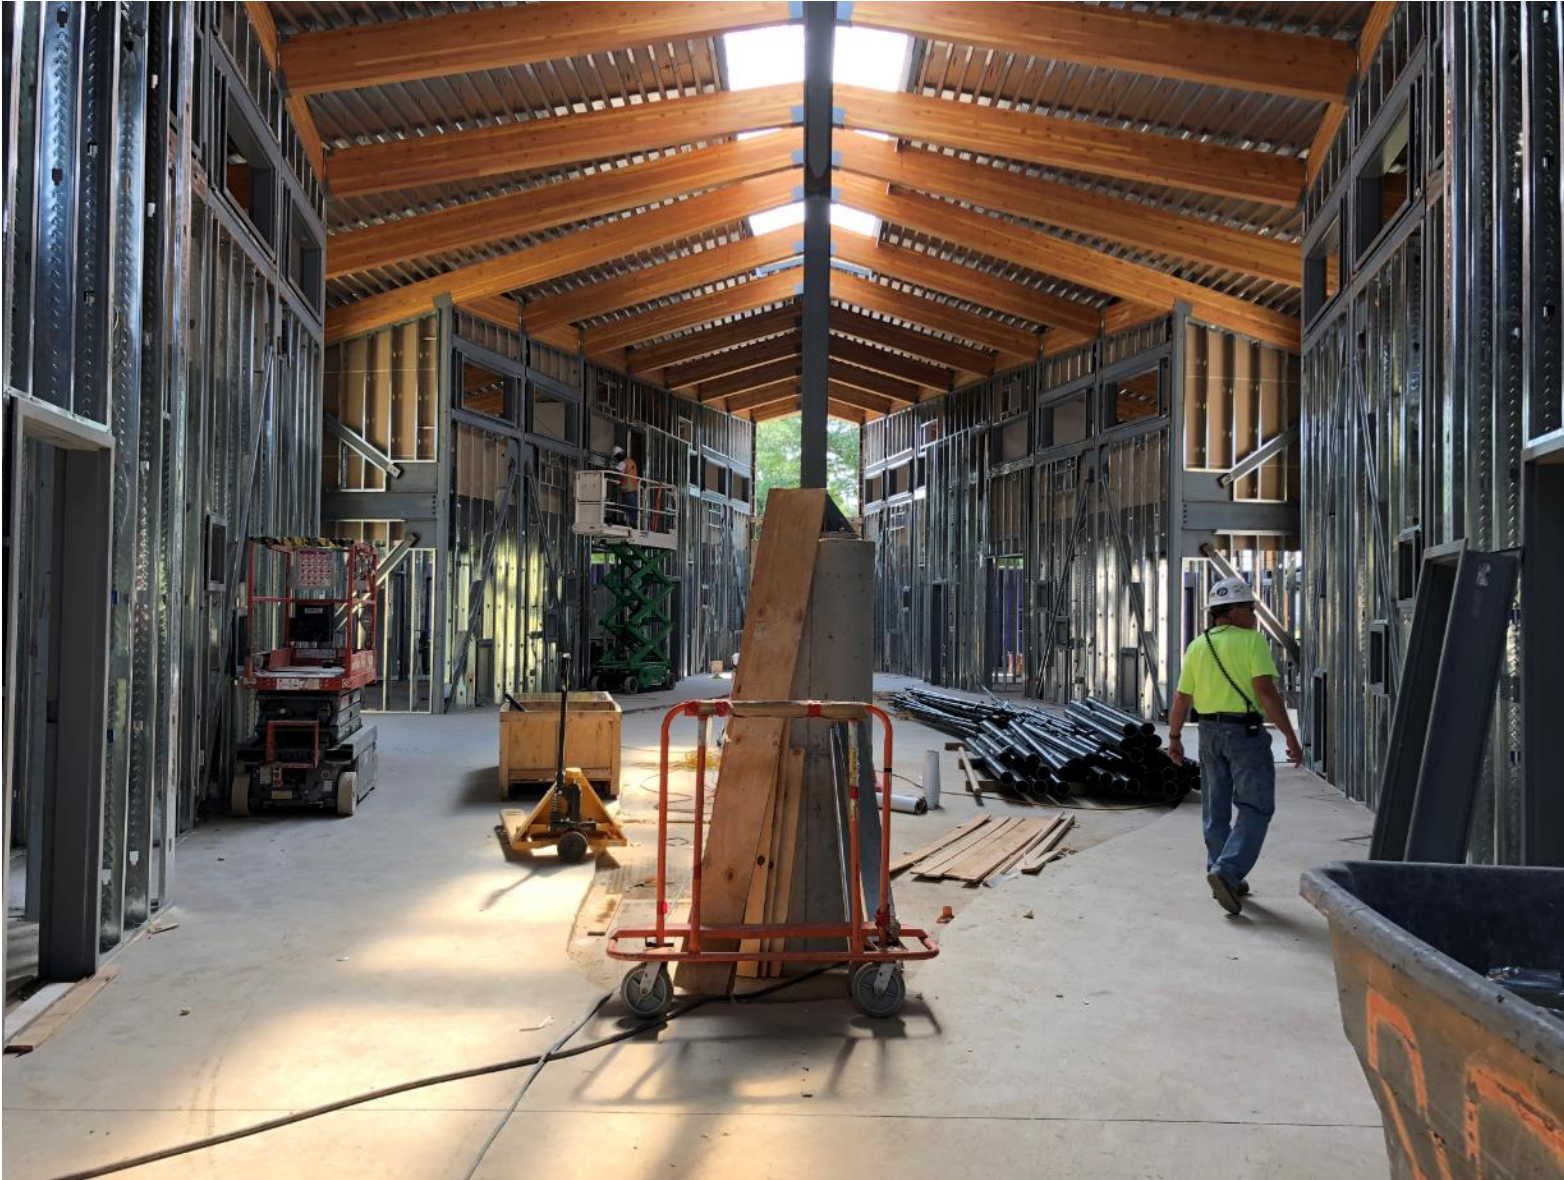
East Wing facing East.

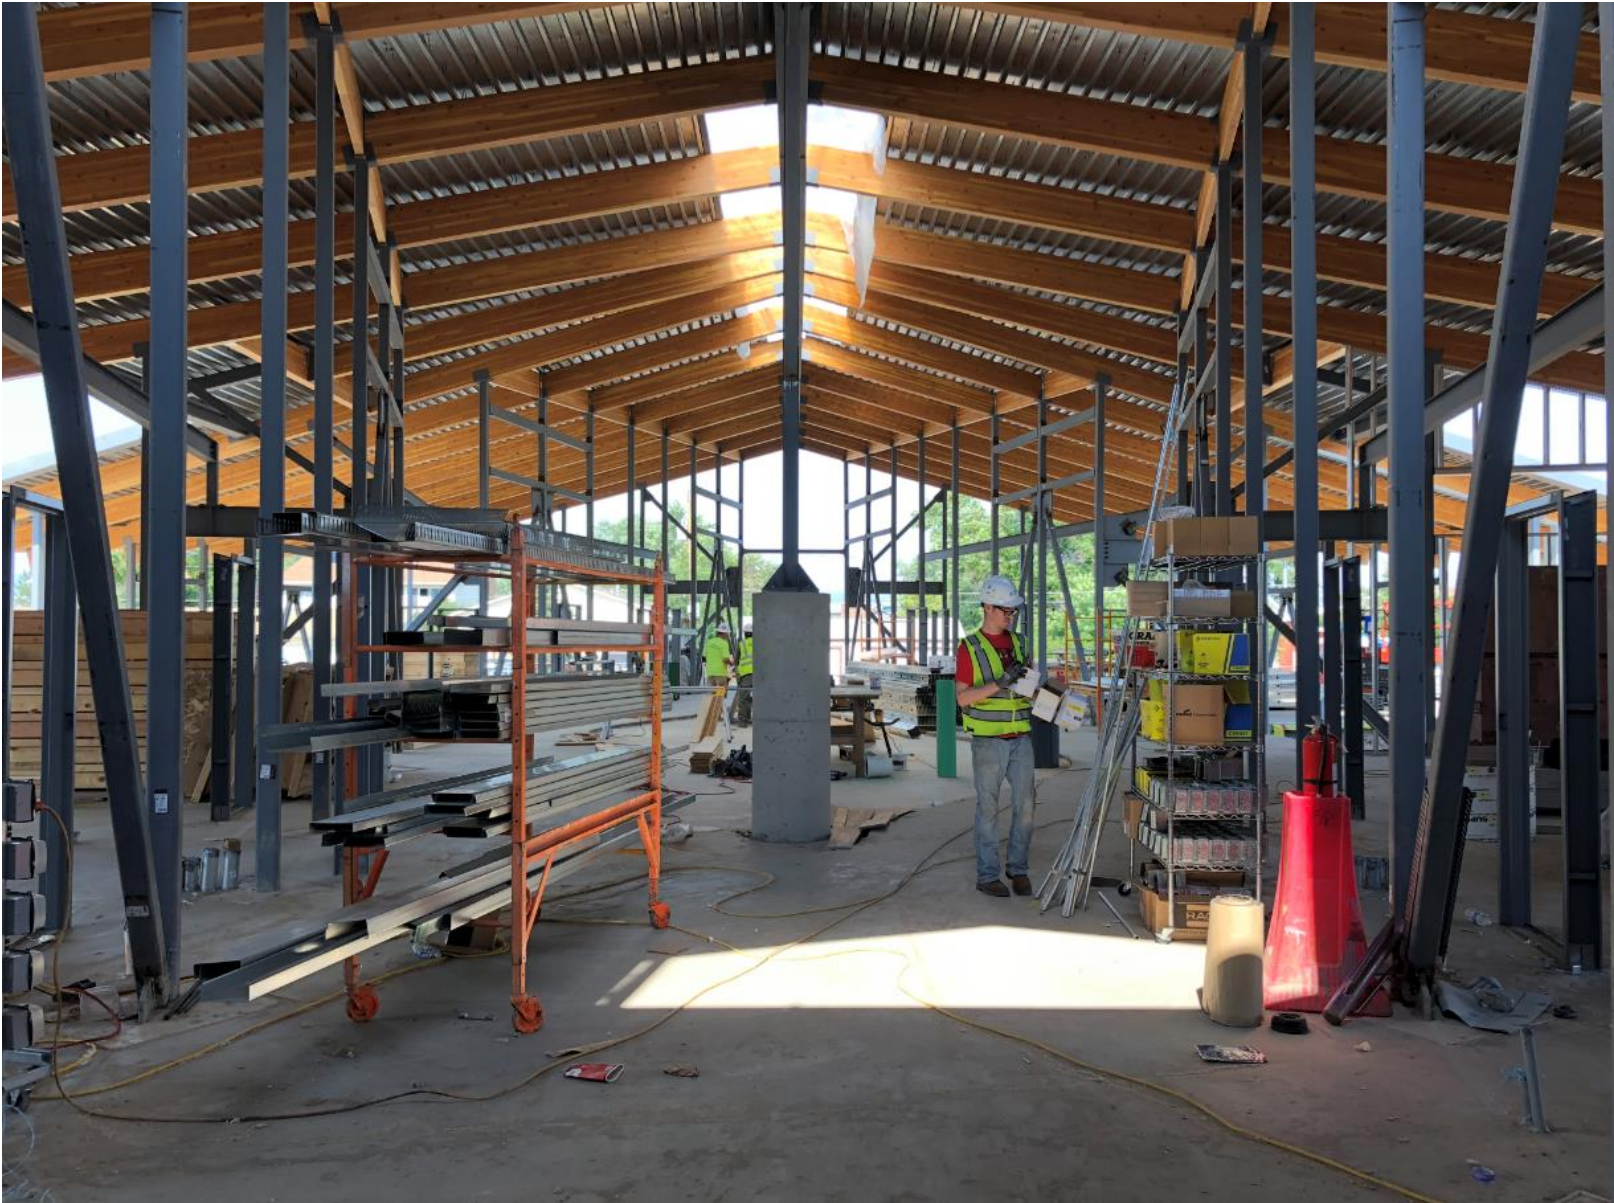
West Wing facing West.

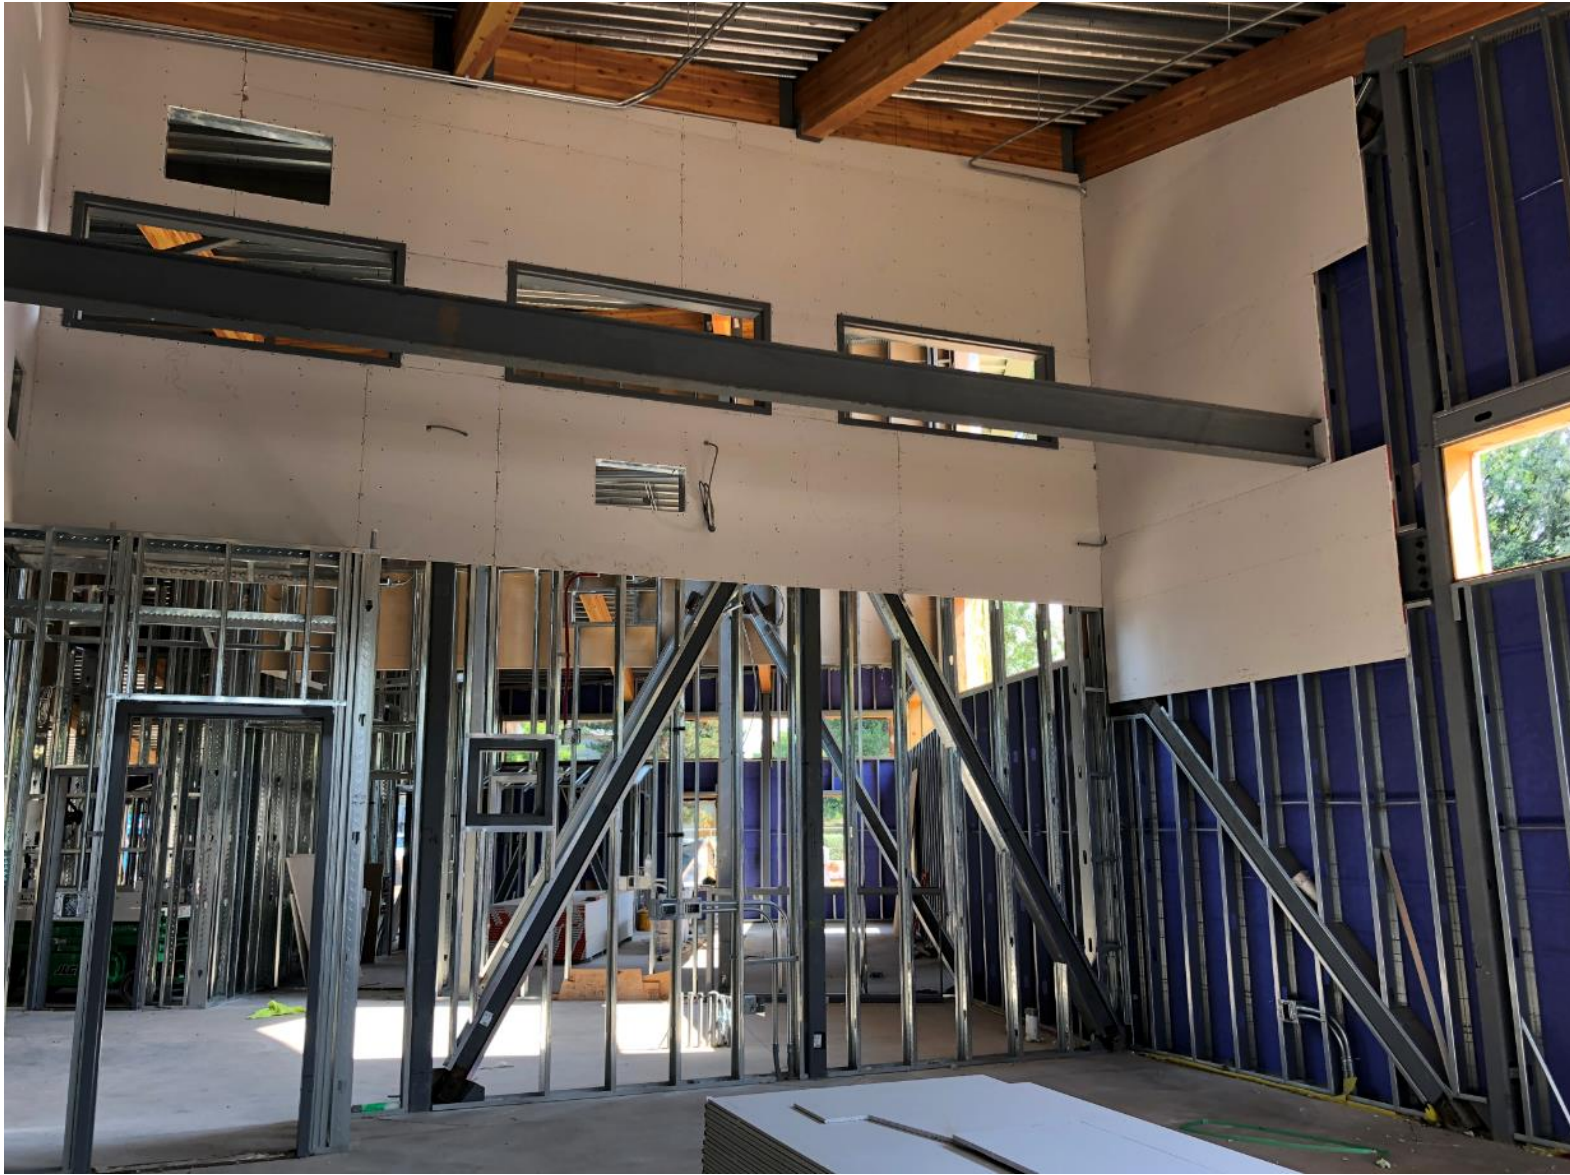
Drywall being installed in classrooms.

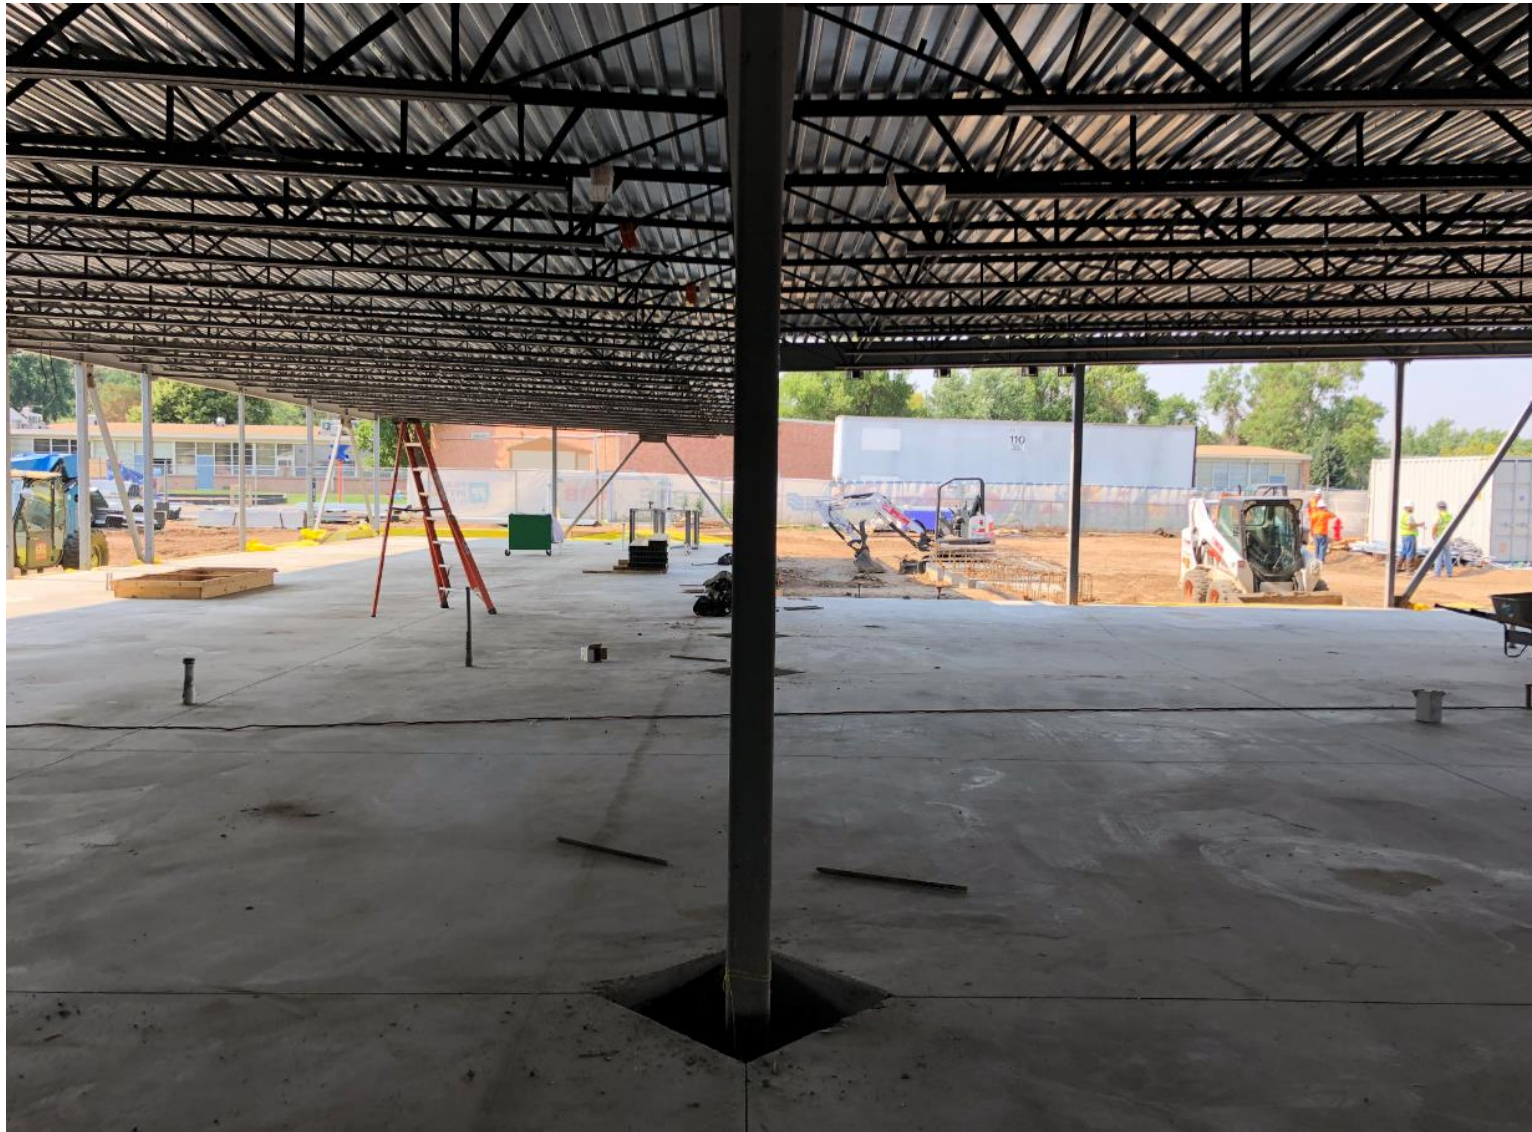
Central body looking south at main entrance. Central slab poured.

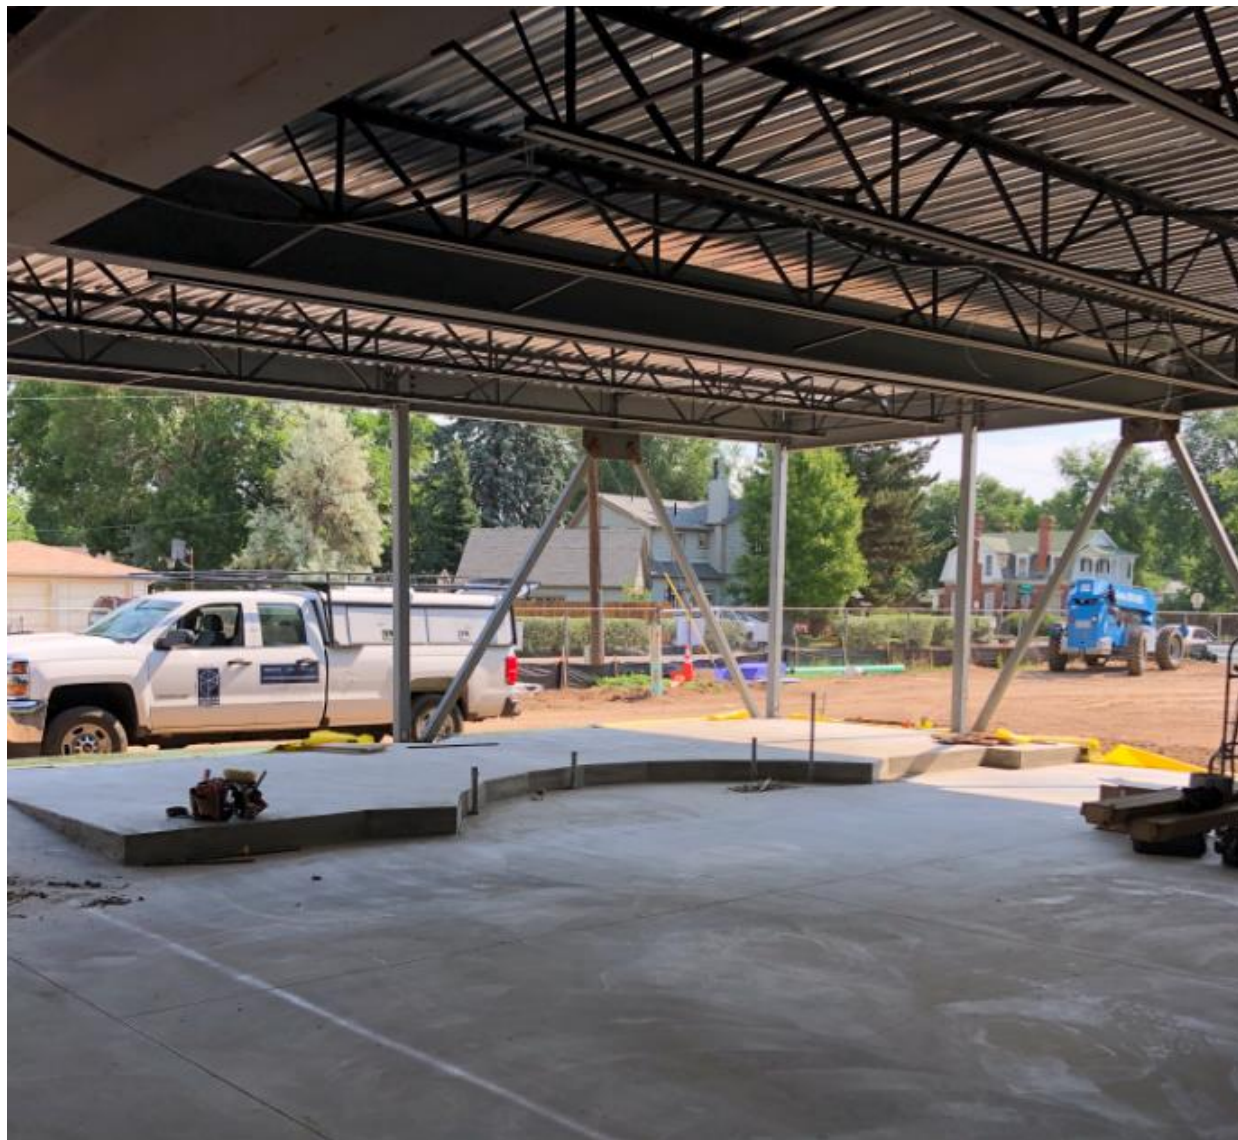
Raised platform in PD room.

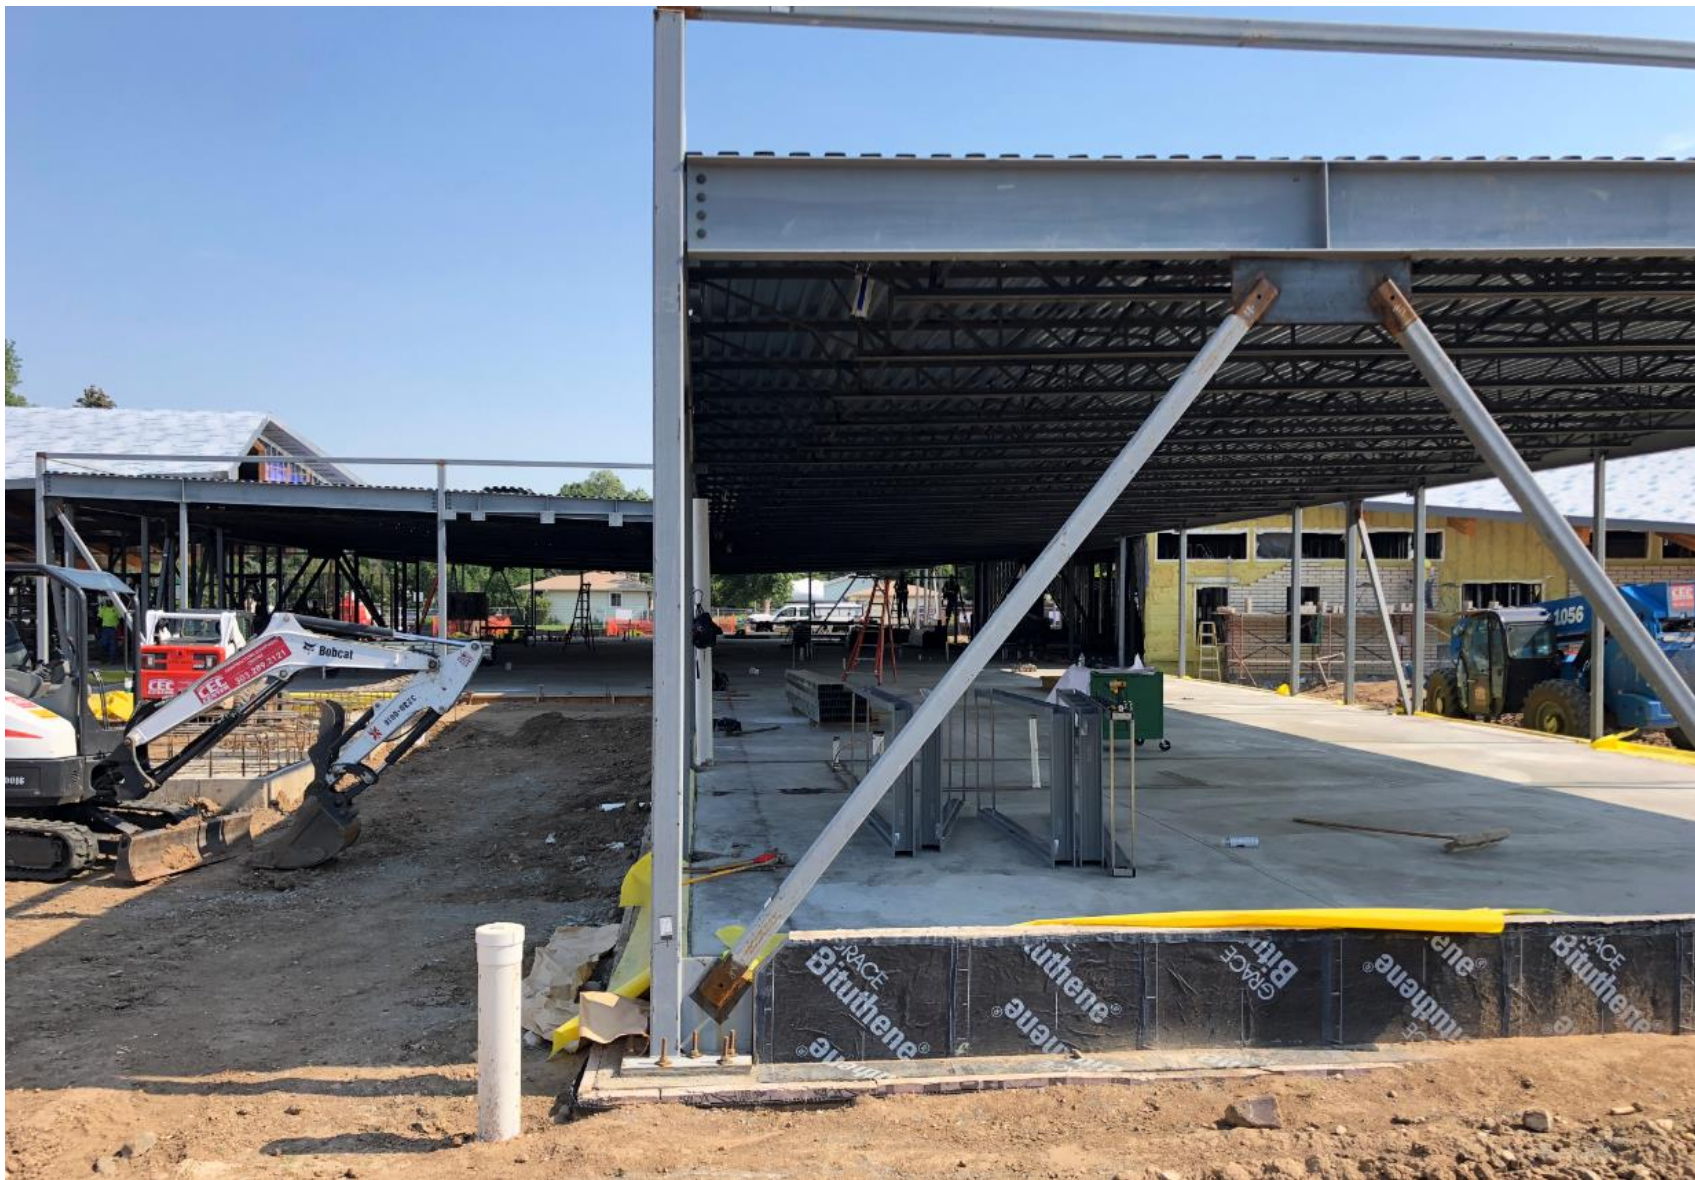
Central body, looking at main entrance area.
