Maddox ECE Construction Report

July 16, 2018

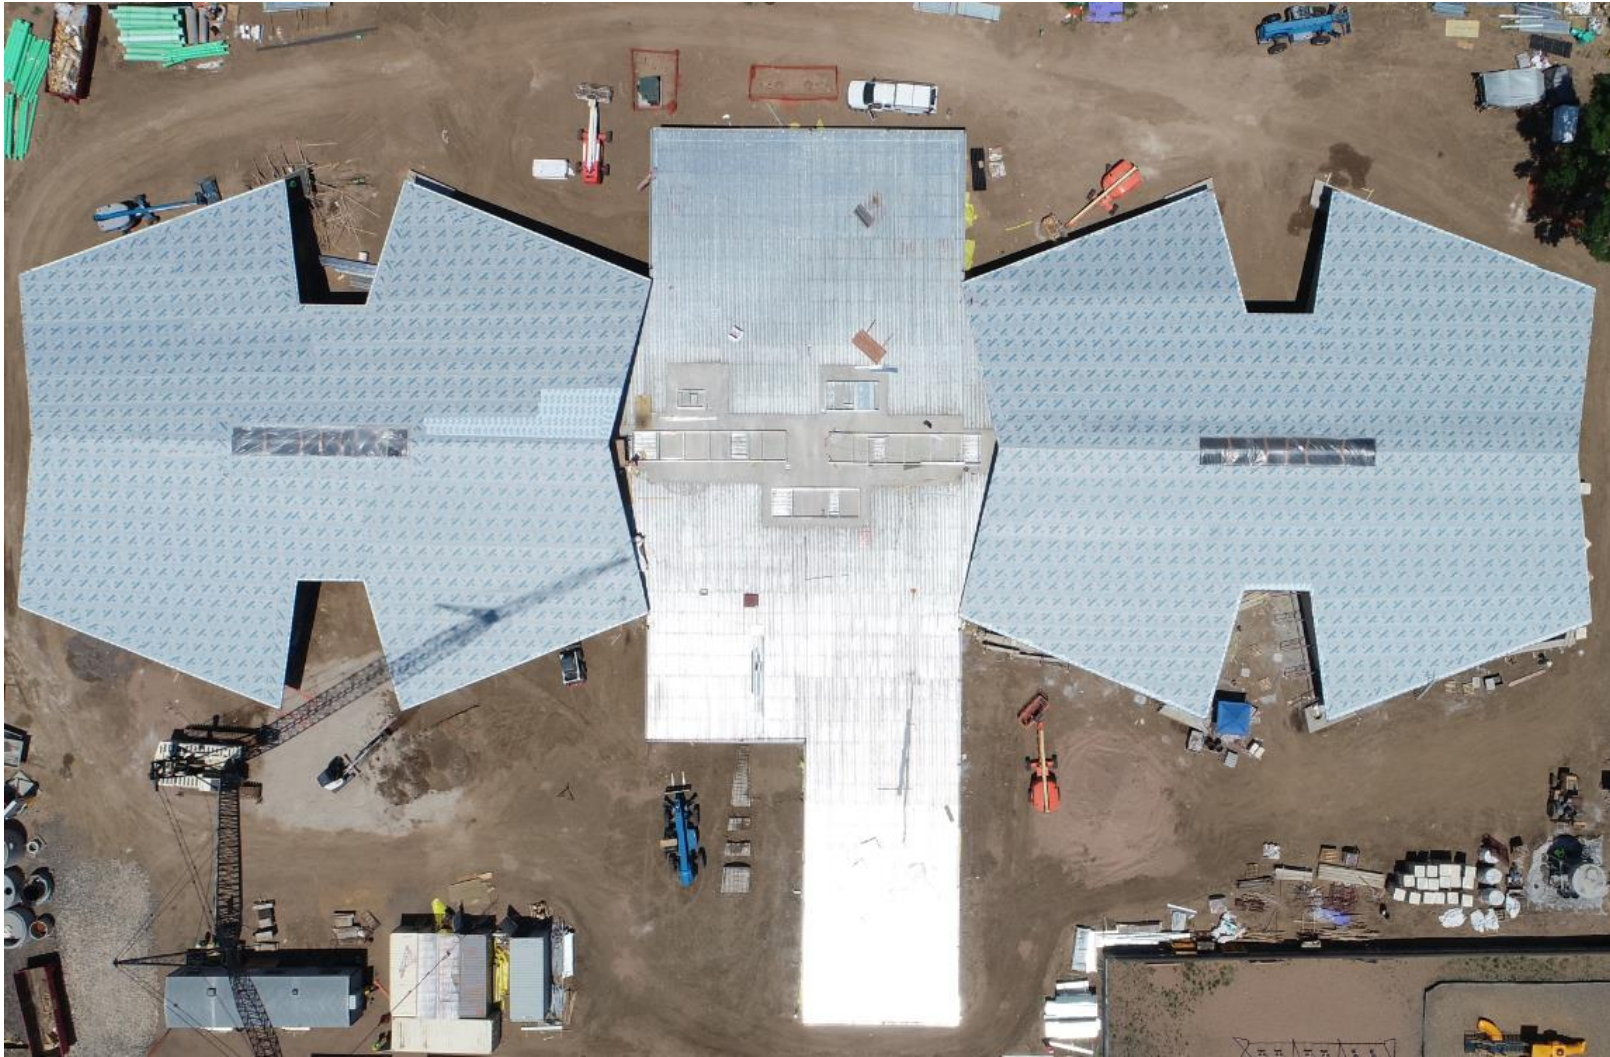
Aerial view.

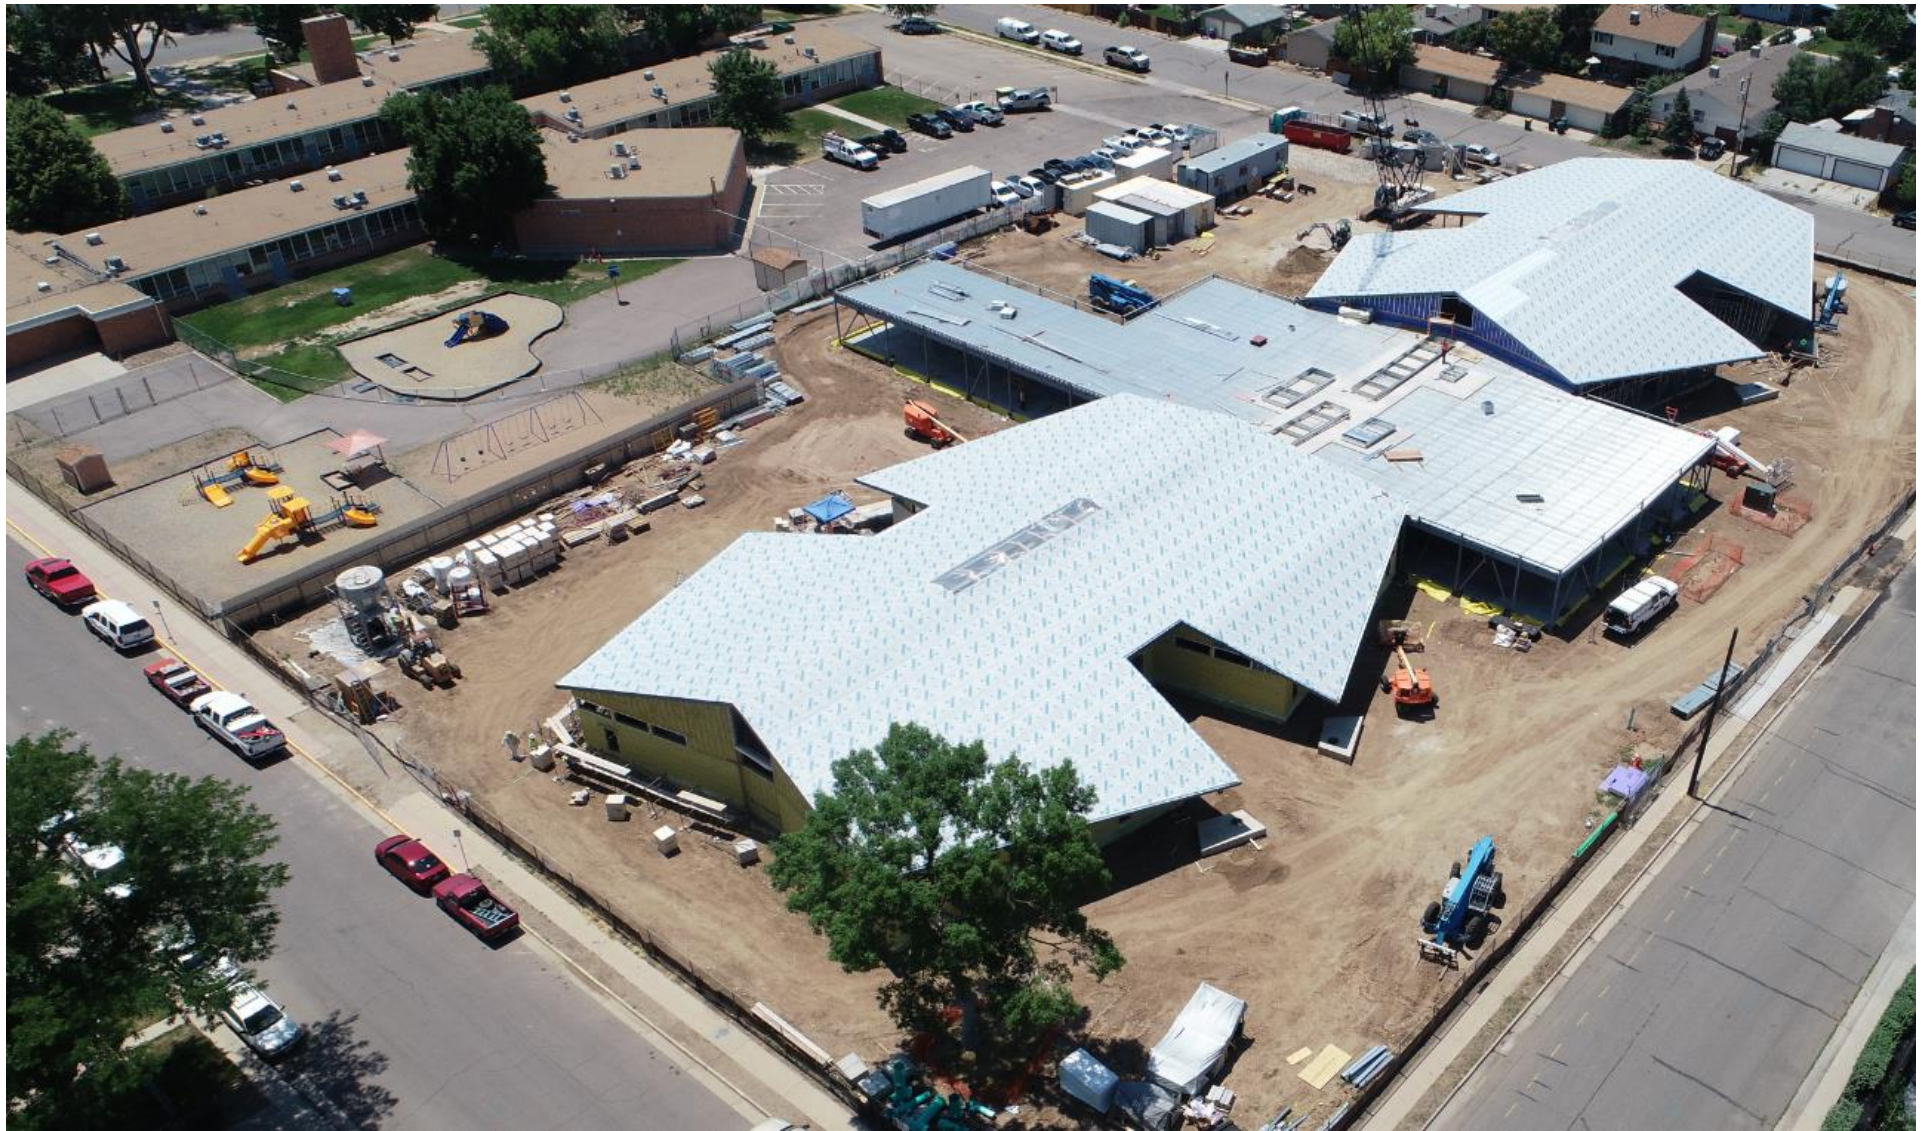
Aerial view.

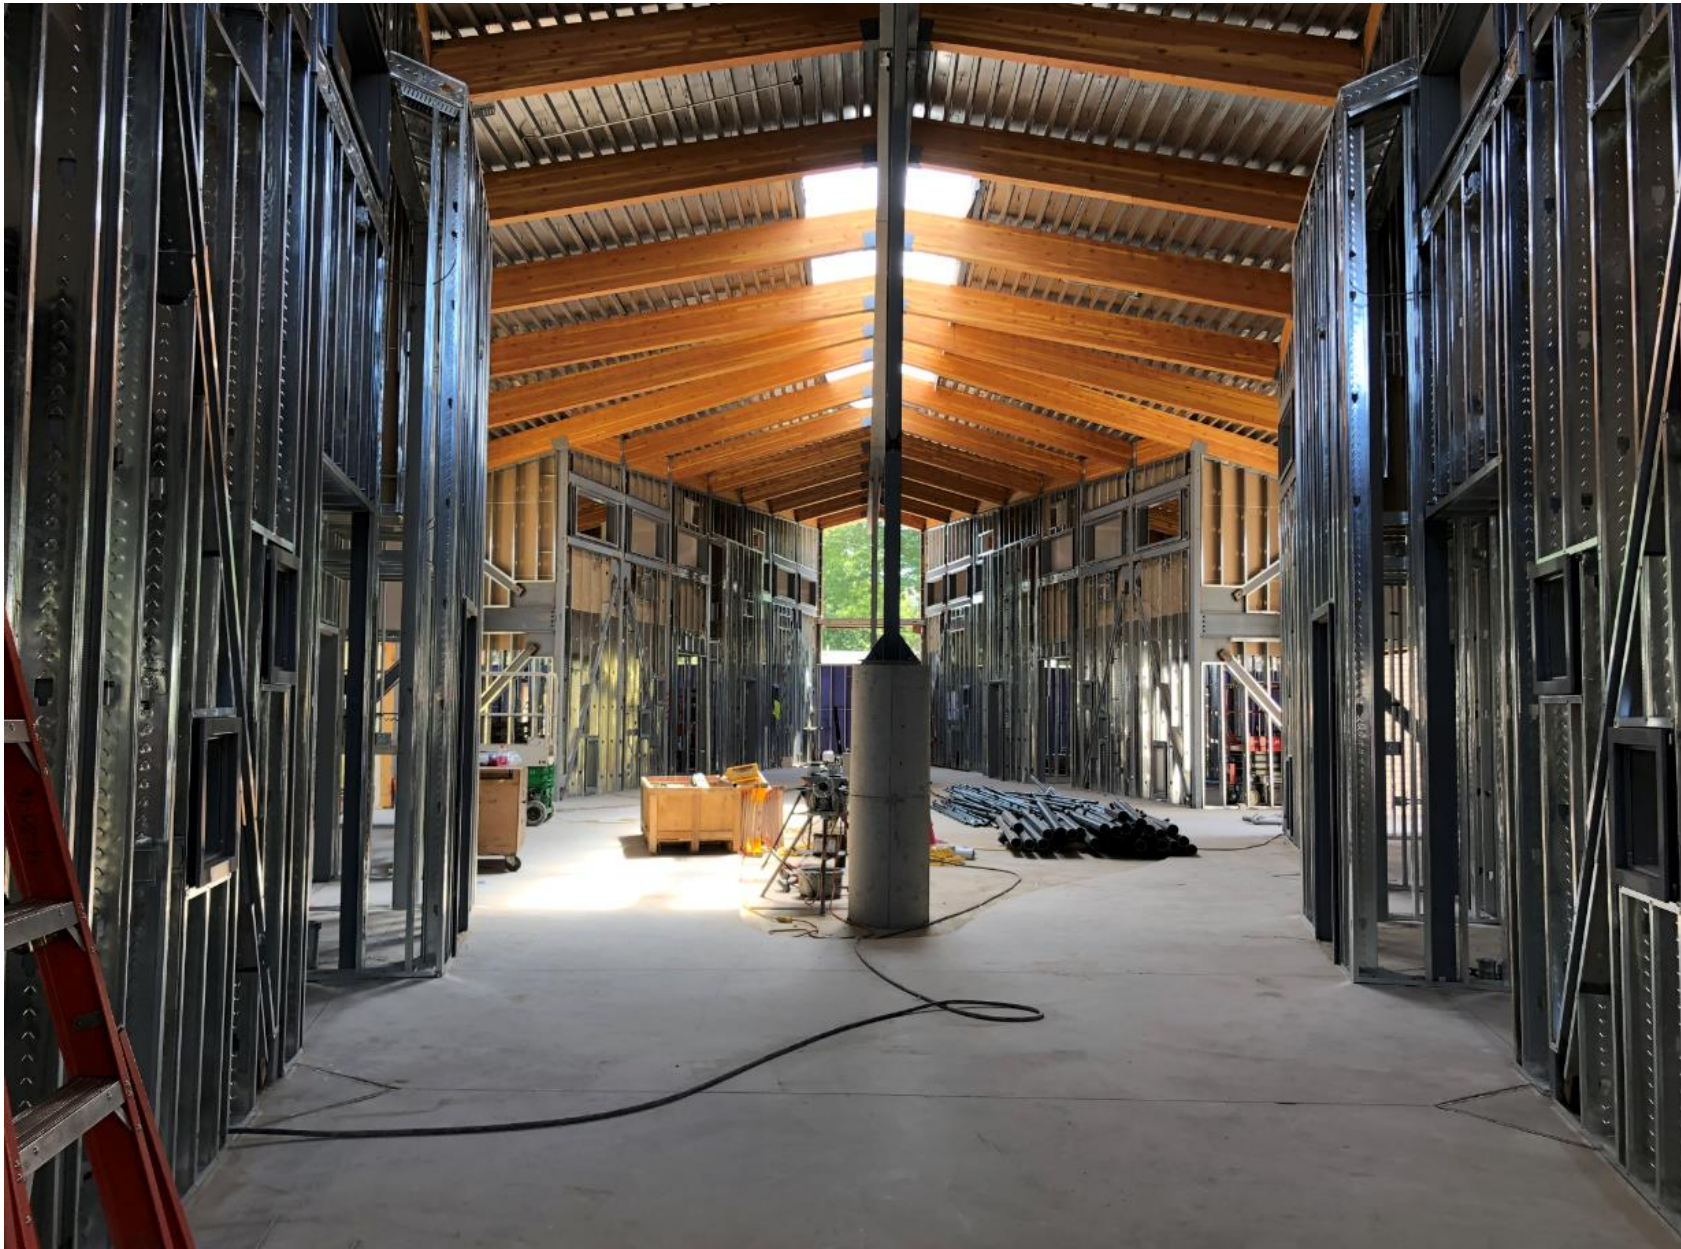
East Wing facing East.

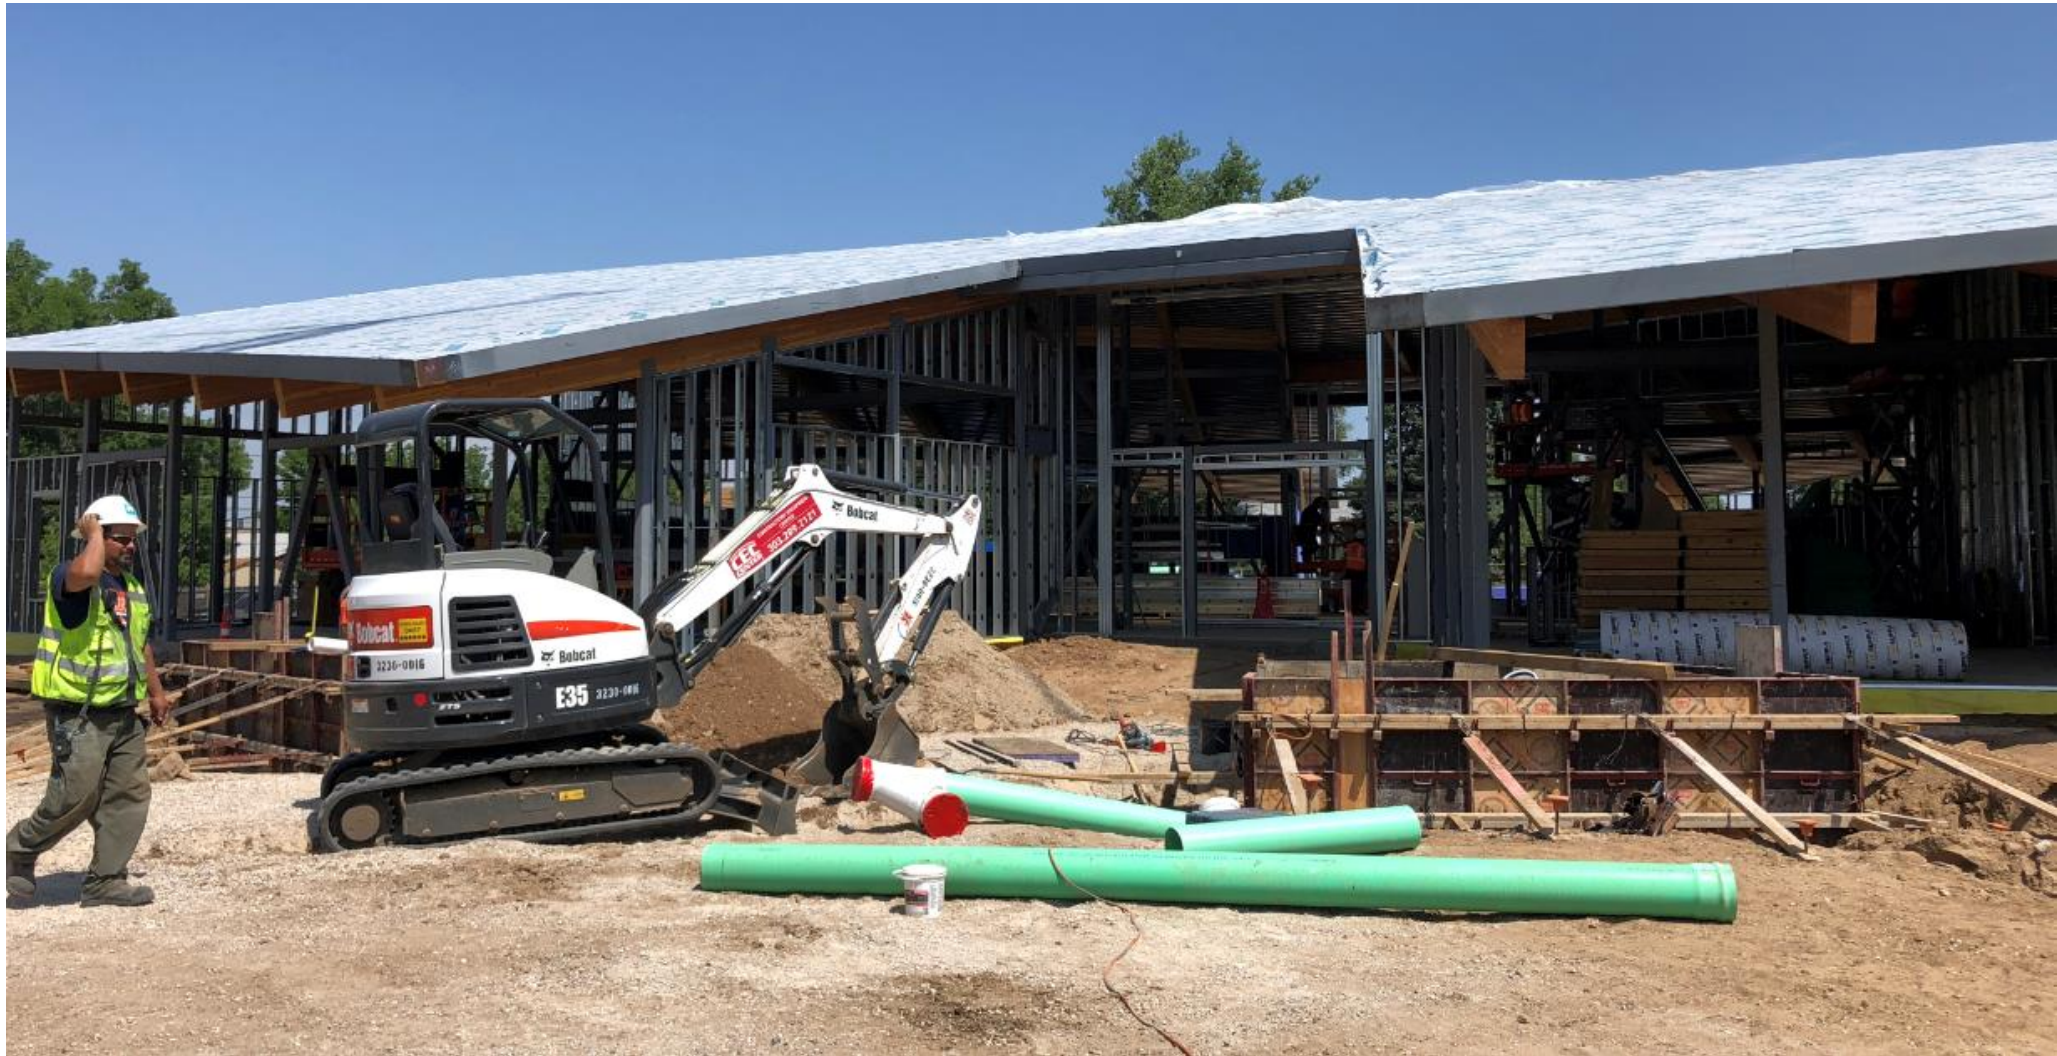
West Wing facing North.

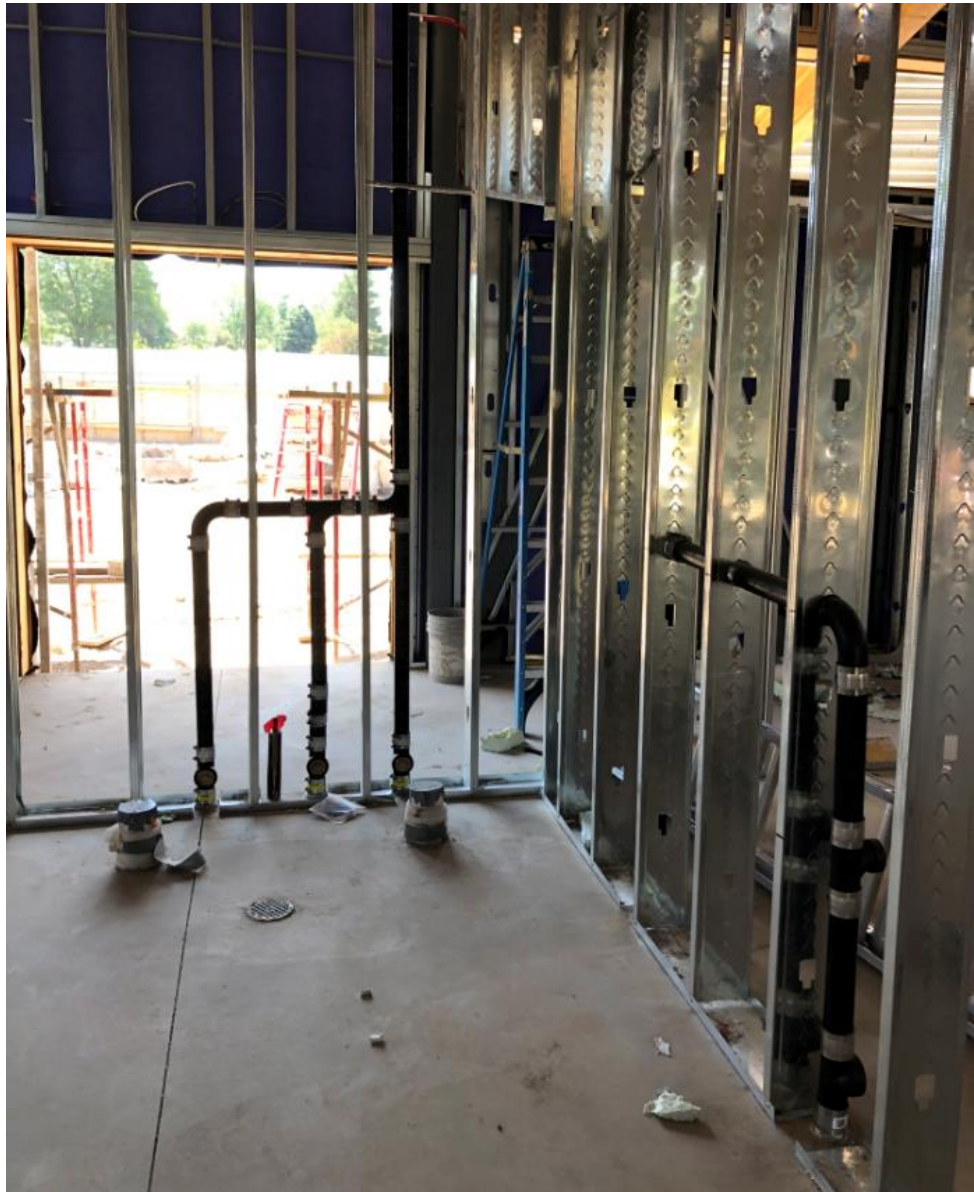
Plumbing installed in bathrooms.

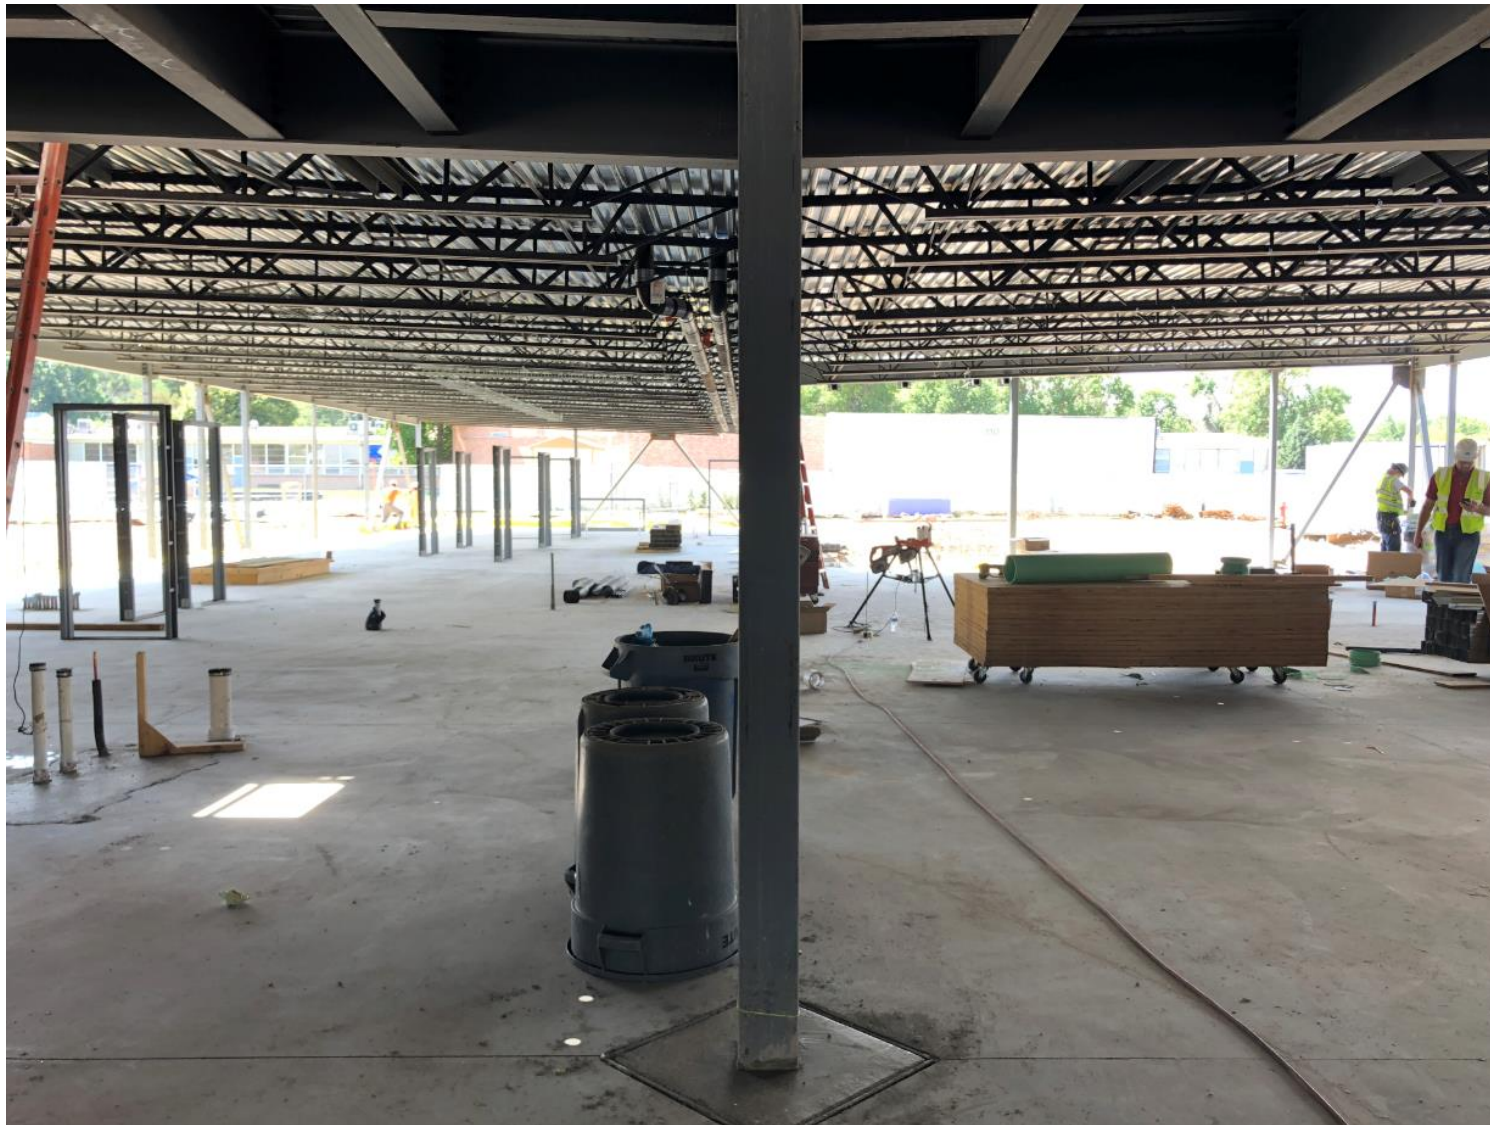
Central body looking south at main entrance.

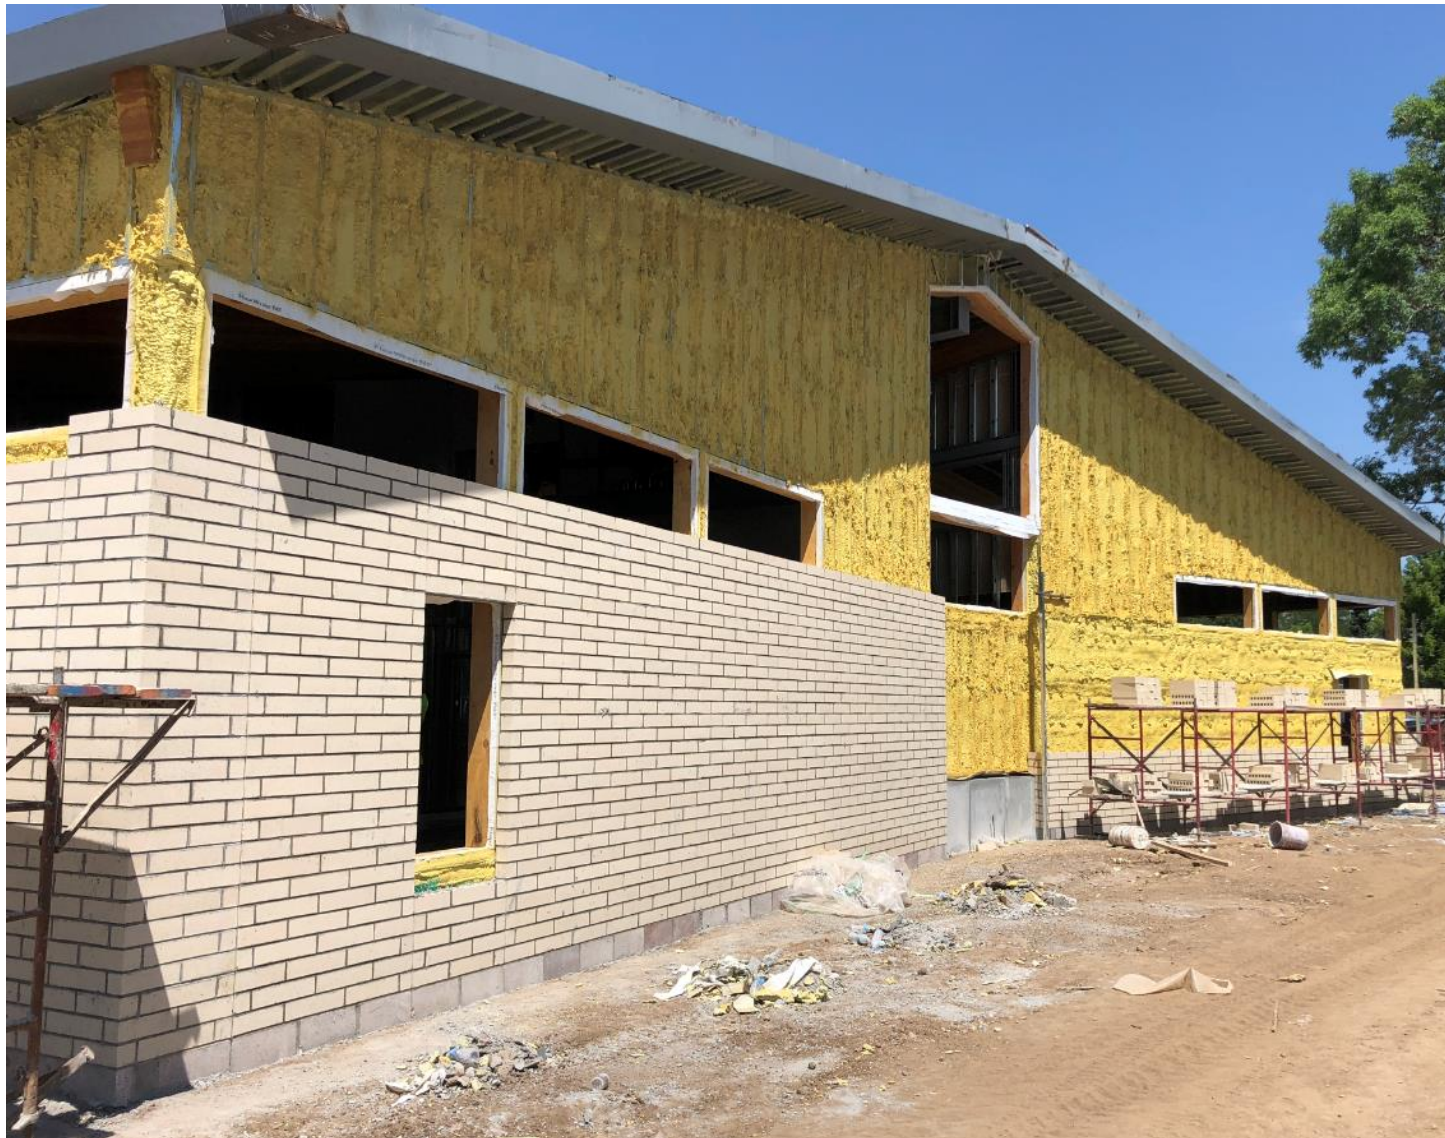
Brick installation on East wing.

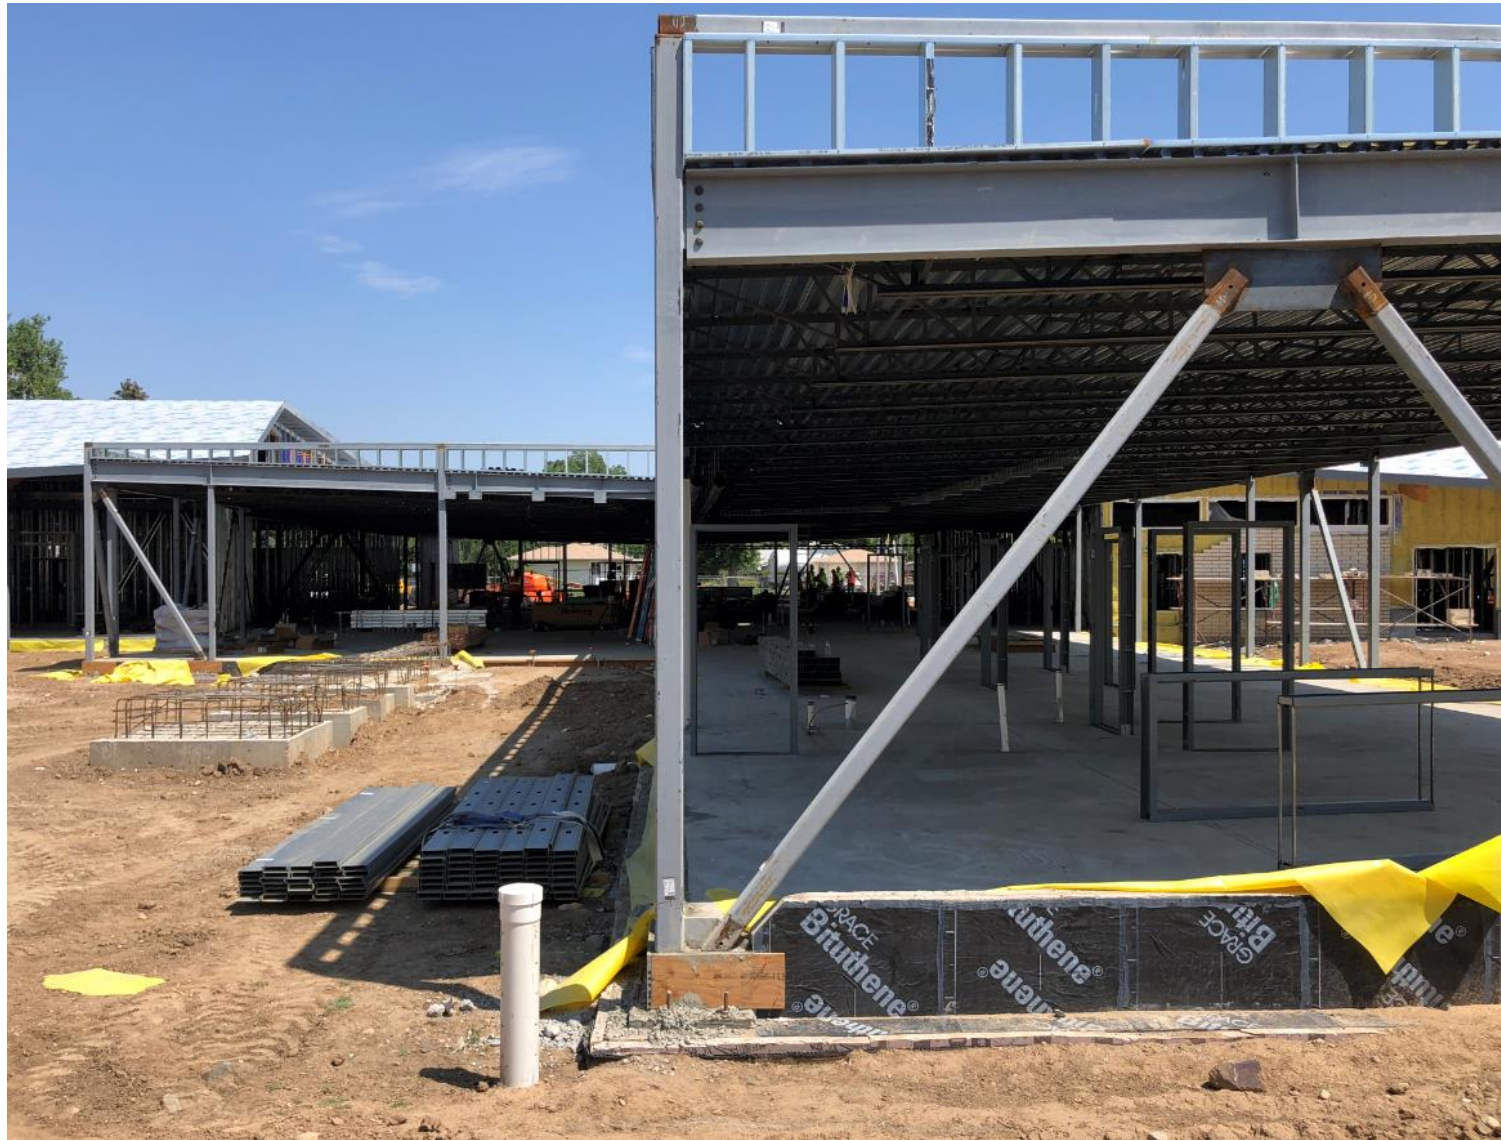
Central body, looking at main entrance area. Door frames installed.
