Maddox ECE Construction Report

July 30, 2018

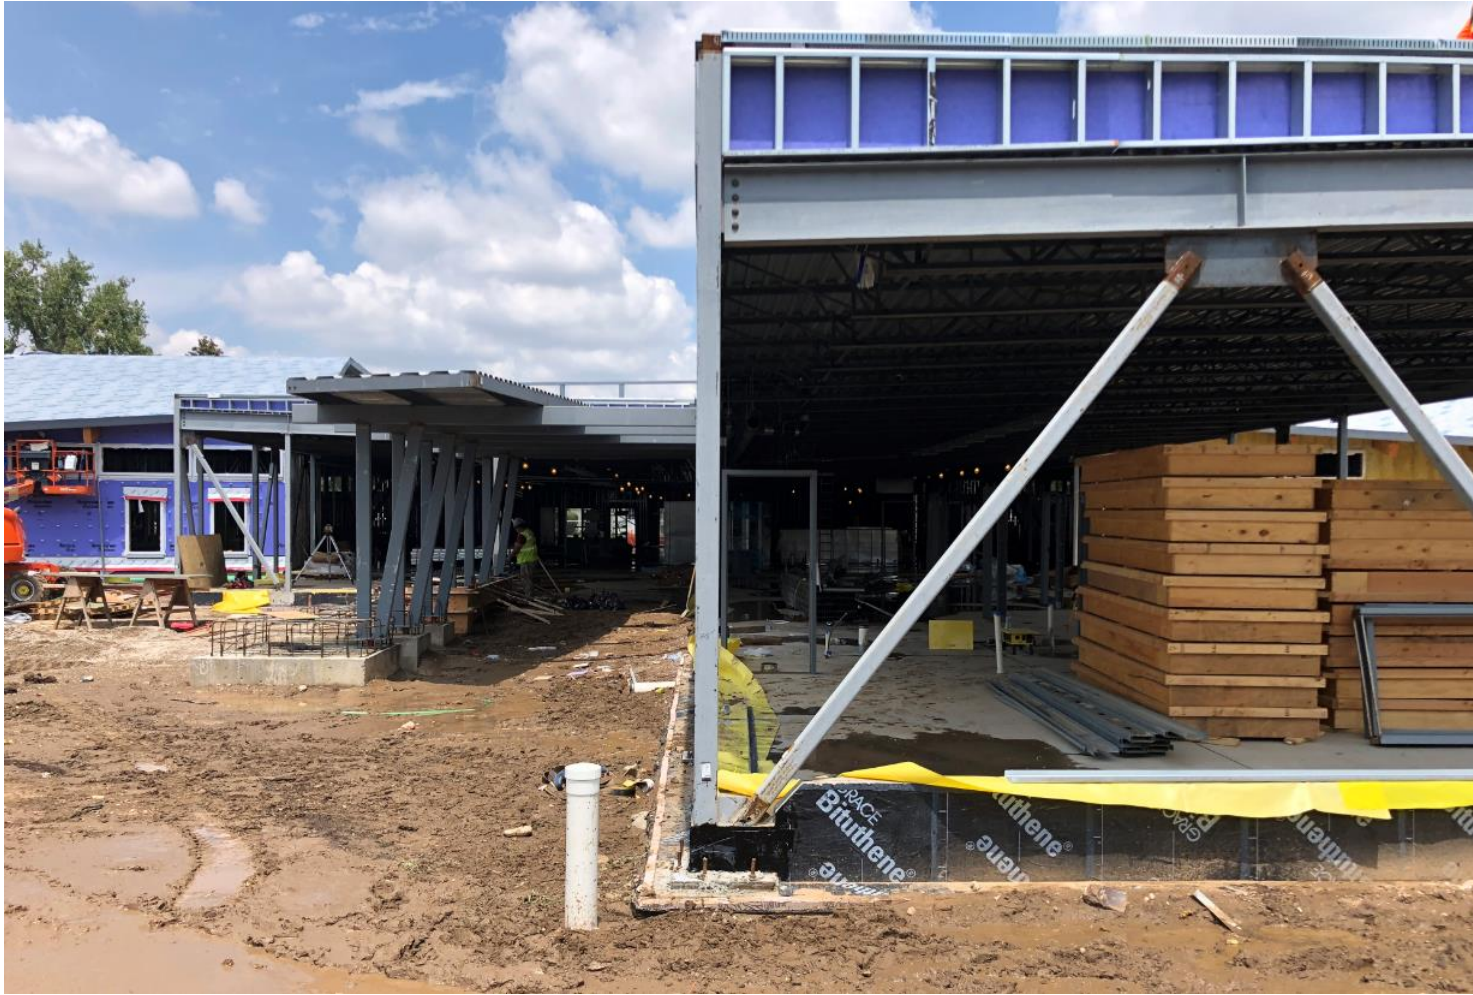
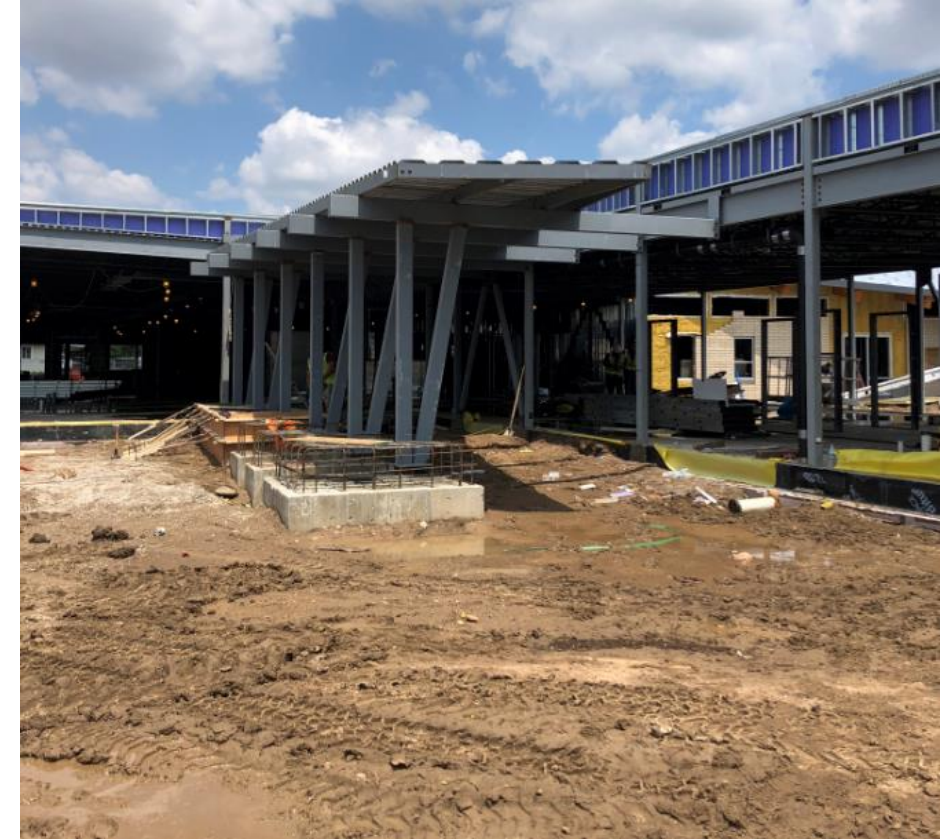
Main entrance area.

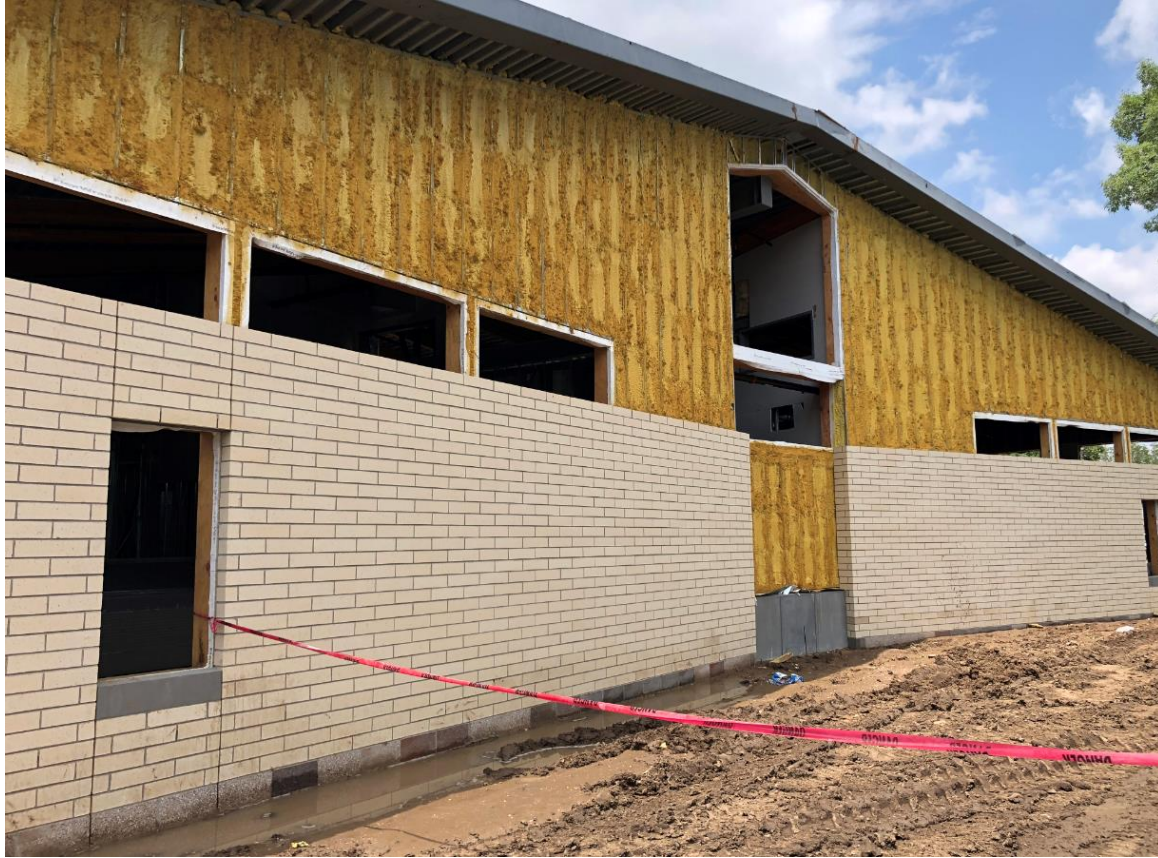
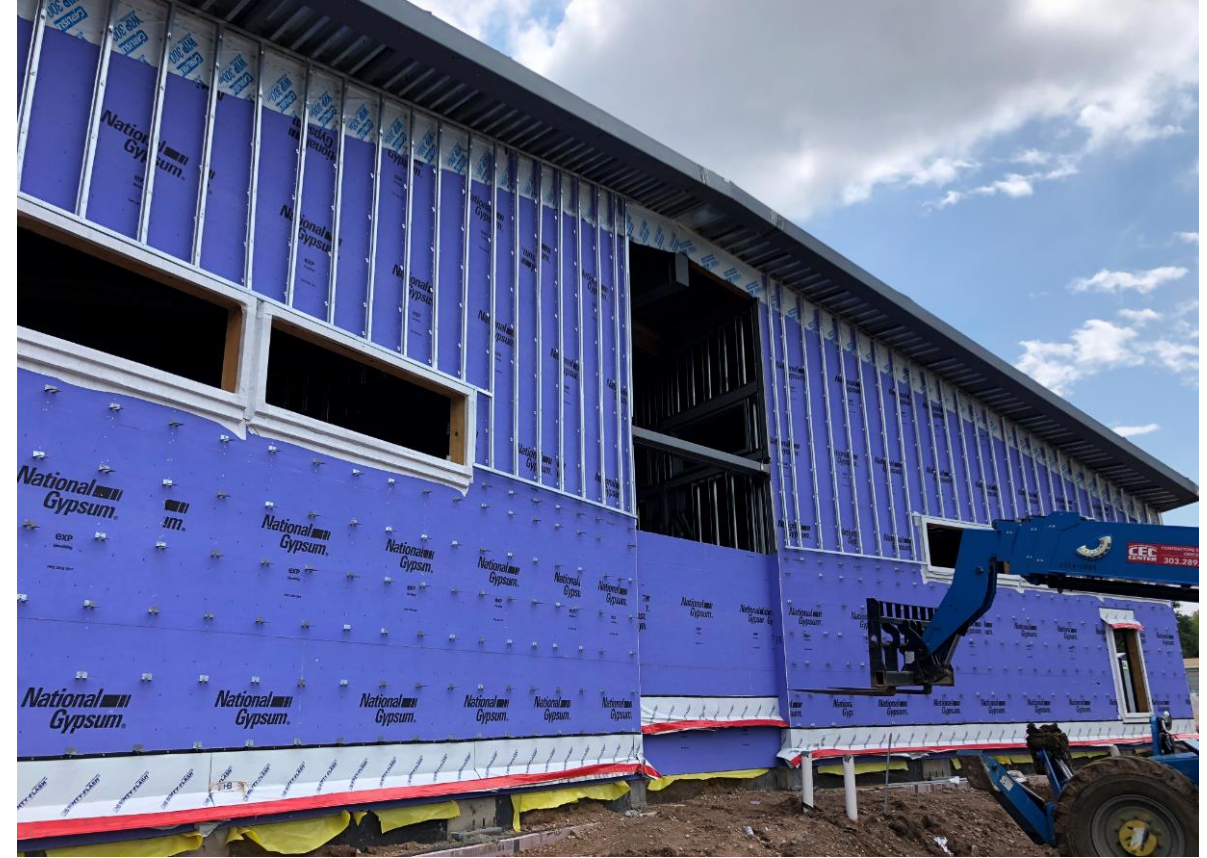
East side brick & West side framing.

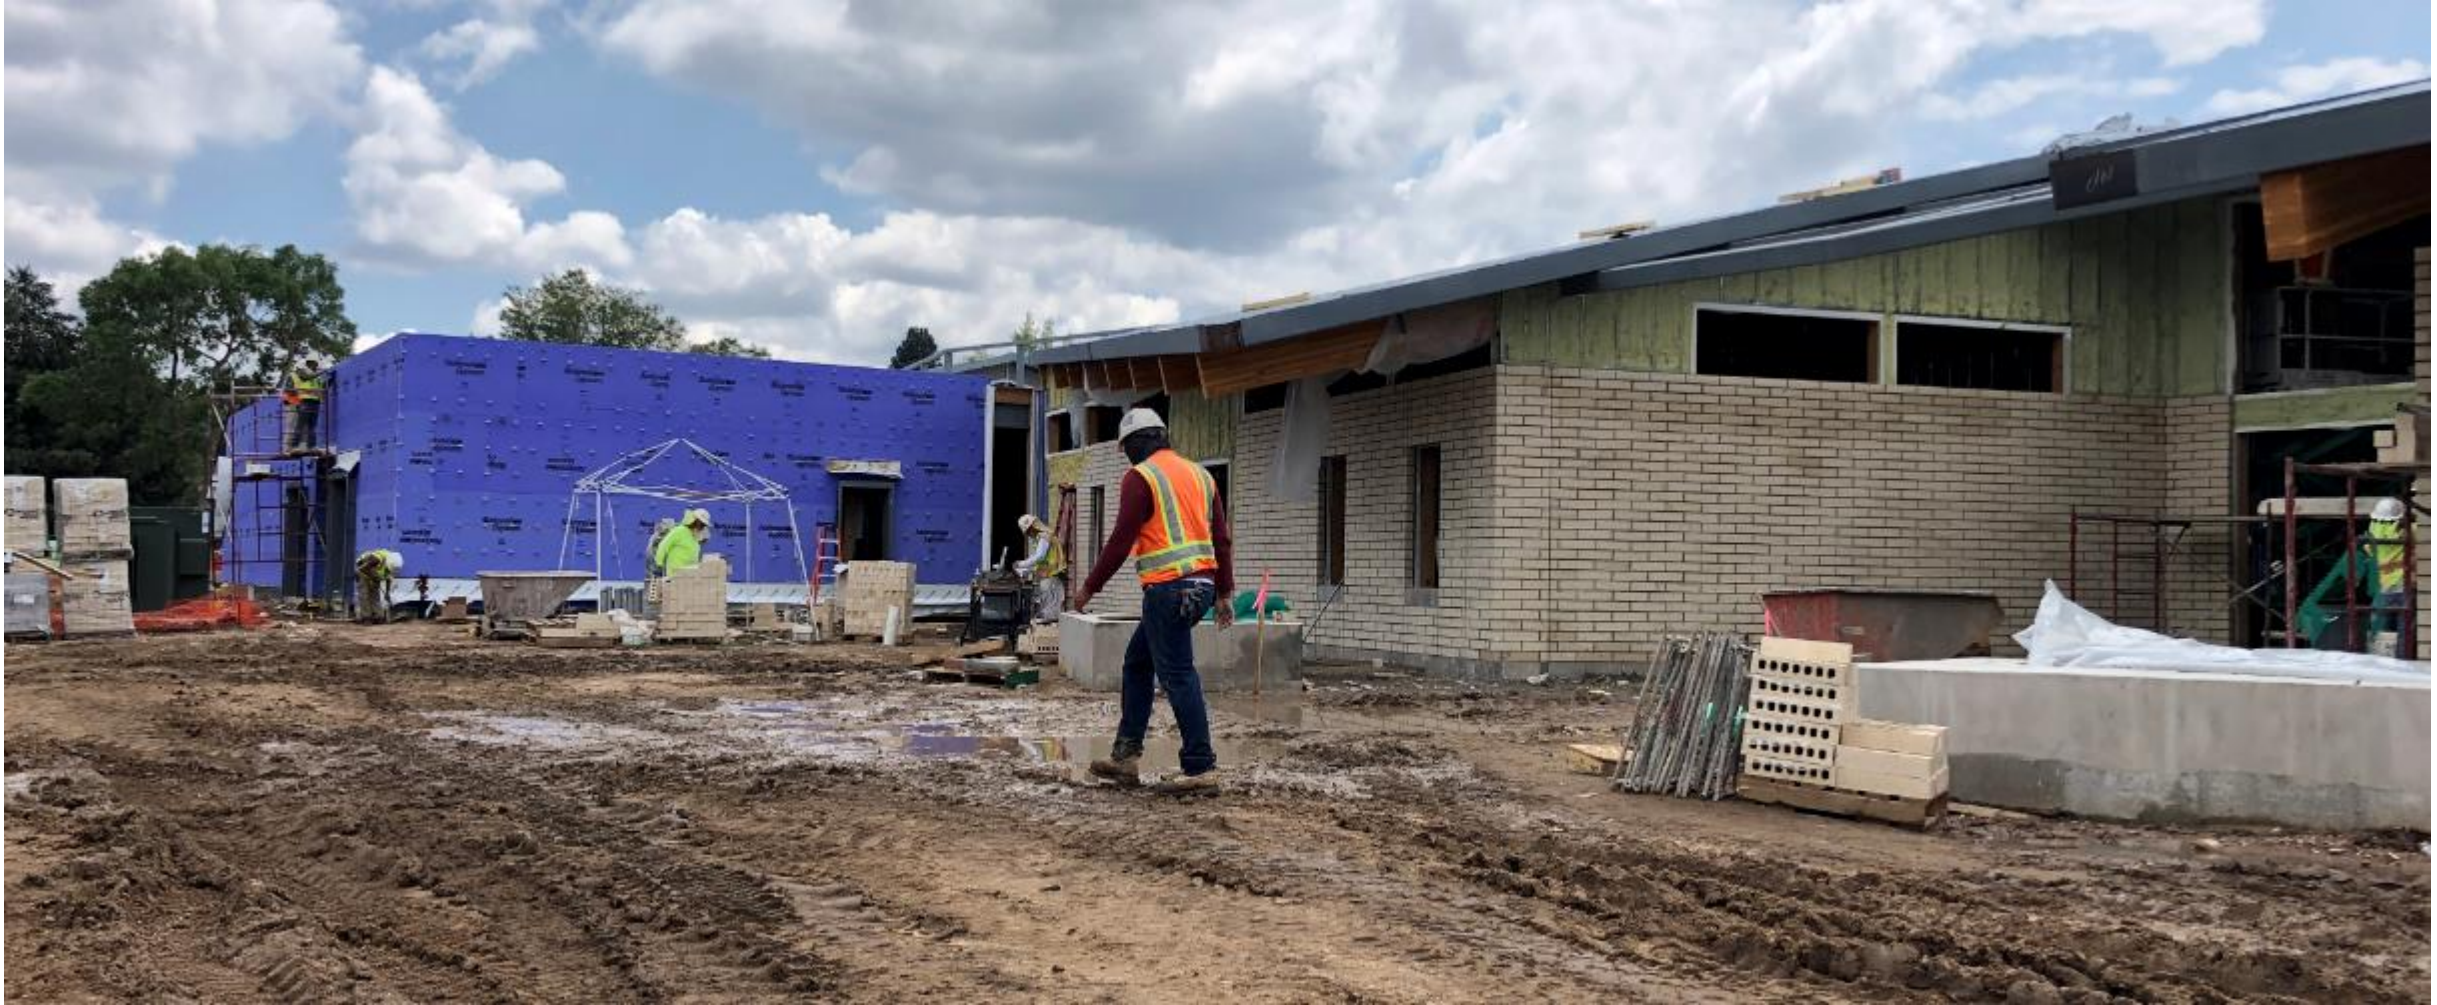
Exterior brick & brick ties on North side.

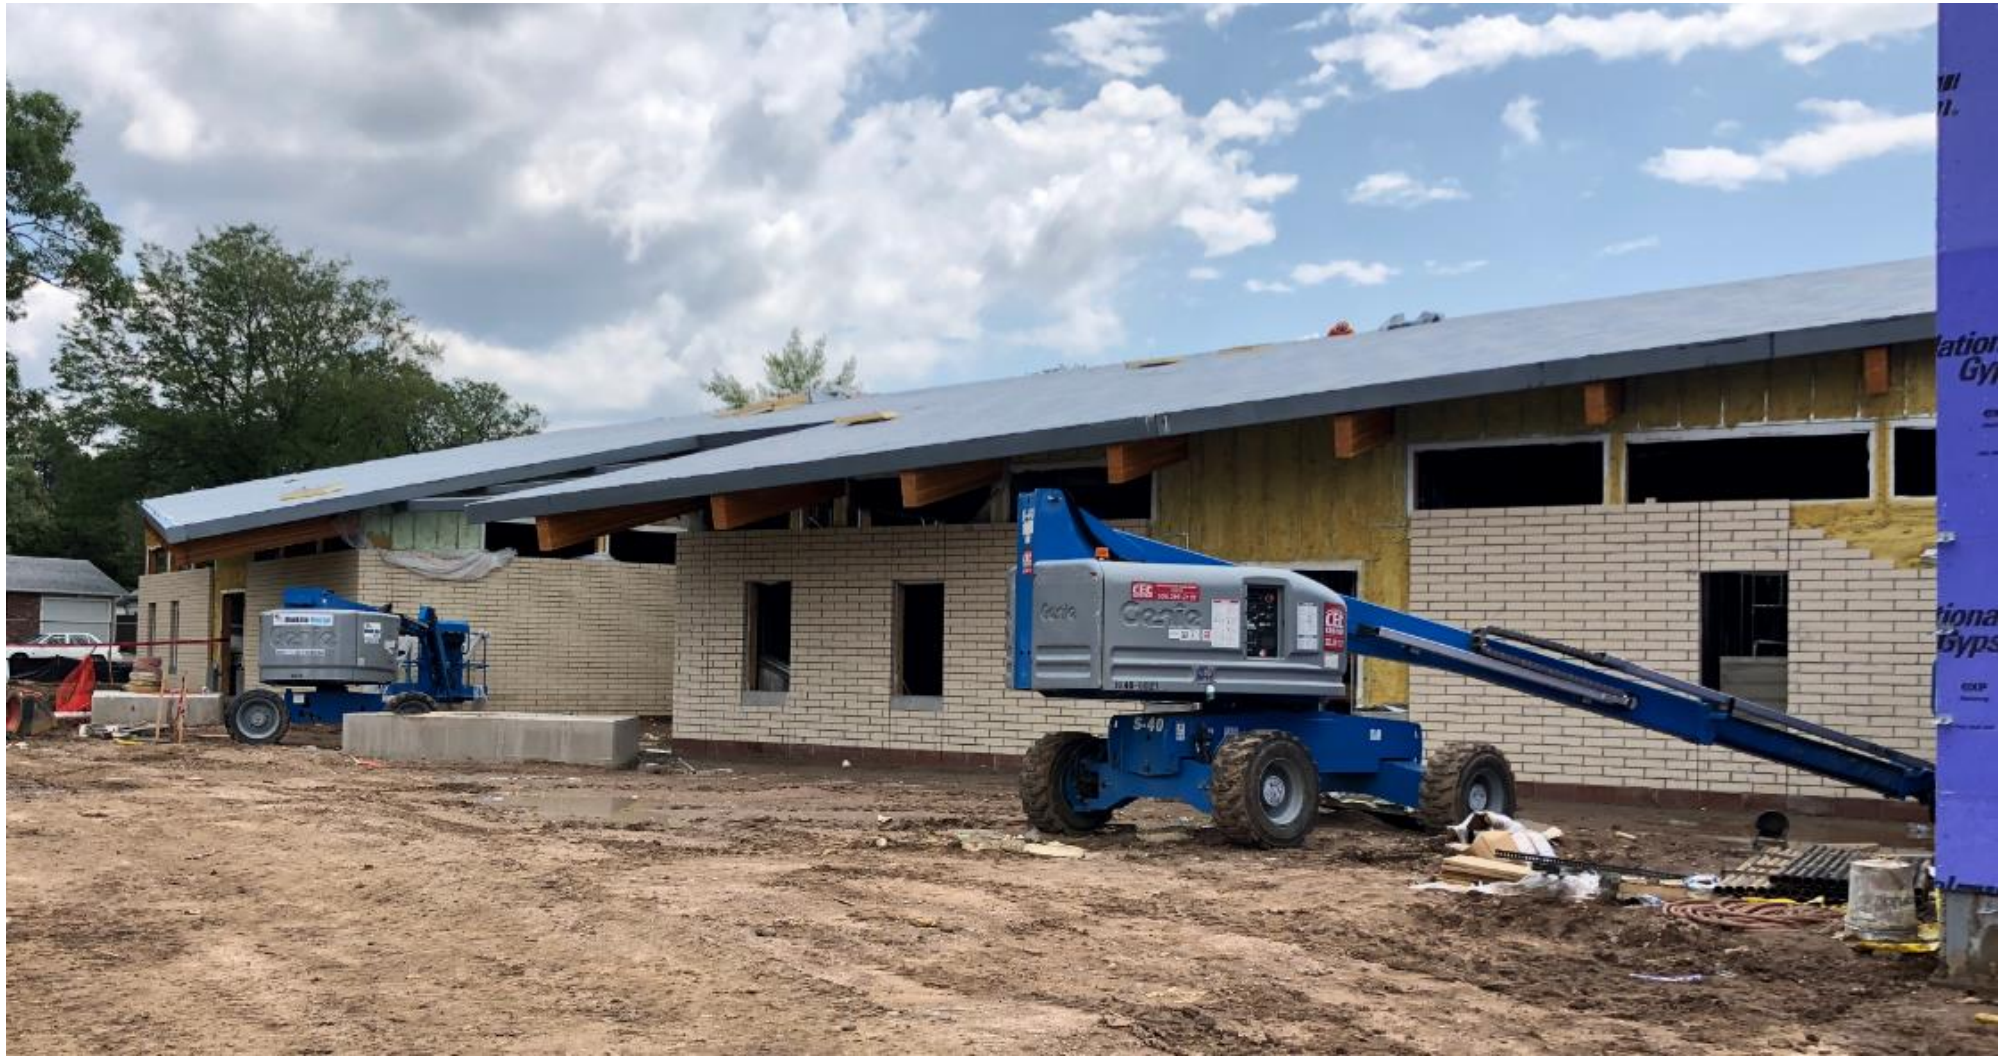
Northeast exterior brick.

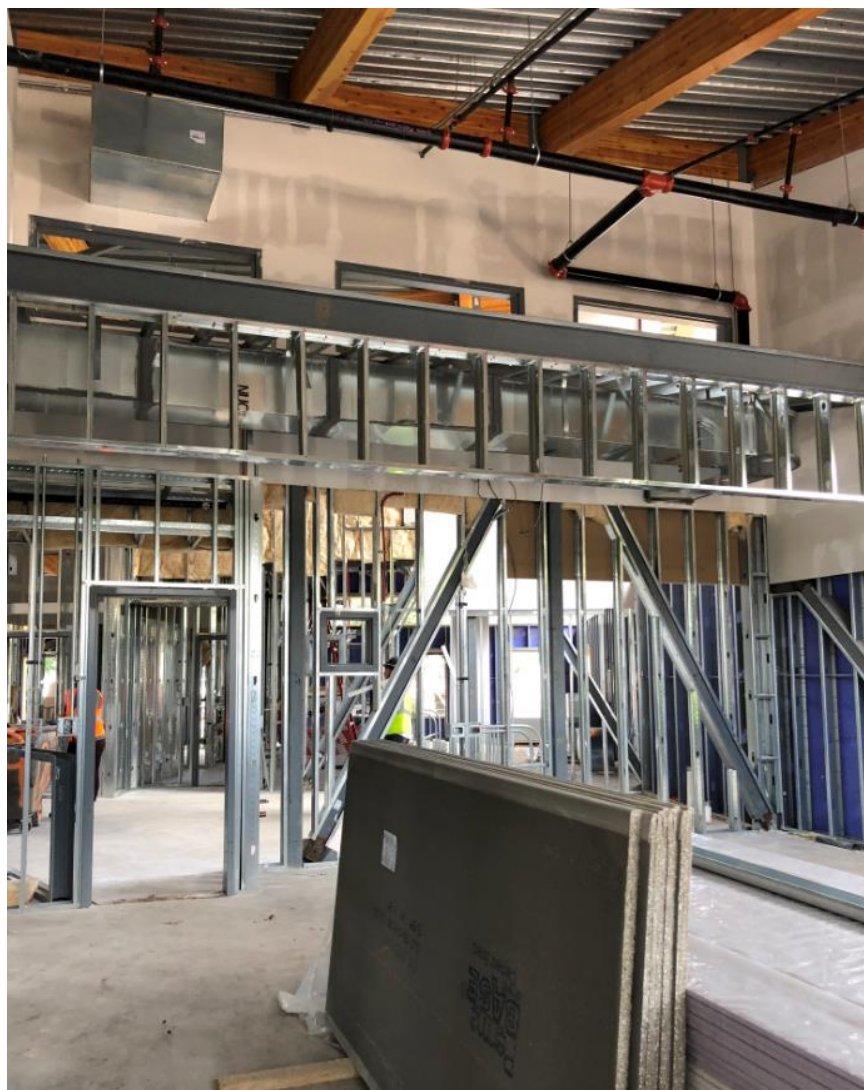
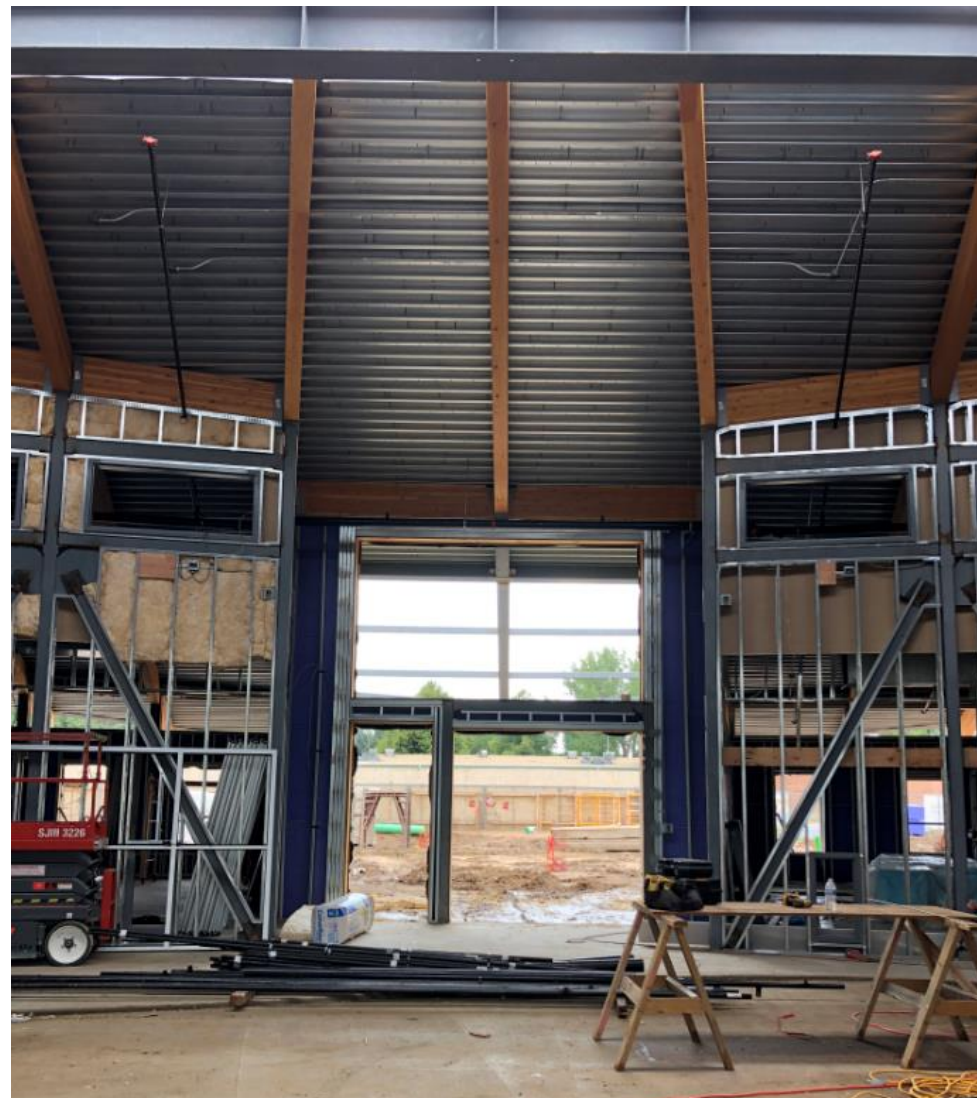
Classroom soffits (left) view of playground entrance (right).

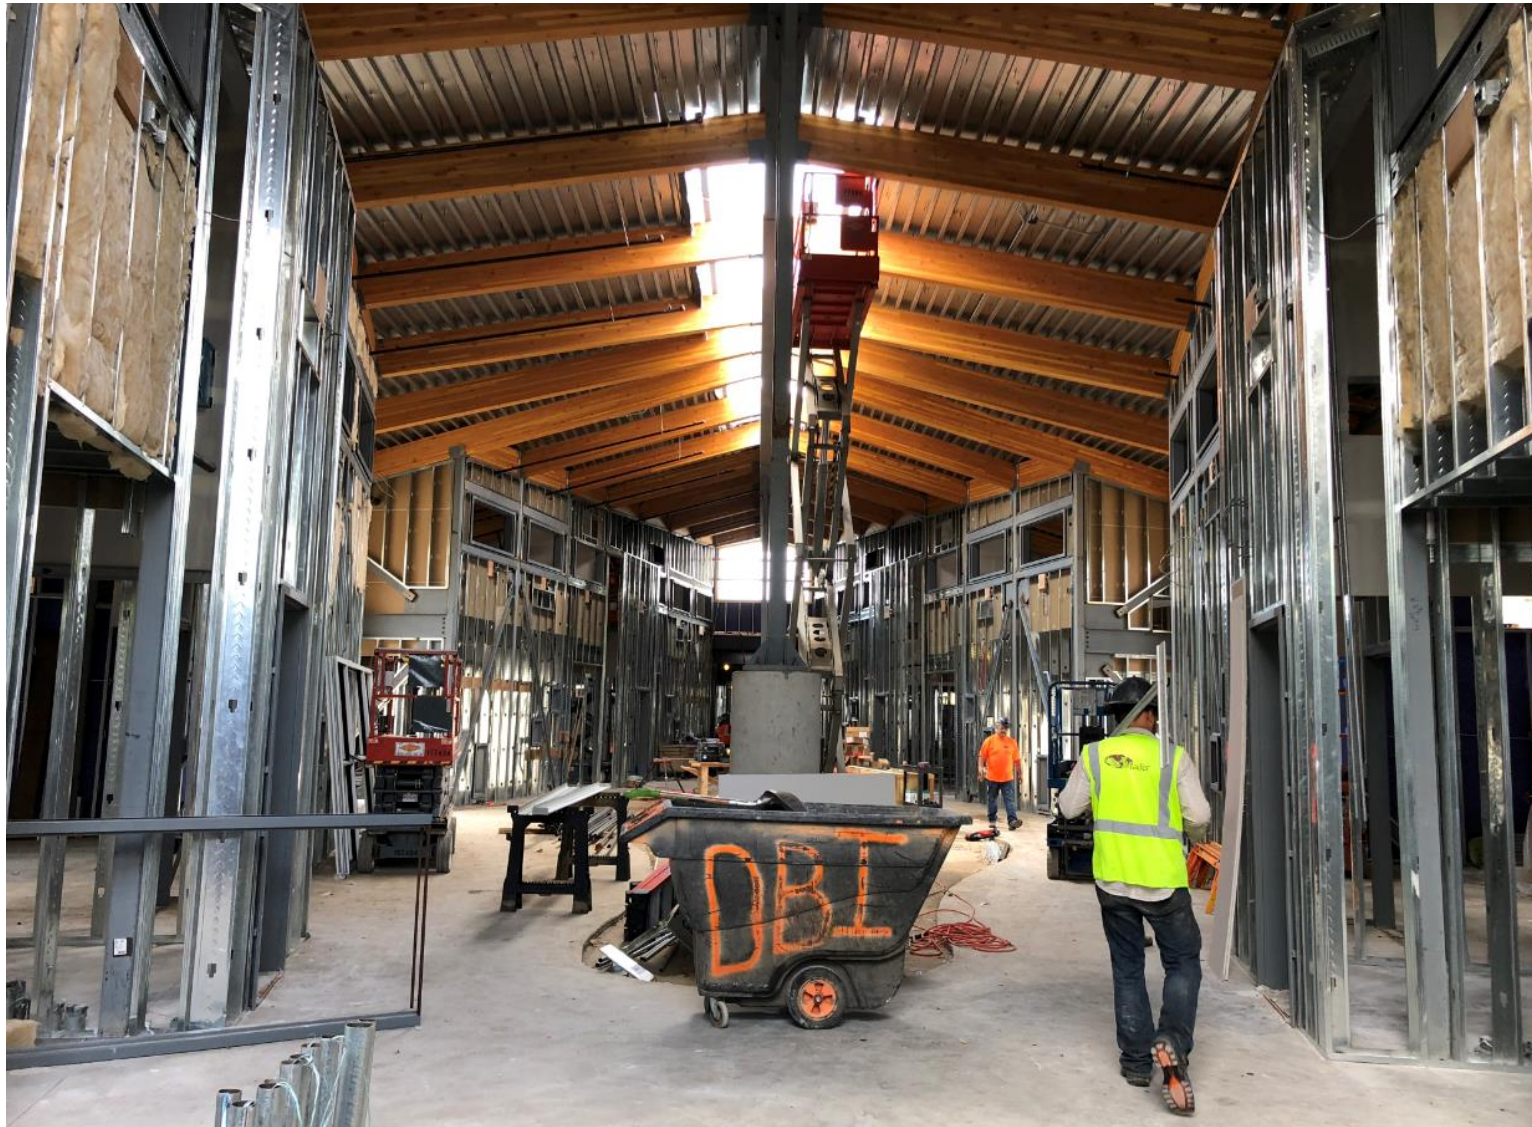
East wing with insulation installation.
